ROOF CONDITION SURVEY

For
Town of Sudbury
19 Sudbury Public Buildings
Sudbury, Massachusetts

February 3, 2012

RBA Project No. 201056.00

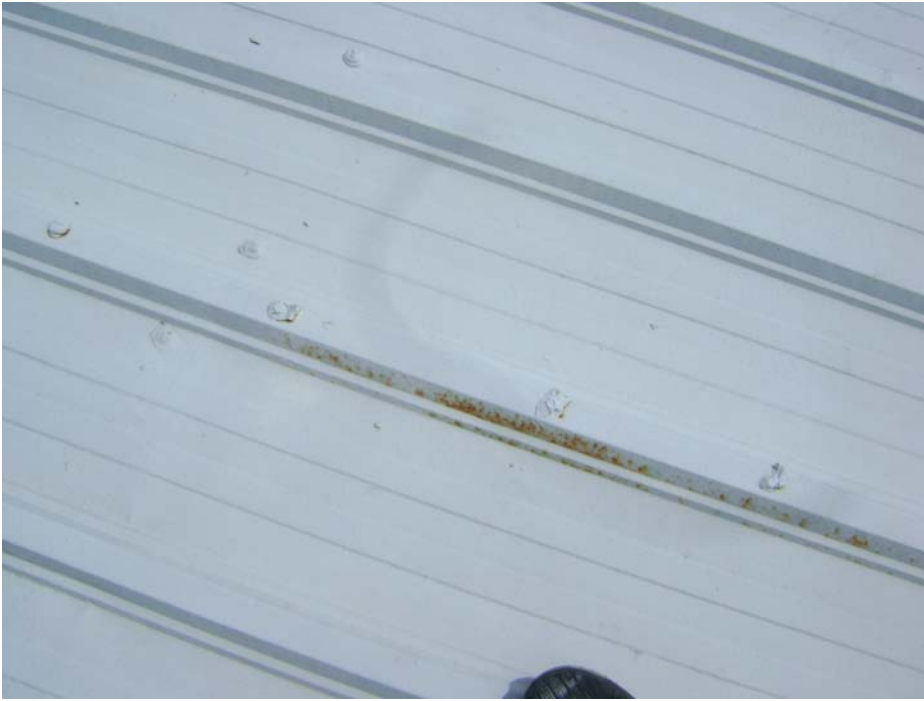
Photo No. 13

Description: Rust Penetrating Through Coating on Roof Area No. 4

2. Implement repairs to the steep-sloped metal roof (Roof Area No. 4 & 4A at 3,275 SF) in year **2014**. Repair work includes removing and replacing panel seam repair materials, reflashings rooftop penetrations, re-securing panel fasteners and installing new panel fasteners as needed, remove membrane system labeled Roof Area No. 4A, and installation of a fluid applied waterproofing membrane complete with a manufacturer's warranty (minimum 10-years).

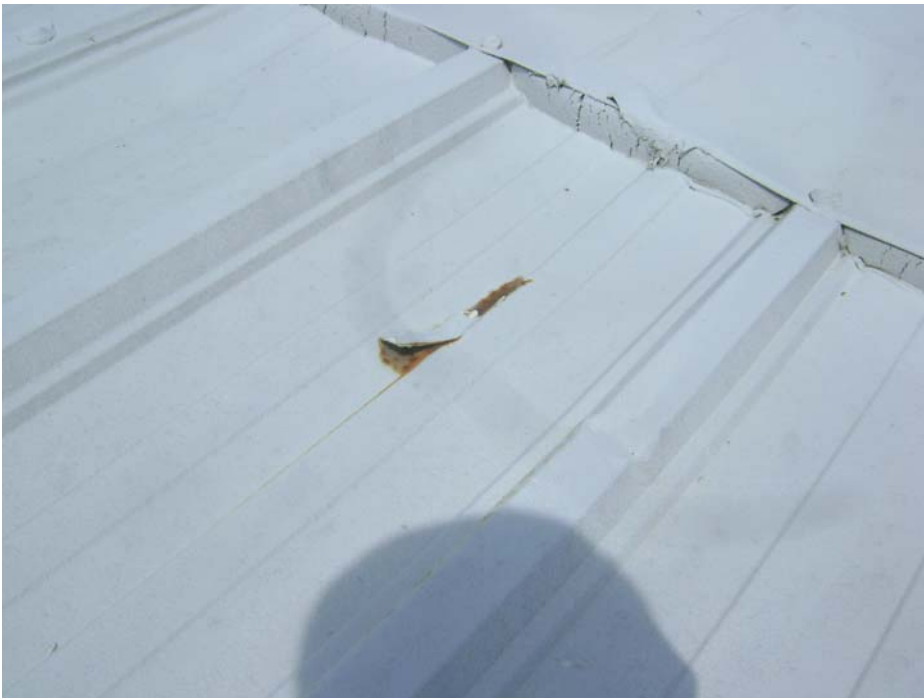
Photo No. 14

Description: Deteriorated Metal Roof Panel & Open Seam at Roof Area No. 4 & 4A Intersection

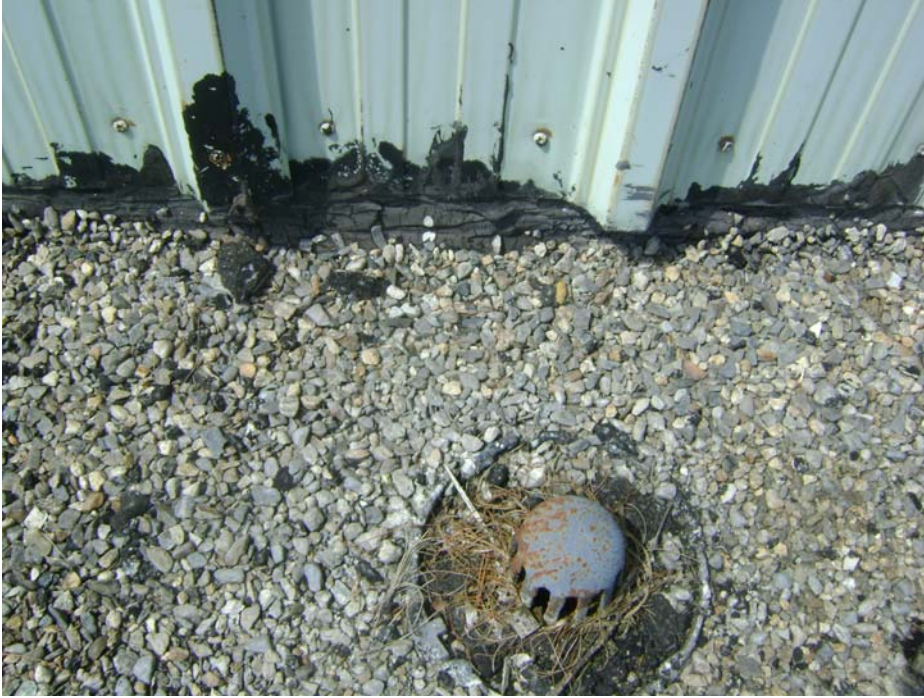
Photo No. 15

Description: Flashing Cement Cracking on Roof Area No. 3

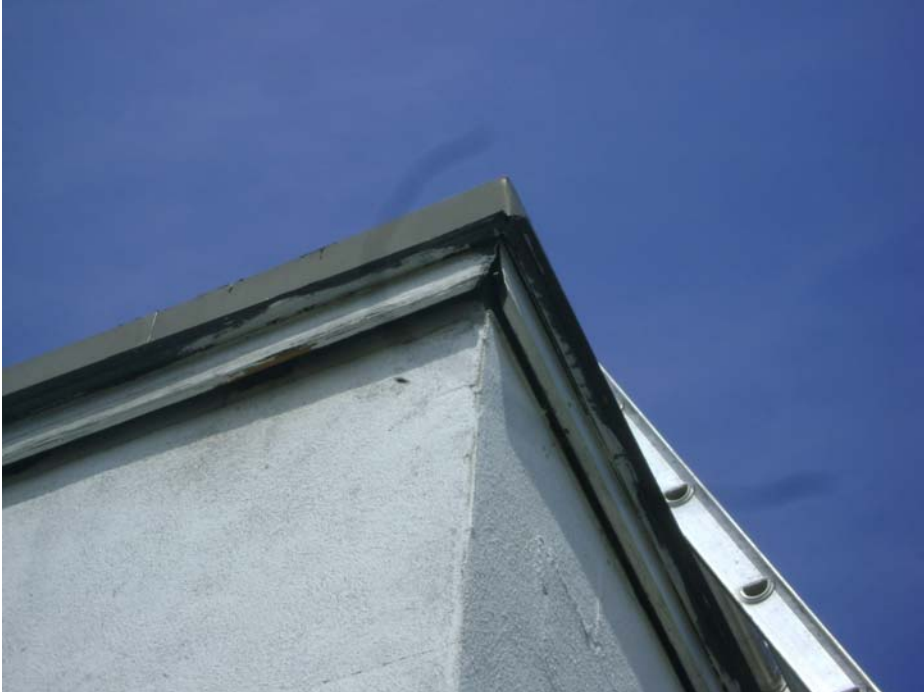
Photo No. 16

Description: Deteriorated Wood Fascia on Roof Area No. 3

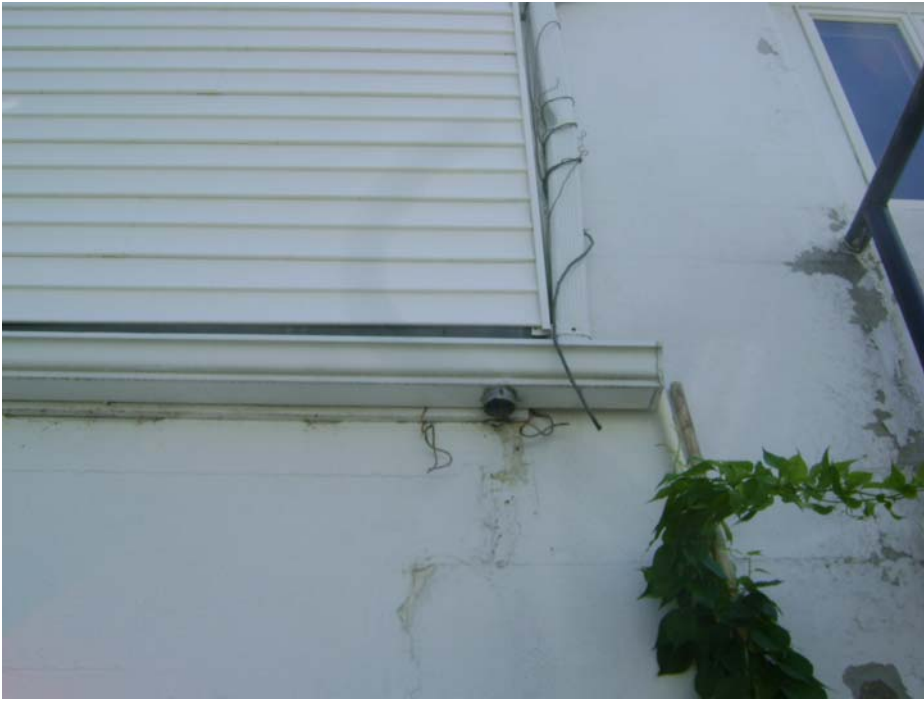
Photo No. 19

Description: Missing Downspout & Cracked Mortar Joints

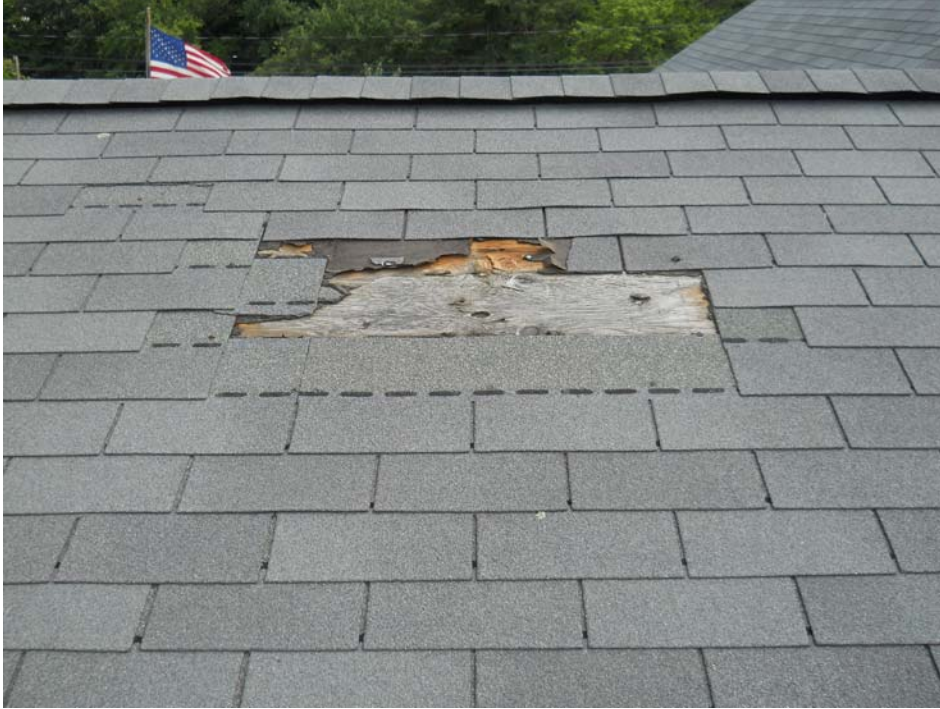
Photo No. 03

Description: Asphalt shingles have been missing for years – note the weathered plywood sheathing.

1. Implement repairs to the steep-sloped shingle roof (Roof Area Nos. 1 & 2 at 4,135 SF) in year **2010**. Repair work includes replacing deteriorated wood roof decking and missing shingles; seal voids in joints of the copper step flashing.
2. Replace the steep-sloped shingle roof (Roof Area Nos. 1 & 2 at 4,135 SF) in year **2018**. Replacement includes installation of a new heavy duty architectural asphalt shingle system complete with felt underlayment, ice and water barrier membrane, ventilation improvements, gutters and downspouts, and a roofing manufacturer's material warranty (minimum 40-year time frame).

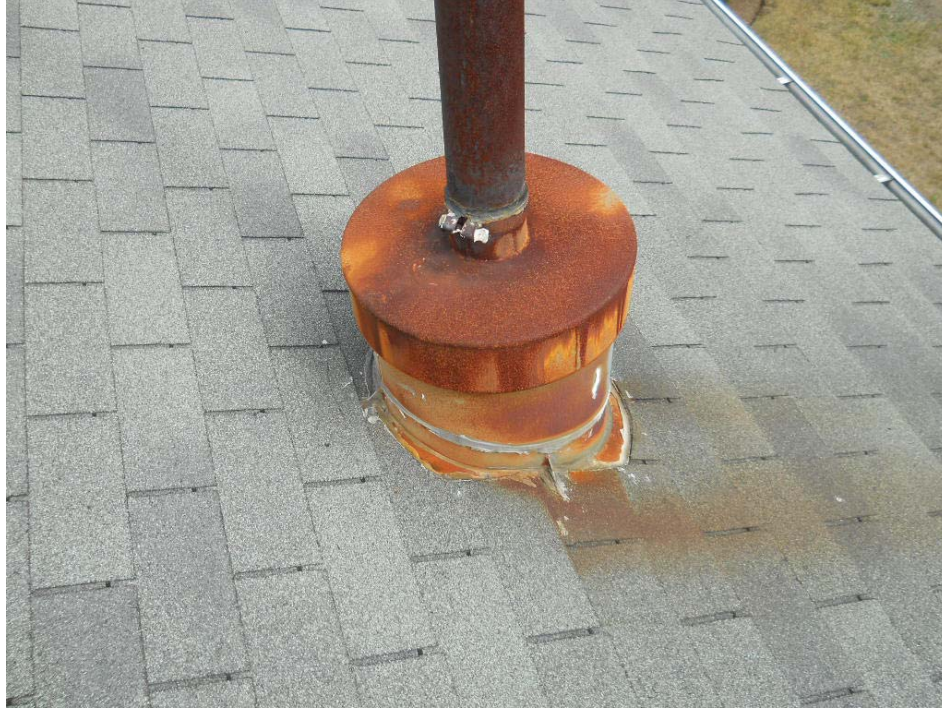
Photo No. 03

Description:
Generator exhaust stack is the apparent source of at least one leak.

1. Implement repairs to the steep-sloped shingle roof (Roof Area Nos. 1-3 at 10,160 SF) in year **2010**. Repair work includes replacing hot pipe vent assembly and flashing accordingly.
2. Replace the steep-sloped shingle roof (Roof Area Nos. 1-3 at 10,160 SF) in year **2015**. Replacement includes installation of a new heavy duty architectural asphalt shingle system complete with felt underlayment, ice and water barrier membrane, ventilation improvements, gutters and downspouts, and a roofing manufacturer's material warranty (minimum 40-year time frame).

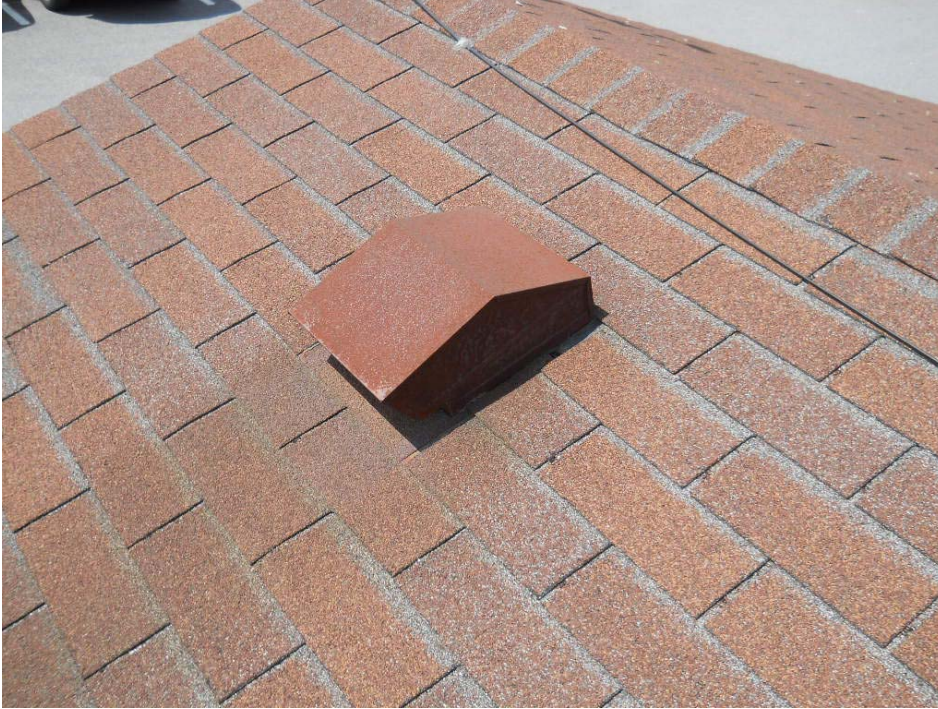
Photo No. 05

Description: Roof vents are rusted.

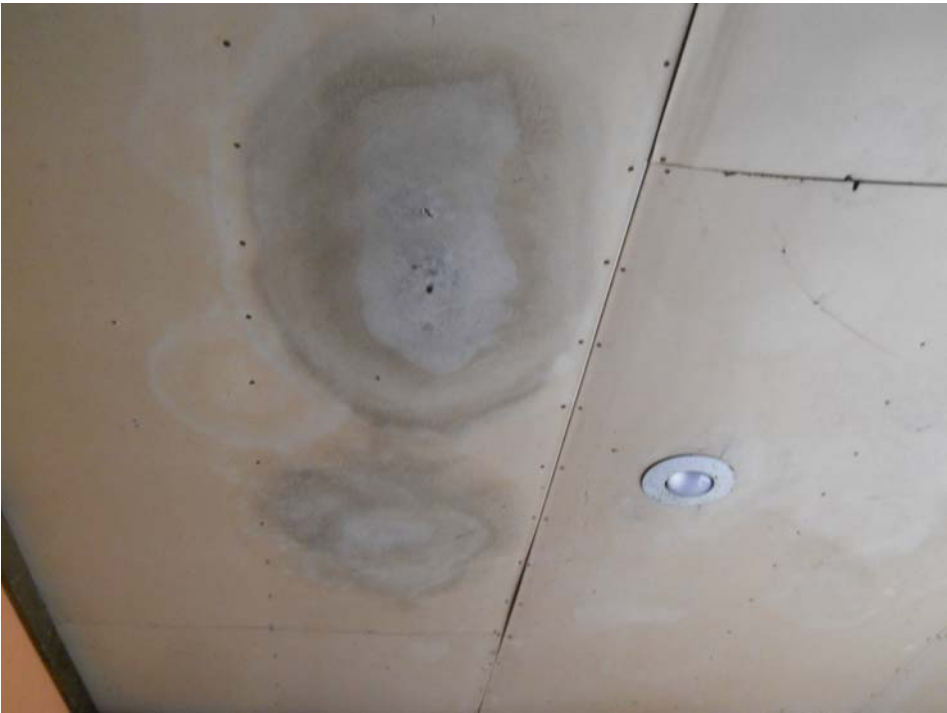
Photo No. 06

Description: Water Stained Ceiling

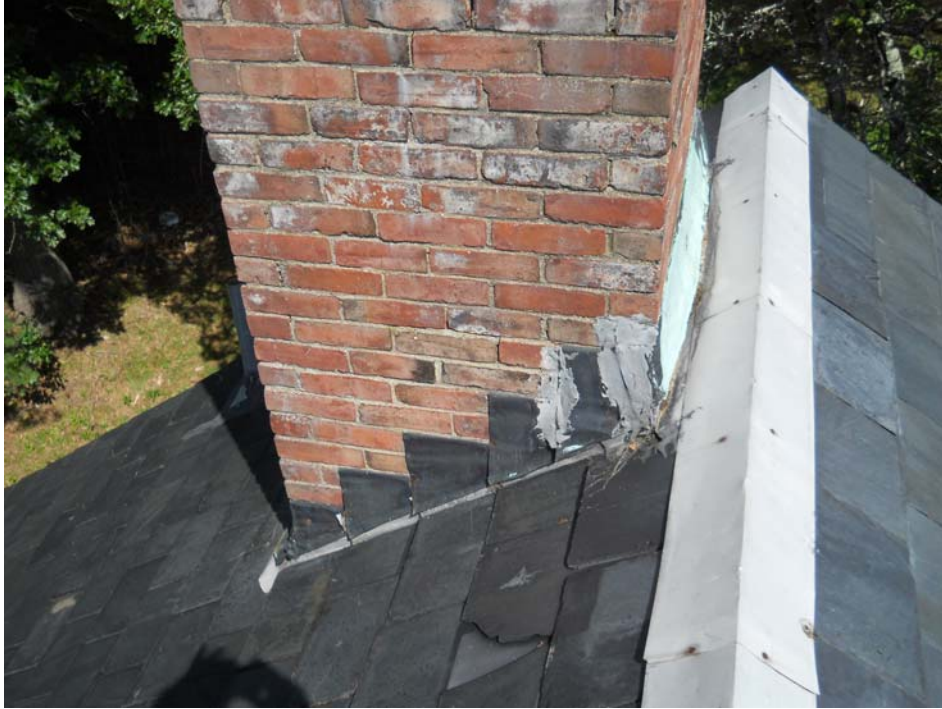
Photo No. 07

Description: Chimney Flashing in Poor Condition & Broken Slate

1. Implement repairs in **year 2011**. Repairs to include selective replacement of cracked/broken slate; replacement of ridge cap; replacement of cupola structure; repairs to step flashing at chimney.

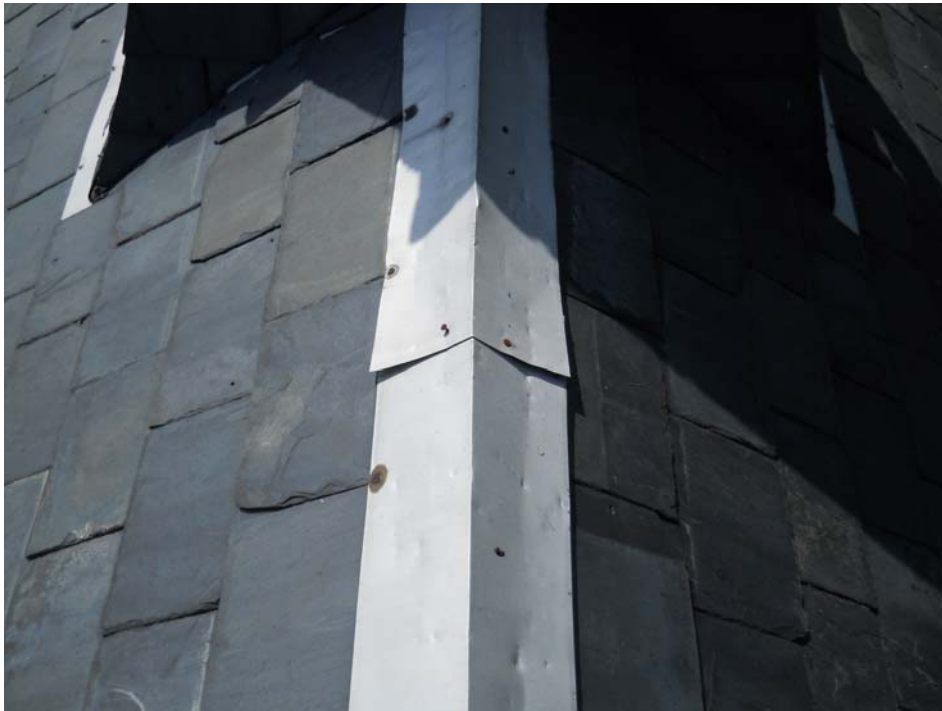
Photo No. 08

Description: Metal Ridge Cap in Poor Condition.

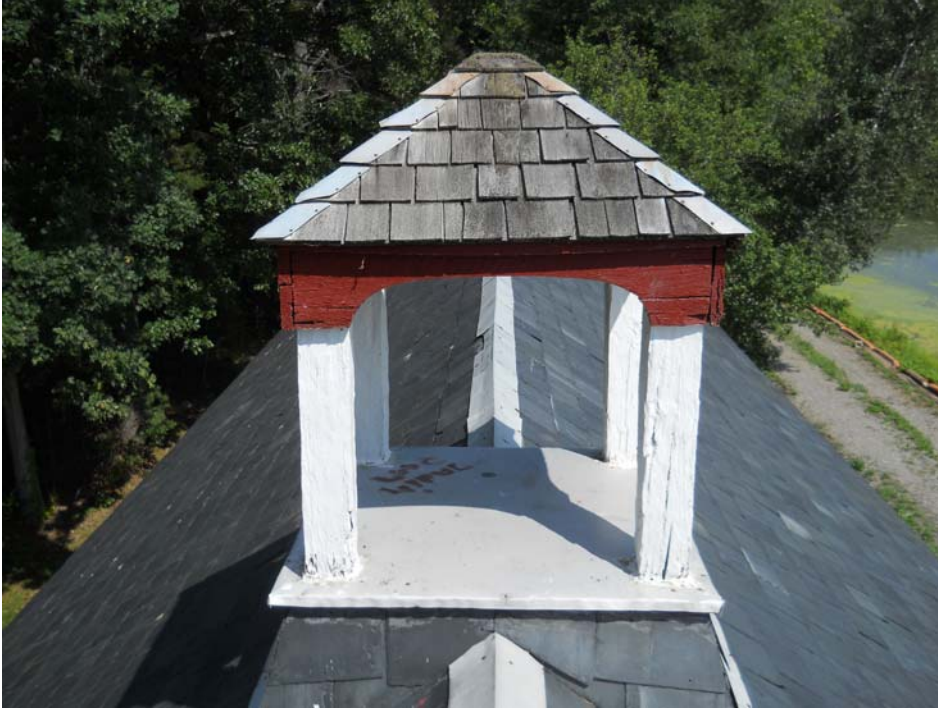
Photo No. 09

Description: Metal Ridge Cap in Poor Condition.

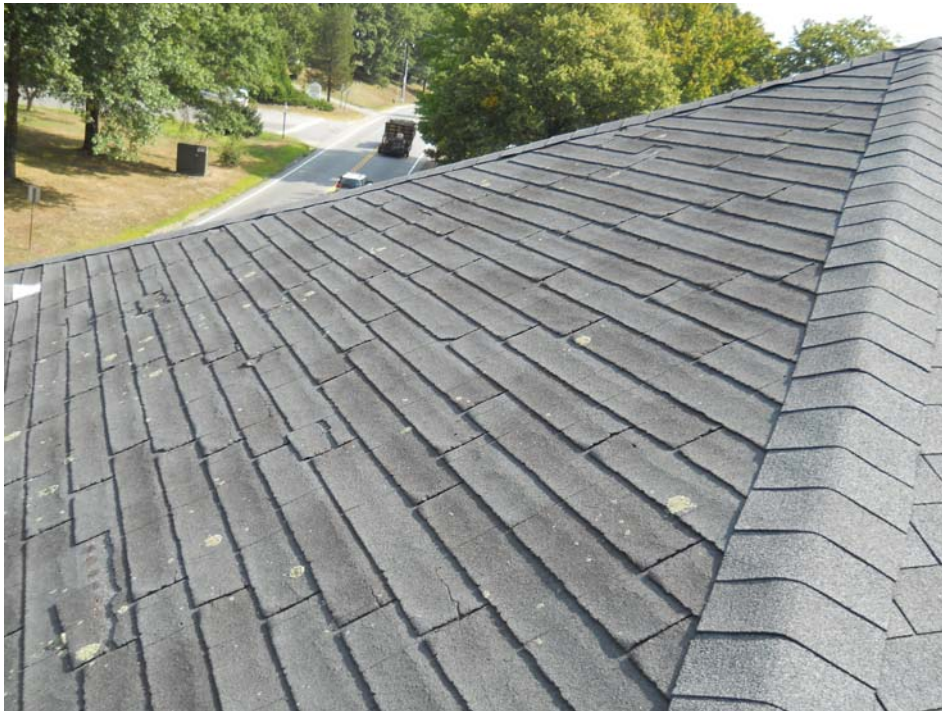
Photo No. 10

Description:
Deteriorated
Shingles on Roof
Area No. 2. This
roof leaks in the
vicinity of the two
chimneys.

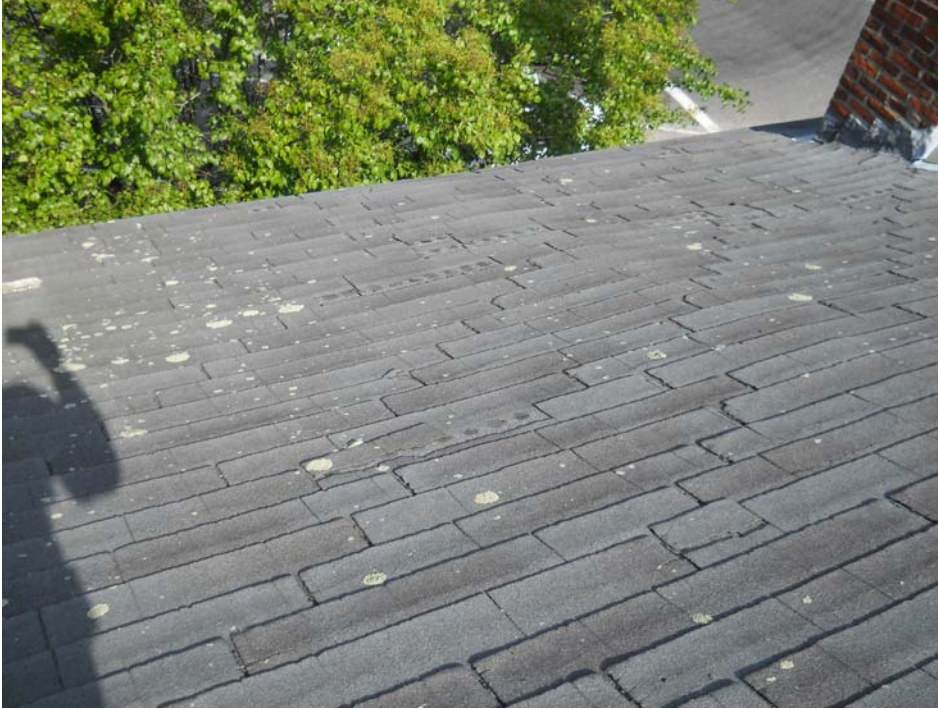
Photo No. 11

Description:
Deteriorated
Shingles on Roof
Area No. 2

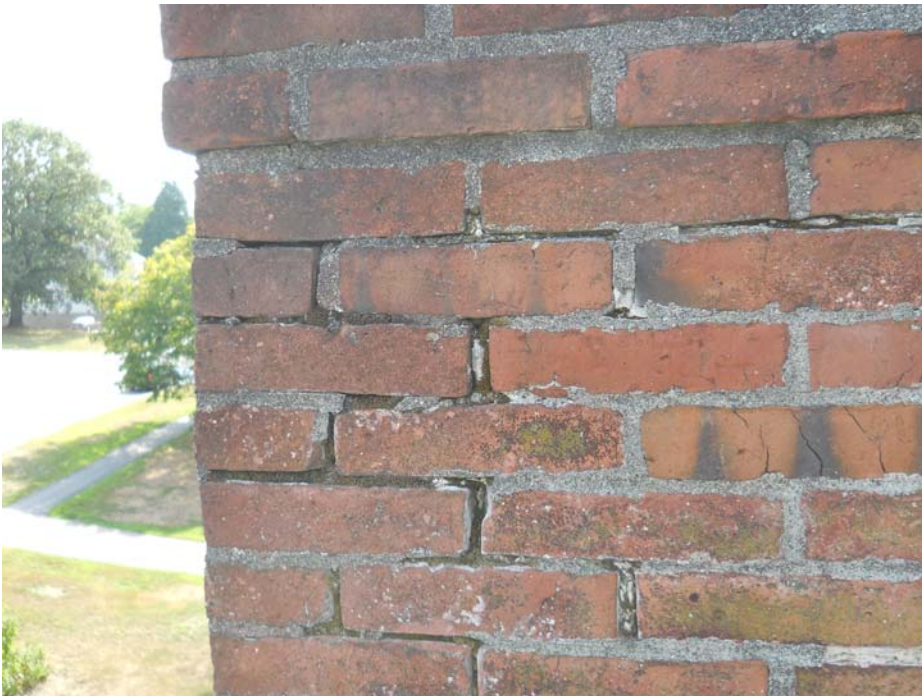
Photo No. 14

Description:
Deteriorated Mortar
in Chimney

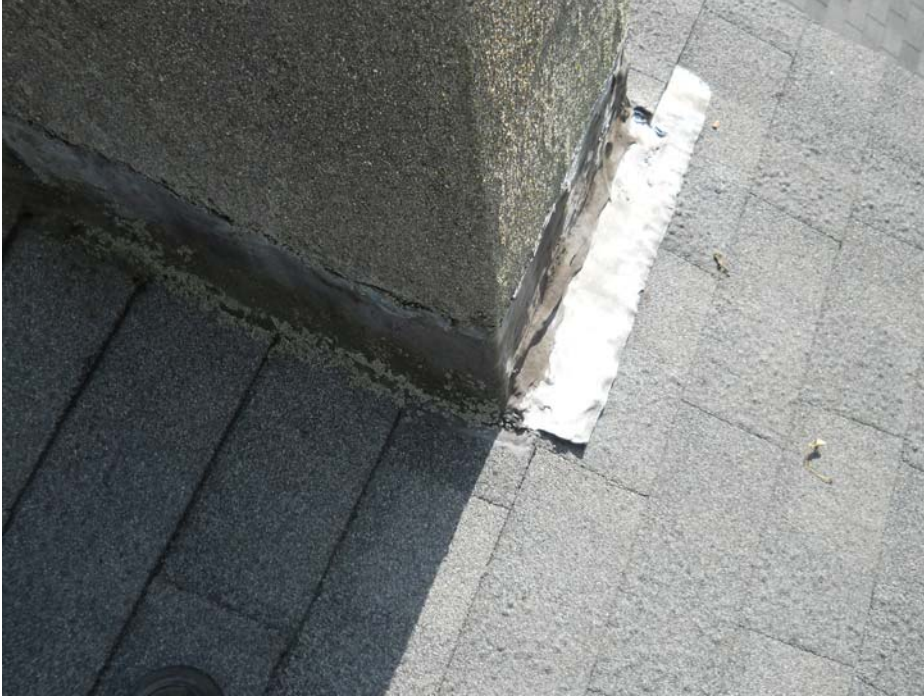
Photo No. 15

Description:
Improper Chimney
Flashing on Roof
Area No. 4

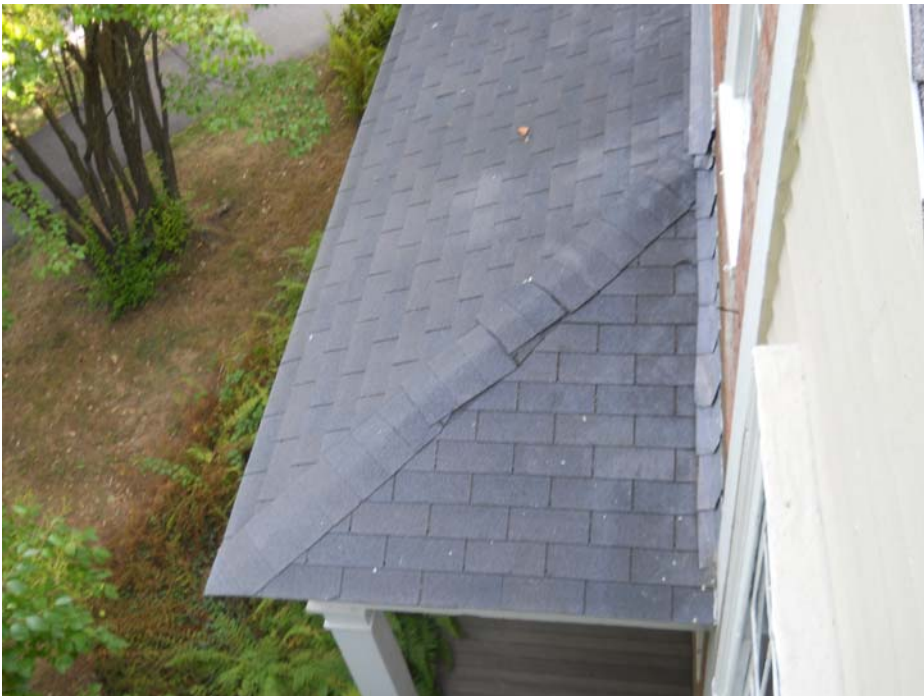
Photo No. 16

Description:
Loose Hip Cap on
Roof Area No. 1

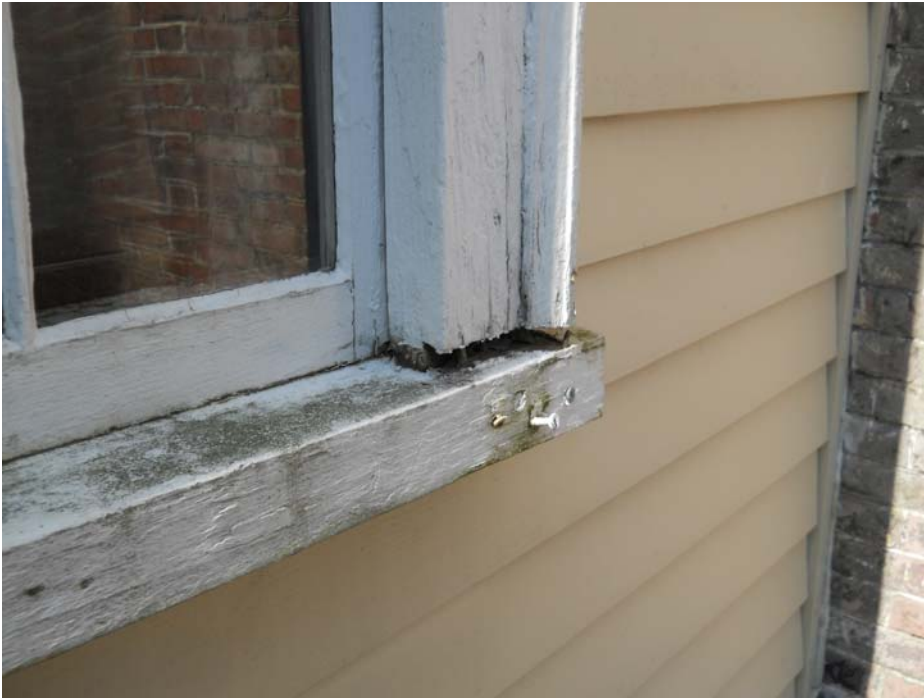
Photo No. 19

Description:
Deteriorated Window Frame

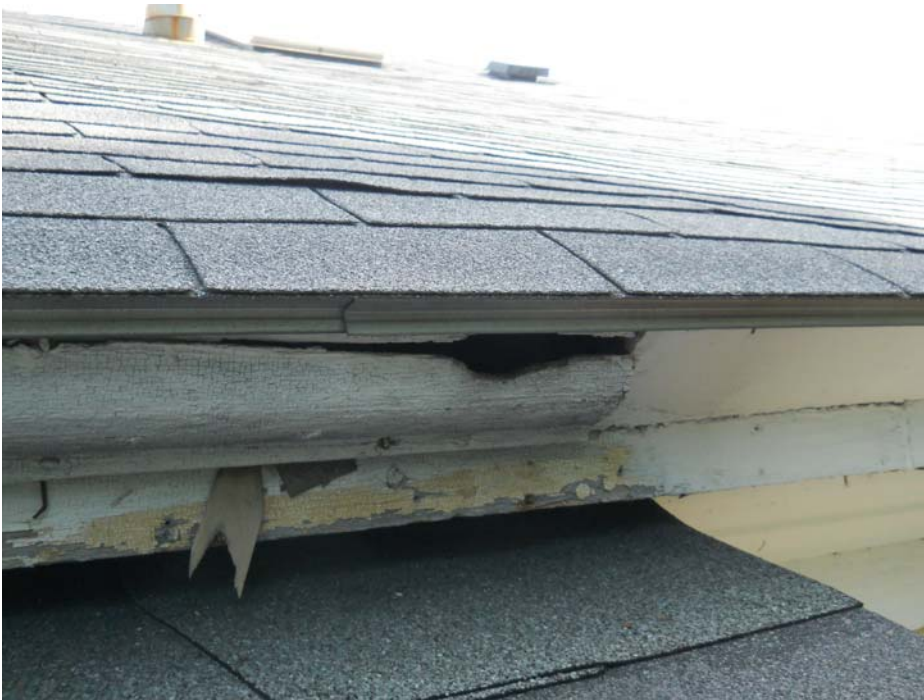
Photo No. 20

Description:
Deteriorated Wood Fascia On Roof Area No. 2

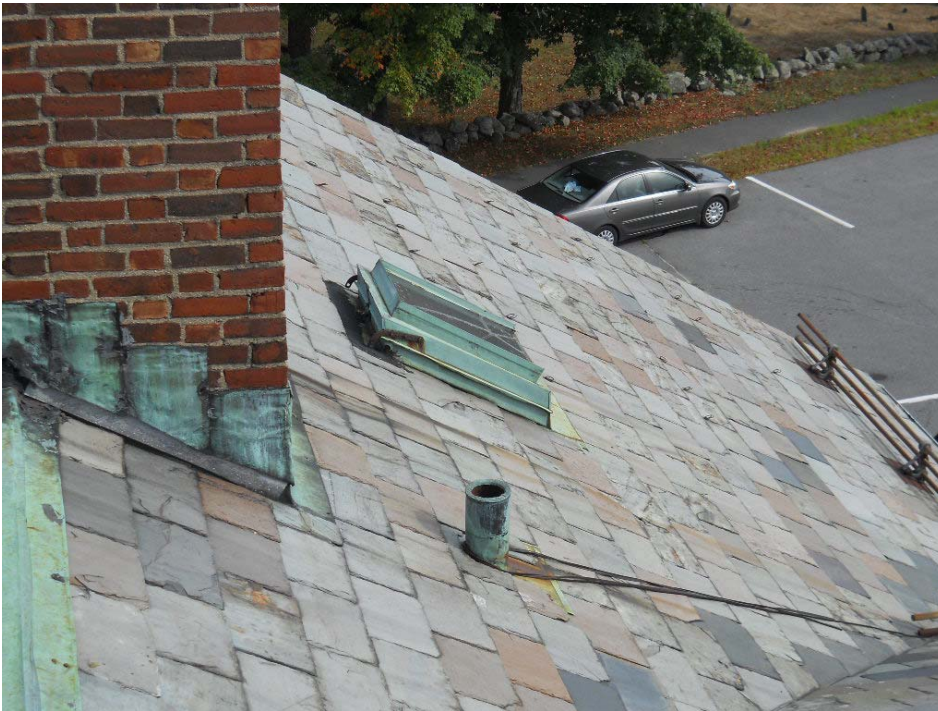
Photo No. 06

Description: Aged
skylight/access
hatch is the
apparent source of
leaks.

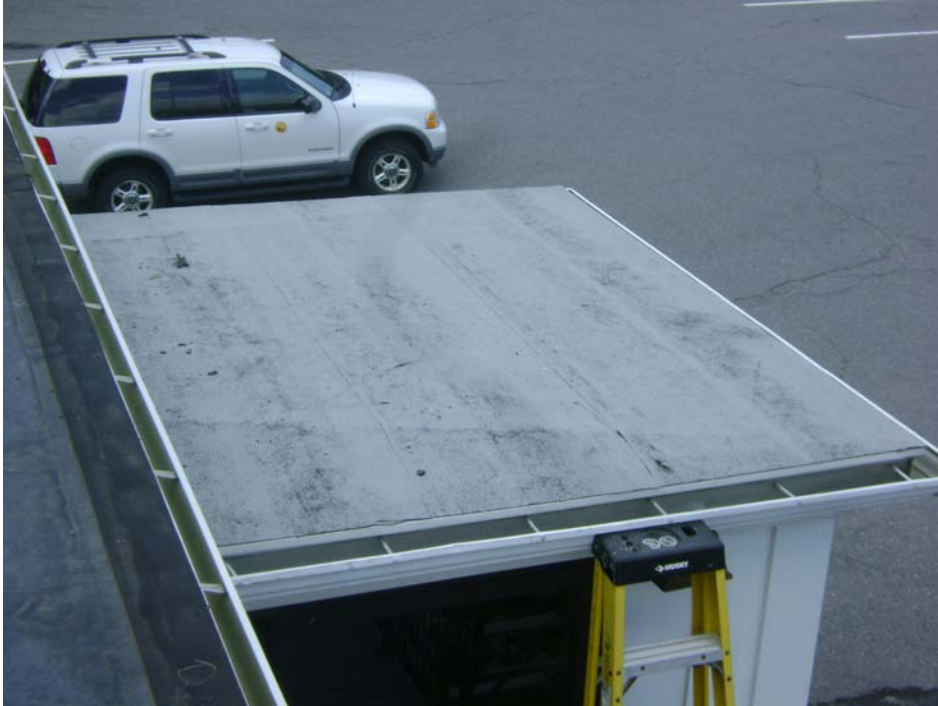
Photo No. 09

Description: Roll
roofing is worn.

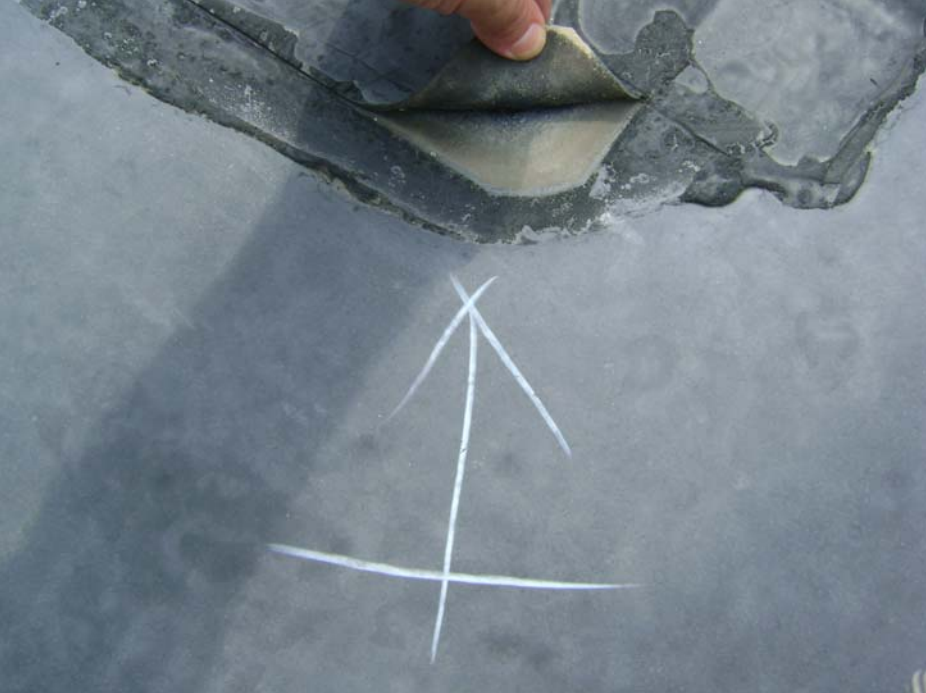
<p>Photo No. 14</p> <p>Location: Goodnow Library</p> <p>Description: Previously Marked Deficiency on Roof Area No. 3</p>

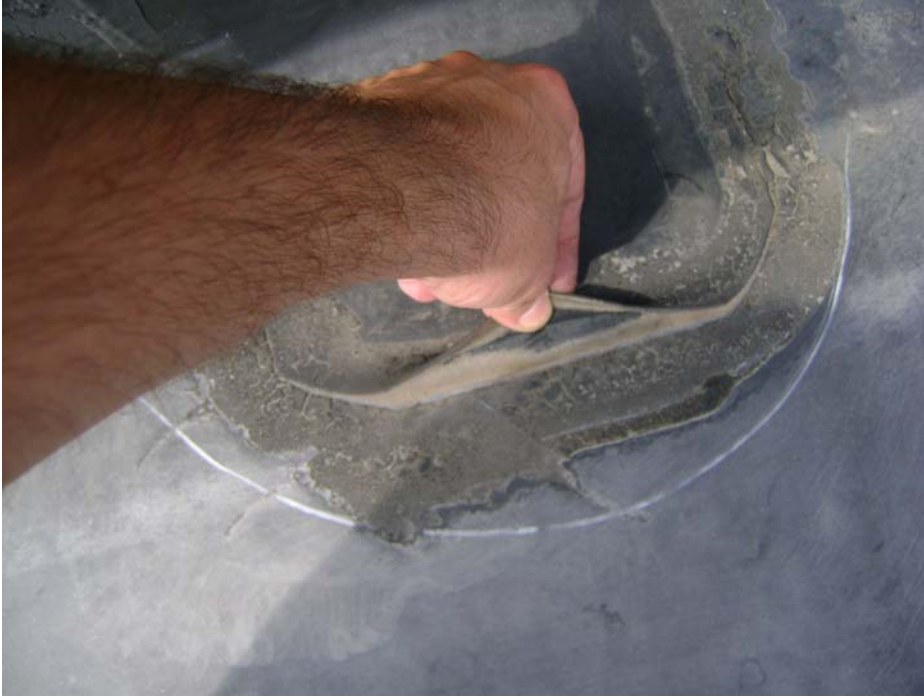
Photo No. 15

Description:
Previously Marked
Deficiency on Roof
Area No. 3

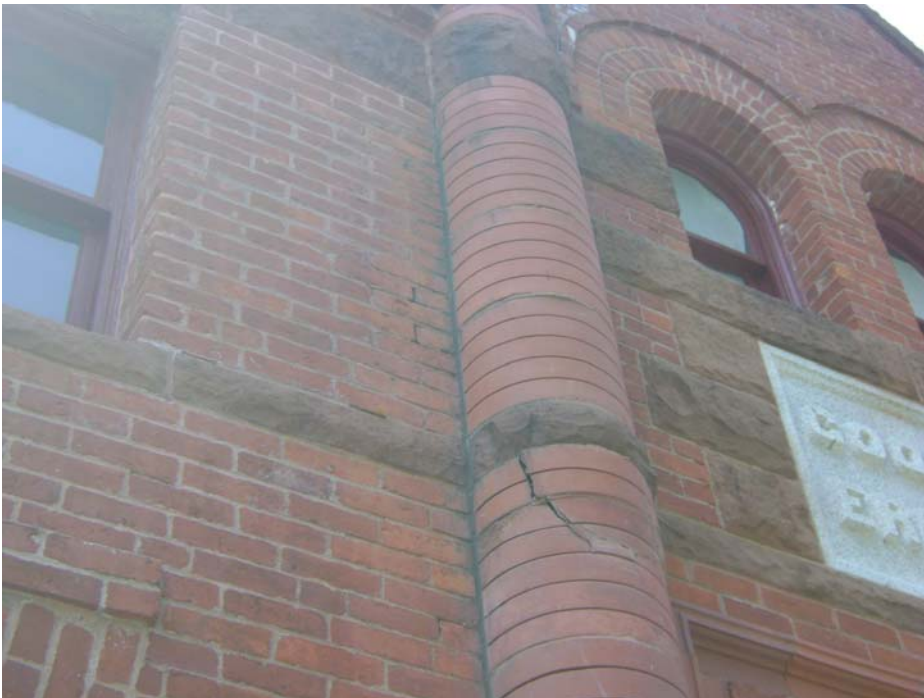
Photo No. 18

Description:
Deteriorated
Masonry Column

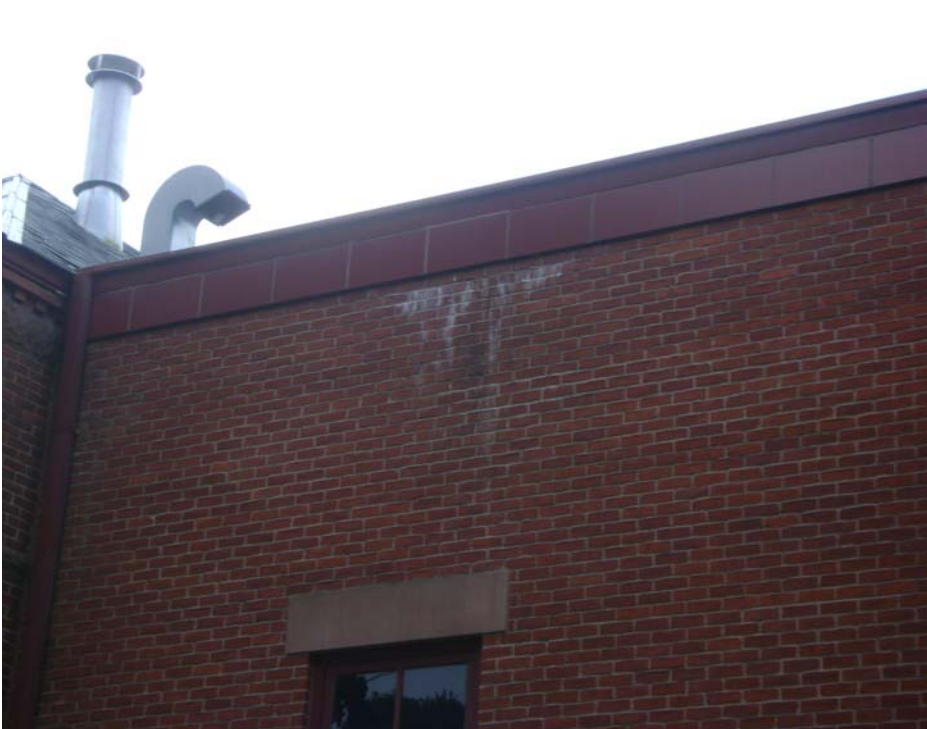
<p>Photo No. 19</p> <p>Location: Goodnow Library</p> <p>Description: Efflorescence Caused by Water Run-Off from Roof Area No. 2</p>

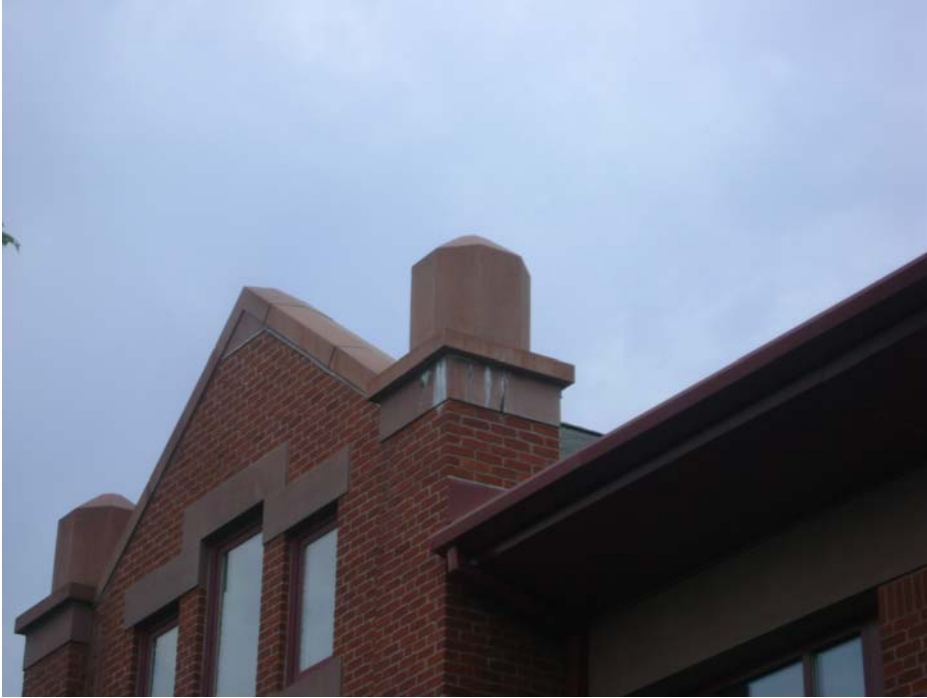
<p>Photo No. 20</p> <p>Location: Goodnow Library</p> <p>Description: Efflorescence & Cracked Masonry on Roof Area No. 4</p>

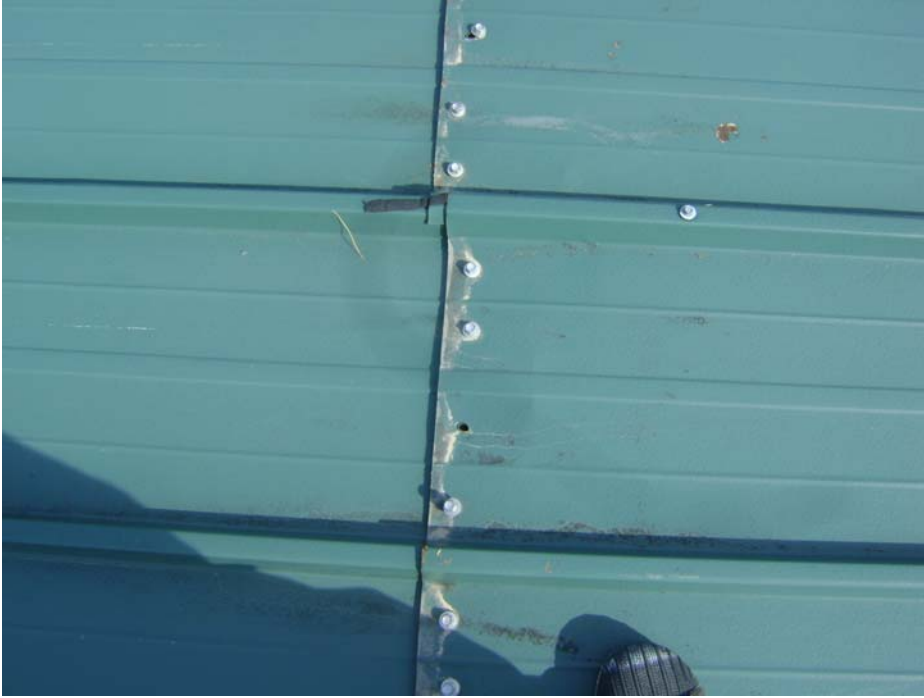
Photo No. 15

Description:
Screws Missing &
Popping Out on
Roof Area No. 3

1. Implement repairs to the steep-sloped metal roof (Roof Area No. 3 at 17,525 SF) in year **2011**. Repair work includes reflashings rooftop penetrations and associated crickets, re-securing panel fasteners and installing new panel fasteners as needed.
2. Implement repairs to the steep-sloped shingle roof (Roof Area No. 1 at 10,500 SF) in year **2011**. Repair work includes resecuring shingle nails and repairing holes as needed.

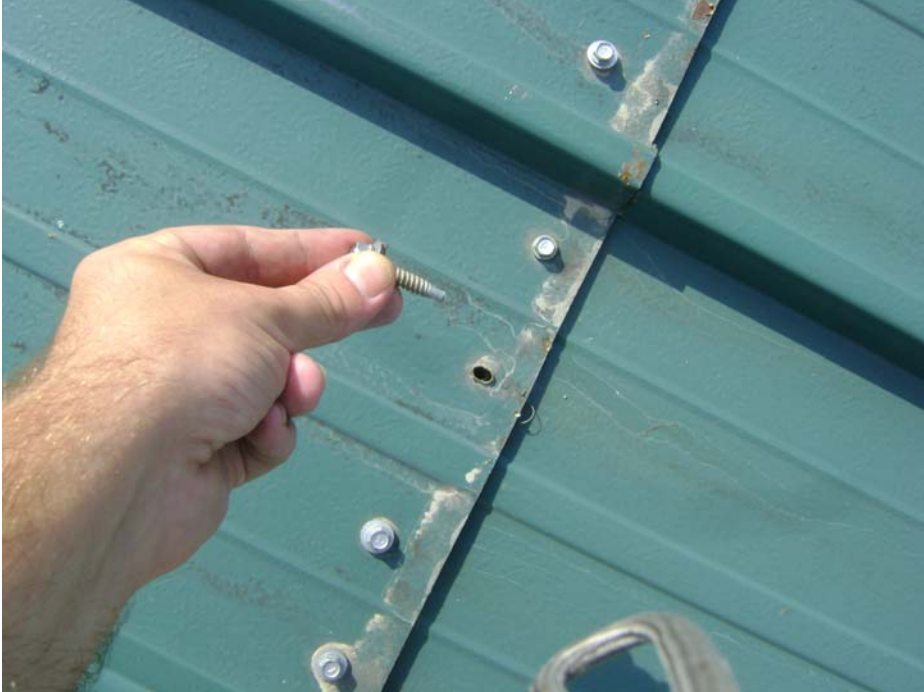
Photo No. 16

Description:
Popped Out Screw

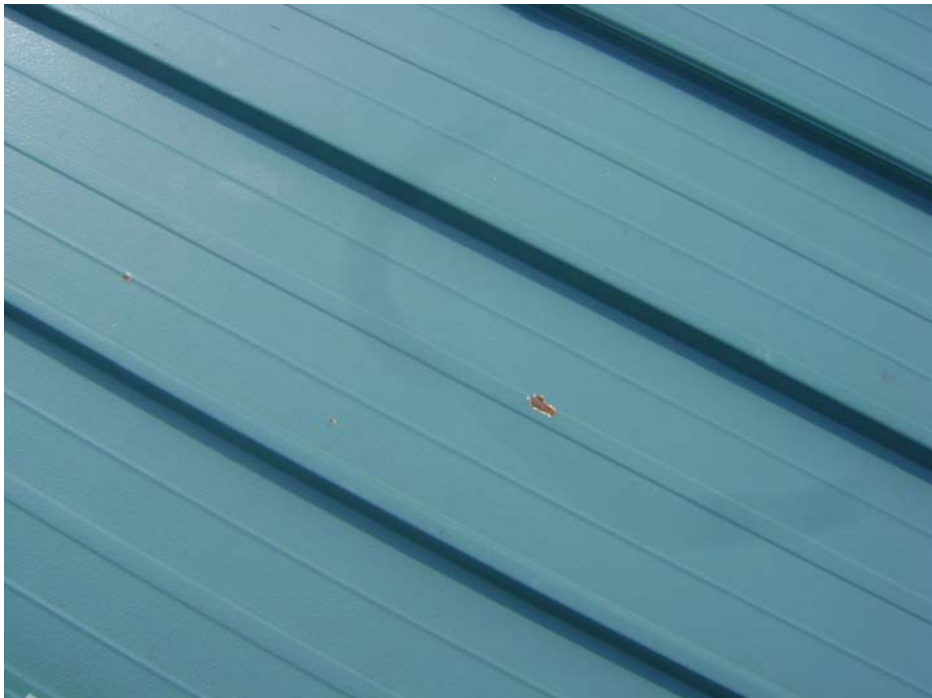
<p>Photo No. 17</p> <p>Location: DPW Office & Garage</p> <p>Description: Rust Spot on Roof Area No. 3</p>

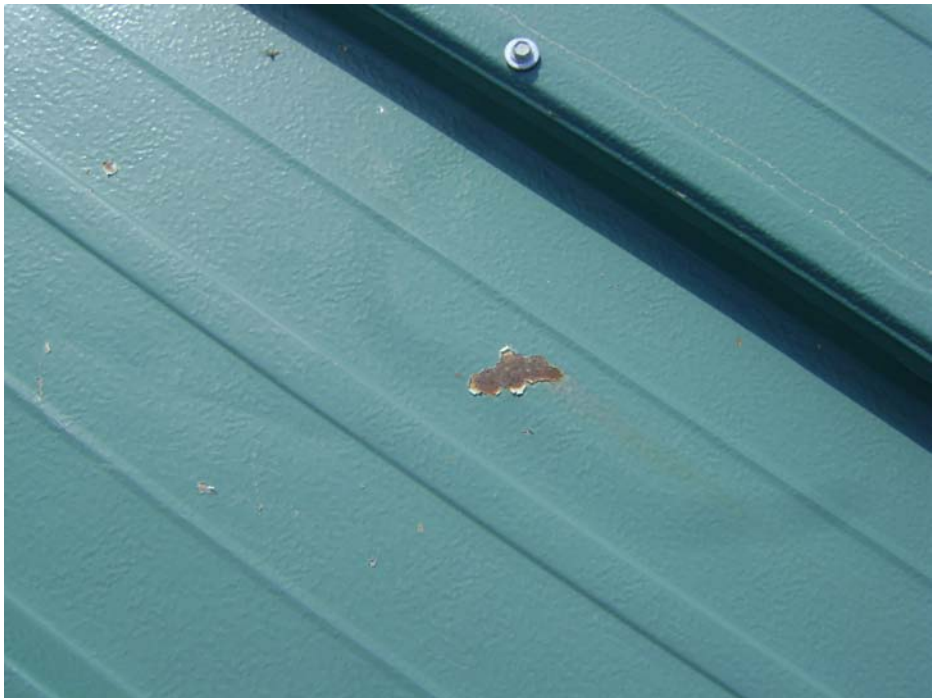
<p>Photo No. 18</p> <p>Location: DPW Office & Garage</p> <p>Description: Rust Spot on Roof Area No. 3</p>

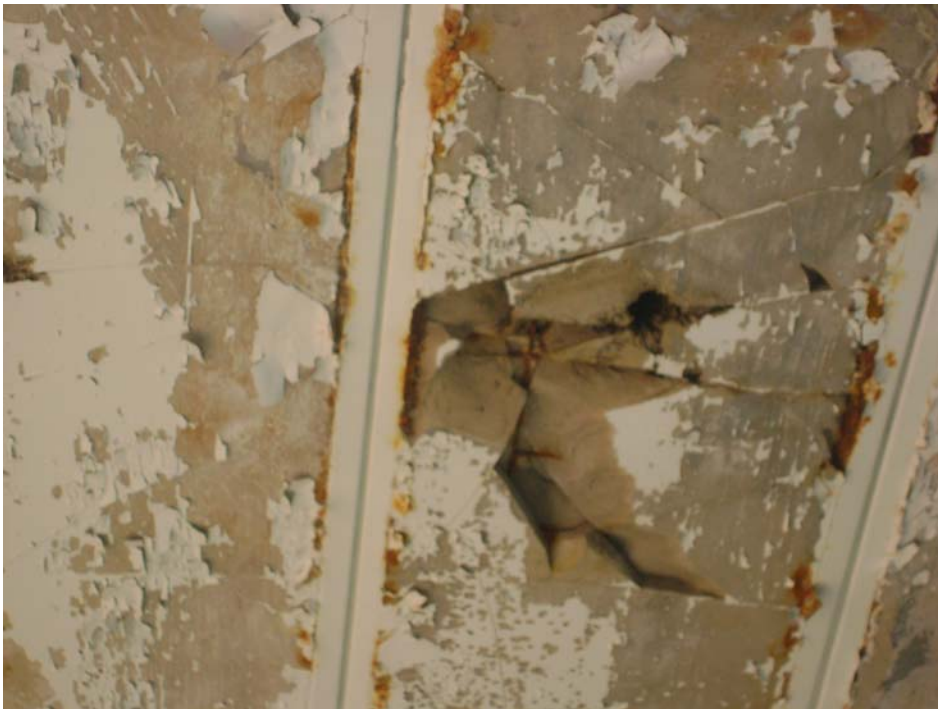
Photo No. 04

Description: Damaged roof deck plank at roof area #17.

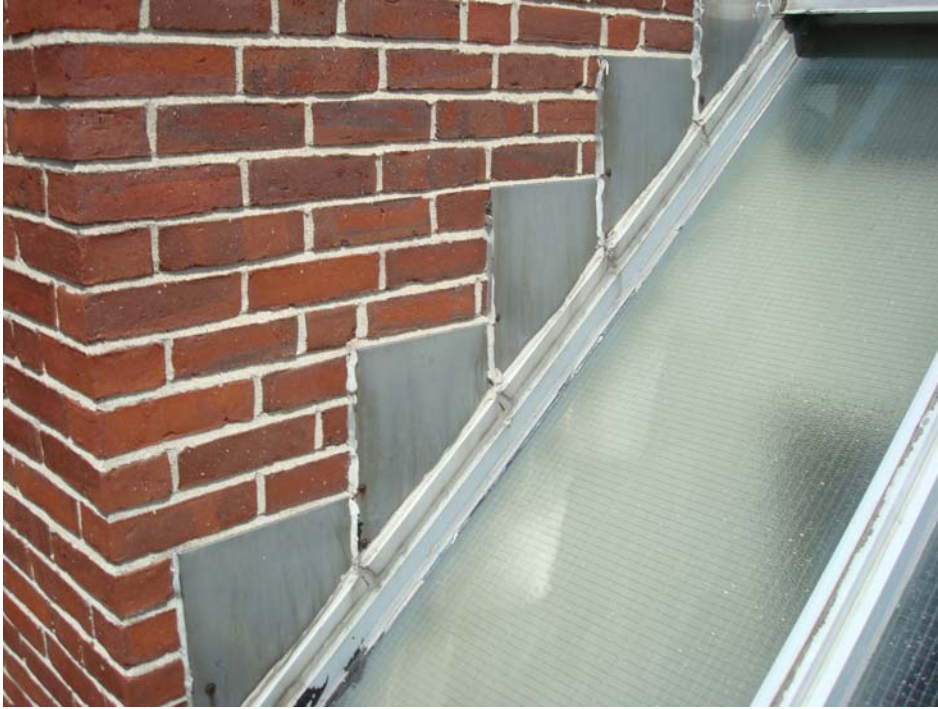
Photo No. 05

Description: Numerous sealant repairs at monitor windows.

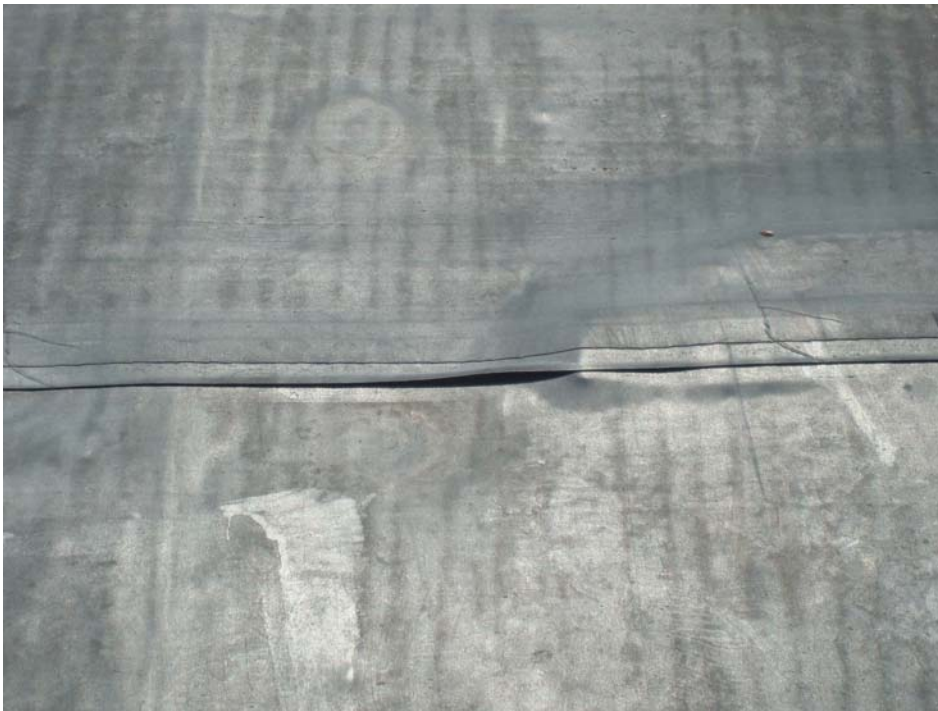
Photo No. 06

Description: Typical failed seam.
