ROOF CONDITION SURVEY

For
Town of Sudbury
19 Sudbury Public Buildings
Sudbury, Massachusetts

February 3, 2012

RBA Project No. 201056.00

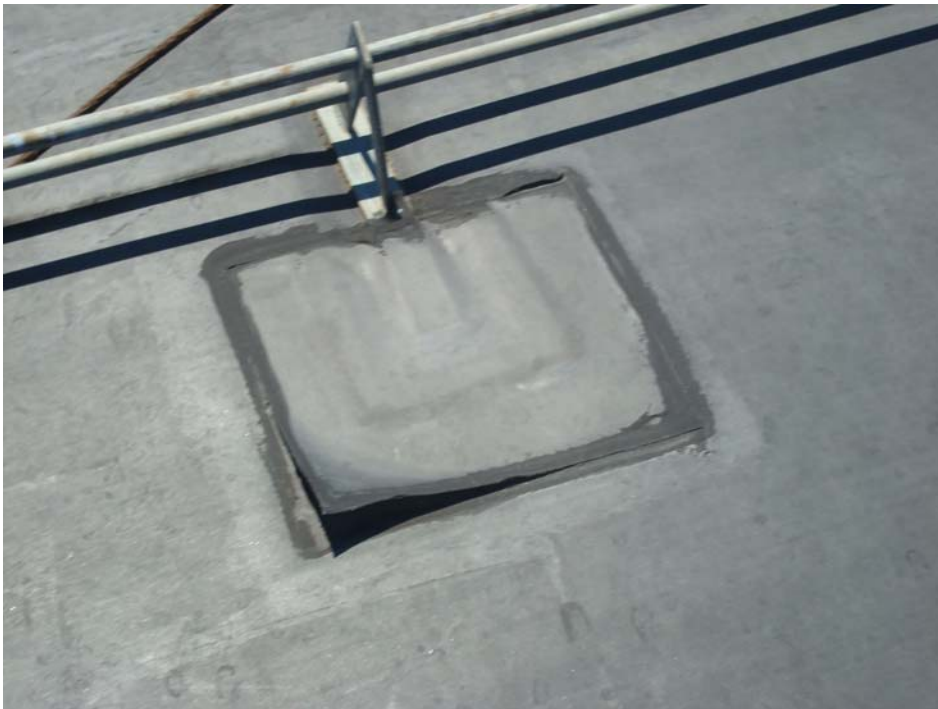
Photo No. 06

Description: Many seams and flashings over snow guard bases are failed.
