ROOF CONDITION SURVEY

**For
Town of Sudbury**

**Fairbank Complex
40 Fairbank Road
Sudbury, Massachusetts**

February 3, 2012

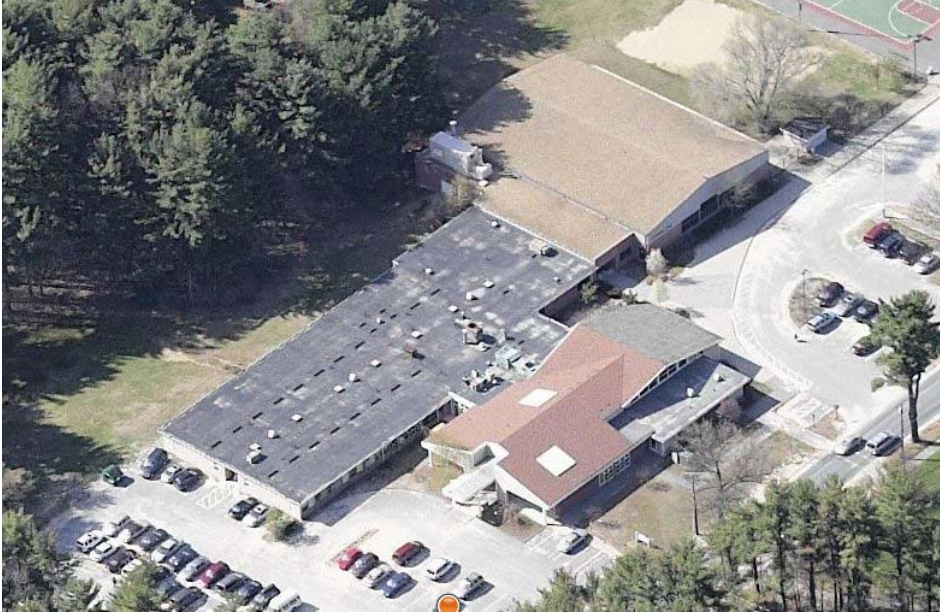
Photo No. 01

Description: Aerial View of Roof. Roof Area No. 1 is at the top of the picture.

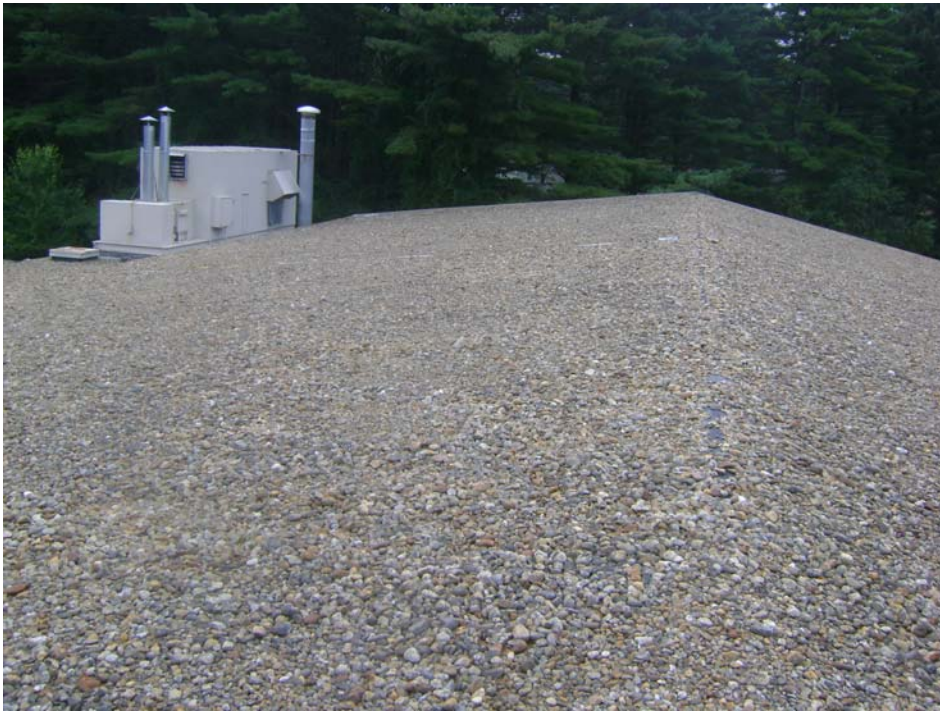
Photo No. 02

Description: Overview of Roof Area No. 1. Note that stone ballast has migrated away from the roof ridge.

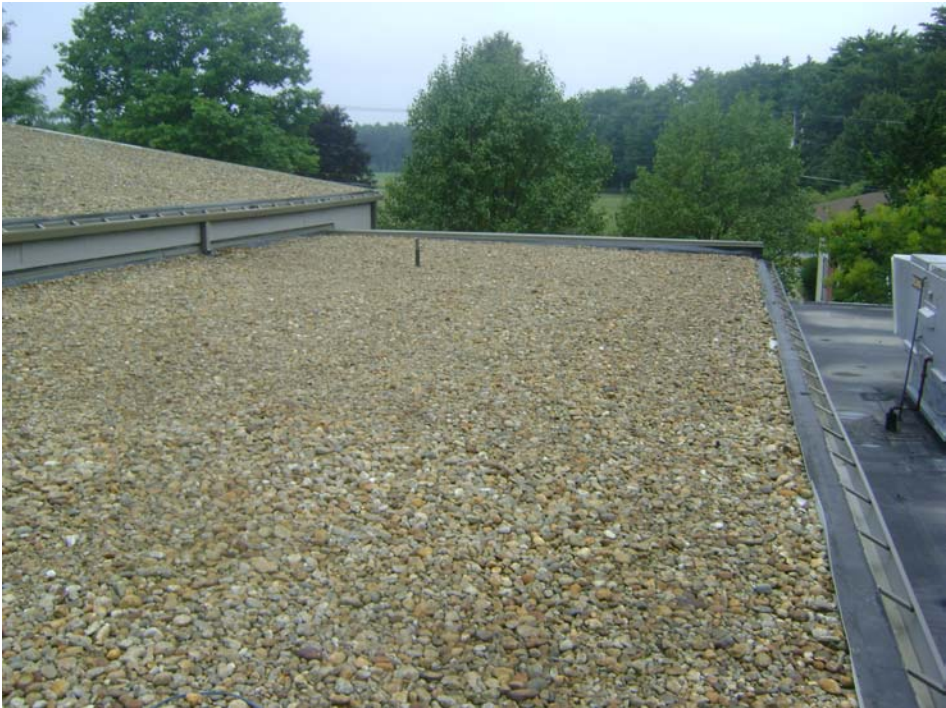
Photo No. 03

Description:
Overview of Roof Area No. 2

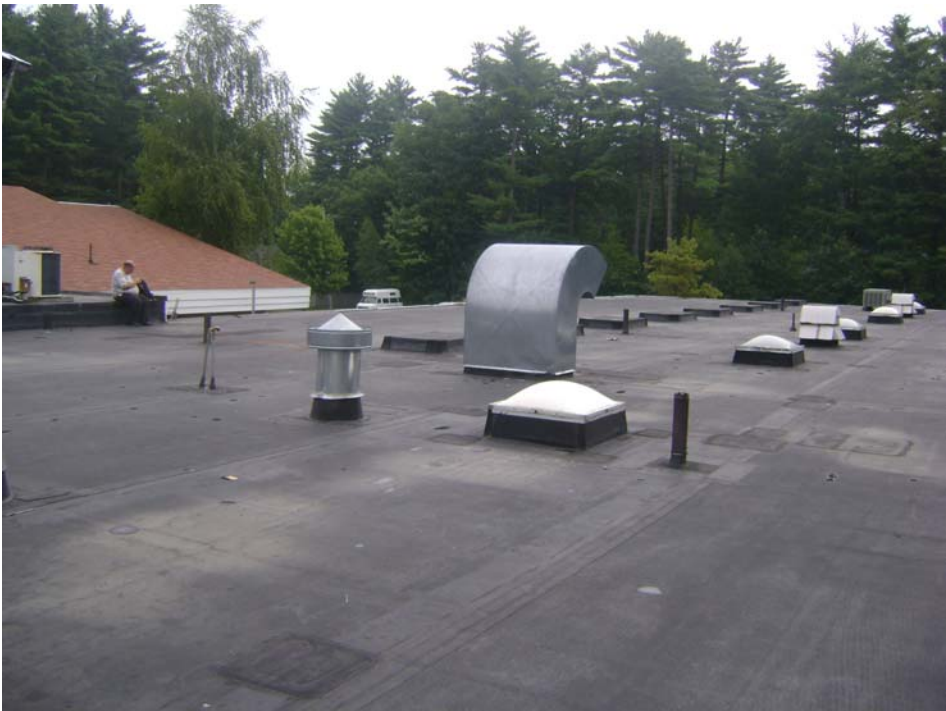
Photo No. 04

Description:
Partial overview of Roof Area No. 3

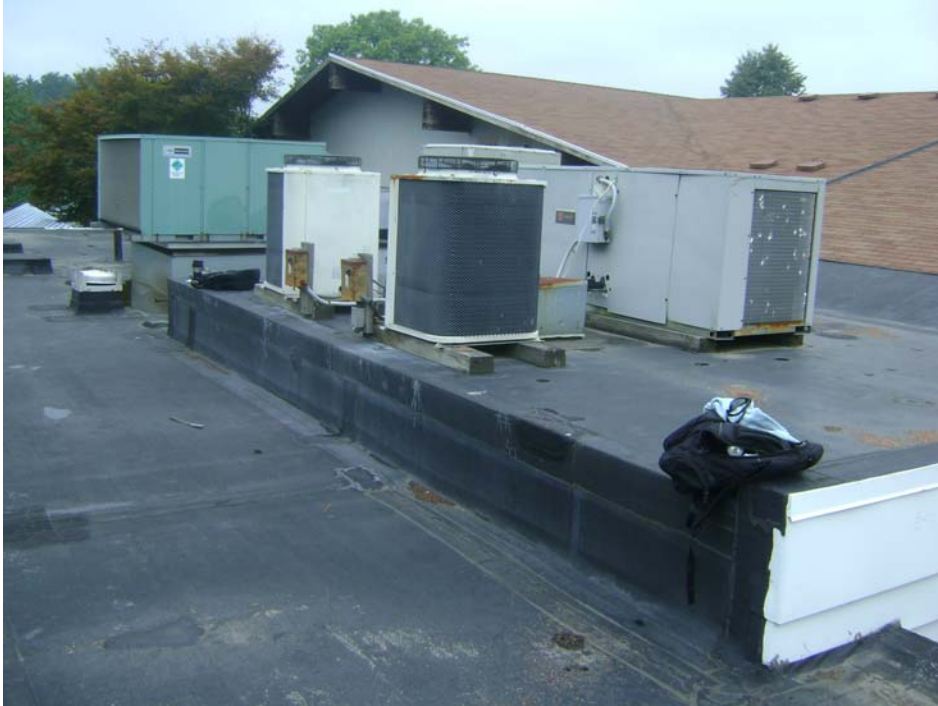
Photo No. 05

Description:
Partial overview of
Roof Area No. 4

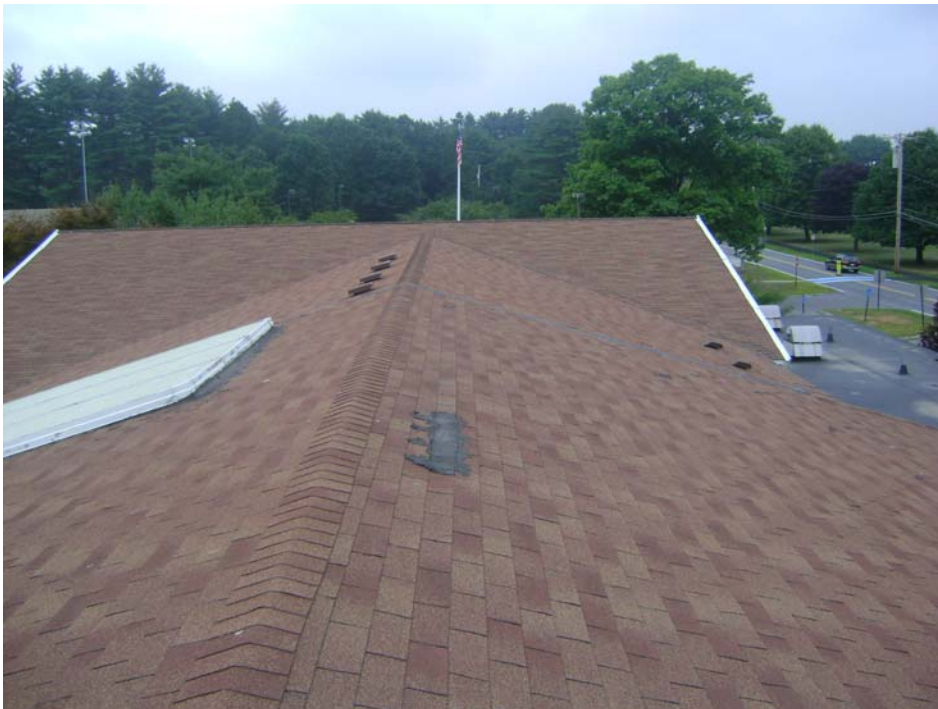
Photo No. 06

Description:
Overview of Roof
Area Nos. 5A, 5B
and 5C.

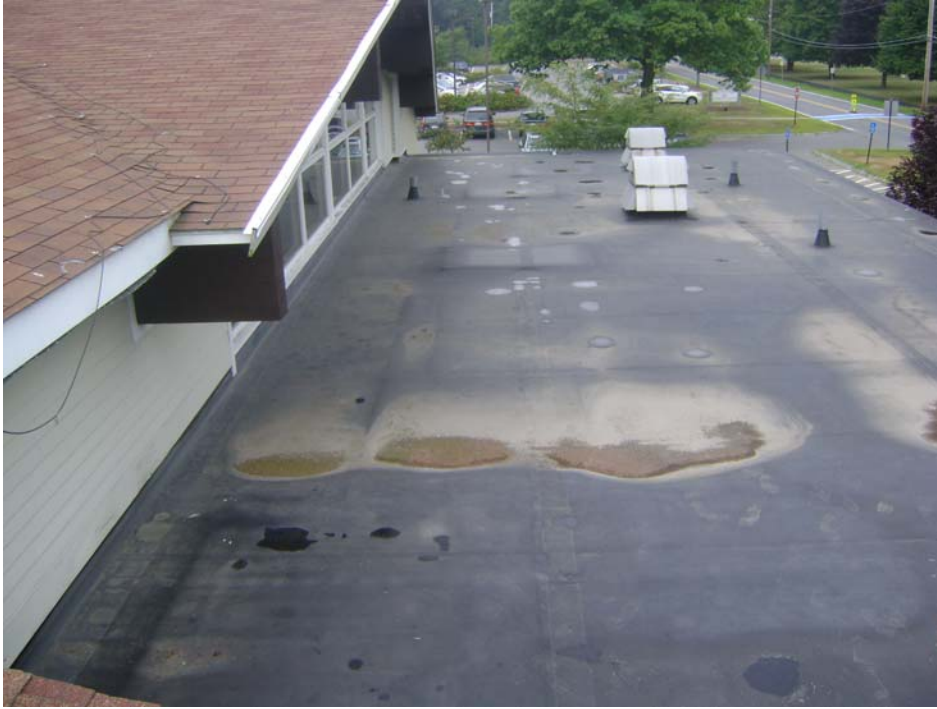
Photo No. 07

Description:
Overview of Roof Area No. 6.

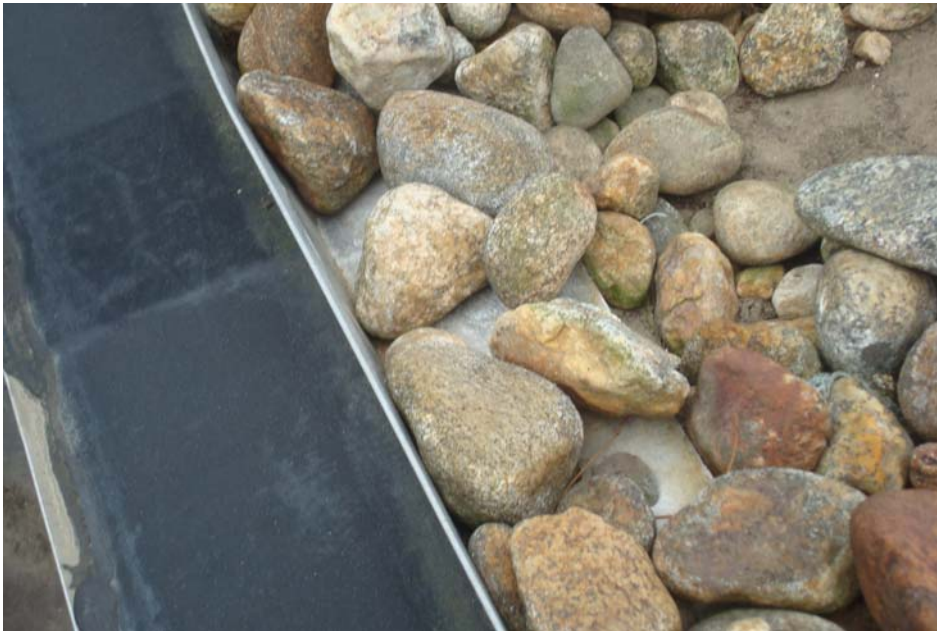
Photo No. 08

Description:
Ballast retention bar of Roof Area No. 1 is loose.

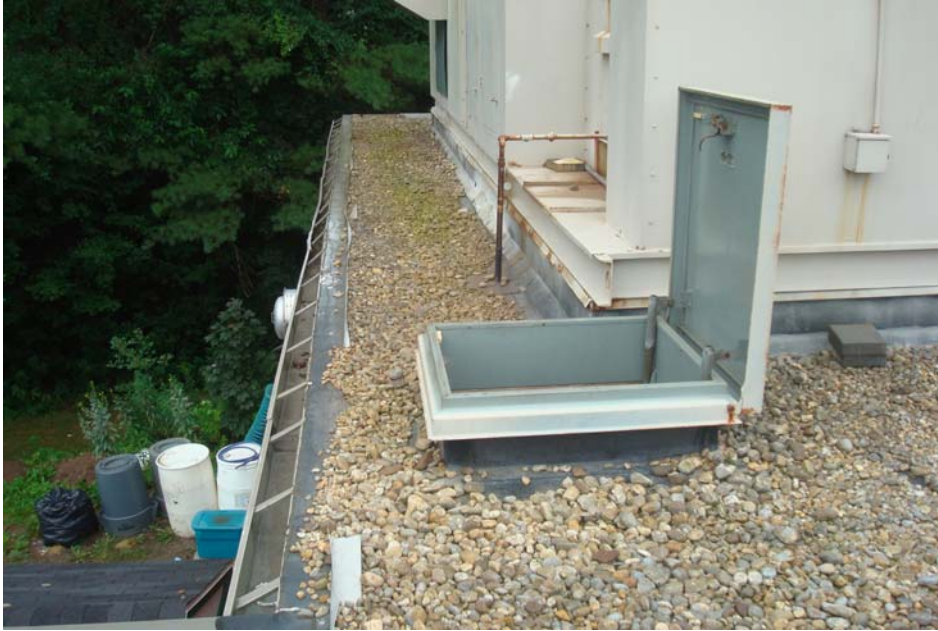
Photo No. 09

Description: Roof hatch on Roof Area No. 2 opens towards the roof edge creating a safety concern.

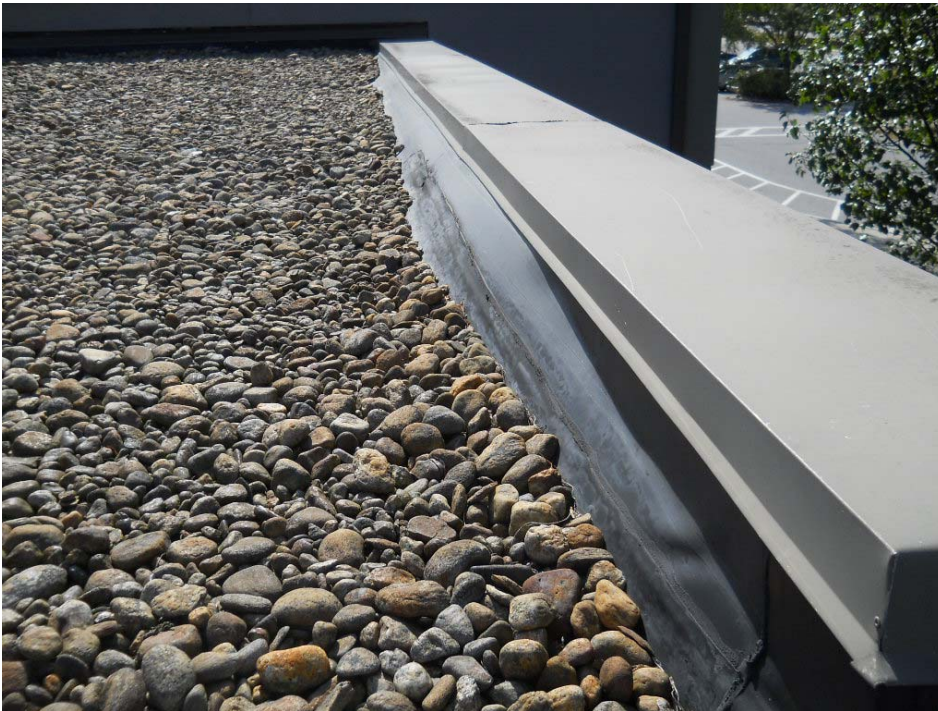
Photo No. 10

Description: EPDM base flashings of Roof Area No. 2 are pulling away from the parapet due to membrane shrinkage.

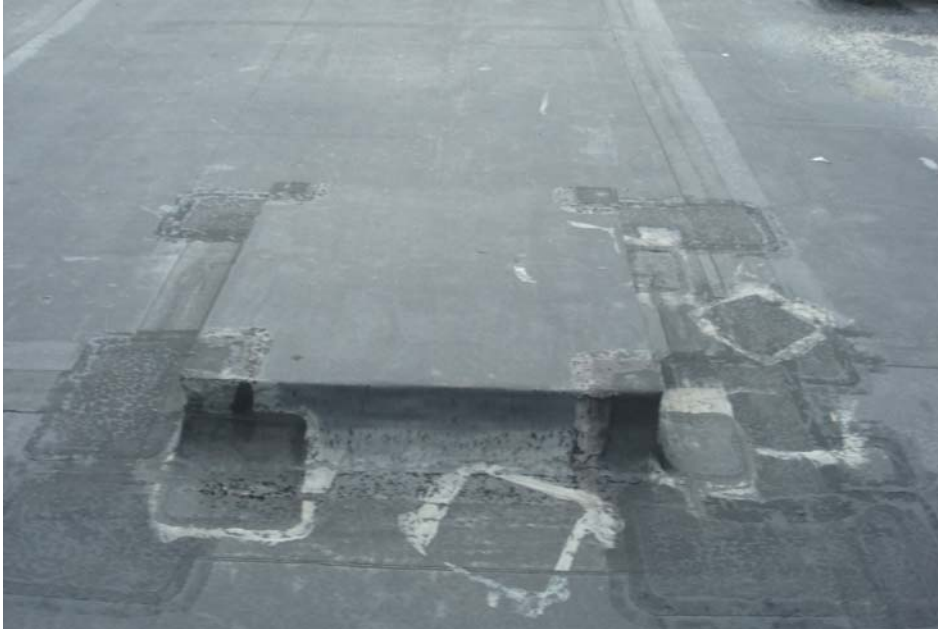
Photo No. 11

Description: Roof Area No. 3: Enclosed skylight curb has had numerous EPDM repairs.

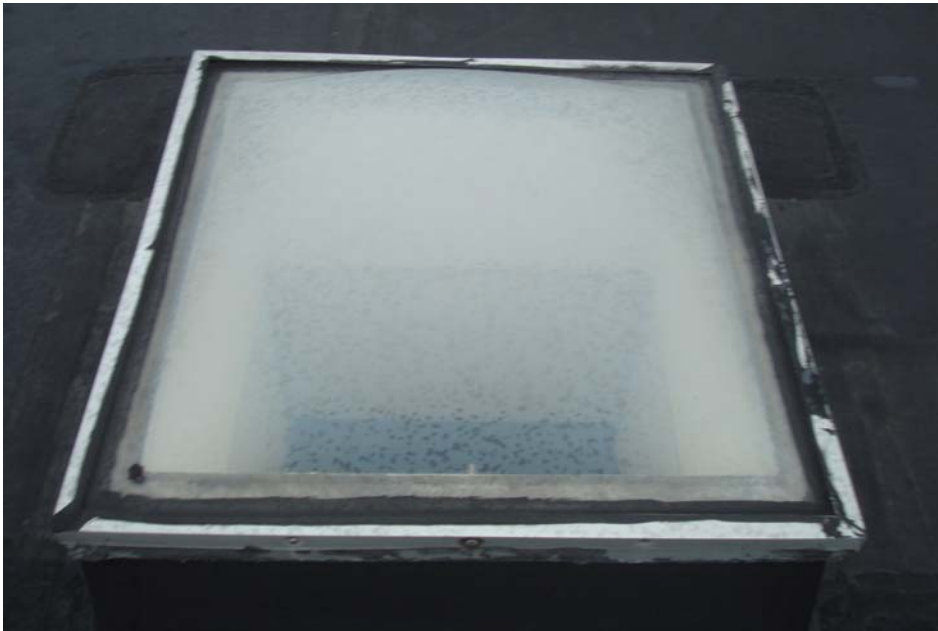
Photo No. 12

Description: Roof Area No. 3: Skylight domes are weathered and brittle.

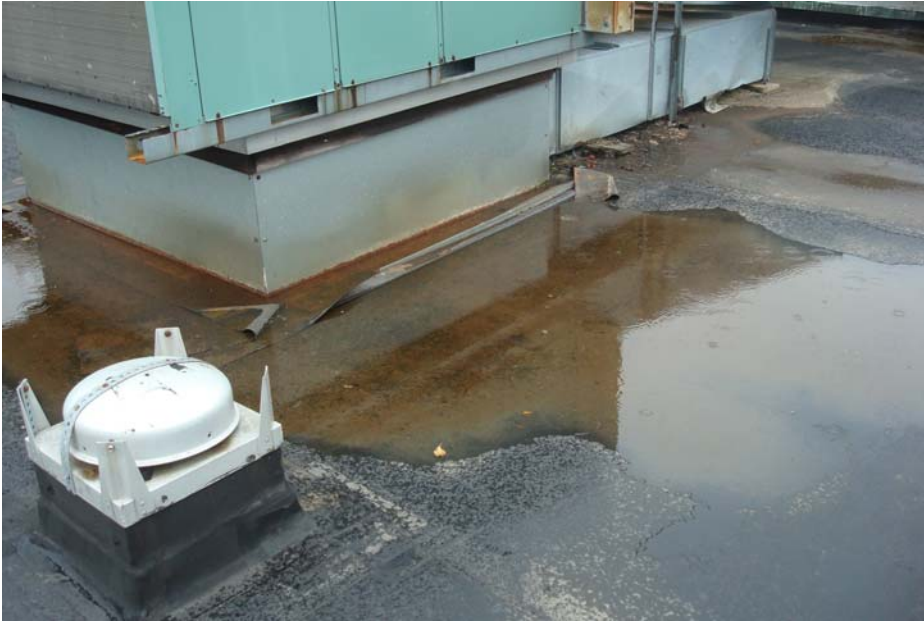
Photo No. 13

Description: Roof Area No. 3 drains poorly. Mechanical equipment is rusting.

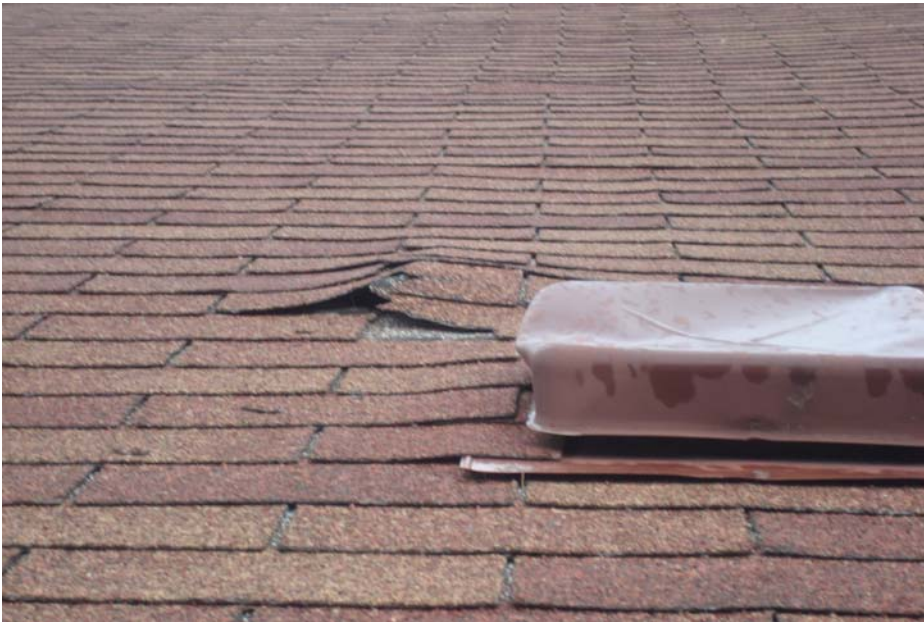
Photo No. 14

Description: Plywood roof decking on Roof Area No. 5B has popped up.

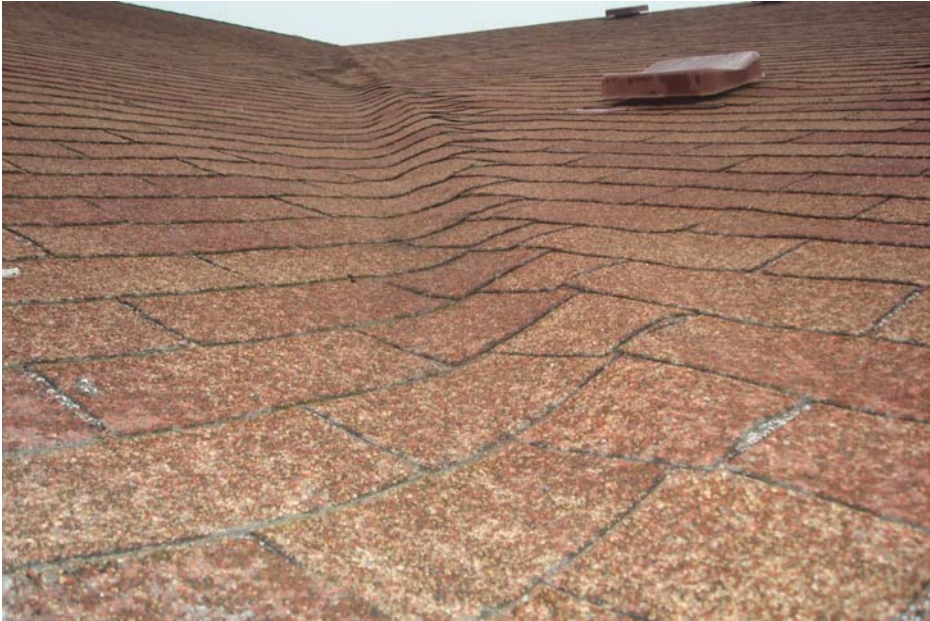
| | <p>Photo No. 15</p> <p>Location: Fairbank Complex</p> <p>Description: Shingle valley between Roof Areas 5B and 5C is irregular due to loose or poorly applied plywood roof decking.</p> |
