SUDBURY TO HUDSON 115KV UNDERGROUND TRANSMISSION LINE

UNDERGROUND TRANSMISSIONS ENGINEERING SERVICES

Eversource

20 OCTOBER 2016

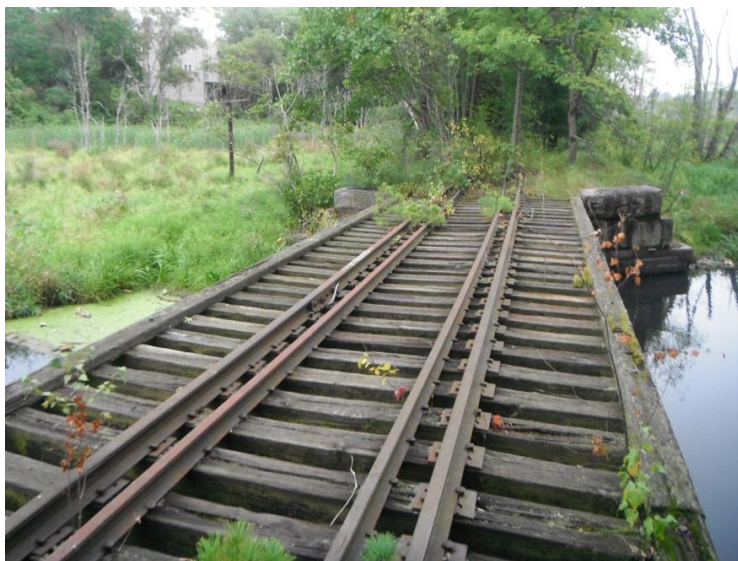
2.1 Hop Brook #127 (STA 50+00)

This bridge appeared to be in a condition that would allow for rehabilitation and repurposing of the bridge. The steel members appeared to be in satisfactory condition while the foundations remain in question. To do this an experienced bridge inspector would need to perform a full inspection as well as work with the design team to understand the modifications that would need to be performed to utilize for the Underground Transmission Lines.

If the bridge is deemed unacceptable the existing bridge would be removed and replaced with a bridge design to carry both pedestrian traffic and the Underground Transmission Lines. The new bridge would not exceed the existing footprint of the existing bridge.

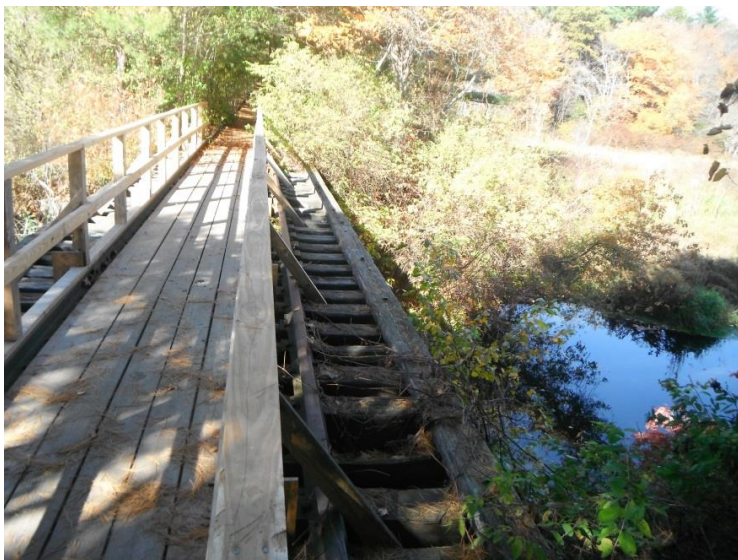
2.2 Hop Brook #128 (STA 215+50)

This bridge also appeared to be in satisfactory condition to rehab and repurpose. The steel members appeared to be in a satisfactory condition while the foundations remain in question. This would require an experienced bridge inspector as well for inspection and understand from the design team what modifications would be done to the bridge.

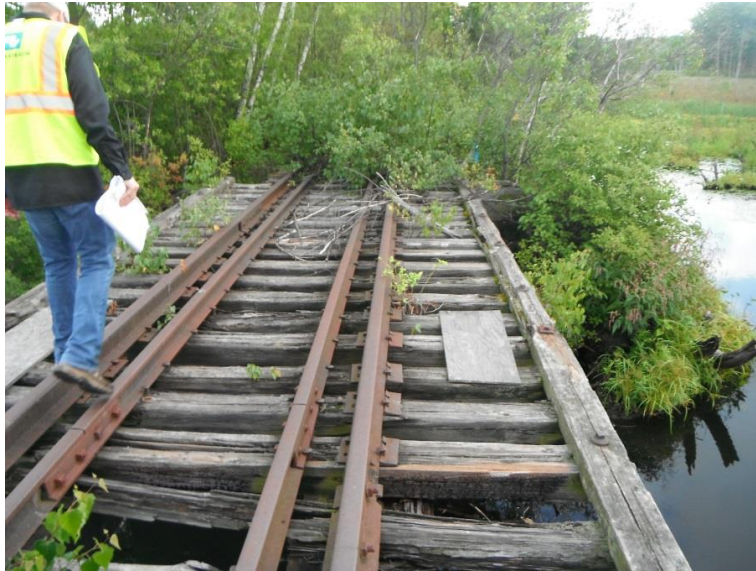
2.3 Fort Meadow (STA 361+00)

The bridge was in poor condition and very much deteriorated. The foundation abutments were missing and the bridge was only being held up by piers in the water. This bridge would require removal. The wood was rotted or missing, foundations missing, etc.

After some discussions and investigations a few options for the bridge at STA 361+00 which is in deteriorated condition or if any of the other bridges turn out to be unsalvageable are replacing the bridges with a precast or steel truss type bridge. These would be pre-manufactured and shipped to the site to minimize erection time and impact to the area. Some examples of the options can be seen in the following pictures.

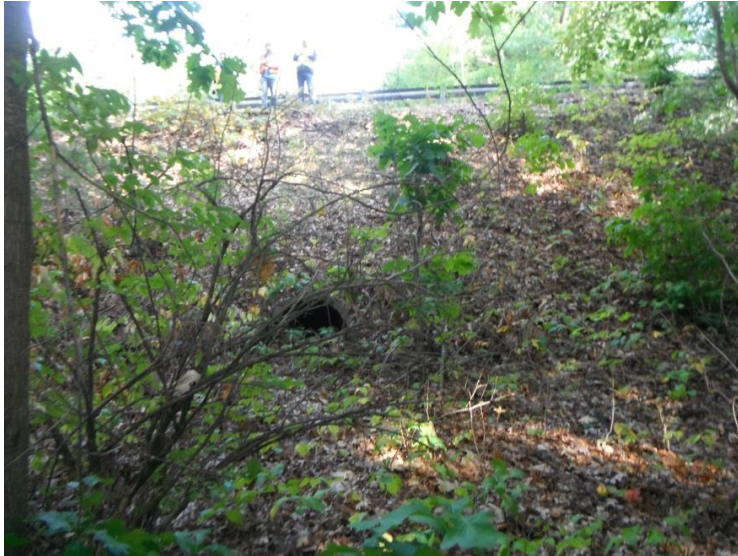
3.1 Chestnut Street Crossing

The route is located some distance below Chestnut Street (approximately 20ft) and to cross it will require a road closure for up to approximately 2 months. To allow for the bike bath a precast section could be installed of roughly 9ft high by 12ft wide that would allow for a passage way under Chestnut Street. The transmission duct bank would be installed underneath the bike path in the passage way.

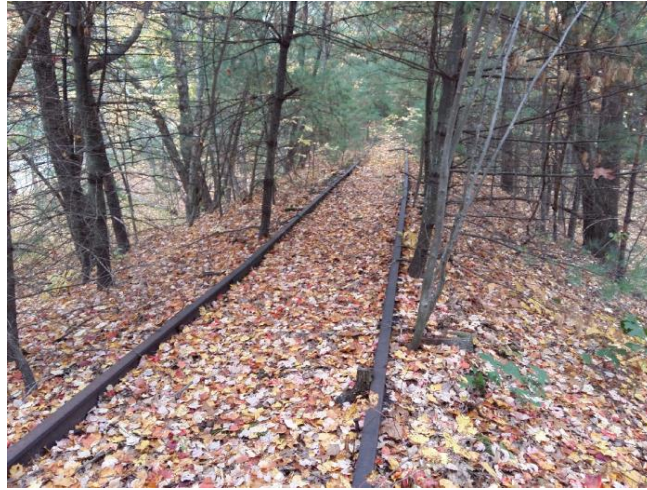
3.2.1 Typical Fill Section Without Restrictions

Much of the alignment is built in fill consisting of the track and ballast with approximately 1.5:1 side slopes on each side. The fill sections can either be widened to accommodate the additional width of the roadway and the ductbank or cut down in elevation until the top width is wide enough to accommodate the new roadway and ductbank. These areas can be modified relatively easily but may require substantial cut or fill.

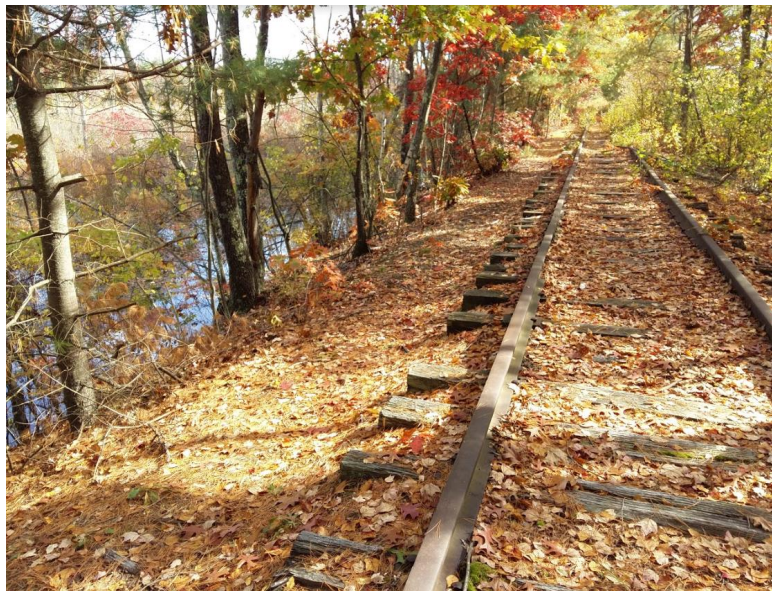
3.2.2 Typical Fill Sections With Restrictions

Approximately 25% of the areas observed were built in fill but have restrictions that will make it difficult to either widen the berm or cut in elevation. These areas are generally adjacent to wetlands. The water levels in some areas will limit the amount of cut that can occur. In these areas the ductbank and road will have to share the same corridor to minimize the width. Manholes will have to be adjusted so that they are not placed in these areas.

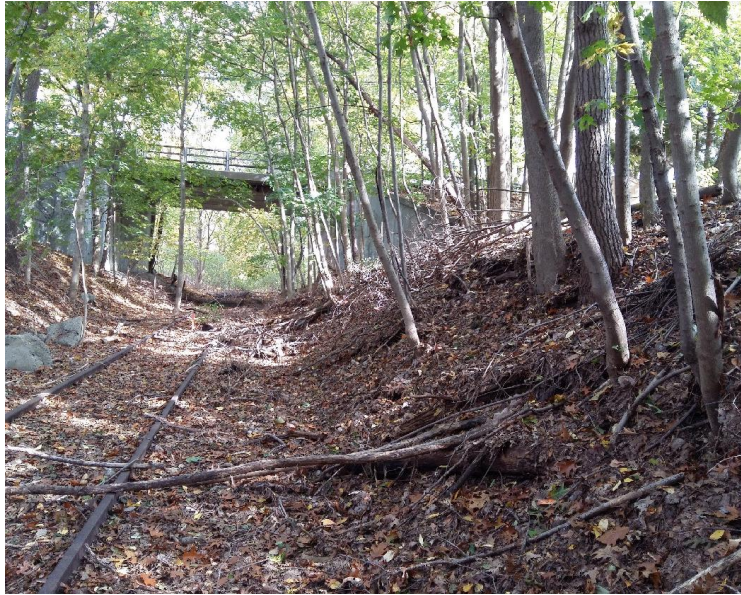
3.2.3 Typical Cut Sections

A small percentage of the route is built in a cut section. These areas generally have shallow ditches adjacent to the railway ballast. If these areas are widened to accommodate the additional width required, then care will have to be taken to ensure the drainage is maintained. This will likely require substantially more cut in order to maintain the profile.
