February 4, 2016
File No. 3888.02

Re: Proposed Redevelopment Project
528 Boston Post Road, Sudbury, MA
RTNs 3-03037, 3-17106, and 3-27243

EXPLORATION LOCATION PLAN

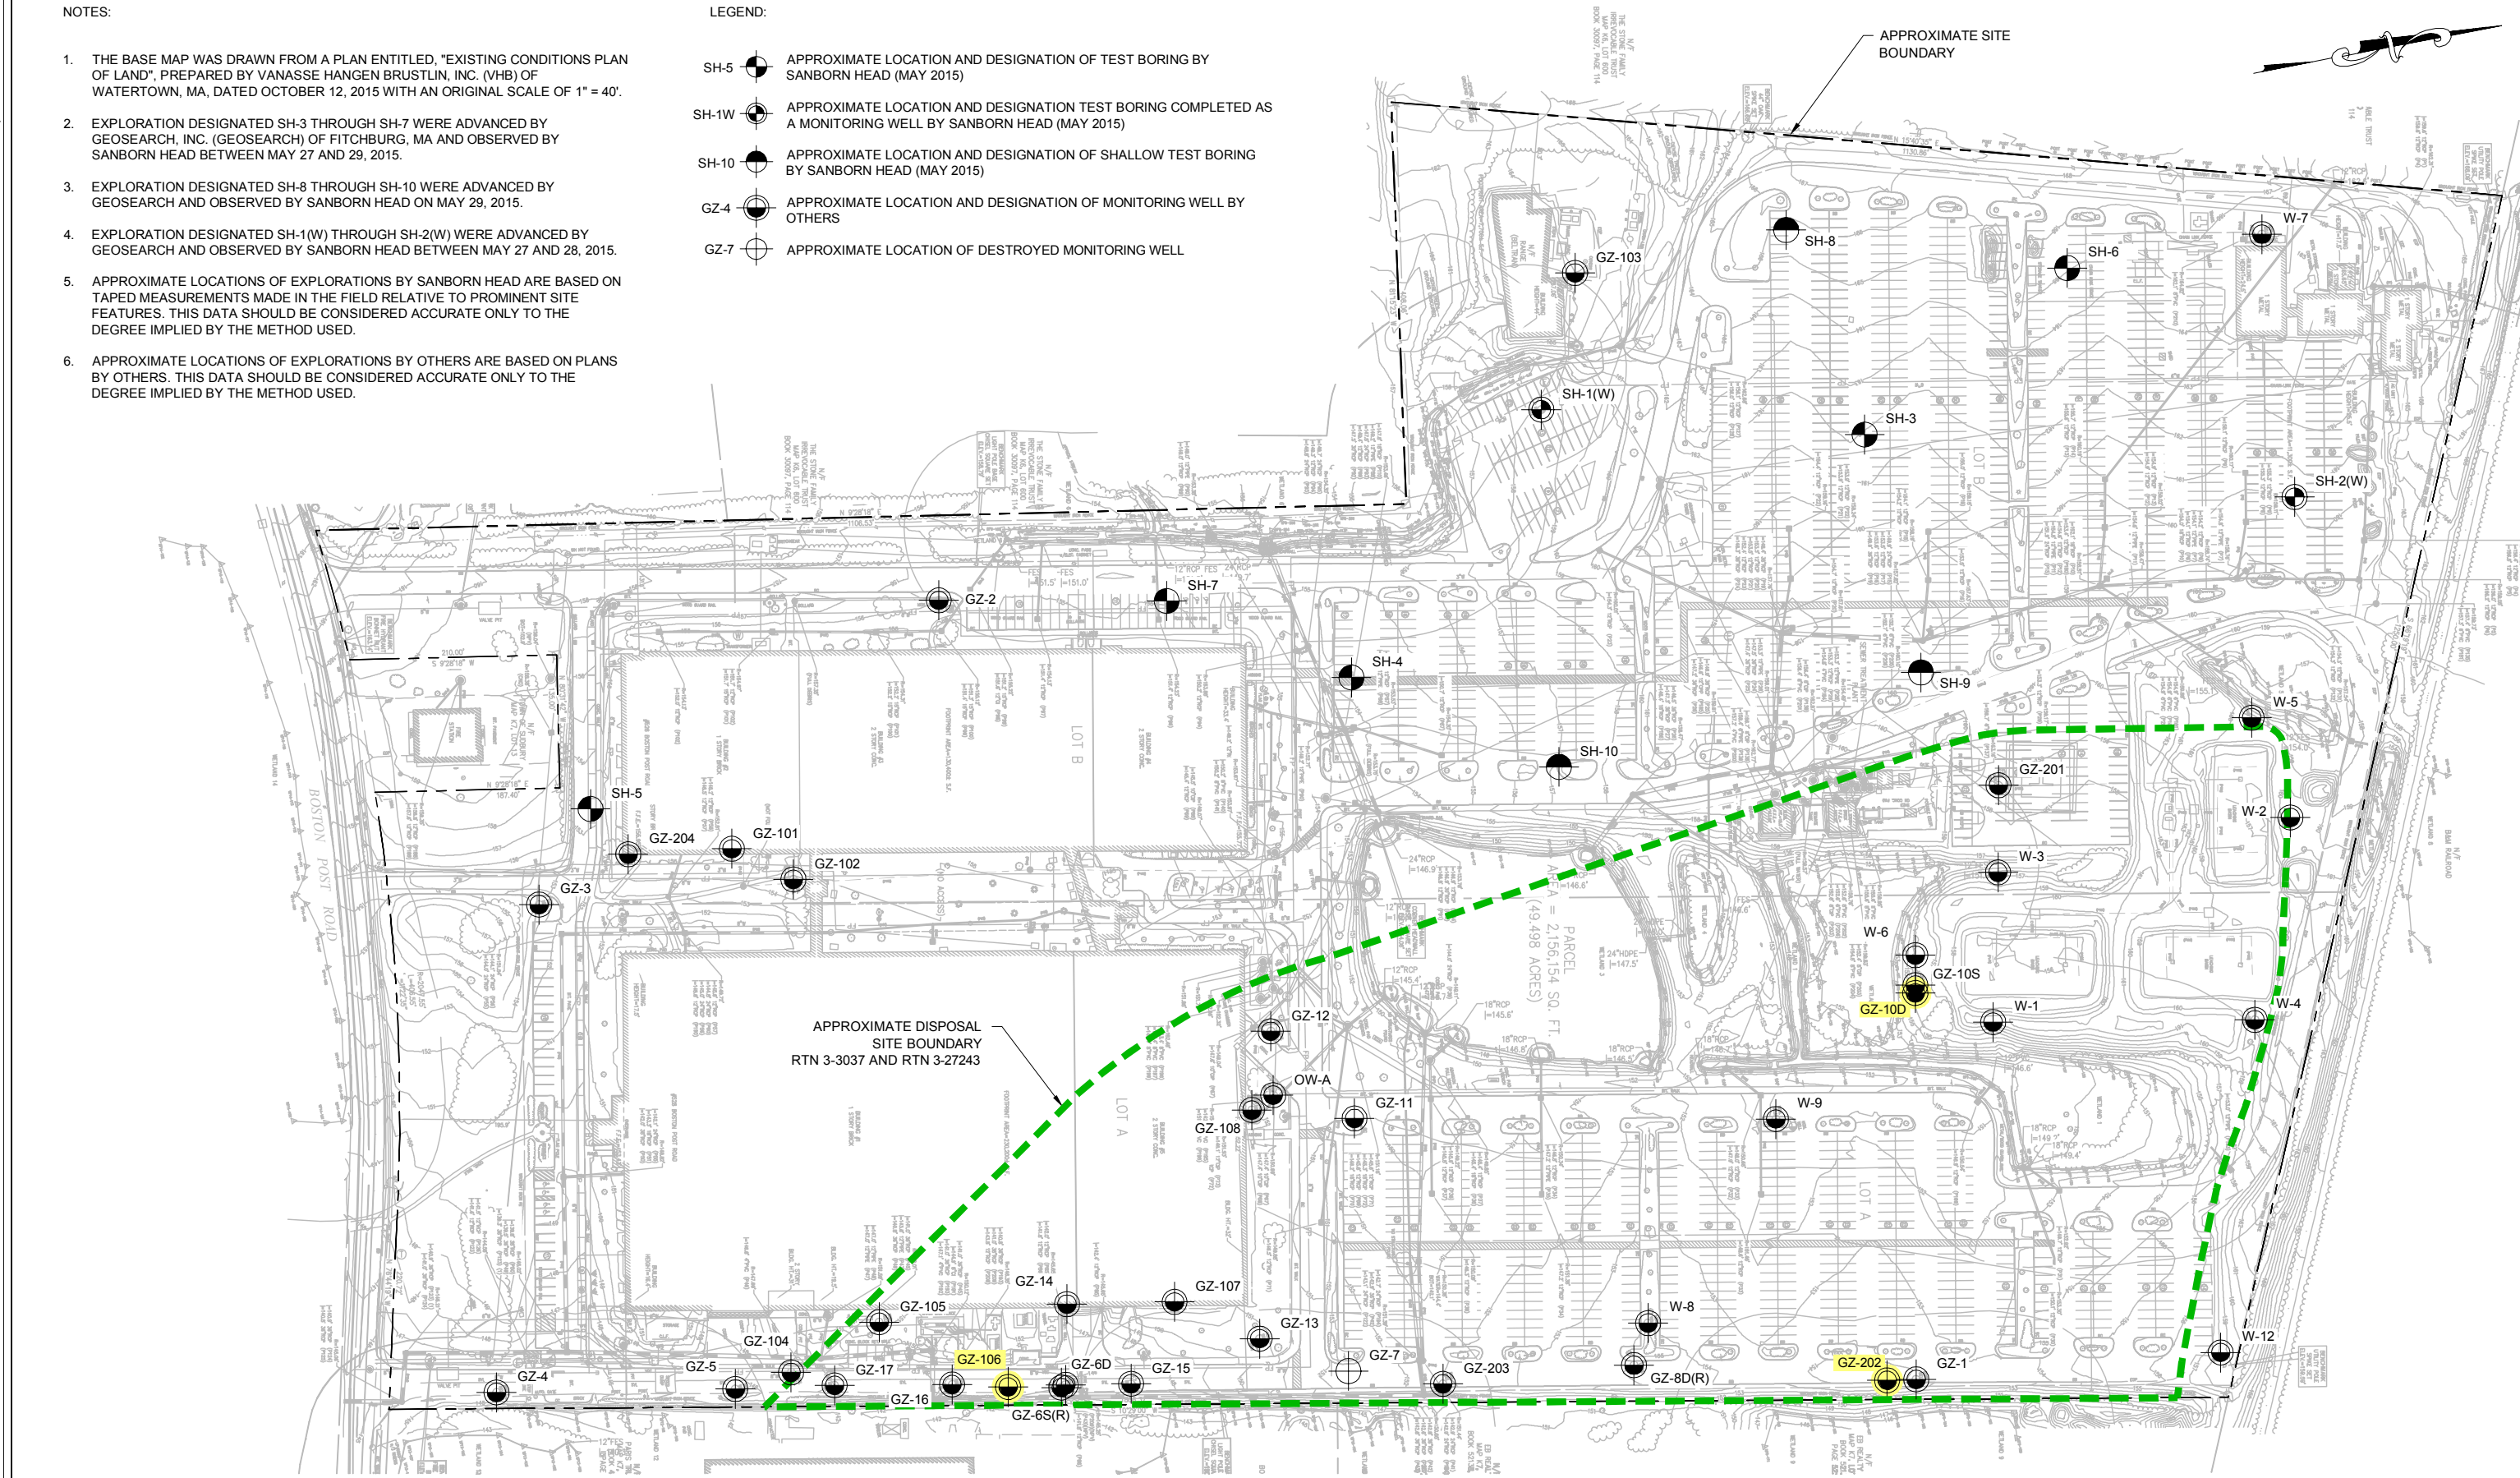
Freon 7 was also detected in one groundwater well (GZ-106) at a concentration of 45 µg/L in 2015. GZ-106 is also highlighted in yellow on the attached figure. Although this concentration slightly exceeds the previously derived Method 2 GW-2 standard of 13 µg/L, this concentration is significantly lower than the Freon 7 level detected in GZ-106 during prior sampling rounds performed in 2013. Freon 7 has not been detected above the Method 2 GW-2 standard in the wells surrounding GZ-106. This data further supports that the residual groundwater concentrations in GZ-106 are localized and naturally decreasing over time.
