Bruce Freeman Rail Trail Culvert Inventory

TO: Bill O'Rourke, Deputy Director of Public Works
FROM: Janet Moonan, P.E., and Eric Ohanian, P.E., Tighe & Bond
COPY: Dan Nason, Director of Public Works, Dave Loring, P.E., Tighe &
DATE: Bond March 1, 2018, updated April 19, 2018

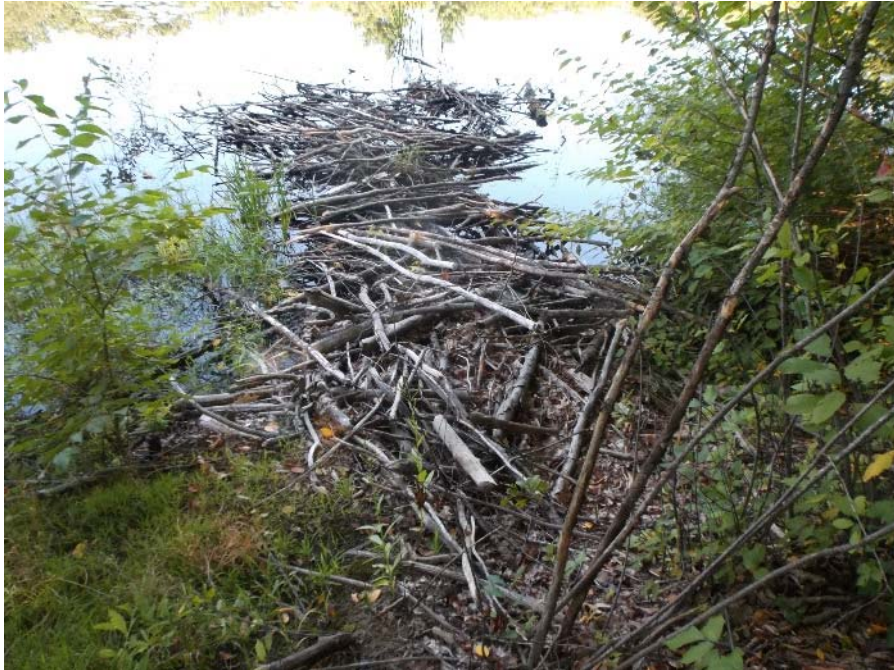
There is excessive debris buildup upstream due to Beaver Dam, which is restricting flow. Debris should be removed. Pipe appears to be approximately 6" interior diameter with a 1.5 inch wall thickness, which may be undersized depending on hydraulic needs of the site. Upsizing the culvert at this location could have impacts to the abutting wetlands systems. A site visit and further evaluation are needed to determine if replacement is appropriate.

Photo 1: Looking upstream from Culvert 3

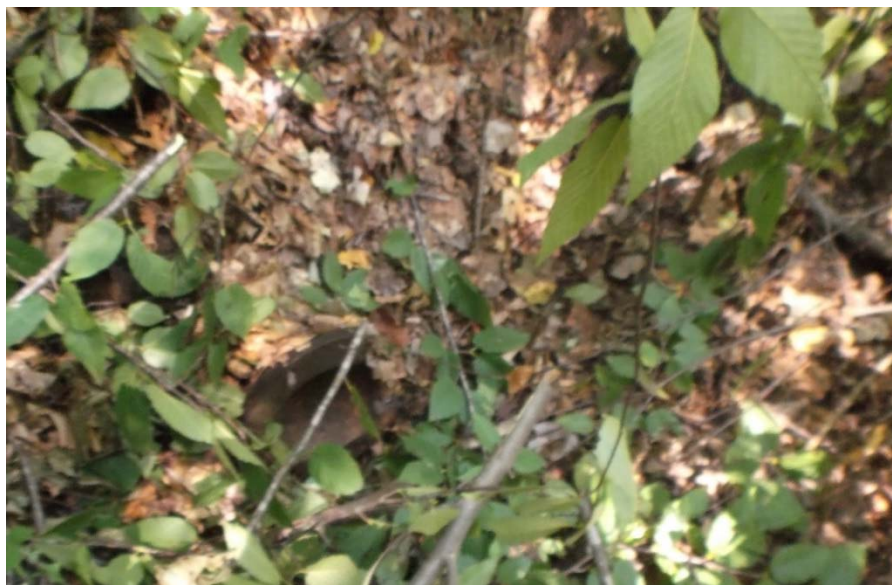
Photo 2: Pipe may be outlet of Culvert 3

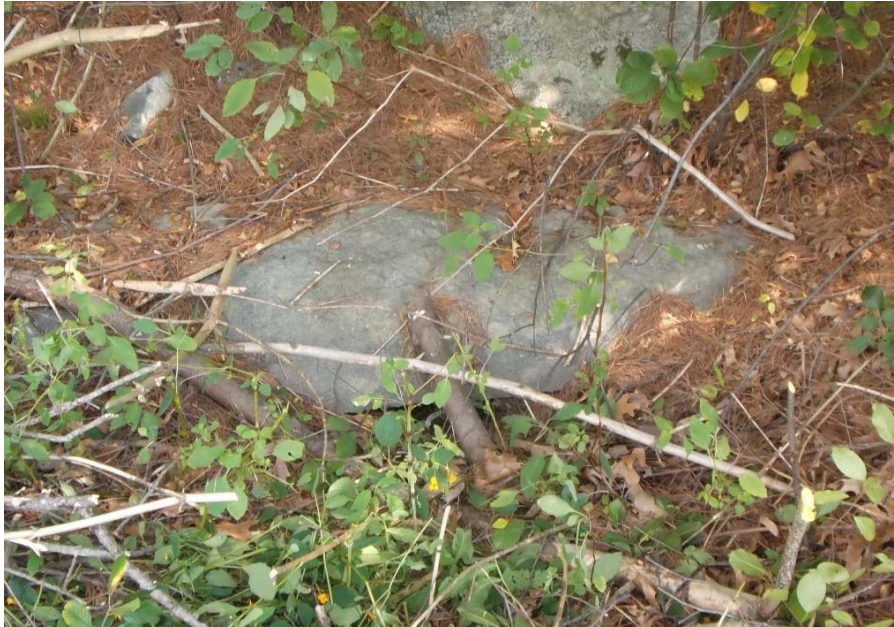
Culvert appears to be mostly blocked with debris and have minimal hydraulic capacity. This culvert appears to be a candidate for replacement, however, additional information is needed (e.g. Is there a history of flooding here? Does this culvert ever see flow?) At a minimum, culvert needs to be cleaned to remove sediment and obstructions at the inlet.

Photo 3: Inlet of BF200

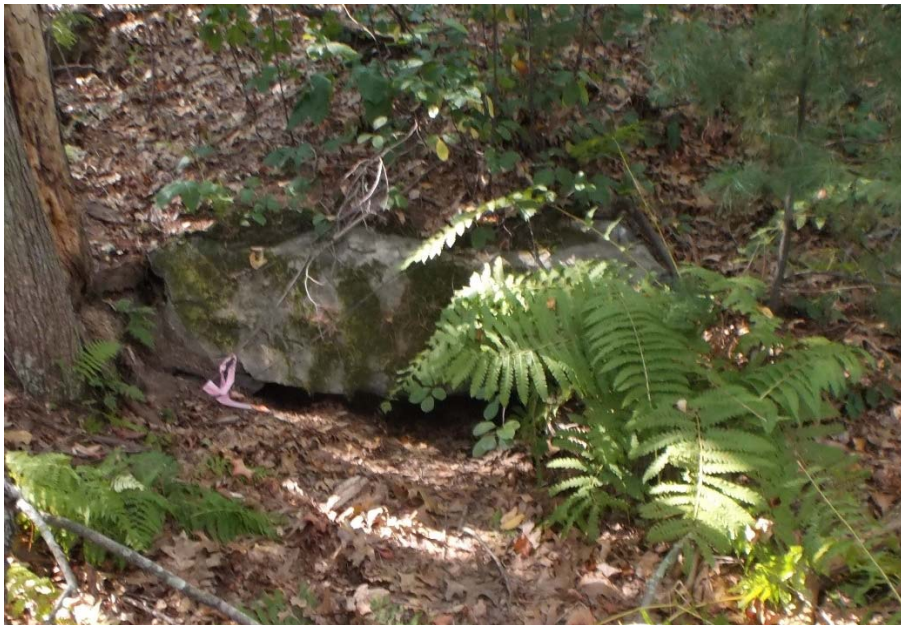
Photo 4: Outlet of BF200

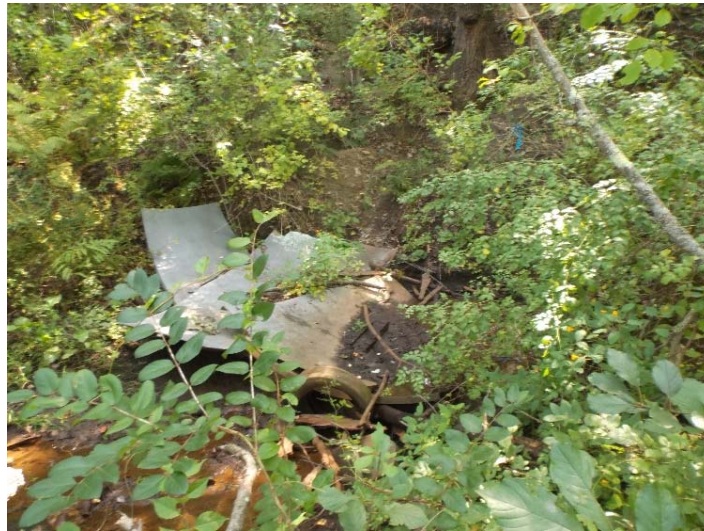
There are heavy obstructions (trash, wood) upstream of the culvert. It is difficult to identify the inlet and outlet from the photographs. Town staff could not complete inventory because culvert is submerged. Culvert needs to be cleaned to remove sediment and obstructions for further assessment to be completed.

Photo 5: Culvert 14 looking upstream

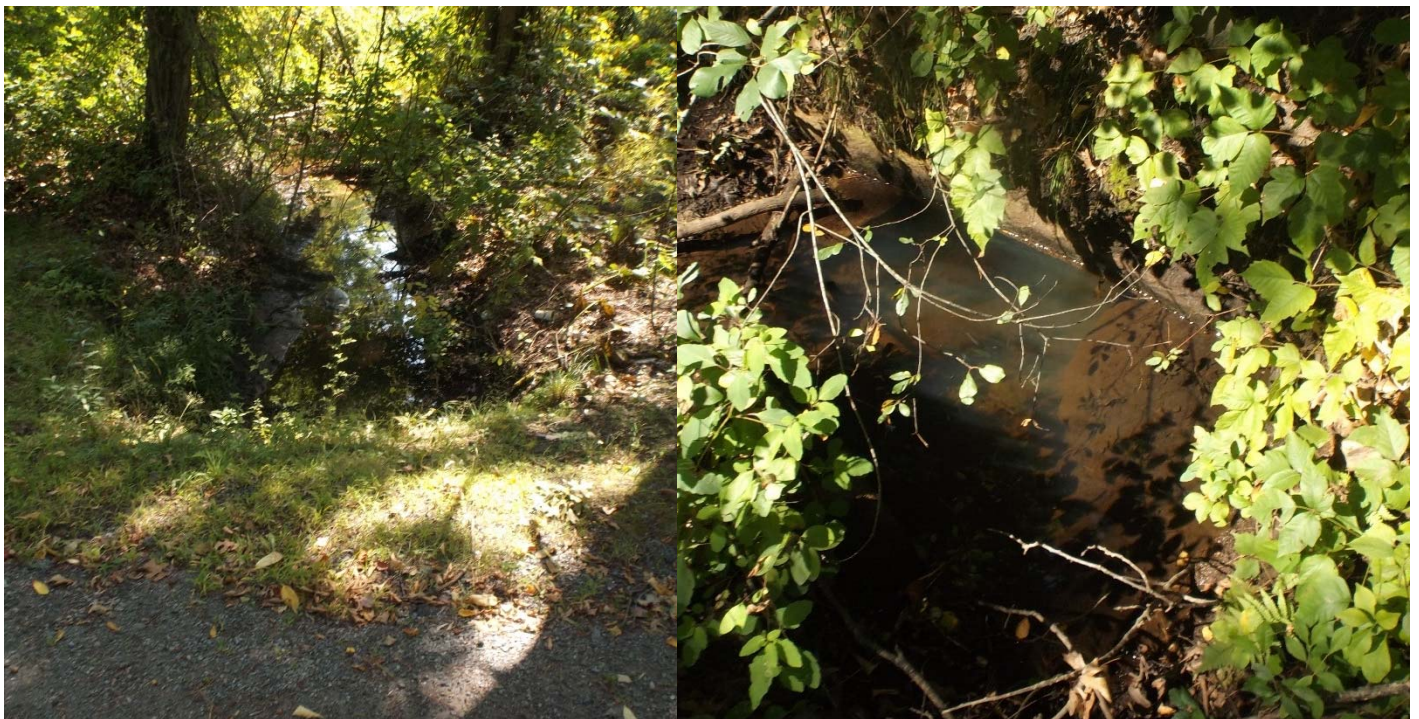
Photo 6: Downstream views at Culvert 14 (left stream channel, culvert outlet)

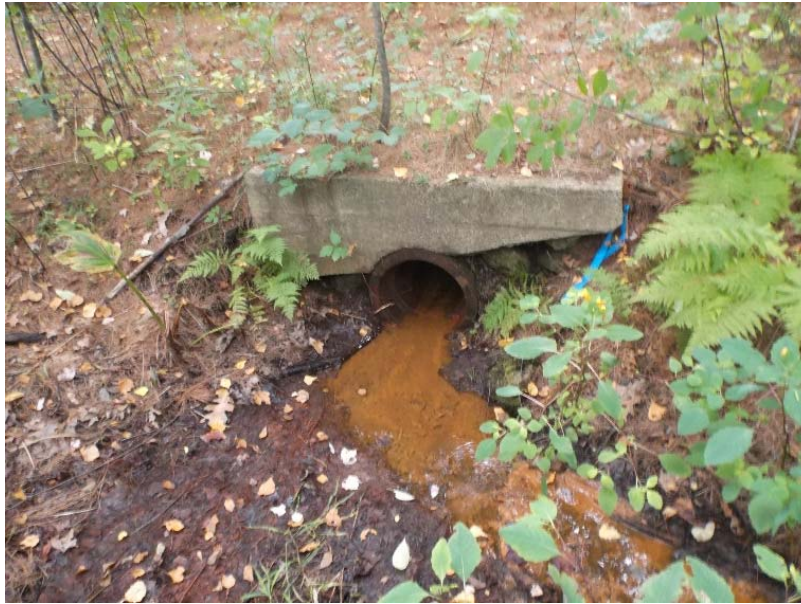
Headwalls appear unstable and susceptible to collapse, which could block streamflow. Pipe appears to be in good condition. If issues are limited to the headwall, one low cost option would be to remove the concrete on upstream side and stabilize the area with riprap. Depending on actual site conditions, headwalls may need to be replaced.

Photo 7: Inlet of Culvert 100

- Two culverts need repairs:
 - The headwalls of Culvert 100, at both the inlet and outlet, are failing. Depending on actual site conditions, headwalls could be removed and area could be stabilized with riprap or headwalls could be replaced. Culvert does not likely need to be replaced.

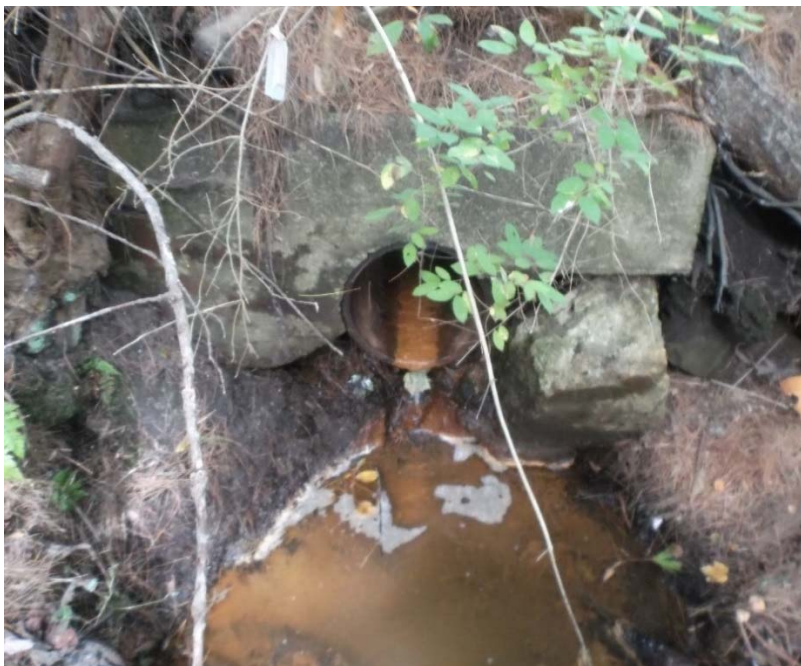
Photo 8: Outlet of Culvert 100

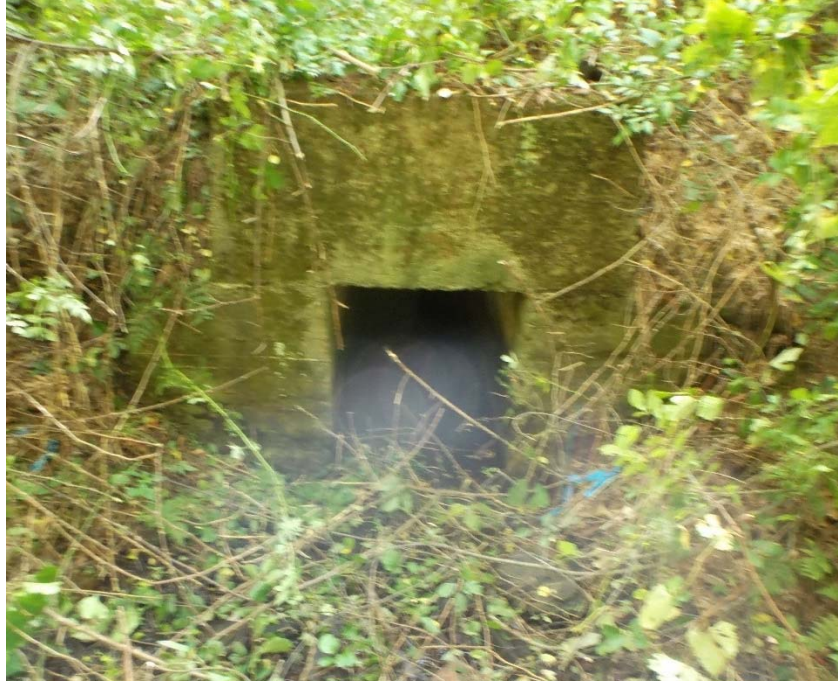
The upstream headwall appears stable. The interior from the outlet needs to be assessed to verify that there is not material coming through joints between stones that make up the culvert walls/roof, which would indicate a potential structural issue.

Photo 9: Inlet of Culvert 29

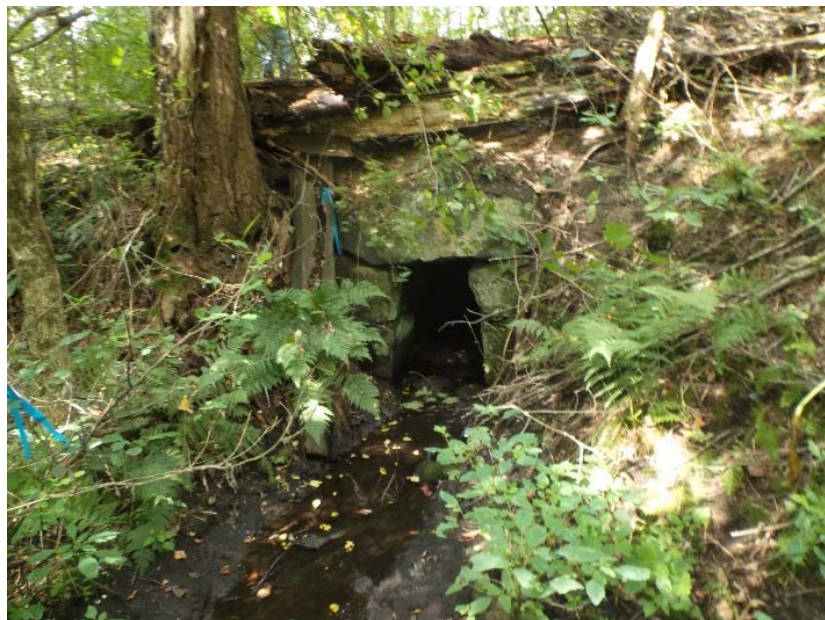
Photo 10: Outlet of Culvert 29

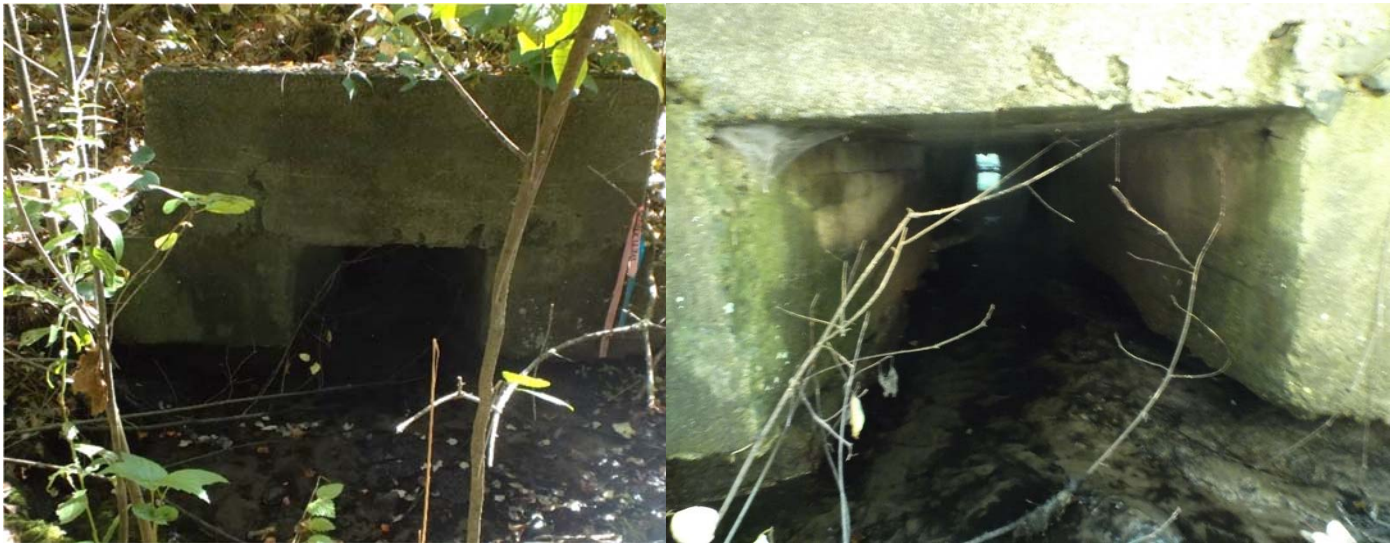
From the photographs there appears to be minor spalling and cracking in the concrete. Inventory information provided by Town staff notes medium severity scour under the footers at the inlet. The stability of the embankment on the downstream end needs to be confirmed as the slope of riprap appears steep and spot repairs appear to have been made to improve stability. If the embankment is unstable, repairs or replacement is needed. The photographs do not allow us to confirm stability of the embankment on the upstream end.

Photo 11: Inlet of Culvert 30

- The stability of the Culvert 30 outlet embankment needs to be confirmed as the slope of riprap appears steep and spot repairs appear to have been made to improve stability. If the embankment is unstable, repairs or replacement is needed.

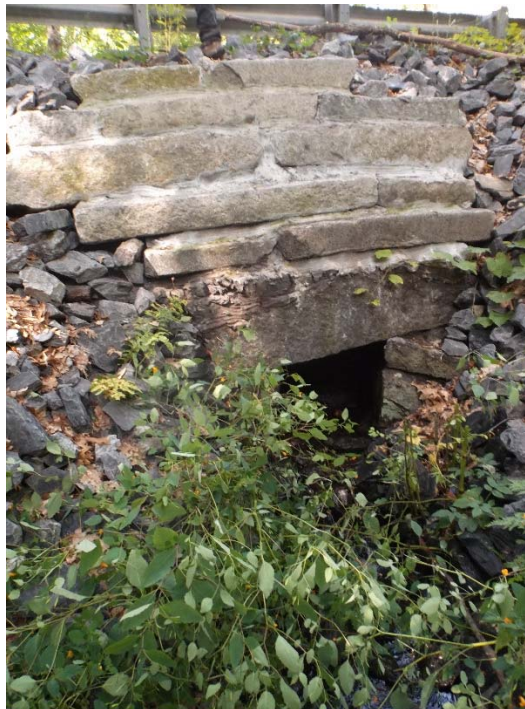
Photo 12: Outlet of Culvert 30

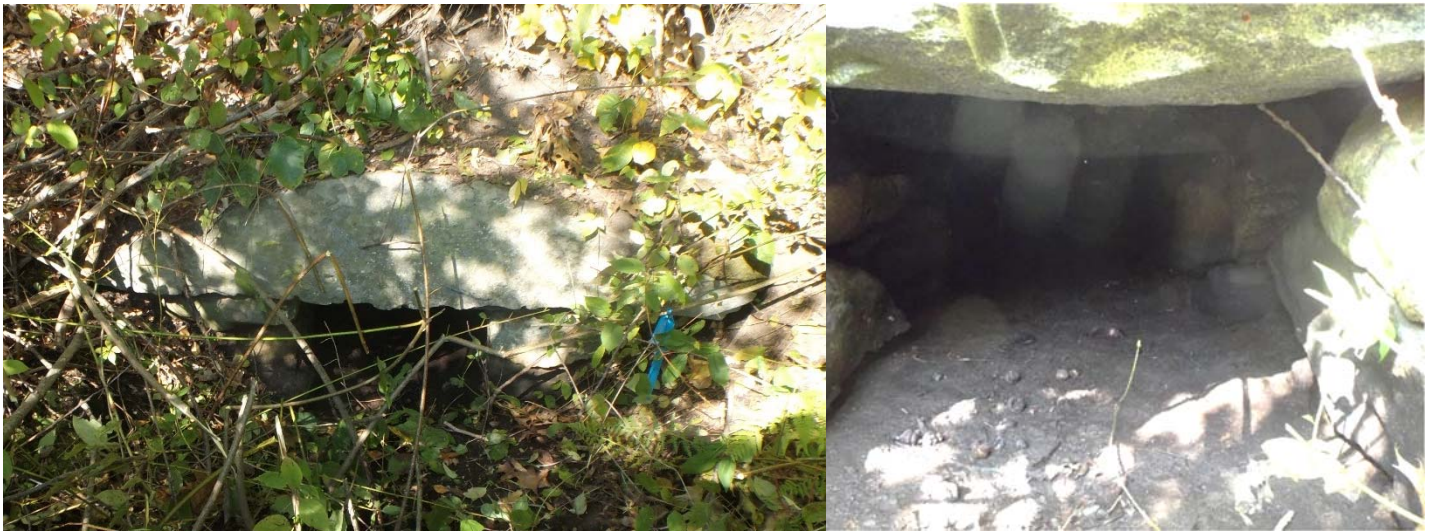
Culvert needs to be cleared of obstructions for further assessment to be completed, especially on upstream end. Verify that there is not loss of backfill material through joints between stones. If loss of backfill material above the culvert is noted, the culvert should be repaired or replaced depending on severity of issues. The culvert width appears to become smaller at the outlet end, reducing flow capacity and increasing the likelihood of getting clogged with debris.

Photo 13: Inlet of Culvert 21

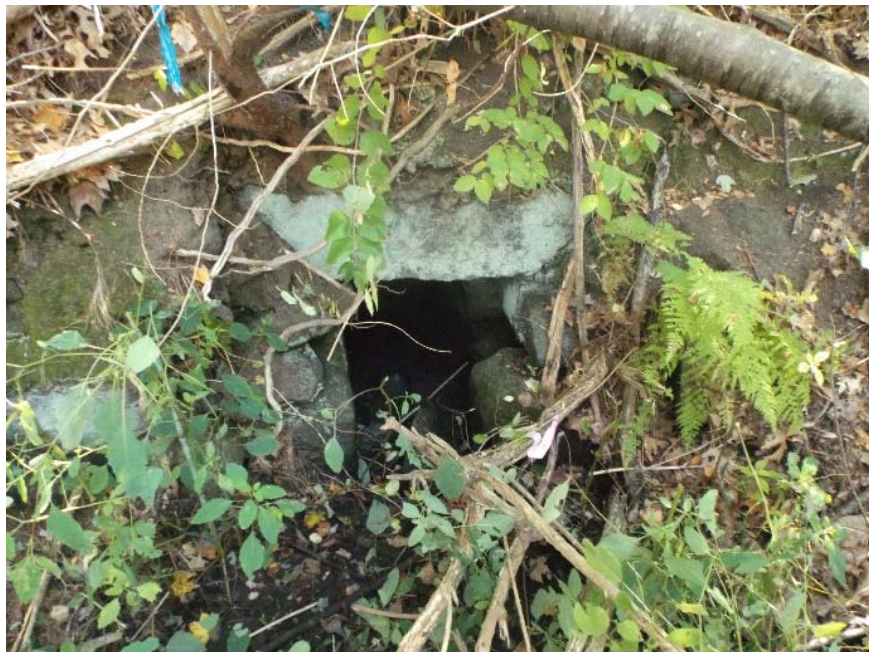
Photo 14: Outlet of Culvert 21

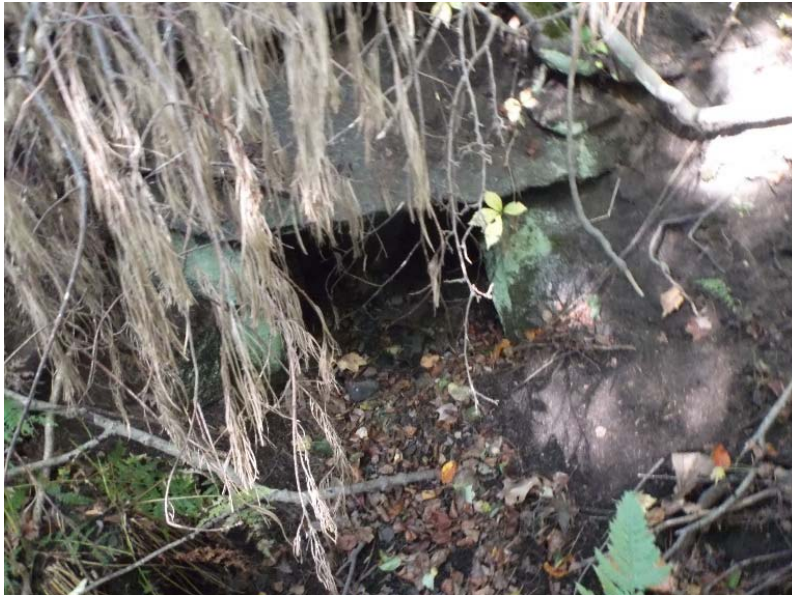
Culvert needs to be cleaned to remove obstructions for further assessment to be completed. Culvert needs verification that stones on upstream and downstream headwall continue to be stable and to verify that there is not loss of backfill material through joints between stones. If headwalls or culvert interior need stabilization, consider repair versus replacement options.

Photo 15: Inlet of Culvert BF202

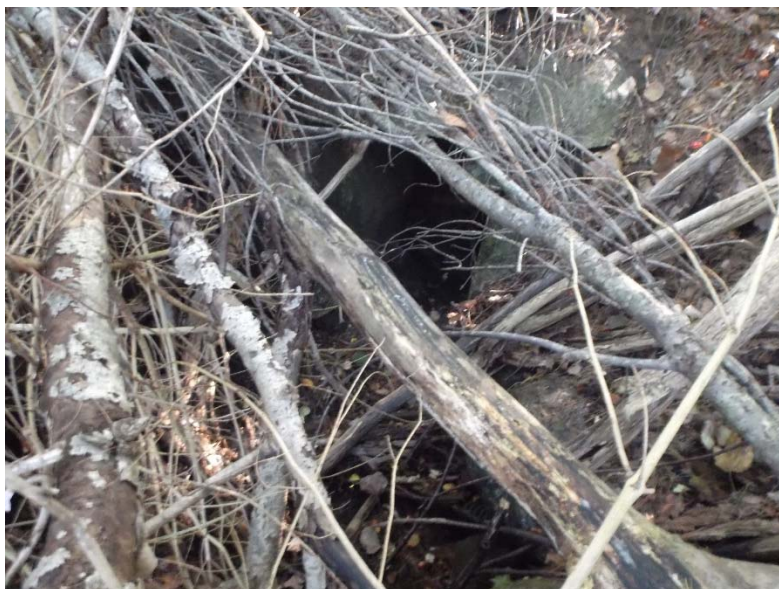
Photo 16: Outlet of Culvert BF202

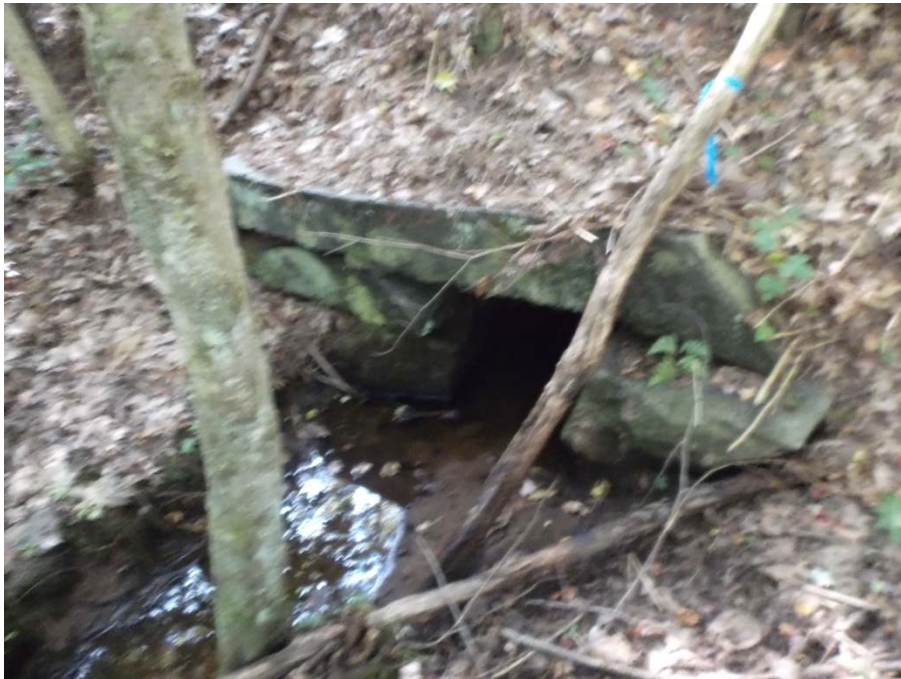
Culvert needs verification that stones on upstream and downstream headwall continue to be stable and to verify that there is not loss of backfill material through joints between stones. If headwalls or culvert interior need stabilization, consider repair versus replacement options.

Photo 17: Inlet of Culvert 101

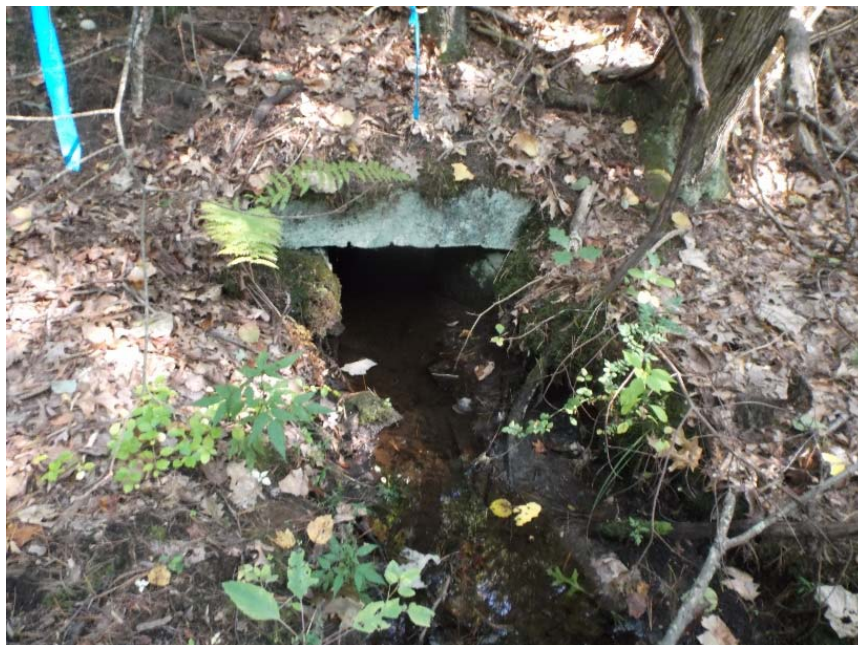
Photo 18: Outlet of Culvert 101

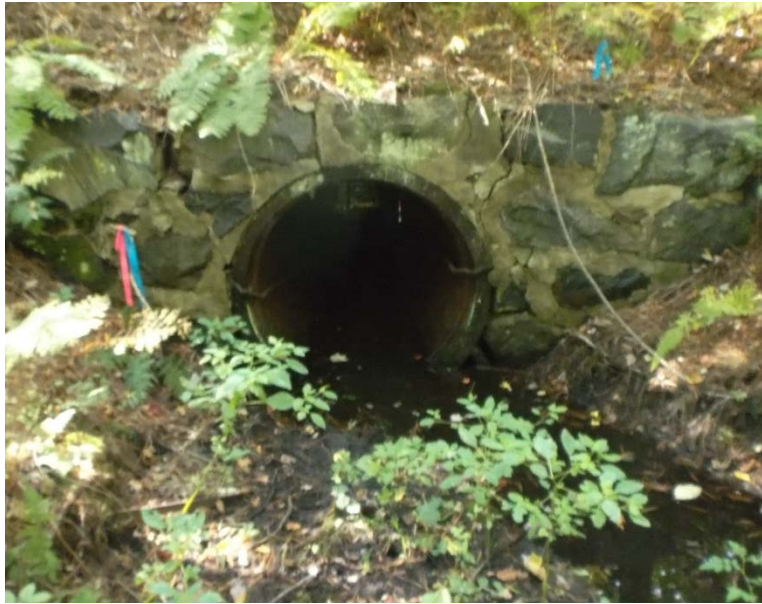
Headwalls need to be repointed with mortar. Pipe appears to be in good condition. Photograph shows steel rods that extend through pipe at inlet – confirm purpose.

Photo 19: Inlet of Culvert BF203

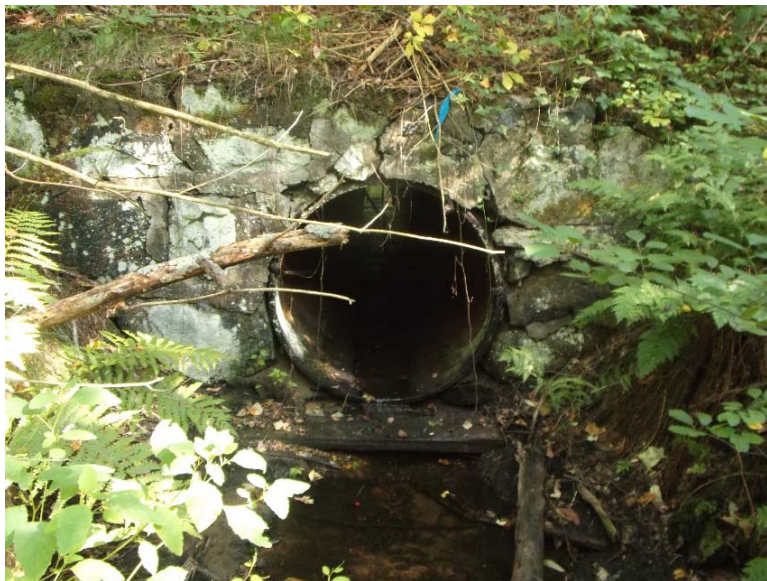
Photo 20: Outlet of Culvert BF203

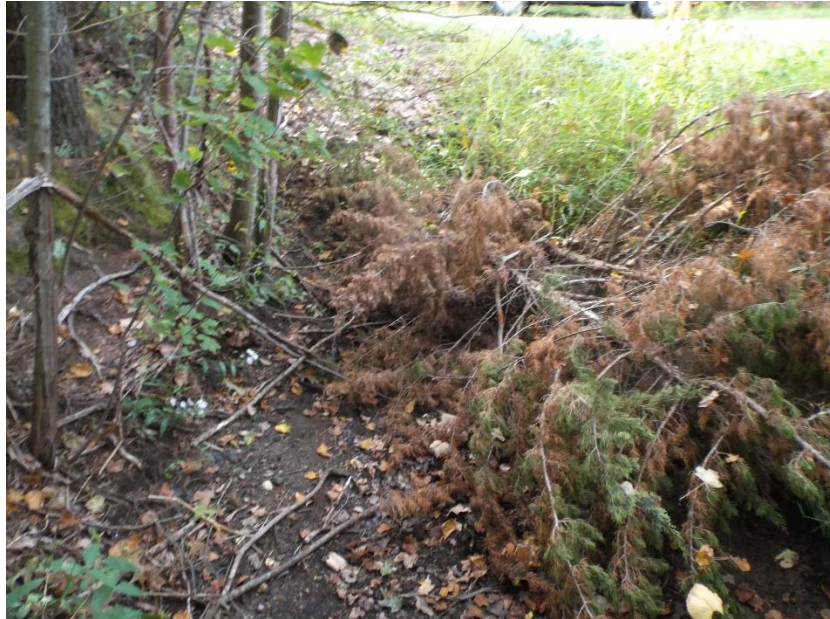
Debris blocks upstream end and reduces hydraulic capacity. It is difficult to determine the culvert condition from the photograph. The inventory data note the inlet and outlet are 1' diameter corrugated metal pipe. Area upstream and downstream of culvert needs to be cleaned to remove obstructions and confirm culvert.

Photo 21: Inlet of Culvert BF204

- If Culvert BF204, under Morse Road, truly is a small diameter culvert, debris removal and further evaluation is needed to determine if replacement is warranted.

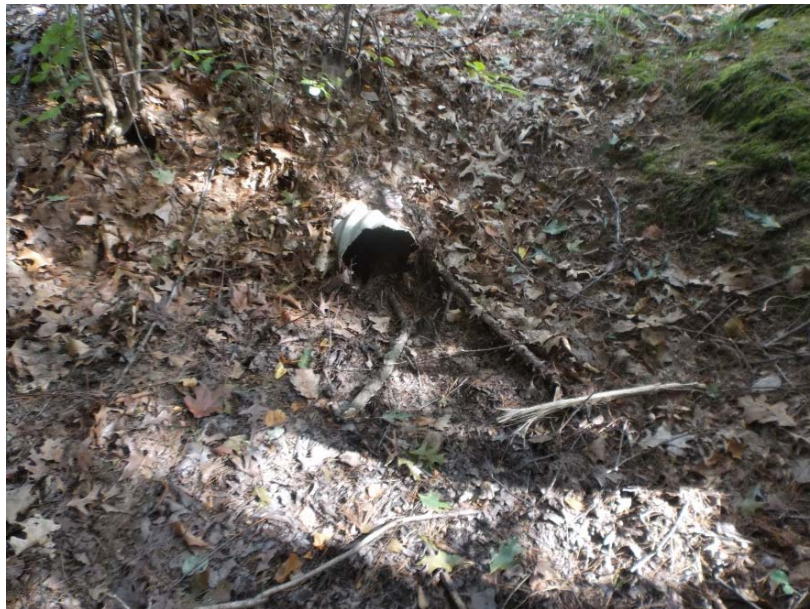
Photo 22: Outlet of Culvert BF204

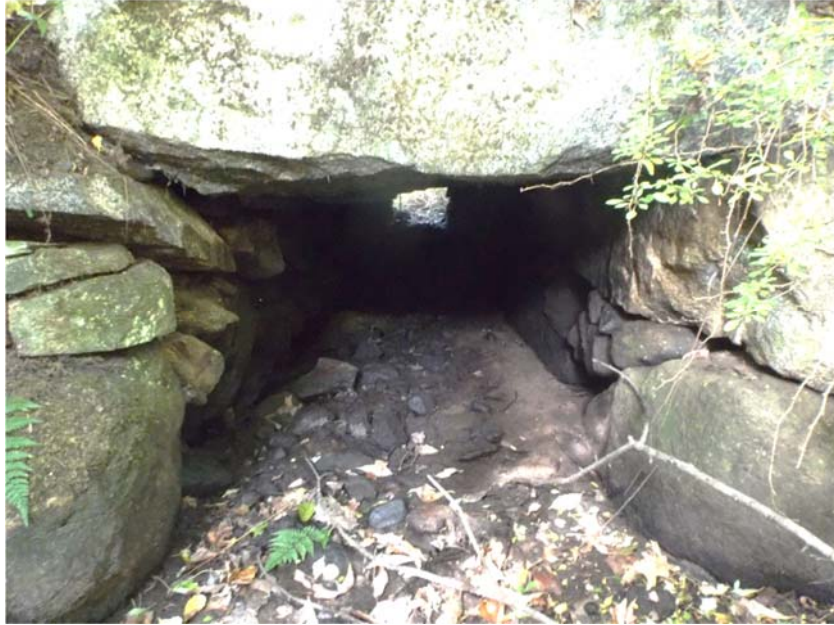
Culvert needs verification that stones on inlet and outlet headwall continue to be stable and to verify that there is not loss of backfill material through joints between stones. If headwalls or culvert interior need stabilization, consider repair versus replacement options.

Photo 23: Inlet of Culvert 75

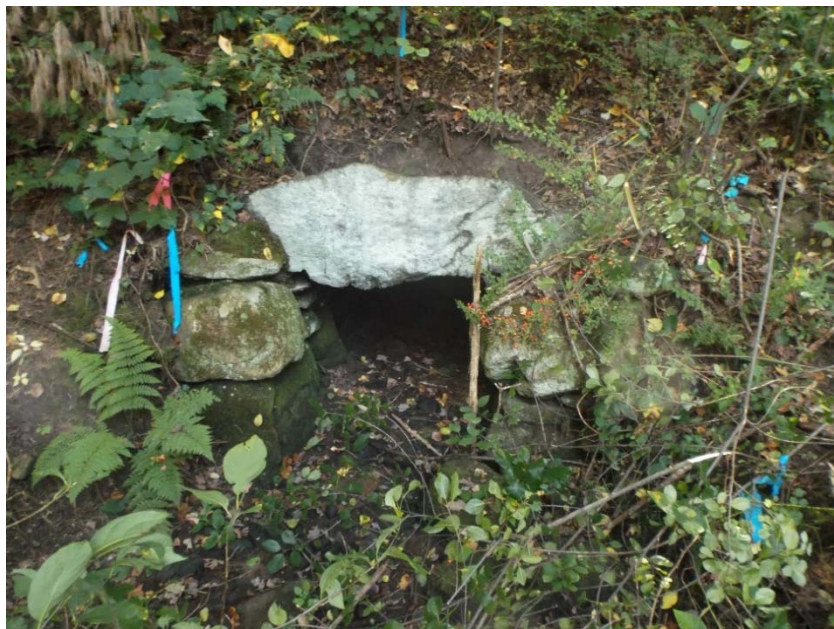
Photo 24: Outlet of Culvert 75

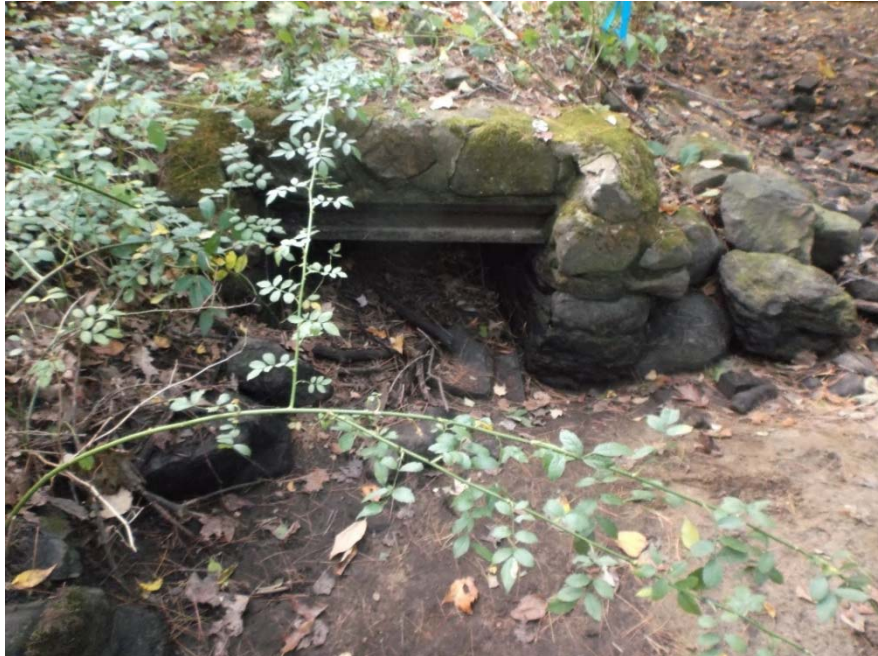
Based on the photographs and inventory information provided by the Town, this outlet of this culvert appears to be blocked. Sediment and material needs to be removed to determine the outlet condition. We cannot determine if the culvert has collapsed. If the culvert has collapsed, it should be replaced. A site visit by is needed to confirm specific next steps.

Photo 25: Inlet of Culvert 32

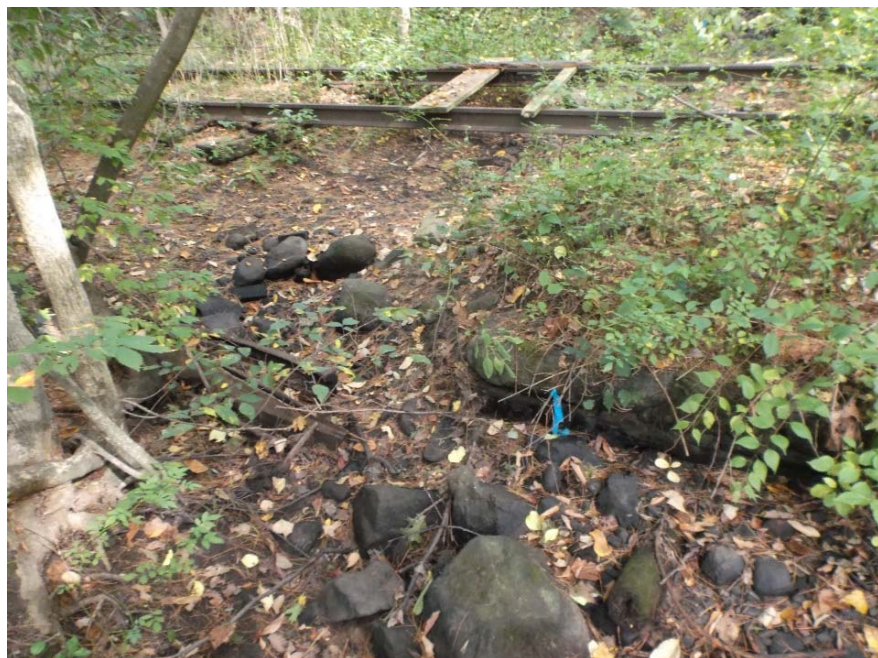
Photo 26: Outlet of Culvert 32

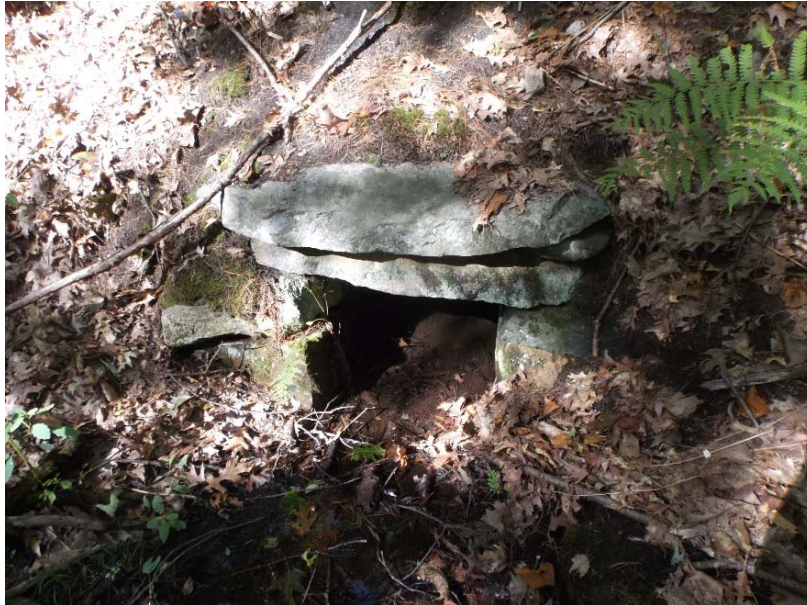
The outlet of this culvert may be collapsed as indicated by the granite block shown at an angle protruding from the water. There is significant debris preventing flow on the downstream side. Culvert needs to be cleaned to remove sediment and obstructions and further assessed.

Photo 27: Inlet of Culvert 107

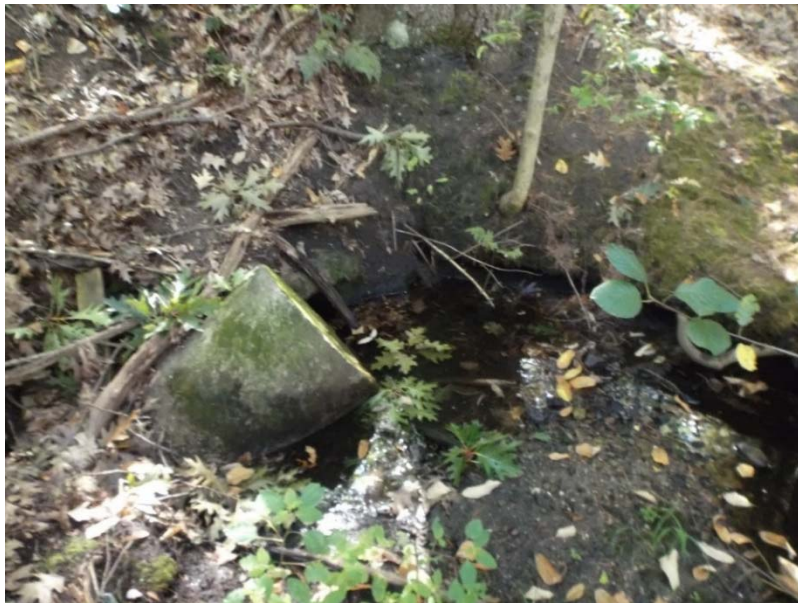
Photo 28: Outlet of Culvert 107

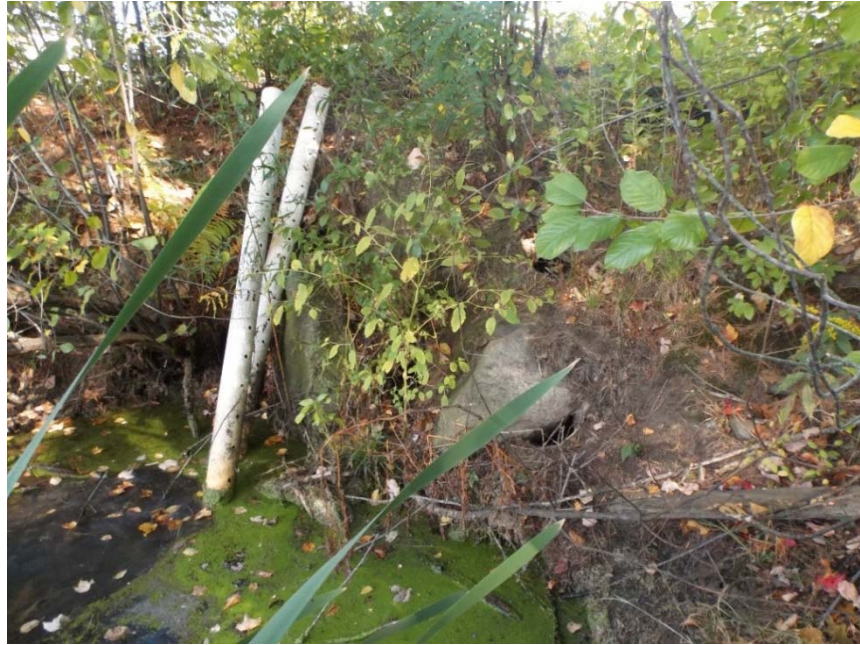
The photographs show a mostly submerged culvert and there is vegetative growth that is blocking the view of the inlet and outlet, therefore the condition cannot be assessed. Additional information is needed (is there a history of flooding at this location?) Debris appear to be reducing hydraulic capacity. Culvert needs to be cleaned to remove sediment and obstructions.

Photo 29: Inlet of Culvert 158

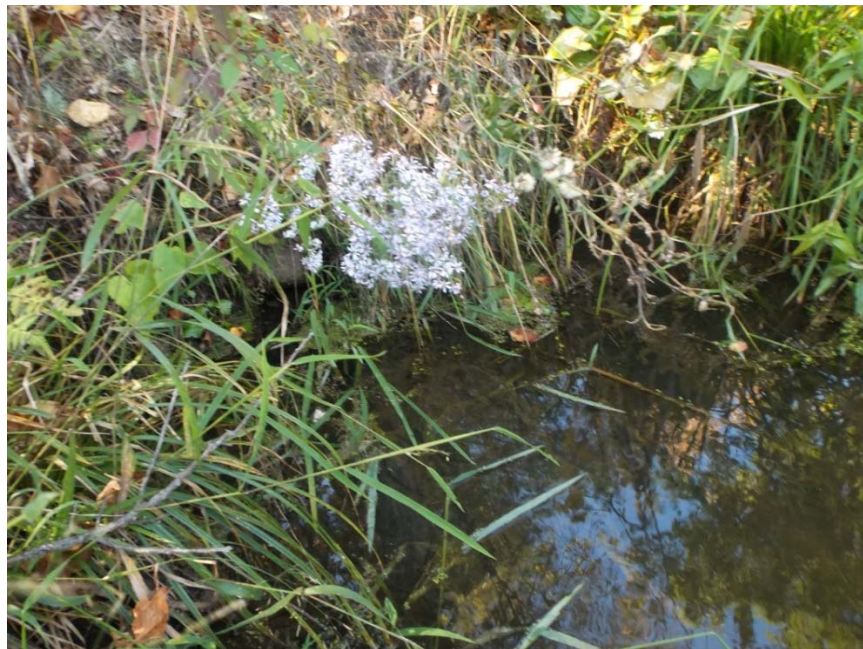
Photo 30: Outlet of Culvert 158
