Field Inspection Report #10

Project Name:	Bruce Freeman Rail Trail	Submitted to:	Andy Sheehan, Town Manager		
Inspection Date:	09/12/2023	Project Address:	Sudbury, MA		
F&O Project #:	20200785.C10	City:	Sudbury	State:	MA
MassDOT Project #	608164	Client:	Town of Sudbury		
		Photos Included:	11 photos

Date/Inspector(s)/Time:	09/12/2023 John Deskavich 9:30 AM – 12:00 PM
-------------------------	--

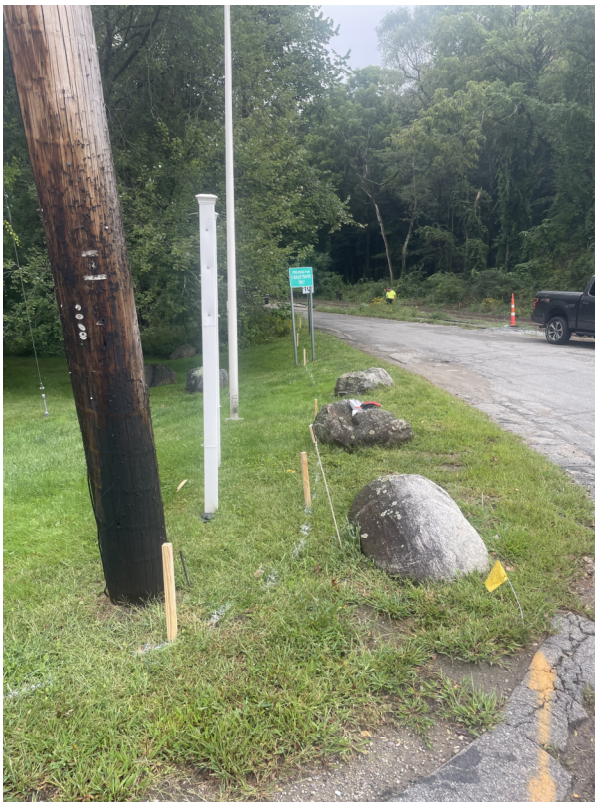
- Grade stakes laid out for proposed driveway widening at Ti-Sales Driveway.
- Rough grading for the trail base. No signs of major washout from previous storm events.

Photo 1: STA 175+50 looking North. Grade stakes placed at Ti Sales Driveway for new opening.

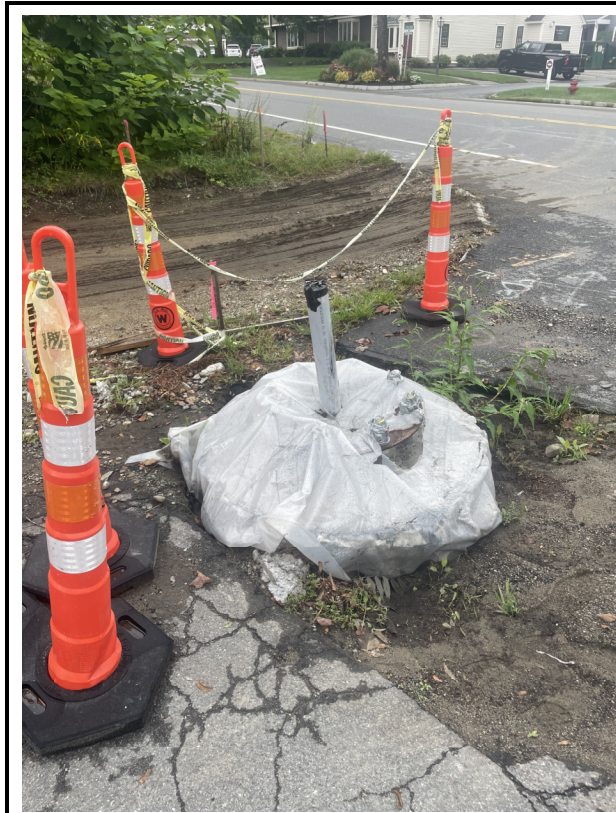
Photo 3: STA 175+50. Signal foundation installed at Ti Sales Driveway is coned off and covered to protect from vehicle damage.

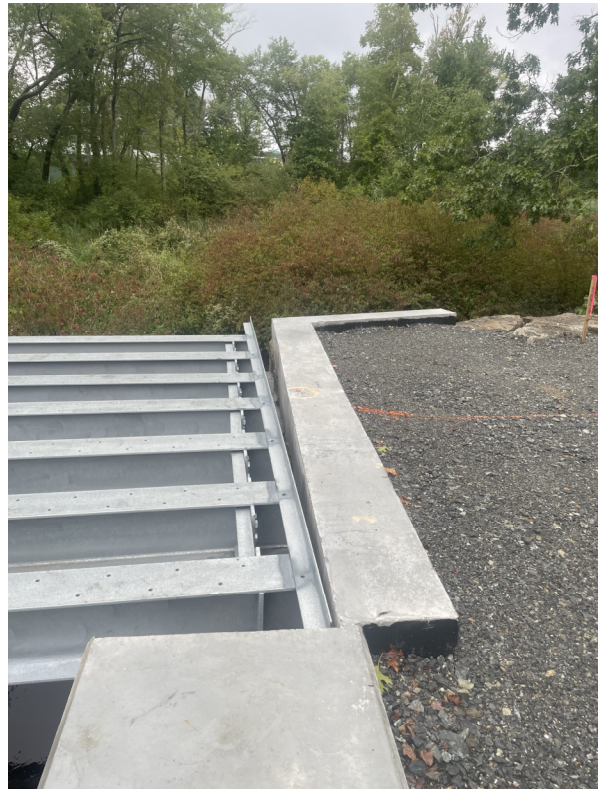
- Steel structure for the new crossing at Hop Brook has been erected. No signs of major deformities.

Photo 4: STA 191+00 facing East. Steel Structure erected at Hop Brook.

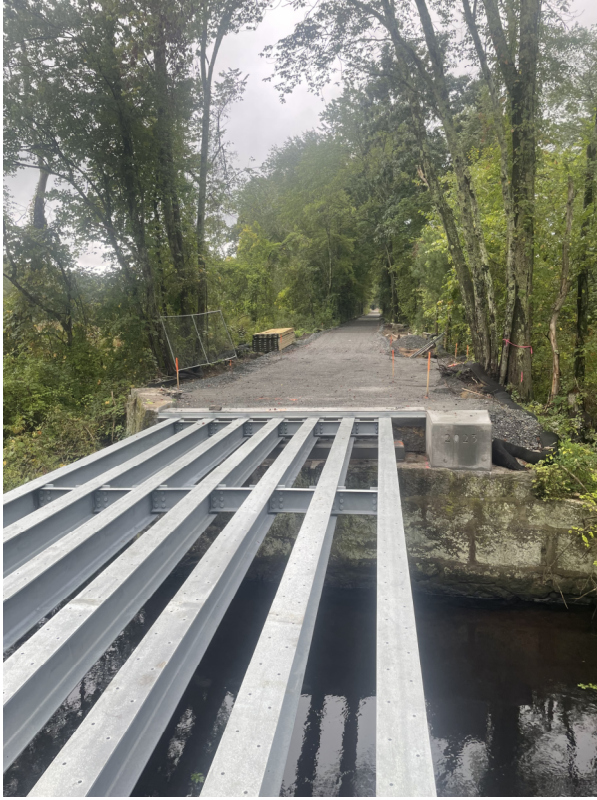
Photo 5: STA 191+00 looking North. Steel Structure at Hop Brook.

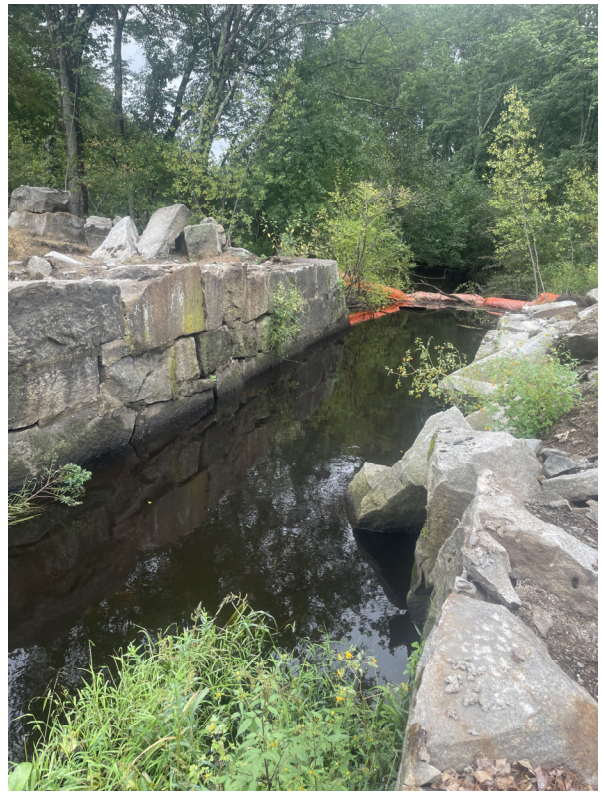
- Only the existing wingwalls are present. Grading along both approaches has occurred.
- No signs of sediment collecting in the stream or nearby wetland areas.
- No signs of major washout along the sides of the trail due to storm events.

Photo 6: STA 264+50 looking East. Pantry Brook crossing.

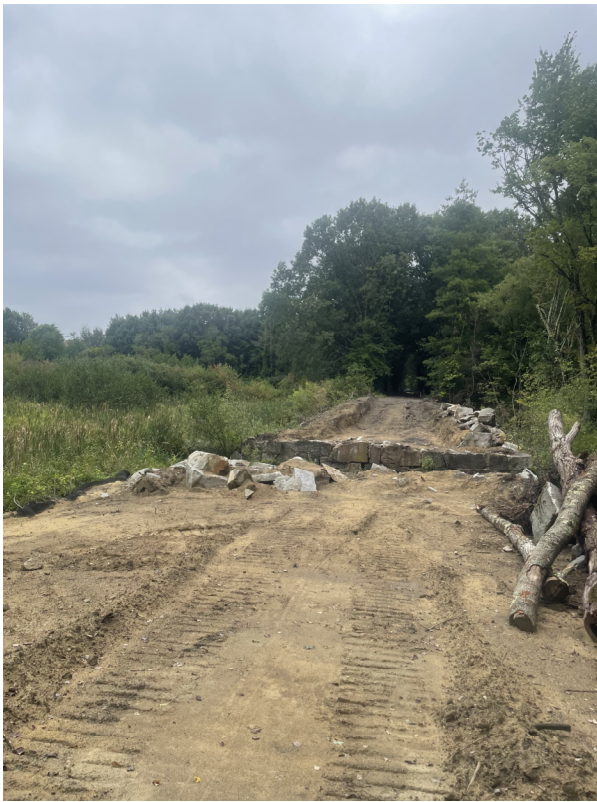
Photo 7: STA 264+00 looking North. Pantry Brook crossing.

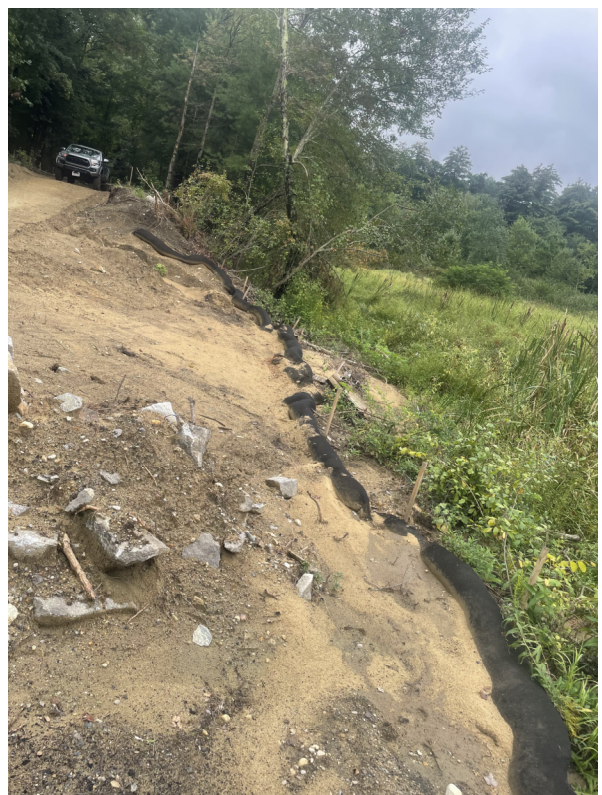
Photo 8: STA. 265+00 looking south at the side slope of Pantry Brook.

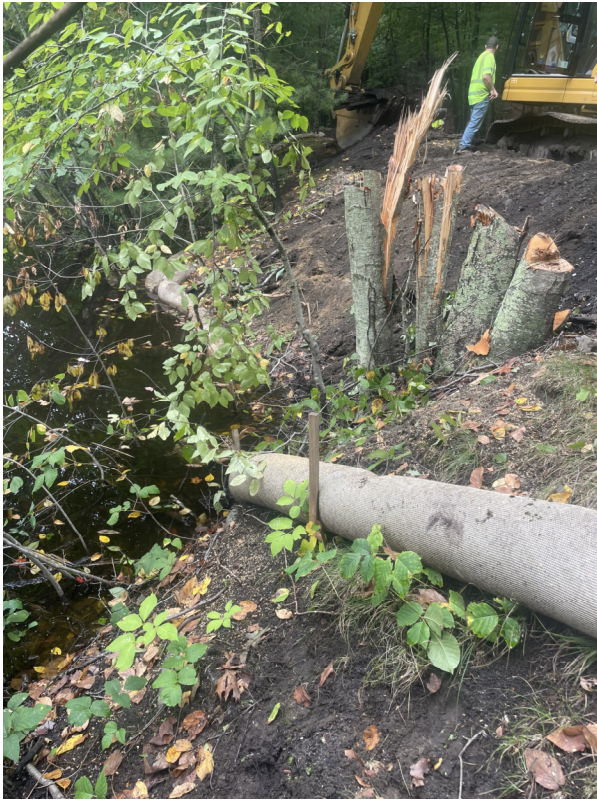
- At the request of the Massachusetts Department of Transportation, F&O observed progress near STA 332+00 and 333+00. The western wetland pond area appeared to have higher than normal water levels. Although water levels were higher than normal, no signs of slope failure were noticed between the wetlands and the western limit of the proposed trail.
- There is an existing 8” Cast Iron/Steel pipe that provides a hydraulic connection between the wetland pond and the other side of the trail. It was observed that there is steady flow

Photo 9. STA 332+00 looking North in between wetland pond area and western limit of proposed trail. Approximate location of the inlet for hydraulic connection.

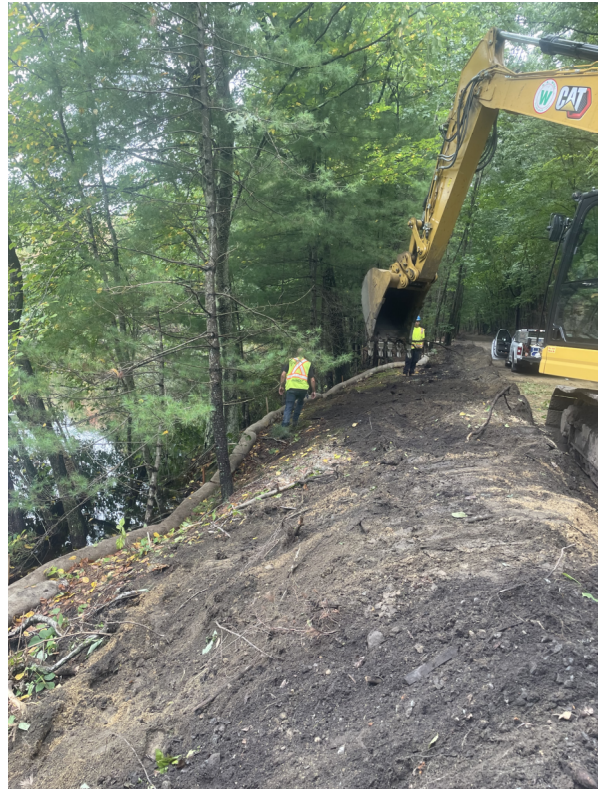
Photo 10. STA 332+00 looking North in between the wetland pond area and western limit of proposed trail. Side slope leading to pond appears to be in stable condition even after major rain events.

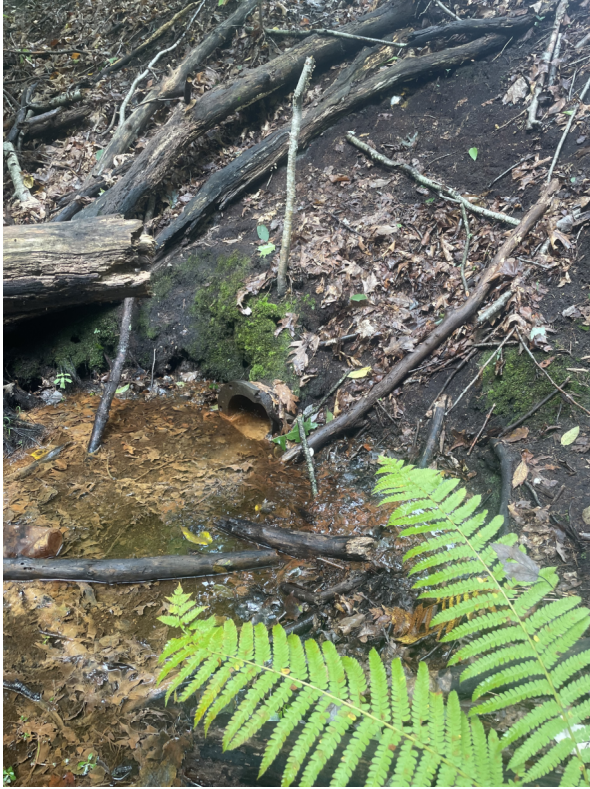
coming out the outlet of the pipe from the pond area. It is unknown currently where the inlet of the pipe is. The pipe appears to be in appropriate condition for re-use.

Photo 11: STA 332+00 at eastern limit of the proposed trail. Outlet for the existing hydraulic connection.
