DPW Offices and Garage

Town of Sudbury ADA Transition Plan

October 2020

Institute for Human Centered Design

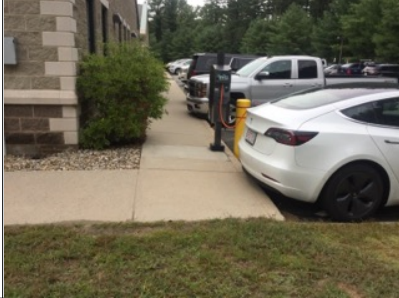
Exterior route < 36" wide Exterior route < 48" wide	27.75" -	Ensure that a clear width of 36" min. is maintained at the accessible route with 48" preferred per 521 CMR. Relocate car charging station so that there is 36" clear min. Trim hedges and install wheel stops so that vehicles do not block the sidewalk. (Cost is beyond the scope of the project.)	1	-	\$0
Off-Street Parking Lot or Garage												
2	Parking Lot - Car Accessible Space Access Aisle	Ext.		Off-Street Parking Lot or Garage	Visitor

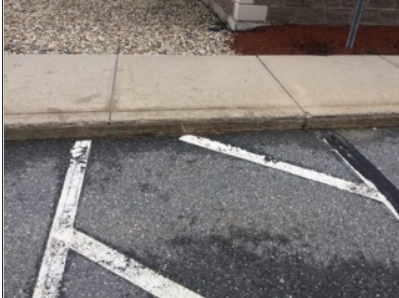
Access aisle does not adjoin an accessible route	-	Ensure the access aisle by the car accessible space adjoins an accessible route. Provide a curb ramp.	1	2800	\$2800

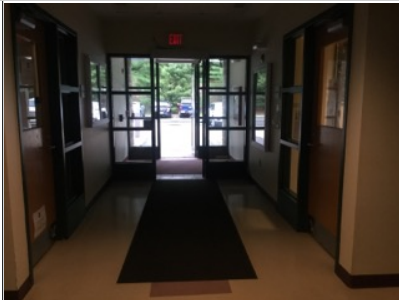
Emergency Exit												
3	Central Exit	1		Emergency Exit	N/A

Tactile sign not provided at exit Illuminated Int. Symbol of Acc. not provided (MAAB) Mat not securely attached	- - -	Provide tactile exit signs with raised characters and braille at exit doors. Mount signs between 48"- 60" above the finished floor located on the latch side of the door. Provide an illuminated sign with the International Symbol of Accessibility. Secure the mat.	1	432 Labor	\$432
4	South Exit	1		Emergency Exit	N/A

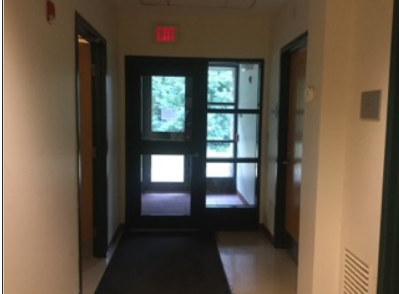
Tactile sign not provided at exit Illuminated Int. Symbol of Acc. not provided (MAAB) Mat not securely attached	- - -	Provide tactile exit signs with raised characters and braille at exit doors. Mount signs between 48"- 60" above the finished floor located on the latch side of the door. Provide an illuminated sign with the International Symbol of Accessibility. Secure the mat.	1	432 Labor	\$432

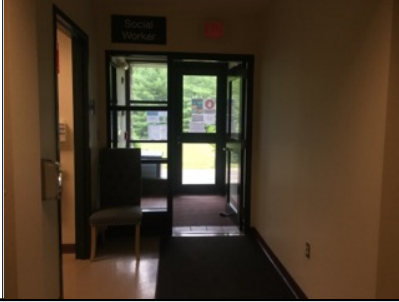
Tactile sign not provided at exit Illuminated Int. Symbol of Acc. not provided (MAAB) Mat not securely attached	- - -	Provide tactile exit signs with raised characters and braille at exit doors. Mount signs between 48"- 60" above the finished floor located on the latch side of the door. Provide an illuminated sign with the International Symbol of Accessibility. Secure the mat.	1	432 Labor	\$432
Access to Goods and Services												
Interior Access Route												
6	Women's Toilet Room	1		Interior Access Route	N/A

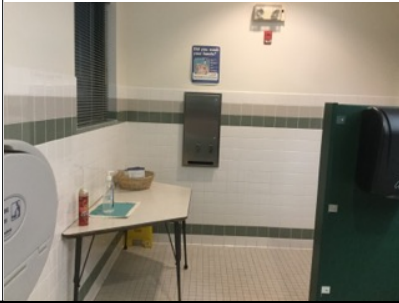
Route < 36" wide	30"	Relocate table to ensure that a clear width of 36" min. is maintained at the accessible route. Route is allowed to narrow to narrow to 32" for a depth of 24".	1	Labor	\$0
7	Board of Health	1		Interior Access Route	N/A

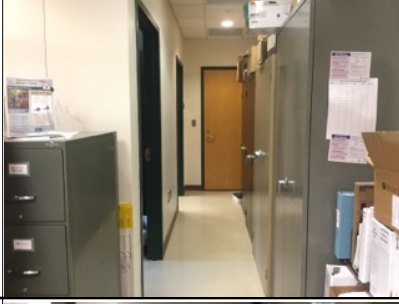
Route < 36" wide	35.25"	Relocate cabinets to ensure that a clear width of 36" min. is maintained at the accessible route.	1	Labor	\$0

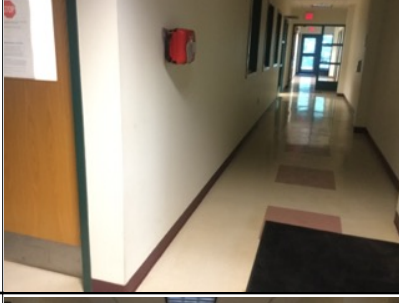
8	Corridor by Main Entrance	1		Interior Access Route	N/A

Obstructed by protruding objects	5"	Relocate or recess fire alarm box.	1	256	\$256
9	Application Forms Area/Overlook	1		Interior Access Route	N/A

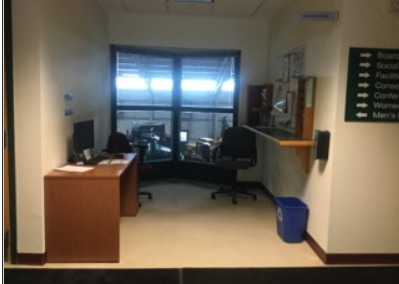
Obstructed by protruding objects	41.5"	Provide a cane-detectable barrier on the open side of the high counter.	1	306	\$306

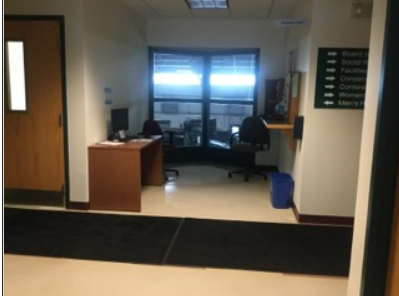
Surface not stable, firm, and slip-resistant	-	Secure mats.	2	Labor	\$0
11	Transfer Station Cemetery Department	1		Interior Access Route	N/A

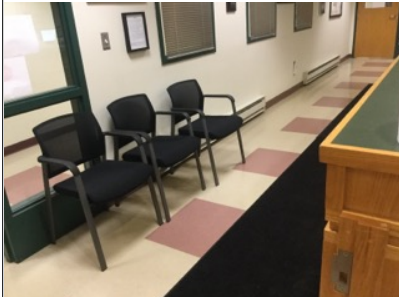
Surface not stable, firm, and slip-resistant	-	Secure mat.	1	Labor	\$0
Doors, Doorways, & Gates												
12	Women's Toilet Room	1		Doors, Doorways, & Gates	Toilet Room

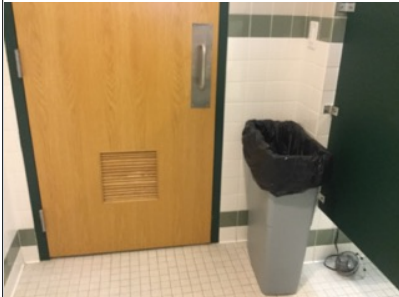
Maneuvering clearance(s) not provided	-	Relocate trash container so that there is 18" min. on the pull side of the door.	1	Labor	\$0
13	Conference Room	1		Doors, Doorways, & Gates	Meeting Room

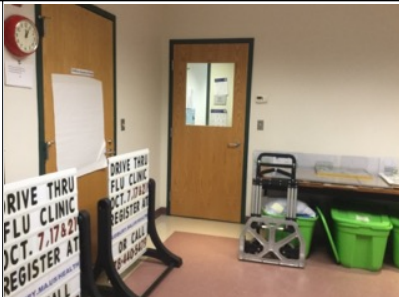
Maneuvering clearance(s) not provided	-	Relocate table so that there is 18" min. on the latch side of the door.	1	Labor	\$0
Signage												
14	Transfer Station Cemetery Department	1		Signage	Designation

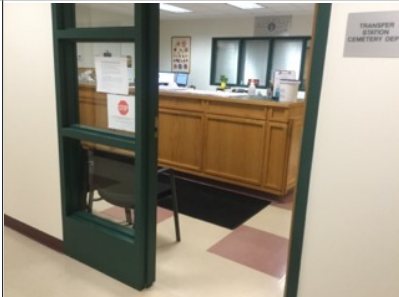
Sign not located on the latch side of the door	-	Locate sign at permanent rooms alongside the door on the latch side.	1	Labor	\$0

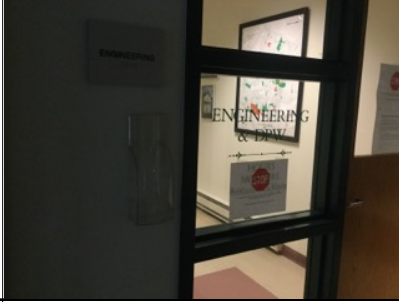
Signage lacks clear floor space	-	Remove the plastic container to ensure that a clear floor space of 18" by 18" is centered on the tactile characters.	1	Labor	\$0
16	Conservation	1		Signage	Designation

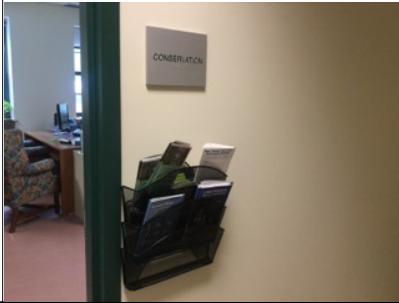
Signage lacks clear floor space	-	Remove the file folder to ensure that a clear floor space of 18" by 18" is centered on the tactile characters.	1	Labor	\$0
Operable Parts												
17	Application Forms Area/Overlook	1		Operable Parts	Other

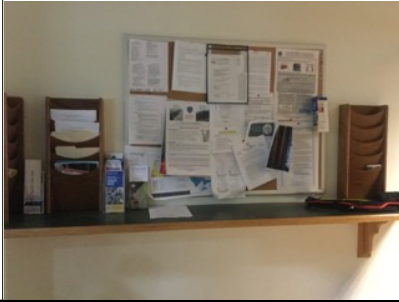
Reach < 15" or > 48"(forward/side approach)	63"	Relocate one of each form to be located between 15"- 48" above the finished floor.	1	Labor	\$0
18	Transfer Station Cemetery Department	1		Operable Parts	Clothes Rod/Hooks

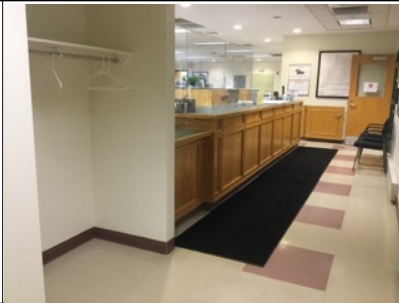
Reach < 15" or > 48"(forward/side approach)	62.5"	Relocate clothes rod to be no higher than 48" above the finished floor.	1	256	\$256

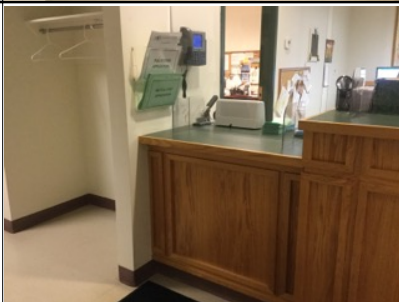
19	Transfer Station Cemetery Department	1		Operable Parts	Other

Reach < 15" or > 48"(forward/side approach)	56"	Relocate one of each form to be located between 15"- 48" above the finished floor.	1	Labor	\$0

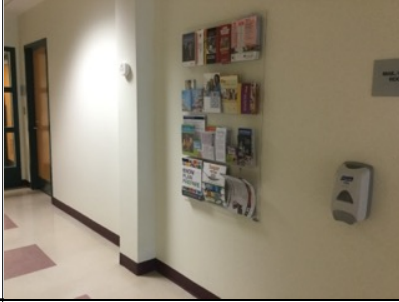
Reach < 15" or > 48"(forward/side approach)	61", 73"	Relocate one of each form to be located between 15"- 48" above the finished floor.	1	Labor	\$0
21	Corridor Near Mail/Copy Room	1		Operable Parts	Other

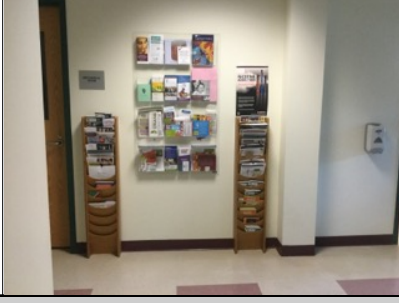
Reach < 15" or > 48"(forward/side approach)	61", 73"	Relocate one of each form to be located between 15"- 48" above the finished floor.	1	Labor	\$0
Dining or Work Surfaces												
22	Conservation	1		Dining or Work Surfaces	Work Surface

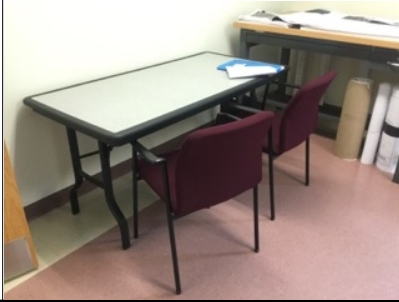
Knee or toe clearance not provided	26.5"	Provide at least 1 dining or work surface with 27" min. knee and toe clearance.	1	700	\$700
23	Director of Operations	1		Dining or Work Surfaces	Work Surface

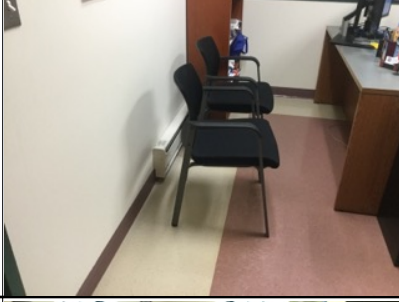
Clear floor space not provided at work surface	44"	Relocate desk so that there is 48" clear min.	1	Labor	\$0

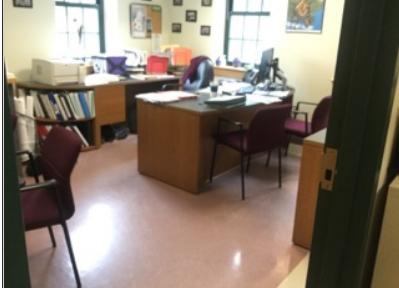
24	Conservation	1		Dining or Work Surfaces	Work Surface

Clear floor space not provided at work surface	37"	Relocate desk so that there is 48" clear min.	1	Labor	\$0

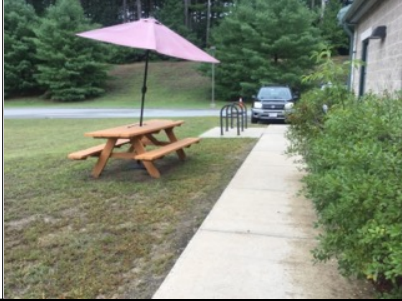
Picnic table not on an accessible route	-	Ensure that the dining surface is connected to an accessible route. (Cost estimate for a 6' long 4' wide concrete route.)	1	384	\$384
Toilet & Bathing Rooms												
Lavatory												
26	Men's Toilet Room	1		Lavatory	N/A

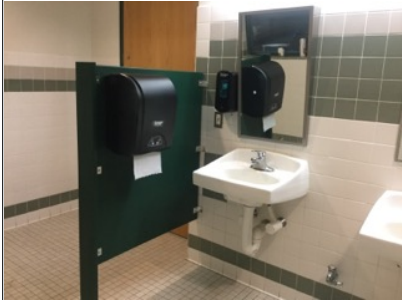
Dispensers not within reach range	47"	Lower the soap dispenser to 42" max. above the floor.	1	353	\$353
Toilet Compartment												
27	Women's Toilet Room	1		Toilet Compartment

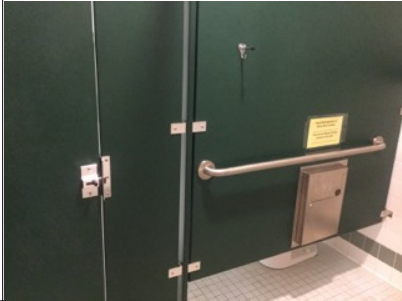
Door has non-compliant hardware	-	Provide hardware that can be operable with one hand and not require tight grasping, pinching, or twisting of the wrist.	1	70	\$70
28	Men's Toilet Room	1		Toilet Compartment	Accessible Compartment

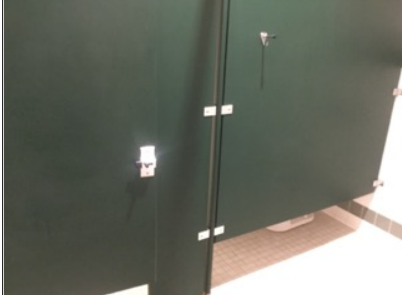
Door has non-compliant hardware Door has malfunctioning self-closing hinge	- -	Provide hardware that can be operable with one hand and not require tight grasping, pinching, or twisting of the wrist. Repair hinge.	1	70 Labor	\$70

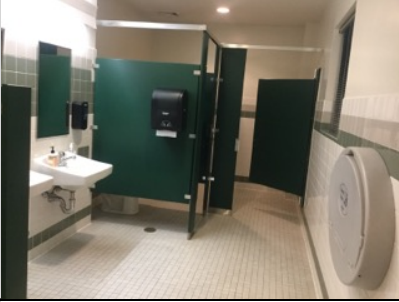
Door has malfunctioning self-closing hinge	-	Repair hinge.	1	Labor	\$0
30	Women's Toilet Room	1		Toilet Compartment

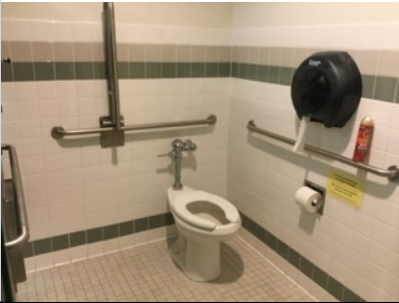
Non-compliant toilet paper dispenser	-	Remove toilet paper dispenser that is mounted above the grab bar.	1	353	\$353
Urinal												
31	Men's Toilet Room	1		Urinal	N/A

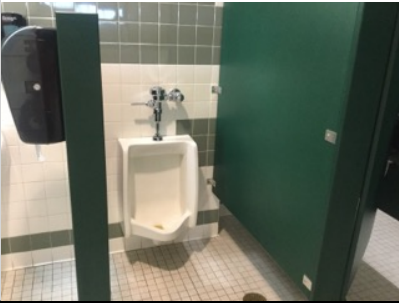
Urinal recessed > 24" has > 36" clear width	32"	If urinal is recessed greater than 24" ensure there is a clear width of 36". Relocate the partition.	1	353	\$353
Dispensers												
32	Women's Toilet Room	1		Dispensers	Tampon Dispenser

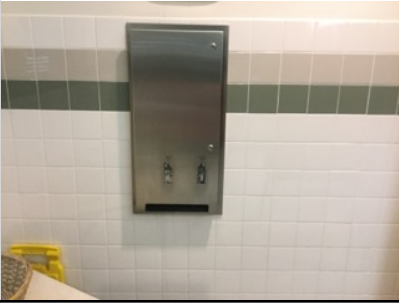
Not operable with a closed fist	-	Provide a dispenser that can be operable with one hand and not require tight grasping, pinching, or twisting of the wrist.	1	1000	\$1000
33	Women's Toilet Room	1		Dispensers	Paper Towel Dispenser

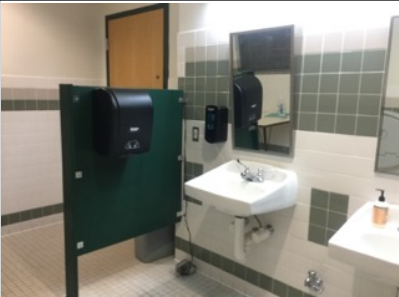
Dispenser acts as a protruding object	9"	Relocate paper towel dispensers out of the circulation path.	2	256	\$512

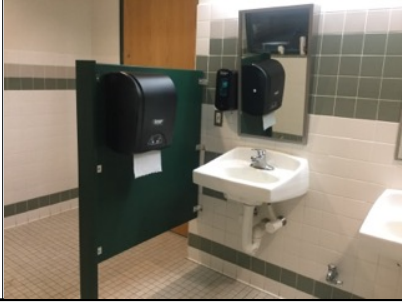
Dispenser acts as a protruding object	9"	Relocate paper towel dispensers out of the circulation path.	2	256	\$512
Additional Access												
Drinking Fountains												
35	Drinking Fountain Near Women's Toilet Room	1		Drinking Fountains	Low

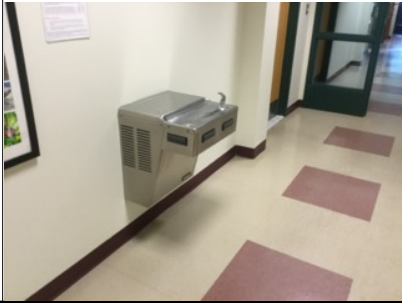
No drinking fountain provided for standing users Knee or toe clearance not provided	- 26"	Install a Hi-Lo drinking fountain. Provide knee and toe clearance, 27" min. high at drinking fountain for seated users.	1	4216	\$4216
Overall Review												
36	DPW Garage	1

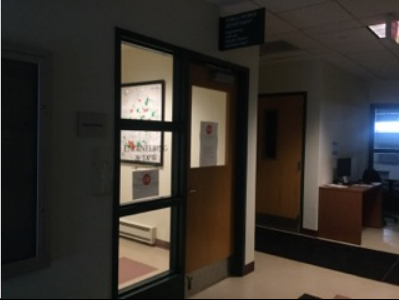
Recommend increasing lighting in this area so that signage is more legible.	1	-	\$0
39	Engineering Conference Room	1

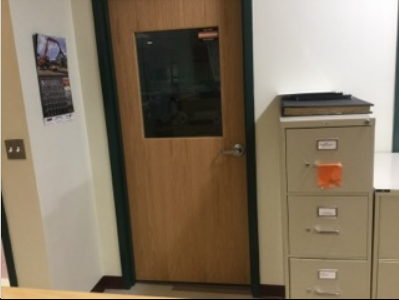
Recommend providing designation sign with raised character and braille even though a sign is not provided.	1	-	\$0
40	Front Walkway	Ext.

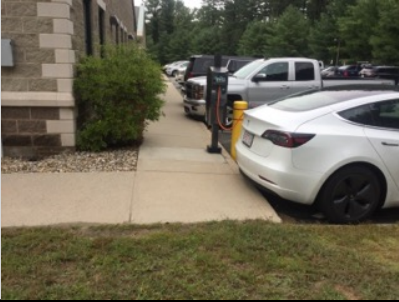
Recommend providing an accessible vehicle charging station with 3' min. access aisles on each side and a 10'-13' wide vehicle space.	1	-	\$0
41	Picnic Table by North Exit	Ext.

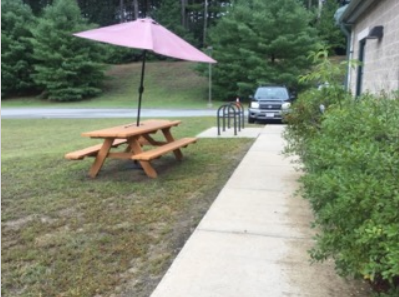
Recommend providing an accessible 48-inch wide route around the picnic table with concrete, asphalt or stone dust.	1	-	\$0
