Flynn Building

Town of Sudbury ADA Transition Plan

December 2020

Institute for Human Centered Design

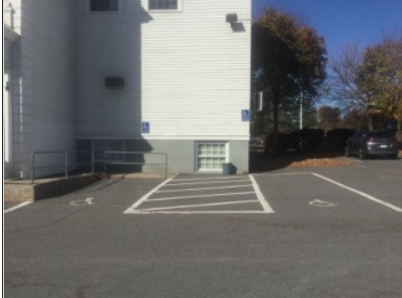
Sign does not have the designation "Van Accessible"	-	Add the designation "Van Accessible" to one of the two accessible parking spaces by the building entrance.	1	500	\$500
Entrance												
2	Inaccessible Entrance at South Stair	G		Entrance	Secondary Entrance

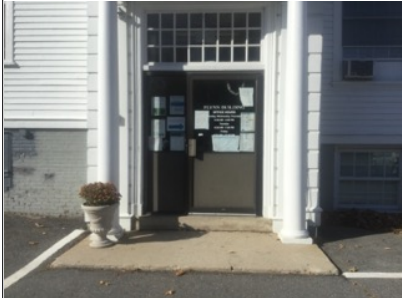
Entrance not on an accessible route Directional sign to accessible entrance not provided	- -	Provide a directional sign indicating the location of the nearest accessible entrance.	1	346	\$346
3	Accessible Entrance at North Stair	G		Entrance	Main Entrance

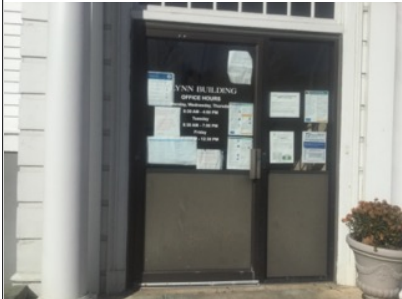
International Symbol of Accessibility not provided	-	Provide a sign with the International Symbol of Accessibility (ISA).	1	346	\$346

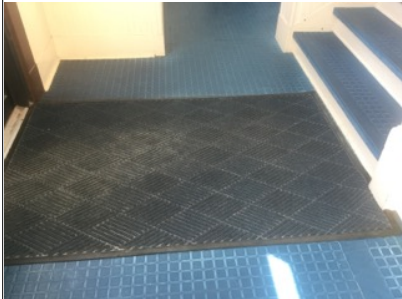
4	Accessible Entrance at North Stair	G		Entrance	Main Entrance

Mat not securely attached	-	Secure the mat.	1	Labor	\$0

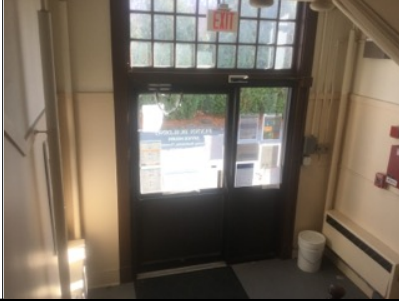
Tactile sign not provided at exit	-	Provide tactile exit signs with raised characters and braille at exit doors. Mount signs between 48"- 60" above the finished floor located on the latch side of the door.	1	232	\$232
6	North Stair (Accessible) Exit	G		Emergency Exit

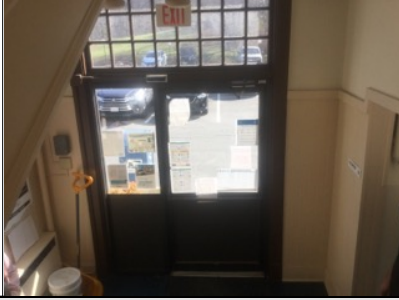
Tactile sign not provided at exit Illuminated Int. Symbol of Acc. not provided (MAAB)		Provide tactile exit signs with raised characters and braille at exit doors. Mount signs between 48"- 60" above the finished floor located on the latch side of the door. Provide an illuminated sign with the International Symbol of Accessibility.	1	432	\$432
Access to Goods and Services												
Interior Access Route												
7	Corridor	1		Interior Access Route	N/A

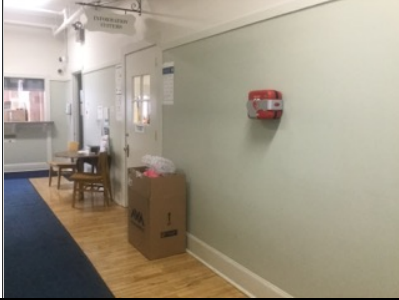
Obstructed by protruding objects	5.5"	Relocate red box out of the circulation path.	1	Labor	\$0

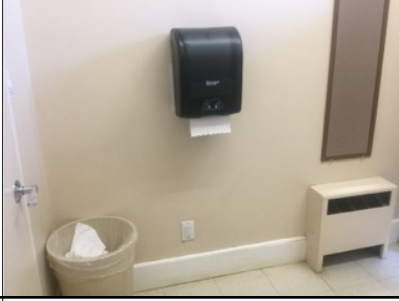
8	Men's Toilet Room	1		Interior Access Route	N/A

Obstructed by protruding objects	9"	Relocate paper towel dispenser out of the circulation route and the door maneuvering clearance.	1	256	\$256
9	Treasurer/ Tax Collector and Accounting	1		Interior Access Route	N/A

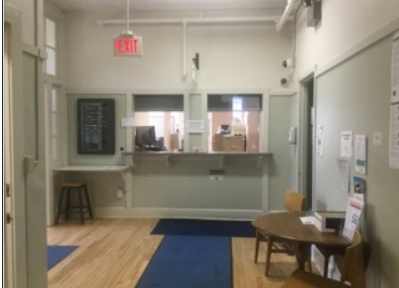
Surface not stable, firm, and slip-resistant	-	Secure mat.	1	Labor	\$0

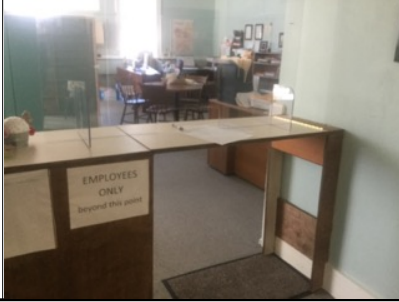
Surface not stable, firm, and slip-resistant	-	Secure the mat.	1	Labor	\$0
Doors, Doorways, & Gates												
11	Information Systems	1		Doors, Doorways, & Gates	Office

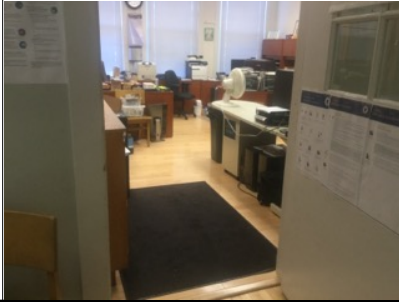
Clear width at door < 32"	30.5"	Install offset hinges to ensure that the door has a clear width of 32 inches.	1	2232	\$2232
12	Single-User Toilet Room	2		Doors, Doorways, & Gates	Toilet Room

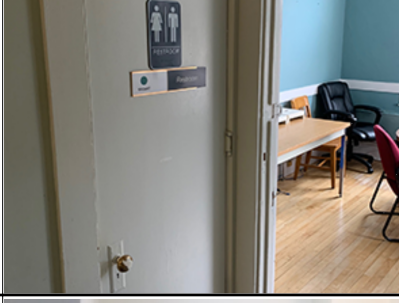
Clear width at door < 32" Hardware not operable with a closed fist	25.75" -	Widen the door so that there is 32" min. clear width. Provide hardware that can be operable with one hand and not require tight grasping, pinching, or twisting of the wrist. (Cost is included in Toilet Room record, ID # 55.)	1	-	\$0
13	Women's Toilet Room	1		Doors, Doorways, & Gates	Toilet Room

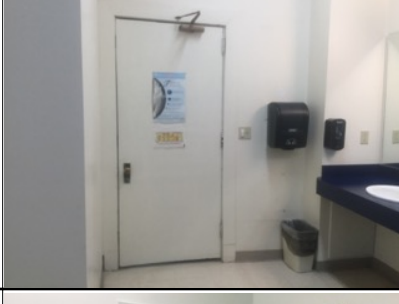
Maneuvering clearance(s) not provided	5"	Provide an automatic door opener.	1	3060	\$3060

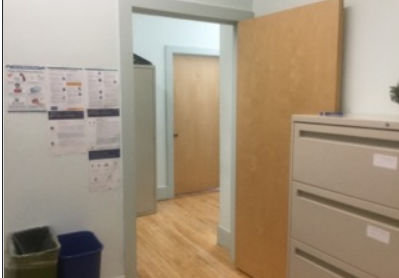
14	Human Resources (West Office) Path to Human Resources & Assistant Town Manager	2		Doors, Doorways, & Gates	Office

Maneuvering clearance(s) not provided	43.75"	Relocate file cabinet to provide 60" deep of maneuvering clearance at door.	1	Labor	\$0

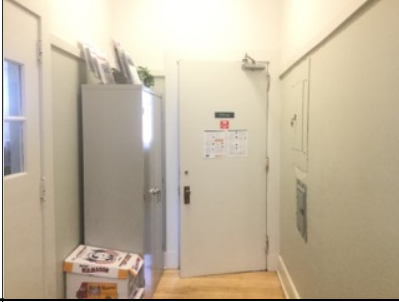
Maneuvering clearance(s) not provided Hardware not operable with a closed fist Door requires > 5 lbs. of force to open	6" - 15 lbs.	Relocate furniture out of the required 18" maneuvering clearance on the latch side of the door. Provide hardware that can be operable with one hand and not require tight grasping, pinching, or twisting of the wrist. Adjust closers so doors do not require more than 5 pounds of force to open.	1	484 Labor	\$484
16	Women's Toilet Room	1		Doors, Doorways, & Gates	Toilet Room

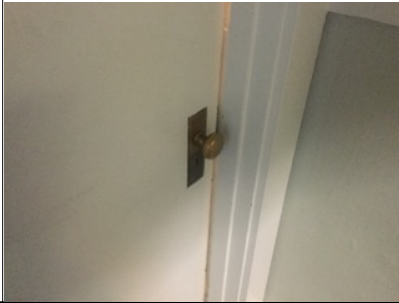
Hardware not operable with a closed fist	-	Provide hardware that can be operable with one hand and not require tight grasping, pinching, or twisting of the wrist.	1	484	\$484
17	Assessors Office	1		Doors, Doorways, & Gates	Office

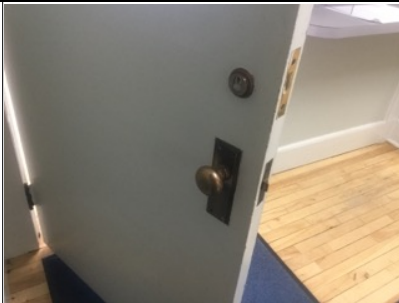
Hardware not operable with a closed fist	-	Provide hardware that can be operable with one hand and not require tight grasping, pinching, or twisting of the wrist.	1	484	\$484

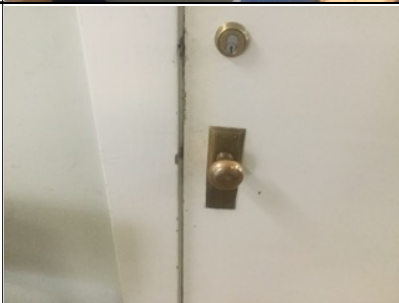
18	Information Systems	1		Doors, Doorways, & Gates	Office

Hardware not operable with a closed fist	-	Provide hardware that can be operable with one hand and not require tight grasping, pinching, or twisting of the wrist.	1	484	\$484
19	Small Meeting Room/ Thompson Conference Room	2		Doors, Doorways, & Gates	Meeting Room

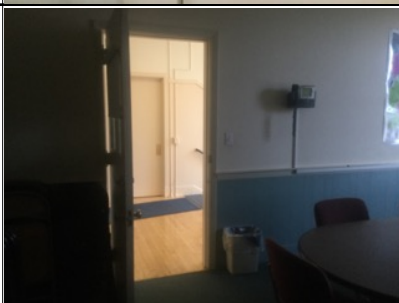
Hardware not operable with a closed fist	-	Provide hardware that can be operable with one hand and not require tight grasping, pinching, or twisting of the wrist.	1	484	\$484

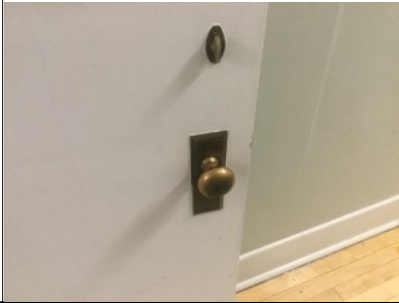
Hardware not operable with a closed fist	-	Provide hardware that can be operable with one hand and not require tight grasping, pinching, or twisting of the wrist.	1	484	\$484
22	Human Resources and Assistant Town Manager Entrance	2		Doors, Doorways, & Gates	Office

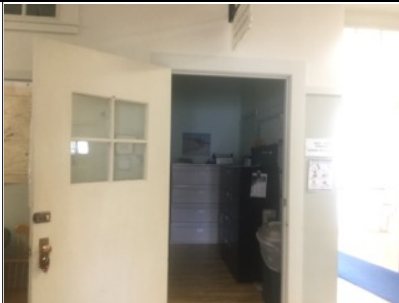
Hardware not operable with a closed fist	-	Provide hardware that can be operable with one hand and not require tight grasping, pinching, or twisting of the wrist.	1	484	\$484
23	Human Resources (West Office)	2		Doors, Doorways, & Gates	Office

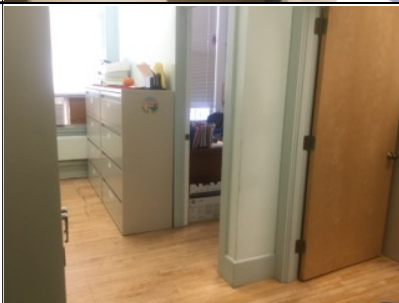
Hardware not operable with a closed fist	-	Provide hardware that can be operable with one hand and not require tight grasping, pinching, or twisting of the wrist.	1	484	\$484

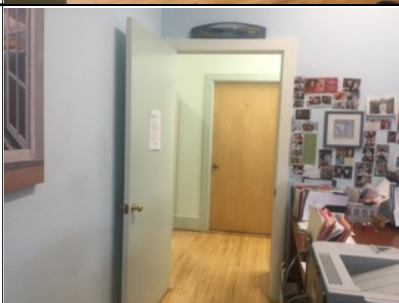
24	Human Resources (East Office)	2		Doors, Doorways, & Gates	Office

Hardware not operable with a closed fist	-	Provide hardware that can be operable with one hand and not require tight grasping, pinching, or twisting of the wrist.	1	484	\$484

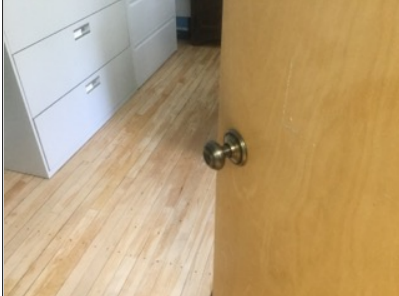
Hardware not operable with a closed fist	-	Provide hardware that can be operable with one hand and not require tight grasping, pinching, or twisting of the wrist.	1	484	\$484
26	Planning & Community Development	2		Doors, Doorways, & Gates	Classroom

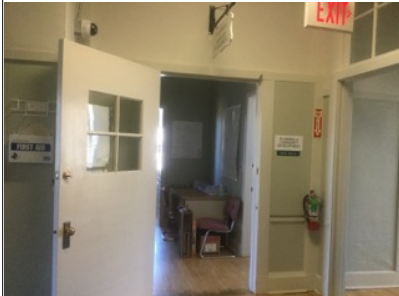
Hardware not operable with a closed fist	-	Provide hardware that can be operable with one hand and not require tight grasping, pinching, or twisting of the wrist.	1	484	\$484
27	Community Housing Coordinator	2		Doors, Doorways, & Gates	Office

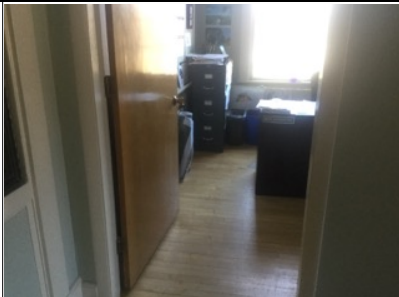
Hardware not operable with a closed fist	-	Provide hardware that can be operable with one hand and not require tight grasping, pinching, or twisting of the wrist.	1	484	\$484
28	Credit Union	2		Doors, Doorways, & Gates	Office

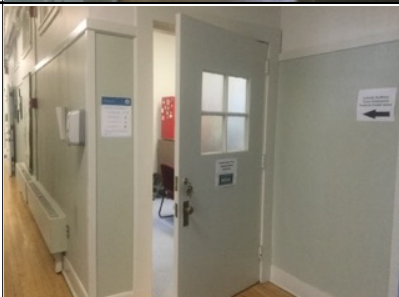
Hardware not operable with a closed fist	-	Provide hardware that can be operable with one hand and not require tight grasping, pinching, or twisting of the wrist.	1	484	\$484

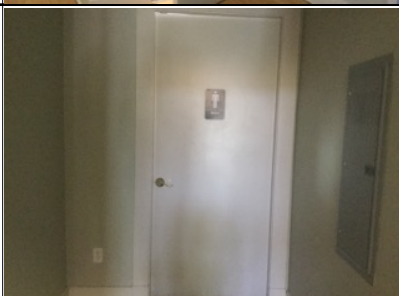
29	Men's Toilet Room	1		Doors, Doorways, & Gates	Toilet Room

Hardware not operable with a closed fist Door requires > 5 lbs. of force to open	- 11 lbs.	Provide hardware that can be operable with one hand and not require tight grasping, pinching, or twisting of the wrist. Adjust closers so doors do not require more than 5 pounds of force to open.	1	484 Labor	\$484

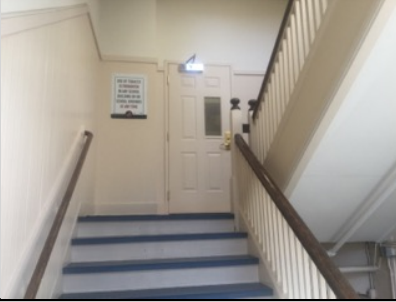
Door requires > 5 lbs. of force to open	14 lbs.	Adjust closers so doors do not require more than 5 pounds of force to open.	1	Labor	\$0
Elevator												
31	Elevator			Elevator	Interior

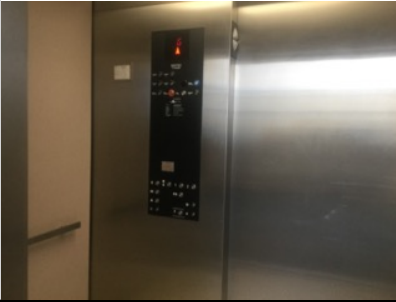
Audible car position indicators not provided	-	Install audible car position indicators.	1	1700	\$1700
Signage												
32	North Stair by Assessors Office	1		Signage	Egress

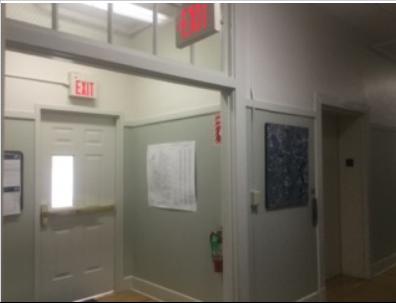
Signage is not provided Raised characters not provided on sign Braille not provided on sign	- - -	Locate compliant signage alongside the door on the latch side. Provide text with raised characters duplicated in braille on sign.	1	232	\$232
33	South Stair Exit	1		Signage	Egress

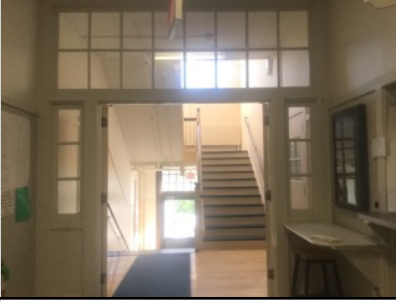
Signage is not provided Raised characters not provided on sign Braille not provided on sign	- - -	Locate compliant signage alongside the door on the latch side. Provide text with raised characters duplicated in braille on sign.	1	232	\$232

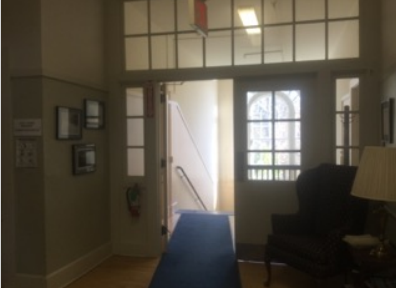
34	South Stair	2		Signage	Egress

Signage is not provided Raised characters not provided on sign Braille not provided on sign	- - -	Locate compliant signage alongside the door on the latch side. Provide text with raised characters duplicated in braille on sign.	1	232	\$232

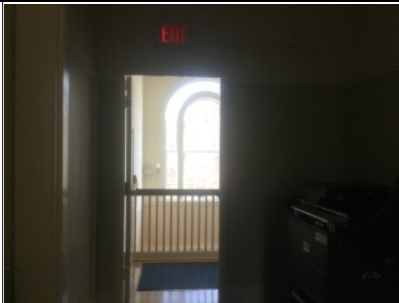
Signage is not provided Raised characters not provided on sign Braille not provided on sign	- - -	Locate compliant signage alongside the door on the latch side. Provide text with raised characters duplicated in braille on sign.	1	232	\$232
36	Small Meeting Room/ Thompson Conference Room	2		Signage	Designation

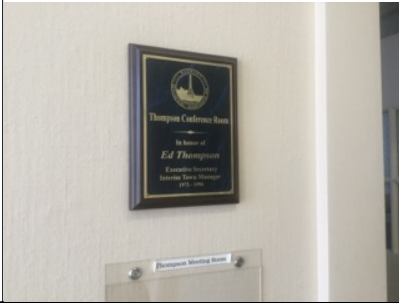
Raised characters not provided on sign Braille not provided on sign	- -	Provide text with raised characters duplicated in braille on sign.	1	232	\$232
37	Town Counsel	2		Signage	Designation

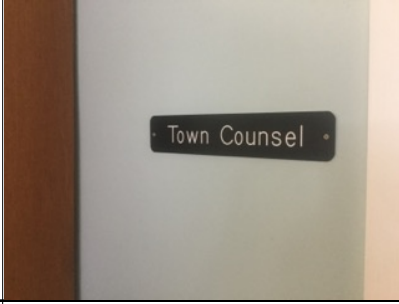
Raised characters not provided on sign Braille not provided on sign	- -	Provide text with raised characters duplicated in braille on sign.	1	232	\$232
38	Large Meeting Room	2		Signage	Designation

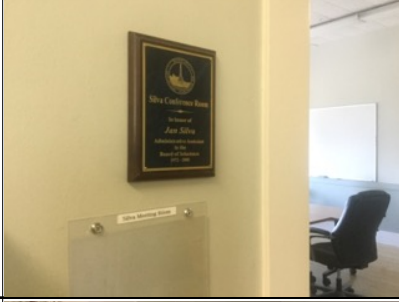
Raised characters not provided on sign Braille not provided on sign	- -	Provide text with raised characters duplicated in braille on sign.	1	232	\$232

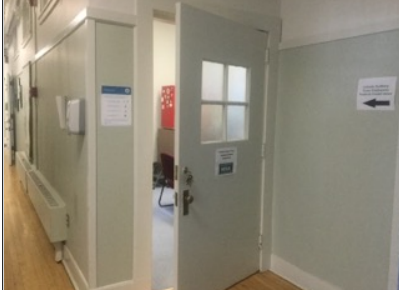
39	Credit Union	2		Signage	Designation

Raised characters not provided on sign Braille not provided on sign	- -	Provide text with raised characters duplicated in braille on sign.	1	232	\$232

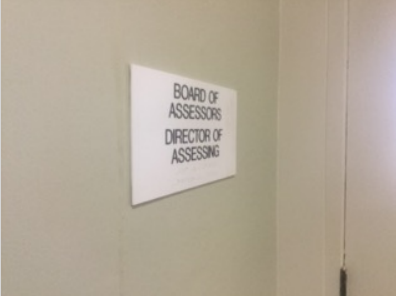
Sign not located on the latch side of the door	-	Locate sign at permanent rooms alongside the door on the latch side.	1	Labor	\$0
41	Information Systems	1		Signage	Designation

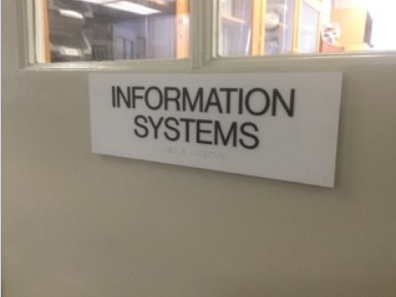
Sign not located on the latch side of the door	-	Locate sign at permanent rooms alongside the door on the latch side.	1	Labor	\$0
42	Single-User Toilet Room	2		Signage	Designation

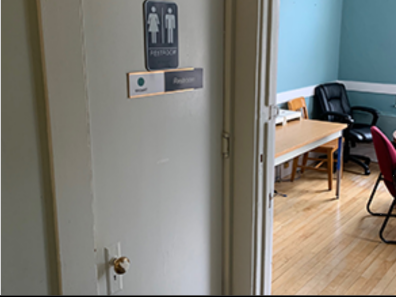
Sign not located on the latch side of the door	-	Locate sign at permanent rooms alongside the door on the latch side.	1	Labor	\$0
43	North and South Entrances	Ext.		Signage	Informational

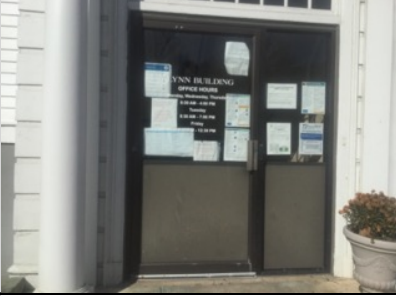
Non glare finish and contrast not provided on sign	-	Install a sign with a non-glare finish with characters that have a high contrast to the background.	2	232	\$464
44	Selectmen, Town Manager, Town Counsel and Notary Office	2		Signage	Designation

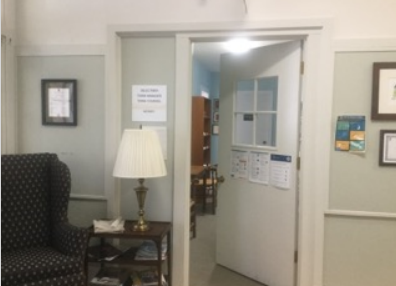
Clear floor space not provided at sign	-	Relocate furniture so that there is a clear floor space of 18" min. by 18" min. centered on the tactile characters at the tactile sign.	1	Labor	\$0

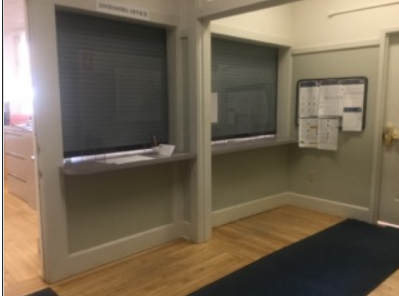
Counter > 36" high	36.75"	Provide a counter that is 36" max. above the ground or finished floor.	1	880	\$880
46	Treasurer/ Tax Collector and Accounting	1		Service Counter	N/A

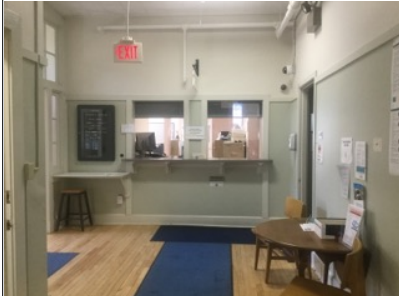
Counter > 36" high	41.25" -	Provide a counter that is 36" max. above the ground or finished floor.	1	880	\$880
Operable Parts												
47	First Aid Kit by Women's Toilet Room	1		Operable Parts	Other

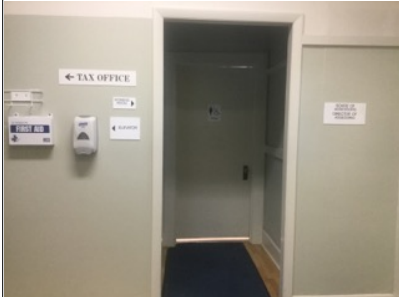
Reach < 15" or > 48"(forward/side approach)	58.25"	Relocate first aid kit so that controls are between no higher than 48" max. above the finished floor.	1	Labor	\$0
48	Small Meeting Room/ Thompson Conference Room	2		Operable Parts	Clothes Rod/Hooks

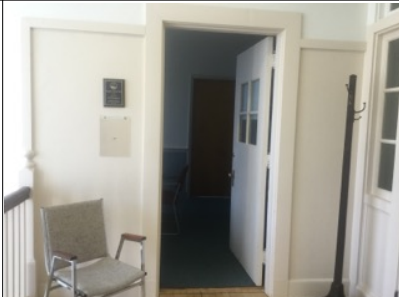
Reach < 15" or > 48"(forward/side approach)	68"	Provide a a coat hook at 48" max. above the finished floor.	1	150	\$150

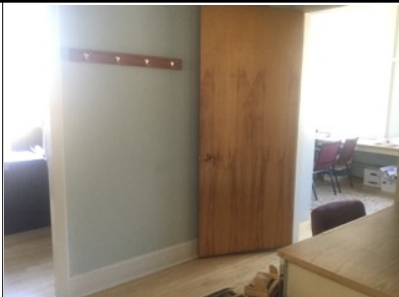
49	Planning & Community Development	2		Operable Parts	Clothes Rod/Hooks

Reach < 15" or > 48"(forward/side approach)	66"	Provide one coat hook no higher than 48" max. above the finished floor.	1	150	\$150

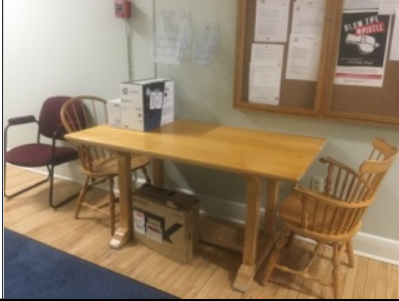
Knee or toe clearance not provided	-	Provide at least 1 work surface with 27" min. knee and toe clearance.	1	700	\$700
51	Corridor by Treasurer/ Tax Collector and Accounting	1		Dining or Work Surfaces	Work Surface

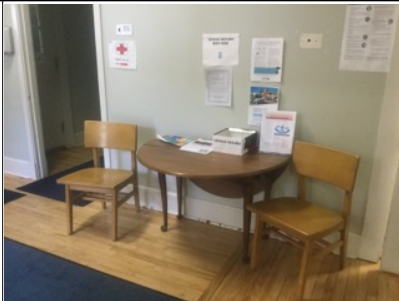
Knee or toe clearance not provided	26.5"	Provide at least 1 work surface with 27" min. knee and toe clearance.	1	700	\$700
52	Selectmen's Office	2		Dining or Work Surfaces	Work Surface

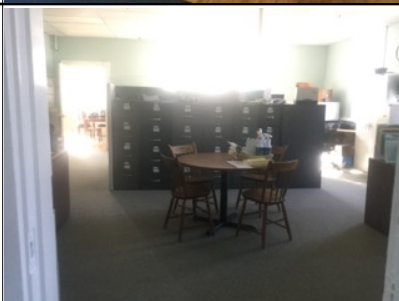
Knee or toe clearance not provided	-	Provide at least 1 work surface with toe clearance.	1	700	\$700
53	Town Manager's Office	2		Dining or Work Surfaces	Work Surface

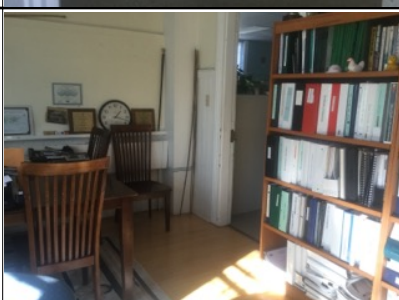
Knee or toe clearance not provided	25.75"	Provide at least 1 work surface with 27" min. knee and toe clearance.	1	700	\$700

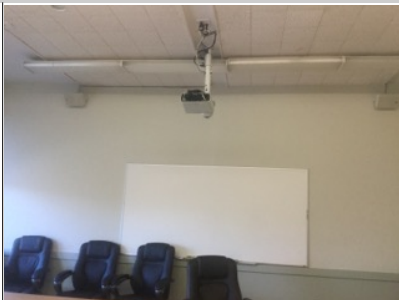
Assembly Area												
54	Large Meeting Room	2		Assembly Area	N/A

Assistive listening devices not provided	-	If audible communication is integral to the use of the space, provide an assistive listening system.	1	1214	\$1214
Toilet & Bathing Rooms

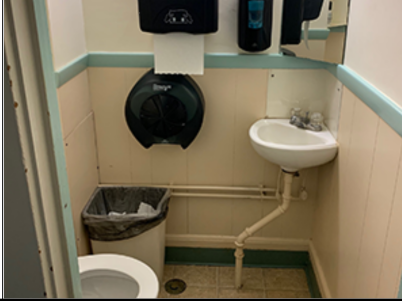
Turning space not provided Accessible plumbing fixtures or stalls not provided Grab bars not provided	42" x 53" - -	Renovate and enlarge toilet room or add an accessible single-user toilet room on this floor.	1	24604	\$24604
Toilet Compartment												
56	Women's Toilet Room	1		Toilet Compartment	Accessible Compartment

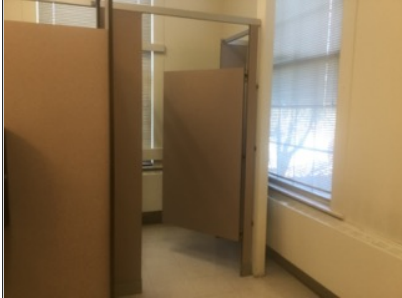
Door has malfunctioning self-closing hinge	-	Repair hinge.	1	Labor	\$0
57	Men's Toilet Room	1		Toilet Compartment	Accessible Compartment

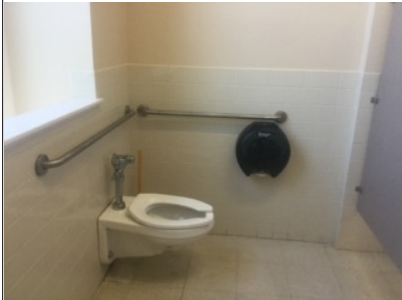
Side grab bar < 42" long Clearance at toilet < 72" clear depth (MAAB) Toilet lacks 42" min. clear in front of toilet (MAAB)	36" 36.5" 61.5"	Provide a side wall grab bar that is 42" long min. located 12" max. from the rear wall. Toilet compartment size complies with ADA but not 521 CMR (MAAB). If a variance was not sought during the time of construction, relocate toilet to adjacent wall to ensure that there is 72" min. deep at toilet and 42" min. clear in front of the toilet. (Cost is for grab bar only.)	1	898	\$898

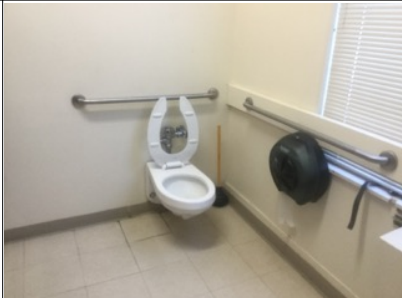
58	Women's Toilet Room	1		Toilet Compartment	Accessible Compartment

Centerline < or > 18" (MAAB)	21.25"	Relocate toilet so the centerline is 18" from the side wall.	1	2828	\$2828
Best Practice

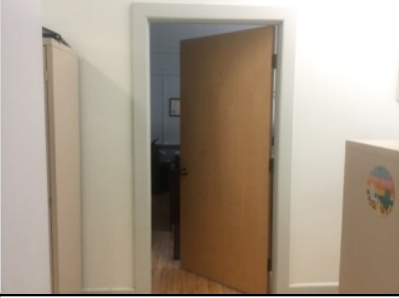
Recommend providing signage with raised characters and braille at rooms where signage is not provided.	1	-	\$0
62	Accessible Entrance Walkway	Ext.

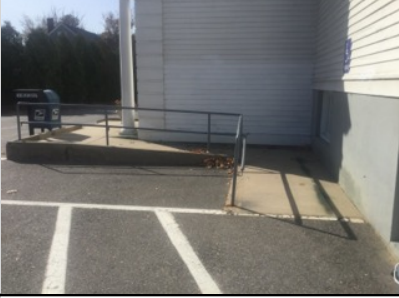
Recommend providing edge protection on the side of the sloped walkway.	1	-	\$0
63	Accessible Entrance Stairs	Ext.

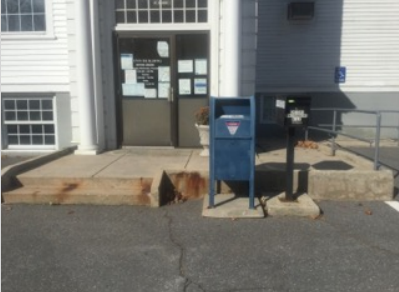
Recommend providing handrails at exterior stairs.	1	-	\$0
