# Hosmer House

## Town of Sudbury ADA Transition Plan

December 2020

## Hosmer House

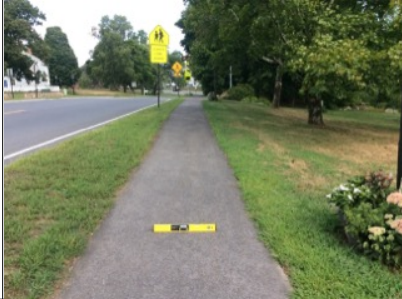
ID	Location	Floor	Room	Element	Type	Photo	Issues	Current Measure	Recommendations	Quantity	Price	Cost Estimation
<b>Approach and Entrance</b>												
<b>Exterior Access Route</b>												
1	Sidewalk East of House	Ext.		Exterior Access Route	Sidewalk

Cross slope > 1:50 (2.00%)	5.8% - 10%	Reduce cross slope to be no steeper than 1:50 (2.00%). (Cost estimate for 30' long 4' wide asphalt route.)	1	1200	\$1200
2	Sidewalk West of Town Hall (Toward Parking Lot)	Ext.		Exterior Access Route	Sidewalk

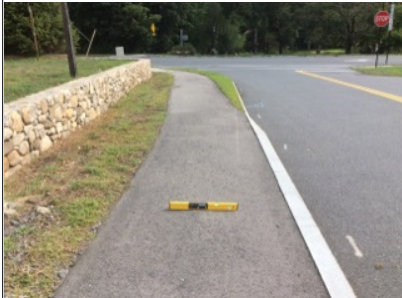
Cross slope > 1:50 (2.00%)	5.2%	Reduce cross slope to be no steeper than 1:50 (2.00%). (Cost estimate for 10' long 4' wide asphalt route.)	1	400	\$400
3	Garden Path Behind House	Ext.		Exterior Access Route	Walkway

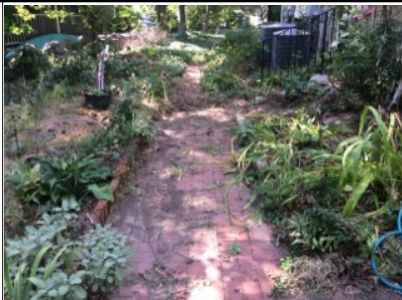
Cross slope > 1:50 (2.00%) Route not maintained in operable working condition	5.6% -	Reduce cross slope to be no steeper than 1:50 (2.00%). Ensure the accessible route is maintained in operable working condition. (Cost estimate for 60' long by 4' wide brick paver walkway.)	1	3440	\$3440

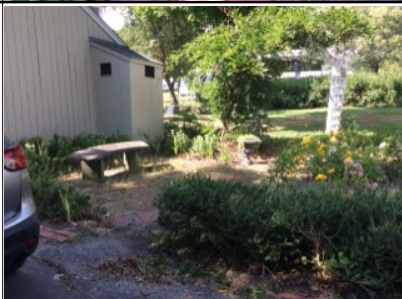
4	Garden East of Garage	Ext.		Exterior Access Route	Walkway

Accessible route not provided	-	Ensure an accessible route is provided to the garden east of the garage and to one bench in this area. (Cost estimate for 6' long 4' wide brick paver walkway.)	1	688	\$688
<b>Entrance</b>												
5	Main Entrance Hallway	1		Entrance	Main Entrance

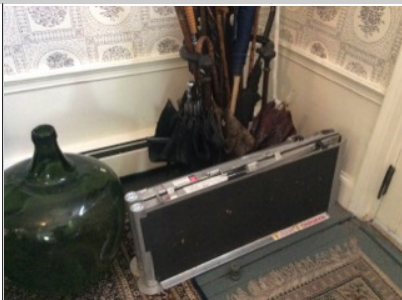
Entrance not on an accessible route	-	The temporary ramp to the main entrance is not compliant for a level change that is greater than 8.5 inches. On occasions when the house is open to the public, IHCD recommends renting an accessible metal portable ramp with compliant handrails and landings and a running slope no greater than 8.33 percent.	1	-	\$0

The temporary ramp to the main entrance is not compliant for a level change that is greater than 8.5 inches. (On occasions when the house is open to the public, IHCD recommends renting an accessible metal portable ramp with compliant handrails and landings and a running slope no greater than 8.33 percent.)

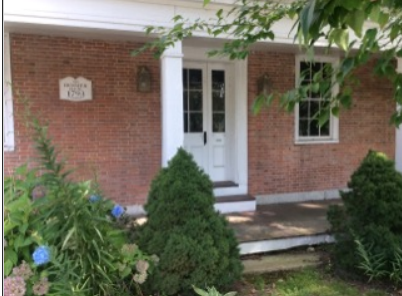
ID	Location	Floor	Room	Element	Type	Photo	Issues	Current Measure	Recommendations	Quantity	Price	Cost Estimation
6	General Store Entrance	Ext.		Entrance	Secondary Entrance

Entrance not on an accessible route Directional sign to accessible entrance not provided Clear width at door is < 32"	- - 27.25"	Provide a directional sign indicating the location of the nearest accessible entrance. Alteration of the door width may not be feasible. Compliance with the requirements may threaten or destroy the historic significance of the building.	1	346	\$346
7	General Store Entrance	1		Entrance	Secondary Entrance

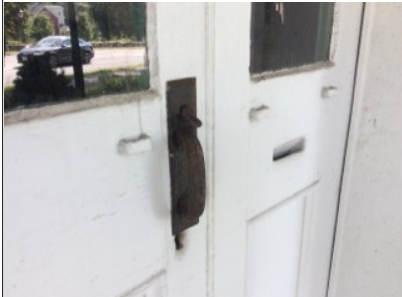
Hardware not operable with a closed fist	-	Provide hardware that can be operable with one hand and not require tight grasping, pinching, or twisting of the wrist.	1	484	\$484
<b>Access to Goods and Services</b>												
<b>Means of Egress</b>												
8	Back Hallway Exit	1		Means of Egress	N/A

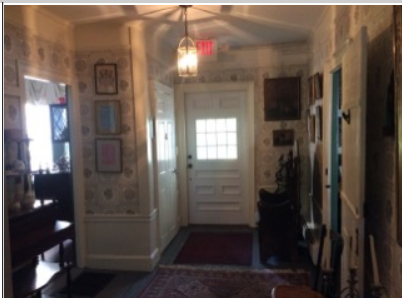
Tactile exit sign not provided	-	Ensure tactile exit signs with raised characters and braille are provided at exit doors. Mount signs between 48"- 60" above the finished floor located on the latch side of the door.	1	232	\$232

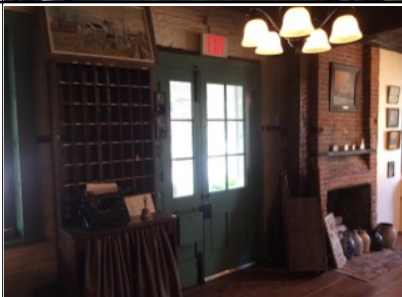
9	General Store Exit to Concord Road	1		Means of Egress	N/A

Tactile exit sign not provided	-	Ensure tactile exit signs with raised characters and braille are provided at exit doors. Mount signs between 48"- 60" above the finished floor located on the latch side of the door.	1	232	\$232
<b>Interior Access Route</b>												
10	Dining Room	1		Interior Access Route	N/A

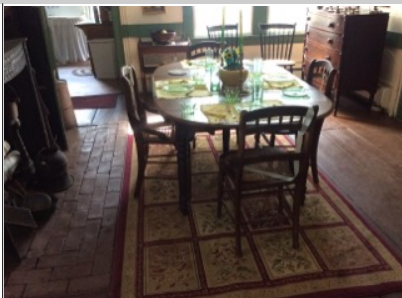
Route < 36" wide	30.5"	Ensure that a clear width of 36" min. is maintained at the accessible route. Route is allowed to narrow to 32" wide min. for 24" of depth.	1	Labor	\$0

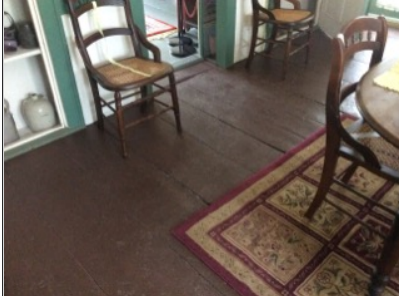
ID	Location	Floor	Room	Element	Type	Photo	Issues	Current Measure	Recommendations	Quantity	Price	Cost Estimation
11	Dining Room	1		Interior Access Route	N/A

Route < 36" wide	25.75"	Ensure that a clear width of 36" min. is maintained at the accessible route. Route is allowed to narrow to 32" wide min. for 24" of depth.	1	Labor	\$0
12	Dining Room - Route to Kitchen	1		Interior Access Route	N/A

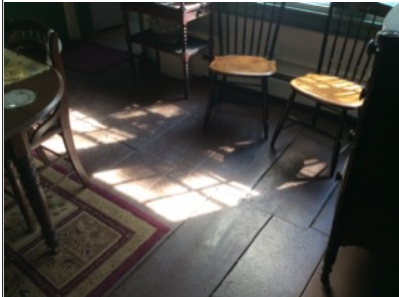
Route < 36" wide	28.75"	Ensure that a clear width of 36" min. is maintained at the accessible route. Route is allowed to narrow to 32" wide min. for 24" of depth.	1	Labor	\$0
13	Doorway From Dining Room to Hallway	1		Interior Access Route	N/A

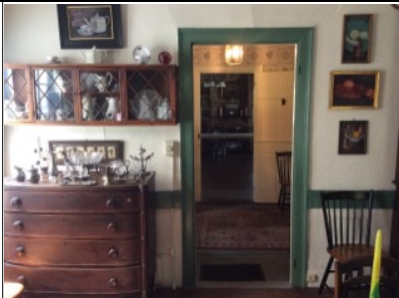
Obstructed by protruding objects	10.75"	Provide a cane-detectable barrier underneath the overhead cabinet.	1	306	\$306
14	Second Floor	2		Interior Access Route	N/A

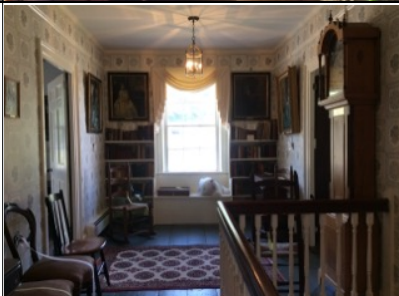
Accessible route not provided	-	Provide a video of the rooms on the second floor or photographs to provide program accessibility.	1	-	\$0

There is no accessible route to the second floor. It is recommended that Hosmer House provide a video or photographs of the rooms on the second floor to provide program accessibility for visitors who are unable to visit the second floor themselves.

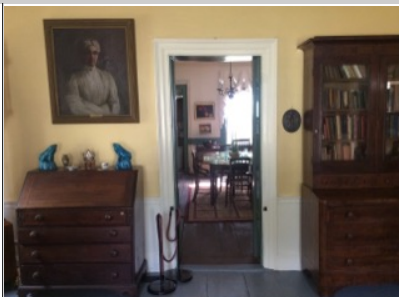
<b>Doors, Doorways, &amp; Gates</b>												
15	Doorway From Living Room to Dining Room	1		Doors, Doorways, & Gates	Circulation

Clear width at door < 32" Threshold > 1/2" high	30.5" 1"	Provide offset hinges at door to provide 32" min. clear width. The historic hinges of these doors could be retained in storage. Alteration to the threshold may not be feasible. Compliance with the requirements may threaten or destroy the historic significance of the building. Provide a video of the rooms or photographs to provide program accessibility.	1	2232	\$2232

The door between the living room and dining room has less than 32 inches of clear width. (IHCD recommends providing swing-clear/offset hardware to increase the overall width at the door. The historic hinges on these doors could be retained and even displayed for visitors who wish to see them.) Two door thresholds on the first floor are higher than allowed. (For these, alteration may not be feasible. Compliance with the requirements may threaten or destroy the historic significance of the building. Use videos or photographs to provide program accessibility). Also, the back egress door lacks compliant hardware.

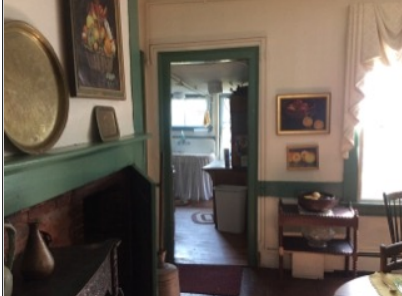
ID	Location	Floor	Room	Element	Type	Photo	Issues	Current Measure	Recommendations	Quantity	Price	Cost Estimation
16	Doorway From Dining Room to Kitchen	1		Doors, Doorways, & Gates	Circulation

Mat not securely attached	-	Secure the mat.	1	Labor	\$0
17	Living Room	1		Doors, Doorways, & Gates	Circulation

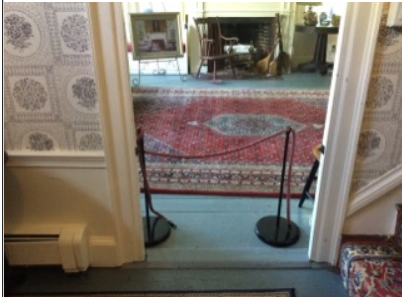
Threshold > 1/2" high	1"	Alteration may not be feasible. Compliance with the requirements may threaten or destroy the historic significance of the building. Provide a video of the rooms or photographs to provide program accessibility.	1	-	\$0
18	Emergency Egress From Back Hallway	1		Doors, Doorways, & Gates	Emergency Egress

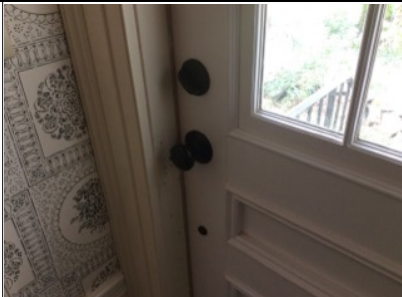
Hardware not operable with a closed fist	-	Provide hardware that can be operable with one hand and not require tight grasping, pinching, or twisting of the wrist.	1	484	\$484
<b>Service Counter</b>												
19	General Store	1		Service Counter	N/A

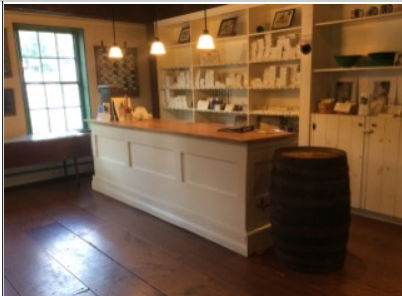
Counter > 36" high	39.25"	Provide another table that is 36" max. above the ground or finished floor.	1	500	\$500

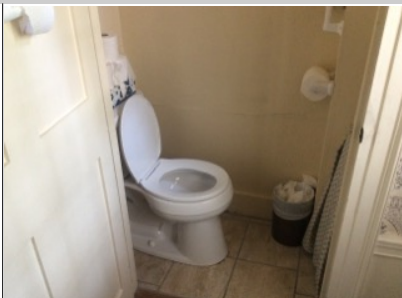
<b>Toilet &amp; Bathing Rooms</b>												
<b>Overall Access</b>												
20	Toilet Room	1		Overall Access	Toilet Room

Turning space not provided Accessible plumbing fixtures or stalls not provided	- -	As toilet room was renovated in 1983, an accessible toilet room would have been required at the time as part of 521 CMR unless a variance was sought at the time. Recommend providing an accessible toilet room on this level if a toilet room is provided to the public.	1	-	\$0

As the first floor toilet room was renovated in 1983, an accessible toilet room would have been required at the time under 521 CMR, unless a variance was sought. IHCD recommends providing an accessible toilet room on this level if the toilet room is available for use by the public.

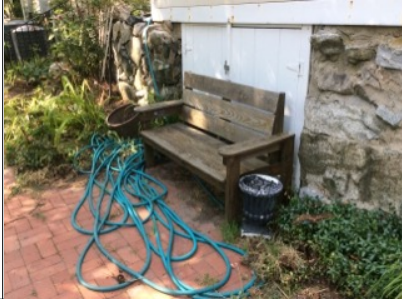
ID	Location	Floor	Room	Element	Type	Photo	Issues	Current Measure	Recommendations	Quantity	Price	Cost Estimation
Best Practice												
21	Garden Path Behind House and East of the Garage	1

-	Recommend providing a level clear floor space of 36" wide min. by 48" deep min. alongside one bench in each garden so that a wheelchair user can sit alongside a person seated on the bench.	2	-	\$0
22	Living Room	1

- Recommend providing a level clear floor space of 36" wide min. by 48" deep min. alongside one bench in each garden so that a wheelchair user can sit alongside a person seated on the bench.

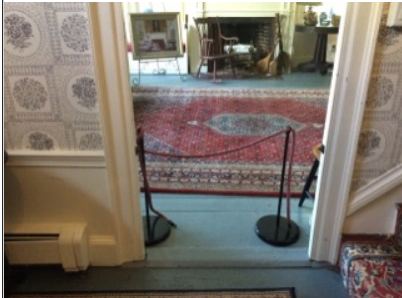
-	Recommend providing stanchions that stand out more from the background and are easier to see.	1	-	\$0
23	Garden Path Behind House	Ext.

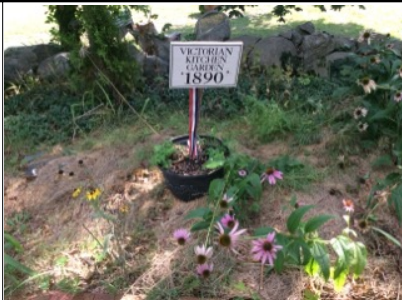
-	Recommend locating sign regarding the Victorian kitchen garden on an accessible route.	1	-	\$0
24	Stairs Outside of Back Hallway Exit	Ext.

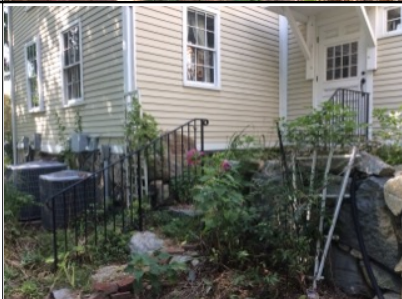
-	Stairs may be hazardous for users. Recommend renovating stairs.	1	-	\$0
25	General Store Entrance	Ext.

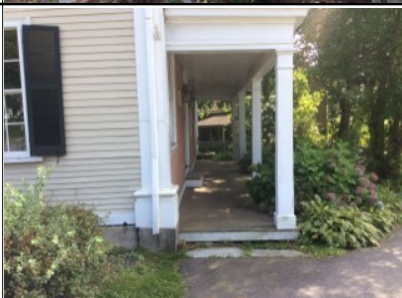
-	Recommend providing handrails on the stairs to the porch.	1	-	\$0

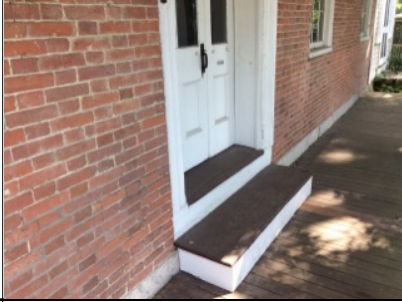
ID	Location	Floor	Room	Element	Type	Photo	Issues	Current Measure	Recommendations	Quantity	Price	Cost Estimation
26	General Store Entrance Door Stairs	Ext.

-	Risers and treads are different sizes. It may not be technically feasible to adjust risers or treads, however stairs may be hazardous for users. Recommend providing a railing on at least one side.	1	-	\$0
27	Driveway East of House	Ext.

- At the stairs to the door to the general store, risers and treads are different sizes. It may not be technically feasible to adjust risers or treads, however stairs may be hazardous for users. Recommend providing a railing on at least one side.

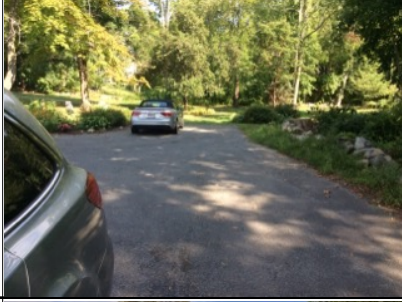
-	Recommend providing a drop off area in the driveway and allowing visitors who are not able to walk from one of the Town Hall parking lots to park in the driveway.	1	-	\$0
28	Lower Town Hall Parking Lot	Ext.				 		-	Recommend providing a van accessible parking space in this lot as it is closer to the Hosmer House than the lot behind Town Hall.	1	-	\$0

- Recommend providing a drop-off area in the driveway and allowing visitors who are not able to walk from one of the Town Hall parking lots to park in the driveway.
