Loring Parsonage

Town of Sudbury ADA Transition Plan

October 2020

Institute for Human Centered Design

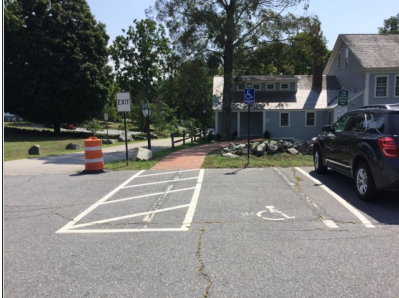
Total # of parking Total # of designated accessible parking spaces Total # of designated van accessible spaces Sign does not have the designation "Van Accessible" Van space < 132" or <96" wide Access aisle not compliant	6 1 0 - - -	Provide at least one van accessible parking space for the facility. (Cost estimate includes "Van Accessible" sign and restriping.)	1	800	\$800
Entrance												
2	Lobby - Northeast Accessible Entrance	1		Entrance	Main Entrance

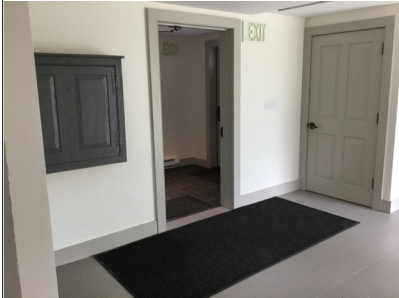
Mat not securely attached	-	Secure the mat.	1	Labor	\$0
Emergency Exit												
3	Stairwell - Exit to East Side of Building	1		Emergency Exit	N/A

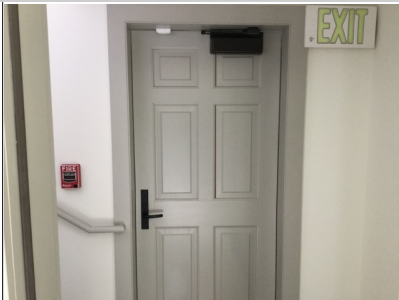
Tactile sign not provided at exit Directional sign to accessible emergency exit not provided	- -	Provide tactile exit signs with raised characters and braille at exit doors. Mount signs between 48"- 60" above the finished floor located on the latch side of the door. Provide a directional sign indicating the location of the nearest accessible emergency exit.	2	232	\$464

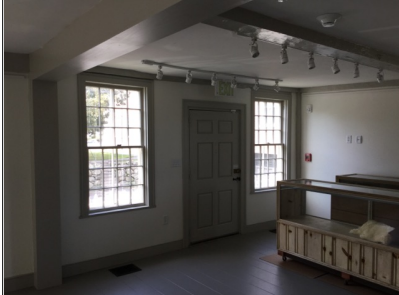
4	Exhibit Space - Exit to West Side of Building	1	106	Emergency Exit	N/A

Tactile sign not provided at exit Directional sign to accessible emergency exit not provided	- -	Provide tactile exit signs with raised characters and braille at exit doors. Mount signs between 48"- 60" above the finished floor located on the latch side of the door. Provide a directional sign indicating the location of the nearest accessible emergency exit.	2	232	\$464

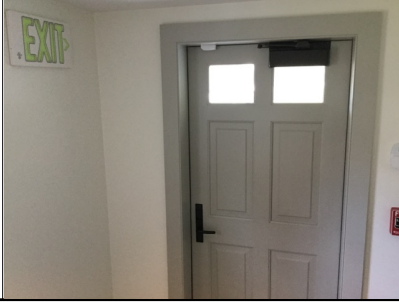
Tactile sign not provided at exit Illuminated Int. Symbol of Acc. not provided (MAAB)	- -	Provide tactile exit signs with raised characters and braille at exit doors. Mount signs between 48"- 60" above the finished floor located on the latch side of the door. Provide an illuminated sign with the International Symbol of Accessibility.	1	432	\$432
Access to Goods and Services												
Interior Access Route												
6	Lobby - Northeast Door to Parking Lot	1		Interior Access Route	N/A

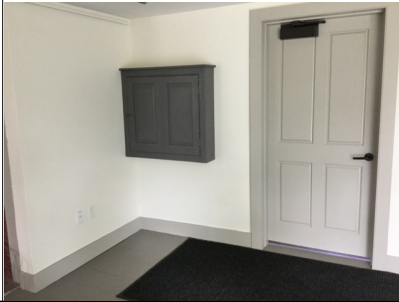
Obstructed by protruding objects	7.75"	Provide a cane-detectable barrier under the cabinet.	1	306	\$306
7	File Room - East Side of Building	2		Interior Access Route	N/A

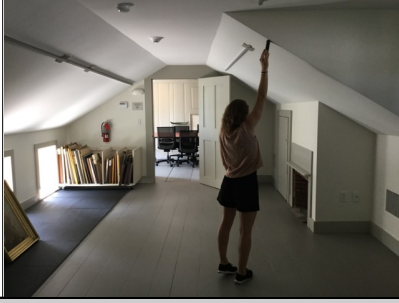
Vertical clearance < 80" above finished floor	-	Provide ADA compliant double belt stanchions on each side of the route where the ceiling is less than 80" above the finished floor. Ensure that the lower horizontal belt of the stanchion is 27 inches maximum above the floor. (Cost estimate for 4 stanchions.)	4	93	\$372

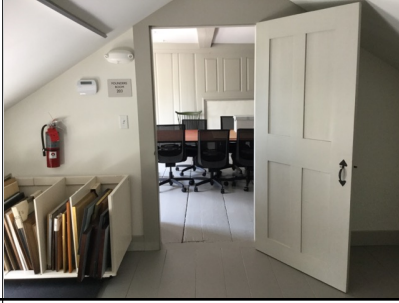
Doors, Doorways, & Gates												
8	File Room to Research Room	2		Doors, Doorways, & Gates	Circulation

Maneuvering clearance(s) not provided	-	Relocate storage to provide 18" clear on the latch side of the door and at sign.	1	Labor	\$0
9	Exhibit Space - Southwest Side of Building	1	106	Doors, Doorways, & Gates	Circulation

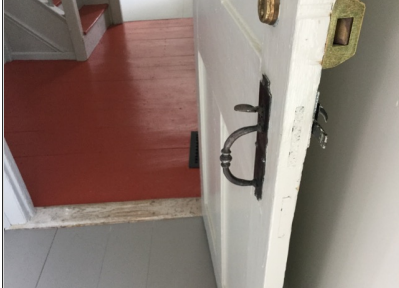
Threshold > 1/2" high Hardware not operable with a closed fist	1.25" -	Alter the threshold to be 1/2" high max. Provide hardware that can be operable with one hand and not require tight grasping, pinching, or twisting of the wrist.	1	634	\$634

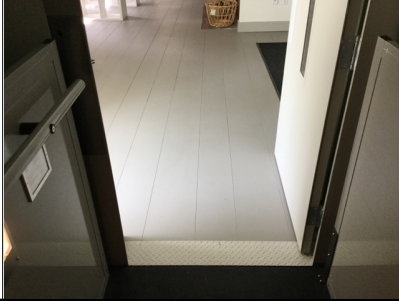
Doors remain open < 20 seconds	13 sec.	Adjust door opening speed.	1	Labor	\$0
11	Platform Lift, East Side of Building	2		Platform Lift or LULA Elevator	Interior

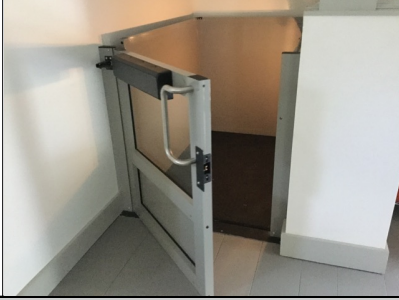
Doors remain open < 20 seconds	13 sec.	Adjust door opening speed.	1	Labor	\$0
Signage												
12	Platform Lift, East Side of Building	2		Signage	Informational

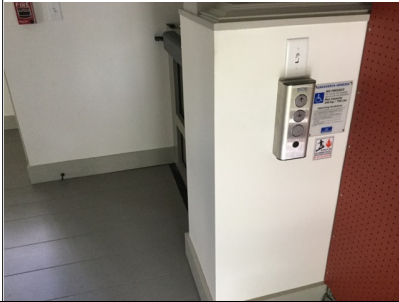
Visual characters < 40" above ground	-	Mount visual sign regarding fire precautions so that the baseline of the lowest character is 40" min. above the finished floor.	1	Labor	\$0
Service Counter												
13	Lobby - East Side of Building	1		Service Counter	N/A

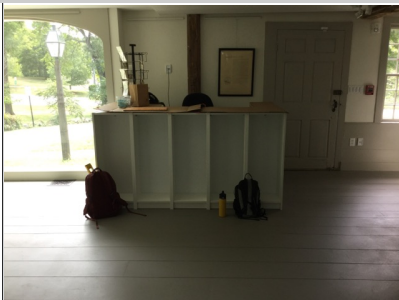
Counter > 36" high	42"	Provide a counter that is 36" max. above the ground or finished floor.	1	880	\$880

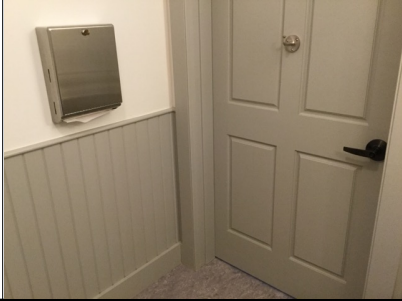
Hook located > 48" high	53.5"	Locate hook no higher than 48" above the finished floor.	1	150	\$150
Best Practice												
15	Platform Lift, East Side of Building	1

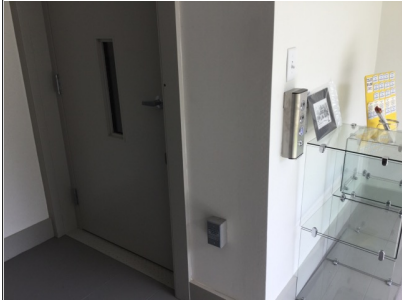
-	Relocate shelves to provide easier access to and clearance at lift controls.	1	-	\$0
16	Exhibit Space - North Side of Building	1	104

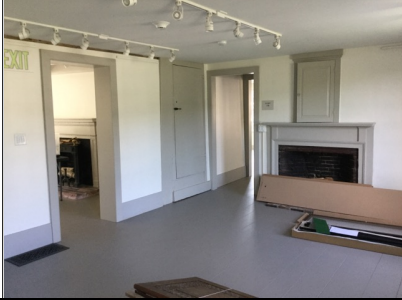
-	Recommend providing signage with raised characters and braille at all permanent rooms including the door between Rooms 104 and 105.	1	-	\$0
17	Main Entrance - Route to Parking Lot	Ext

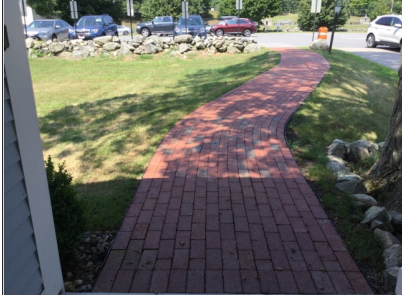
*	Recommend providing edge protection along open sides of walkway.	1	-	\$0
