Loring Elementary School

Town of Sudbury ADA Transition Plan

January 2021

Town of Sudbury
Loring Elementary School

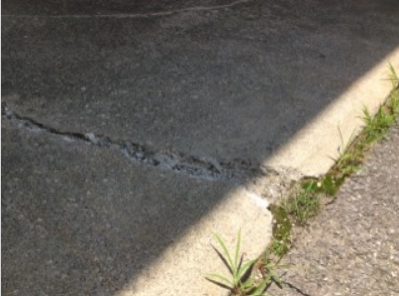
ID	Location	Floor	Room	Element	Type	Photo	Issues	Current Measure	Recommendations	Quantity	Price	Cost Estimation
Approach and Entrance												
Exterior Access Route												
1	Near Gymnasium	Ext.		Exterior Access Route	Exterior

Surface openings > 1/2"	6"	Repair opening. (Cost based on a 4'x4' concrete patch.)	1	256	\$256
2	Courtyard	Ext.		Exterior Access Route	Walkway

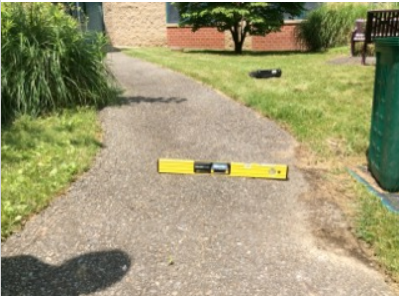
Cross slope > 1:50 (2.00%)	4.5%	Reduce cross slope to be no steeper than 1:50 (2.00%). (Cost base on 15' of asphalt to correct slope.)	1	600	\$600
3	From Main Entrance Towards Exit 11	Ext.		Exterior Access Route	Walkway

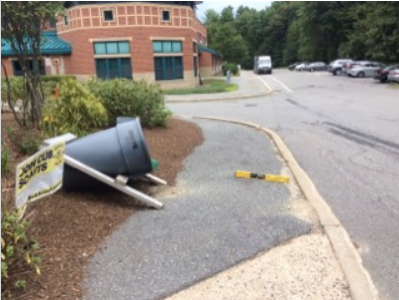
Cross slope > 1:50 (2.00%)	12.8%	Reduce cross slope to be no steeper than 1:50 (2.00%).	1	240	\$240
8	Walkway	Ext.		Exterior Access Route	Walkway

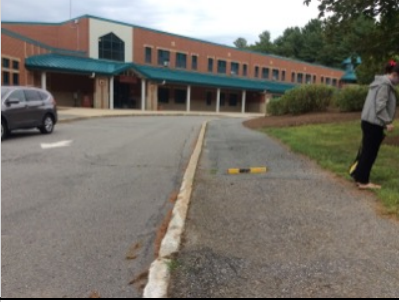
Cross slope > 1:50 (2.00%)	8.3%	Reduce cross slope to be no steeper than 1:50 (2.00%).	1	240	\$240
12	Path to Basketball Court/Upper Playground	Ext.		Exterior Access Route	Walkway

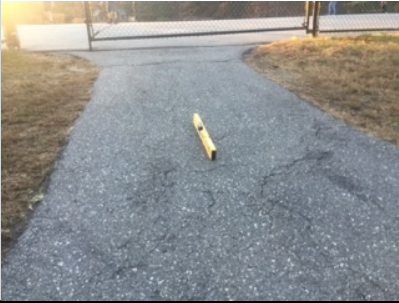
Cross slope > 1:50 (2.00%) Running slope > 1:20 (5%)	4.4% 9.7%	Reduce cross slope to be no steeper than 1:50 (2.00%). Reduce running slope to be no steeper than 1:20 (5%). (Cost based on 4'x6' of asphalt to correct slope.)	1	240	\$240
13	From Exit 11 Towards Exit 10	Ext.		Exterior Access Route	Walkway

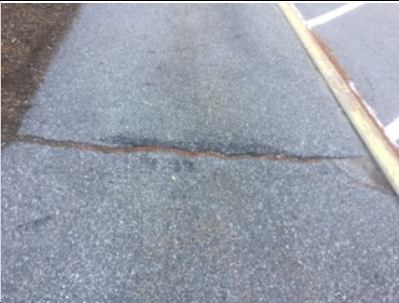
Cross slope > 1:50 (2.00%) Route not maintained in operable working condition	3.8% -	Reduce cross slope to be no steeper than 1:50 (2.00%). Ensure the accessible route is maintained in operable working condition. (Cost for 4'x6' of asphalt to correct slope and repair surface opening.)	1	240	\$240

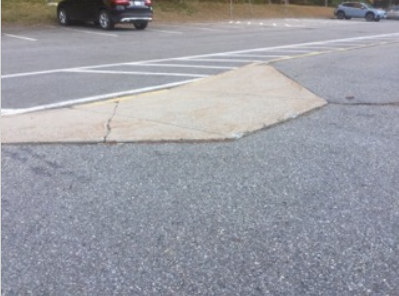
Level changes > 1/4"	.75"	Alter change in level to be 1/4" high max. (Cost based on a concrete patch.)	1	256	\$256
17	From Exit 10 To Exit 8	Ext.		Exterior Access Route	Walkway

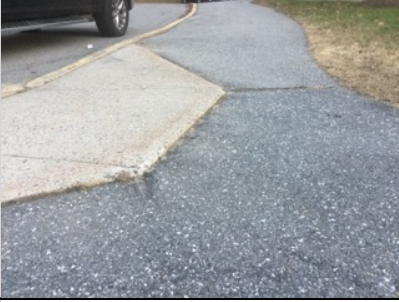
Level changes > 1/4"	1"	Alter change in level to be 1/4" high max. (Cost based on asphalt patch to correct change in level.) (Cost included in ID #37 - Cost for a new compliant curb ramp.)	1	-	\$0
22	Door 9	Ext.		Exterior Access Route	Exterior

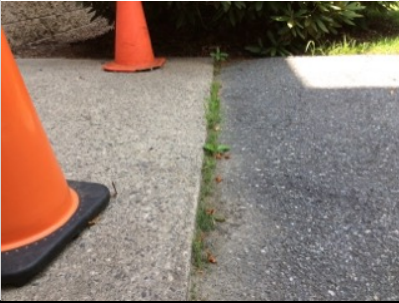
Level changes > 1/4" Accessible route not provided	.75"	Alter change in level to be 1/4" high max. Ensure an accessible route is provided. (Cost based on an asphalt patch.)	1	160	\$160
23	Door 8	Ext.		Exterior Access Route	Exterior

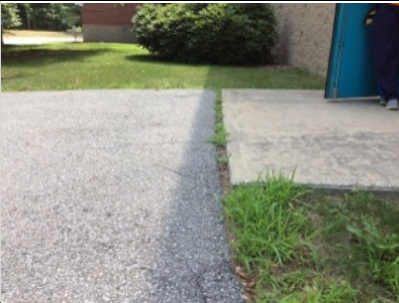
Route not maintained in operable working condition	2"	Ensure the accessible route is maintained in operable working condition. Repair 2" gap with asphalt patch.	1	160	\$160
24	From Main Entrance Towards Exit 11	Ext.		Exterior Access Route	Walkway

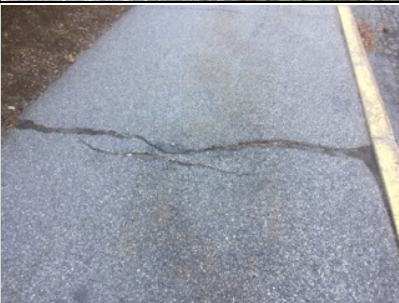
Route not maintained in operable working condition	-	Ensure the accessible route is maintained in operable working condition. Repair deteriorated asphalt.	1	160	\$160

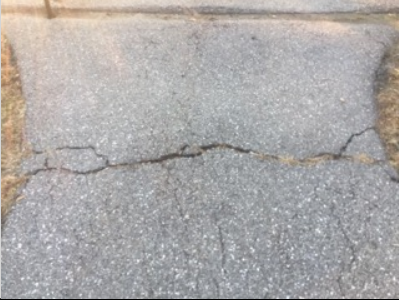
Route not maintained in operable working condition	-	Ensure the accessible route is maintained in operable working condition. (Cost based on 4'x4' of asphalt to repair surface.)	1	160	\$160
27	Entry to Basketball Court/Upper Playground	Ext.		Exterior Access Route	Exterior

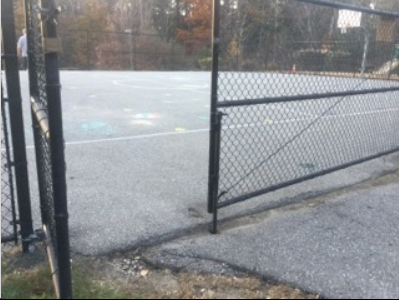
Route not maintained in operable working condition	-	Ensure the accessible route is maintained in operable working condition. Repair surface at gate to basketball court. (Cost based on an asphalt patch.)	1	160	\$160
28	Garden Box	Ext.		Exterior Access Route	Exterior

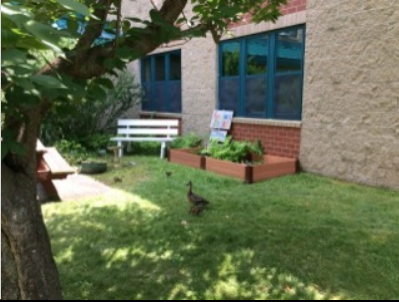
Accessible route not provided	-	Ensure an accessible route is provided to the garden box. (Cost based on a 4' wide min. x 6' long stone dust path from existing walkway to garden box.)	1	192	\$192

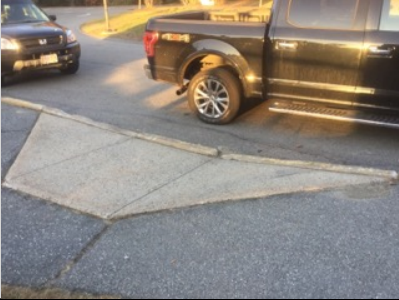
Running slope > 1:12 (8.33%) Transition from curb ramp to street not flush Curb ramp flares > 1:10 (10%)	13.4% - 18.1%	Reduce running slope to be no steeper than 1:12 (8.33%). Ensure transition from curb ramp to street is flush or free of changes in level. Reduce slope at curb ramp flares to be no steeper than 1:10 (10%). (Cost estimate for a new concrete curb ramp.)	1	2800	\$2800
32	Crosswalk Near Woodside Road	Ext.		Curb Ramp	N/A

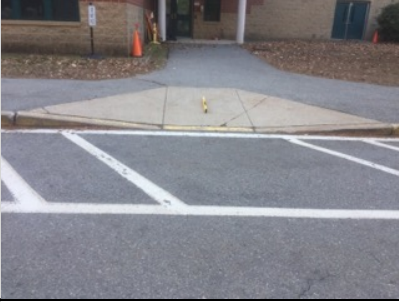
Curb ramp flares > 1:10 (10%)	14%	Reduce slope at up hill curb ramp flare to be no steeper than 1:10 (10%). (Cost estimate for concrete to reduce slope.)	1	256	\$256
37	Curb Ramp at Basketball Court	Ext.		Curb Ramp	N/A

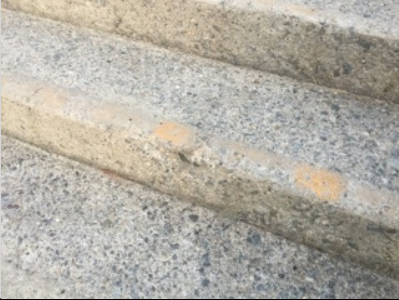
Not maintained in operable working condition	-	Ensure stairs are maintained in operable working condition. The third step from the top, the third step from the middle landing and the last step at the bottom show some chipping and deterioration. Repair surface.	1	Labor	\$0
Access to Goods and Services												
Means of Egress												
42	Egress Door 9	1	154	Means of Egress	N/A

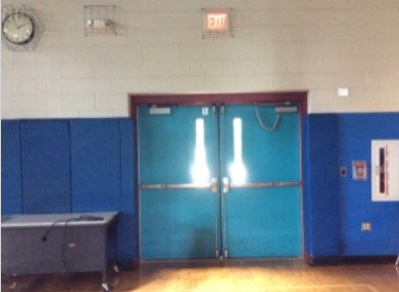
Tactile exit sign not provided	-	Ensure tactile exit signs with raised characters and braille are provided at exit doors. Mount signs between 48"- 60" above the finished floor located on the latch side of the door.	1	232	\$232
43	Egress Door 10	1		Means of Egress	N/A

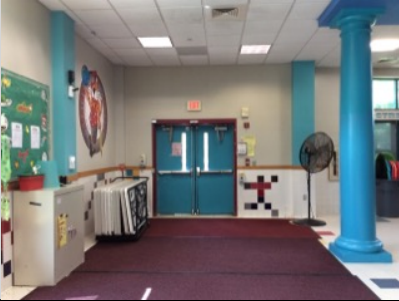
Tactile exit sign not provided Illuminated ISA symbol not provided (MAAB)	- -	Ensure tactile exit signs with raised characters and braille are provided at exit doors. Mount signs between 48"- 60" above the finished floor located on the latch side of the door. Provide an illuminated sign with the International Symbol of Accessibility.	1	432	\$432
47	Door 6 at Gymnasium	1		Means of Egress	N/A

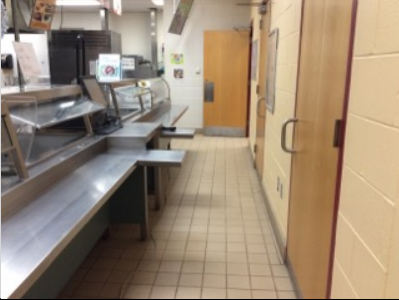
Route < 36" wide	29"	Ensure that a clear width of 36" min. is maintained at the accessible route. (Width decreases at extended counter. If students walk past that counter, maintain 36" min. clear width.)	1	Labor	\$0
52	Music Practice	1	164	Interior Access Route	N/A

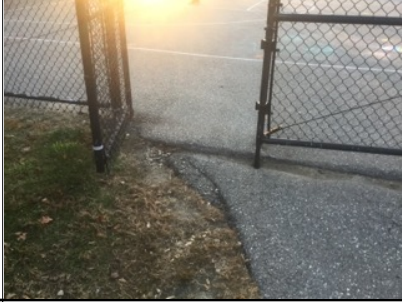
Clear width at door < 32"	24"	Widen the gate so that there is 32" min. clear width.	1	Labor	\$0
57	Room 107	1	107	Doors, Doorways, & Gates	Office

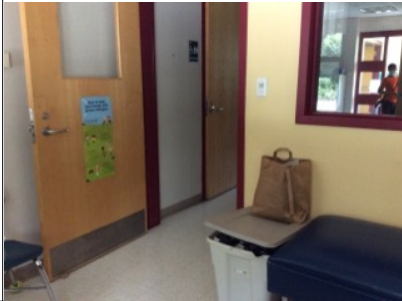
Maneuvering clearance(s) not provided	-	Remove stored items to provide 18" min. pull-side maneuvering clearance at door.	1	Labor	\$0
59	Boys' Toilet Room	1	167	Doors, Doorways, & Gates	Toilet Room

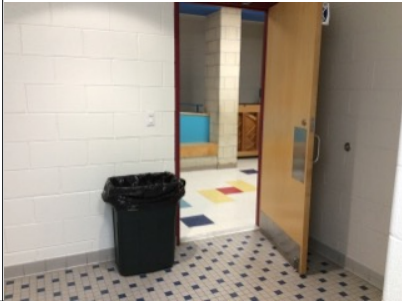
Maneuvering clearance(s) not provided	-	Remove the trash can to provide 18" min. pull-side maneuvering clearance at door.	1	Labor	\$0

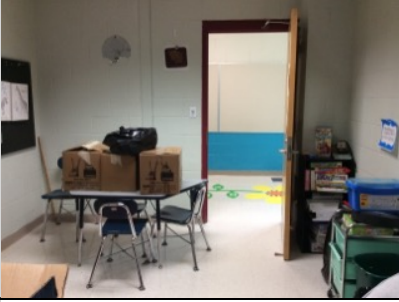
Maneuvering clearance(s) not provided	-	Remove stored objects to provide 18" min. pull-side maneuvering clearance at door.	1	Labor	\$0
62	Kindergarten	1	135	Doors, Doorways, & Gates	Classroom

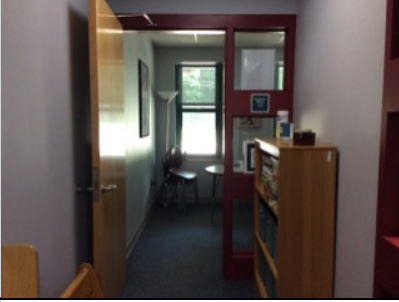
Maneuvering clearance(s) not provided	9"	Remove stored items to provide 18" min. pull-side maneuvering clearance at the door. Labor.	1	Labor	\$0
67	Grade 2 Classroom	2	233	Doors, Doorways, & Gates	Classroom

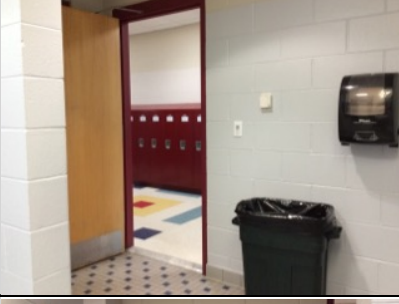
Maneuvering clearance(s) not provided	-	Remove the trash can to provide 18" min. pull-side maneuvering clearance at the door.	1	Labor	\$0
69	Girls' Toilet Room	2	226	Doors, Doorways, & Gates	Toilet Room

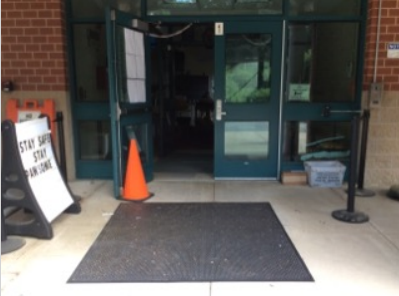
Mat not securely attached	-	Secure the mat.	1	Labor	\$0
72	Administrative Office	1		Doors, Doorways, & Gates	Office

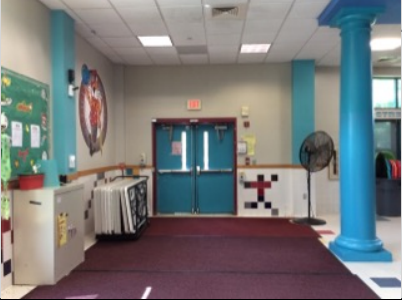
Mat not securely attached	- -	Secure the mat.	1	Labor	\$0
Ramps												
77	Ramp to Stage	1	189	Ramps	Interior

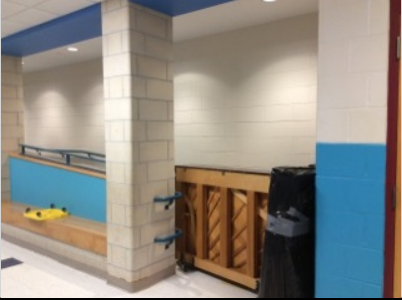
Not maintained in operable working condition	-	Remove stored items from ramp.		Labor	\$0
Stairways												
78	Stairs to Stage	1	188	Stairways	Other

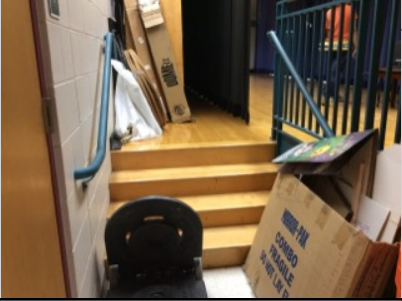
Not maintained in operable working condition	-	Remove stored items blocking stair landing.	1	Labor	\$0
79	Cafetorium Stage	1		Stairways	Other

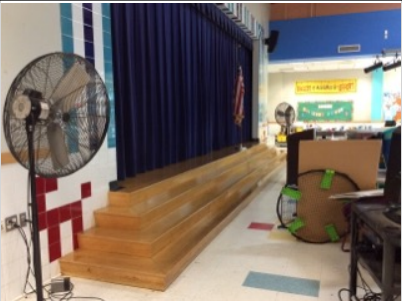
Handrails not provided	-	Provide handrails on at least one side of the stage. (Cost based on 6' of wood railing.)	1	352	\$352
Operable Parts												
80	Main Entrance Door 1	Ext.		Operable Parts	Other

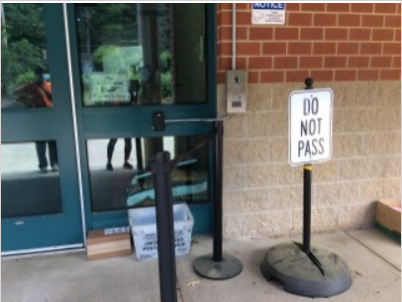
Clear floor space is not provided	-	Keep stored items away from intercom.	1	Labor	\$0

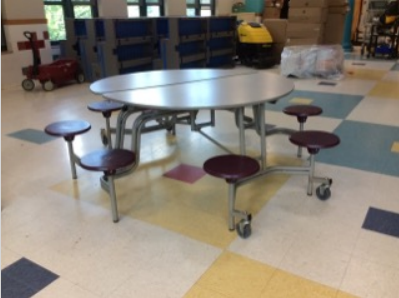
Knee or toe clearance not provided	-	Provide at least 1 dining surface with 24" min. knee and toe clearance.	1	1100	\$1100
82	PT/OT	1		Dining or Work Surfaces	Work Surface

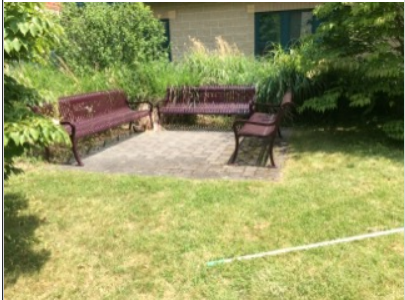
No accessible route to one bench in area	-	Provide an accessible route to 20% of benches in this area. (Cost based on a 48" wide min. x 12' long stone dust path with a max. cross slope of 1:50 (2.00%) and a max. running slope of 1:20 (5.00%).	1	384	\$384
Toilet & Bathing Rooms												
Lavatory												
87	Women's Toilet Room	1		Lavatory	N/A

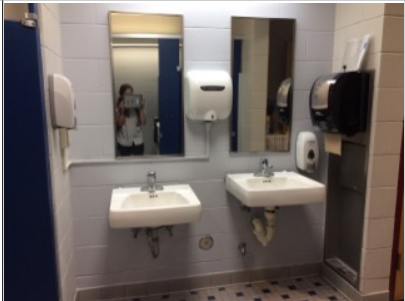
Clear floor space not provided at lavatory	-	Provide at least one lavatory with a 30" min. by 48" min. clear floor space positioned for a forward approach. (Relocate paper towel dispenser out of clear floor space at lavatory.)	1	353	\$353
Toilet Compartment												
88	Men's Toilet Room	1	127	Toilet Compartment	Accessible Compartment

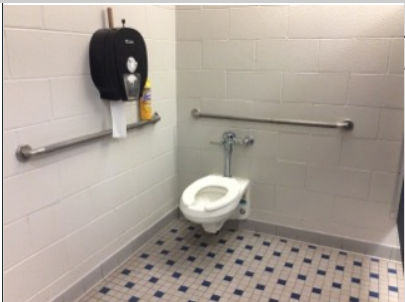
Flush control not on open side Non-compliant toilet paper dispenser	- -	Provide the flush control on the open side of the toilet (transfer side). Relocate toilet paper so that it is 24" min. high, located under the grab bar, and between 7" and 9" from the front of the toilet. Replace dispenser as it does not allow continuous paper flow.	1	727	\$727

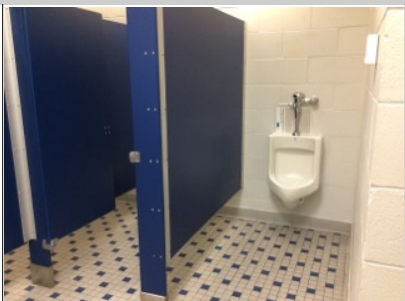
Rim > 17" high	18.5"	Provide at least one urinal with the rim no higher than 17" above the finished floor.	1	3248	\$3248

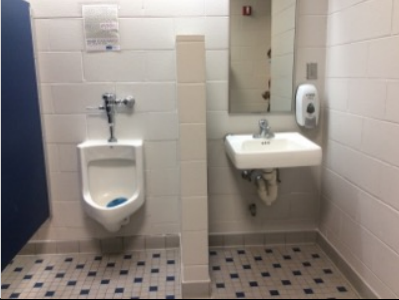
Rim > 17" high	18.5"	Provide at least one urinal with the rim no higher than 17" above the finished floor.	1	3248	\$3248
Dispensers												
91	Boys' Toilet Room	1	167	Dispensers	Paper Towel Dispenser

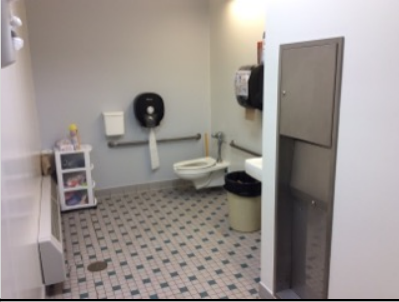
Clearance at toilet < 60" clear wide	34"	Remove storage cabinet to provide a clear floor space that is 60" wide min.	1	Labor	\$0
96	Spanish Classroom Single-User Toilet Room	1	133	Single-User Toilet (Children)	N/A

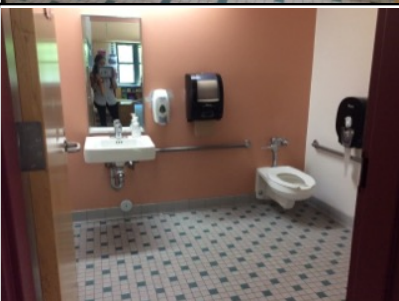
Non-compliant toilet paper dispenser	- -	Relocate toilet paper dispenser so that it is between 14"- 19" above the floor and between 7"- 9" in front of the toilet. Ensure dispensers and other devices are not mounted above grab bars./Replace dispenser as it does not allow continuous paper flow. Also relocate the paper towel and soap dispensers from above the grab bar.	1	1058	\$1058

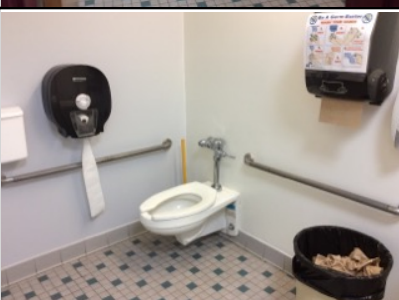
Non-compliant toilet paper dispenser Paper towel dispenser and tampon dispenser above grab bar.	-	Relocate toilet paper dispenser so that it is between 14"- 19" above the floor and between 7"- 9" in front of the toilet. Ensure dispensers and other devices are not mounted above grab bars./Replace dispenser as it does not allow continuous paper flow. Relocate all dispensers so they are not located above the grab bars. (MAAB)	3	300	\$900
Toilet Compartment (Children)												
99	Girls' Toilet Room	2		Toilet Compartment (Children)	Accessible Compartment

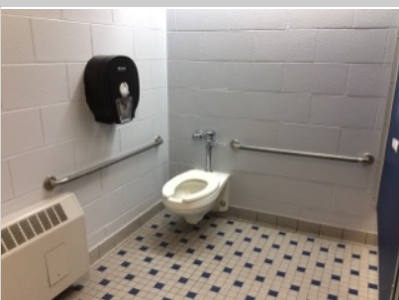
Side or rear grab bar < 25" or > 27" high (Ages 9 - 12) Non-compliant toilet paper dispenser	43" -	Relocate side grab bar to 25"- 27" above the floor. Relocate toilet paper dispenser so that it is between 14"- 19" above the floor and between 7"- 9" in front of the toilet. Ensure dispensers and other devices are not mounted above grab bars./Replace dispenser as it does not allow continuous paper flow.	1	609	\$609

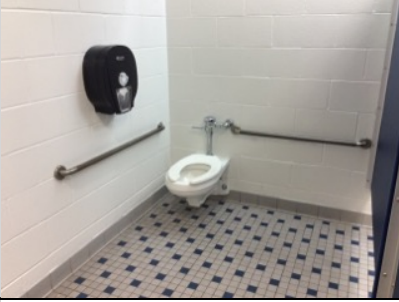
Flush control not on open side Non-compliant toilet paper dispenser	- -	Provide the flush control on the open side of the toilet (transfer side), no higher than 44". Relocate toilet paper dispenser so that it is between 14"- 19" above the floor and between 7"- 9" in front of the toilet. Ensure dispensers and other devices are not mounted above grab bars./Replace dispenser as it does not allow continuous paper flow.	1	727	\$727
101	Boys' Toilet Room	2	227	Toilet Compartment (Children)	Accessible Compartment

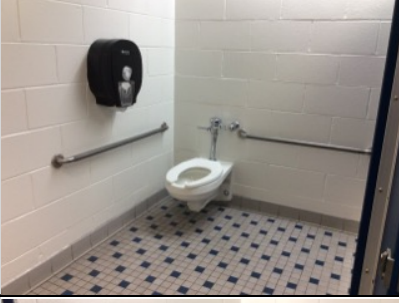
Flush control not on open side Non-compliant toilet paper dispenser	- -	Provide the flush control on the open side of the toilet (transfer side), no higher than 44". Relocate toilet paper dispenser so that it is between 14"- 19" above the floor and between 7"- 9" in front of the toilet. Ensure dispensers and other devices are not mounted above grab bars./Replace dispenser as it does not allow continuous paper flow.	1	1778	\$1778

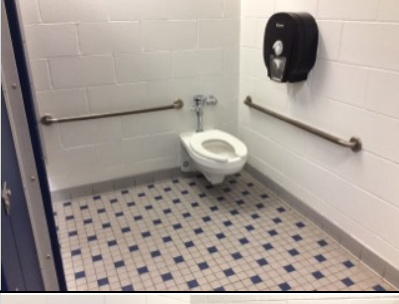
Non-compliant toilet paper dispenser	-	Relocate toilet paper dispenser so that it is between 14"- 19" above the floor and between 7"- 9" in front of the toilet. Ensure dispensers and other devices are not mounted above grab bars./Replace dispenser as it does not allow continuous paper flow.	1	353	\$353
103	Girls' Toilet Room	1	168	Toilet Compartment (Children)	Accessible Compartment

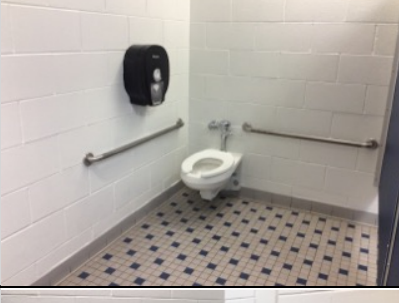
Non-compliant toilet paper dispenser	-	Relocate toilet paper dispenser so that it is between 14"- 19" above the floor and between 7"- 9" in front of the toilet. Ensure dispensers and other devices are not mounted above grab bars./Replace dispenser as it does not allow continuous paper flow.	1	353	\$353
104	Girls' Toilet Room	1	146	Toilet Compartment (Children)	Accessible Compartment

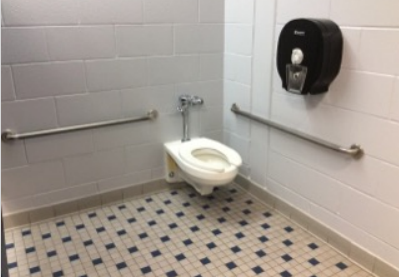
Non-compliant toilet paper dispenser	-	Relocate toilet paper dispenser so that it is between 14"- 19" above the floor and between 7"- 9" in front of the toilet. Ensure dispensers and other devices are not mounted above grab bars./Replace dispenser as it does not allow continuous paper flow.	1	353	\$353

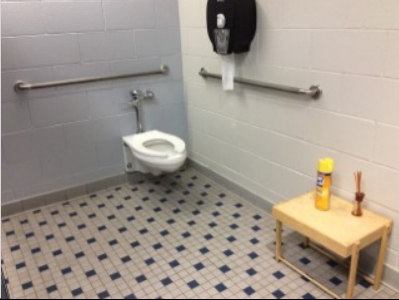
Non-compliant toilet paper dispenser	-	Relocate toilet paper dispenser so that it is between 14"- 19" above the floor and between 7"- 9" in front of the toilet. Ensure dispensers and other devices are not mounted above grab bars. Replace dispenser as it does not allow continuous paper flow.	1	353	\$353
106	Boys' Toilet Room	2	241	Toilet Compartment (Children)	Accessible Compartment

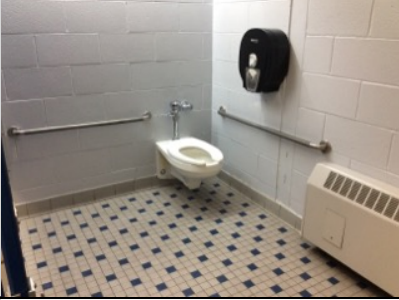
Non-compliant toilet paper dispenser	-	Relocate toilet paper dispenser so that it is between 14"- 19" above the floor and between 7"- 9" in front of the toilet. Ensure dispensers and other devices are not mounted above grab bars./Replace dispenser as it does not allow continuous paper flow.	1	353	\$353
107	Girls' Toilet Room	2	226	Toilet Compartment (Children)	Accessible Compartment

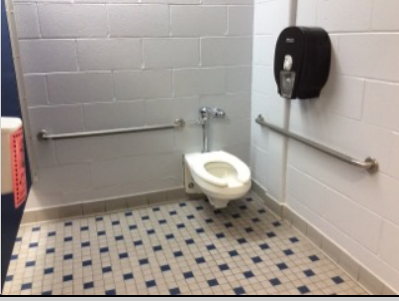
Non-compliant toilet paper dispenser	-	Relocate toilet paper dispenser so that it is between 14"- 19" above the floor and between 7"- 9" in front of the toilet. Ensure dispensers and other devices are not mounted above grab bars./Replace dispenser as it does not allow continuous paper flow.	1	353	\$353

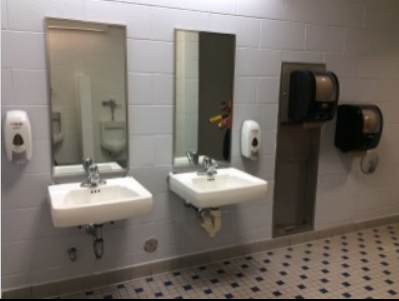
Toe or knee clearances not provided	22"	Provide at least one lavatory with 25" min. knee clearance positioned for a forward approach. Ensure toe clearance is also provided.	1	1686	\$1686
109	Boys' Toilet Room	2	241	Lavatory (Children)	N/A

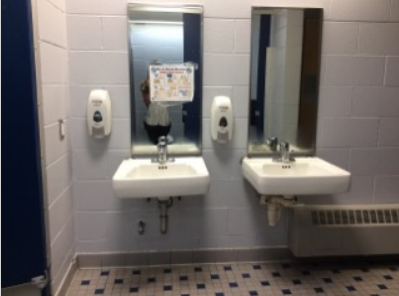
Toe or knee clearances not provided	23"	Provide at least one lavatory with 25" min. knee clearance positioned for a forward approach. Ensure toe clearance is also provided.	1	1686	\$1686
111	Girl's Room	1		Lavatory (Children)	N/A

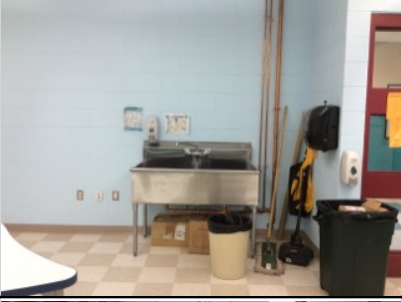
Toe and knee clearances not provided	20.75"	Ensure there is a 27" knee clearance positioned for a forward approach.	1	1686	\$1686
128	Grade 4 Classroom	2	216	Sink	Classroom

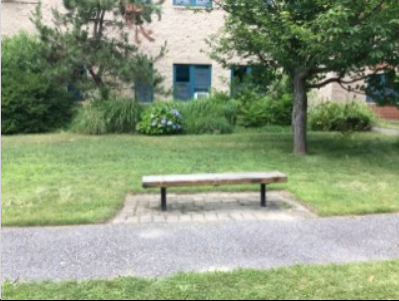
Recommend providing a 36"x48" stable, firm and slip resistant surface at the end of at least one bench in this area so someone using a wheeled mobility device can sit at the end of the bench with shoulder alignment with someone seated on the bench. Suggest asphalt or stone dust as the surface.	1	-	\$0

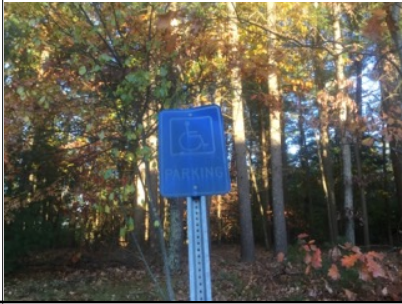
Recommend replacing or repainting the signs with the International Symbol of Accessibility to increase contrast between text and symbols and background and improve legibility of accessible parking signs.	2	-	\$0
