Town Hall

Town of Sudbury ADA Transition Plan

October 2020

Institute for Human Centered Design

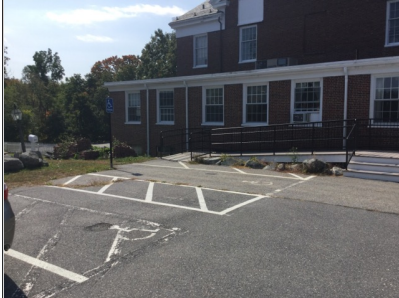
Van space < 132" or <96" wide Sign does not have the designation "Van Accessible"	111" -	Provide one van accessible space that is at least 132" wide. Ensure the access aisle is 60" min. for this space. Add the designation "Van Accessible" to the sign located at the van accessible space. (Cost estimate for repainting two spaces, and striping the landing to the ramp to be 60" min, and providing signage with the designation "Van Accessible" at the van accessible parking space.)	1	1100	\$1100
Exterior Ramp												
2	Accessible Entrance to Meeting Hall	1		Exterior Ramp	N/A

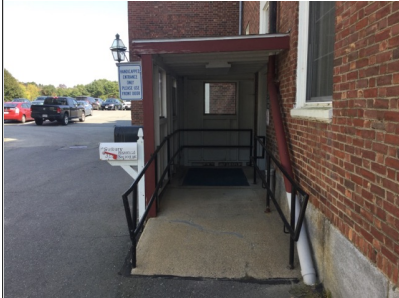
Running slope > 1:12 (8.3%) Edge protection < 4" high	11.2% -	Reduce running slope to be no steeper than 1:12 (8.3%). Provide edge protection that prevents the passage of a 4" diameter sphere, where any portion of the sphere is within 4" of the finished floor or ground surface. (Cost for repaving a concrete ramp to a shallower slope, including 1-1/2" pipe handrails - per 15 linear feet and providing edge protection at the bottom exterior rail.)	1	6587	\$6587

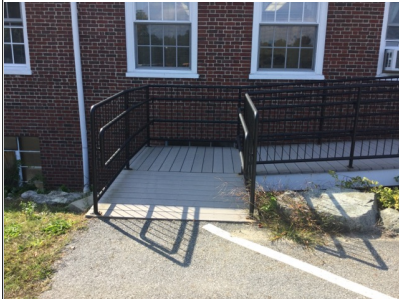
3	East Entrance Ramp	1		Exterior Ramp	N/A

Landing < 60" min. long	49"	Redo striping in the parking lot to ensure that 60" min. deep is provided at the base of the ramp. (Cost listed under ID #1.)	1	-	\$0
Entrance												
4	Entrance to South Stairwell	1		Entrance	Secondary Entrance

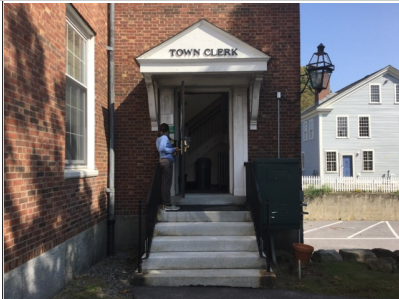
Entrance not on an accessible route Directional sign to accessible entrance not provided	- -	Provide a directional sign indicating the location of the nearest accessible entrance.	1	346	\$346

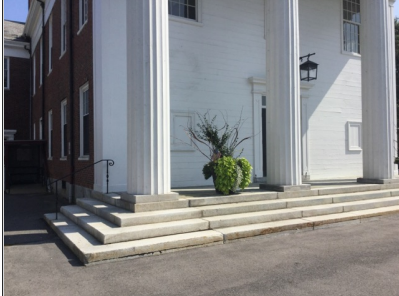
Entrance not on an accessible route Directional sign to accessible entrance not provided	- -	Provide a directional sign indicating the location of the nearest accessible entrance. (Note: Where a directional sign is required, it should be located to minimize backtracking. In some cases, this could mean locating a sign at the beginning of a route, not just at the inaccessible entrance to the building.)	2	346	\$692
6	Lobby From Main Entrance to Meeting Hall	1		Entrance	Main Entrance

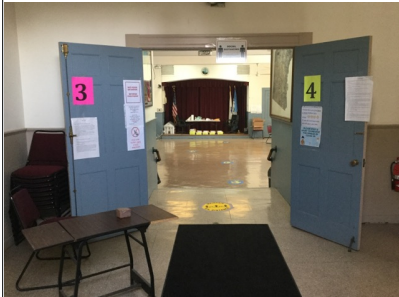
Mat not securely attached	-	Secure the mat.	1	Labor	\$0
7	Accessible Entrance to Meeting Hall	1		Entrance	Secondary Entrance

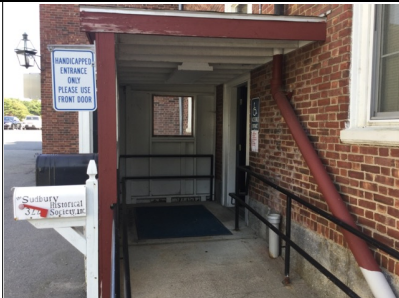
Mat not securely attached	-	Secure the mat.	1	Labor	\$0
8	Main Entrance - West Side of Building	Ext		Entrance	Main Entrance

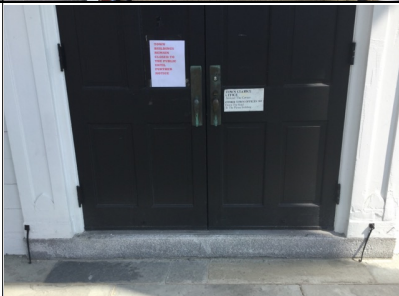
Hardware not operable with a closed fist	- -	Provide hardware that can be operable with one hand and not require tight grasping, pinching, or twisting of the wrist.	1	484	\$484

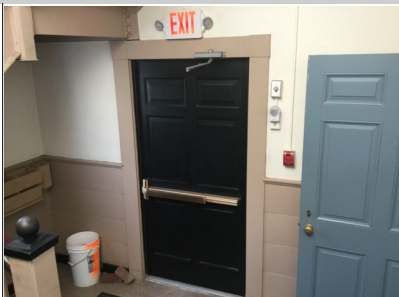
Emergency Exit												
9	Exit From South and North Stairwells	1		Emergency Exit	N/A

Tactile sign not provided at exit Directional sign to accessible emergency exit not provided	- -	Provide tactile exit signs with raised characters and braille at exit doors. Mount signs between 48"- 60" above the finished floor located on the latch side of the door. Provide a directional sign indicating the location of the nearest accessible emergency exit.	4	232	\$928

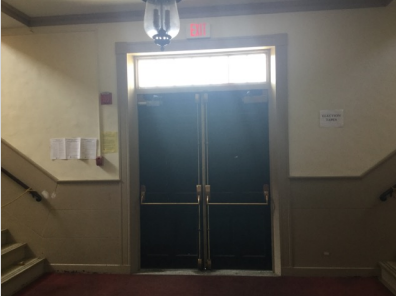
Tactile sign not provided at exit Directional sign to accessible emergency exit not provided Door requires > 15 lbs. of force to open	- - 23 lbs.	Provide tactile exit signs with raised characters and braille at exit doors. Mount signs between 48"- 60" above the finished floor located on the latch side of the door. Provide a directional sign indicating the location of the nearest accessible emergency exit. Adjust closers of exterior doors so doors do not require more than 15 pounds of force.	2	232 Labor	\$464
11	Exit to East Side of Building	1		Emergency Exit	N/A

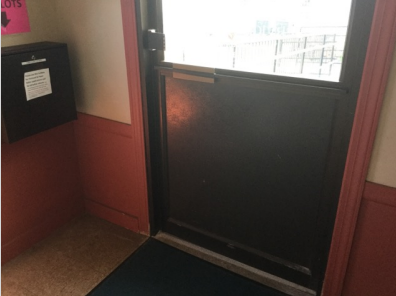
Tactile sign not provided at exit Illuminated Int. Symbol of Acc. not provided (MAAB)	- -	Provide tactile exit signs with raised characters and braille at exit doors. Mount signs between 48"- 60" above the finished floor located on the latch side of the door. Provide an illuminated sign with the International Symbol of Accessibility.	1	432	\$432

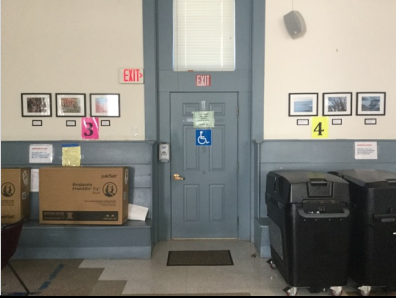
12	Accessible Exit From Meeting Hall	1		Emergency Exit	N/A

Tactile sign not provided at exit Illuminated Int. Symbol of Acc. not provided (MAAB) Maneuvering clearance(s) not provided Mat not securely attached	- - 6.5" -	Provide tactile exit signs with raised characters and braille at exit doors. Mount signs between 48"- 60" above the finished floor located on the latch side of the door. Provide an illuminated sign with the International Symbol of Accessibility. Provide an automatic door opener. Secure the mat.	1	3492 Labor	\$3492
Access to Goods and Services												
Interior Access Route												
13	Men's Toilet Room by Lobby at Main Entrance	1		Interior Access Route	N/A

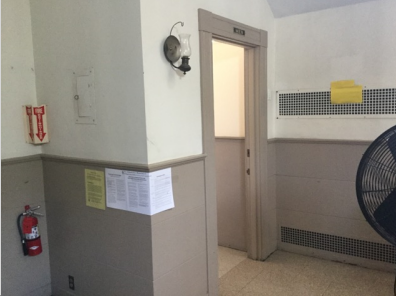
Obstructed by protruding objects	5.25"	Provide a cane-detectable barrier at the light fixture.	1	306	\$306
14	Hallway Between Town Clerk Office and East Side of Building	1		Interior Access Route	N/A

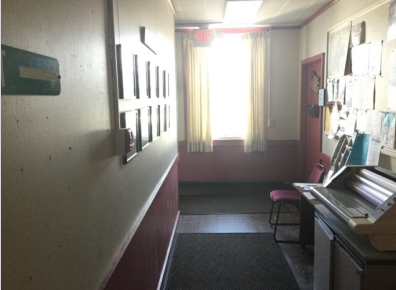
Surface not stable, firm, and slip-resistant	-	Secure mat.	1	Labor	\$0

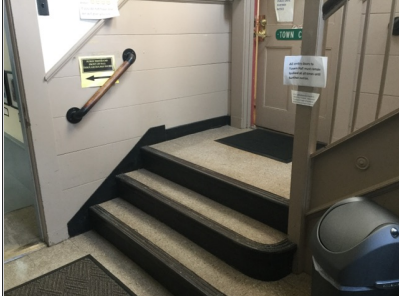
Accessible route not provided	-	There is no interior accessible route to the Town Clerk office. Look into the feasibility of installing a platform lift between the Meeting Hall and this office.	1	21660	\$21660
16	South Stairwell	2		Interior Access Route

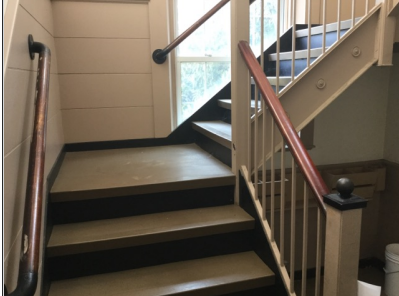
Accessible route not provided	-	At the time of survey, no public programs were provided on the second floor and mezzanine. If public programs will be provided on these levels, consider providing a Limited Use Limited Access (LULA) elevator.	1	-	\$0
Doors, Doorways, & Gates												
17	Hallway Between Town Clerk Office and East Exit	1		Doors, Doorways, & Gates	Circulation

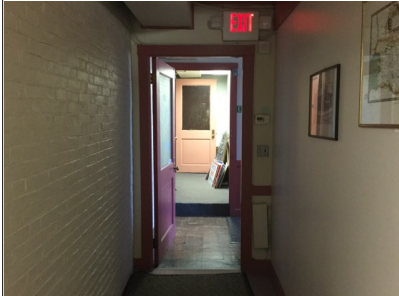
Mat not securely attached Hardware not operable with a closed fist	- -	Secure the mat. Provide hardware that can be operable with one hand and not require tight grasping, pinching, or twisting of the wrist.	1	Labor 484	\$484

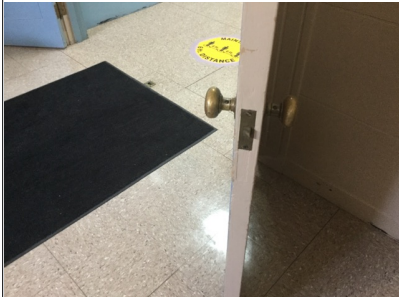
18	Meeting Hall Door	1		Doors, Doorways, & Gates	Other

Hardware not operable with a closed fist	-	Provide hardware that can be operable with one hand and not require tight grasping, pinching, or twisting of the wrist.	1	484	\$484
19	Women's Toilet Room by Lobby at Main Entrance	1		Doors, Doorways, & Gates	Toilet Room

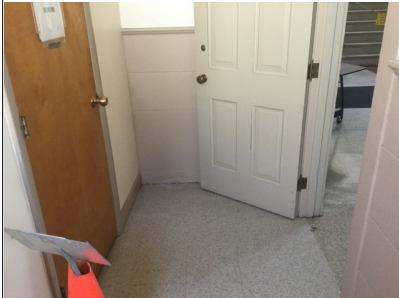
Hardware not operable with a closed fist	-	Provide hardware that can be operable with one hand and not require tight grasping, pinching, or twisting of the wrist.	1	484	\$484

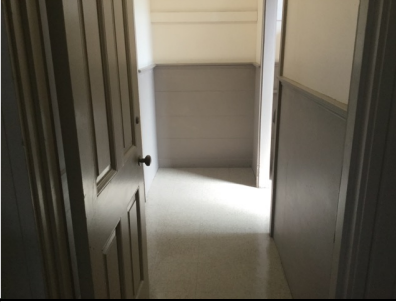
Hardware not operable with a closed fist	-	Provide hardware that can be operable with one hand and not require tight grasping, pinching, or twisting of the wrist.	1	484	\$484
21	South Stairwell to Meeting Hall	1		Doors, Doorways, & Gates	Circulation

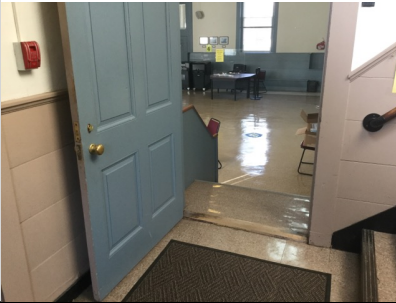
Hardware not operable with a closed fist	-	Provide hardware that can be operable with one hand and not require tight grasping, pinching, or twisting of the wrist.	1	484	\$484
Signage												
22	Employee Only Toilet Room - Meeting Hall	1		Signage	Designation

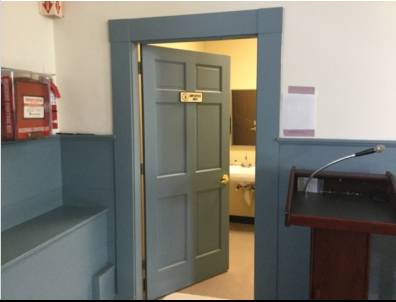
Raised characters not provided on sign Braille not provided on sign International Symbol of Acc. not provided Sign not located on the latch side of the door	- - - -	Provide text with raised characters duplicated in braille on sign. Provide a sign with the International Symbol of Accessibility. Locate sign at permanent rooms alongside the door on the latch side.	1	232 Labor	\$232

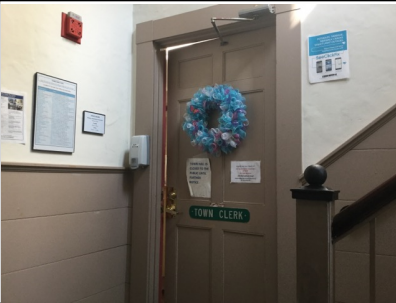
23	South Stairwell - Entrance to Town Clerk Office	1		Signage	Designation

Raised characters not provided on sign Braille not provided on sign Sign not located on the latch side of the door	- - -	Provide text with raised characters duplicated in braille on sign. Locate sign at permanent rooms alongside the door on the latch side.	1	232 Labor	\$232
24	Ramp at East Entrance to Town Clerk and Veteran's Services	Ext		Signage	Informational

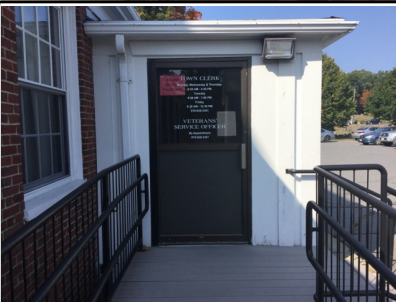
Non glare finish and contrast not provided on sign	-	Install a sign with a non-glare finish with characters that have a high contrast to the background.	1	232	\$232

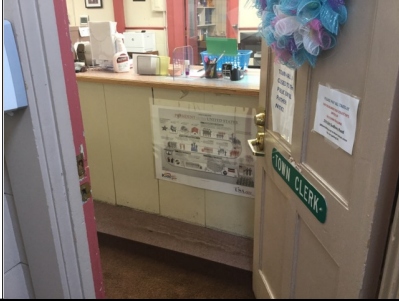
Counter > 36" high	42.25"	Provide a counter that is 36" max. above the ground or finished floor.	1	880	\$880
26	Town Clerk Office	1		Service Counter	N/A

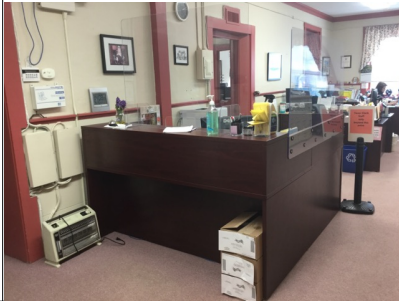
Counter > 36" high Knee clearance not compliant	44.25" 10.75"	Provide a counter that is 36" max. above the ground or finished floor. Ensure that knee clearance is 17" min. for a forward approach.	1	880	\$880
Operable Parts												
27	Town Clerk Office Brochures	1		Operable Parts	Other

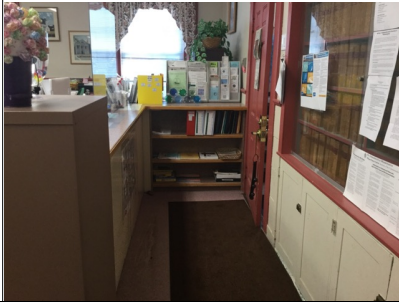
Reach < 15" or > 48"(forward/side approach)	60"	Relocate one of each type of form to be no higher than 48" above the finished floor.	1	Labor	\$0
Dining or Work Surfaces												
28	Meeting Hall	1		Dining or Work Surfaces	Work Surface

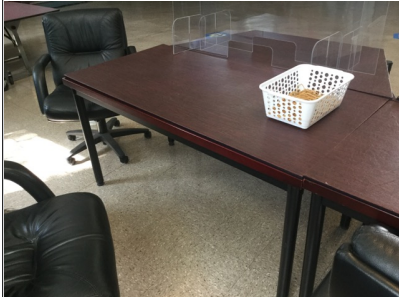
At least one or 5% accessible tables not provided Knee or toe clearance not provided	- 26"	Provide at least 1 work surface with 27" min. knee and toe clearance.	1	700	\$700

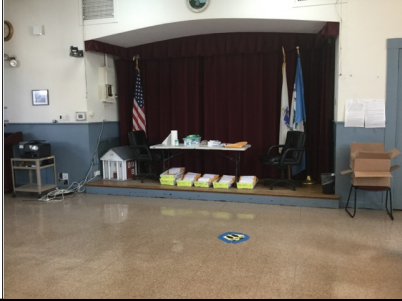
Accessible route to stage not provided	8"	Provide a portable ramp to the stage.	1	500	\$500
Toilet & Bathing Rooms												
Overall Access												
30	Employee Only Toilet Room - Meeting Hall	1		Overall Access	Toilet Room

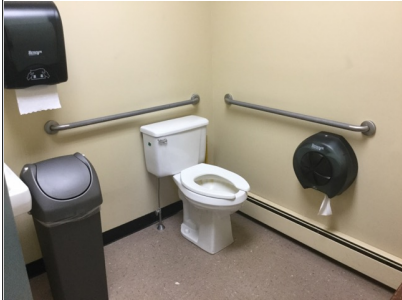
Audible and visible alarms not provided	-	When fire system is updated, ensure that a visible and audible fire alarm is installed.	1	-	\$0
Lavatory												
31	Employee Only Toilet Room - Meeting Hall	1		Lavatory	N/A

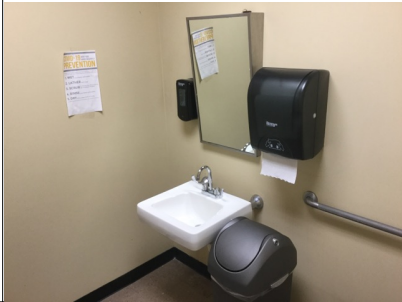
Toe or knee clearances not provided Dispensers not within reach range Paper towel dispenser mounted over grab bar	24.5" 50", 46"	Provide at least one lavatory with knee and toe clearance positioned for a forward approach. Lower soap and paper towel dispensers to 42" max. above the floor. Relocate paper towel dispenser so that it is not mounted above the rear grab bar.	1	2198	\$2198

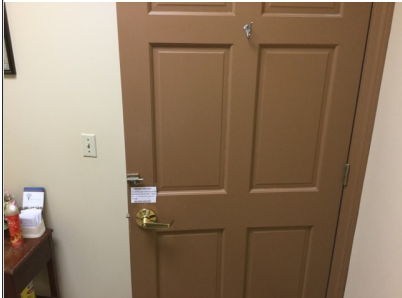
Hook located > 48" high	65.75"	Locate hook no higher than 48" above the finished floor.	1	150	\$150

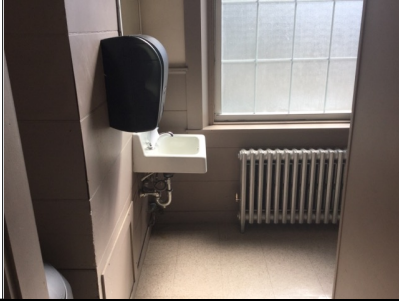
Dispenser acts as a protruding object	-	Relocate paper towel dispenser out of the circulation path.	1	256	\$256
Best Practice												
34	Meeting Hall Entrance	1

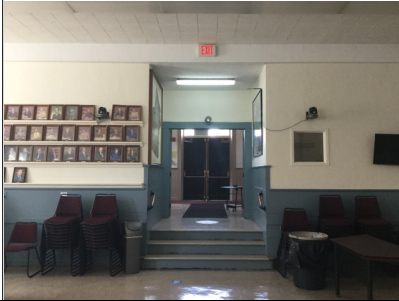
Recommend providing color contrast strips on the stair treads to increase visibility.	1	-	\$0
35	Meeting Hall	1

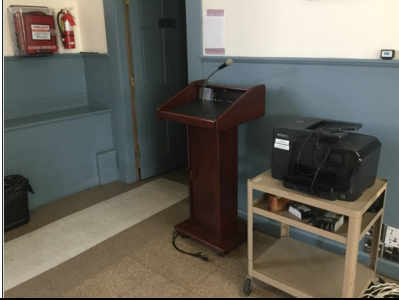
Recommend providing an adjustable-height podium.	1	-	\$0
36	Entrance to South Stairwell	1

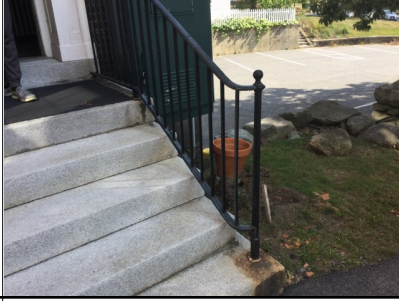
Recommend providing color contrast strips on the stair treads to increase visibility. Recommend providing handrails with a 1-1/4" to 1-1/2" circular cross section, and ensuring that the sloped bottom extension extends one tread depth minimum beyond last riser nosing in same direction as stair flight.	1	-	\$0

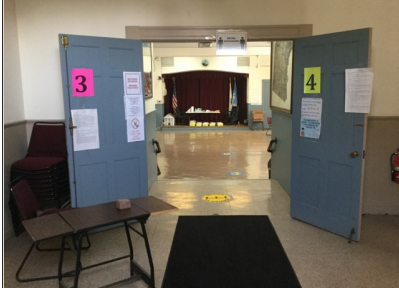
37	Lobby From Main Entrance to Meeting Hall	1

-	Recommend providing designation signage with raised characters and braille where no signage is present.	1	-	\$0

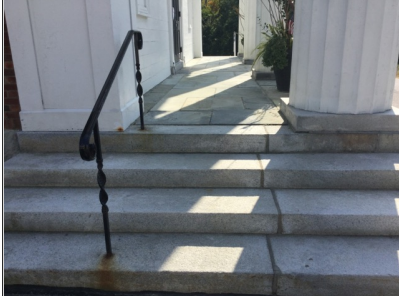
Recommend providing color contrast strips on the stair treads to increase visibility. Recommend providing handrails with a 1-1/4" to 1-1/2" circular cross section, and ensuring that the sloped bottom extension extends one tread depth minimum beyond last riser nosing in same direction as stair flight. Recommend providing a second handrail.	1	-	\$0
39	West Side of Building	Ext

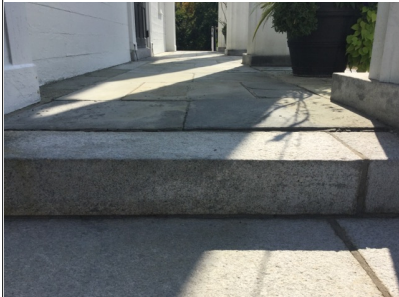
Recommend repairing uneven surface at the top of the stairs to prevent tripping, although it is not part of the accessible route.	1	-	\$0
40	Accessible Entrance to Meeting Hall	Ext

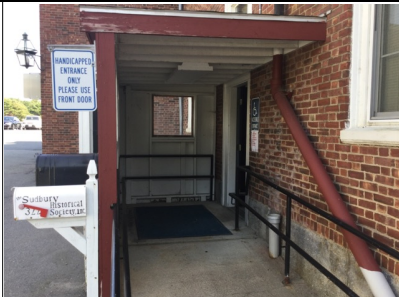
Provide clear information about the locations of destination spaces at each entrance. Avoid terms such as "handicapped" and use the term "accessible" instead.	1	-	\$0
