# Broadacres Farm

## Town of Sudbury ADA Transition Plan

September 2020

Institute for Human Centered Design

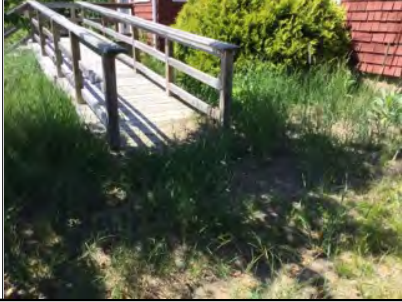
ID	Location	Floor	Room	Element	Type	Photo	Issues	Current Measure	Recommendations	Quantity	Price	Cost Estimation
<b>Exterior Ramp</b>												
6	House - Main Entrance	Ext.		Exterior Ramp	N/A

No lower handrail 18"-20" high provided Ramp < 48" wide Handrails do not extend 12" past top & bottom Handrails have non-compliant cross section Ramp is not located on an accessible route	- 35" - -	Rebuild ramp so that there is 48" inches clear. Provide a lower handrail between 18" to 20" high on each side. Provide handrails that extend horizontally above the landing for 12" min. beyond the top and bottom of ramp runs. Provide handrails with 1-1/4" to 1-1/2" circular cross sections. (Cost estimate for a new 30' pressure treaded wood ramp.).	1	7843	\$7843
<b>Entrance</b>												
7	Horse Riding Practice Building Inaccessible Door	Ext.		Entrance	Secondary Entrance

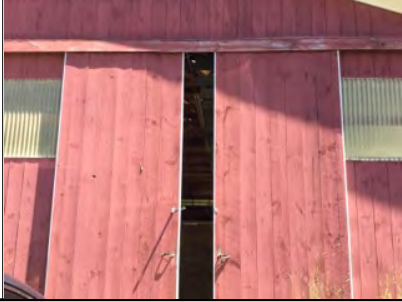
ID	Location	Floor	Room	Element	Type	Photo	Issues	Current Measure	Recommendations	Quantity	Price	Cost Estimation
11	Horse Riding Practice Building Main Entrance	Ext.		Entrance	Main Entrance

Door requires > 15 lbs. of force to open	-	Provide an accessible door into the facility. (Cost estimate for installing a solid core wood door.)	1	2972	\$2972
<b>Emergency Exit</b>												
12	Kitchen Egress	1		Emergency Exit	N/A

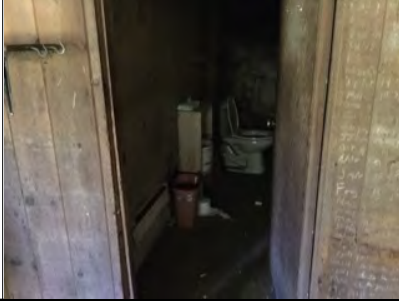
ID	Location	Floor	Room	Element	Type	Photo	Issues	Current Measure	Recommendations	Quantity	Price	Cost Estimation
<b>Overall Access</b>												
26	Horse Barn Toilet Room	1		Overall Access	Toilet Room

Turning space not provided Accessible plumbing fixtures or stalls not provided	40" -	Add an accessible single-user toilet room.	1	24604	\$24604
27	Kitchen Bathroom in the House	1		Overall Access	Toilet Room

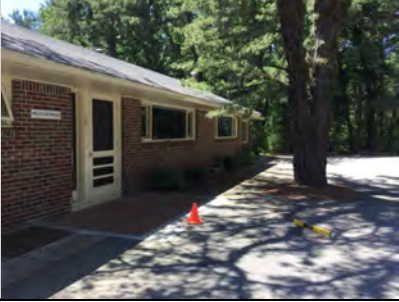
ID	Location	Floor	Room	Element	Type	Photo	Issues	Current Measure	Recommendations	Quantity	Price	Cost Estimation
11	Building 4 - Route to Entrance	1		Exterior Access Route	Exterior

Running slope > 1:20 (5%)	11.4%	Reduce running slope to be no steeper than 1:20 (5%). Route by entrance has an excessive slope due to tree roots. Address issues when designing ramp at entrance.	1	-	\$0
12	Building 6 - Barn Entrance	Ext.		Entrance	Main Entrance

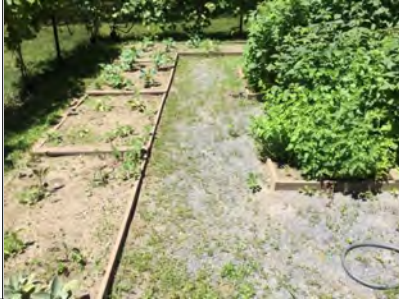
ID	Location	Floor	Room	Element	Type	Photo	Issues	Current Measure	Recommendations	Quantity	Price	Cost Estimation
<b>Approach and Entrance</b>												
<b>Exterior Access Route</b>												
1	Garden	Ext.		Exterior Access Route	Exterior

Exterior route < 48" wide Surface is not stable, firm, and slip-resistant Route not maintained in operable working condition	36" - -	Ensure that a clear width of 48" min. is maintained at the accessible route. Provide and maintain a stone dust route. (Cost estimate for 180' long, 4' wide stone dust route.)	1	5760	\$5760
2	Sandbox 1	Ext.		Exterior Access Route	Exterior

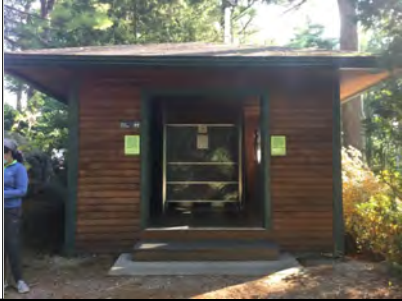
ID	Location	Floor	Room	Element	Type	Photo	Issues	Current Measure	Recommendations	Quantity	Price	Cost Estimation
<b>Entrance</b>												
26	Men's and Women's Toilet Rooms by Swimming Pool	Ext.		Entrance	Main Entrance

Entrance not on an accessible route	15"	Provide a ramp to the entrance. (Cost estimate for a 15' long straight concrete ramp with compliant platforms at the top and bottom.)	1	17702	\$17702
<b>Emergency Exit</b>												
27	Toilet Rooms by Swimming Pool	1		Emergency Exit	N/A

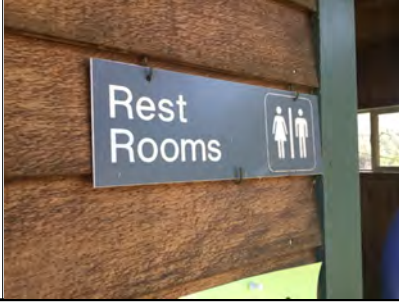
ID	Location	Floor	Room	Element	Type	Photo	Issues	Current Measure	Recommendations	Quantity	Price	Cost Estimation
30	Men's and Women's Toilet Rooms by Swimming Pool	Ext.		Signage	Designation

Raised characters not provided Raised characters < 48" or > 60 " above ground Braille not provided	- 74" -	Provide text with raised characters duplicated in braille. Mount signs so that the baseline of the lowest tactile character is 48" min. above the finished floor and the baseline of the highest tactile character is 60" max. above the finished floor.	1	346	\$346
<b>Benches</b>												
31	Center of Garden	Ext.		Benches	N/A

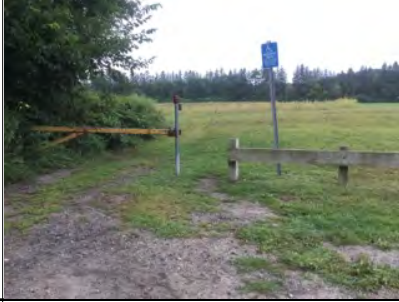
Access aisle not provided	-	Provide a marked access aisle that is at least 60" wide and a marked vehicle space that is 96" wide min.	1	300	\$300
7	Parking Lot Near Wayside Opening in Center	Ext.		Off-Street Parking Lot or Garage	Visitor

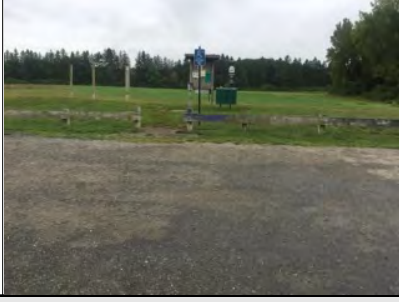
Access aisle not provided Sign does not have the designation "Van Accessible"	- -	Provide a marked access aisle that is at least 96" wide. Add the designation "Van Accessible" to the sign located at the van accessible space.	1	800	\$800
<b>Access to Goods and Services</b>												
<b>Operable Parts</b>												
8	Lost and Found on Back of Wayside	Ext.		Operable Parts	Lost and Found

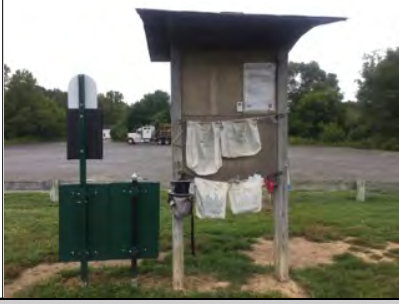
Element not on an accessible route Side reach > 54"	- 58"	Provide an accessible route to the lost and found area. Relocate lost and found between 15" - 48" above the finished floor. (Cost estimate for a 20' long 4' wide stone dust route.)	1	640 Labor	\$640

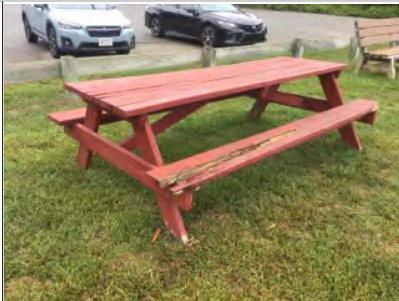
Toe or knee clearance at table not provided Picnic table not on an accessible route	- -	Provide at least one picnic table with top between 28"- 34" above the ground and 27" clear height underneath. Ensure that the dining surface is connected to an accessible route. (Cost estimate for an accessible picnic table and a 37" long by 4' wide stone dust path from the entrance to the table.)	1	2584	\$2584

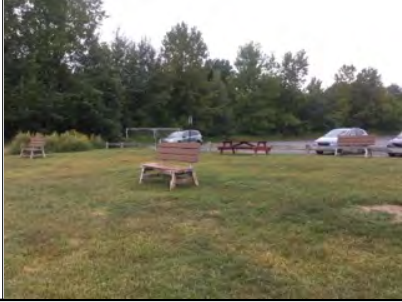
No accessible route to one bench in this area	-	Provide an accessible route to at least one bench in this area. (Cost estimate for a 30' long, 4' wide stone dust route).	1	960	\$960
<b>Play and Sport Areas</b>												
<b>Field</b>												
11	Soccer Nets by Parking Lot and Benches	Ext.		Field	Soccer

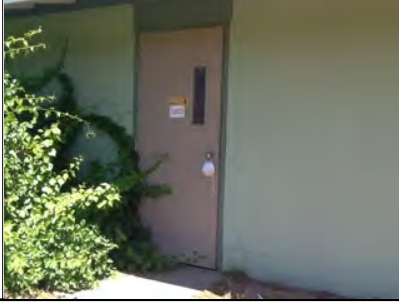
Hardware not operable with a closed fist	-	Provide hardware that can be operable with one hand and not require tight grasping, pinching, or twisting of the wrist.	1	484	\$484
<b>Access to Goods and Services</b>												
<b>Interior Access Route</b>												
17	South Concession Stand Women's Toilet Room	1		Interior Access Route	Interior

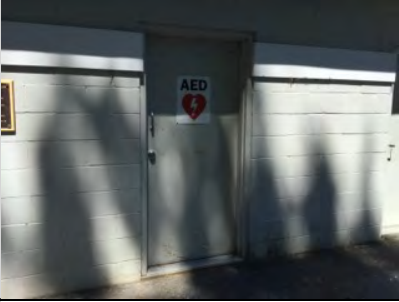
Threshold > 1/2" high	3"	Alter the threshold to be 1/2" high max.	1	150	\$150
22	North (Lower Featherland) Concession Stand Women's Toilet Room	Ext.		Doors, Doorways, & Gates	Toilet Room	 	Threshold > 1/2" high	3"	Alter the threshold to be 1/2" high max.	1	150	\$150
23	North (Lower Featherland) Concession Stand Men's Toilet Room	Ext.		Doors, Doorways, & Gates	Toilet Room

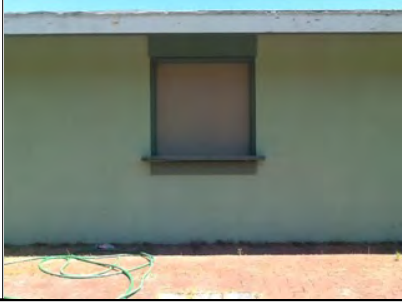
Counter > 36" high	41"	Provide a counter that is 36" max. above the ground.	1	880	\$880
<b>Picnic Tables</b>												
32	Picnic Area in Front of North Concession Stand in Lower Featherland Park	Ext.		Picnic Tables	N/A

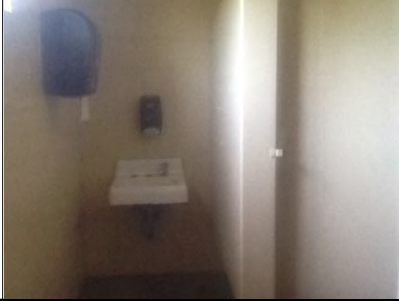
Controls > 42" (MAAB) Dispenser acts as a protruding object	50" -	Relocate the paper towel dispenser so that the operable part is 42" max. above the finished floor and out of the circulation path.	1	256	\$256
<b>Play and Sport Areas</b>												
<b>Field</b>												
41	Baseball Field 1 Entrance Team Seating Area 1	Ext.		Field	Baseball

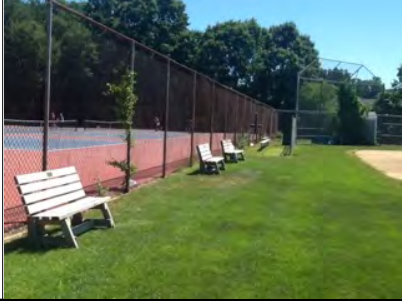
No accessible route to one bench in this area	-	Provide an accessible route to at least one bench in this area. (Cost estimate for 4' long by 4' wide stone dust route.)	1	128	\$128
<b>Trash / Recycling</b>												
22	North Center Tennis Entrance	Ext.		Trash / Recycling	N/A

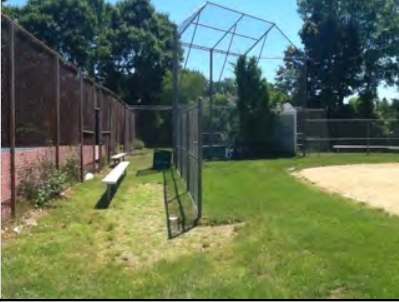
Accessible spaces are not provided at team seating	-	Provide a 36" x 48" clear floor space at team seating alongside bench. (Cost estimate for 3' by 4' stone dust area.)	2	96	\$192
26	Southeast Softball Field Team Seating	Ext.		Field	Softball

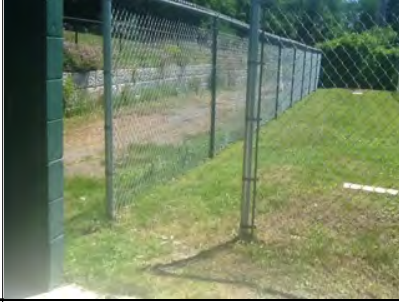
Practice areas are not on an accessible route	-	Provide an accessible route to pitching practice area. (Cost estimate for 10' long, 4' wide asphalt route.)	1	400	\$400
36	Baseball Field, Route Between West Team Seating Area and Pitching Practice Area	Ext.		Field	Baseball

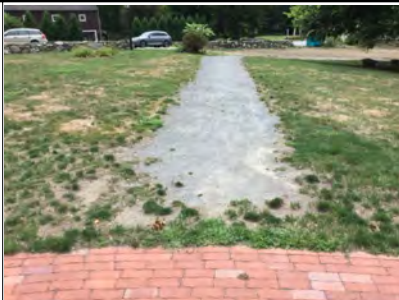
Route not maintained in operable working condition	-	Ensure the accessible route is maintained in operable working condition.	1	Labor	\$0
4	Crosswalk at the Intersection of Hudson and Concord Roads	Ext.		Exterior Access Route	Exterior

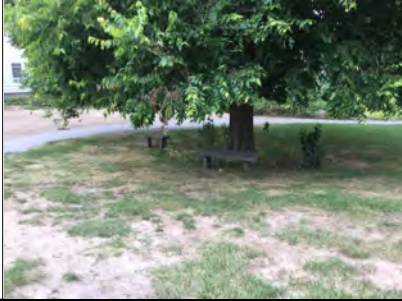
No accessible route to one bench in this area	-	Provide an accessible route to at least one bench in this area.  (Cost based on a new 4' wide min. x 15' stone dust path.)	1	600	\$600
<b>Best Practice</b>												
<b>Bench</b>												
6	Walkway From World War I Memorial to the Intersection of Hudson and Concord Roads	Ext.		Bench	N/A

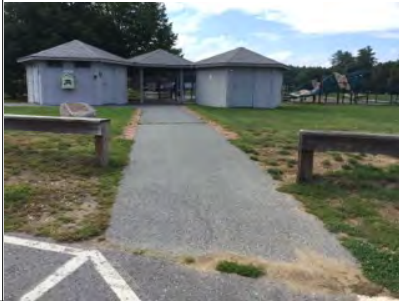
Route not maintained in operable working condition	-	Ensure the accessible route is maintained in operable working condition.	1	Labor	\$0

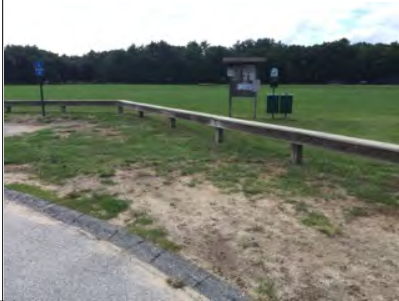
Accessible route not provided	- -	Ensure an accessible route is provided to the wayside and the dog waste bag dispenser. Either relocate both to an accessible location or provide a firm, stable and slip resistant route to both.  (Cost based on a 4' wide min. x 15' long stone dust path to both amenities.)	1	480	\$480
5	From Right Side of Parking 1 to Accessible Path 2	Ext.		Exterior Access Route	Exterior

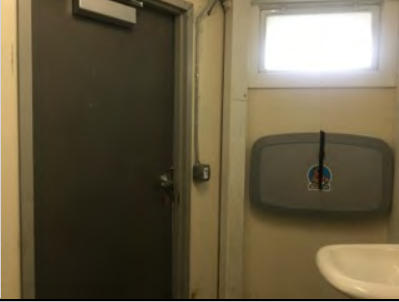
Audible and visible alarms not provided	-	When fire system is updated, ensure that a visible and audible fire alarm is installed.	1	-	\$0
<b>Single-User Toilet</b>												
21	Women's Accessible Toilet Room	Ext.		Single-User Toilet	N/A

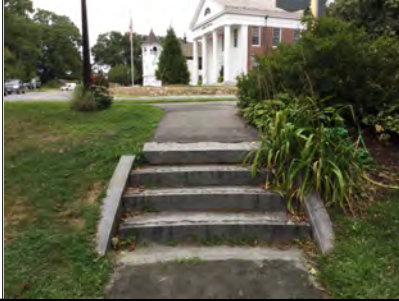
Handrails not provided	-	Provide handrails. (Cost estimate for 20' of metal handrail.)	1	1480	\$1480
<b>Picnic Tables</b>												
17	Near Old Sudbury Road Entrance	Ext.		Picnic Tables	N/A

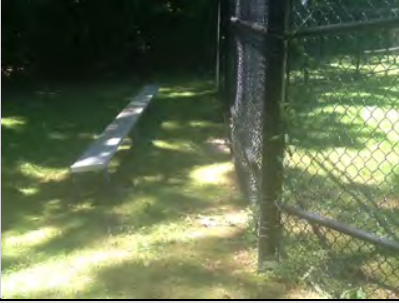
Accessible spaces not provided at sidelines seating Not connected to an accessible-route	- -	Provide a 36" x 48" clear floor space at sidelines seating. Provide an accessible route to the the spectator seating area. (Cost estimate for a 36" by 48" stone dust clear floor space alongside the bench and an 26' long, 4' wide accessible stone dust route from the east team seating area to the spectator seating area.)	1	928	\$928
<b>Best Practice</b>												
6	Sunny Picnic Area	Ext.

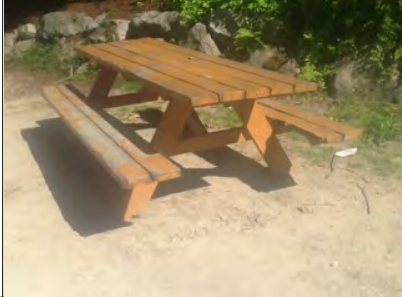
Toe or knee clearance at table not provided	-	Provide at least one picnic table with top between 28"- 34" above the ground and 27" clear height underneath.	1	1400	\$1400
<b>Best Practice</b>												
<b>Memorial</b>												
7	Memorial	Ext.		Memorial	N/A
