ROOF CONDITION SURVEY

For
Town of Sudbury

**Town Hall
322 Concord Road
Sudbury, Massachusetts**

February 3, 2012

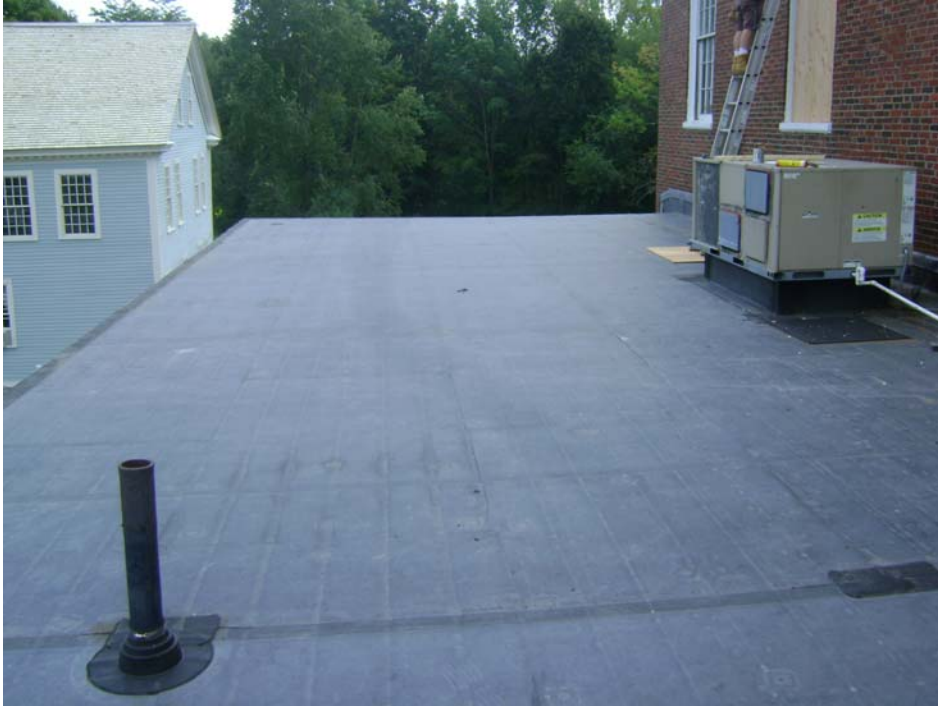
Photo No. 03

The EPDM roofing system that exists on Roof No. 2 reportedly was installed in 2008 and appears in good condition. No warranties are currently in place.

Description: Overview of low slope roof. EPDM roof is in good condition.

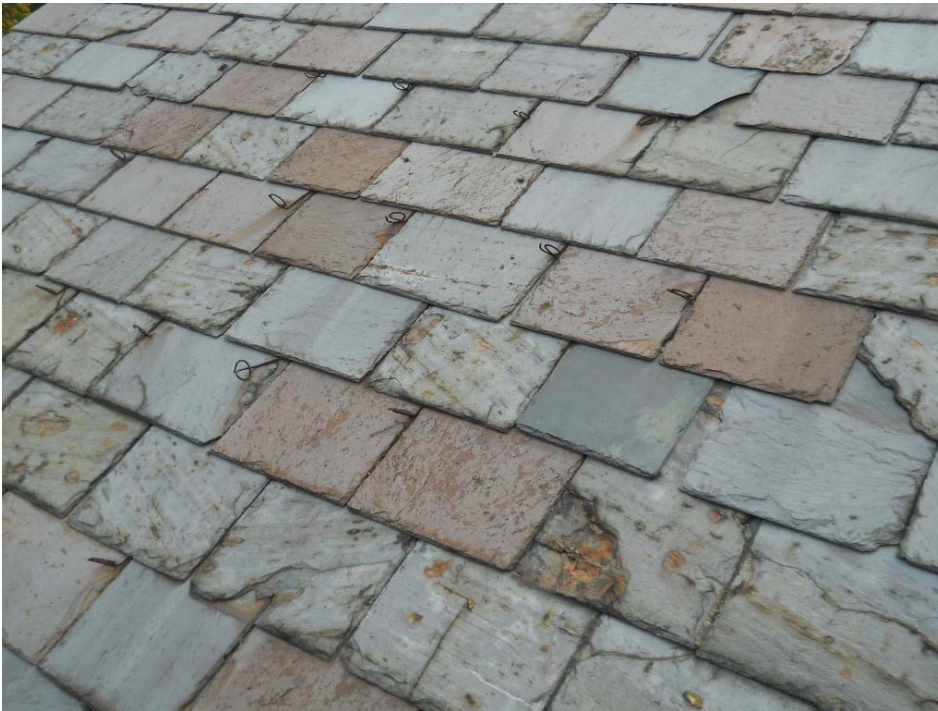
Photo No. 04

Description: Slate roofing is aged but apparently intact.

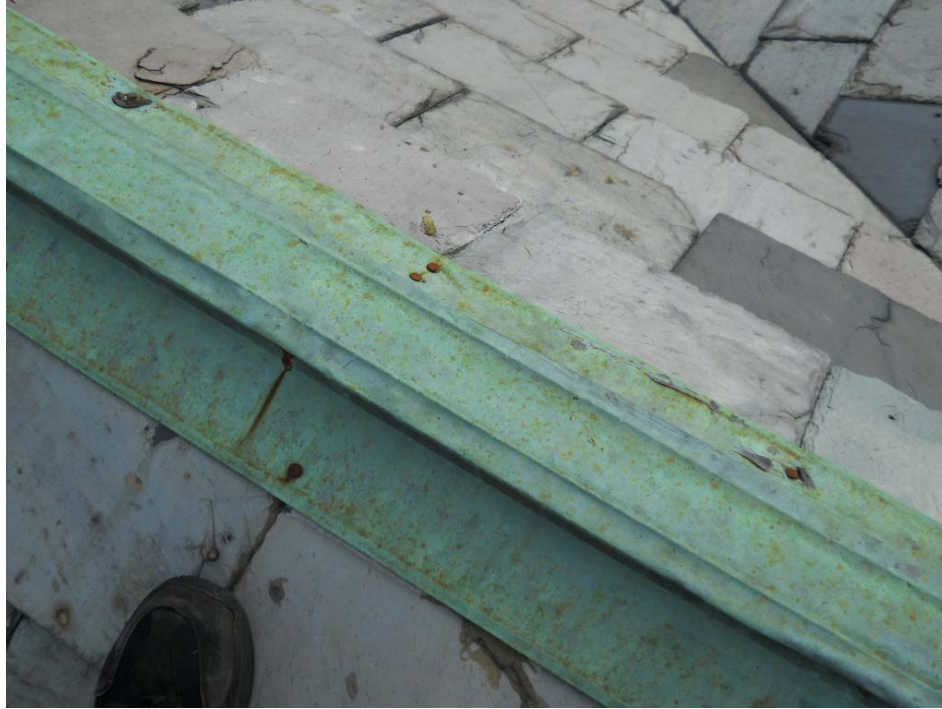
Photo No. 05

Description: Copper ridge cap has been fastened with steel roofing nails rusting in corrosion of the steel fasteners.

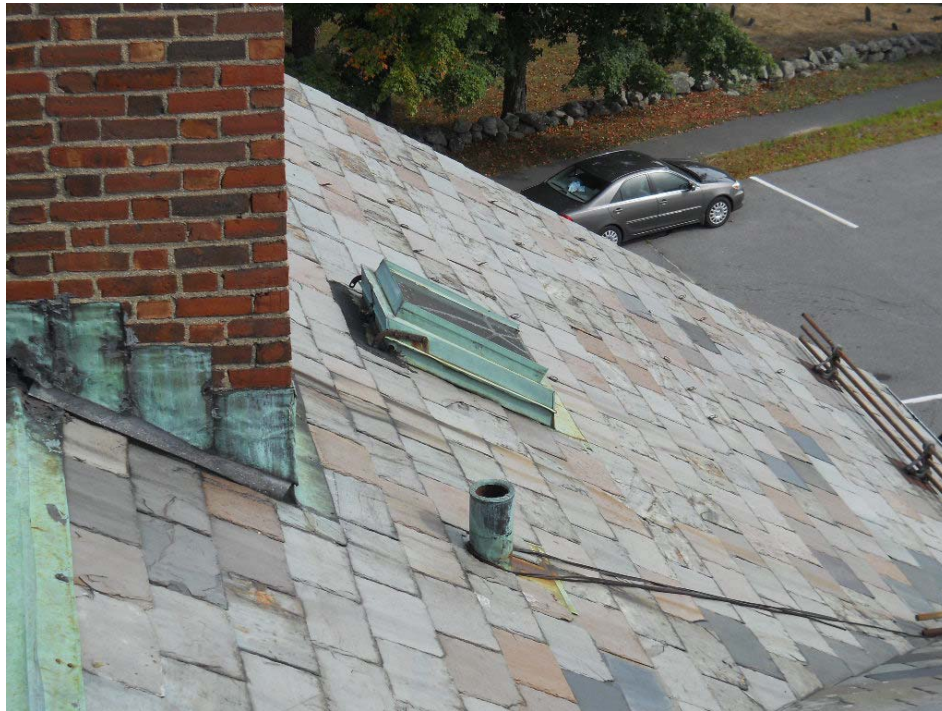
Photo No. 06

The slate roofing system that exists on Roof No. 1 is estimated to be approximately 80-years old. Leakage is reported to occur at the skylight/hatch assembly (tarp collection system is in place). The slate shingles are in good to fair condition. Over the years random slates have been replaced. Many cracked/broken slates were observed. Water staining on the underside of the wood decking was observed. The copper sheetmetal has been resecured with fasteners that are now rusted. Deteriorated masonry was observed at the chimney. Gutter repairs with roofing cement were observed in the copper gutters.

Description: Aged skylight/access hatch is the apparent source of leaks.

1. In an effort to extend the useful service life of the 80-year old slate roofing system (Roof No. 1) the recommendation is to implement preventive maintenance repairs in years **2011, 2015, and 2019**. Recommended repairs include removing skylight/hatch assembly and roofing over, replacing cracked/broken slate, flashing repairs, masonry repairs to the chimney, gutter repairs/replacement as necessary.
2. No corrective repairs are recommended at this time for the EPDM roofing, roll roofing, copper roofing, and shingle roofing.

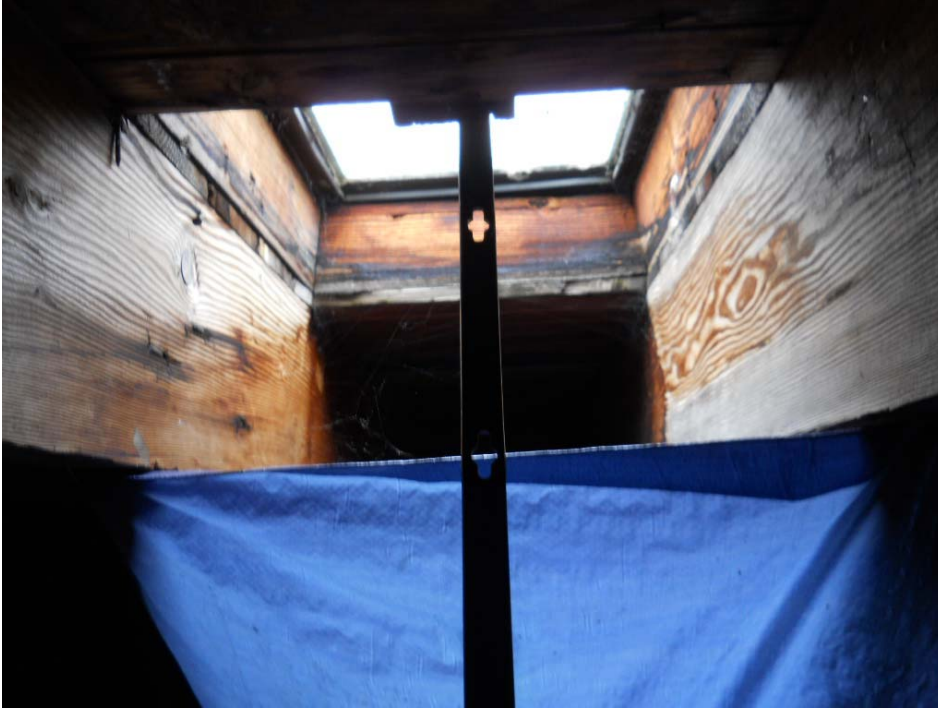
Photo No. 07

Description: Blue tarps installed below the skylight shown above direct water to trash barrels.

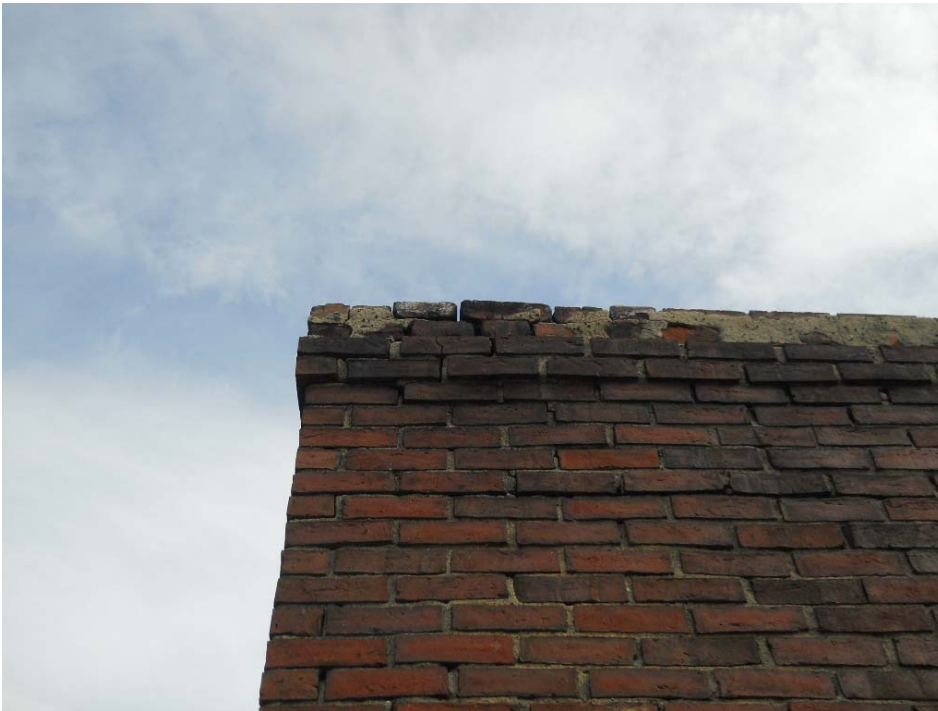
Photo No. 08

Description: Masonry chimney requires repairs.

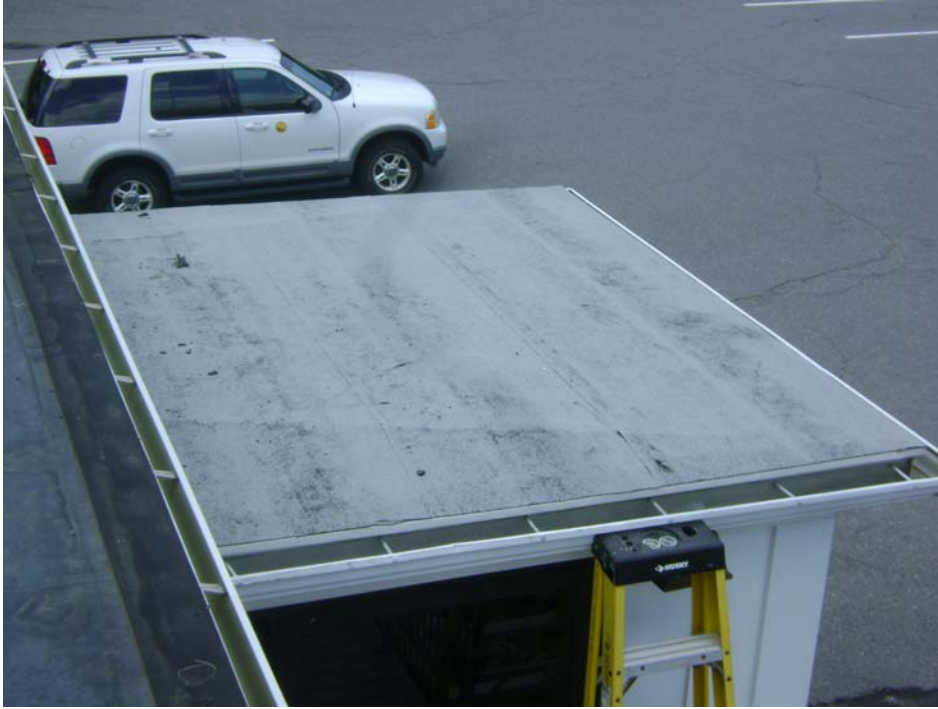
Photo No. 09

Description: Roll
roofing is worn.

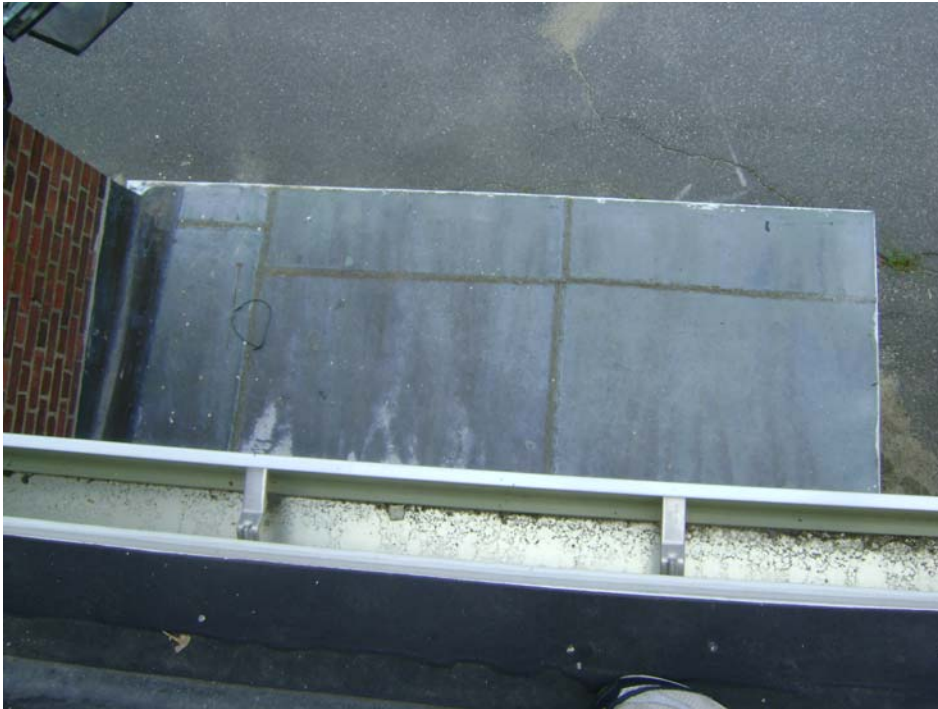
Photo No. 10

Description:
Soldered flat seam
copper roofing is in
fair condition.
