July 17, 2023

Re: Enforcement Order Violation  
Second Response Letter  
31 Lincoln Lane, Sudbury, MA

**Subject: As-Built Topography  
31 Lincoln Lane**

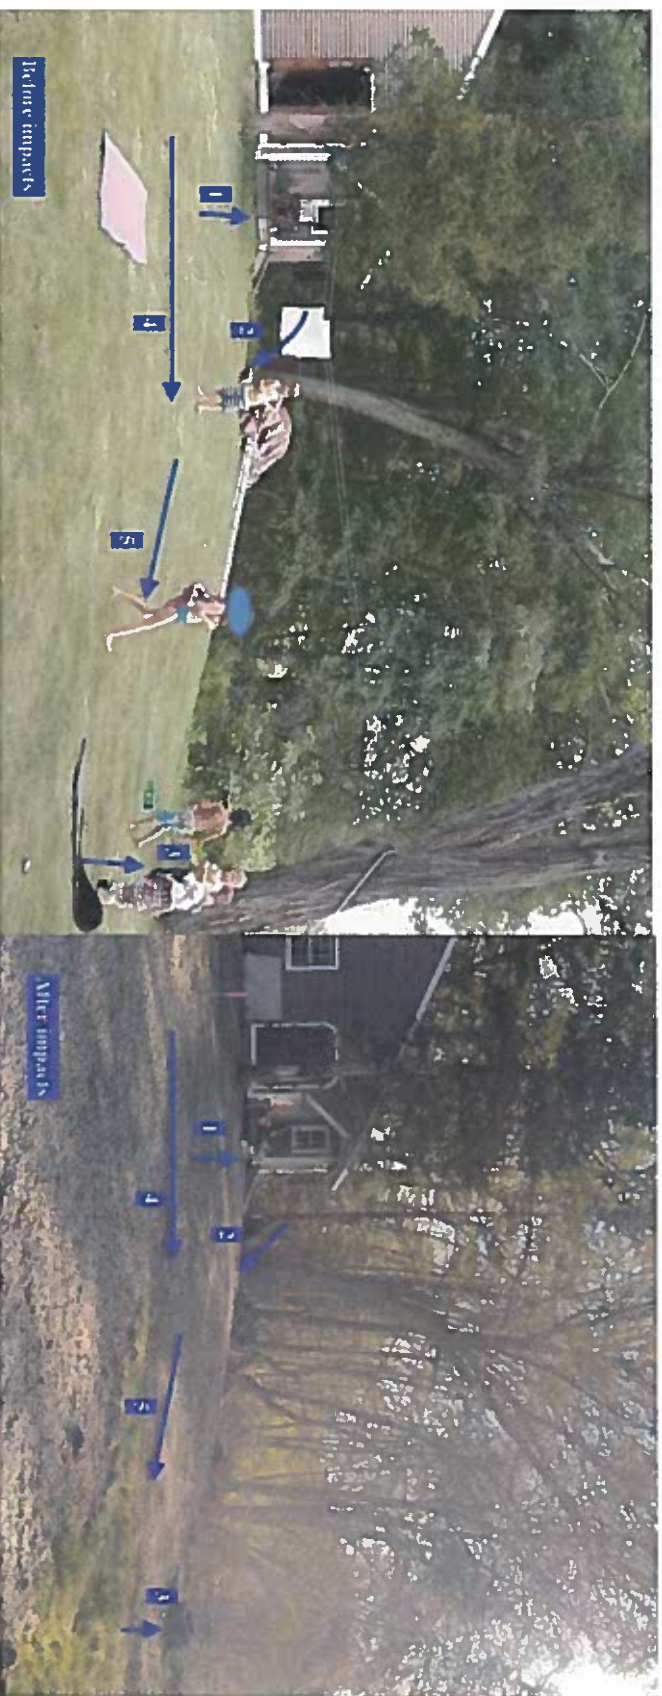
**Figure 1. Pre and Post Work Conditions Photos**

Further evidence that supports that no BLSF and Riverfront Resources were filled, is apparent in the photographs the homeowner has provided of pre and post conditions (see Figure 1 attached). The first photo in Figure 1 is the pre-conditions and the second photo is the post-conditions. As indicated in the photos the elevation of the shed is the same in both photographs (see #1 labeled arrow in each pre and post conditions photo). The elevation of the soils at the tree labeled #2 and #3 are also at the same elevation in each photo (Please note tree #3 was dead, fell during a storm and was removed but the stump and the original soil around the stump remains at the same elevation as shown in the pre-conditions photo). Arrows #4 and #5 show the direction of the level ground from the shed to the start of a gentle slope right after tree #1 towards tree #3, which is consisted in each pre and post work photographs.

**Arrow #1 in each photo shows the soil elevation of the shed at the same elevation in both before and after photos**

**Arrows #2 and #3 shows the elevation at the base of two trees to be the same elevations in both before and after photos**

**Arrows #4 and #5 shows the approximate distance and slope of the pre and post conditions to be relatively the same pre and post all work**

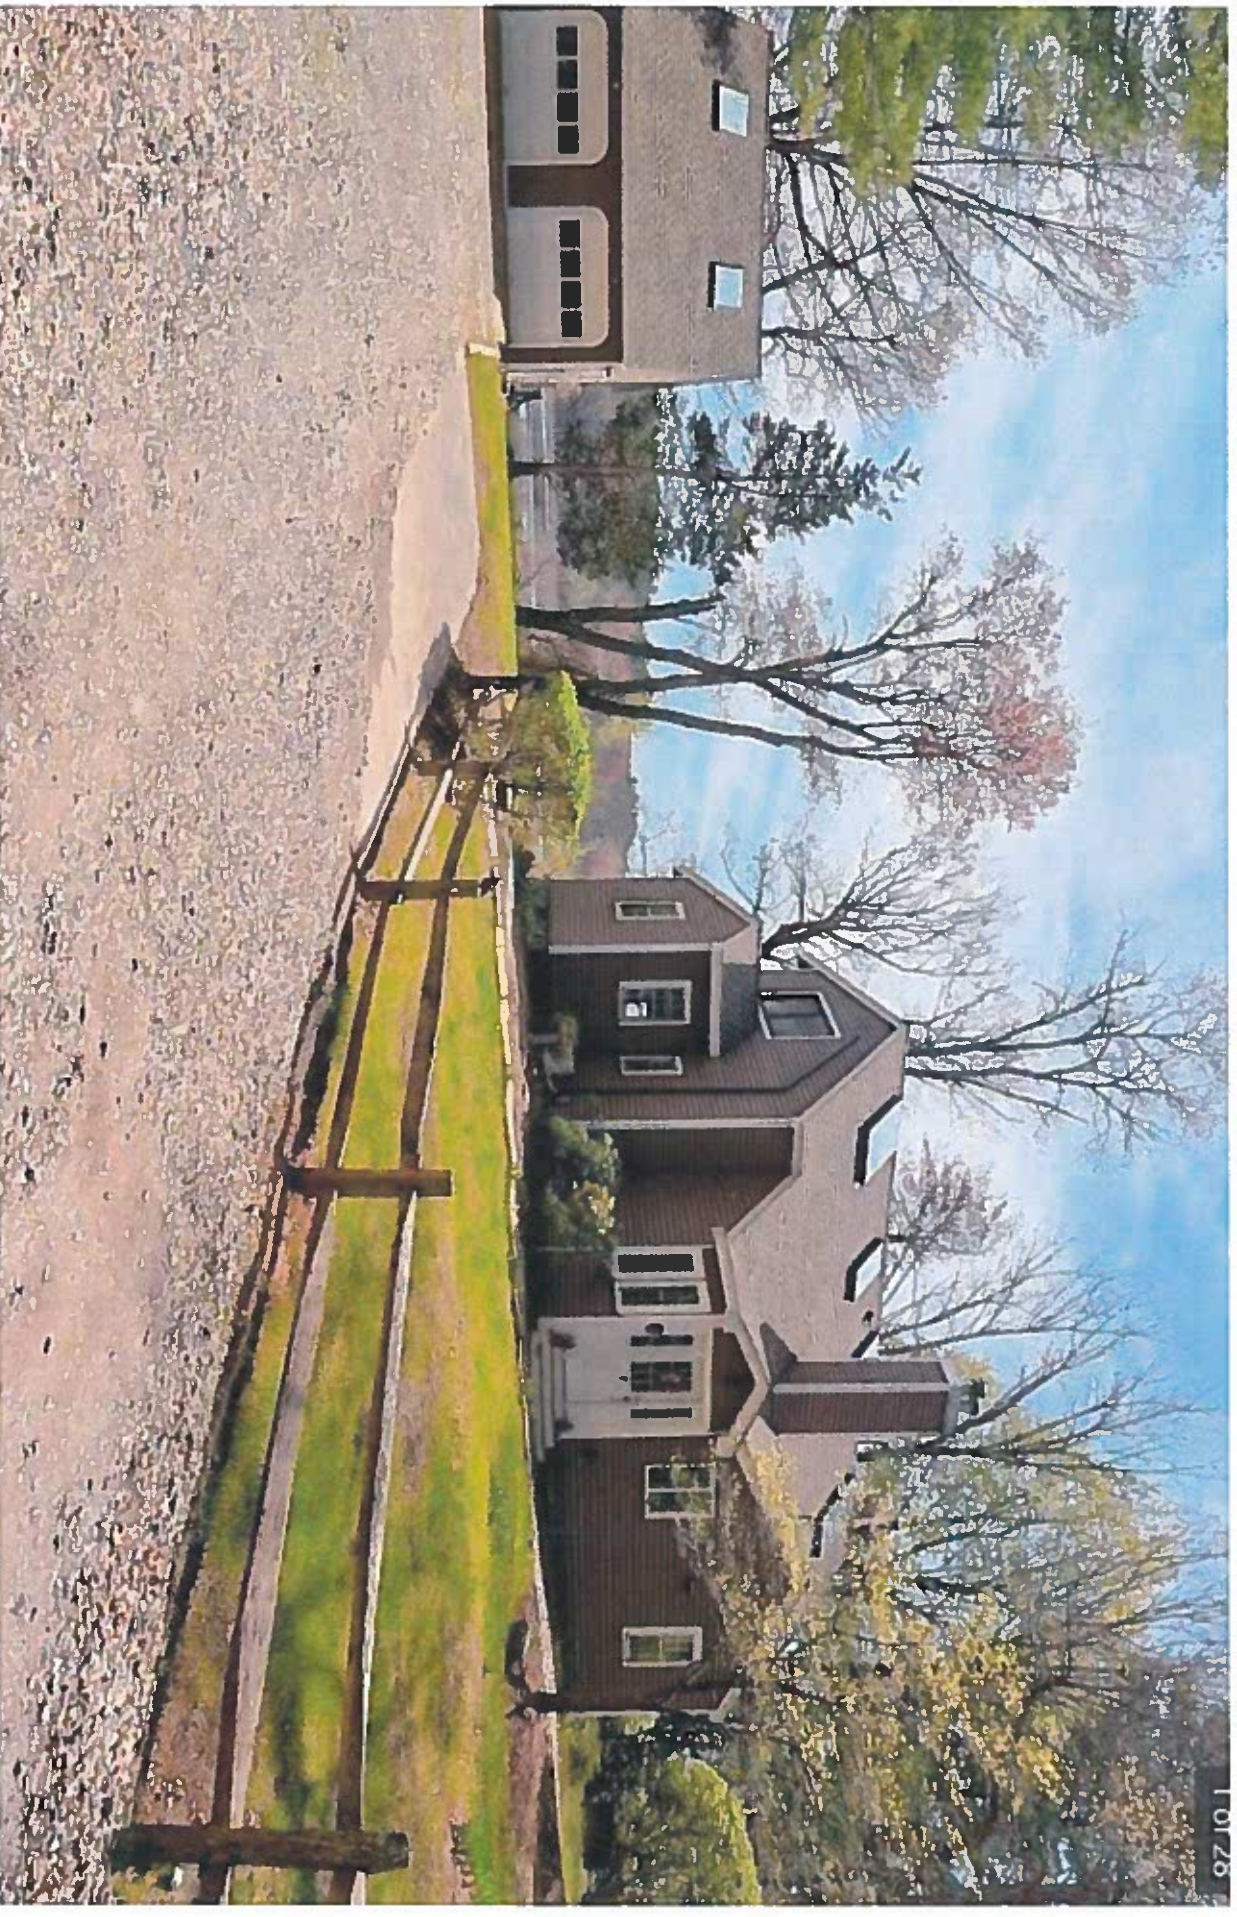
Although the homeowner provided the Commission with a letter from his contractor certifying that the same stone material that was there was used and was placed within the same footprint of the driveway for maintenance purposes the Commission has concerns that the driveway was altered (see enclosed letter). The photograph provided by the homeowner (Figure 2) show the stone in the driveway in 2017 in the same area as well as show the same driveway footprint as currently therefore the driveway was not enlarged or altered. No mitigation is therefore necessary.

**Figure 2. Dated 2017. Shows old stone driveway which was replaced in kind and in same footprint (see attached affidavit from landscaper).**

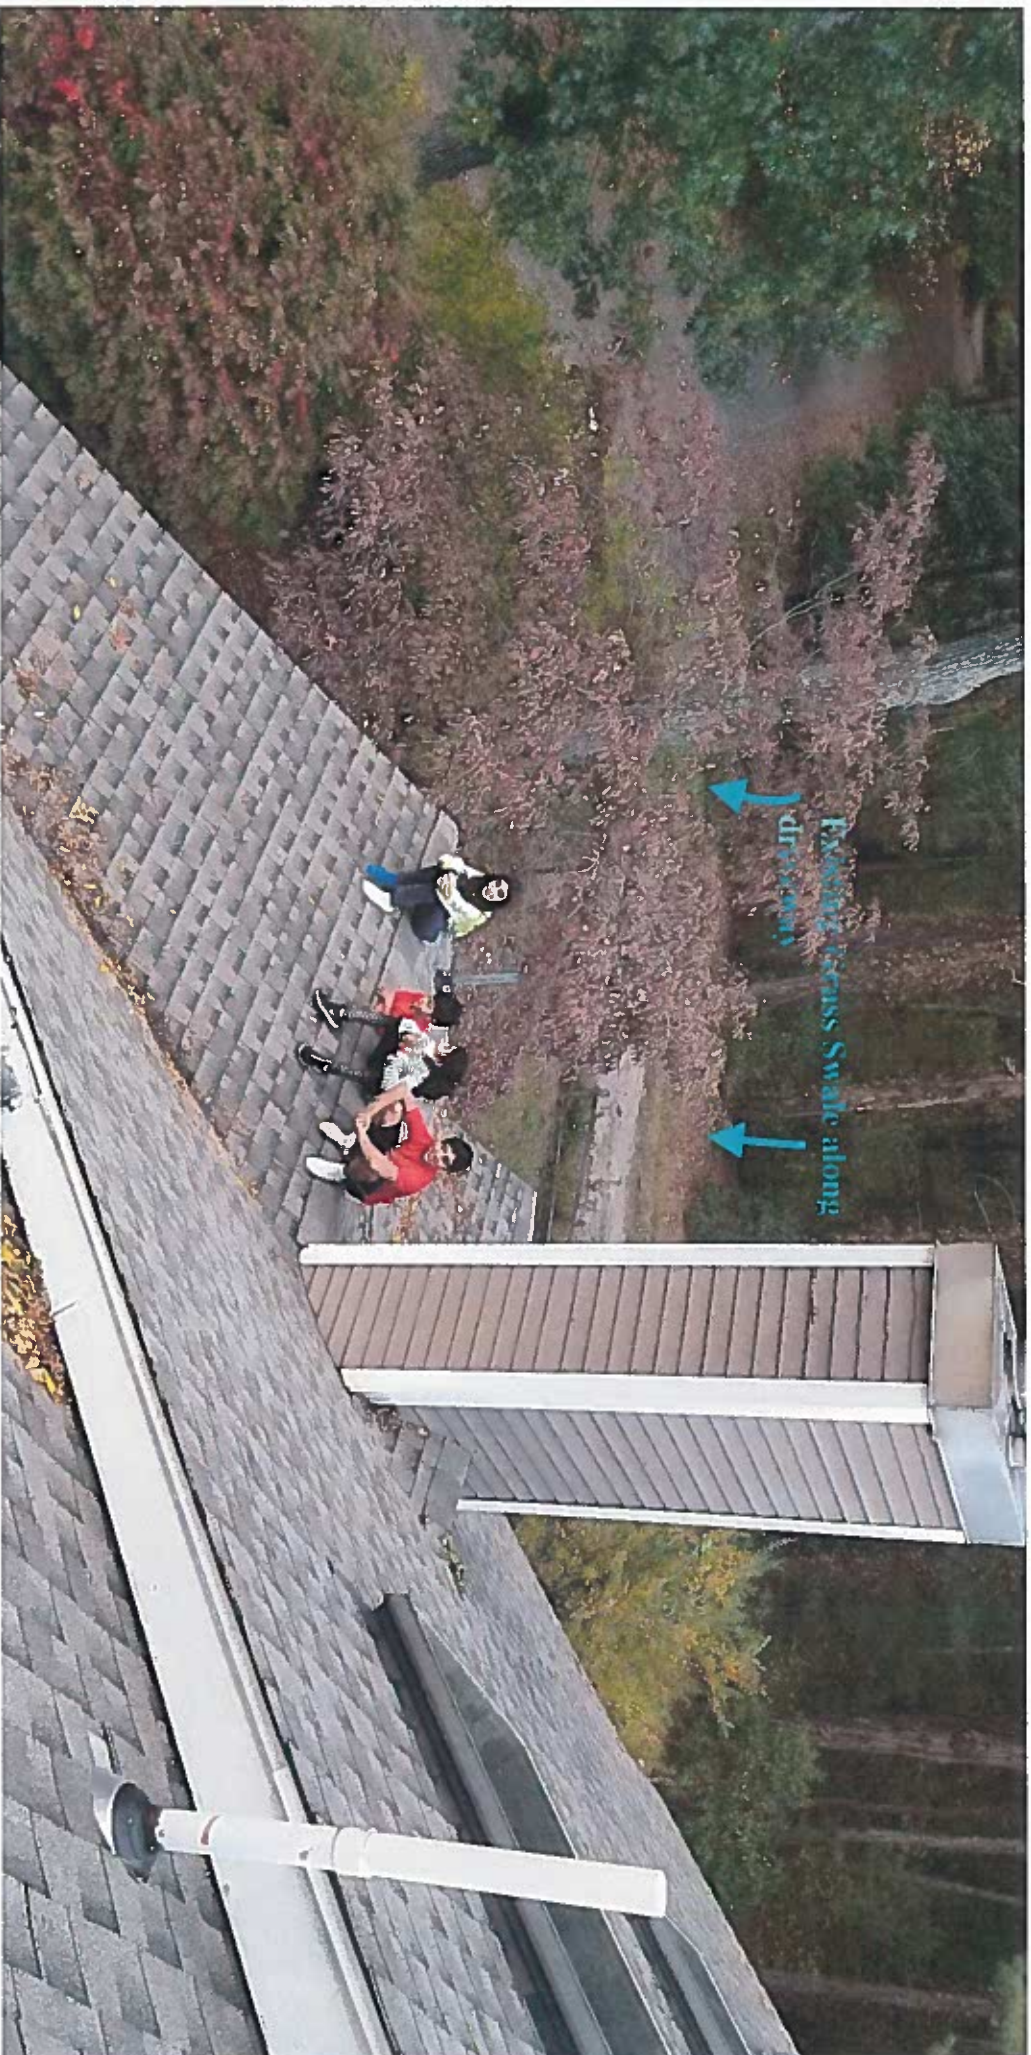
Figure 3. Driveway photo year 2020

The Commission has concerns that the grass strip along the driveway is a recently created lawn area. The homeowner has provided photos in Figure 3 from 2020 that show this lawn area existing prior to 2022. No mitigation is therefore necessary.

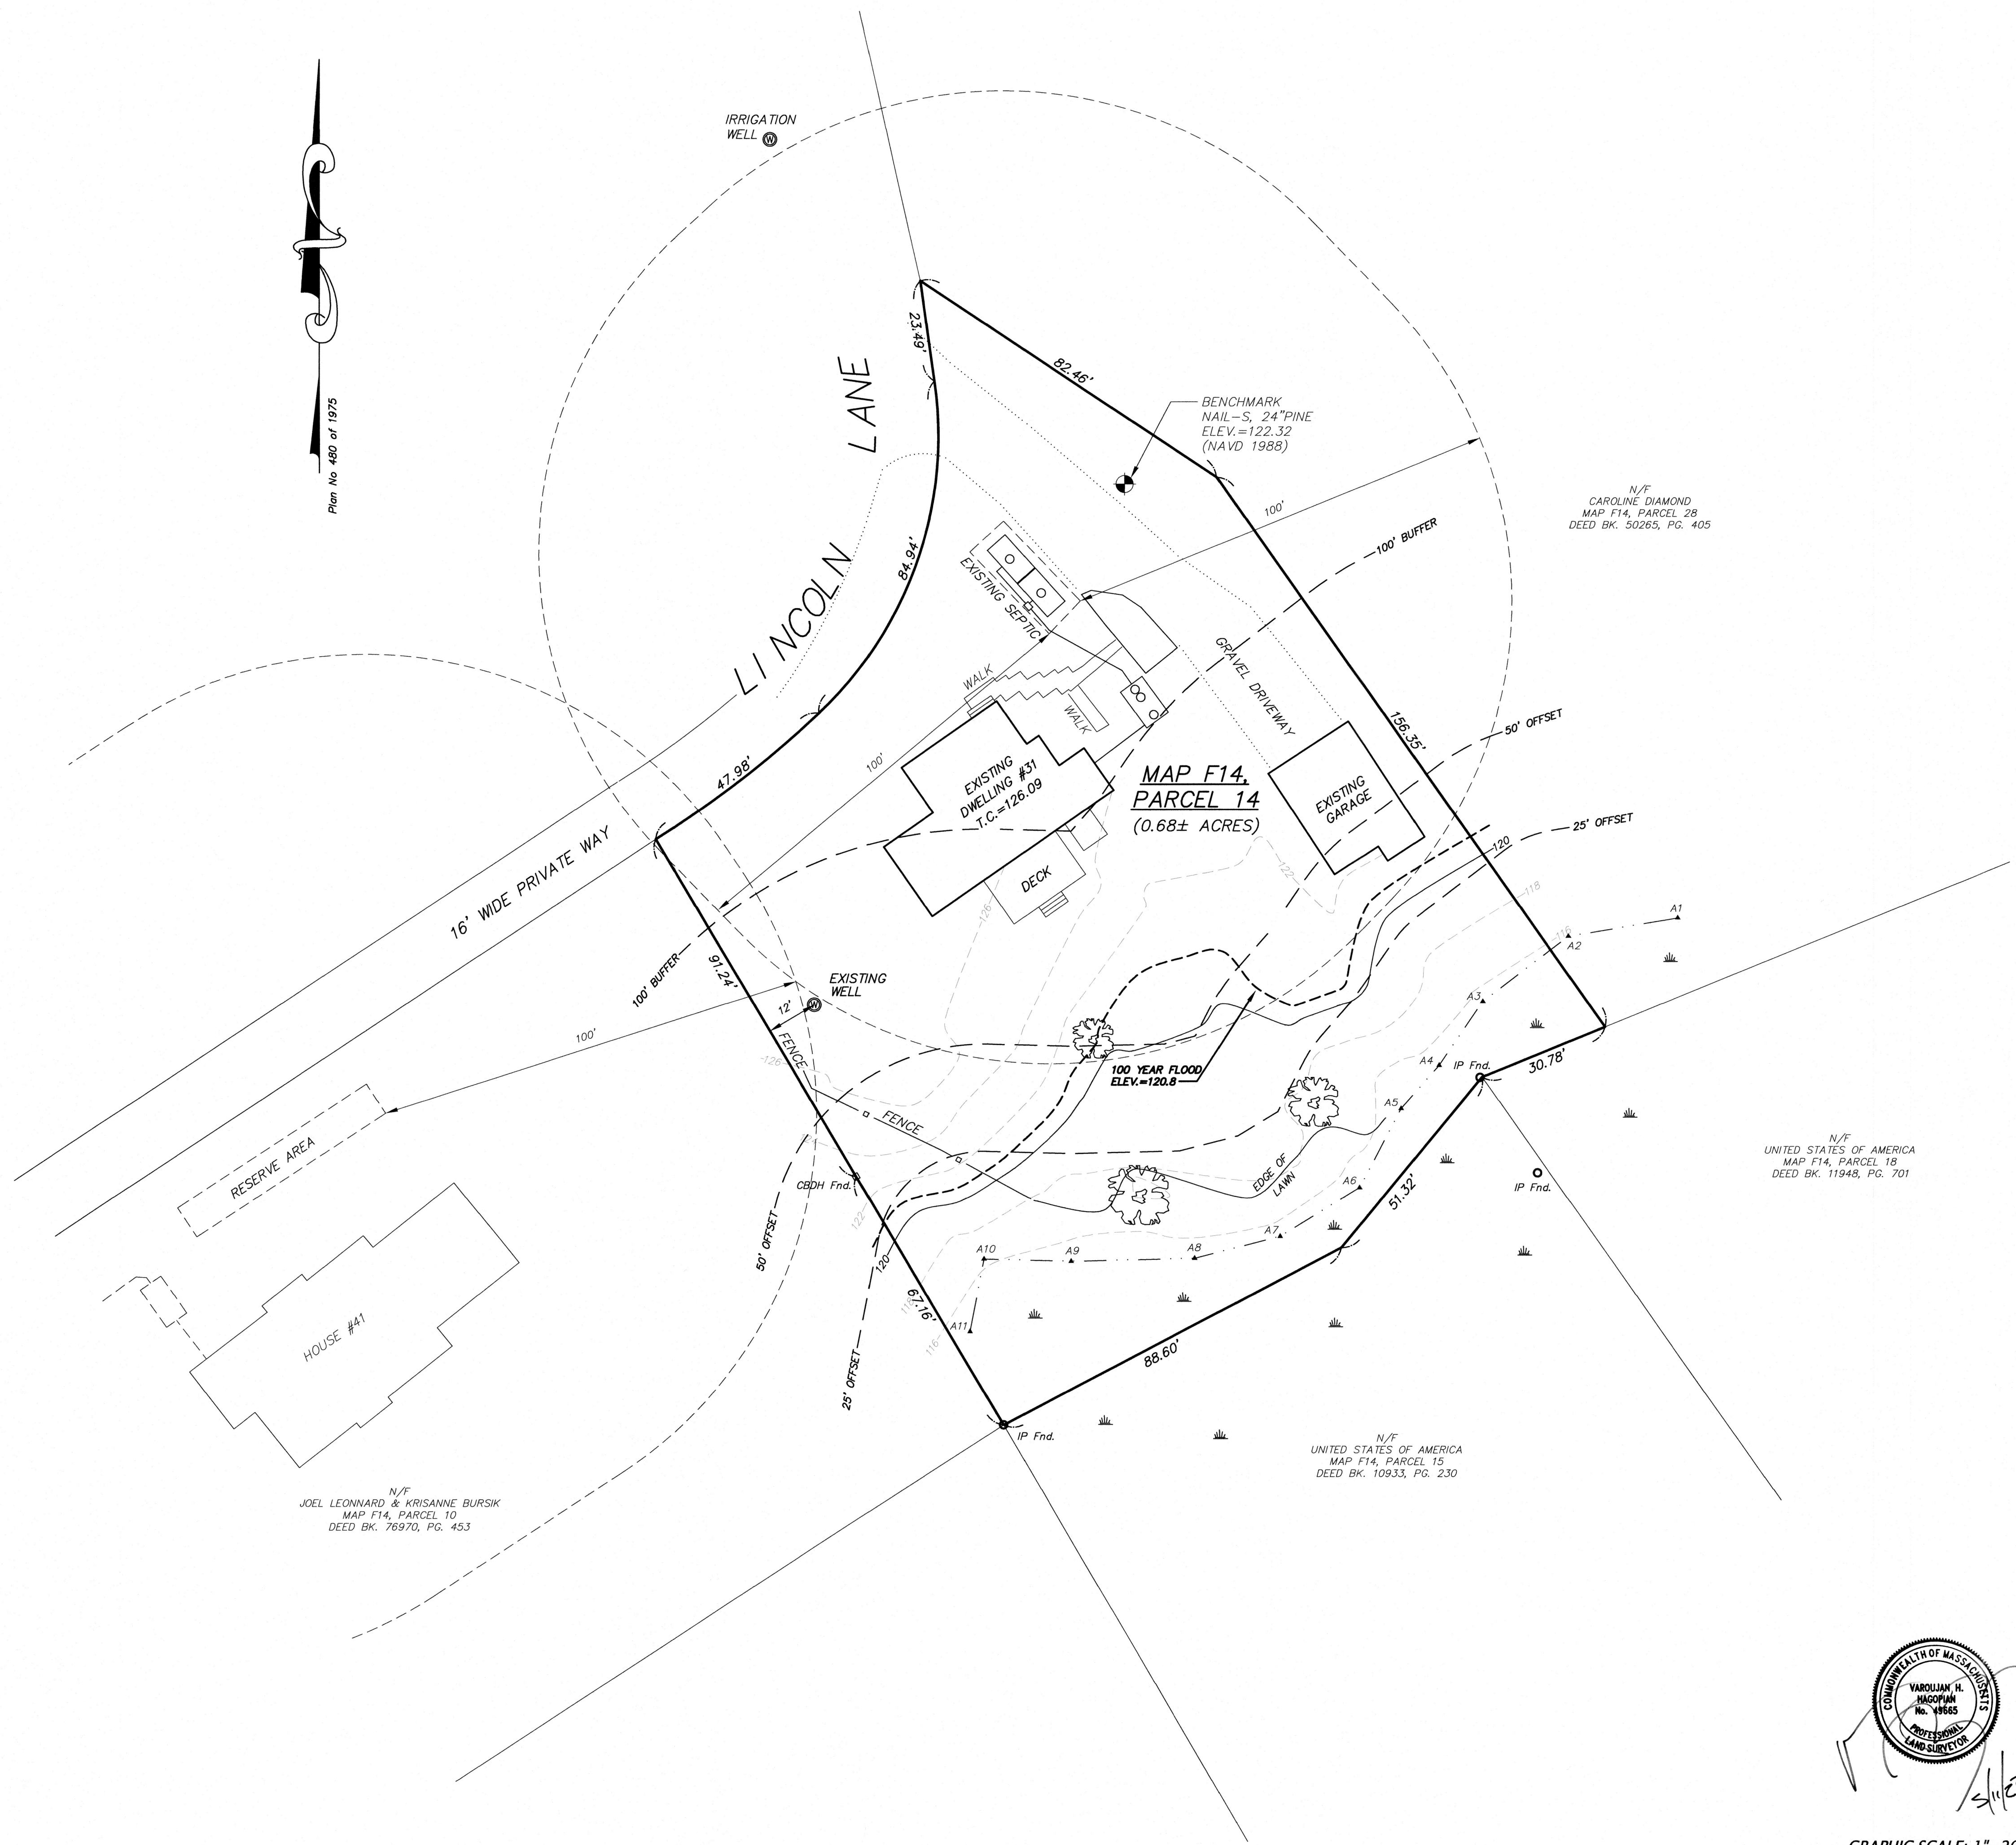
**AS-BUILT WELL PLAN  
(POTABLE WATER WELL)**  
FOR  
**31 LINCOLN LANE  
IN  
SUDBURY, MA**

the de-minimums changes that occurred to the elevations behind the shed within BLSF after the fill pile was removed cannot be detected due to lack of detail of the initial baseline survey.

Based upon visual observation and the available survey data it appears that some amount of disturbance and/or fill had been placed behind the existing shed, and much of the lawn areas had been re-loamed and seeded. However, the original topographic survey does not provide sufficient detail to determine an exact quality or limit of fill that may have been placed. That survey was for the purposes of preparing a well location plan, and the survey points were spread through the yard at a lesser density than would be needed to determine relatively small changes between the existing versus as-built topography. The area to the rear of the shed had a lesser density of survey points since work had not been proposed in this area.

As an alternative, it may be possible to perform several hand test pits to determine the depth or extent of fill that may be present. The limits of the 100-year flood plain were staked in the field to use as reference points if needed.
