# Sudbury Schools Facility Condition Assessment

Town of Sudbury

December 2nd, 2024

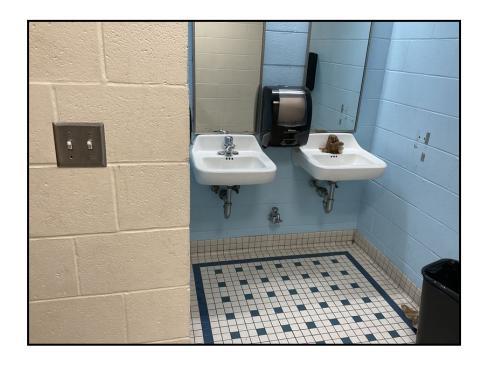
#### Interiors

The hardwood, vinyl tile, porcelain tile, carpet and ceramic tile floor finishes were in good condition. The polished block and painted wall finishes were in good condition. The suspended acoustical tile ceiling finishes were in good condition.

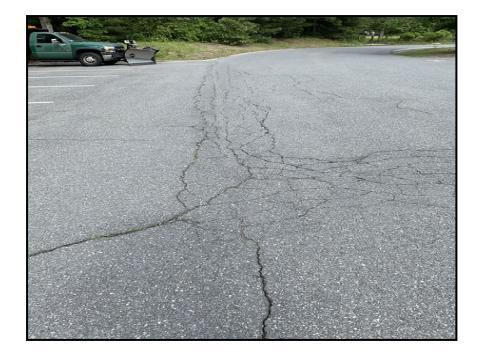
# Site Infrastructure

A portion of the asphalt pavements were in poor condition and in need of resealing as longitudinal and transverse cracking were observed throughout the pavement.

Asset Description	Corrective Action	Notes	Priority	Current Needs	Year
Vehicular Pavements	Crack Fill, Seal Coat, and Restripe Asphalt Pavements	40000 SF	Low	\$83,917	2024
			Total 2024 Needs	\$83,917

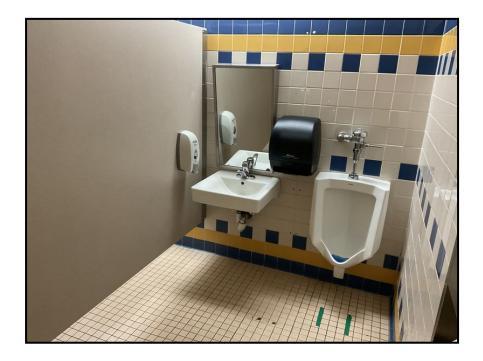
### Interiors

The hardwood, vinyl tile and ceramic tile floor finishes were in good condition; however, the carpet floors were in fair condition due to observed stains. The tile wall finishes were in good condition; however, the painted walls were in fair condition due to observed stains. The painted ceiling finishes were in good condition; however, the suspended acoustical tile ceilings were in fair condition due to observed stains.

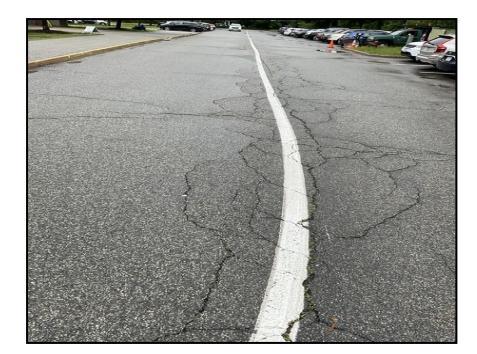
## Site Infrastructure

A portion of the asphalt pavements were in poor condition and in need of resurfacing as longitudinal cracking, transverse cracking, and degradation were observed throughout the pavement.

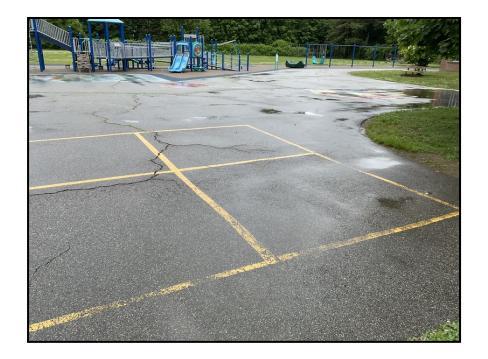
## Site Infrastructure

A portion of the asphalt walkways were in poor condition and in need of resealing as longitudinal and transverse cracking were observed throughout the pavement.
# LORING ELEMENTARY SCHOOL

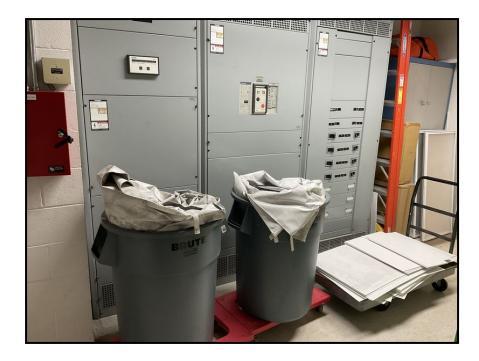
• The fire alarm and detection system is beyond its recommended useful life.

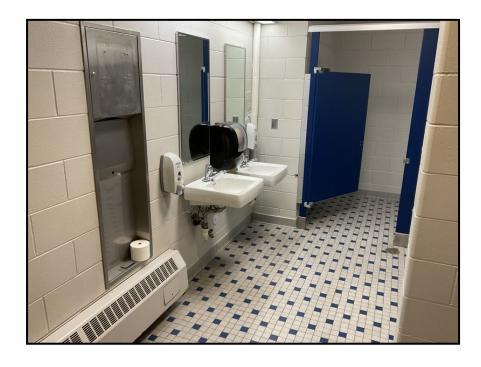
## Interiors

The hardwood, vinyl tile, carpet and ceramic tile floor finishes were in good condition. The painted wall finishes were in fair condition due to observed stains. The painted ceiling finishes were in good condition; however, the suspended acoustical tile ceilings were in fair condition due to observed stains.

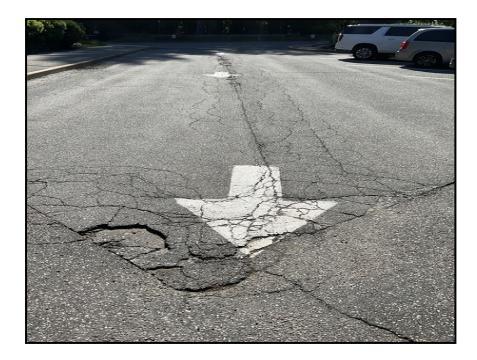
## Site Infrastructure

The asphalt pavements were in poor condition and in need of resurfacing as longitudinal cracking, transverse cracking, and degradation were observed throughout the pavement.

Asset Description	Corrective Action	Notes	Priority	Current Needs	Year
Vehicular Pavements	Resurface Asphalt Pavements	45000 SF	Low	\$275,354	2024
			Total 2024 Needs	\$275,354

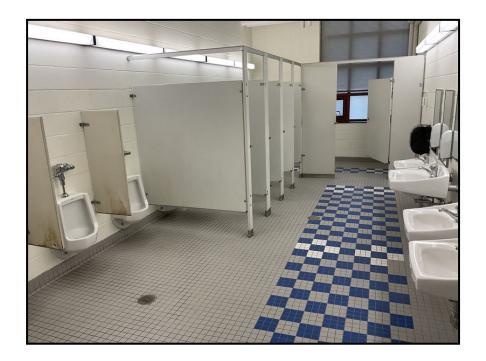
### Interiors

The carpet tile and ceramic tile floor finishes were in good condition; however, the vinyl tile floors were in fair condition due to observed deterioration. The painted wall finishes were in fair condition due to observed stains. The wood and painted ceiling finishes were in good condition; however, the suspended acoustical tile ceilings were in fair condition due to observed stains.

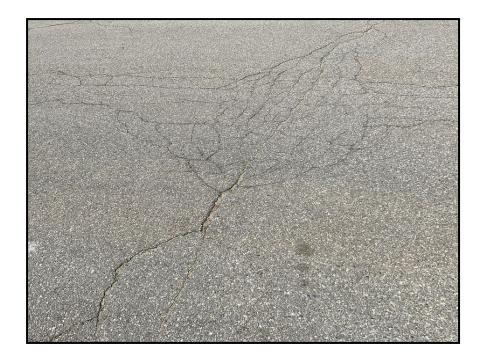
## Site Infrastructure

A portion of the asphalt pavements were in poor condition and in need of resealing as longitudinal and transverse cracking were observed throughout the pavement.

Asset Description	Corrective Action	Notes	Priority	Current Needs	Year
Vehicular Pavements	Crack Fill, Seal Coat, and Restripe Asphalt Pavements	26000 SF	Low	\$54,546	2024
			Total 2024 Needs	\$54,546

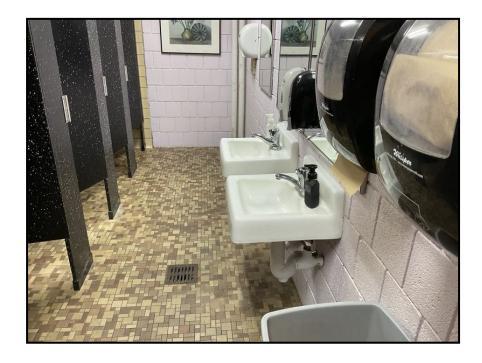
## Interiors

The carpet and hardwood floor finishes were in good condition; however, the vinyl tile and ceramic tile floors were in fair condition due to observed deterioration. The painted wall finishes were in fair condition due to observed stains. The suspended acoustical tile ceiling finishes were in fair condition due to observed stains.

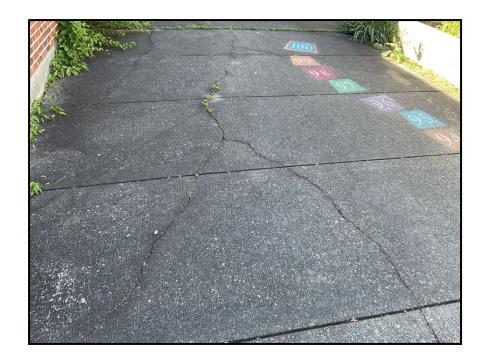
## Site Infrastructure

A portion of the concrete sidewalks were in poor condition and in need of replacement as multiple areas of broken, damaged, and/or heaving pavement were observed.
# APPENDICES

Asset Description	Corrective Action	Notes	Priority	Current Needs	Year
Pedestrian Pavements	Replace Concrete Pavements; 4" Thick	5000 SF	Low	\$96,155	2024
			Total 2024 Needs	\$96,155
