November 24, 2025

## Re: Hop Brook Ponds (Stearns Millpond, Carding Millpond, and Grist Millpond), Sudbury, MA (DEP#301-1283) – 2025 Year End Report

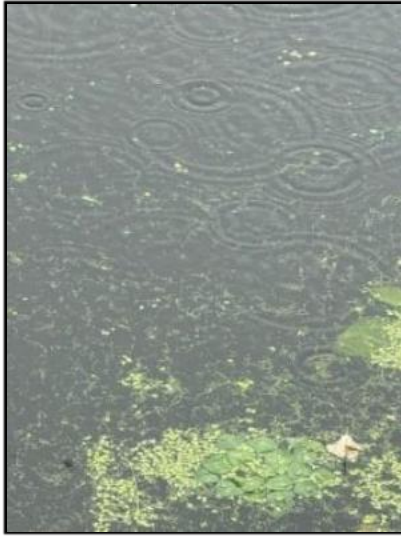
Figure 4: Image depicts one of the several trace density patches of water chestnut observed during the June survey visit.

A visit was conducted at Stearns Millpond, which consisted of vegetation surveys and the collection of basic water quality data. Stearns Millpond contained small patches of trace density water chestnut. Trace to sparse densities of invasive curly-leaf pondweed (*Potamogeton crispus*) were also noted along the littoral zone. Additionally, scattered patches of coontail (*Ceratophyllum demersum*) and duckweed (*Lemna*) were observed around the edges. The delay in plant growth within the millponds can be attributed to complications involving the later-than-average frost timings towards the conclusion of winter. Based on the prevailing invasive assemblages noted during each survey, an initial treatment for water chestnut would be conducted within the waterbody in early July.

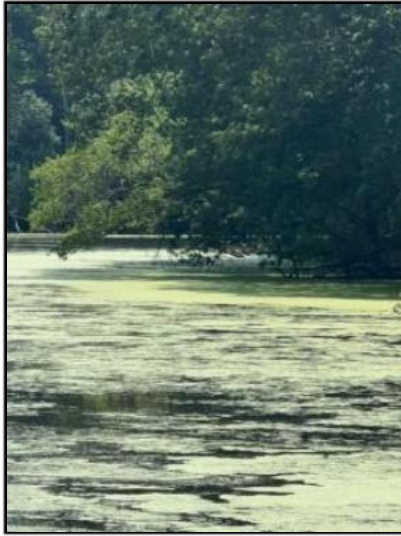
Figure 5: Image depicting the pre-treatment surface conditions of Stearns Millpond during the July treatment visit.

This site visit to Stearns Millpond consisted primarily of a foliar herbicide treatment for the millpond's characteristic invasive water chestnut. A survey and the collection of basic water quality data were also performed. The pond was topped out with moderate to dense waterweed (*Elodea canadensis*) and duckweed, with only a few open water areas being present. Trace densities of a few individual water-chestnut plants were observed throughout the pond. Overall, the water chestnut within Stearns Millpond is at a significantly healthier level, with a large reduction in density from last year. The foliar treatment went without issue and excellent coverage was achieved via airboat. Due to the state of water chestnut assemblage, a switch to removal via hand-pulling may be in order for next year pending the circumstances regarding the species.

As noted, a treatment was conducted for the control of water chestnut. The liquid herbicide, Clearcast (imazamox), was applied using the most appropriate boat, equipped with a calibrated pump, which is used to target the water chestnut plants via foliar application methodology. This method allows for even and precise coverage. Weather was also closely monitored prior to treatment to ensure a treatment date without rain or high winds.

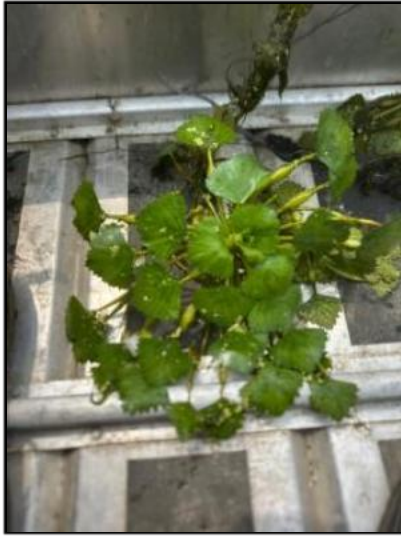
Figure 6: Image depicting one of the several water chestnut plants that were hand-pulled during the August treatment visit to Stearns Millpond.

This site visit to Stearns Millpond consisted of the collection of basic water quality data, completing a survey, and conducting a foliar herbicide treatment. Dissolved oxygen readings continued to maintain healthy levels. Nuisance density pondweeds such as elodea were observed throughout the pond. Additionally, sparse density patches of filamentous algae were scattered throughout the waterbody, often accompanying any topped-out sections of pondweeds. The treatment was conducted to target and curb the presence of any prevailing invasive water chestnut, which was observed in scattered densities around the pond. Very isolated water chestnut populations were hand-pulled and properly disposed of. Overall, the treatment went without issue and excellent coverage was achieved via airboat.

A treatment was conducted for the control of water chestnut. The liquid herbicide, Clearcast (imazamox), was applied using the most appropriate boat, equipped with a calibrated pump, which is used to target the water chestnut plants via foliar application methodology. This method allows for even and precise coverage. Weather was also closely monitored prior to treatment to ensure a treatment date without rain or high winds.

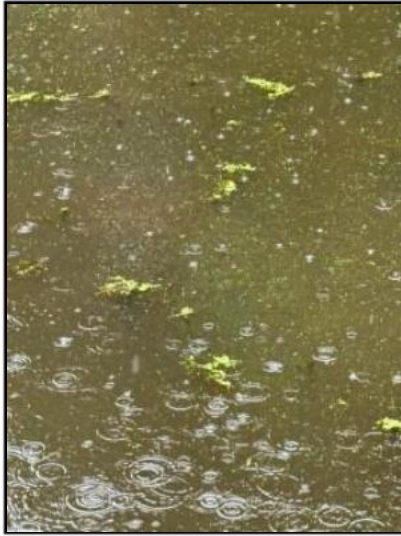
Figure 8: Image depicting the growth of young water chestnut plants that were observed during the June survey visit to Carding Millpond.

Carding Millpond's vegetation assemblage comprised of trace density water chestnut plants within the shallow coves and by the dam. In addition, a few small water chestnut plants were observed below the surface but no major mats had surfaced yet. Trace to sparse densities of invasive curly-leaf pondweed were also noted along a majority of the littoral zone. Water flow was heavy at the time of survey. The delay in plant growth within the millponds can be attributed to complications involving the later-than-average frost timings towards the conclusion of winter. Based on the prevailing invasive assemblages noted during each survey, an initial treatment for water chestnut would be conducted within the waterbody in early July.

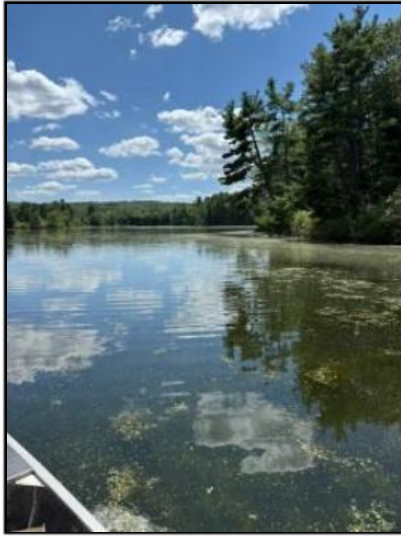
Figure 9: Image depicting the pre-treatment surface conditions of Carding Millpond during the July treatment visit.

The site visit consisted of completing a survey, collecting basic water quality data, and completing the initial treatment. This treatment was delayed compared to the other two waterbodies as the road to the entrance of the pond was being paved, and access to the boat launch was not granted. There was a very little increase of water chestnut observed from pretreatment survey as the plants were very scattered around the pond. The majority of the population was observed around the outlet area near the dam. No large patches were observed throughout the pond. Large patches of duckweed were observed near the inlet areas. The water quality seemed much better than last year. The treatment went well, and excellent coverage was achieved.

A treatment was conducted for the control of invasive water chestnut. Clearcast (imazamox), was paired with a non-ionic surfactant. The mixture was applied to live water chestnut via foliar application using low-volume calibrated spray equipment. This methodology allows for even coverage and distribution to the target water chestnut, while limiting any non-target impacts. Weather was also closely monitored prior to treatment to ensure a treatment date without rain or high winds.

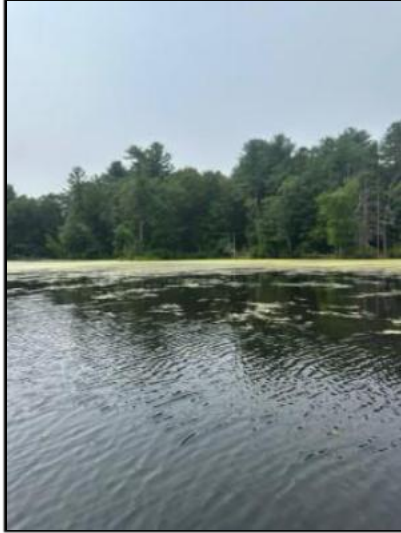
Figure 10: Image depicting the pre-treatment surface conditions within Carding Millpond during the August treatment visit.

This site visit to Carding Millpond consisted of the collection of basic water quality data, performing a survey, and conducting a foliar herbicide treatment. Dissolved oxygen readings continued to maintain healthy levels. Elodea and other pondweeds, such as snail-seed pondweed (*Potamogeton bicupulatus*), thin-leaf pondweed (*Potamogeton pusillus*), and coontail were observed in high densities throughout the entire pond, with many sections of the pond also being covered with watermeal (*Wolffia*). Sparse to moderate density filamentous algae patches were also observed at various locations. The treatment was conducted to target and curb the presence of invasive water chestnut, which was found in scattered patches throughout the pond. Overall, the treatment went without issue and excellent coverage was achieved via airboat.

A follow-up treatment was conducted for the control of water chestnut. The liquid herbicide, Clearcast (imazamox), was applied using the most appropriate boat, equipped with a calibrated pump, which is used to target the water chestnut plants via foliar application methodology. This method allows for even and precise coverage. Weather was also closely monitored prior to treatment to ensure a treatment date without rain or high winds.

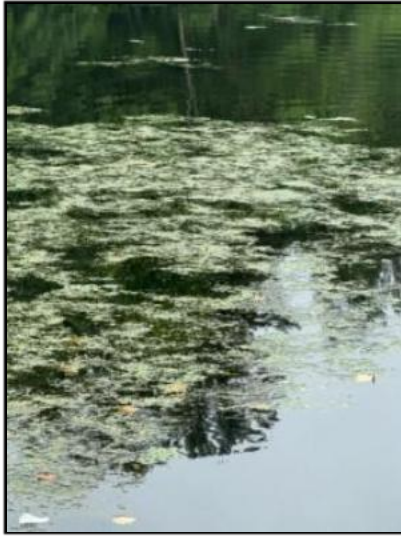
Figure 12: Image depicting the pre-treatment surface conditions of Grist Millpond during the June survey visit.

A visit was conducted at Grist Millpond which consisted of a vegetation survey and the collection of basic water quality data. Grist Millpond contained scattered patches of trace density water chestnut plants near the outlet. The inlet area was clear of any water chestnut plants at the time of survey. However, trace to sparse density invasive curly-leaf pondweed was observed from the outlet to slightly past the millpond's first bottleneck. A few small clumps of waterweed and duckweed were also observed in trace densities near the dam area. The delay in plant growth within the millponds can be attributed to complications involving the later-than-average frost timings towards the conclusion of winter. Based on the prevailing invasive assemblages noted during each survey, an initial treatment for water chestnut would be conducted within the waterbody in early July.

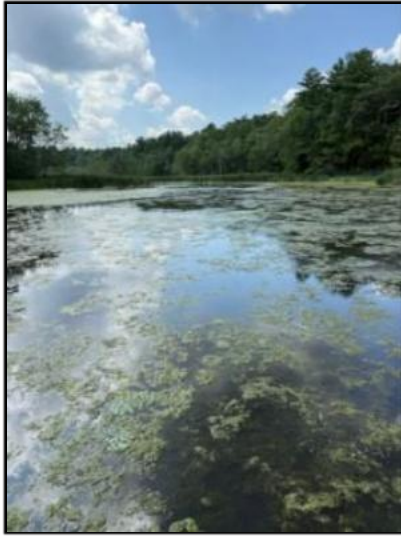
Figure 13: Image depicting the surface conditions of Grist Millpond during the July treatment visit. Trace densities of water chestnut can be seen intermixed with patches of filamentous algae and duckweed.

This site visit to Grist Millpond primarily consisted of a foliar herbicide application for the purpose of treating the millpond's characteristic invasive water chestnut growth. A survey and the collection of basic water quality data were also performed. Although the water clarity was poor due to excess tannin deposits, it was visibly better than last year. The water chestnut has reduced by 90+% from the start of the program. The water chestnut maintained very sparse densities throughout the pond, with the densest area being observed near the outlet. No large patches of water chestnut were observed, as most of the patches were comprised of clumps with 2-4 plants. The foliar treatment went without issue and excellent coverage was achieved via airboat.

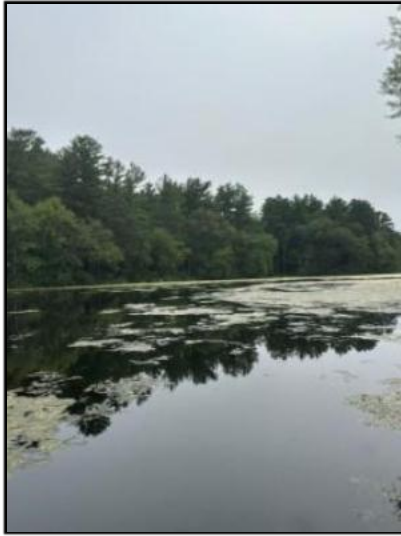
Figure 14: Image depicting the surface conditions of Grist Millpond during the August treatment event.

This site visit to Grist Millpond consisted of the collection of basic water quality data, completing a survey, and performing a foliar herbicide treatment. Elodea and other nuisance density pondweeds were observed the entire pond. These densities were often accompanied by filamentous algae mats on the surface. The treatment was conducted to target and curb the presence of any prevailing invasive water chestnut within the waterbody, which was scattered in sparse densities around the pond. Overall, the treatment went without issue and excellent coverage was achieved via airboat.
