**HOP BROOK
SEDIMENT AND DAM REMOVAL STUDY**

**MARLBOROUGH AND SUDBURY
MASSACHUSETTS**

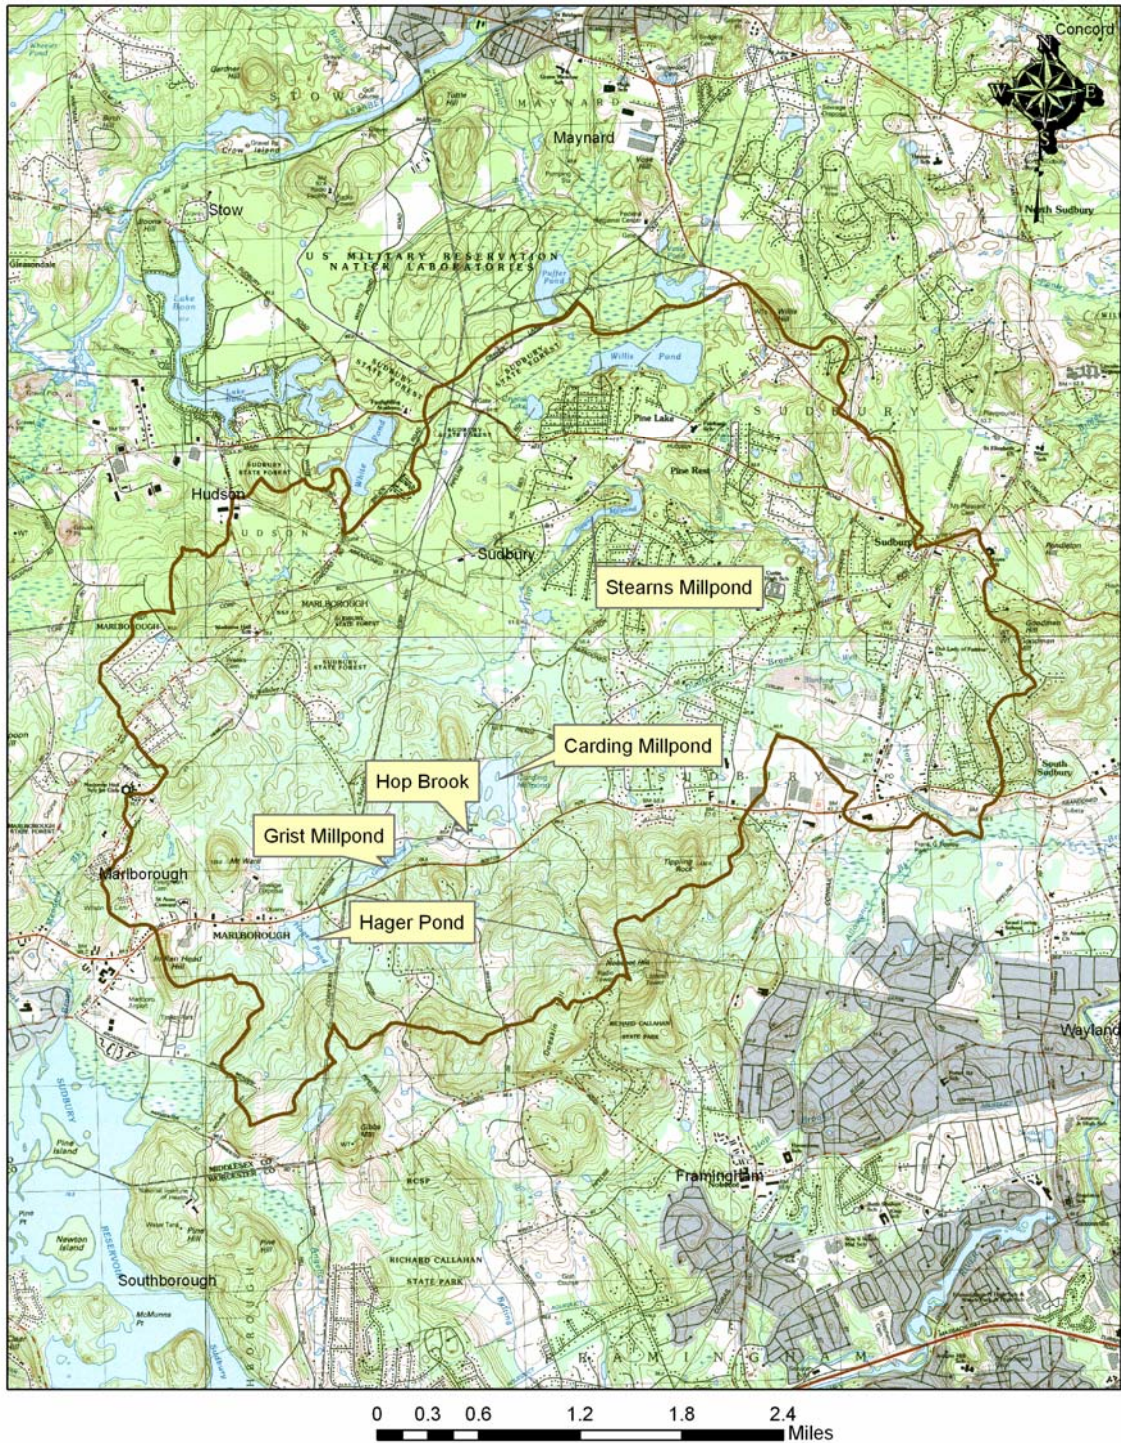
Hop Brook Watershed Map

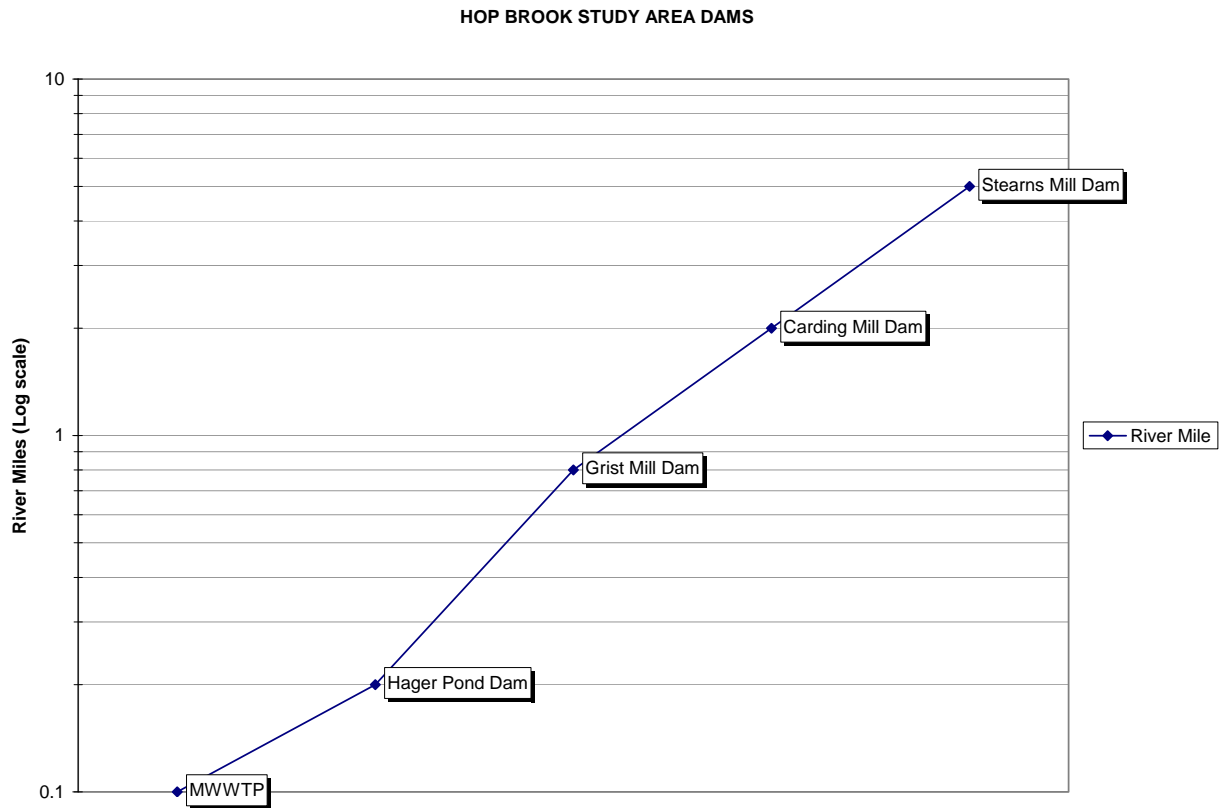
Prior Studies and Reports

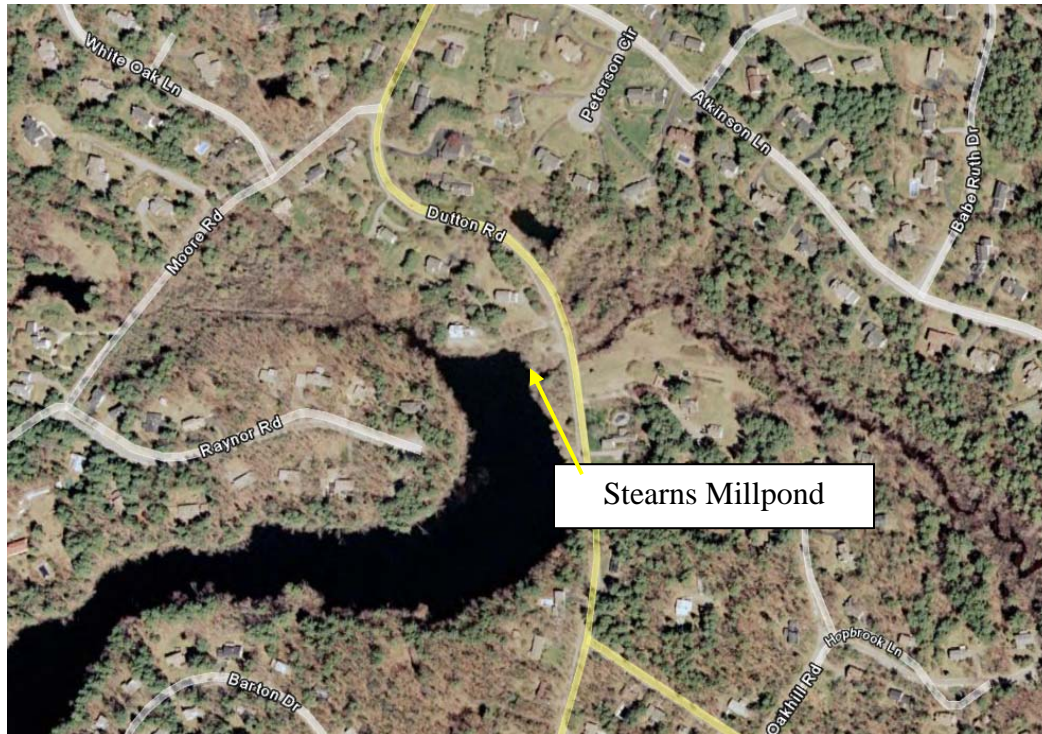
Figure 1: Location of Stearns Millpond Dam

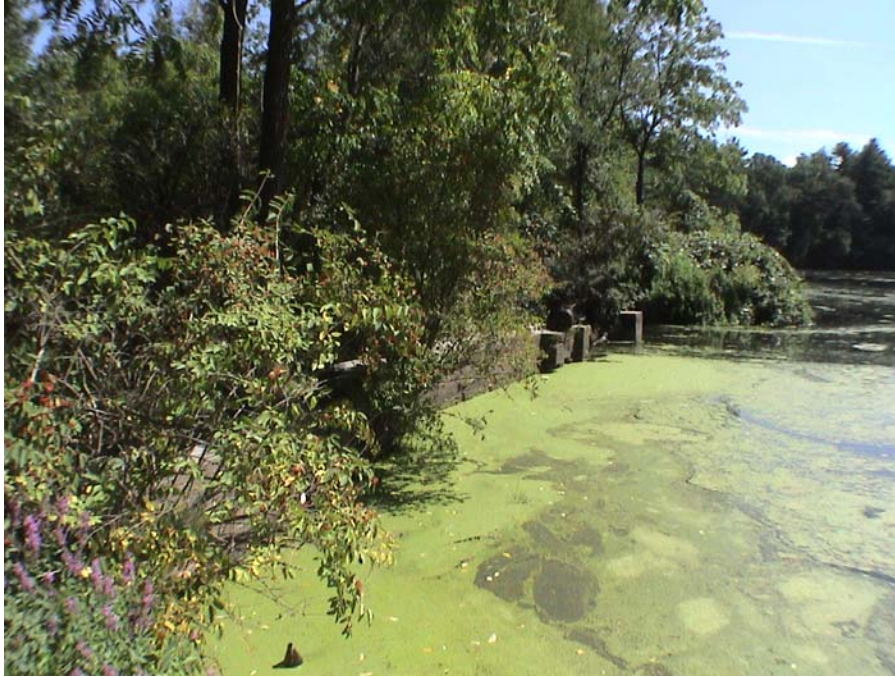
Figure 2: Pond Side View of Stearns Millpond Dam
(Note: Vegetation and tree growth on dam)

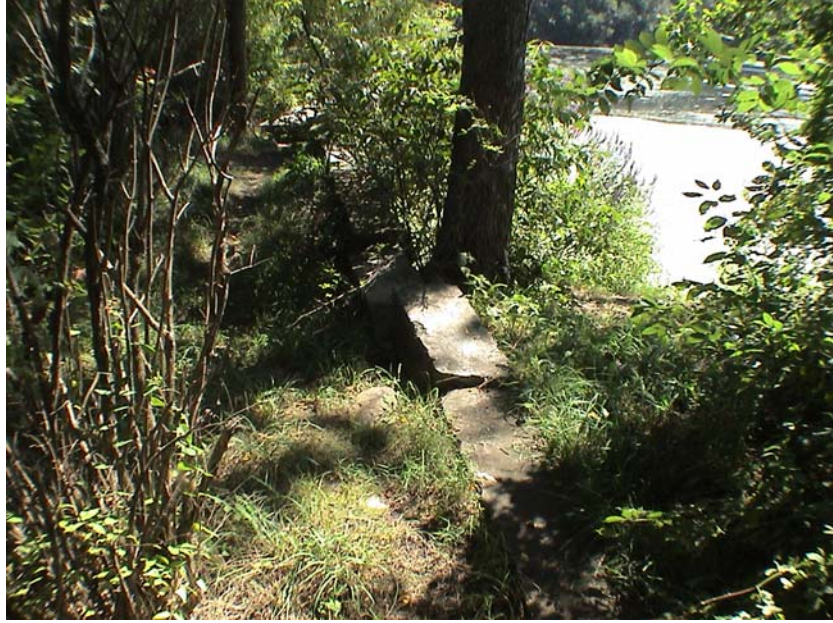
Figure 4: Displaced and Cracked Walls on Left Abutment
(Note: trees and vegetation around walls)

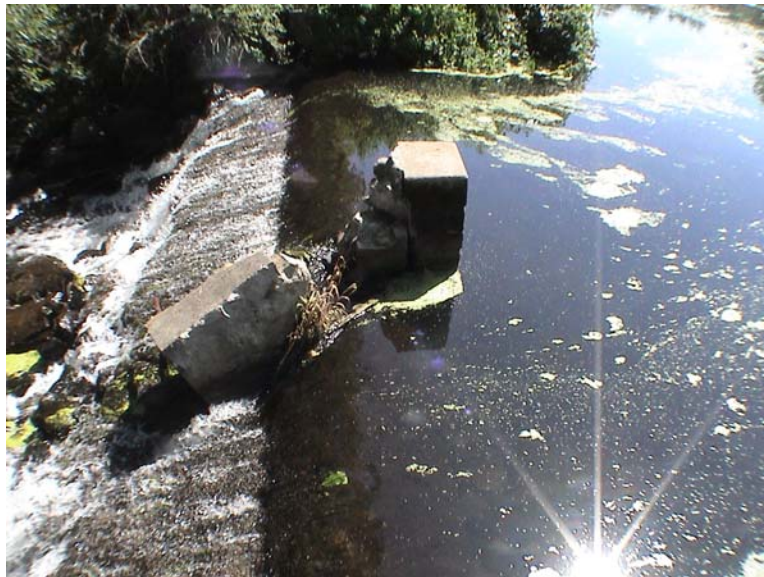
Figure 5: Concrete Spillway Section

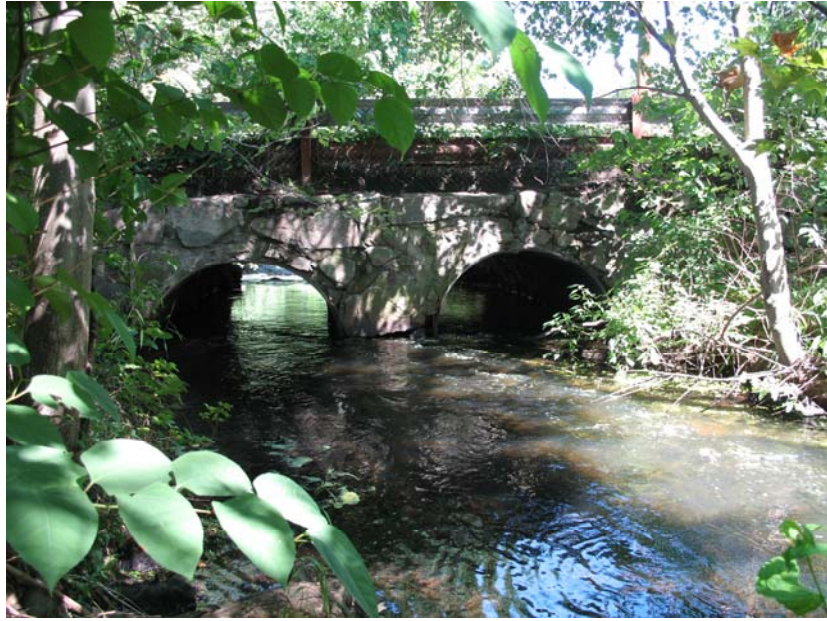
Figure 6: Culvert under Dutton Road

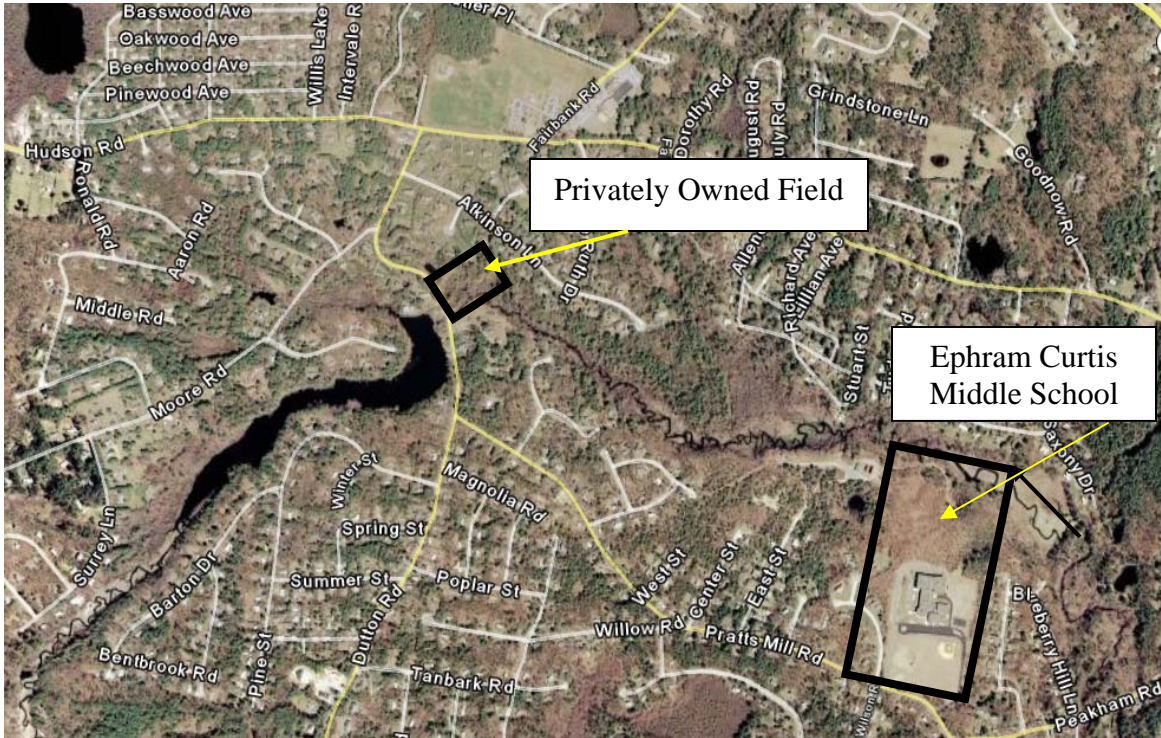
Figure 7: Potential Dewatering Sites for Stearns Millpond Dam

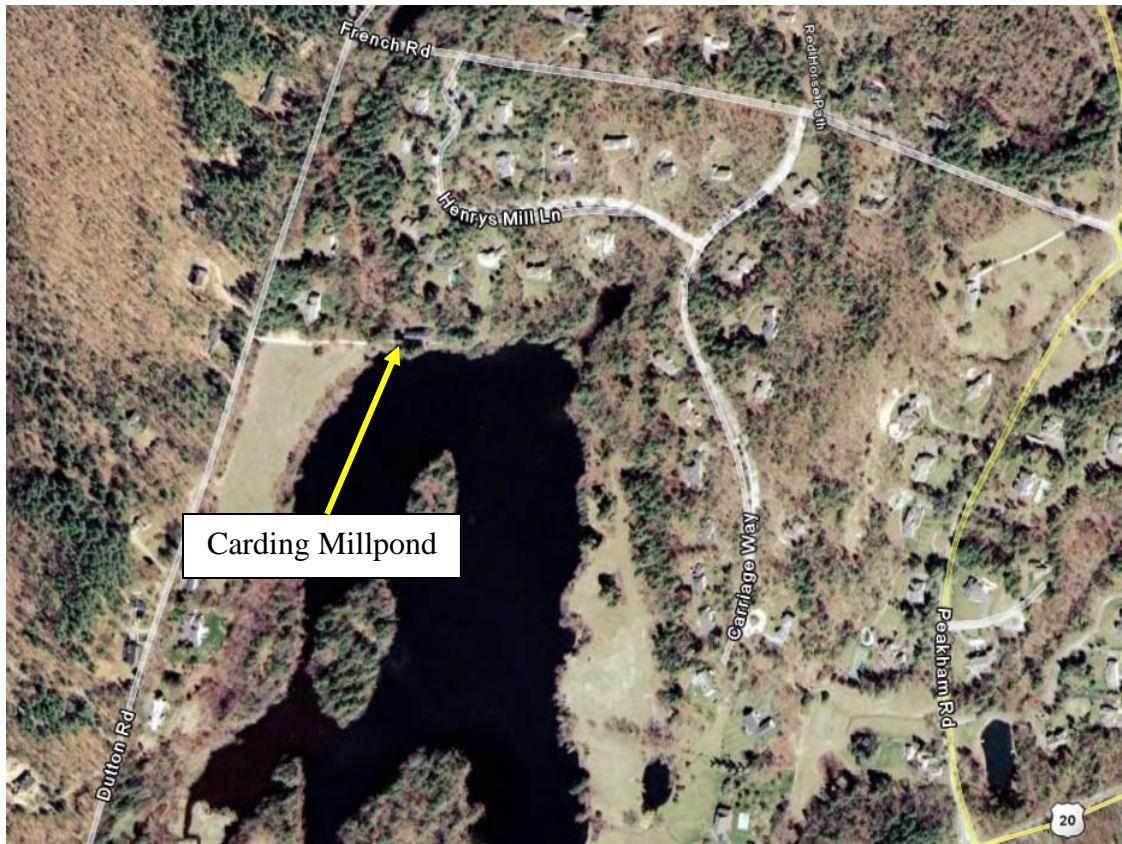
Figure 1: Location of Cardings Millpond Dam

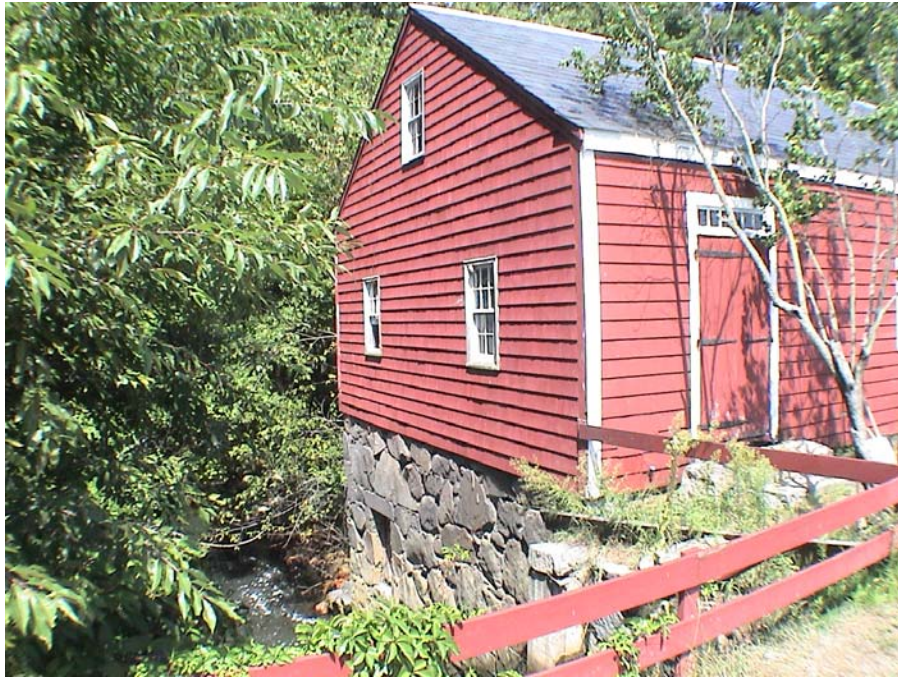
Figure 2: Carding Millpond Building Adjacent to Spillway
(Note: Orange staining beyond rock foundation)

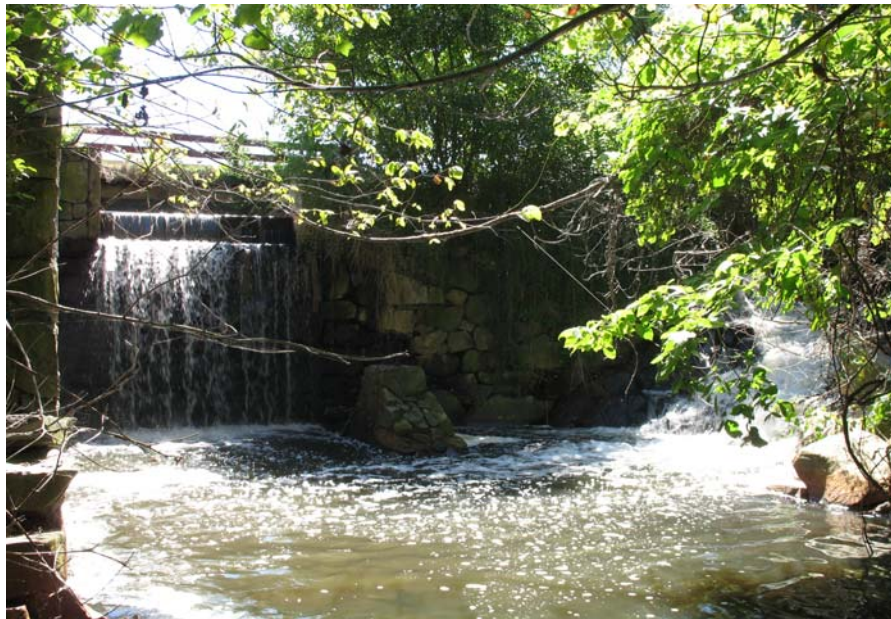
Figure 3: Controlled (left in figure) and Uncontrolled (right in figure) Spillways at Carding Millpond Dam

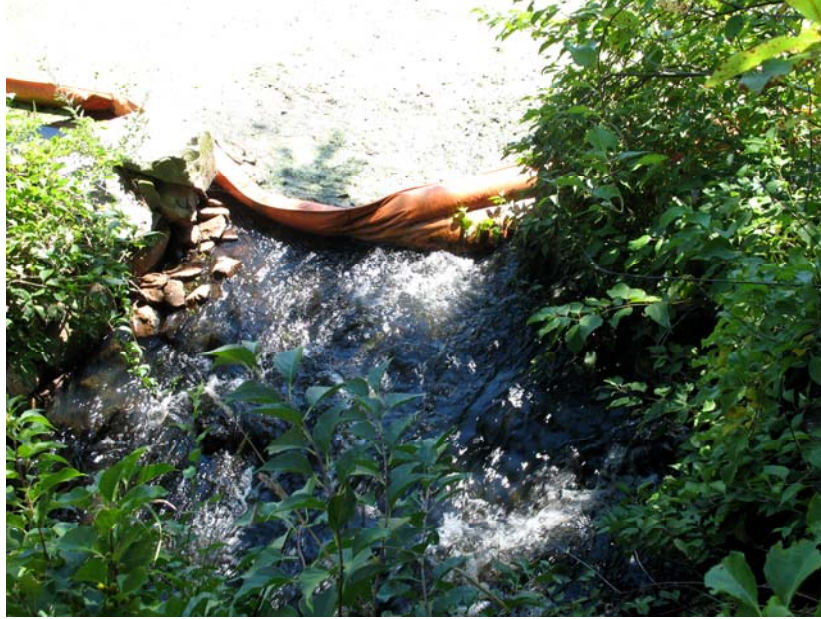
Figure 6: Inlet for Uncontrolled Spillway
(Note: Erosion and vegetation around inlet)

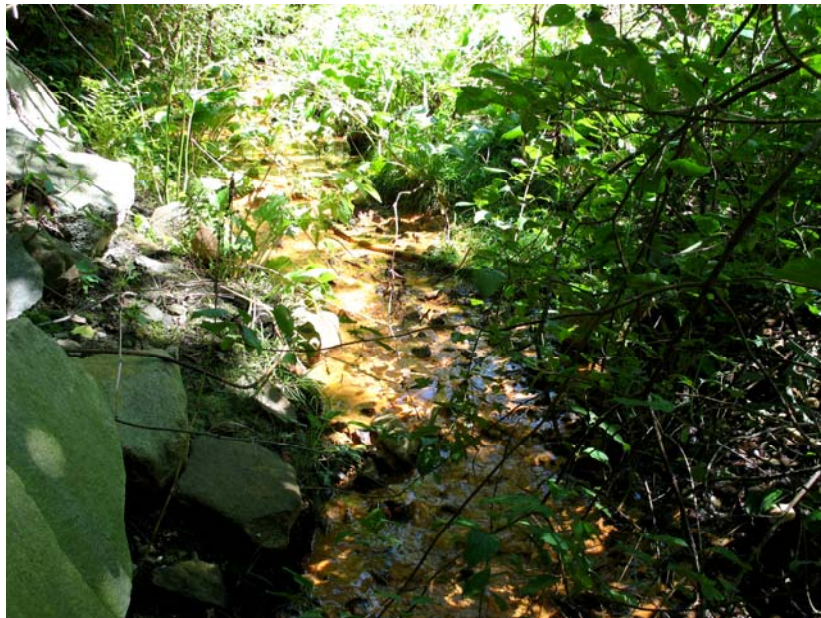
Figure 7: Seepage and Iron Algae Staining Behind Mill Building

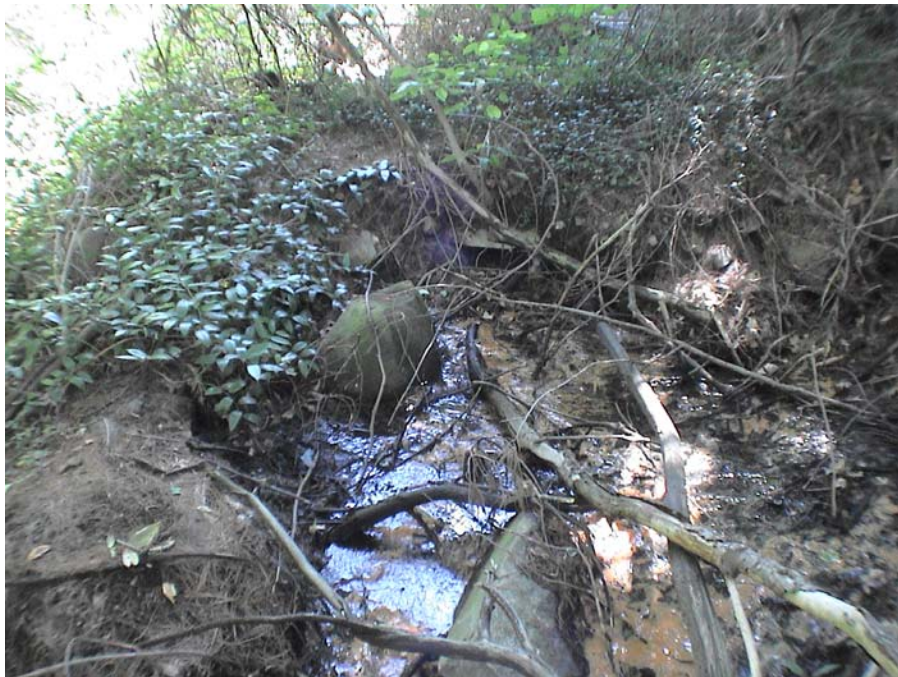
Figure 8: Seepage and Iron Algae Staining on Left Abutment

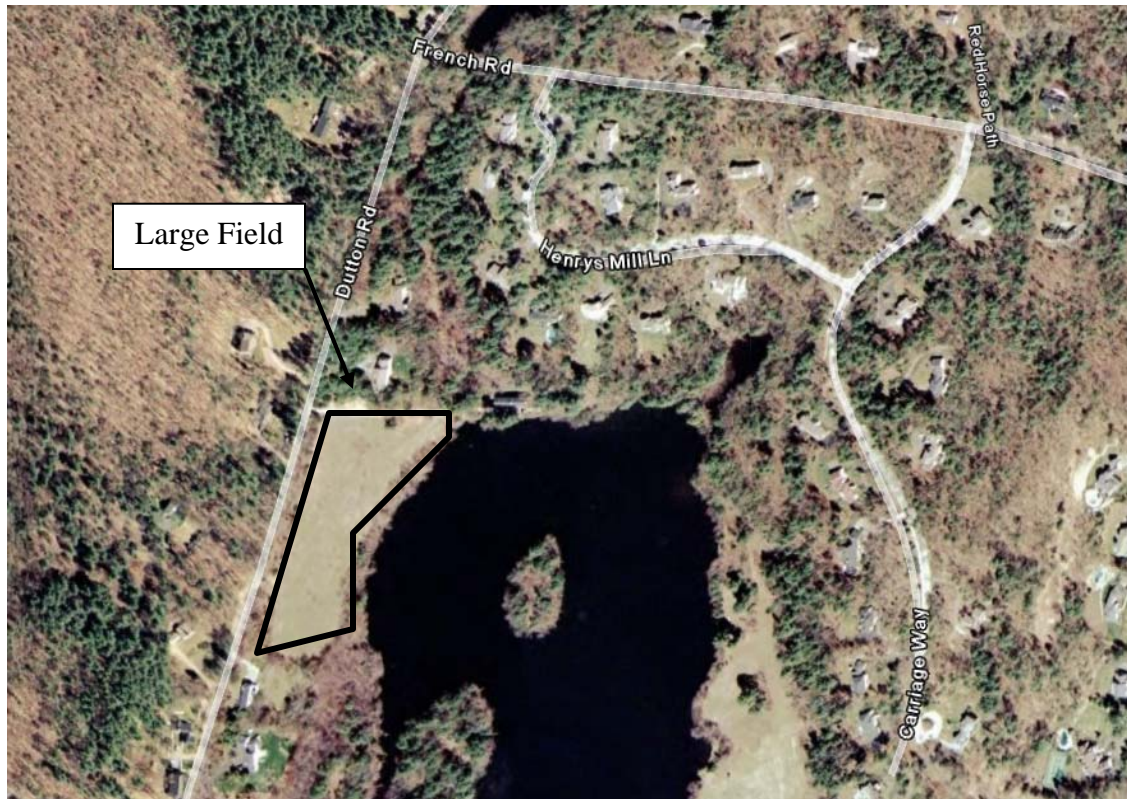
Figure 9: Potential Dewatering Sites for Cardings Millpond Dam

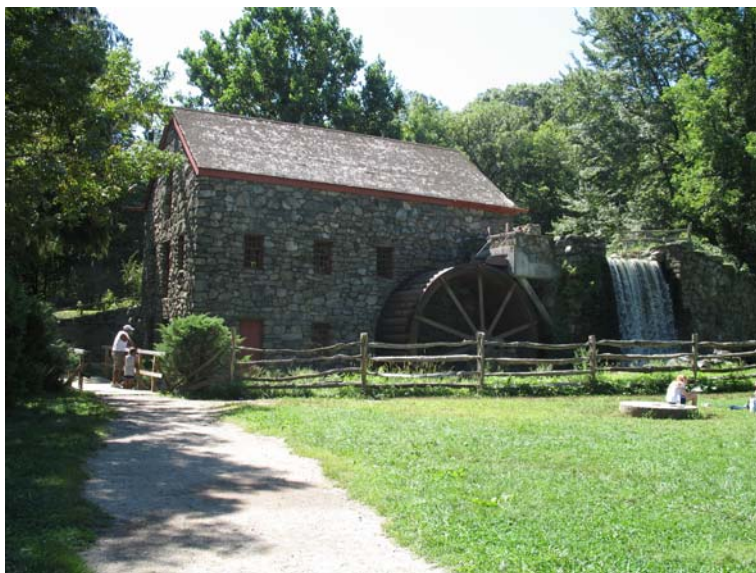
Figure 2: Grist Mill

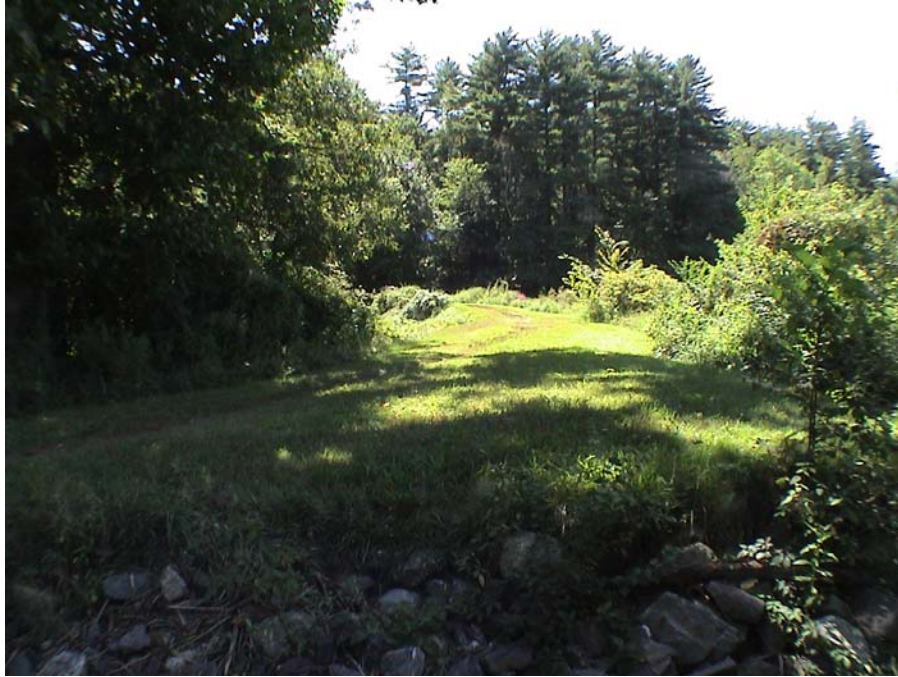
Figure 3: Crest of Earthen Dam

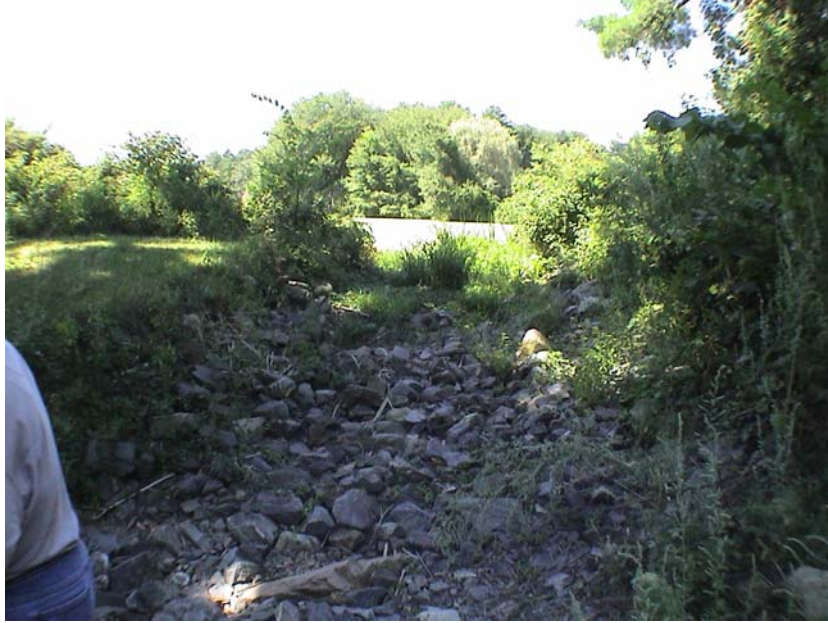
Figure 4: Uncontrolled Rock Spillway

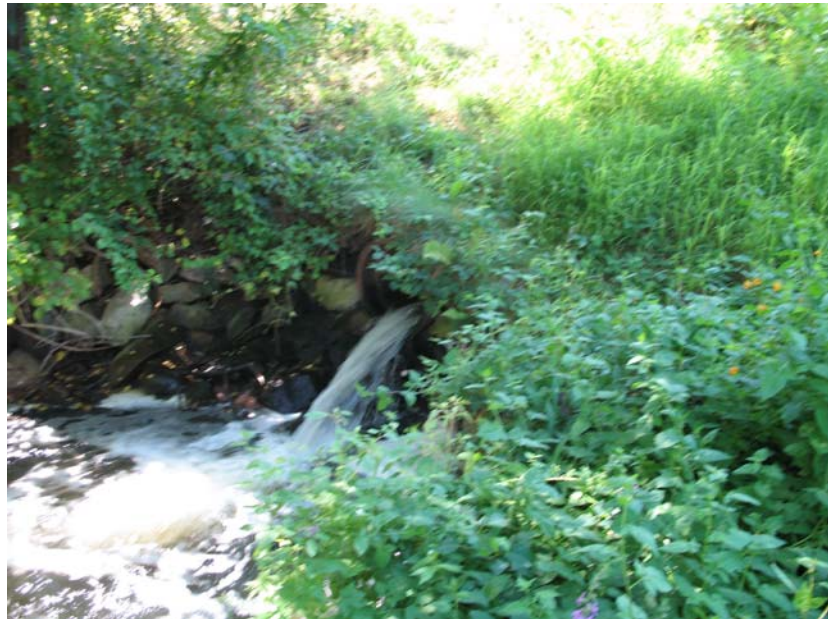
Figure 5: Outlet pipe at Toe of Earth Dam

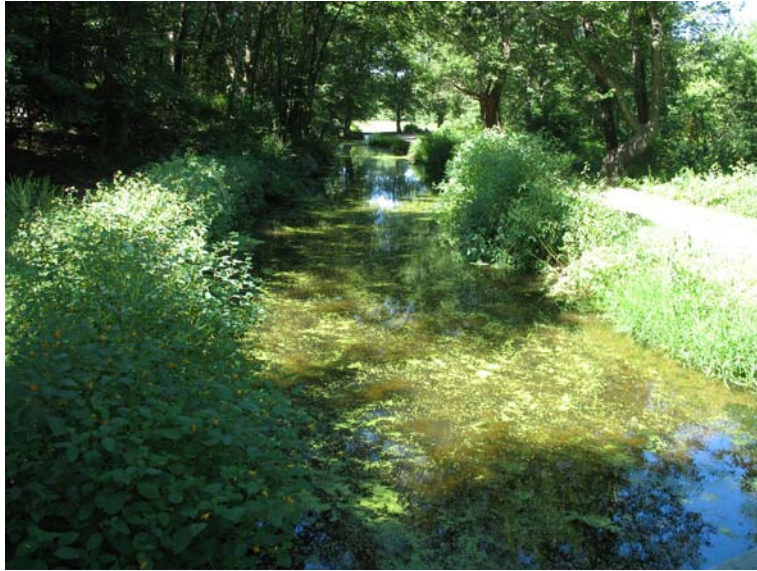
Figure 6: Sluiceway looking toward dam

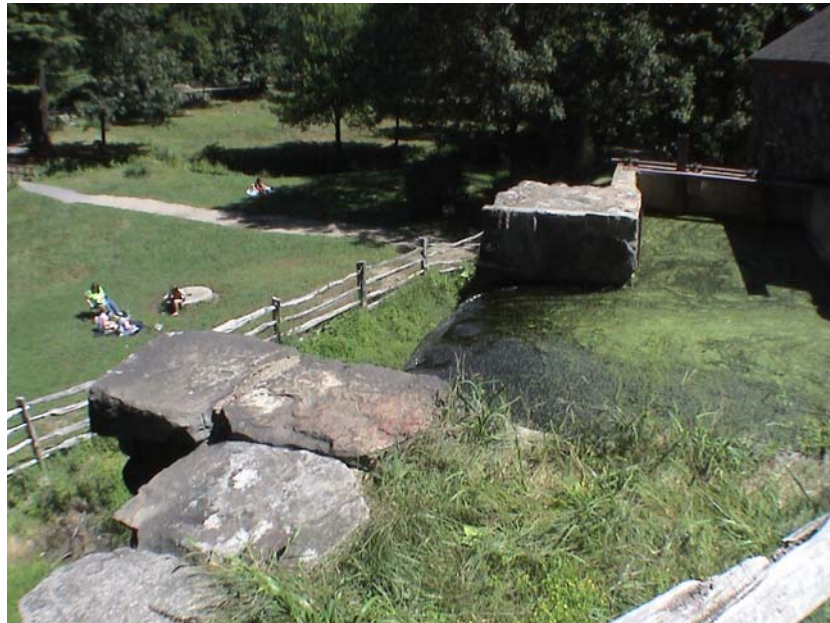
Figure 9: Outfalls at Grist Mill

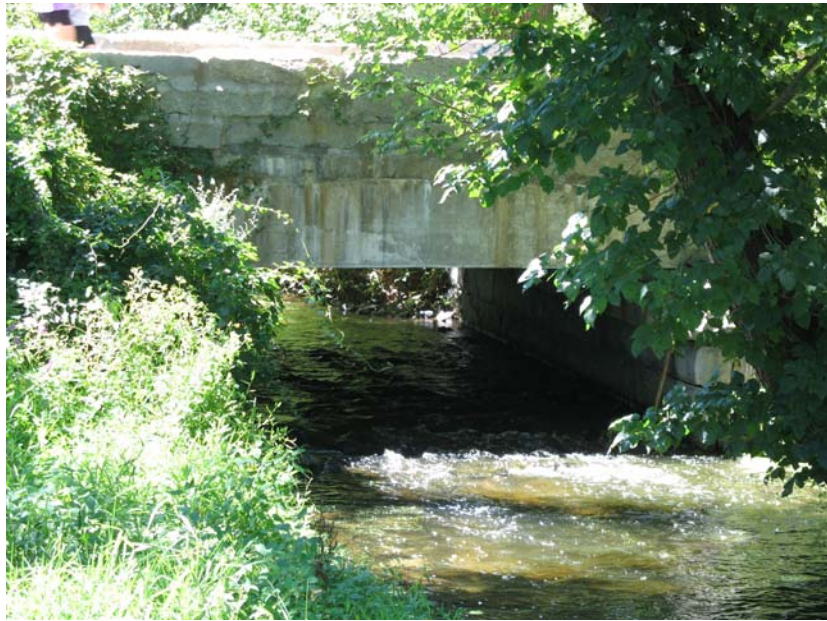
Figure 10(a): Culvert under Wayside Inn Road

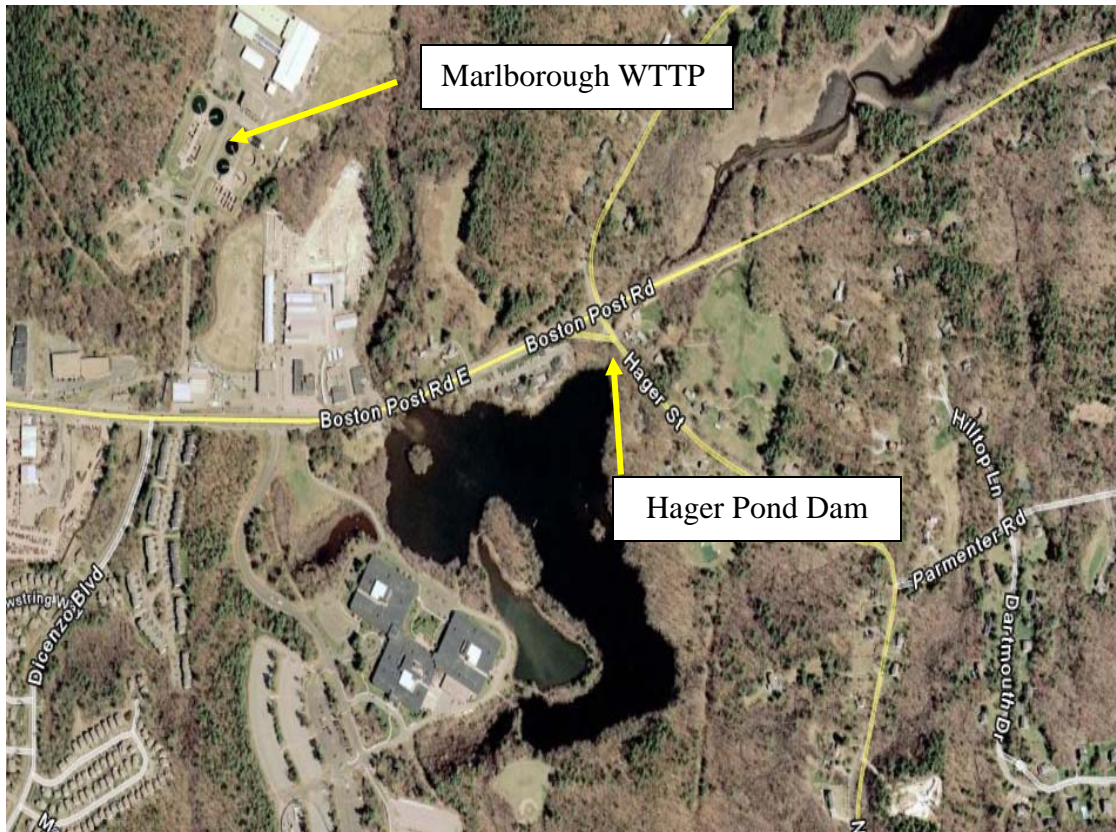
Figure 1: Location of Hager Pond Dam

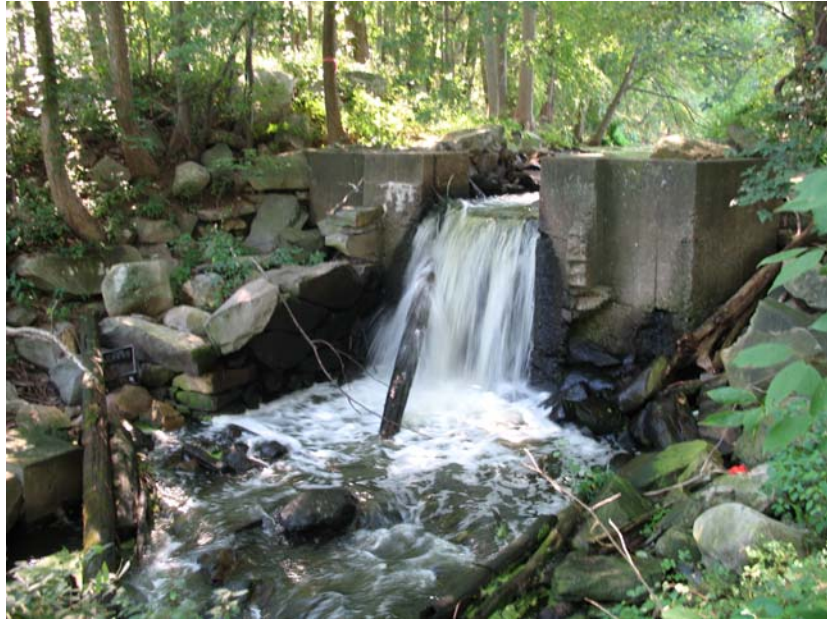
Figure 2: Weir Structure at Hager Pond Dam – Upstream View

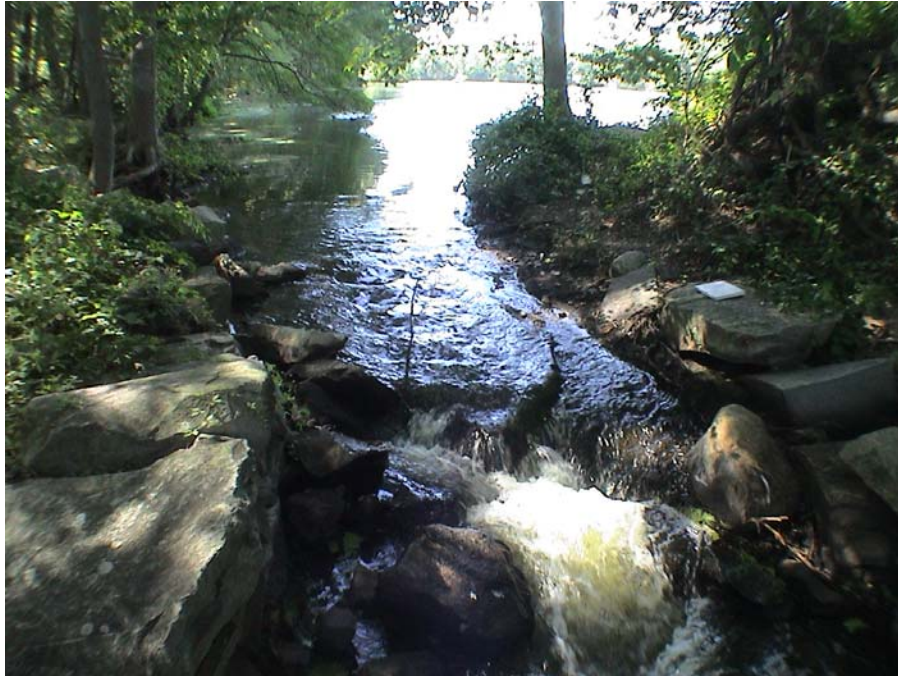
Figure 4: Inlet to Hager Pond Dam

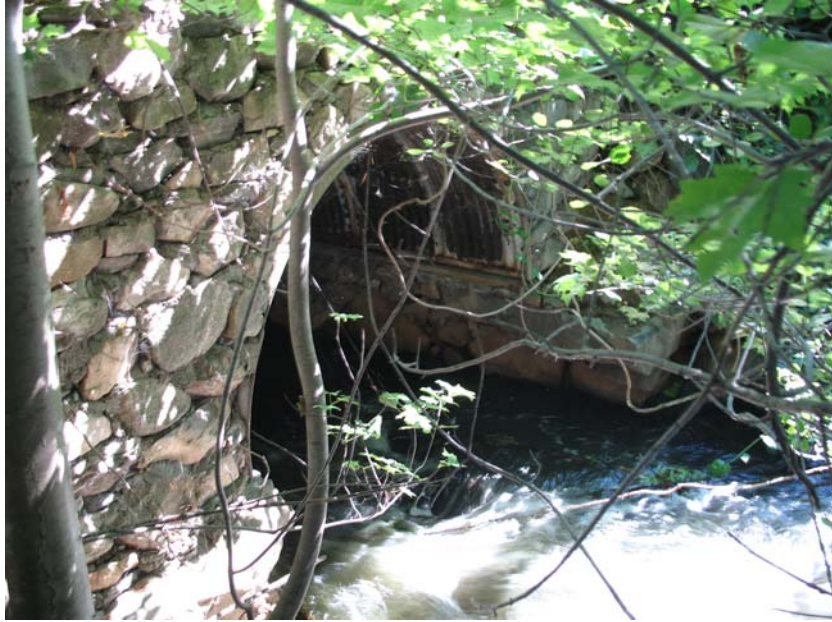
Figure 5: Culvert under Hager Street downstream of Hager Pond Dam

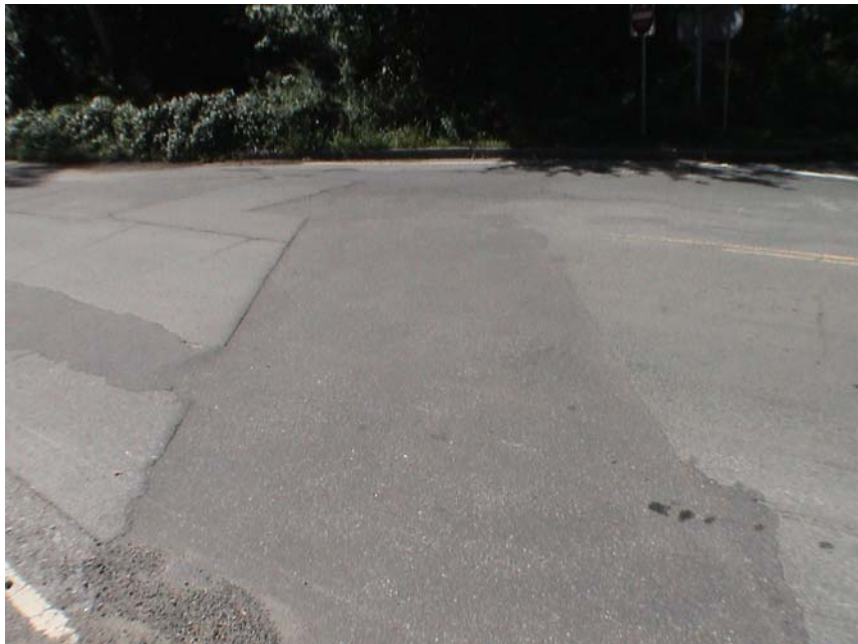
Figure 6: Repairs to Culvert under Hager Street (looking toward Hager Dam)

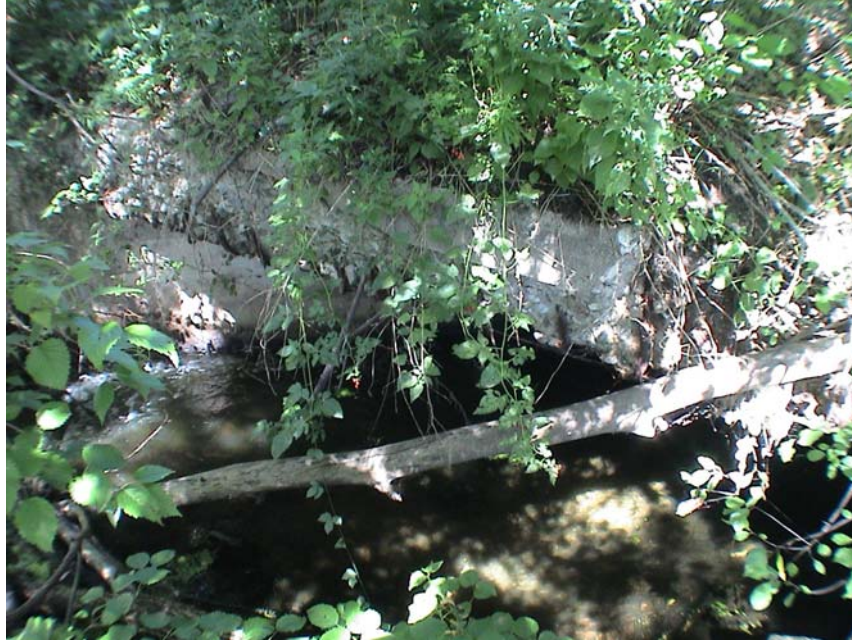
Figure 7: Culvert under Route 20 downstream of Hager Pond Dam

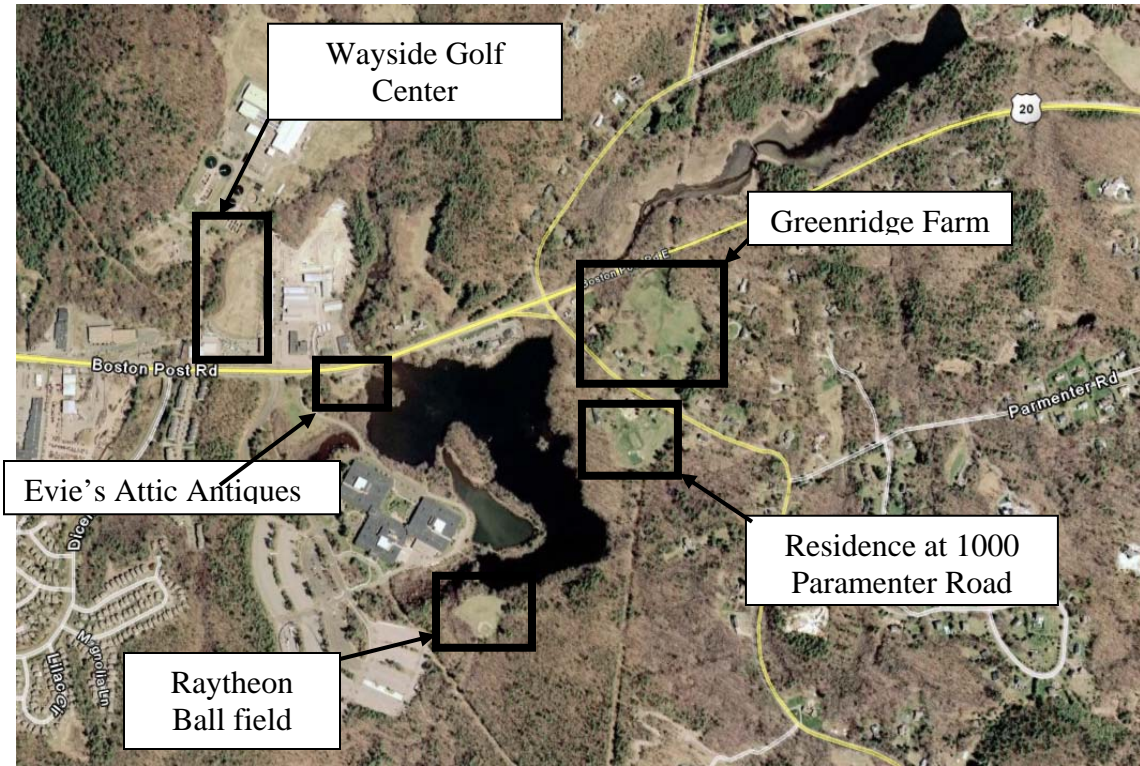
Figure 9: Potential Dewatering Sites for Hager Pond Dam

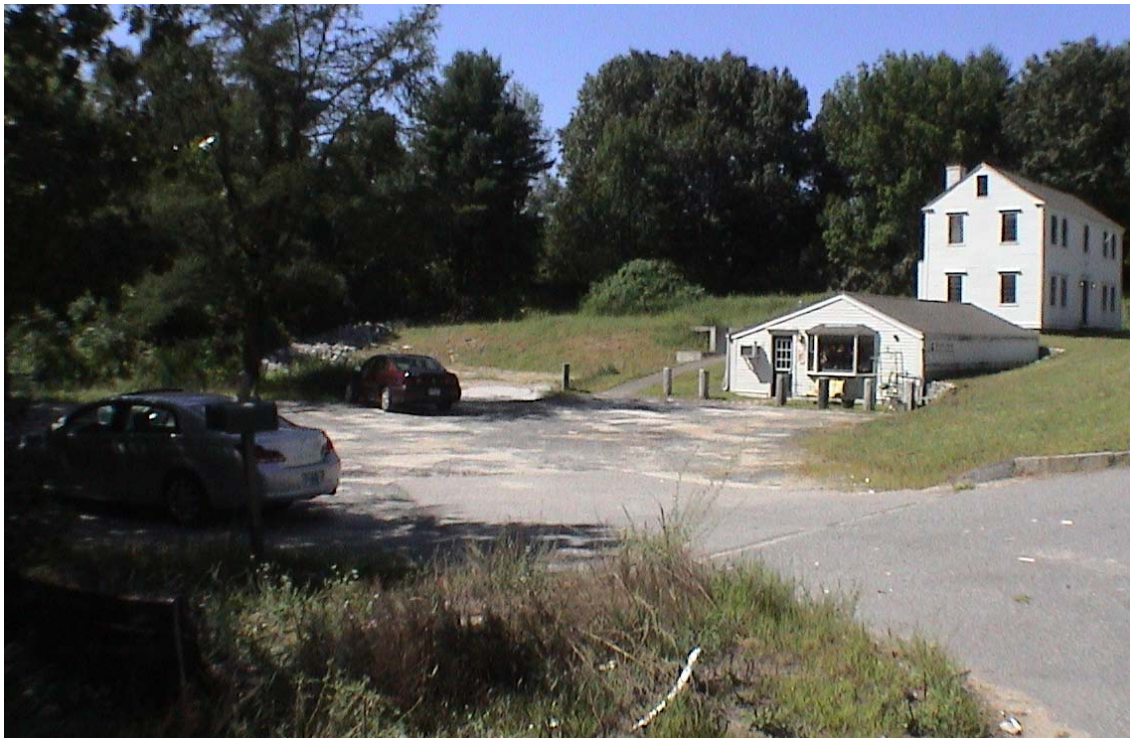
Figure 10: Recommend Dewatering Site – Evie's Attic Antiques

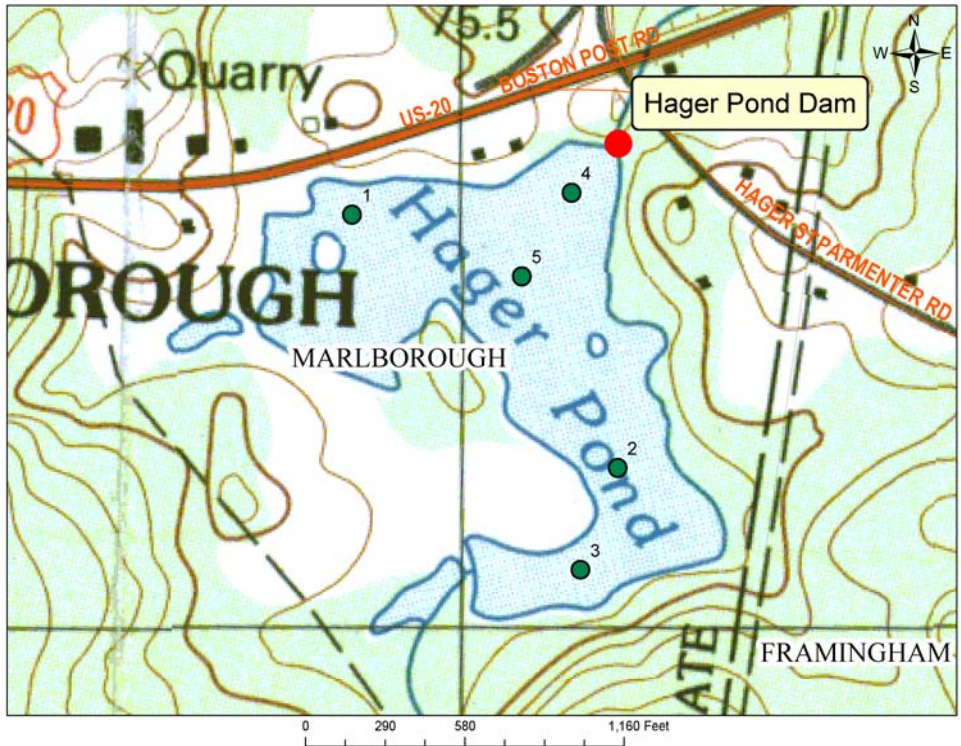
Figure 1: Sampling locations at Hager Pond

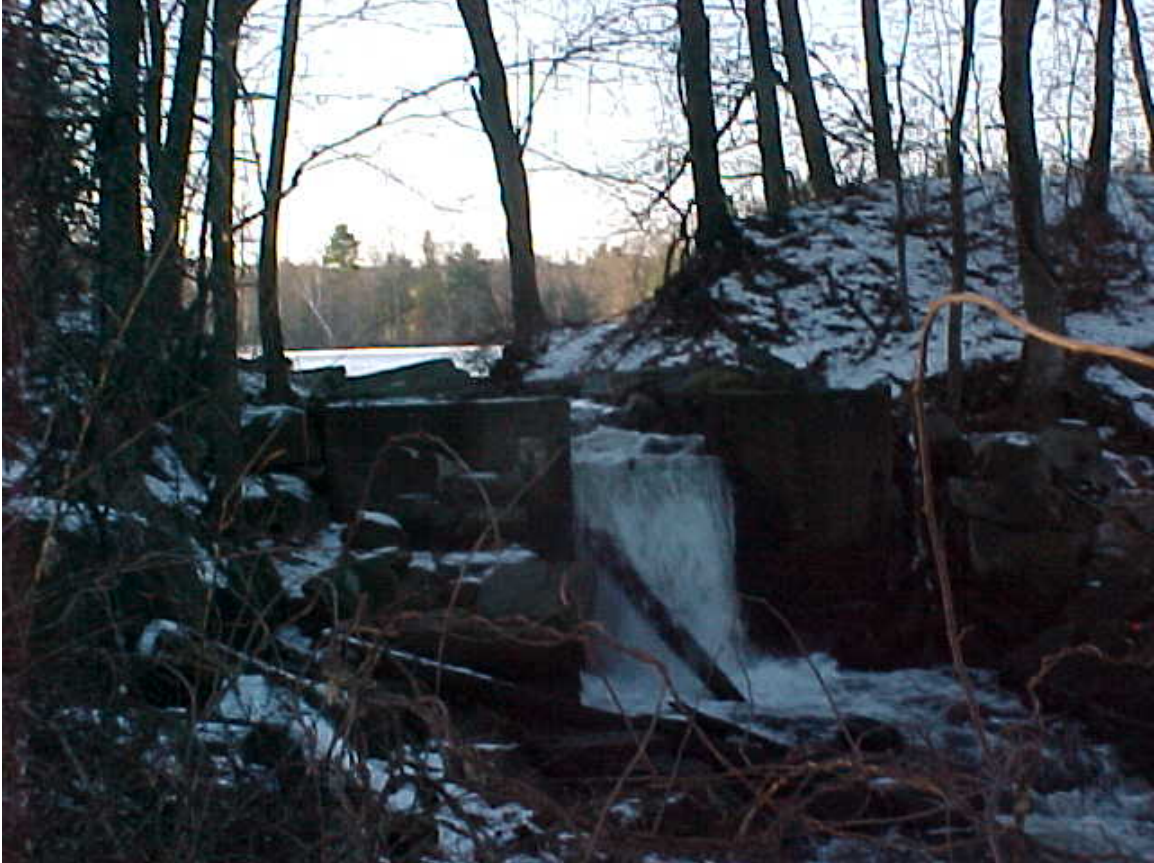
View of Hager Pond and Hager Pond Dam, Marlborough, MA

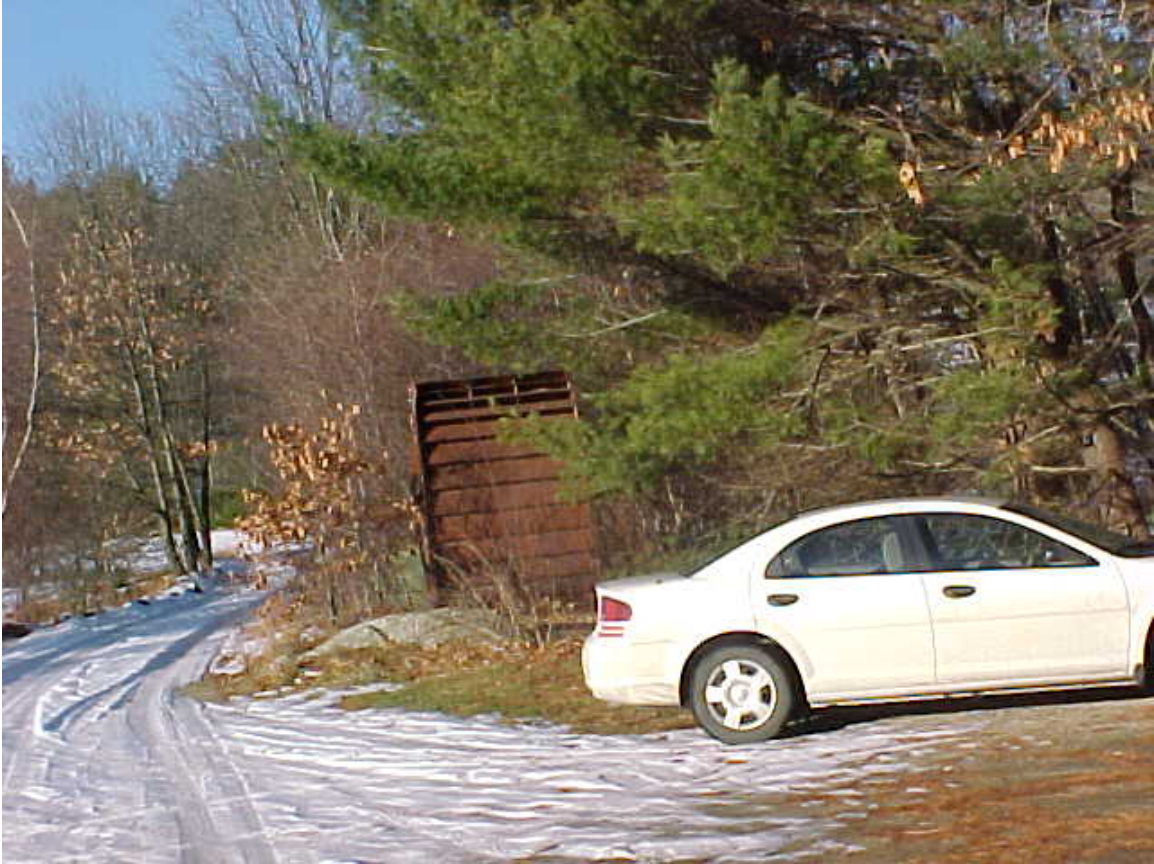
Looking northerly from ROW leading to Dutton Road. Wheel on upland appears to be in process of being repaired.
