**HOP BROOK
SEDIMENT AND DAM REMOVAL STUDY**

**MARLBOROUGH AND SUDBURY
MASSACHUSETTS**

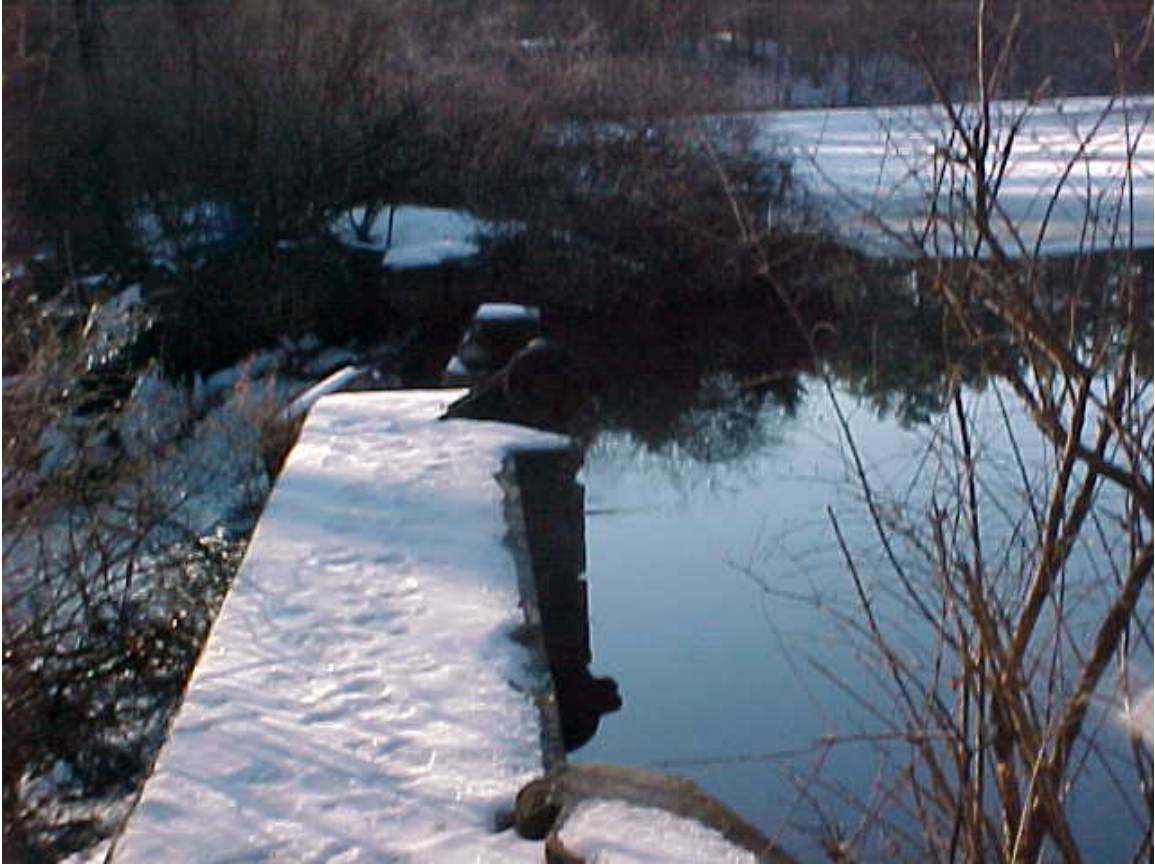
Stearns Millpond Dam, off Dutton Road, Sudbury, MA

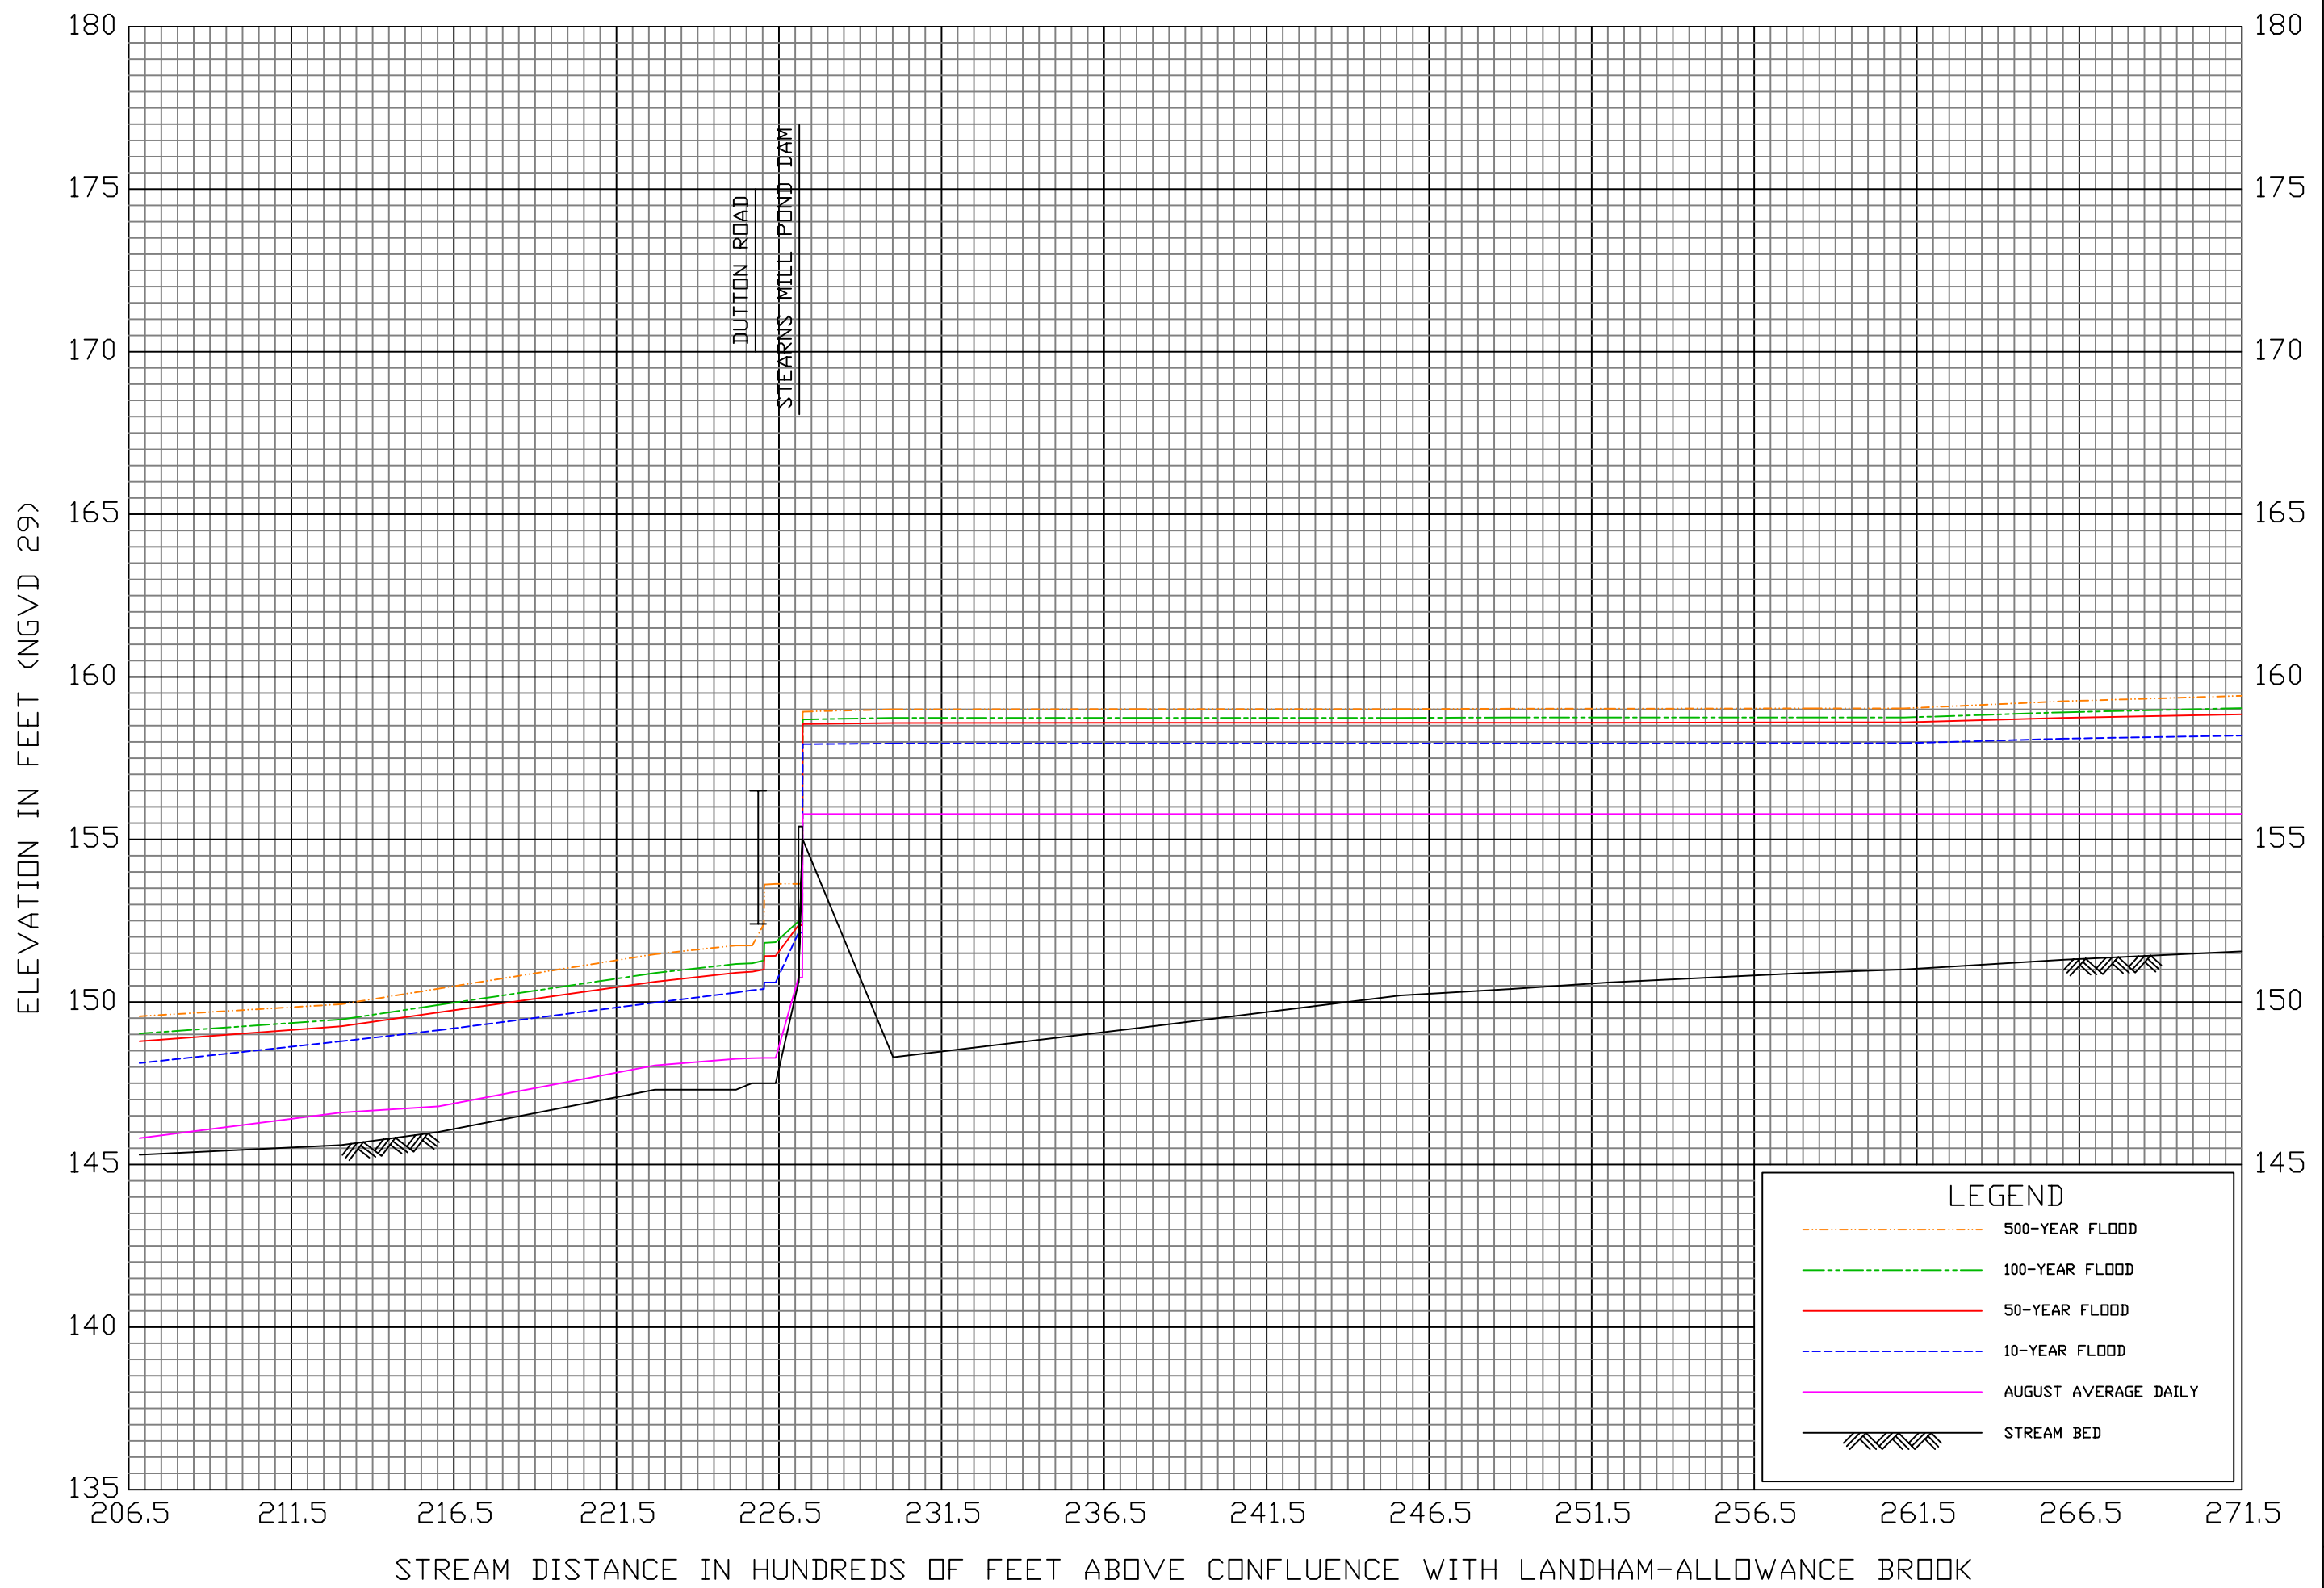
HEC-RAS RESULTS - EXISTING CONDITION PROFILES

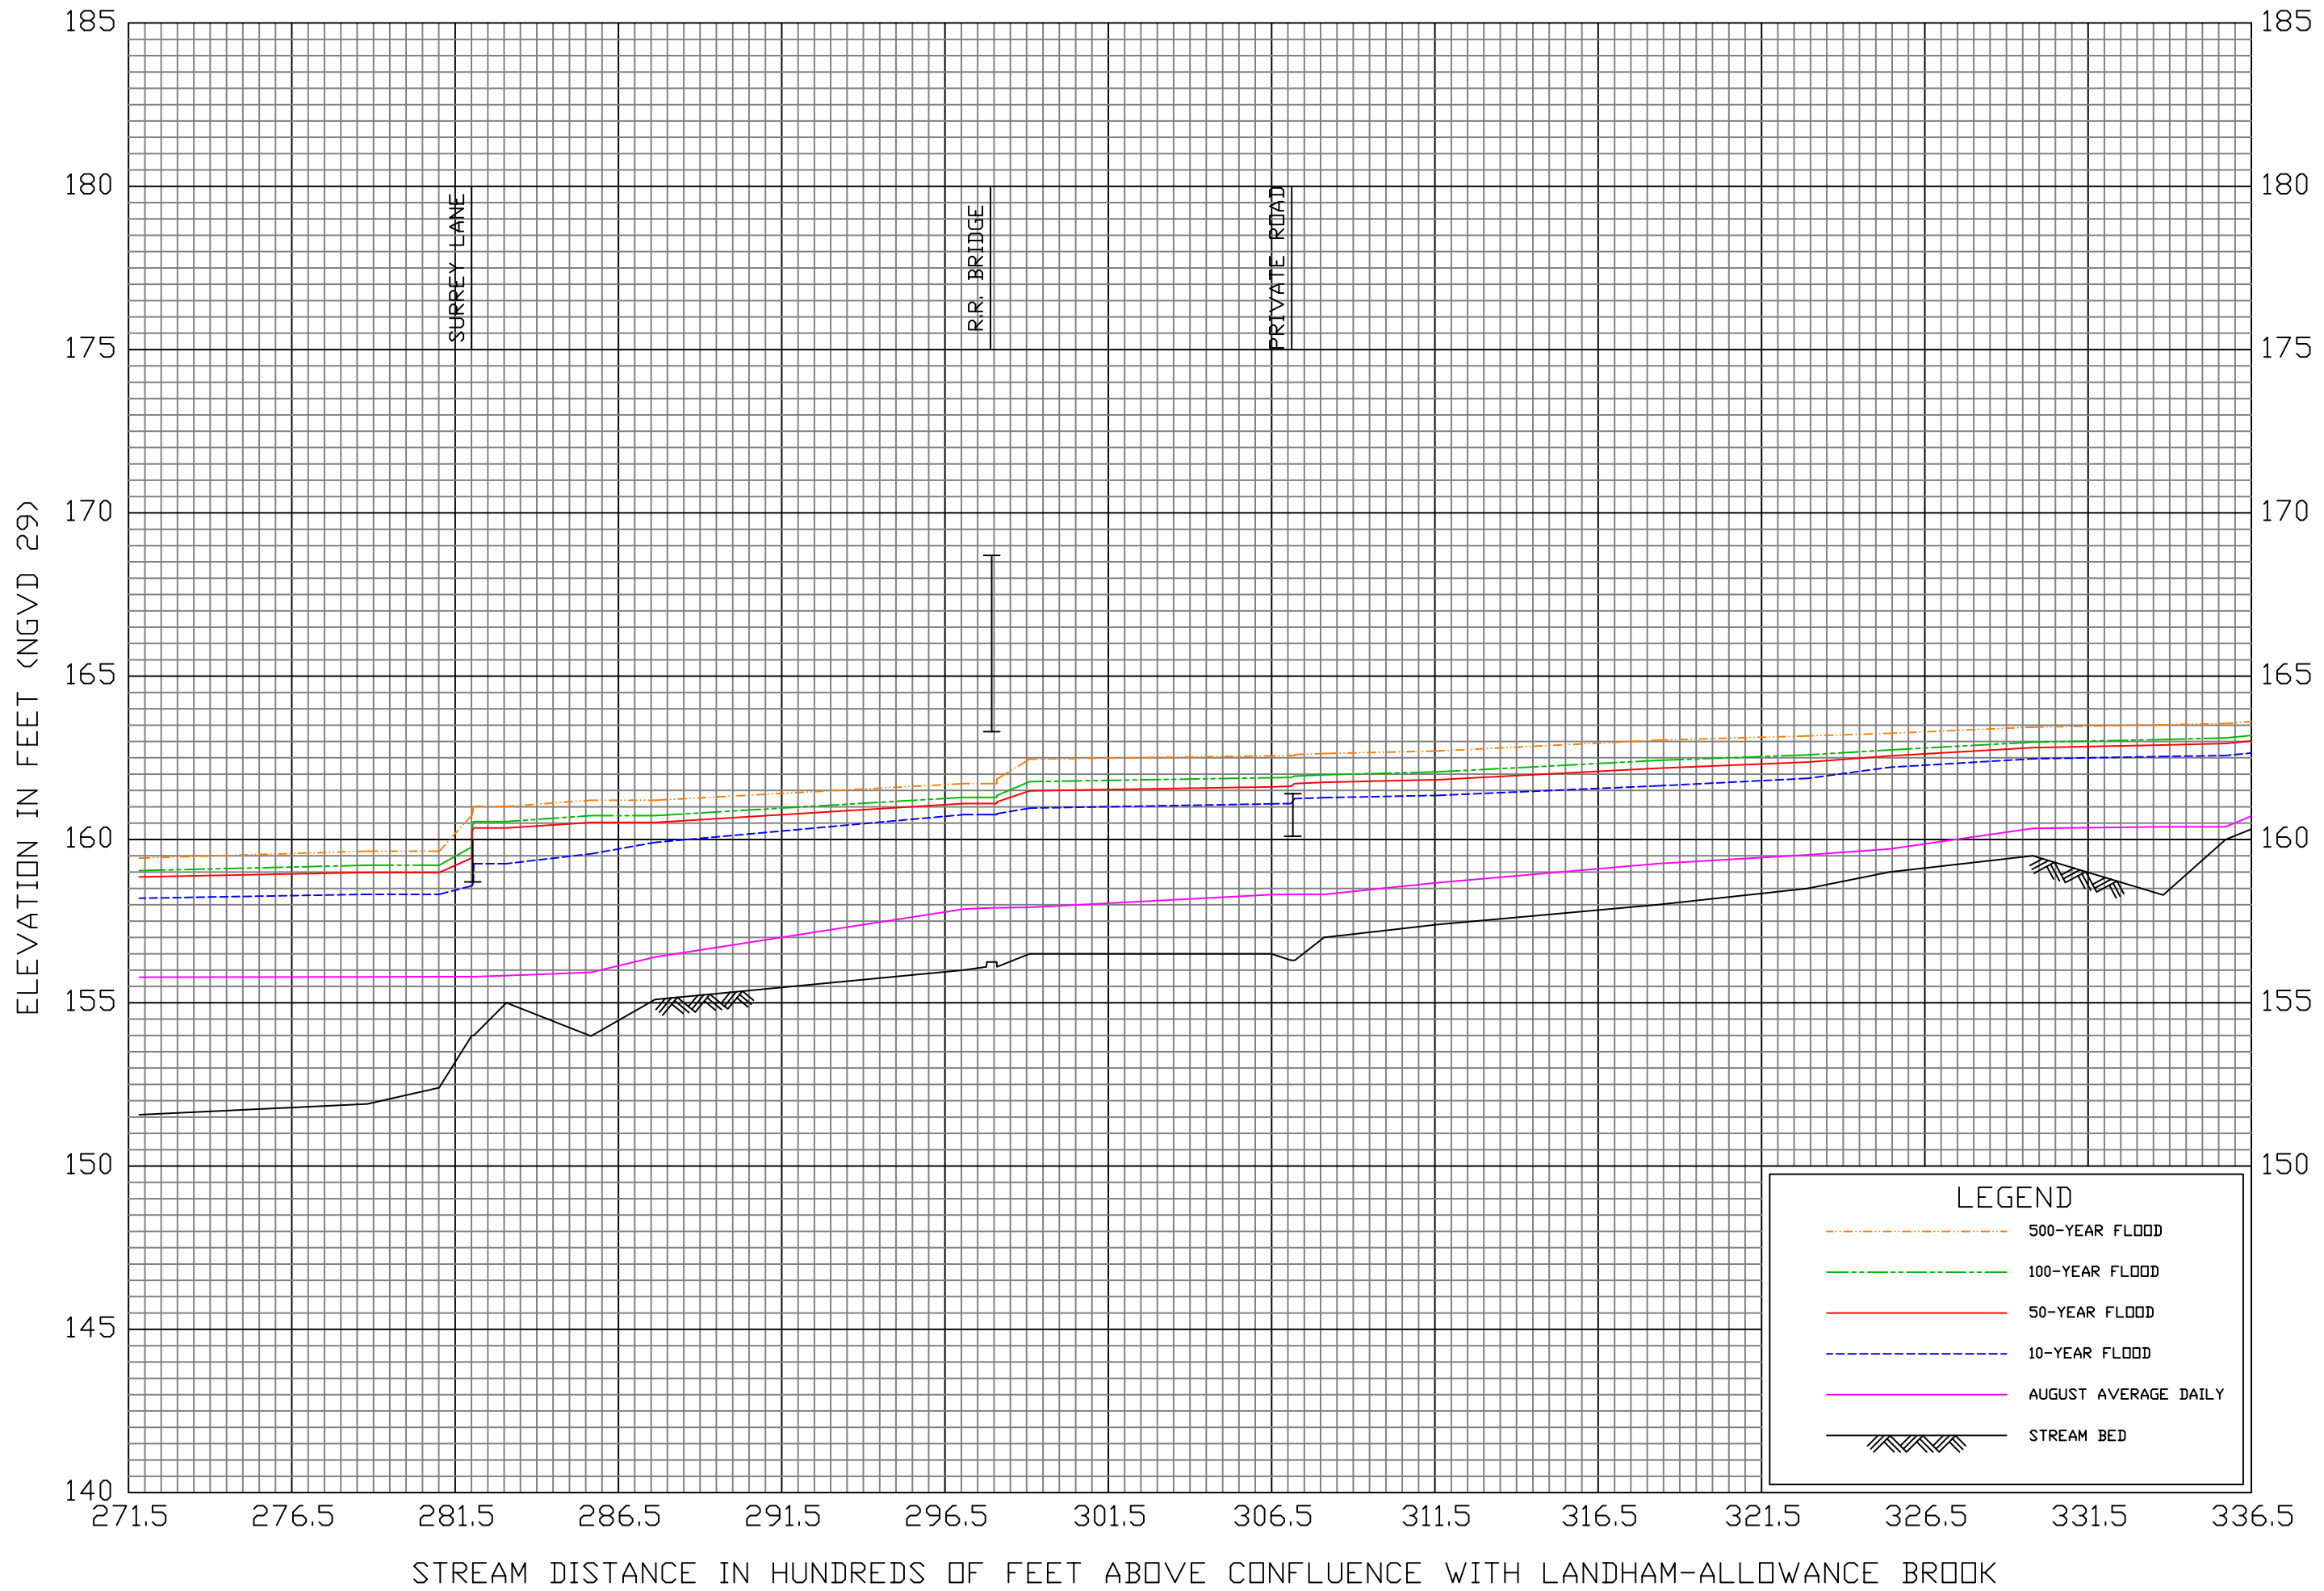
HEC-RAS RESULTS - EXISTING CONDITION PROFILES

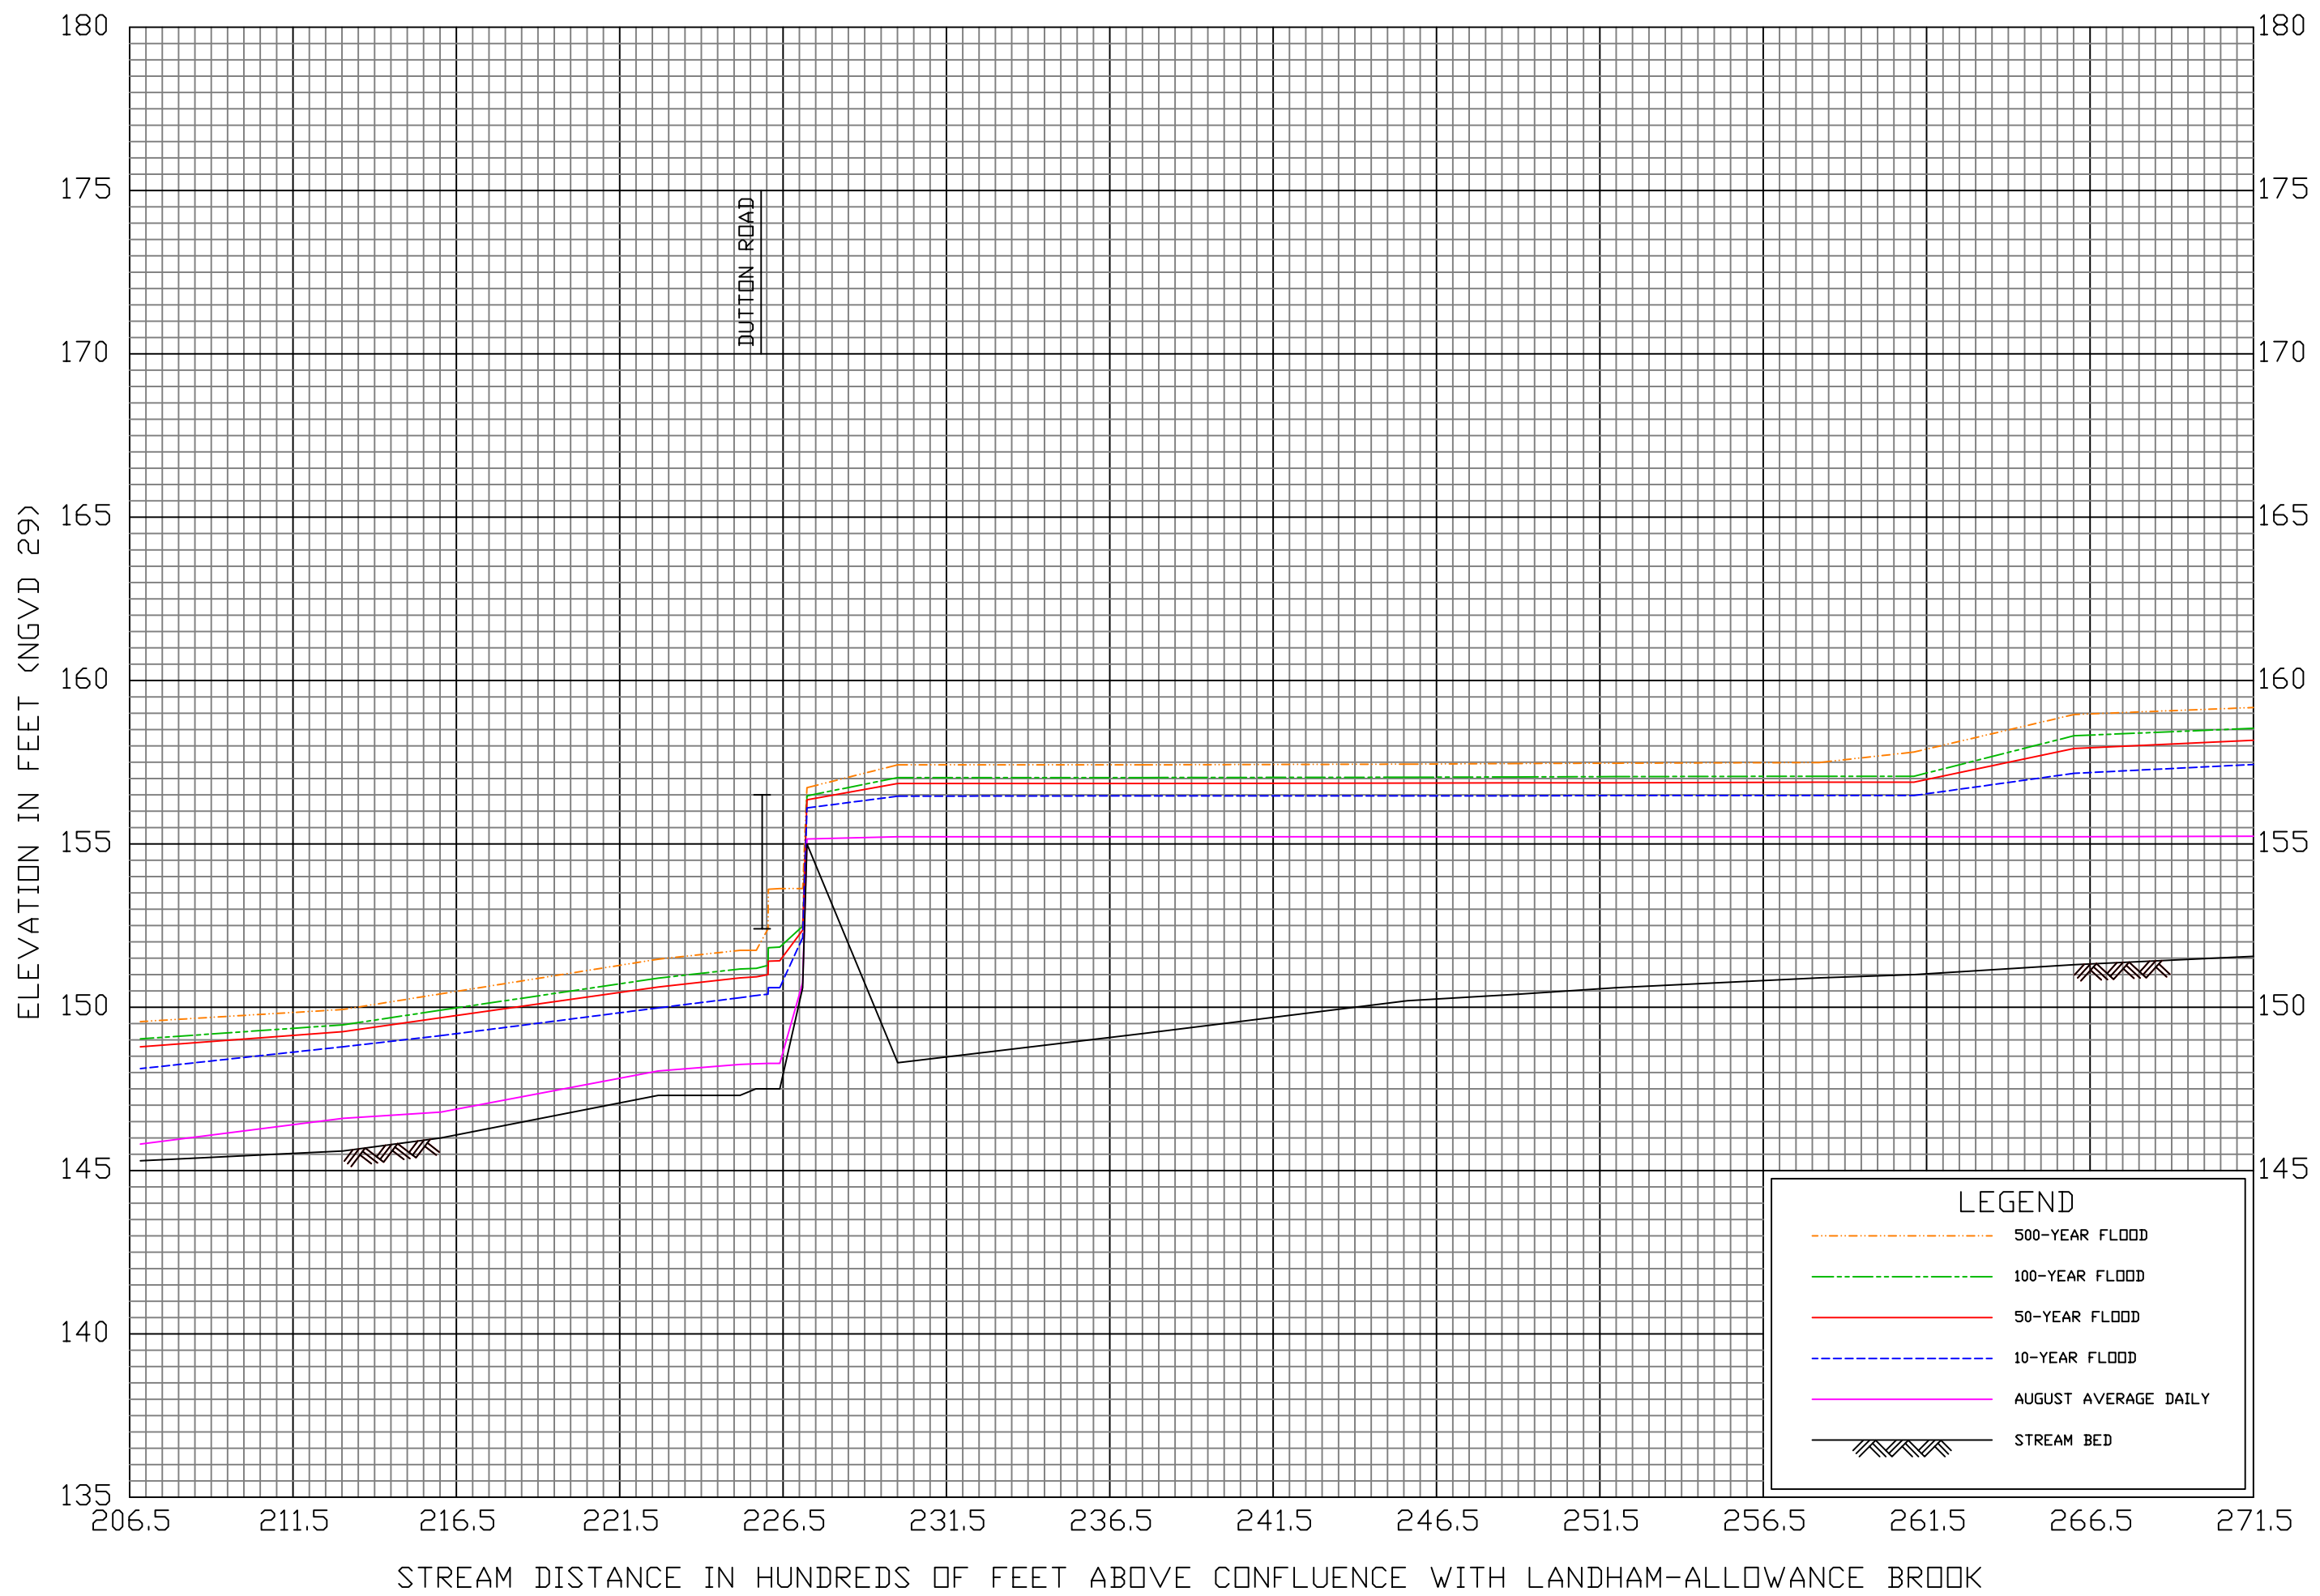
HEC-RAS RESULTS - ALTERNATIVE 2 PROFILES

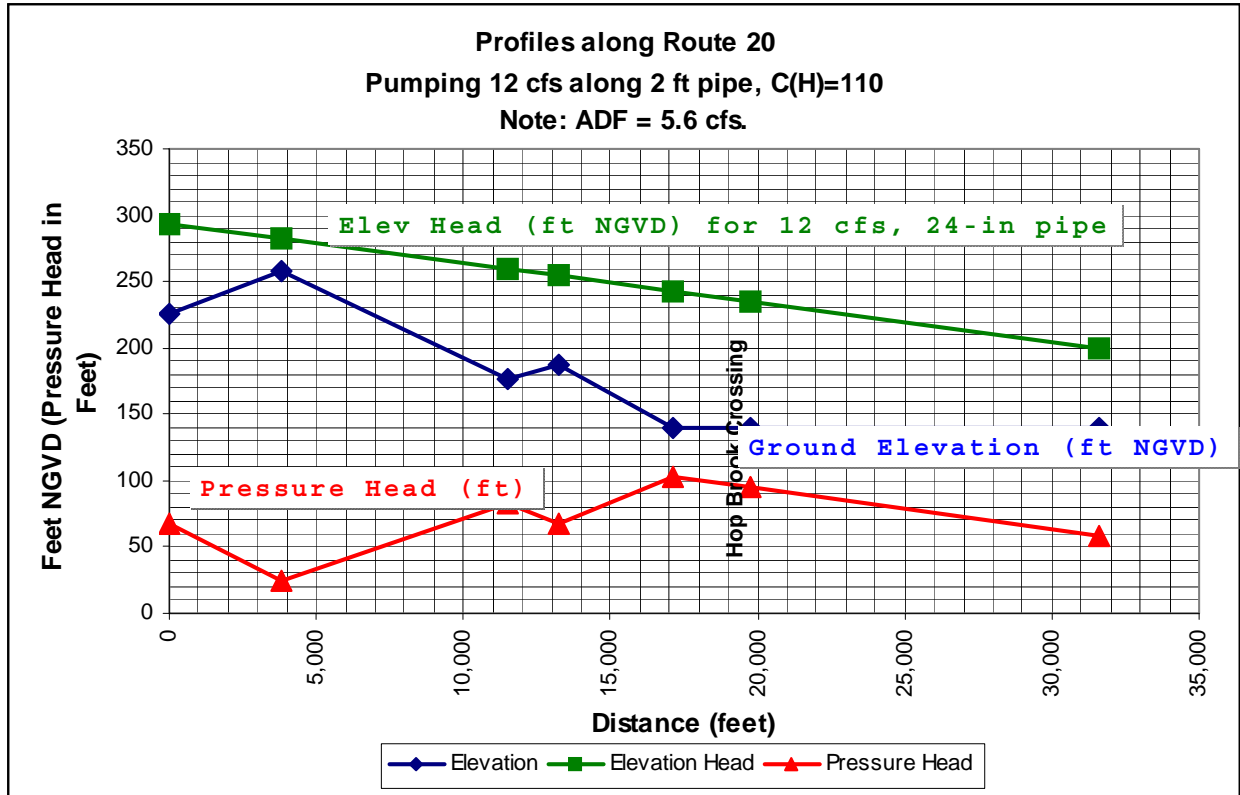
Pipe pressure requirements: 6 miles of 2-ft diameter pipe, for pressures up to 160 ft working head or 320 ft dynamic head (allowing for transient heads).
