Town of Sudbury Warrant Article
Atkinson Pool Funds

2023 Fall Special Town Meeting

Town of Sudbury Warrant Article Q
DPW Roof Top HVAC Unit Replacements

Town of Sudbury Warrant Article J\
DPW Salt Storage Vinyl Cover Replacement

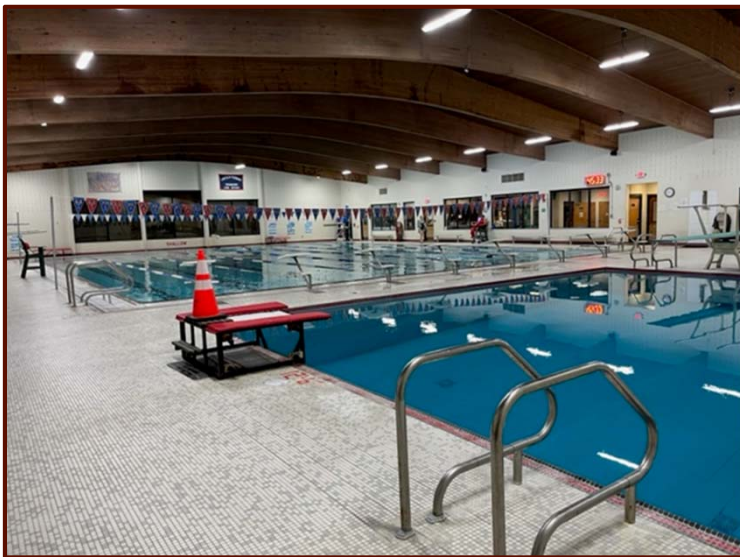
Natatoriums require a large, high capacity dehumidification to control condensate formation from pool water evaporation. They require ventilation to meet building code requirements. The existing high capacity dehumidification equipment has reached its end of life and is experiencing costly repairs and reliability concerns. Adding interior destratification fans and air conditioning will enhance the current design and ensure interior air quality for users and the property.

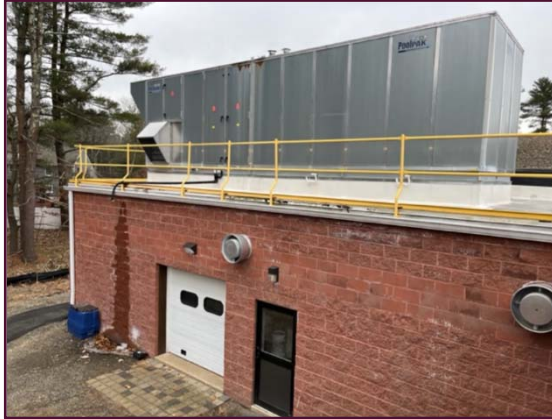
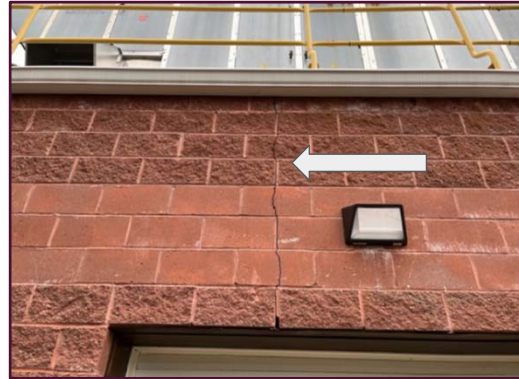
Rooftop Dehumidification Equipment and Structural Concern

Structural concern

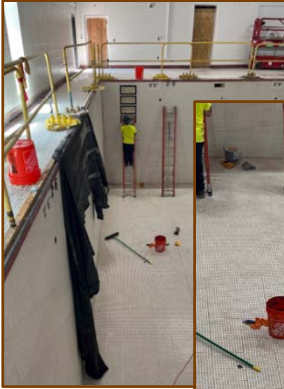
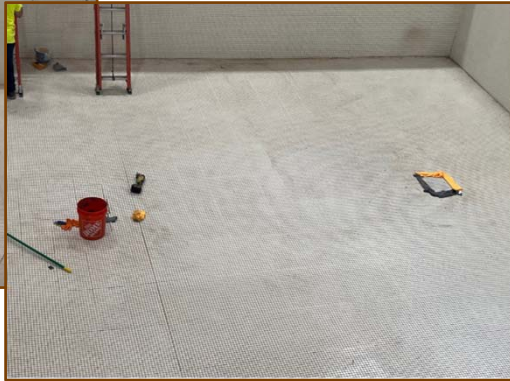
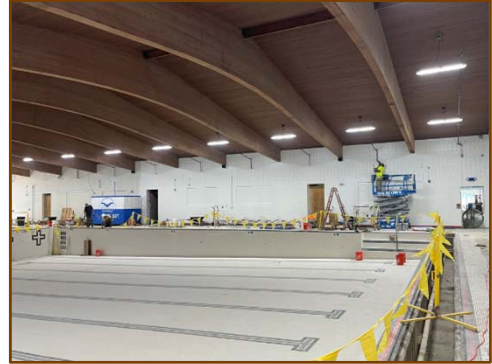
Pool basins Grouting (approx. 7,825 SF)

Atkinson Pools - Empty of Water Photos- July 2023

- Roof-top dehumidification equipment replacement
- Natatorium indoor air destratification
- Tile repair and pool basins grouting
- Dive pool skimmer box replacements
- Boiler/chemical room separation
- Boiler/chemical room structural repair
- Solar ready roof design

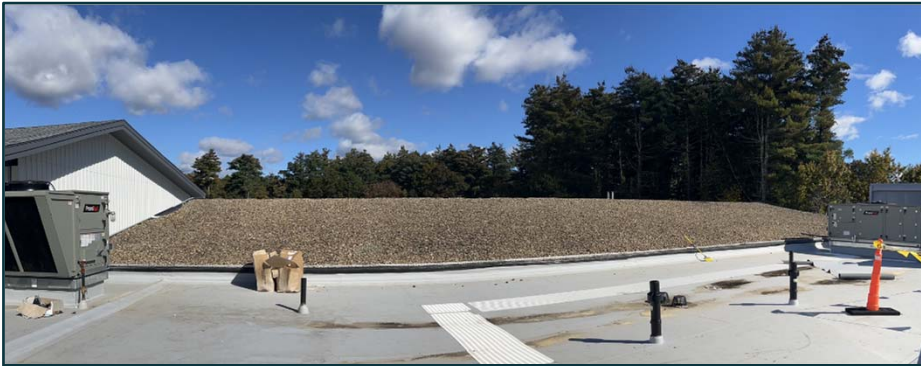
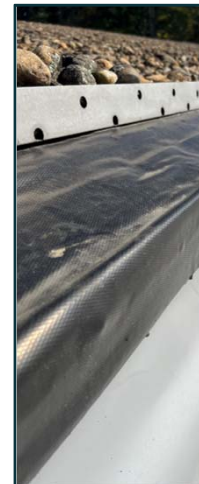
Atkinson Pool Roof

Natorium Roof Description:

- 13,350 s.f. Ballasted EPDM Roof (New Construction 1987)
- Russo Barr 2012 Roof Condition Survey recommended replacement in 2013

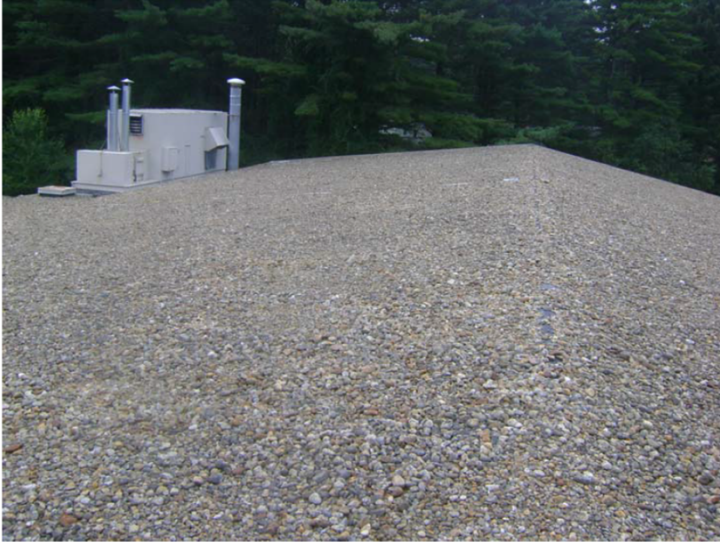
Photo No. 02

Description: Overview of Roof Area No. 1. Note that stone ballast has migrated away from the roof ridge.

Excerpt from 2012 Russo Barr Fairbank Complex Roof Condition Survey

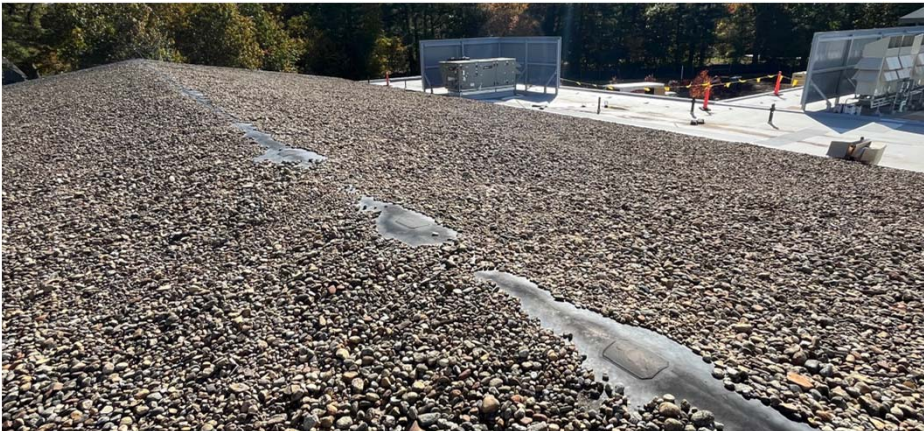
Atkinson Pool Roof

Ballast migration as of October 23, 2023

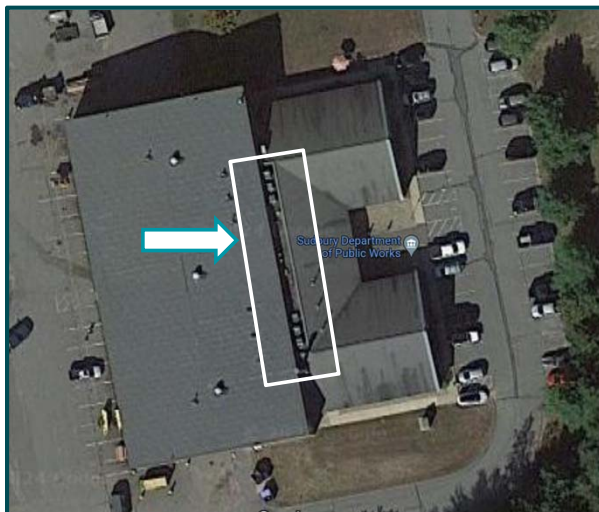
- Roof replacement includes replacing the flat roof section
- Also included as associated repair work includes removing the exposed wood sleepers under the aged HVAC equipment and installing new flashed wood sleepers

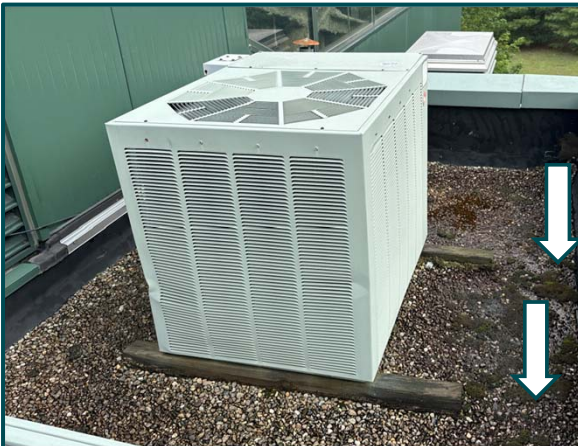
Arrows point to the wood sleepers that are under the HVAC units that are rotten and require replacement.

In order to accomplish this the HVAC unit must be moved along with deteriorated associated components.

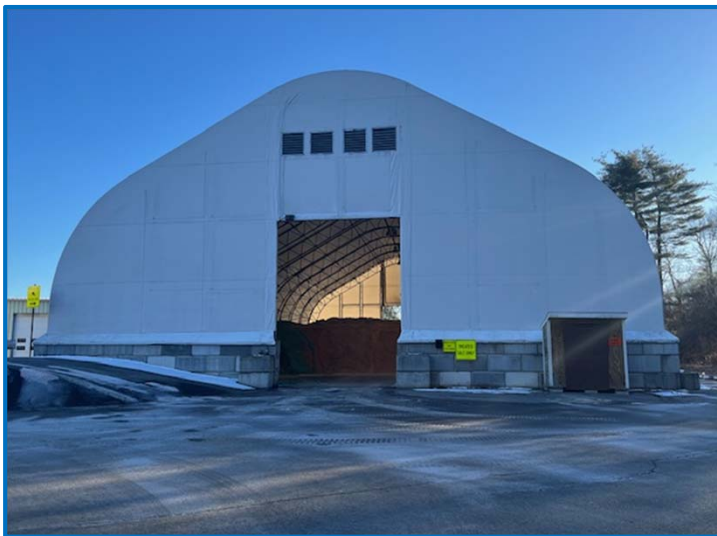
The DPW Salt Shed,
located behind the
DPW Office Building;
houses the Town's
salt storage.

The vinyl cover on the salt storage facility is 20 years old. It has reached the end of its life expectancy. Replacement of this cover in advance of failure will be accomplished with the funding of this vinyl cover replacement.
