Re: MADEP File No. 301-1227
Abbreviated Notice of Resource Area Delineation Response to Comments
Sudbury-Hudson Transmission Reliability Project

Sudbury-Hudson Transmission Reliability Project | Sudbury, Massachusetts

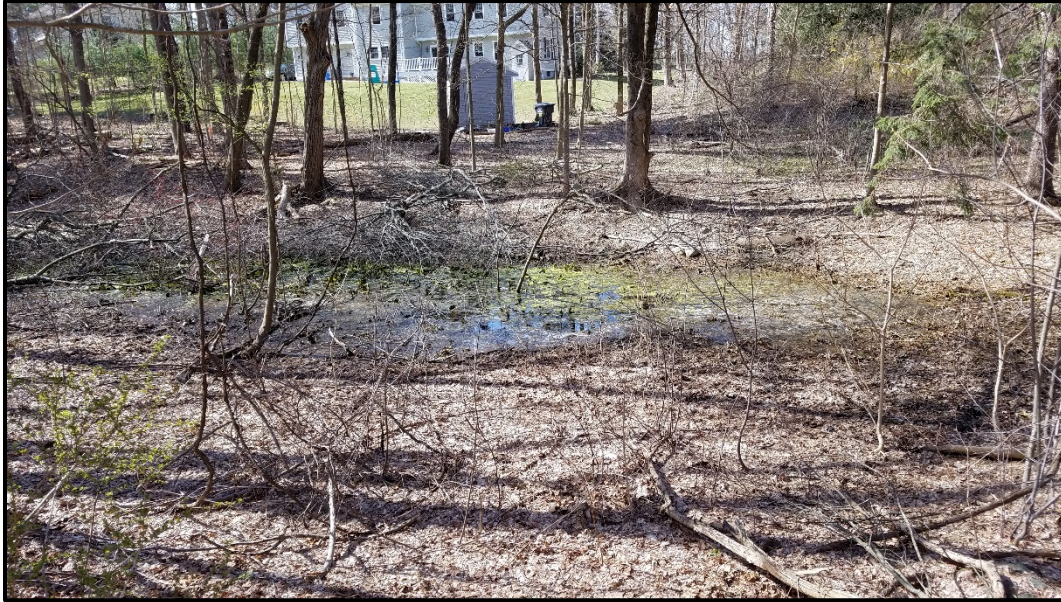
Water levels of Wetland 19 on April 24, 2018

- 8. The culvert between Wetlands 18 and 19 on sheet 31 is not functioning and Wetland 19 is isolated. Mr. Burke believes that Wetland 19 could be a potential vernal pool.**

This was reviewed in the field with Mr. Burke and a discussion was held regarding its potential as a vernal pool. At the time of the site visit, there was standing water present; however, there was a significant rainfall event the previous day and it was difficult to assess true field conditions. Both parties (Mr. Burke and VHB) felt that the isolated wetland likely **does not** hold water long enough (2 months) to meet the criteria for a vernal pool. VHB visited Wetland 19 on April 24 and the water level had significantly receded, which indicates that it does not hold enough water for the required two-month time period.

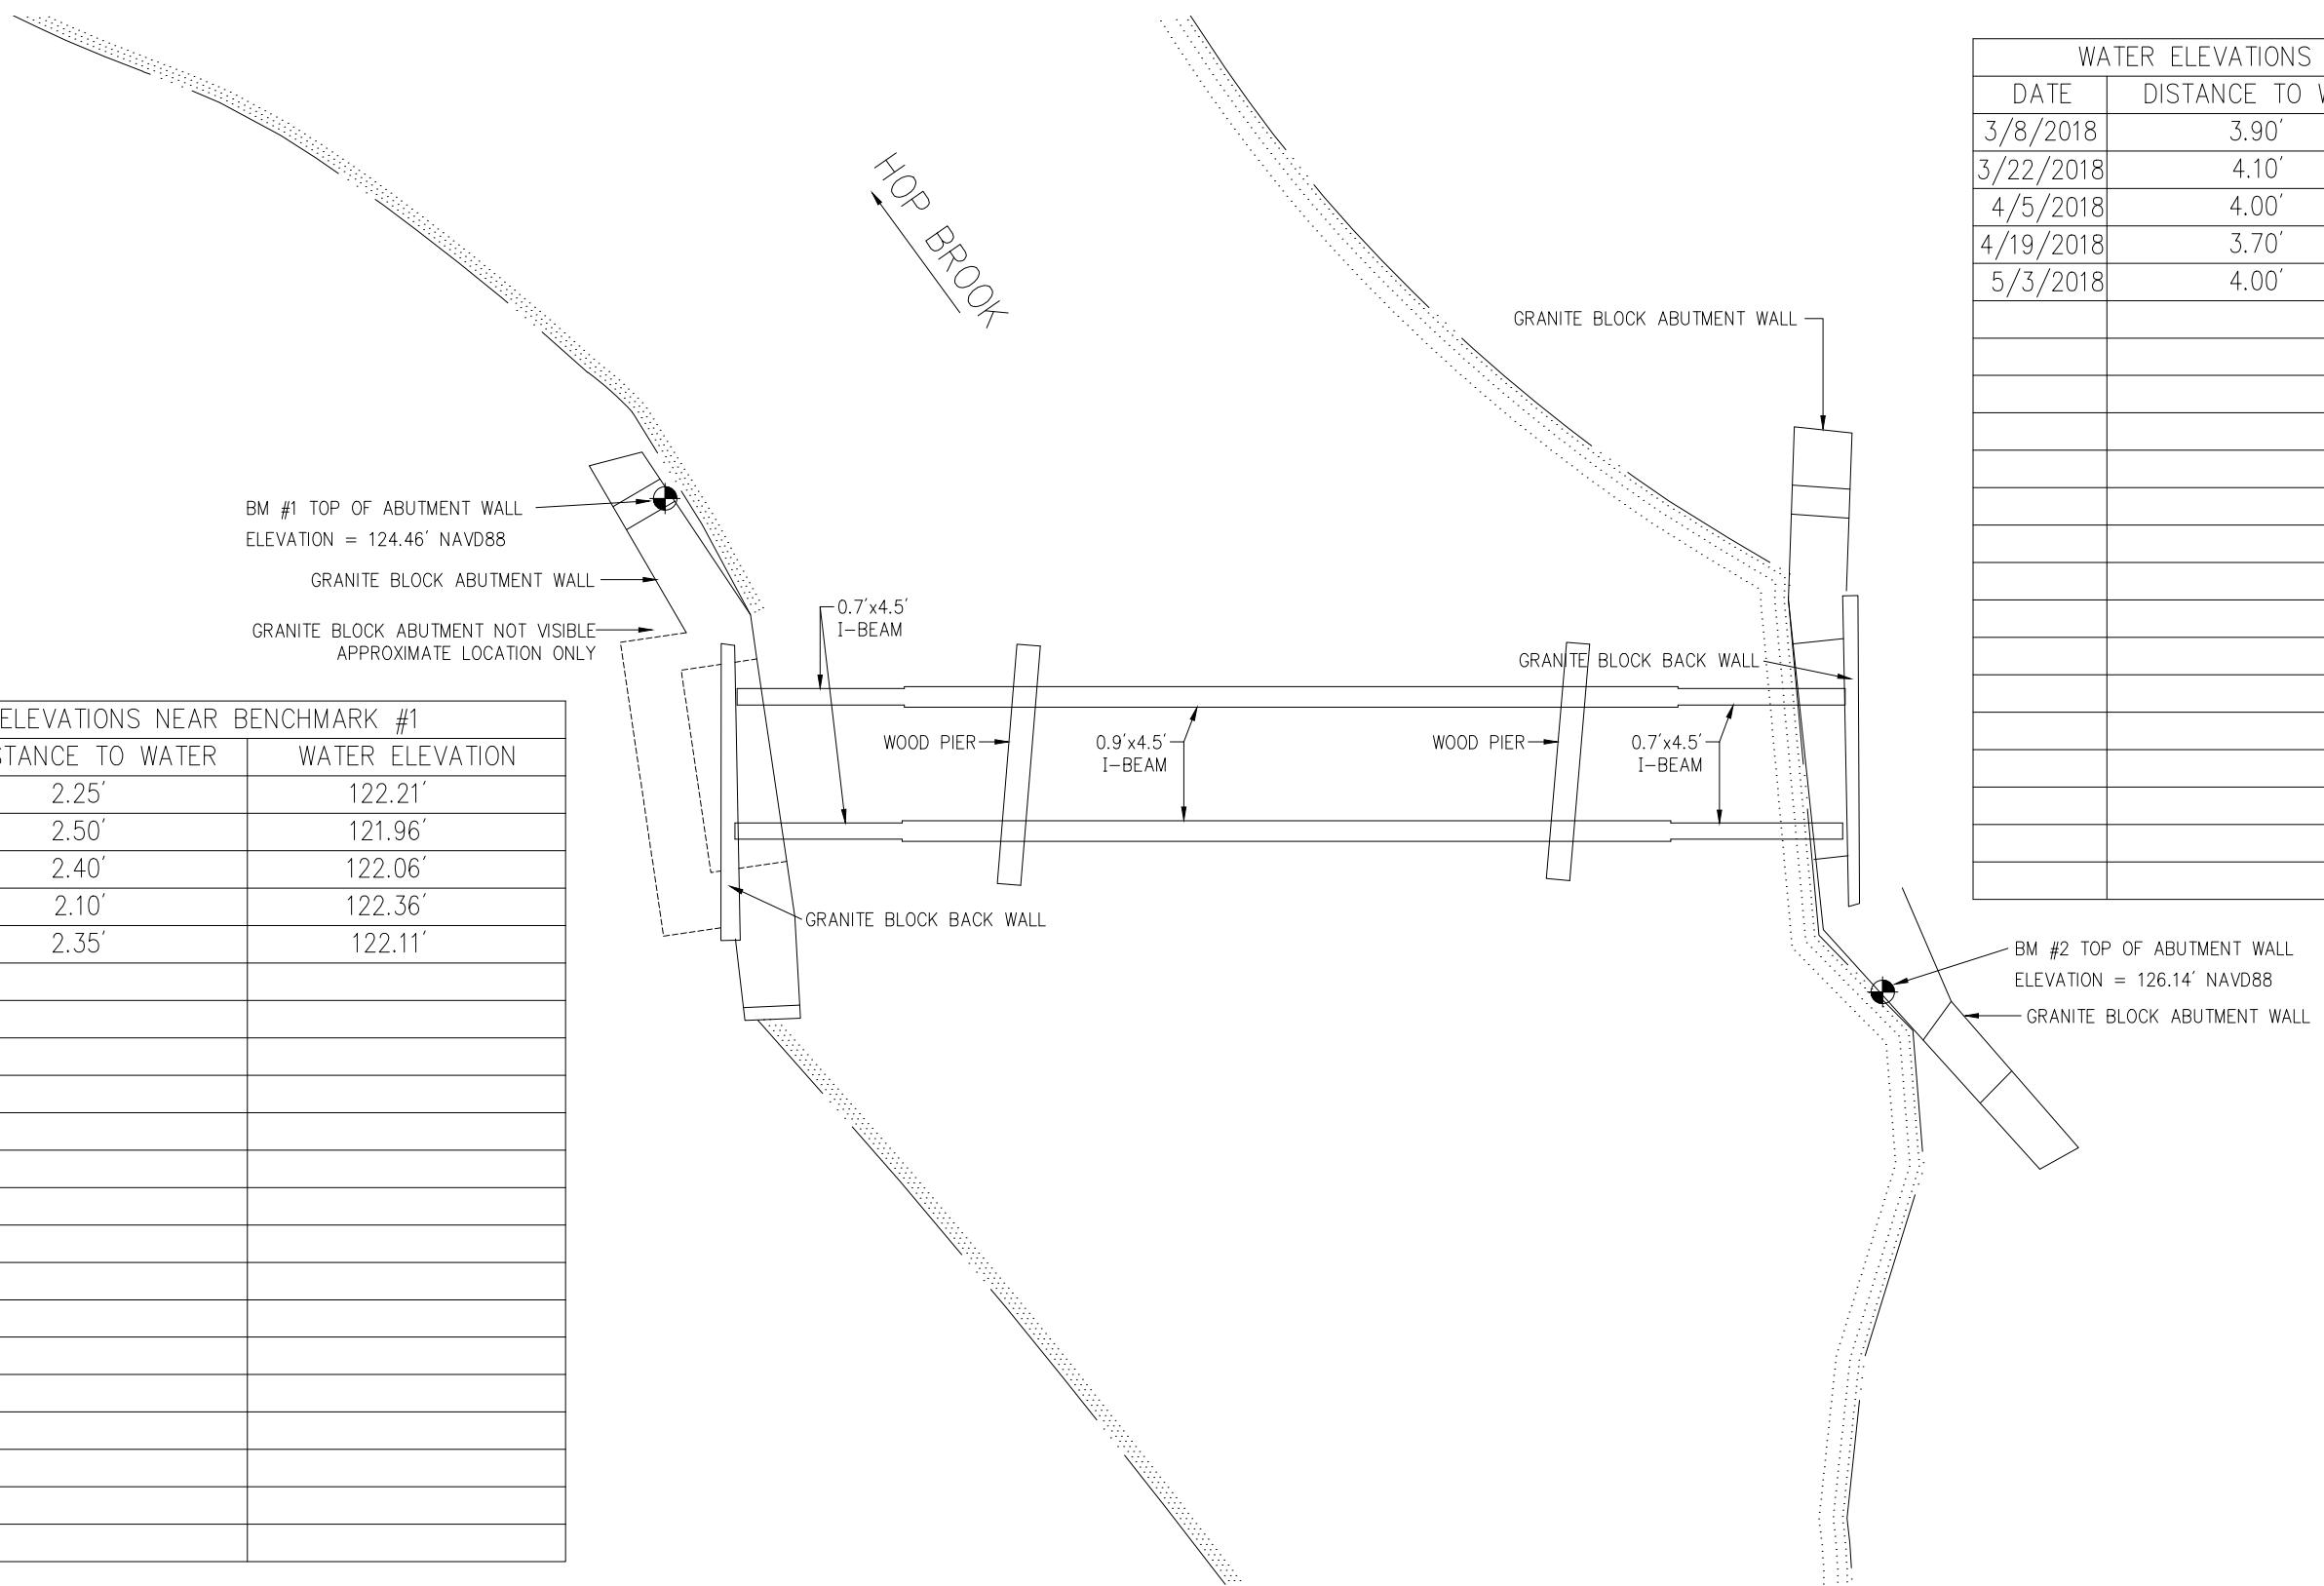
WATER ELEVATIONS NEAR BENCHMARK #2		
DATE	DISTANCE TO WATER	WATER ELEVATION
3/8/2018	3.90'	122.24'
3/22/2018	4.10'	122.04'
4/5/2018	4.00'	122.14'
4/19/2018	3.70'	122.44'
5/3/2018	4.00'	122.14'

WATER ELEVATIONS NEAR BENCHMARK #1		
DATE	DISTANCE TO WATER	WATER ELEVATION
3/8/2018	2.25'	122.21'
3/22/2018	2.50'	121.96'
4/5/2018	2.40'	122.06'
4/19/2018	2.10'	122.36'
5/3/2018	2.35'	122.11'

**Water Elevations Under Bridge 127 Over Hop Brook
Sudbury, Mass.**

VHB established two (2) benchmarks at the eastern Hop Brook crossing. Benchmark 1 is located upstream of the bridge on the top of the western abutment wall and is at elevation 124.46-ft

(NAVD88). Benchmark 2 is located downstream of the bridge on the top of the eastern abutment wall and is at elevation 126.14-ft (NAVD88). One (1) benchmark was established at the western Hop Brook crossing upstream of the bridge on the eastern abutment wall and is at elevation 166.80 (NAVD88) All benchmarks are physically marked in the field with pink paint and VHB is surveying water elevation data once every two weeks. Please see the attached figures with the benchmark locations and water elevation data at both bridge locations for additional information.

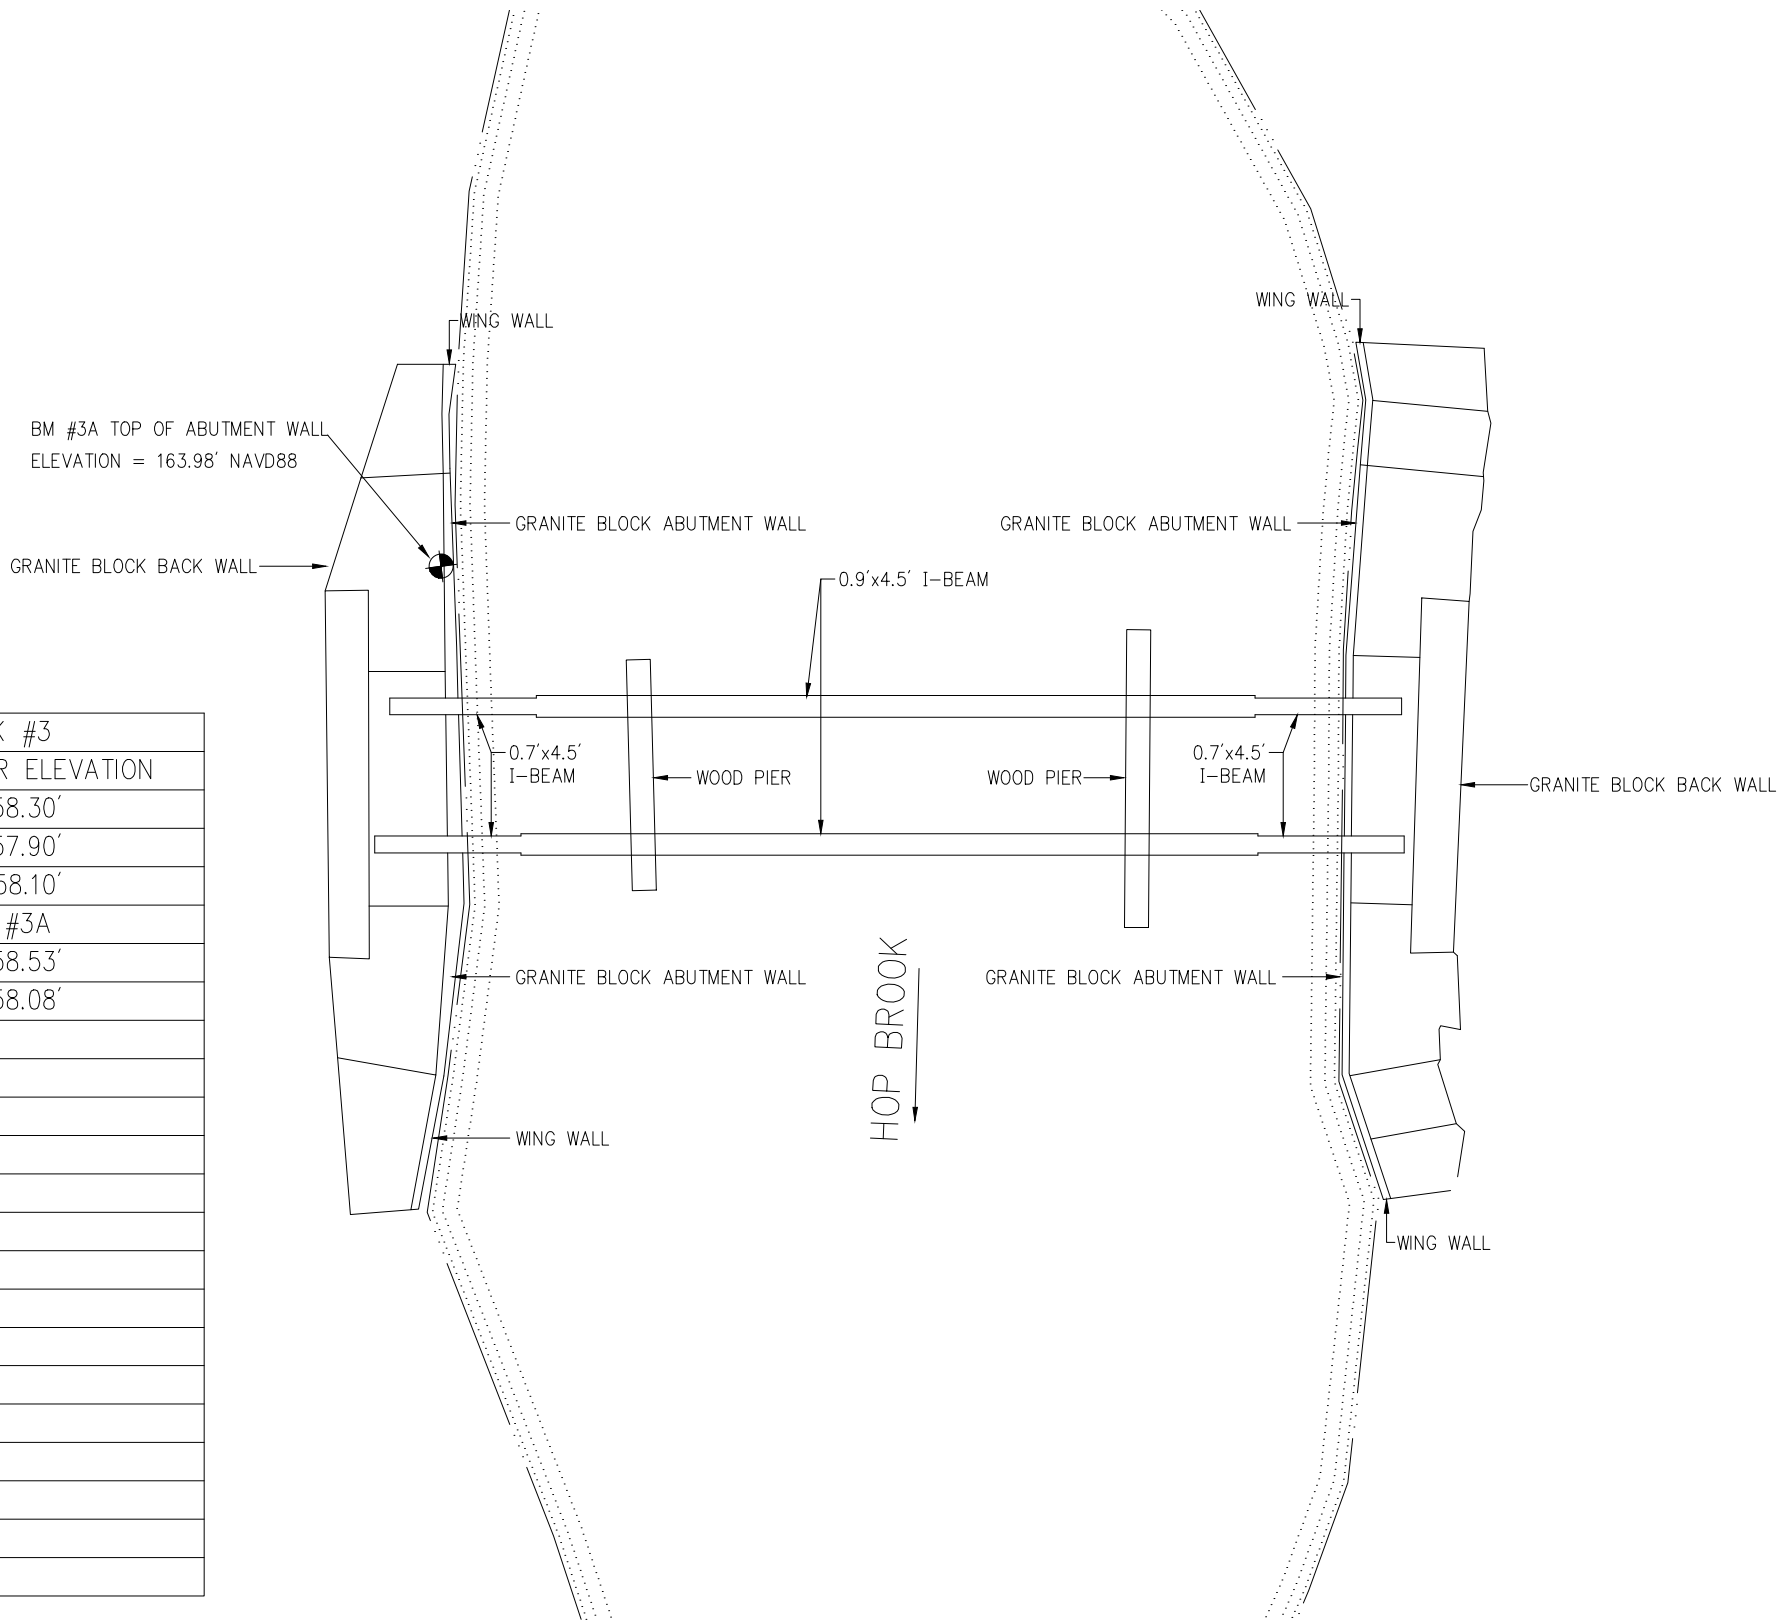
BM #3A TOP OF ABUTMENT WALL
ELEVATION = 163.98' NAVD88

GRANITE BLOCK ABUTMENT WALL
GRANITE BLOCK BACK WALL

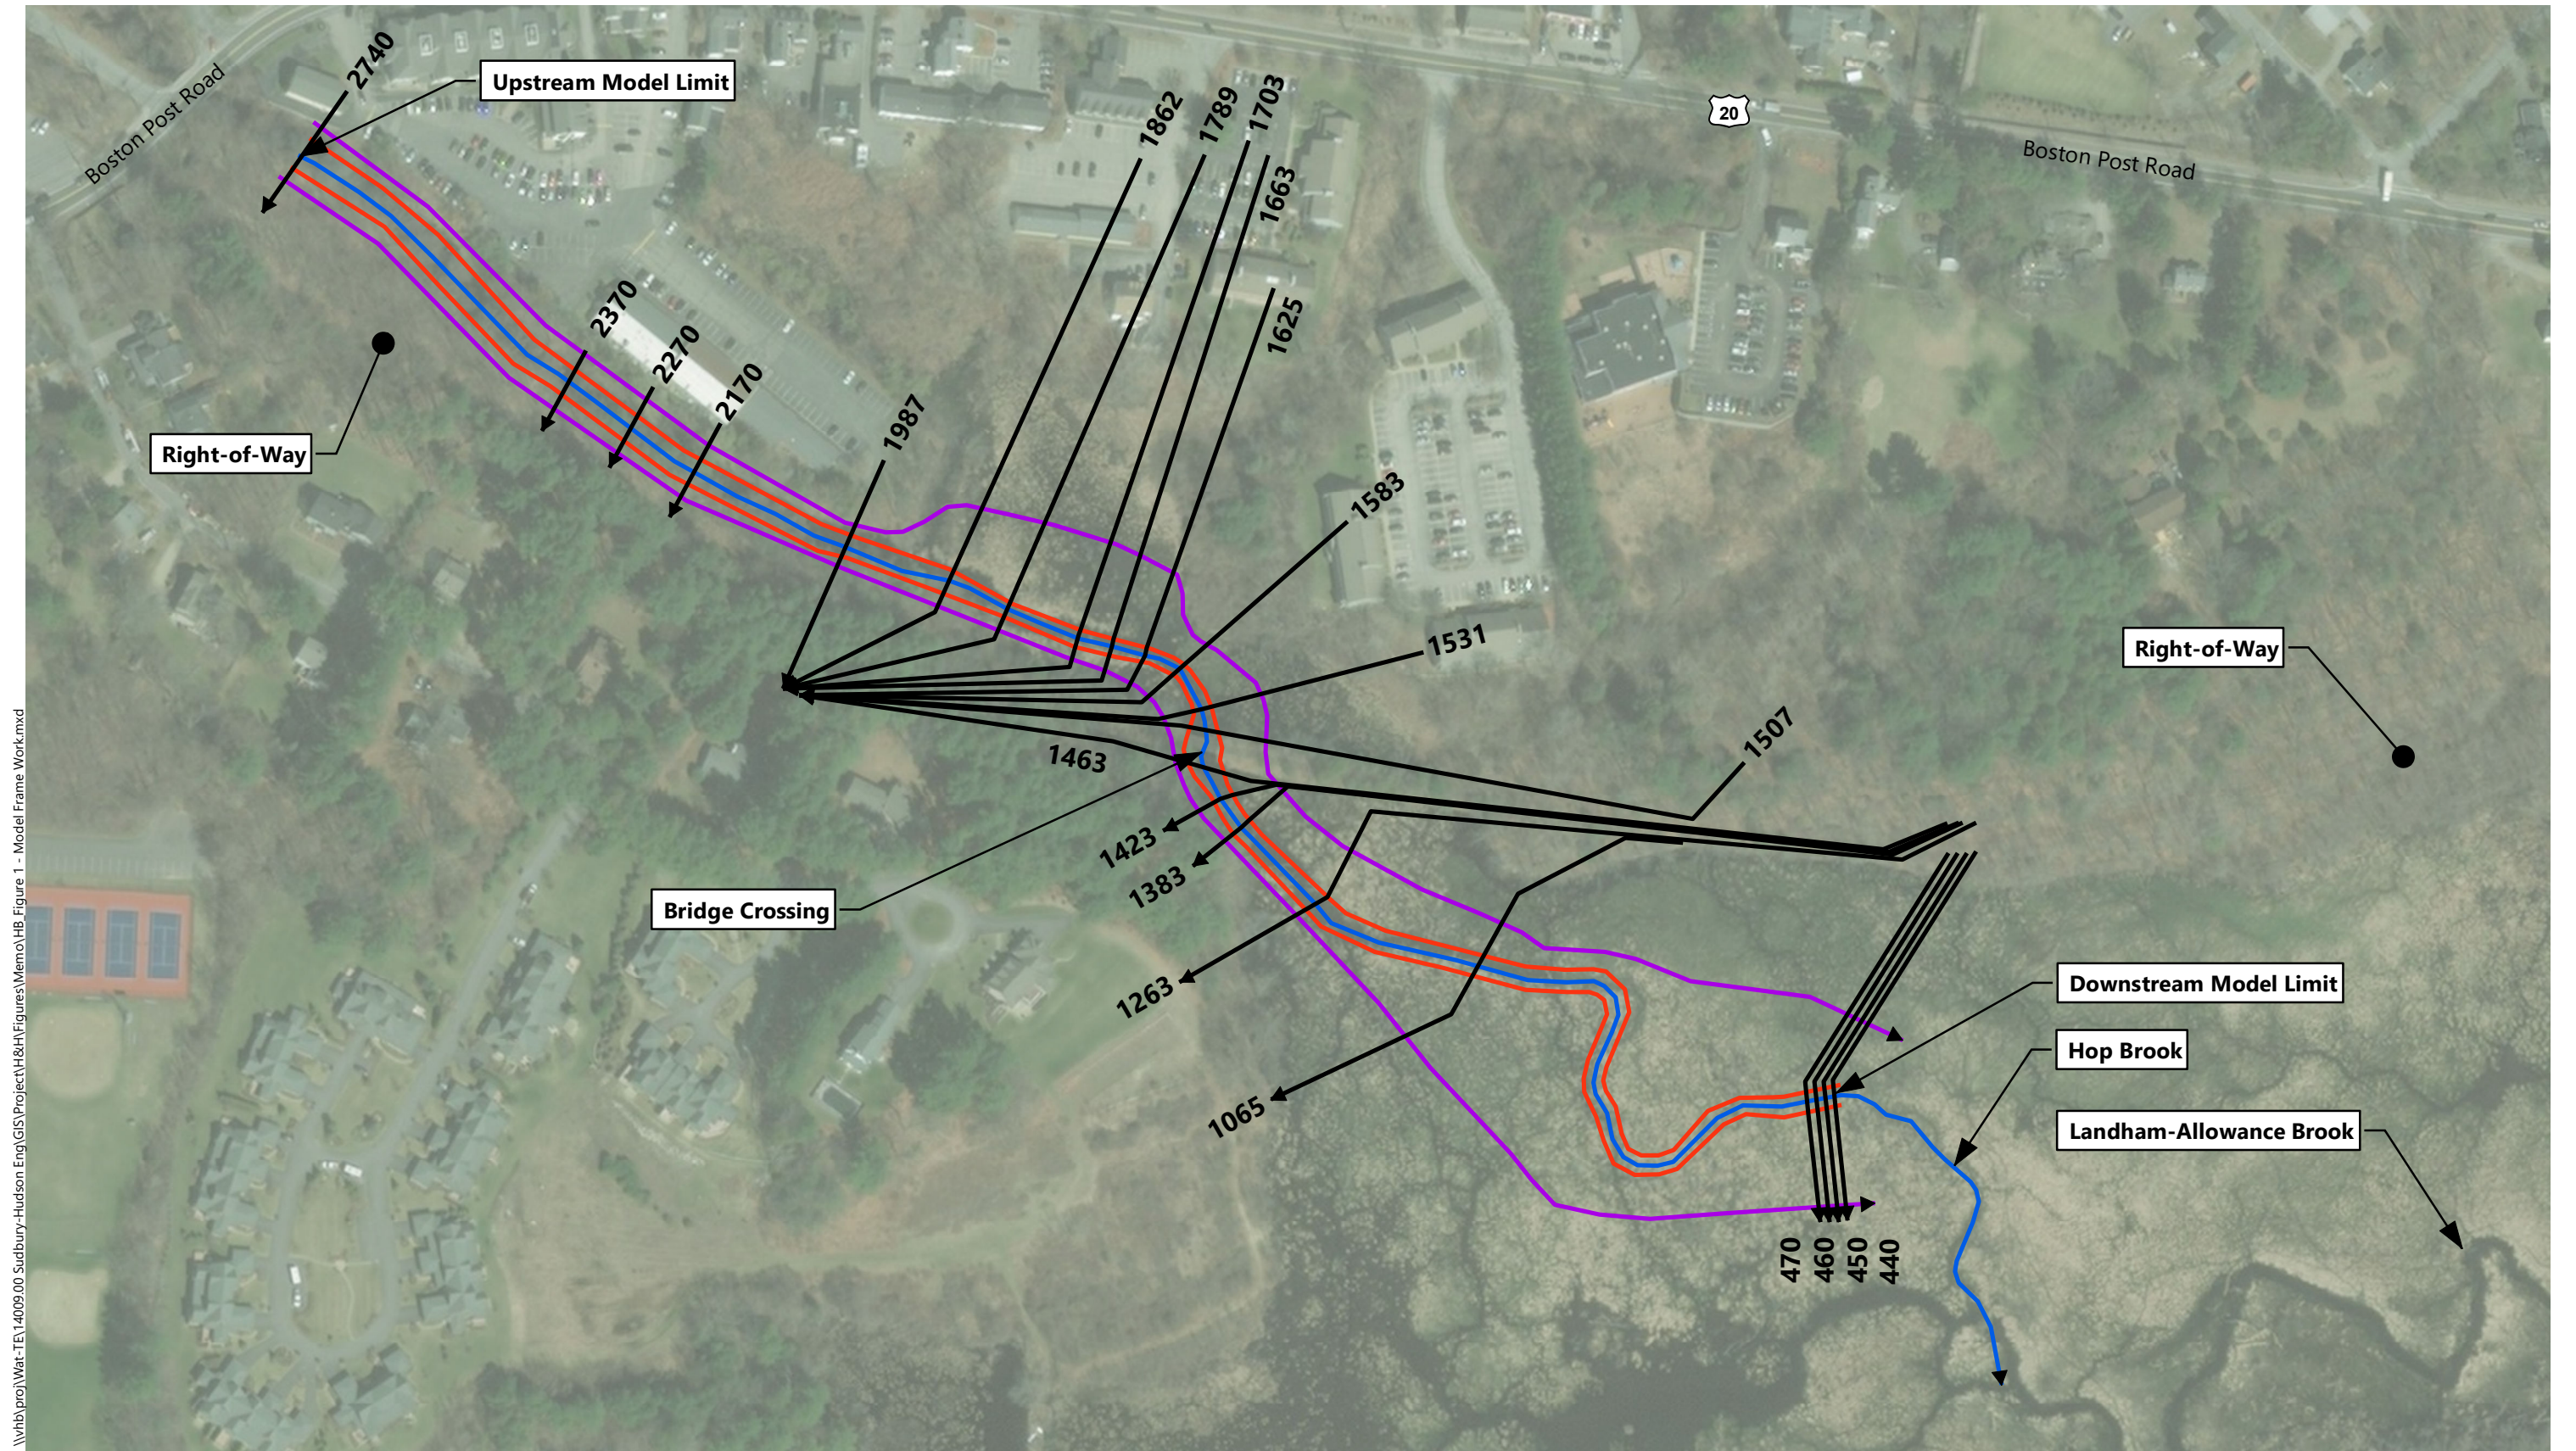
Model Frame Work
Source Info: Google

VHB used the HEC-RAS software (version 5.0.3) to simulate flood profiles along Hop Brook. Figure 1 shows the HEC-RAS model setup. VHB has developed an Corrective Effective model to best represent the existing conditions using:

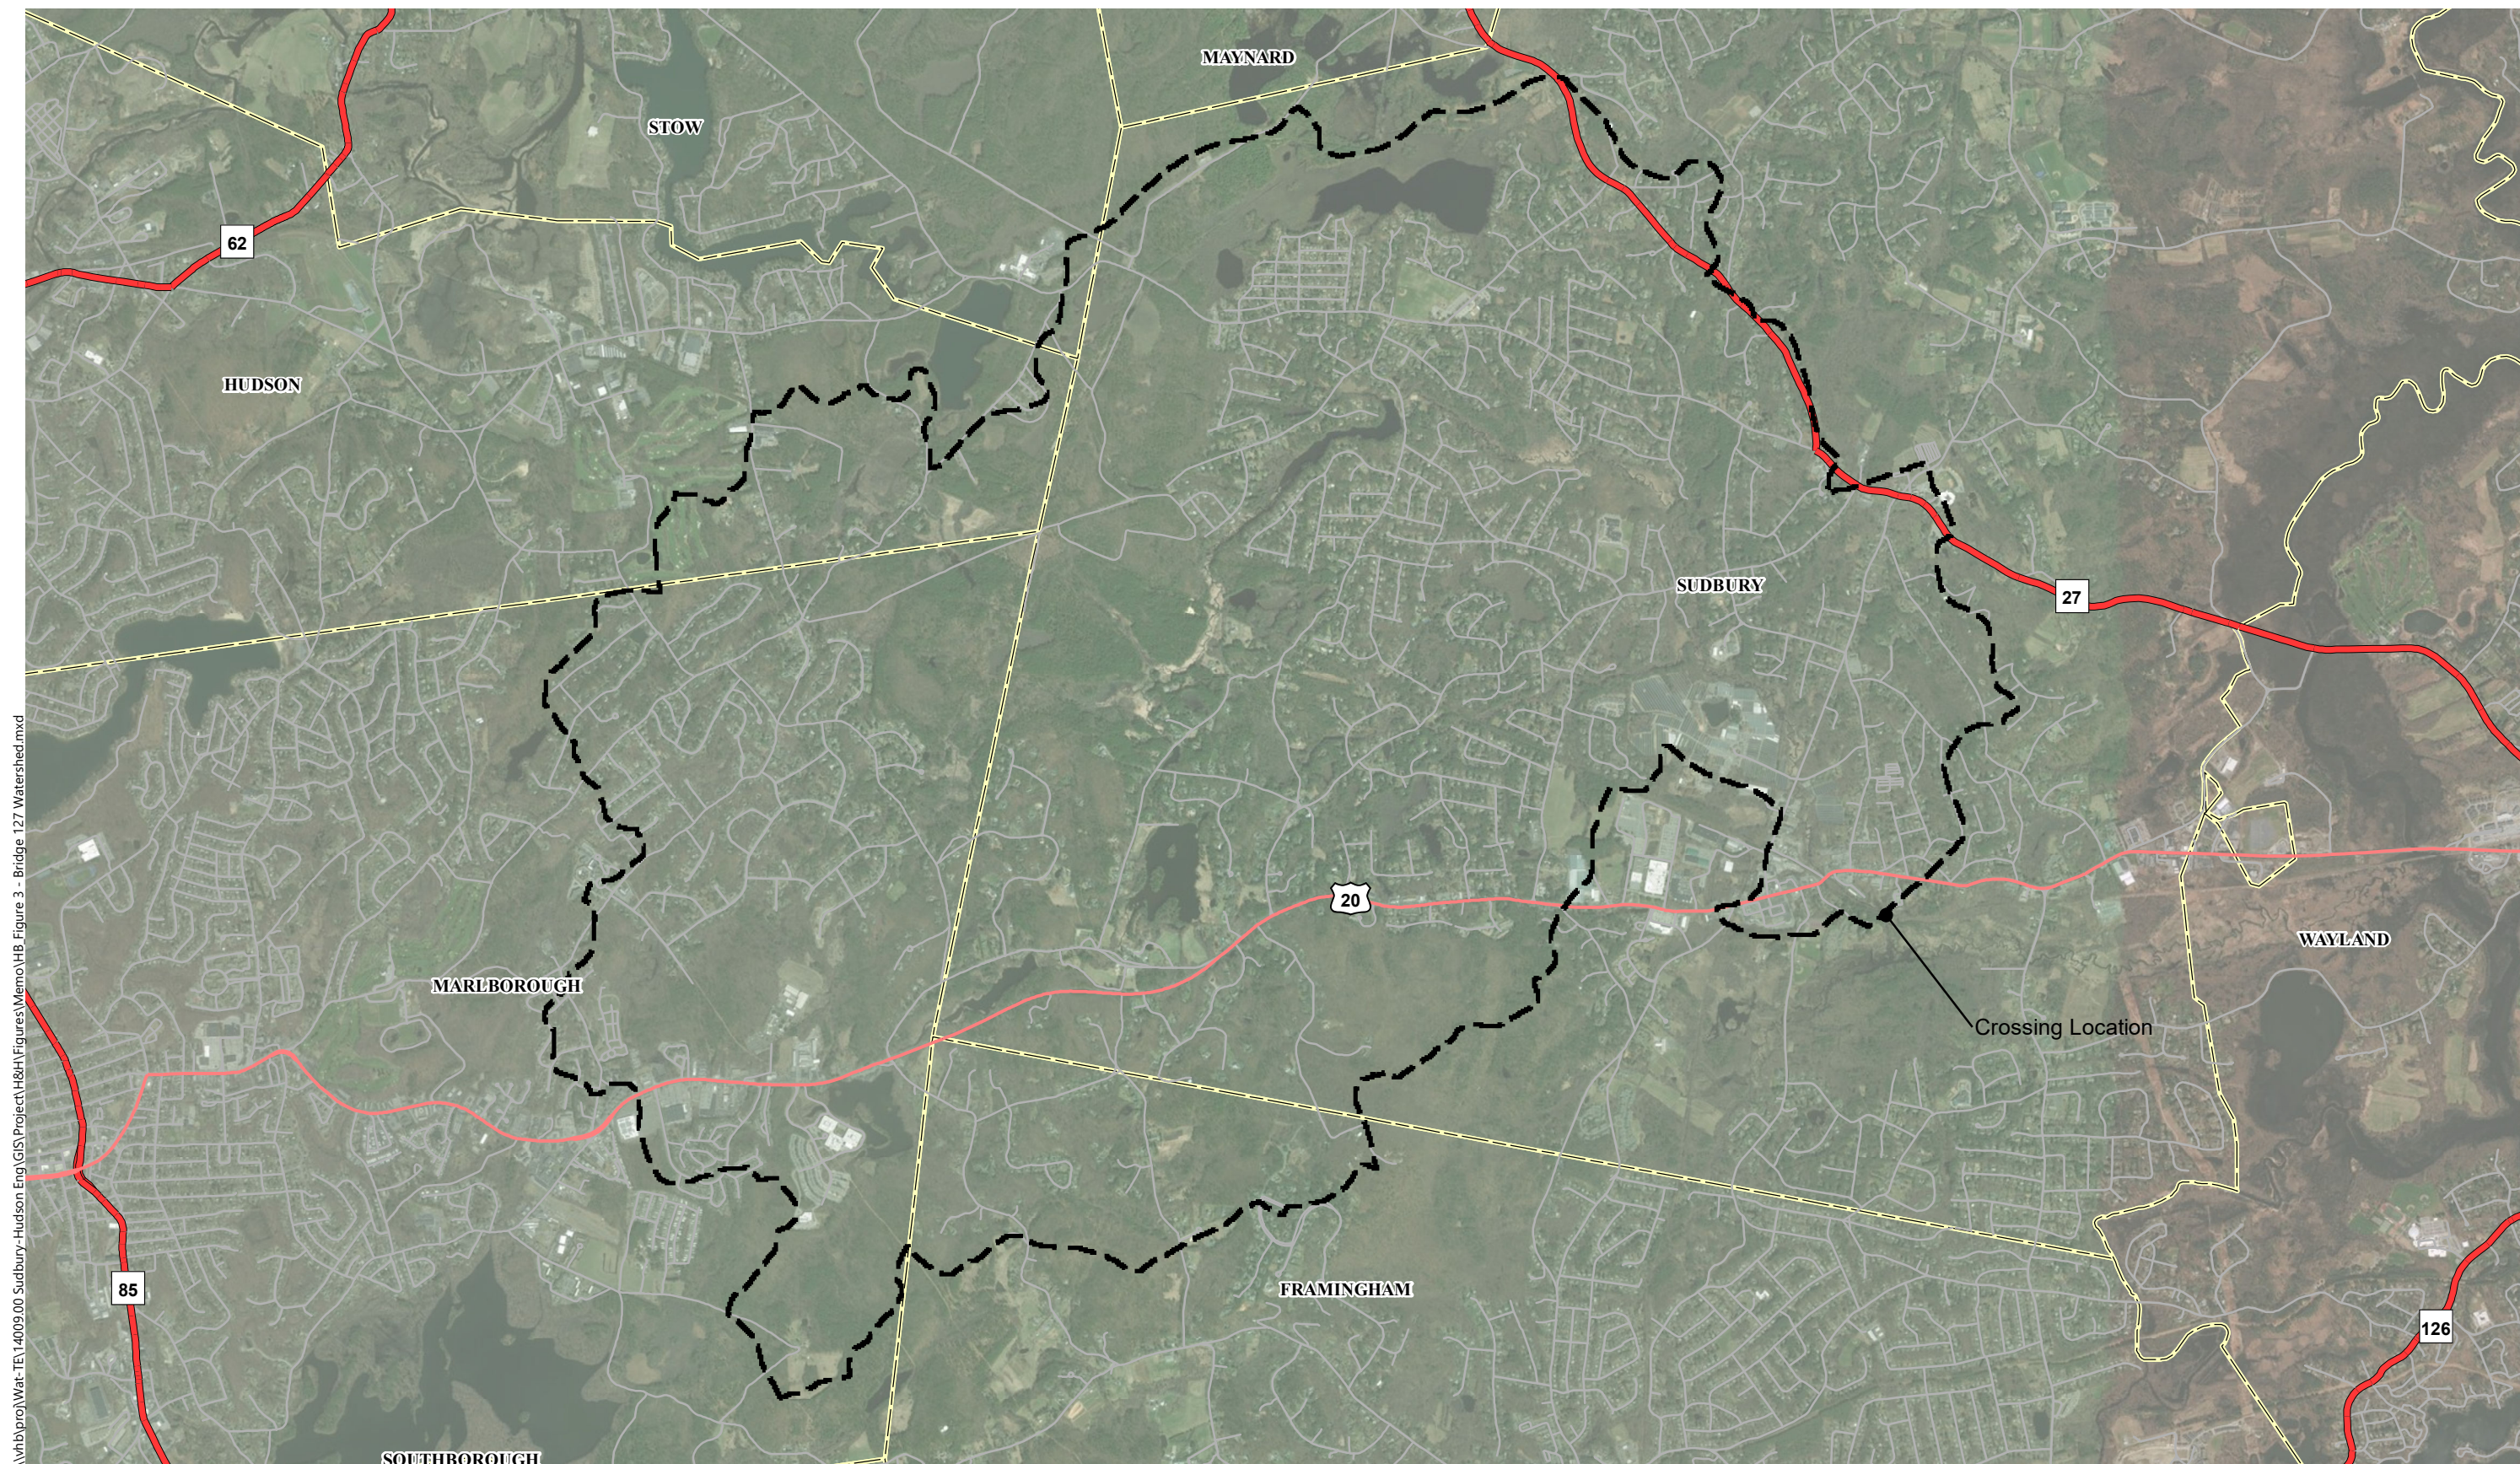
Bridge 127 Watershed
Source Info: Google, NOAA
