Re: MADEP File No. 301-1227
Abbreviated Notice of Resource Area Delineation Response to Comments
Sudbury-Hudson Transmission Reliability Project

Sudbury-Hudson Transmission Reliability Project | Sudbury, Massachusetts

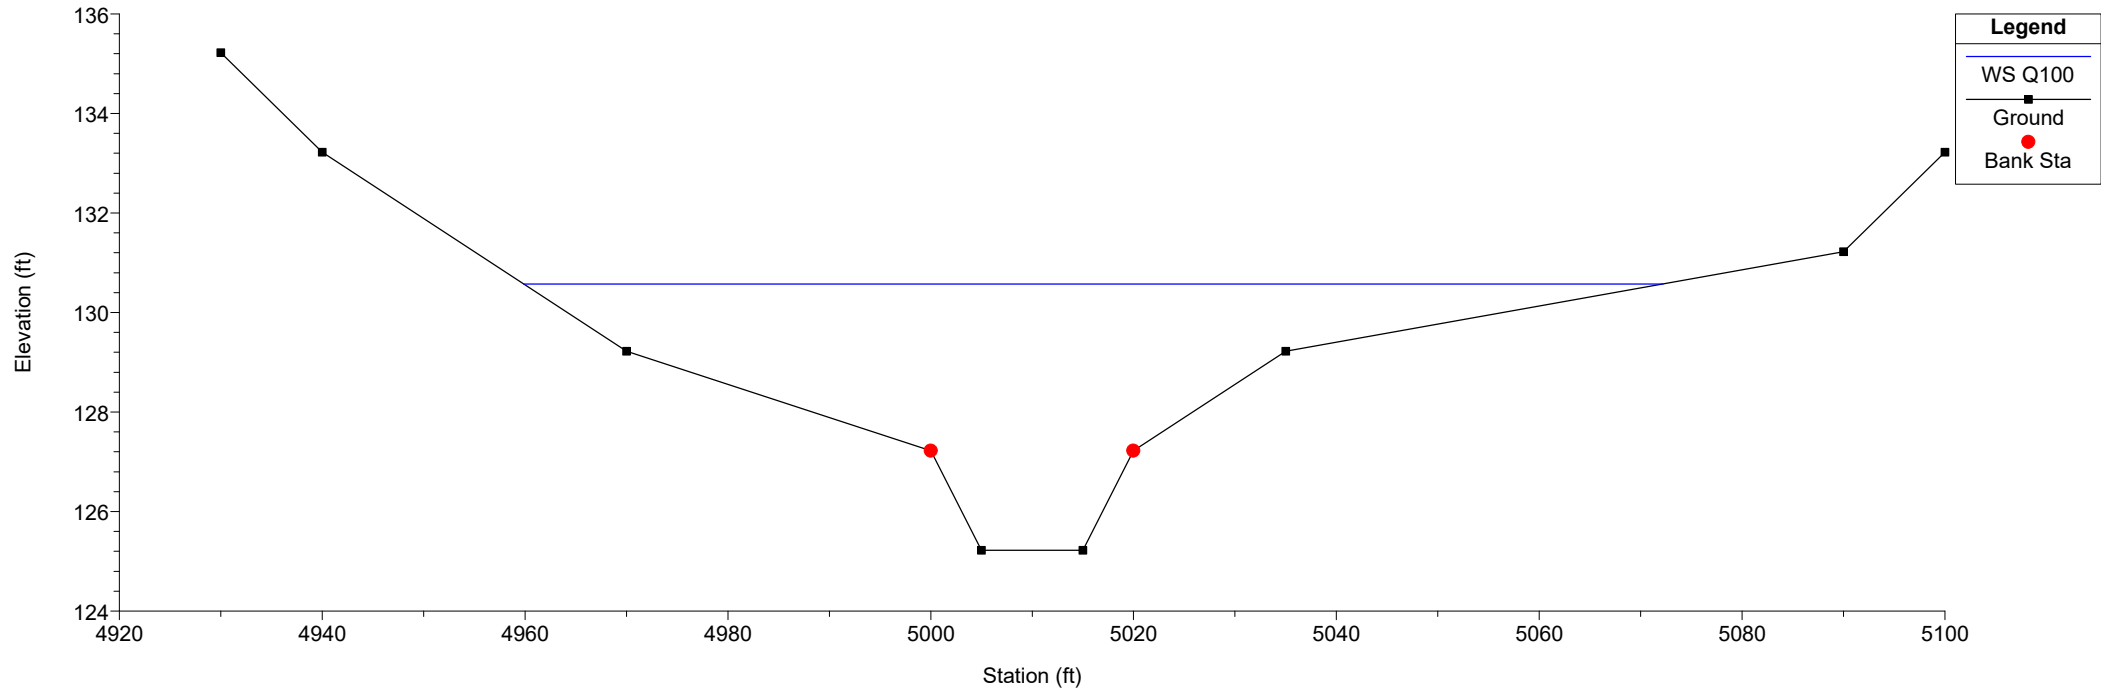
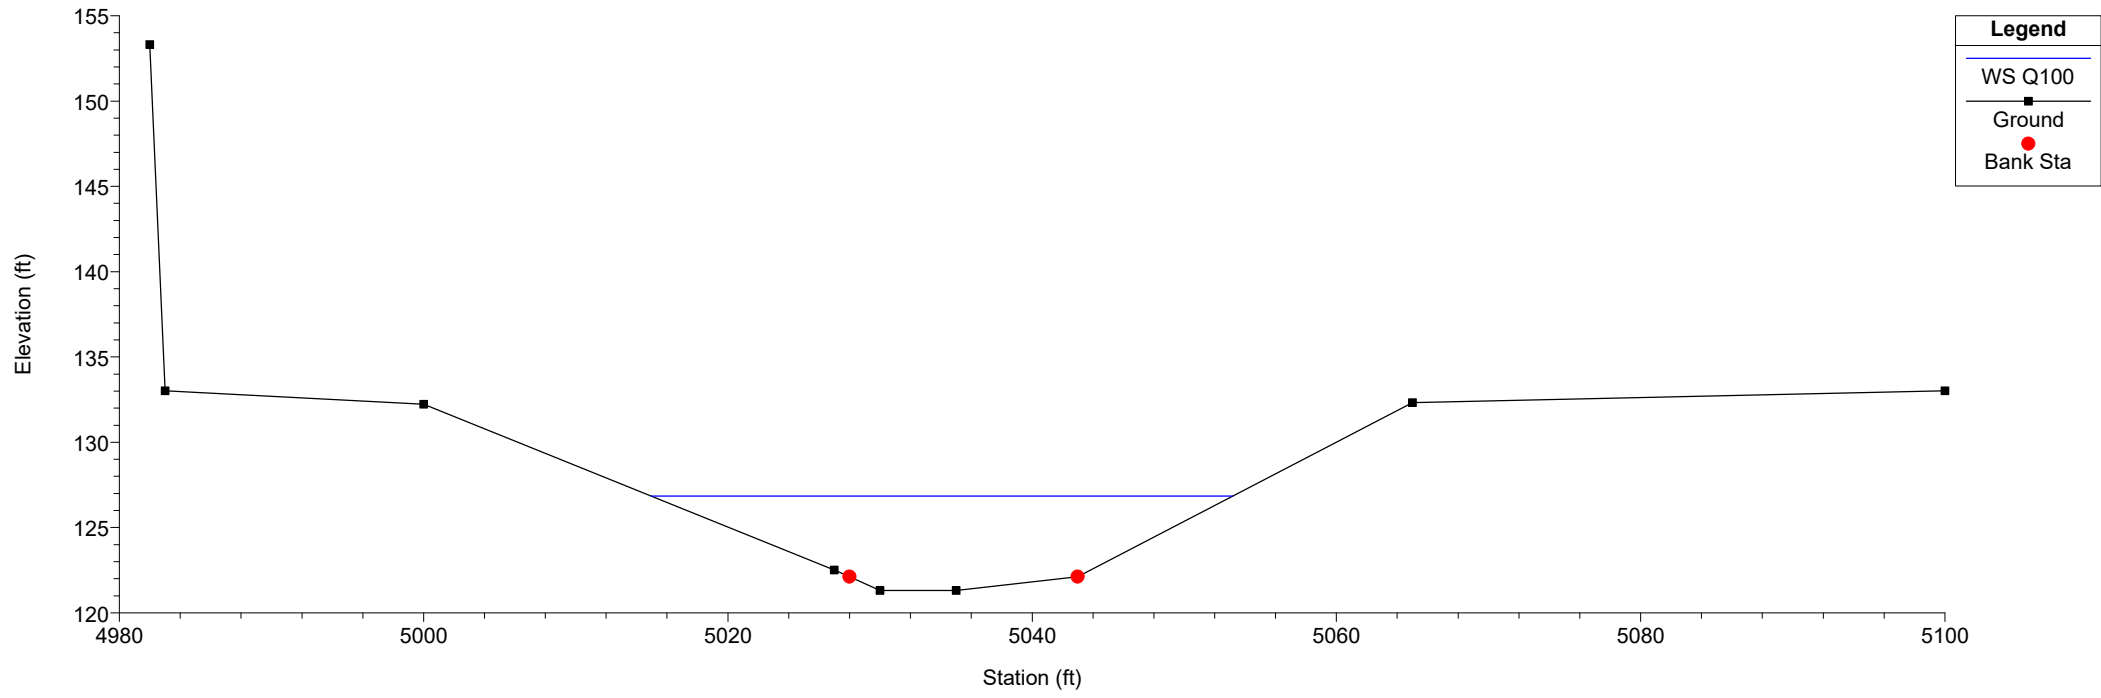
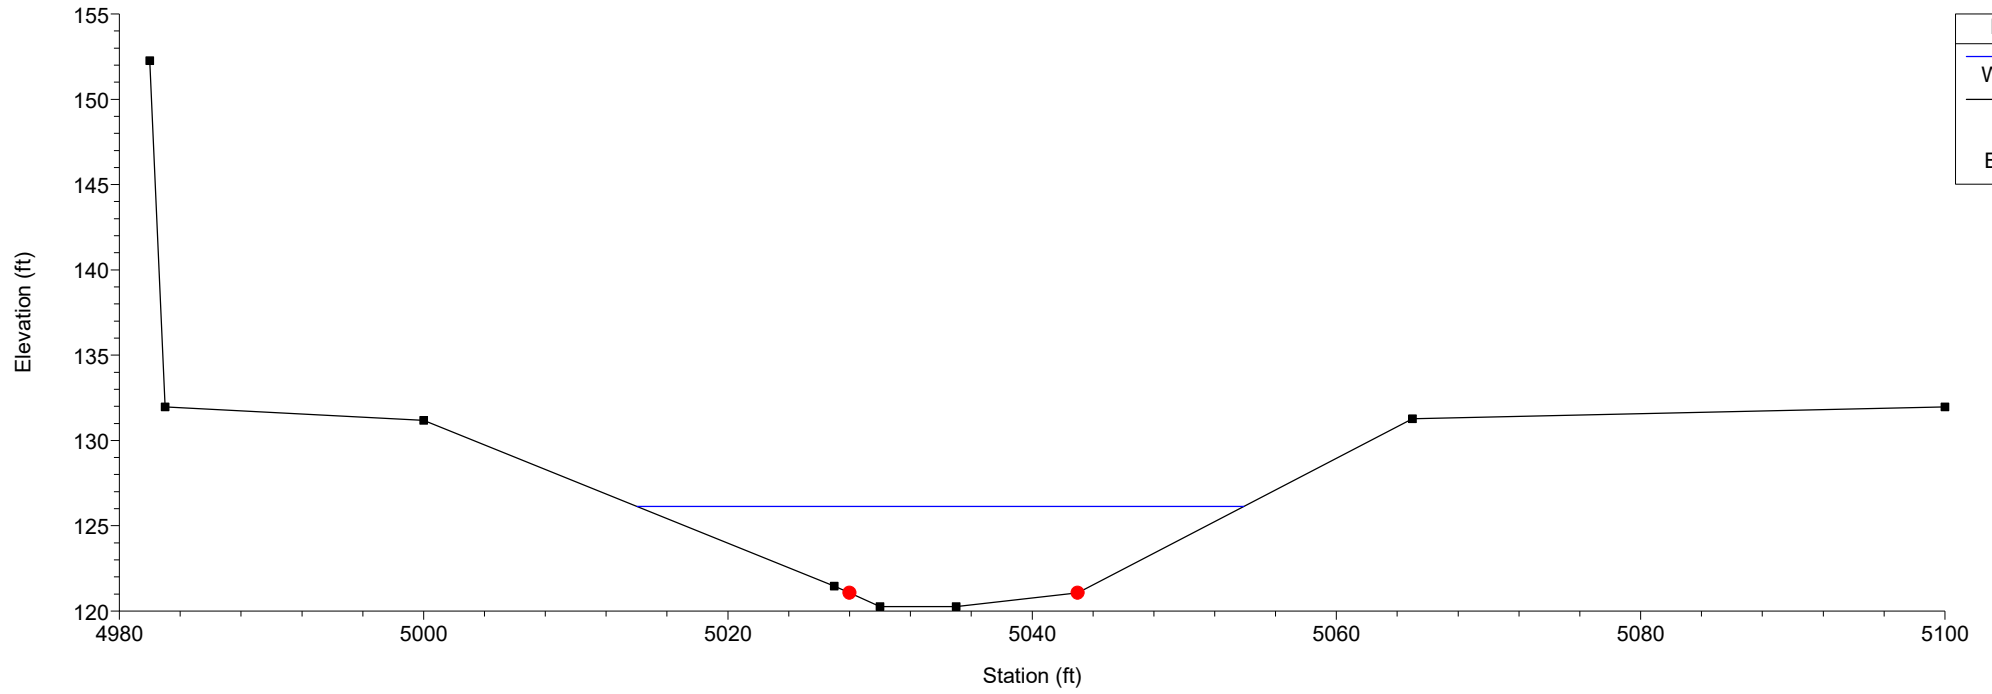
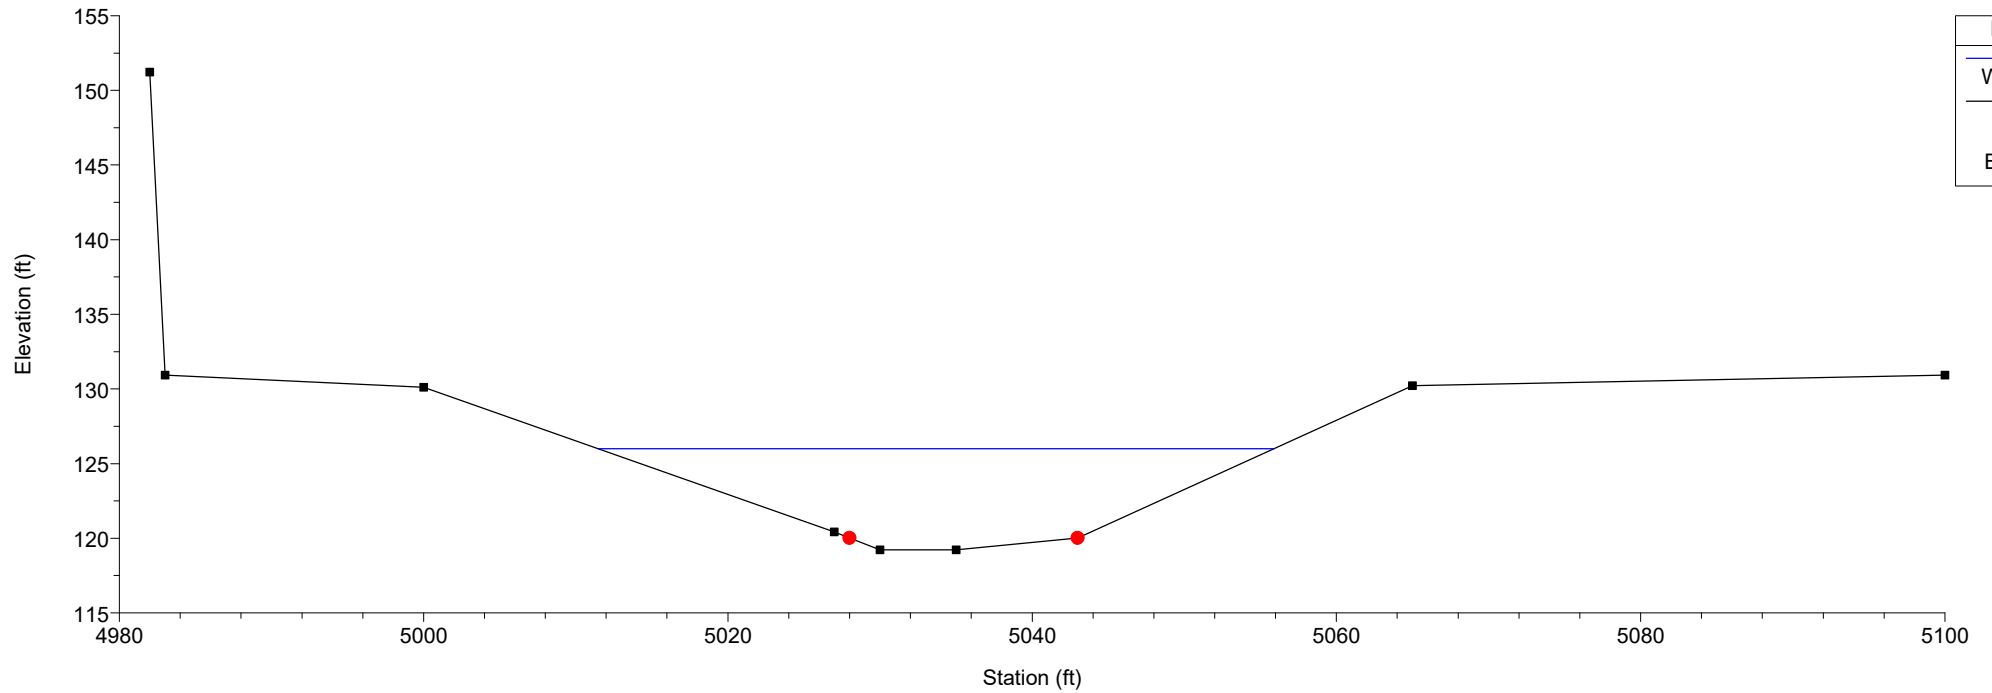
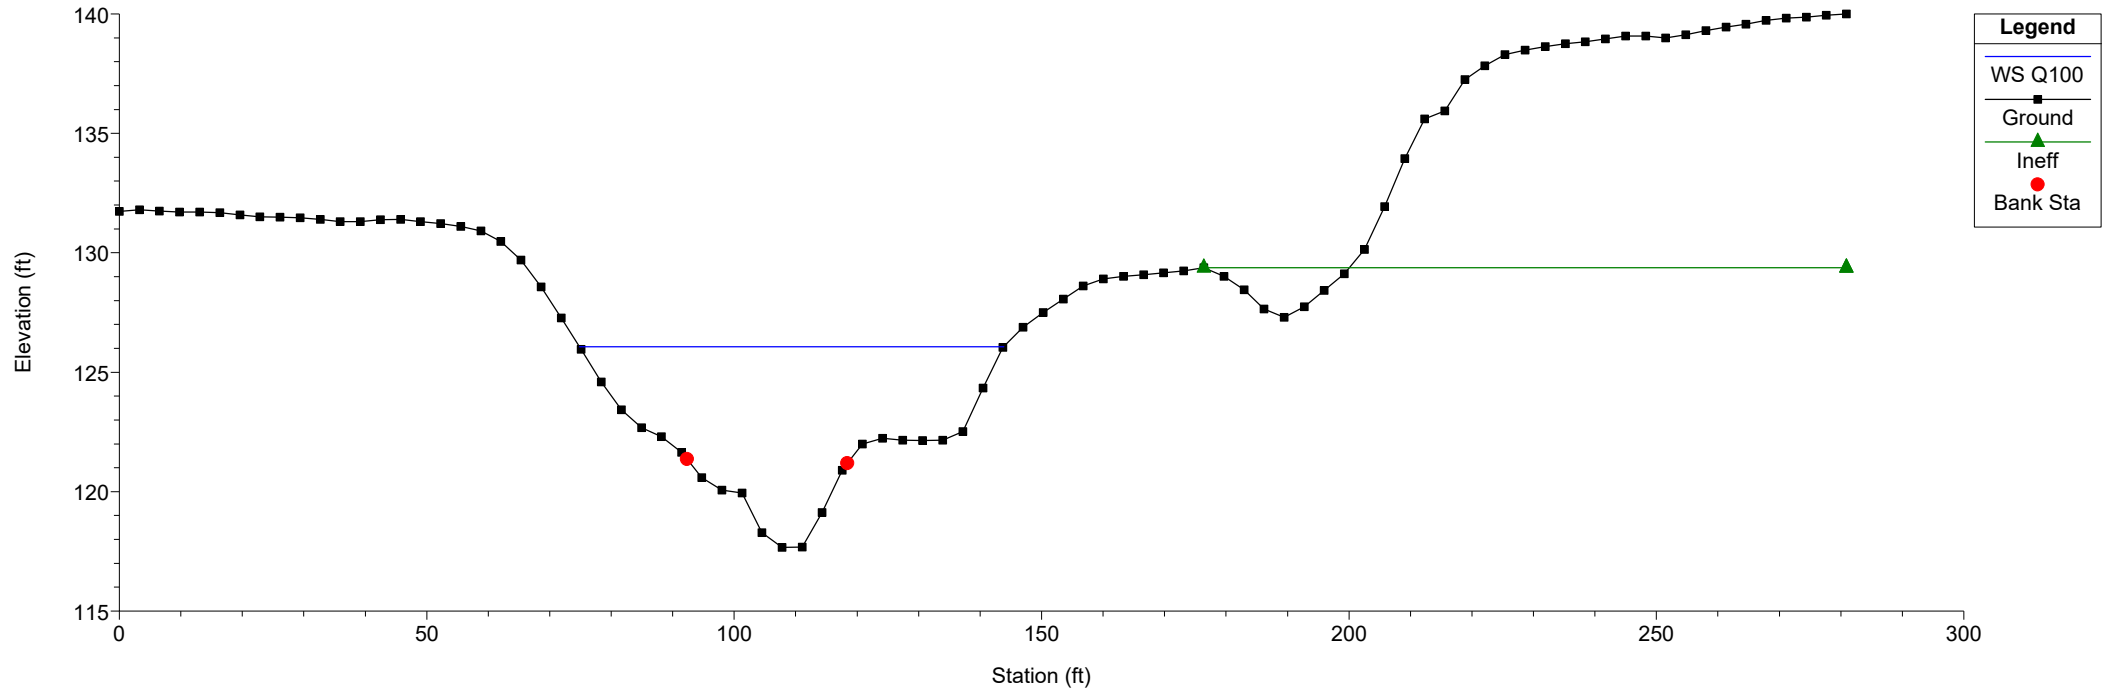
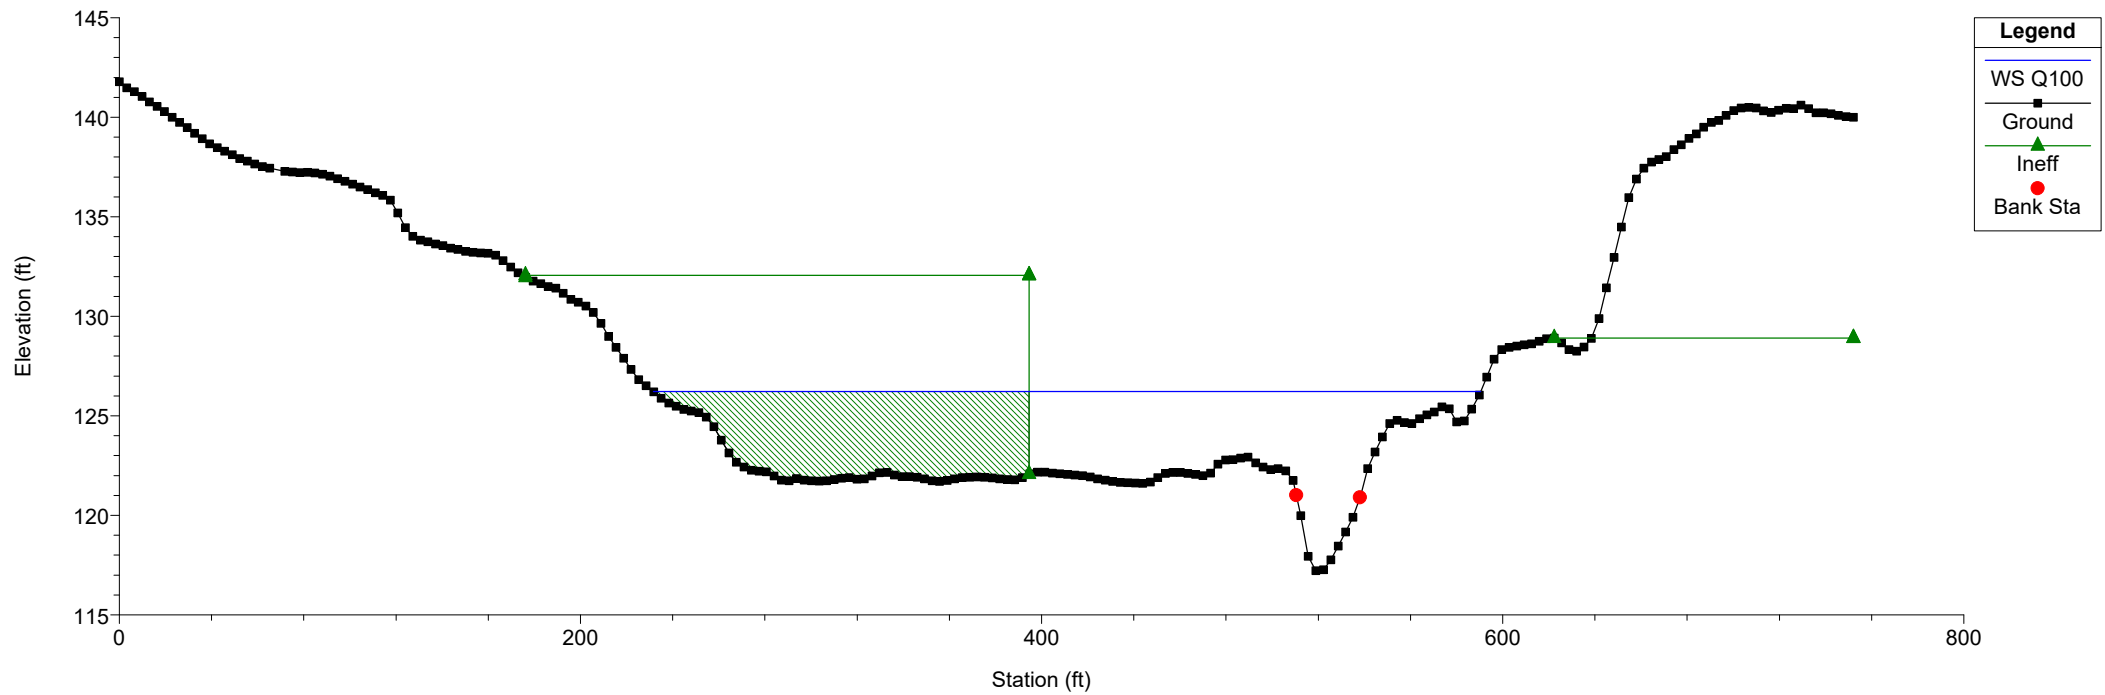
Appendix A: HEC-RAS Cross Sections

HopBrook_BR127 Plan: CorrectedEffective
 RS = 440 XS working upstream from confluence of Hop Brook and Landham-All

The corrected effective model has seven (7) cross-sections from the effective FEMA model. Two (2) cross-sections were added between the two upstream FEMA cross-sections to contribute more detail to the model and more accurately represent existing and proposed conditions. Additional cross-sections were also added from the bathymetric survey of Hop Brook, which was conducted by VHB on February 15, 2018. This survey measured the top of slope elevation of each bank, bottom of slope elevation of each bank, and the elevation of the center of the river along fourteen (14) cross-sections of Hop Brook. The most upstream cross-section is located approximately 500 feet upstream of Bridge 127, and the most downstream cross-section is located approximately 220 feet downstream of Bridge 127. Thirteen (13) of the fourteen (14) surveyed cross-sections were used in the Corrected Effective model. Altogether, there is a total of twenty-two (22) cross-sections in the Corrected Effective model.
