General Wildlife Habitat Assessment Report

Bruce Freeman Rail Trail Sudbury, Massachusetts

Wildlife Habitat Assessment Relative to the 25% Design Submittal dated November 2016

April 8, 2020

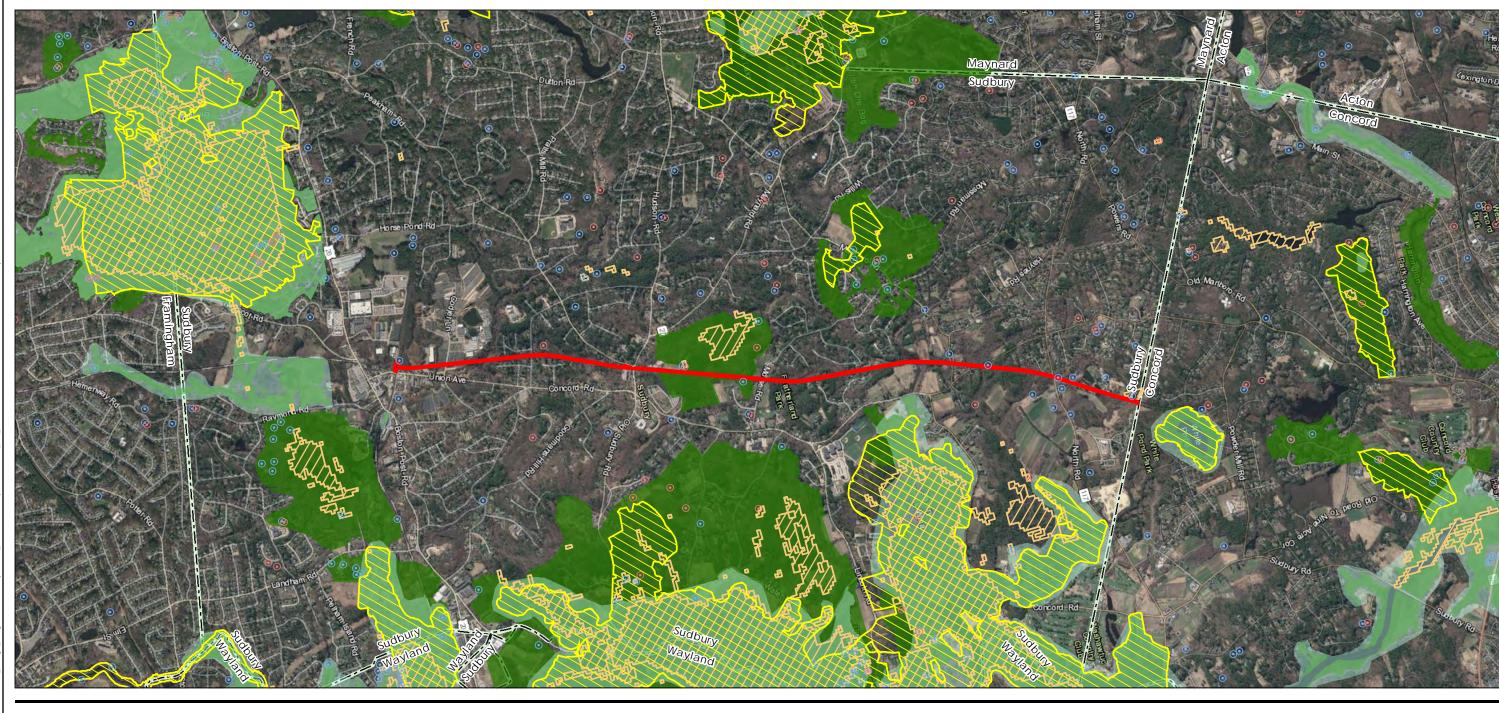
2a

Natural Resources Data Review National Heritage Resources

BioMap2 Core Habitat² (for Species of Conservation Concern) as mapped by the NHESP occurs between Hudson Road (Route 27) and Morse Road (Figure 2a). The Project is not mapped as BioMap2 Critical Natural Landscape, which can overlap with BioMap2 Core Habitat. BioMap2 is intended as a strategic conservation planning tool designed by the by the Massachusetts Department of Fish and Game and Massachusetts Nature Conservancy in 2010 to guide strategic biodiversity conservation to focus land protection and stewardship on areas most critical for ensuring long-term persistence of rare and native species and their habitats, exemplary natural communities, and a diversity of ecosystems and includes
