Massachusetts Department  
of Transportation

Bruce Freeman Rail  
Trail – 25% Design

Vernal Pools & Wildlife Habitat

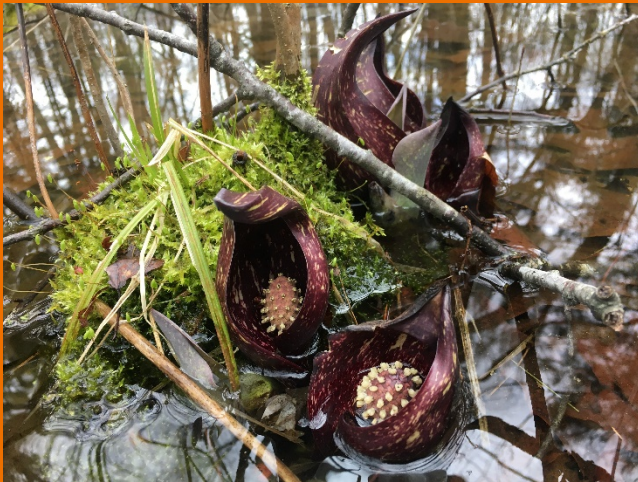
- Refer to Stantec 2018 Vernal Pool memo
- VHB conducted surveys (2015 & 2017)
  - 19 vernal pools
- Stantec conducted survey (2018)
  - 22 vernal pools
- 2009 NHESP VP Certification Guidelines

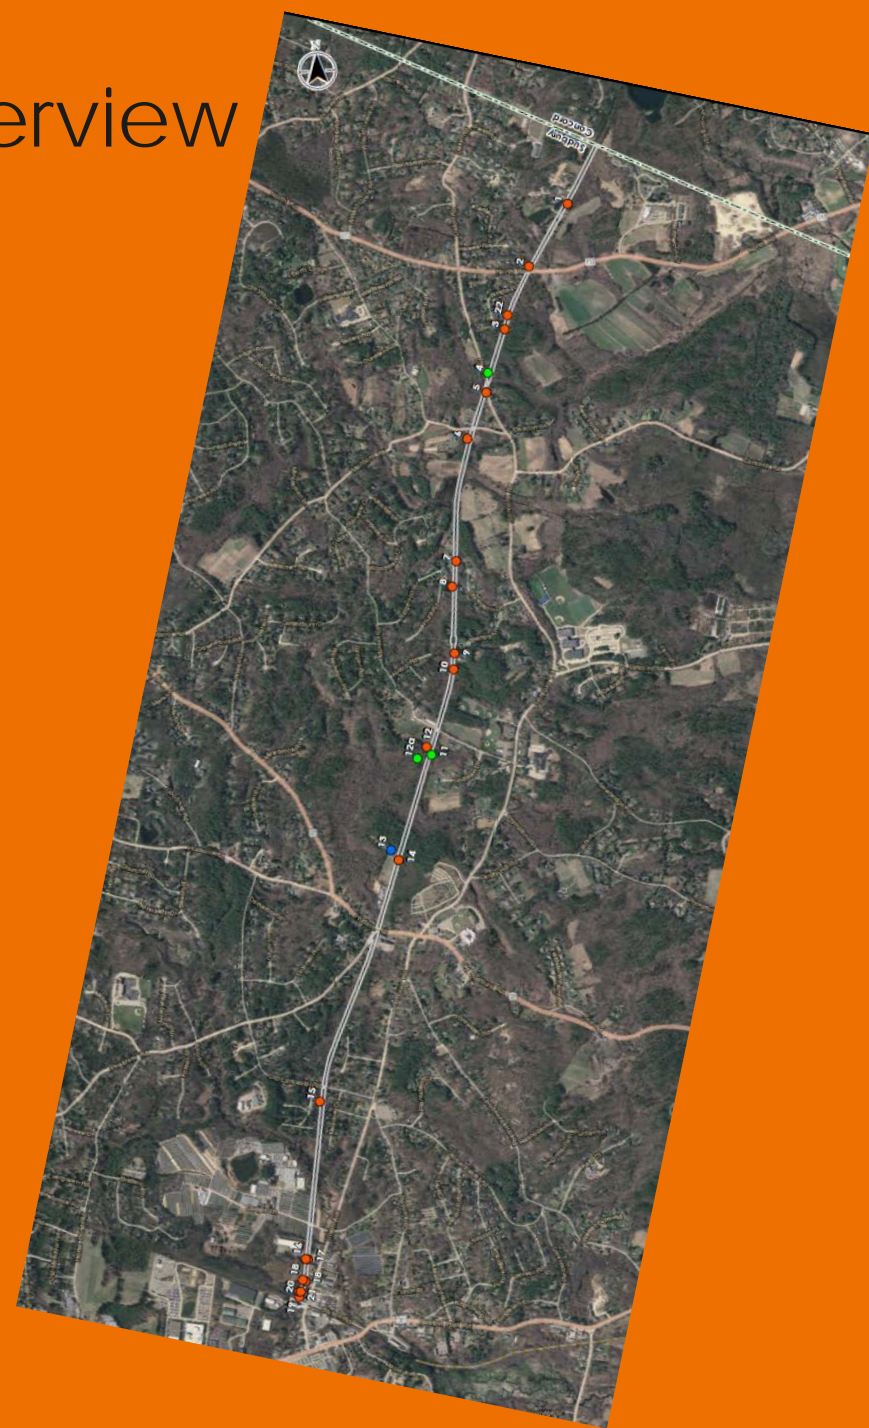
# Vernal Pools Summary

- Vernal pools surveyed 2015, 2017, & 2018
- PVPs 4, 11, 12a, & 16; and CVP 13 meet NHESP criteria in  $\geq 1$  years (green symbol)
- SVP 9; PVPs 17 & 20 may meet town bylaw criteria

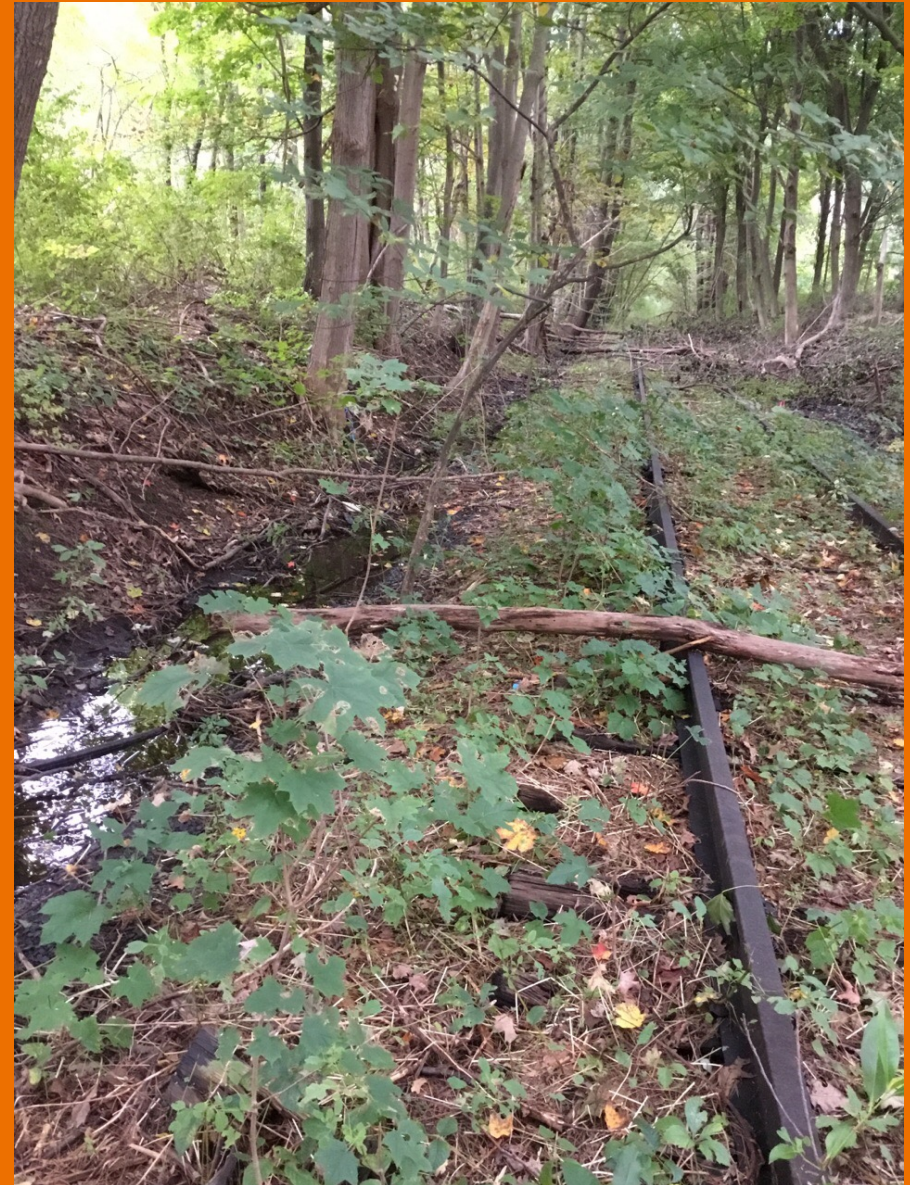
- <5,000 sf BVW
- 10% on single lot or >50 lf of Bank
- 10% on single lot or <5,000 sf BLSF
- Previously Developed Riverfront exempt; however, assessed due to importance to wildlife

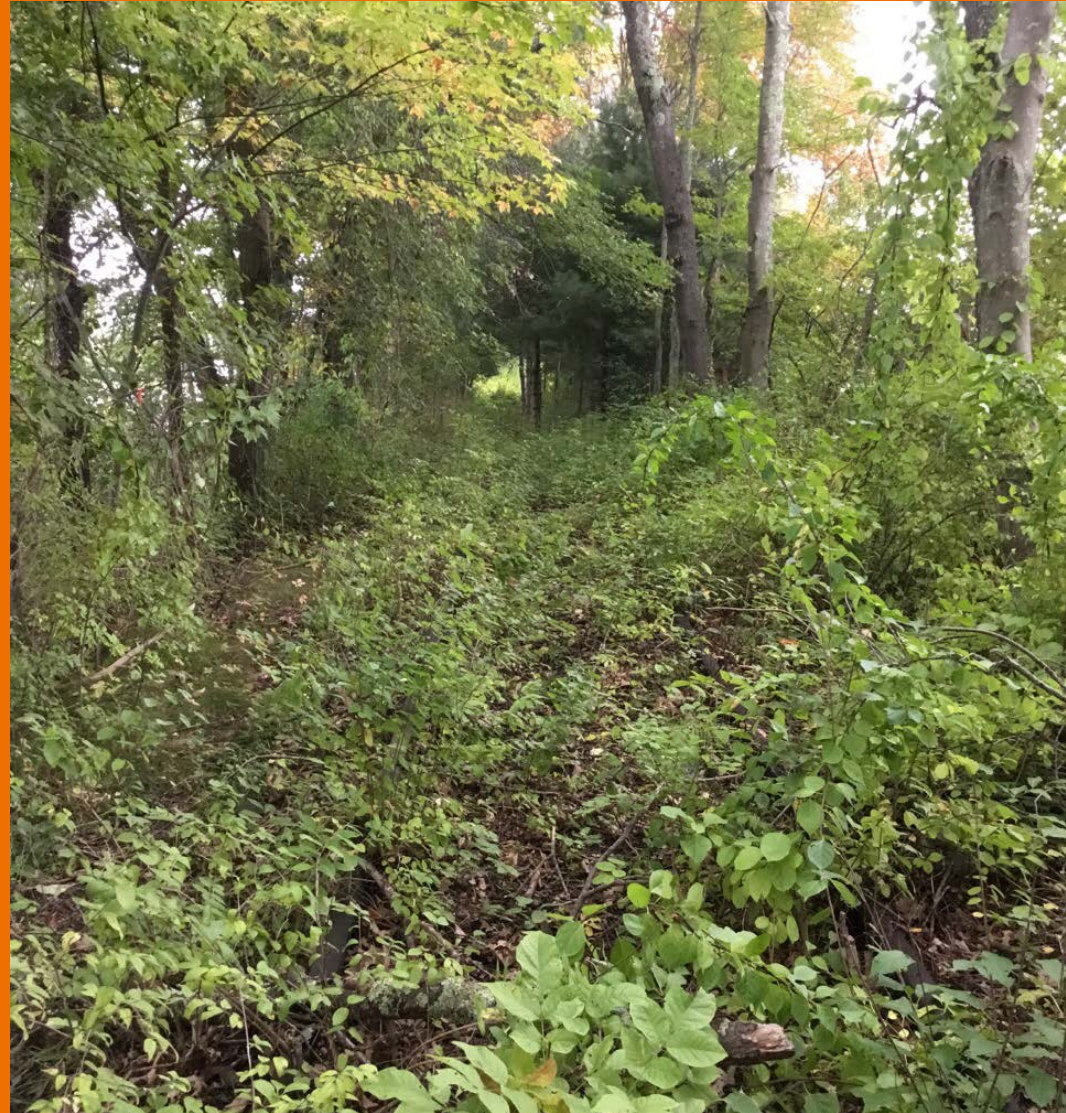
# Wildlife Habitat Evaluation - Impacts

Proposed resource area impacts:

- Bordering Vegetated Wetlands (~4,681 sf)
- Bank (~1,752 lf)
- Bordering Land Subject to Flooding (~76 cy cut & fill)
- Riverfront (previously developed); Hop Brook and unnamed tributary, & Pantry Brook

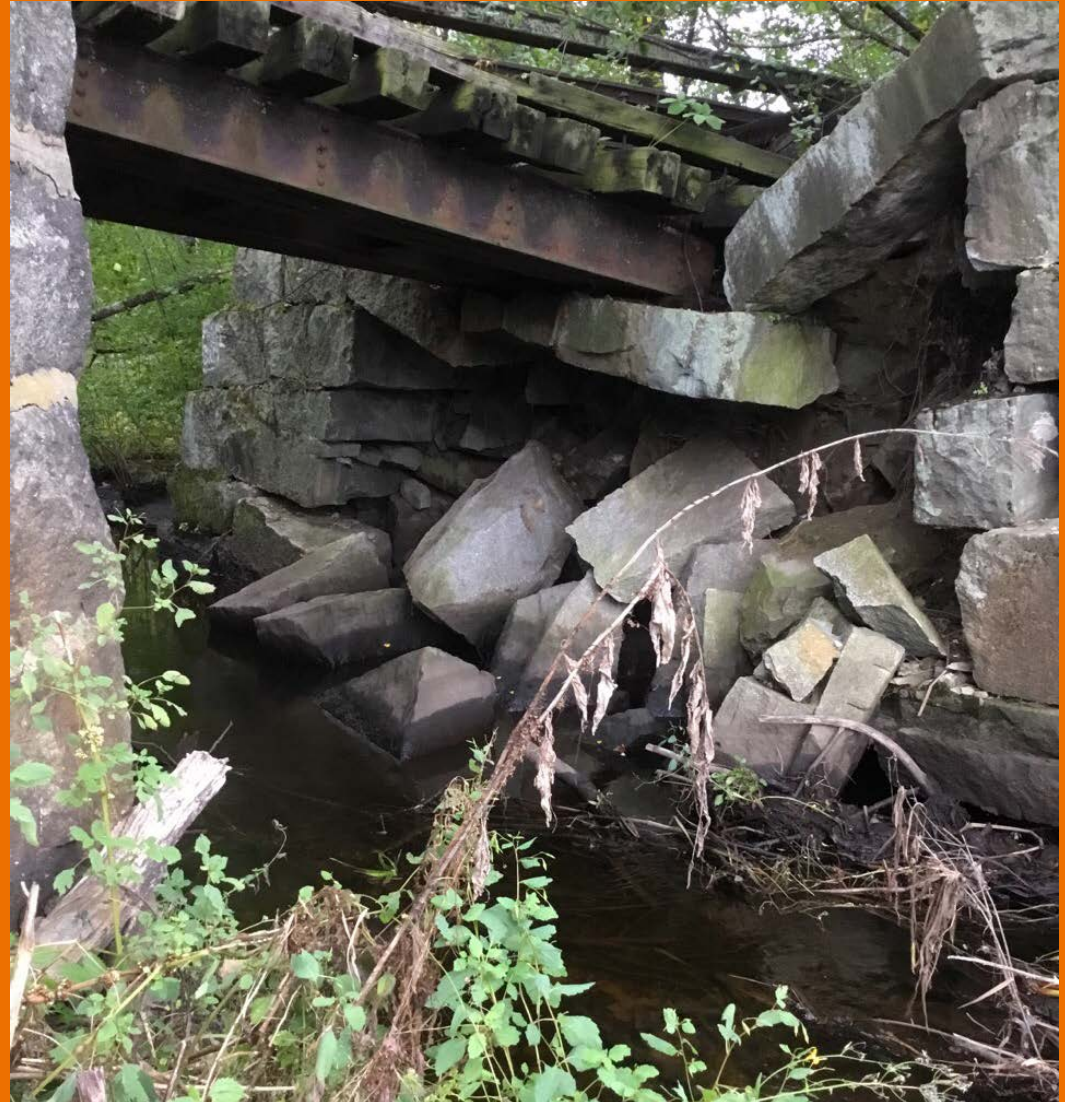
# Wildlife Habitat Evaluation - Results

- Suburban setting
- Adjacent land uses: residential, open space, commercial, & agricultural
- Track, wooden ties, & ballast visible along much of ROW
- Invasive plant species
- Areas of potential encroachment
- Regional/statewide common natural communities & wildlife

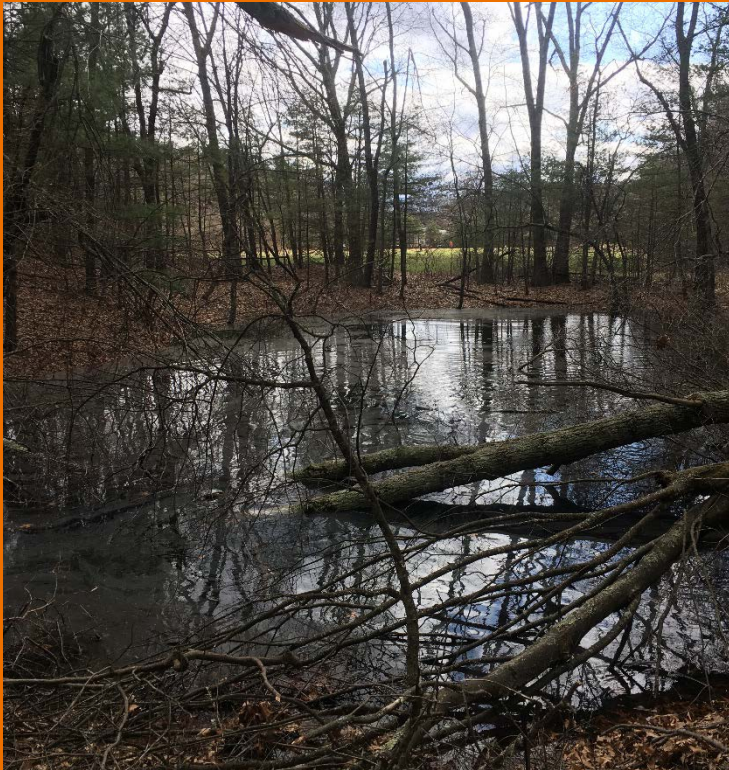
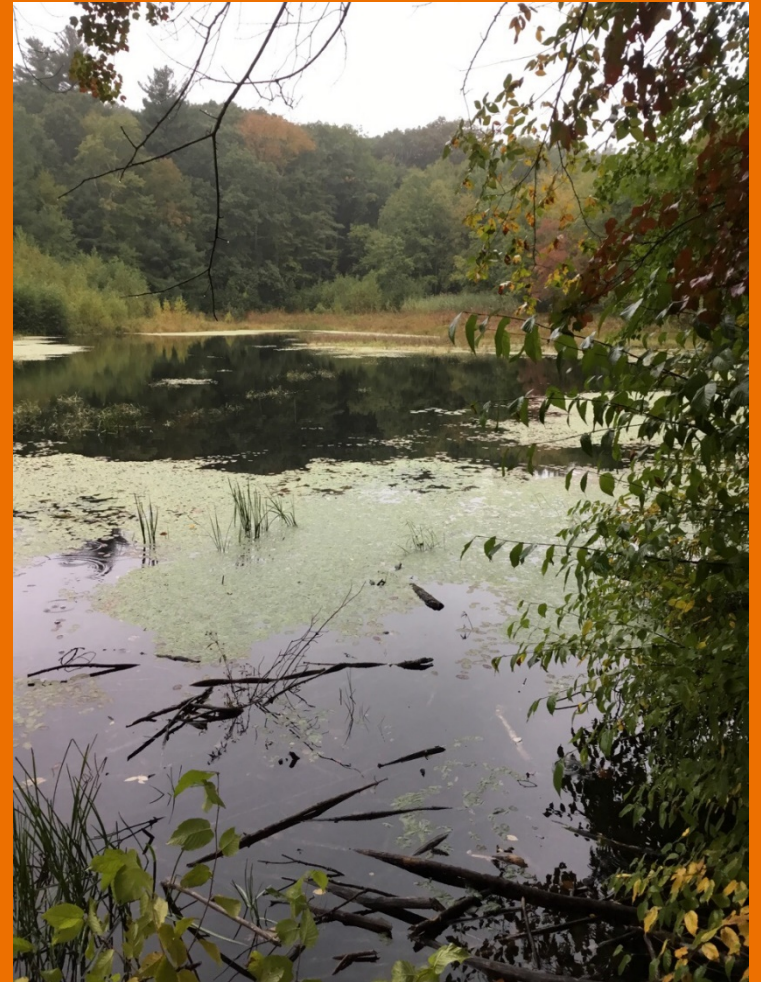
- Coldwater Fisheries Resources: Hop Brook & unnamed tributary
- CVP 1428/CVP #13 (>100 ft from ROW)
- CAPS important habitat: near town line

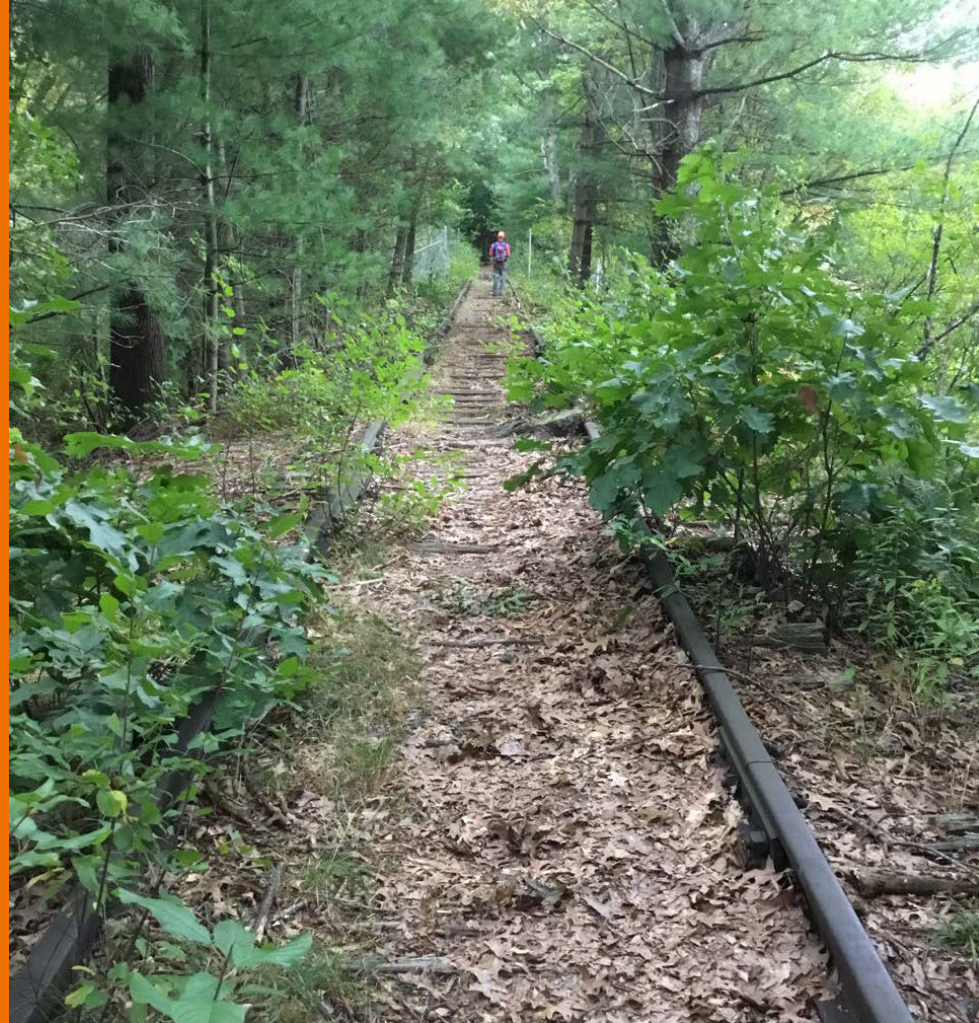
- Locate disturbance to ROW / strategic siting of project elements
- BMPs to protect resource areas
- Use native species at disturbed areas
- MA stream crossing standards
- Wildlife crossing structures (e.g. reuse cattle crossings & permeable barriers)
- Girdle trees / create brush piles
- Full cutoff lens direct lighting
- Educational signage / pet leash & waste
