Re: Old Sudbury Road Culvert Replacements NOI  
Response to Comments

TO: Arthur Allen, EcoTec, Inc.  
PREPARED BY: Daniel Pasquale & Kevin Trainor, Woodard & Curran  
REVIEWED BY: Scott Salvucci, Woodard & Curran  
DATE: February 18, 2021 (revised March 30, 2021)  
RE: Old Sudbury Road Culvert Replacement (#110 & #149) – Hydraulic Analysis

# OLD SUDBURY ROAD CULVERT #149 REPLACEMENT

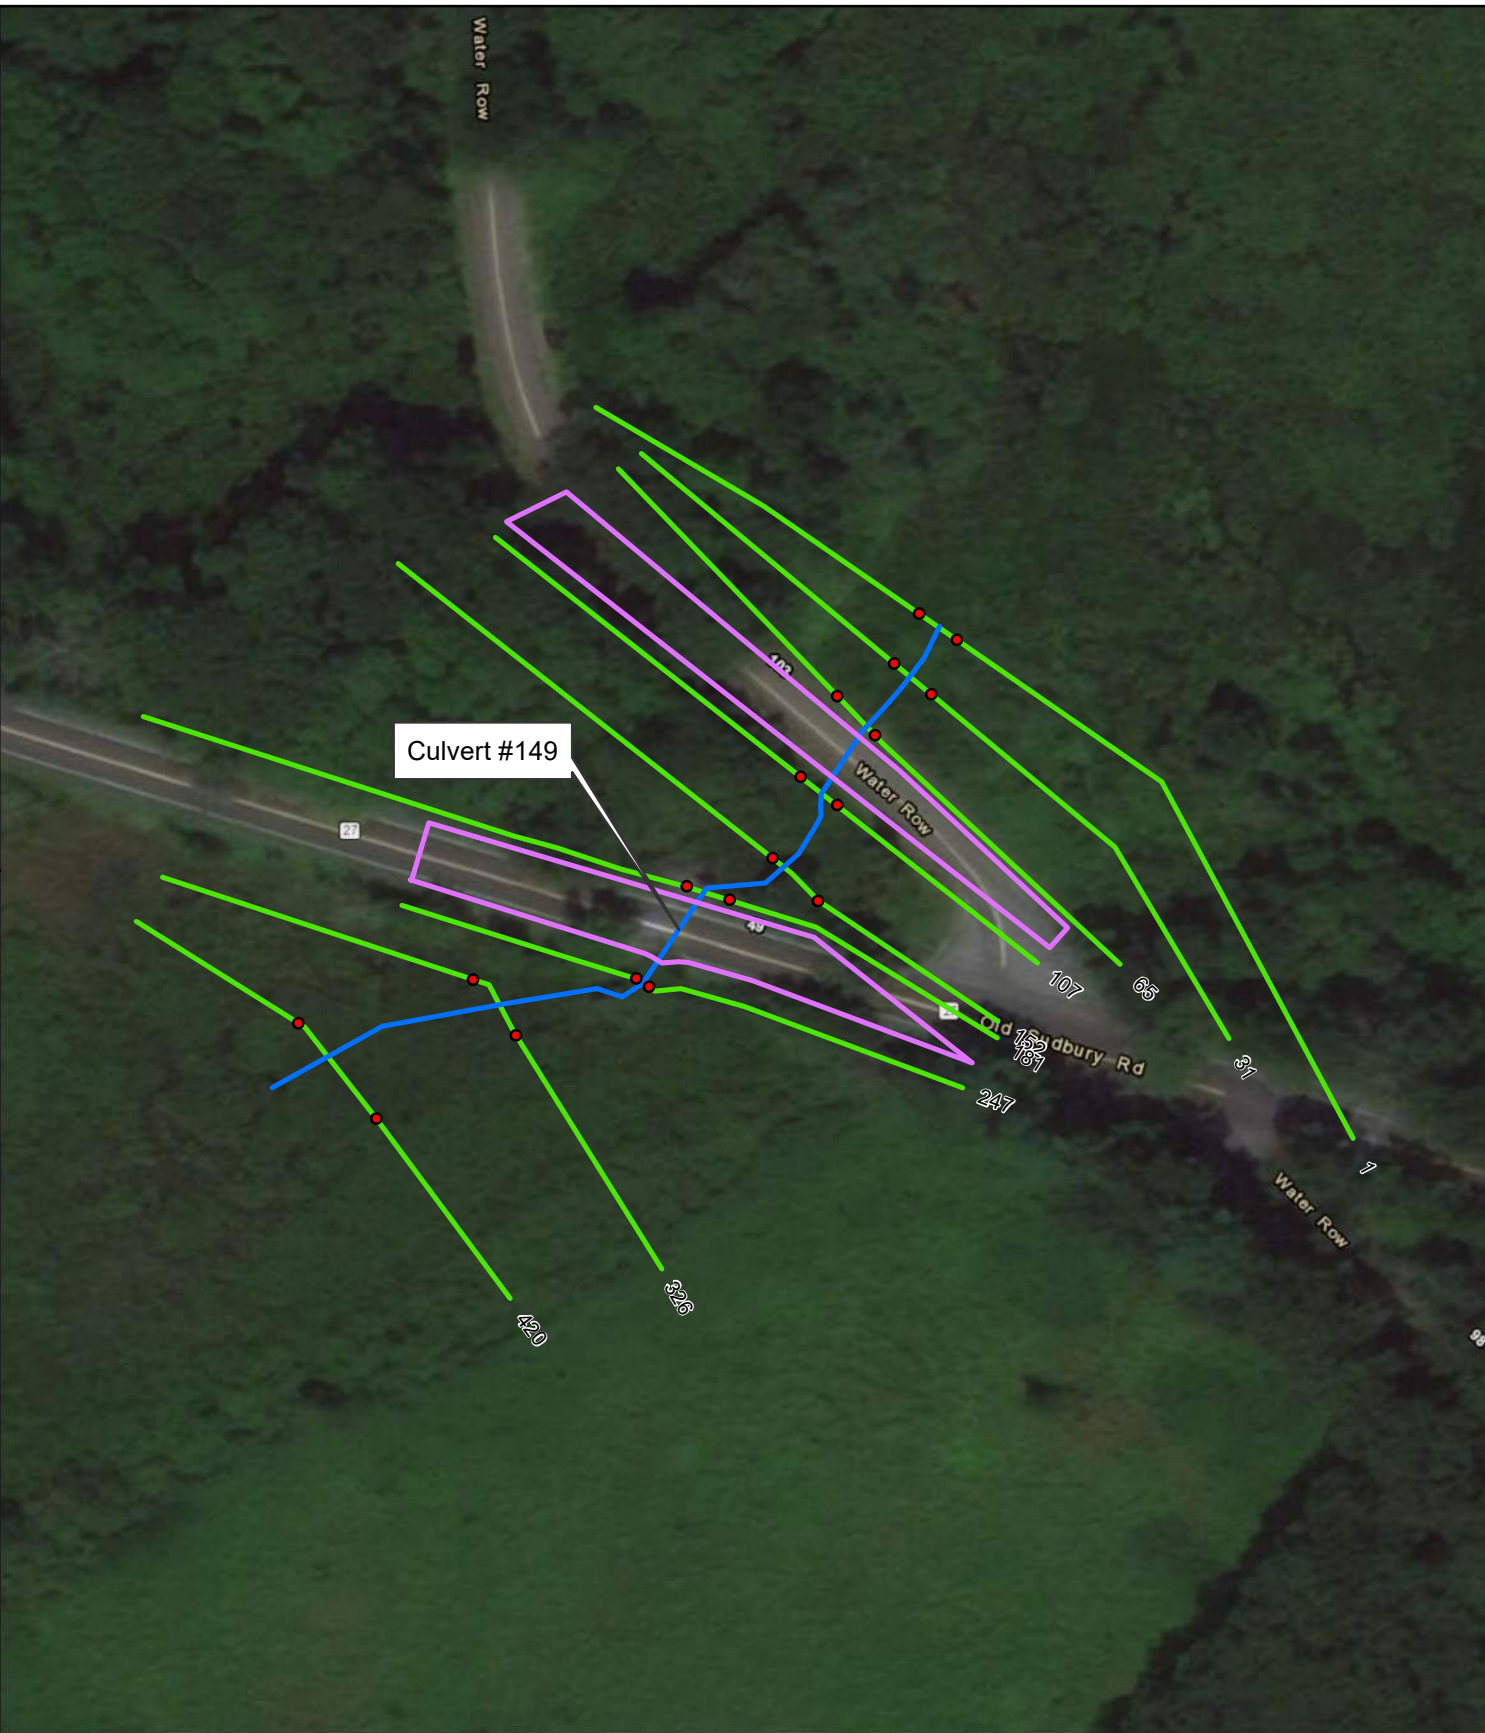
## Figures 2 & 3: Project Area & Conceptual Hydraulic Models

- Stream Bank Locations
- Structure
- Stream
- Cross-Section (Stationing in ft.)

Woodard & Curran has performed a hydraulic analysis of culverts crossing Old Sudbury Road (MA Route 27) in Sudbury, MA. The culverts are identified as Culvert #110 and Culvert #149 and are located approximately 0.4 miles and 200 feet northwest of the intersection of Old Sudbury Road and Water Row. Based on the results of culvert and bridge inspections documented in the “Crossing (Culvert & Bridge) Management Program,” prepared by Tighe & Bond and updated April 30, 2019, these culverts have been identified for replacement. The purpose of this memorandum is to summarize Woodard & Curran’s hydraulic evaluation of these culverts and support development of a Notice of Intent to file an application with the Conservation Commission for authorization to replace both culverts. Please refer to Figures 1 through 3 for Site Location Map and Project Area figures for each culvert location.

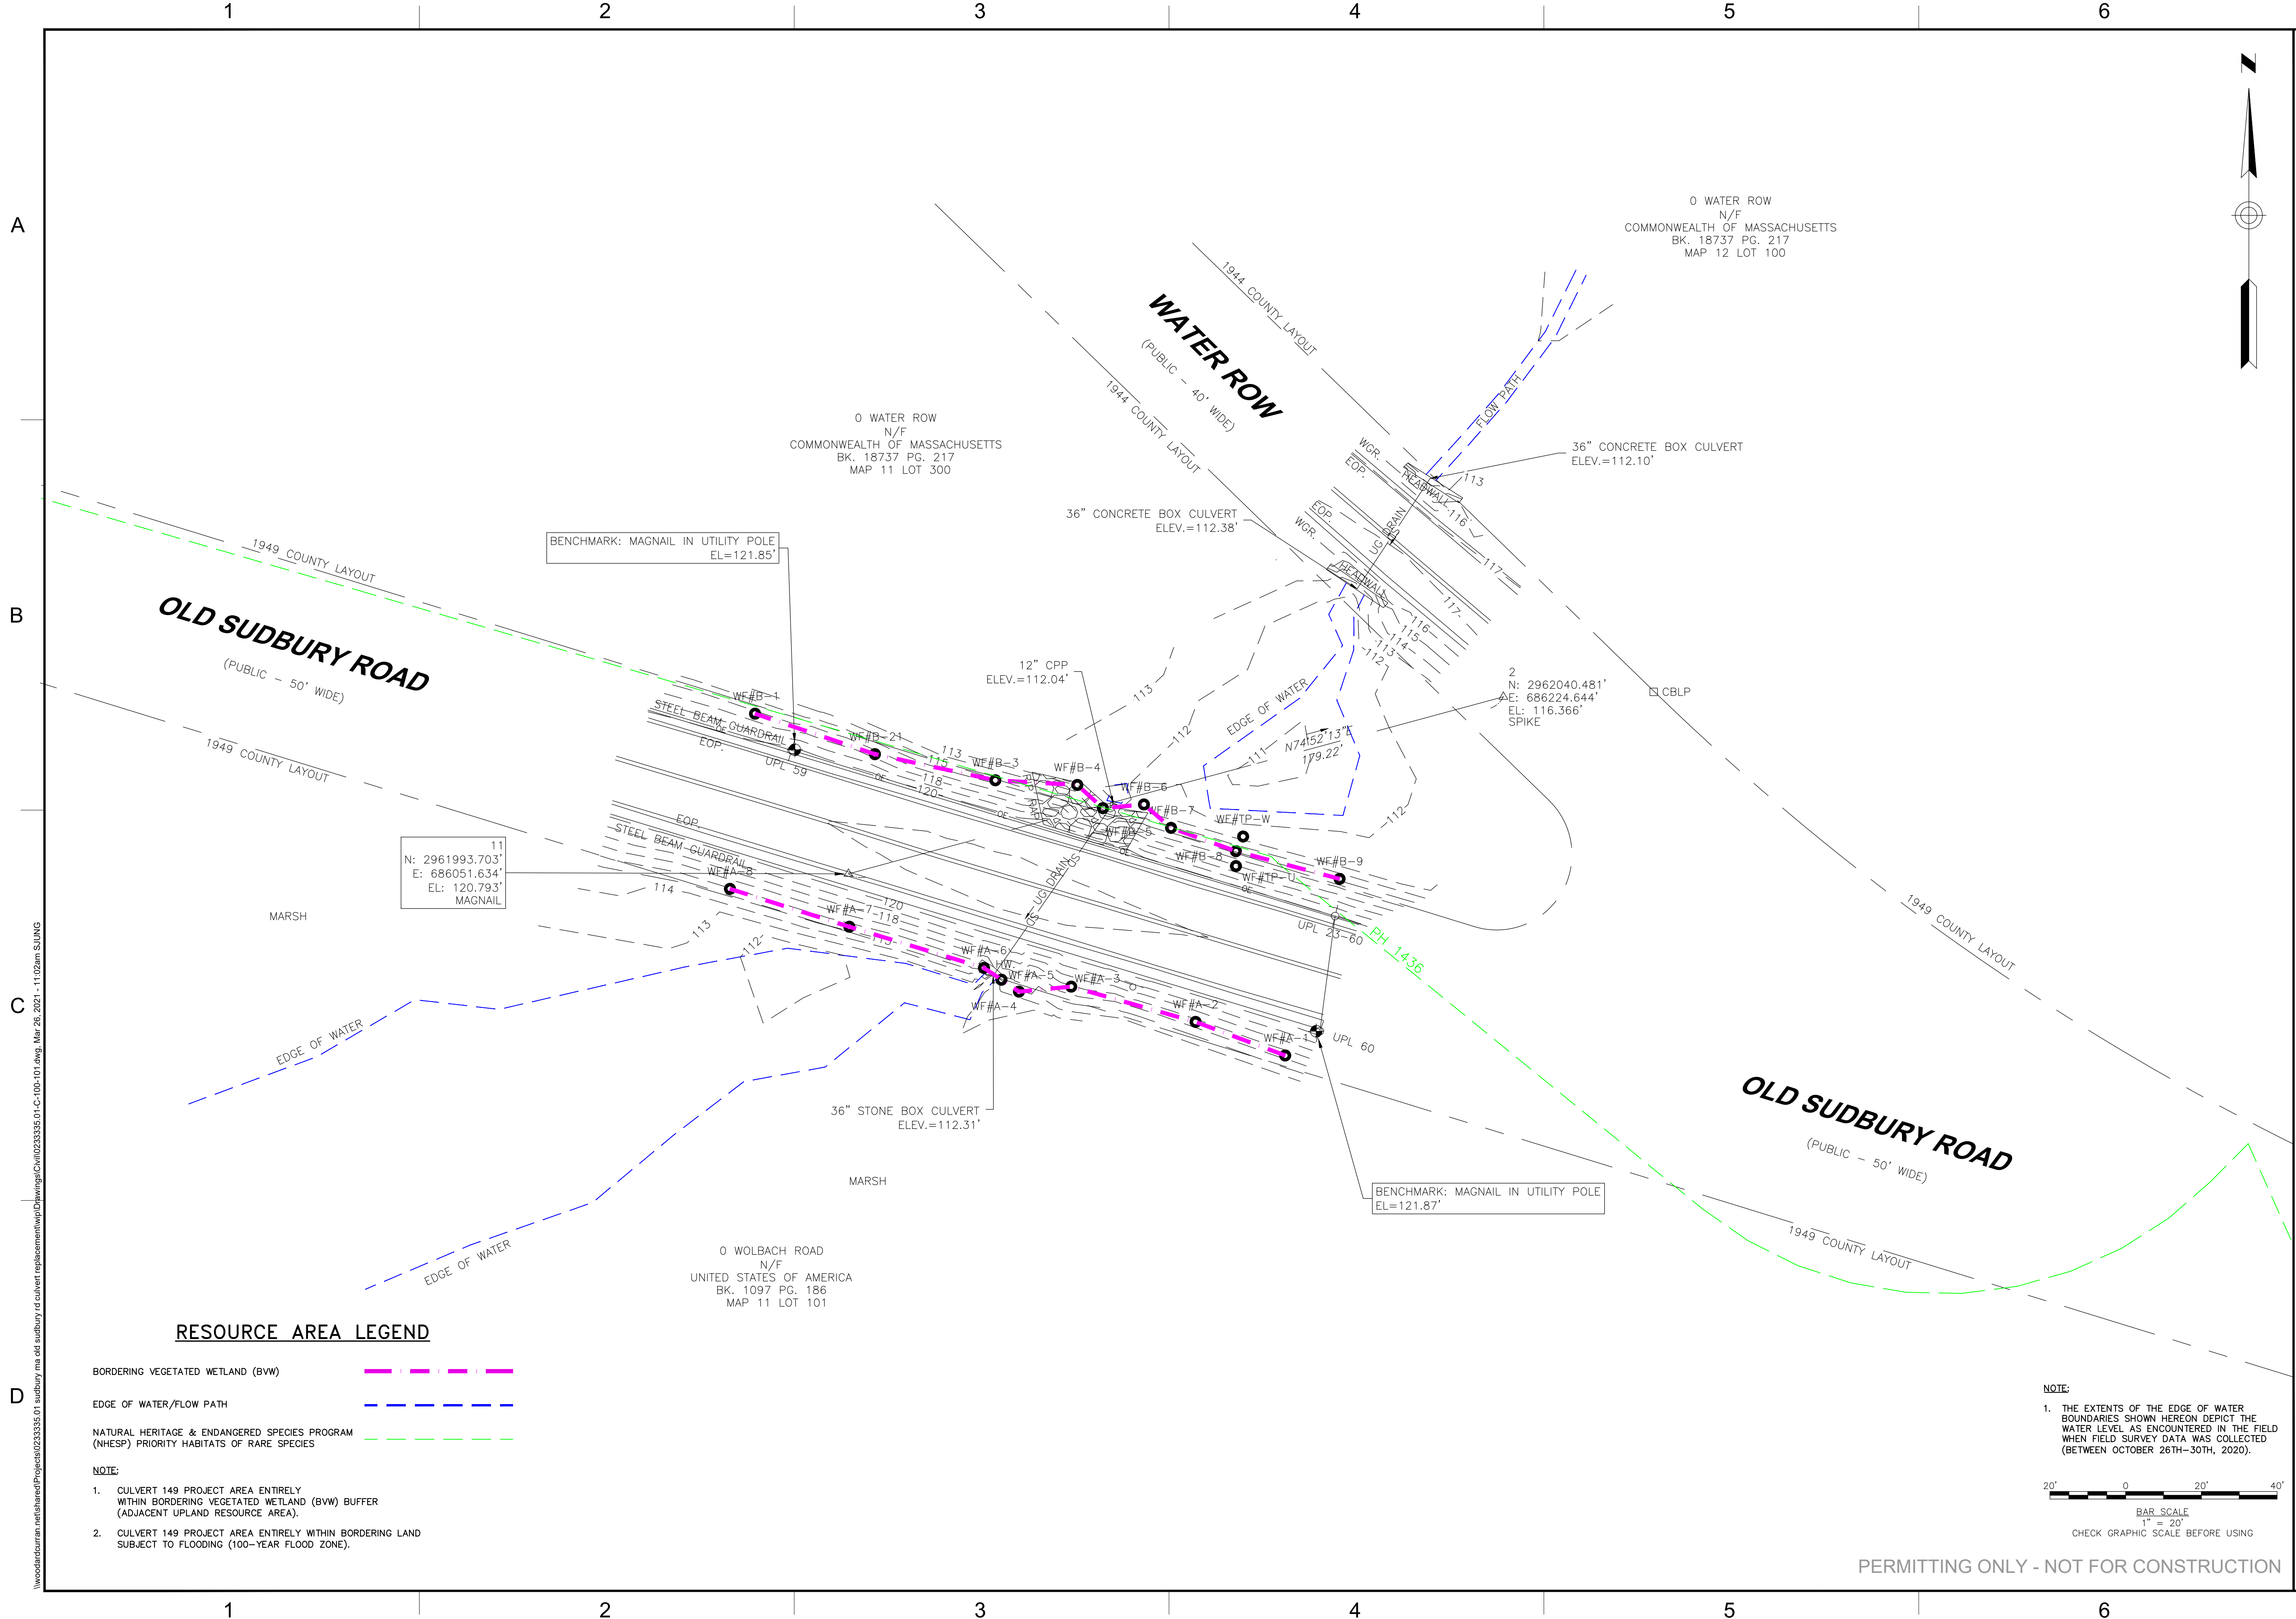
C-101

Please see Note 1 on the revised Sheet C-101.

*Comment 4: The extent of the edge of water at culvert 149 does not reflect current conditions. Currently the outlet is completely submerged.*

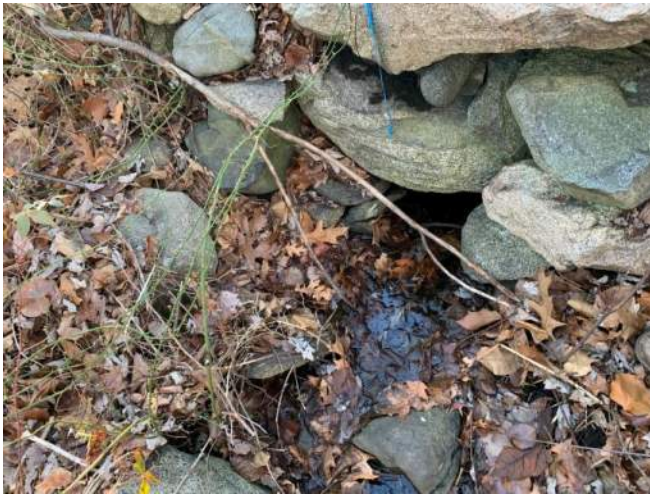
Photograph 1 – Stone headwall Culvert # 110 inlet

The 8-inch-diameter inlet opening and stone stacked headwall at the upstream (north) side of the culvert can be seen on **Photograph 1** below, while the 6-inch-diameter outlet opening and stone stacked headwall at the downstream (south) is shown in **Photograph 2** below.

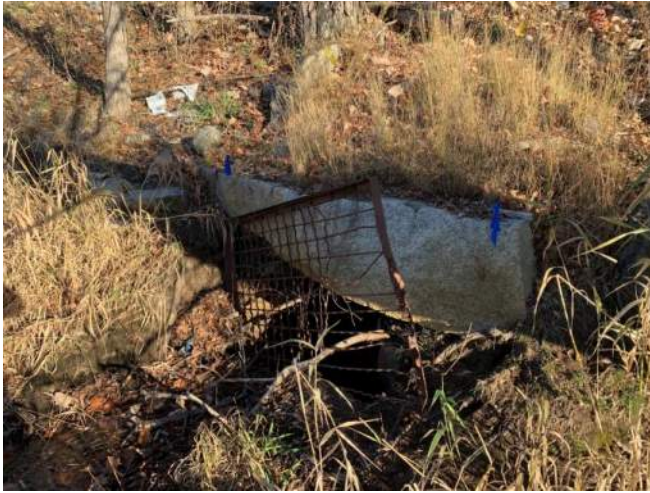
Photograph 3 – Stone headwall Culvert # 149 inlet

the upstream side (south) of the culvert can be seen on **Photograph 3** below, while the 6-inch-diameter storm drain pipe outlet opening with the headwall at the downstream side (north) of the culvert to the east is shown in **Photograph 4** below.

Based on our communications with you, we understand that the proposed culvert replacement being considered for Culvert #149 is a single 5-foot-wide, 7-foot-tall, 4-sided concrete box culvert with a 5-foot opening and 2-foot embedment and would be installed at approximately elevation 109, and in the same approximate alignment as the existing culvert. The stacked stone walls would be replaced with block stone headwalls on both the inlet and outlet sides.

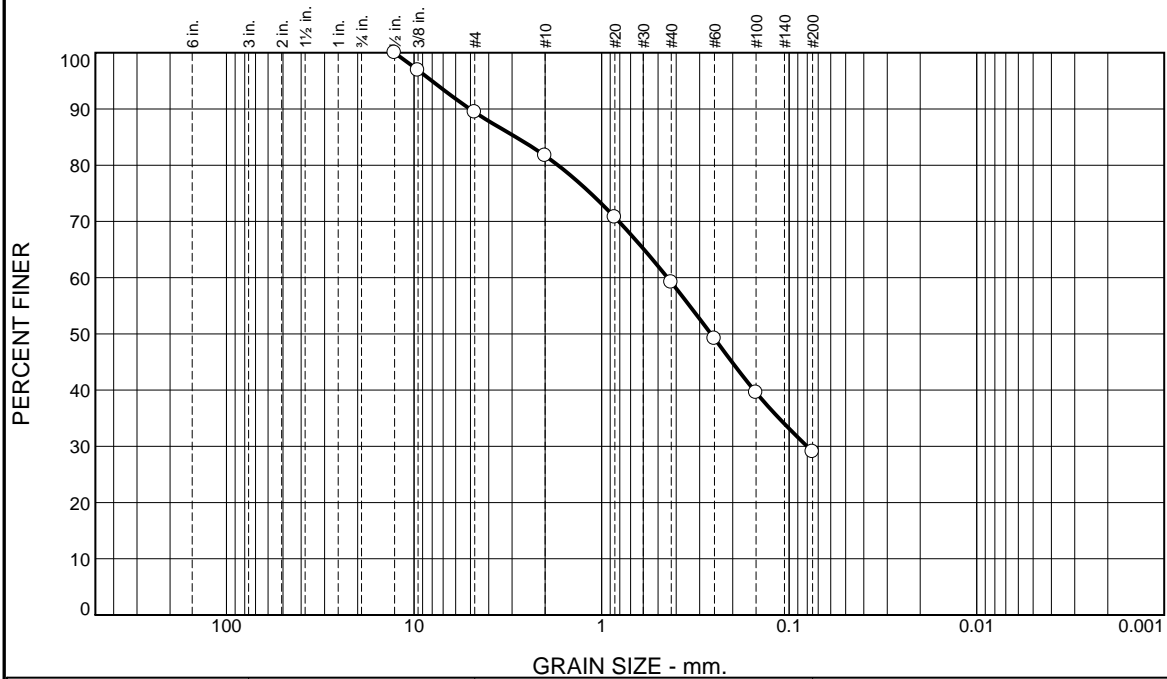
% +3"	% Gravel		% Sand			% Fines	
	Coarse	Fine	Coarse	Medium	Fine	Silt	Clay
0.0	0.0	10.6	7.7	22.5	30.2	29.0

Test Results (D6913 & ASTM D 1140)			
Opening Size	Percent Finer	Spec.* (Percent)	Pass? (X=Fail)
0.5"	100.0		
0.375"	96.9		
#4	89.4		
#10	81.7		
#20	70.7		
#40	59.2		
#60	49.2		
#100	39.6		
#200	29.0

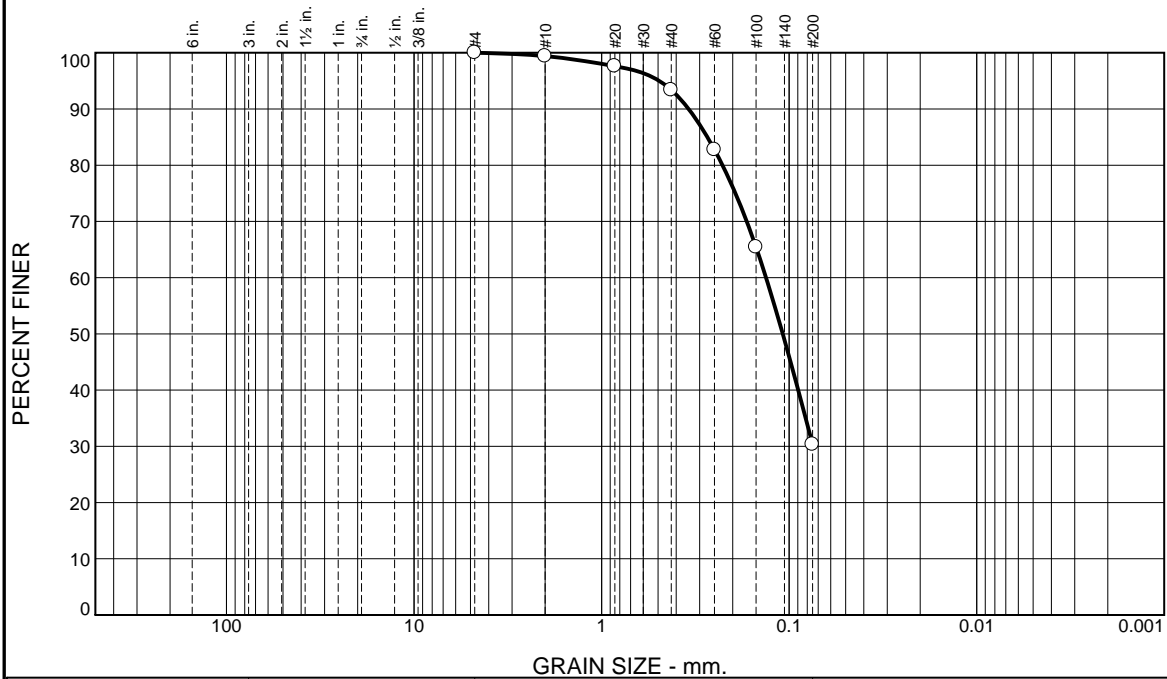
Figure 20-S-3594

% +3"	% Gravel		% Sand			% Fines	
	Coarse	Fine	Coarse	Medium	Fine	Silt	Clay
0.0	0.0	0.0	0.6	6.0	63.1	30.3

Test Results (D6913 & ASTM D 1140)			
Opening Size	Percent Finer	Spec.* (Percent)	Pass? (X=Fail)
#4	100.0		
#10	99.4		
#20	97.6		
#40	93.4		
#60	82.8		
#100	65.4		
#200	30.3

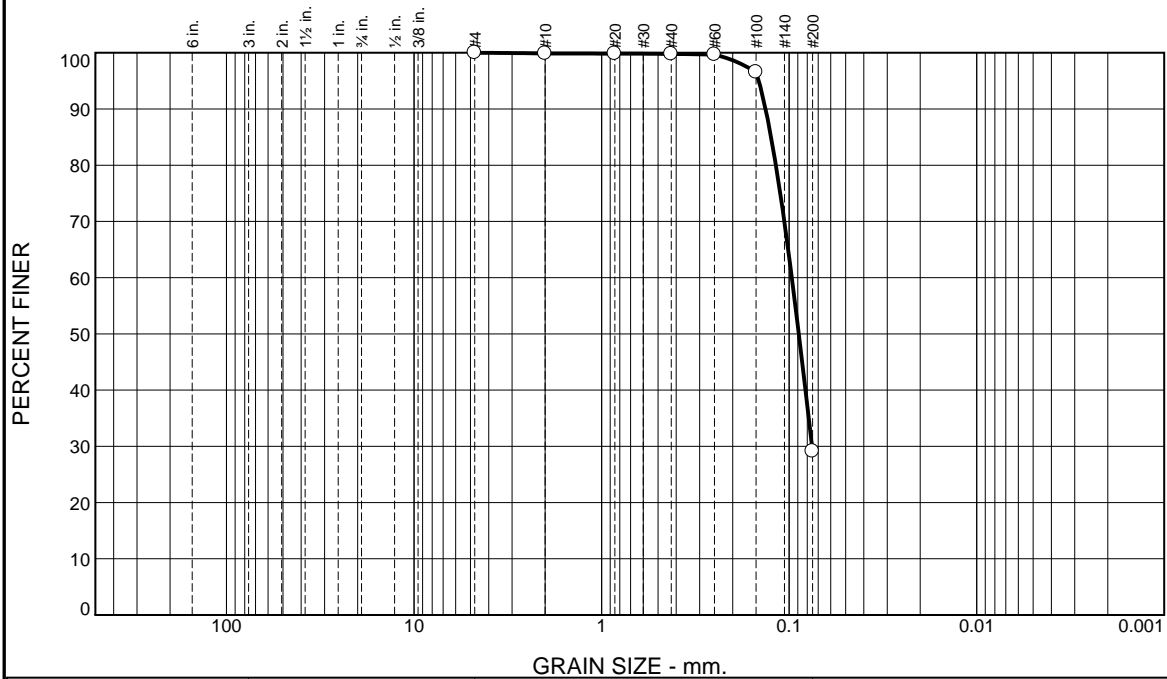
Figure 20-S-3595

% +3"	% Gravel		% Sand			% Fines	
	Coarse	Fine	Coarse	Medium	Fine	Silt	Clay
0.0	0.0	0.0	0.1	0.1	70.7	29.1

Test Results (D6913 & ASTM D 1140)			
Opening Size	Percent Finer	Spec.* (Percent)	Pass? (X=Fail)
#4	100.0		
#10	99.9		
#20	99.8		
#40	99.8		
#60	99.7		
#100	96.5		
#200	29.1
