## **NOTICE OF INTENT**

# Marlboro Road – Pantry Brook Culvert Replacement Sudbury, MA

RE: Marlboro Road Culvert Replacement – Design Basis Memorandum

# TOWN OF SUDBURY, MA MARLBORO ROAD CULVERT REPLACEMENT

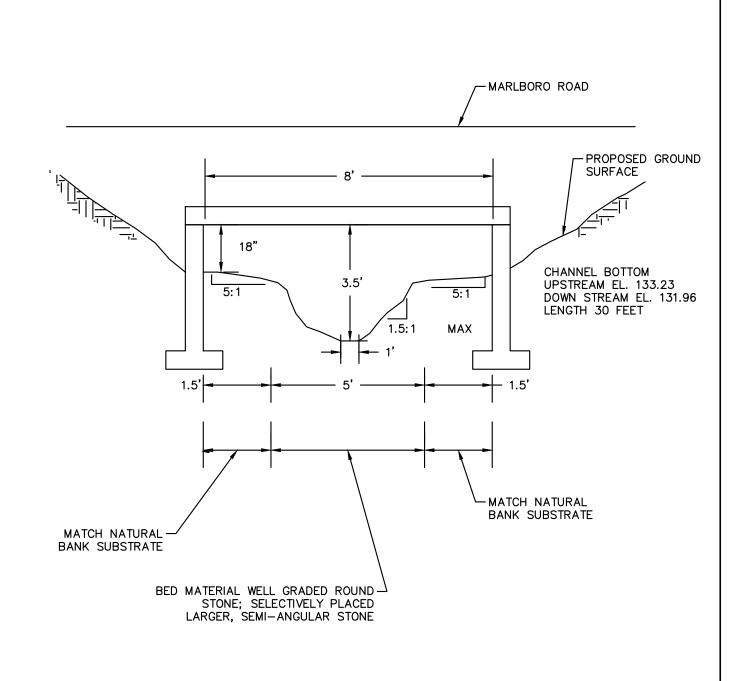
# Figure 6: Replacement Culvert Concept

Based upon the design considerations and hydraulic calculations, the recommended culvert replacement is Alternative 3. Please refer to Figure 6 for a conceptual culvert section.

### PROPOSED CULVERT CONCEPT NOT TO SCALE

Figure 6 – Replacement Culvert Concept

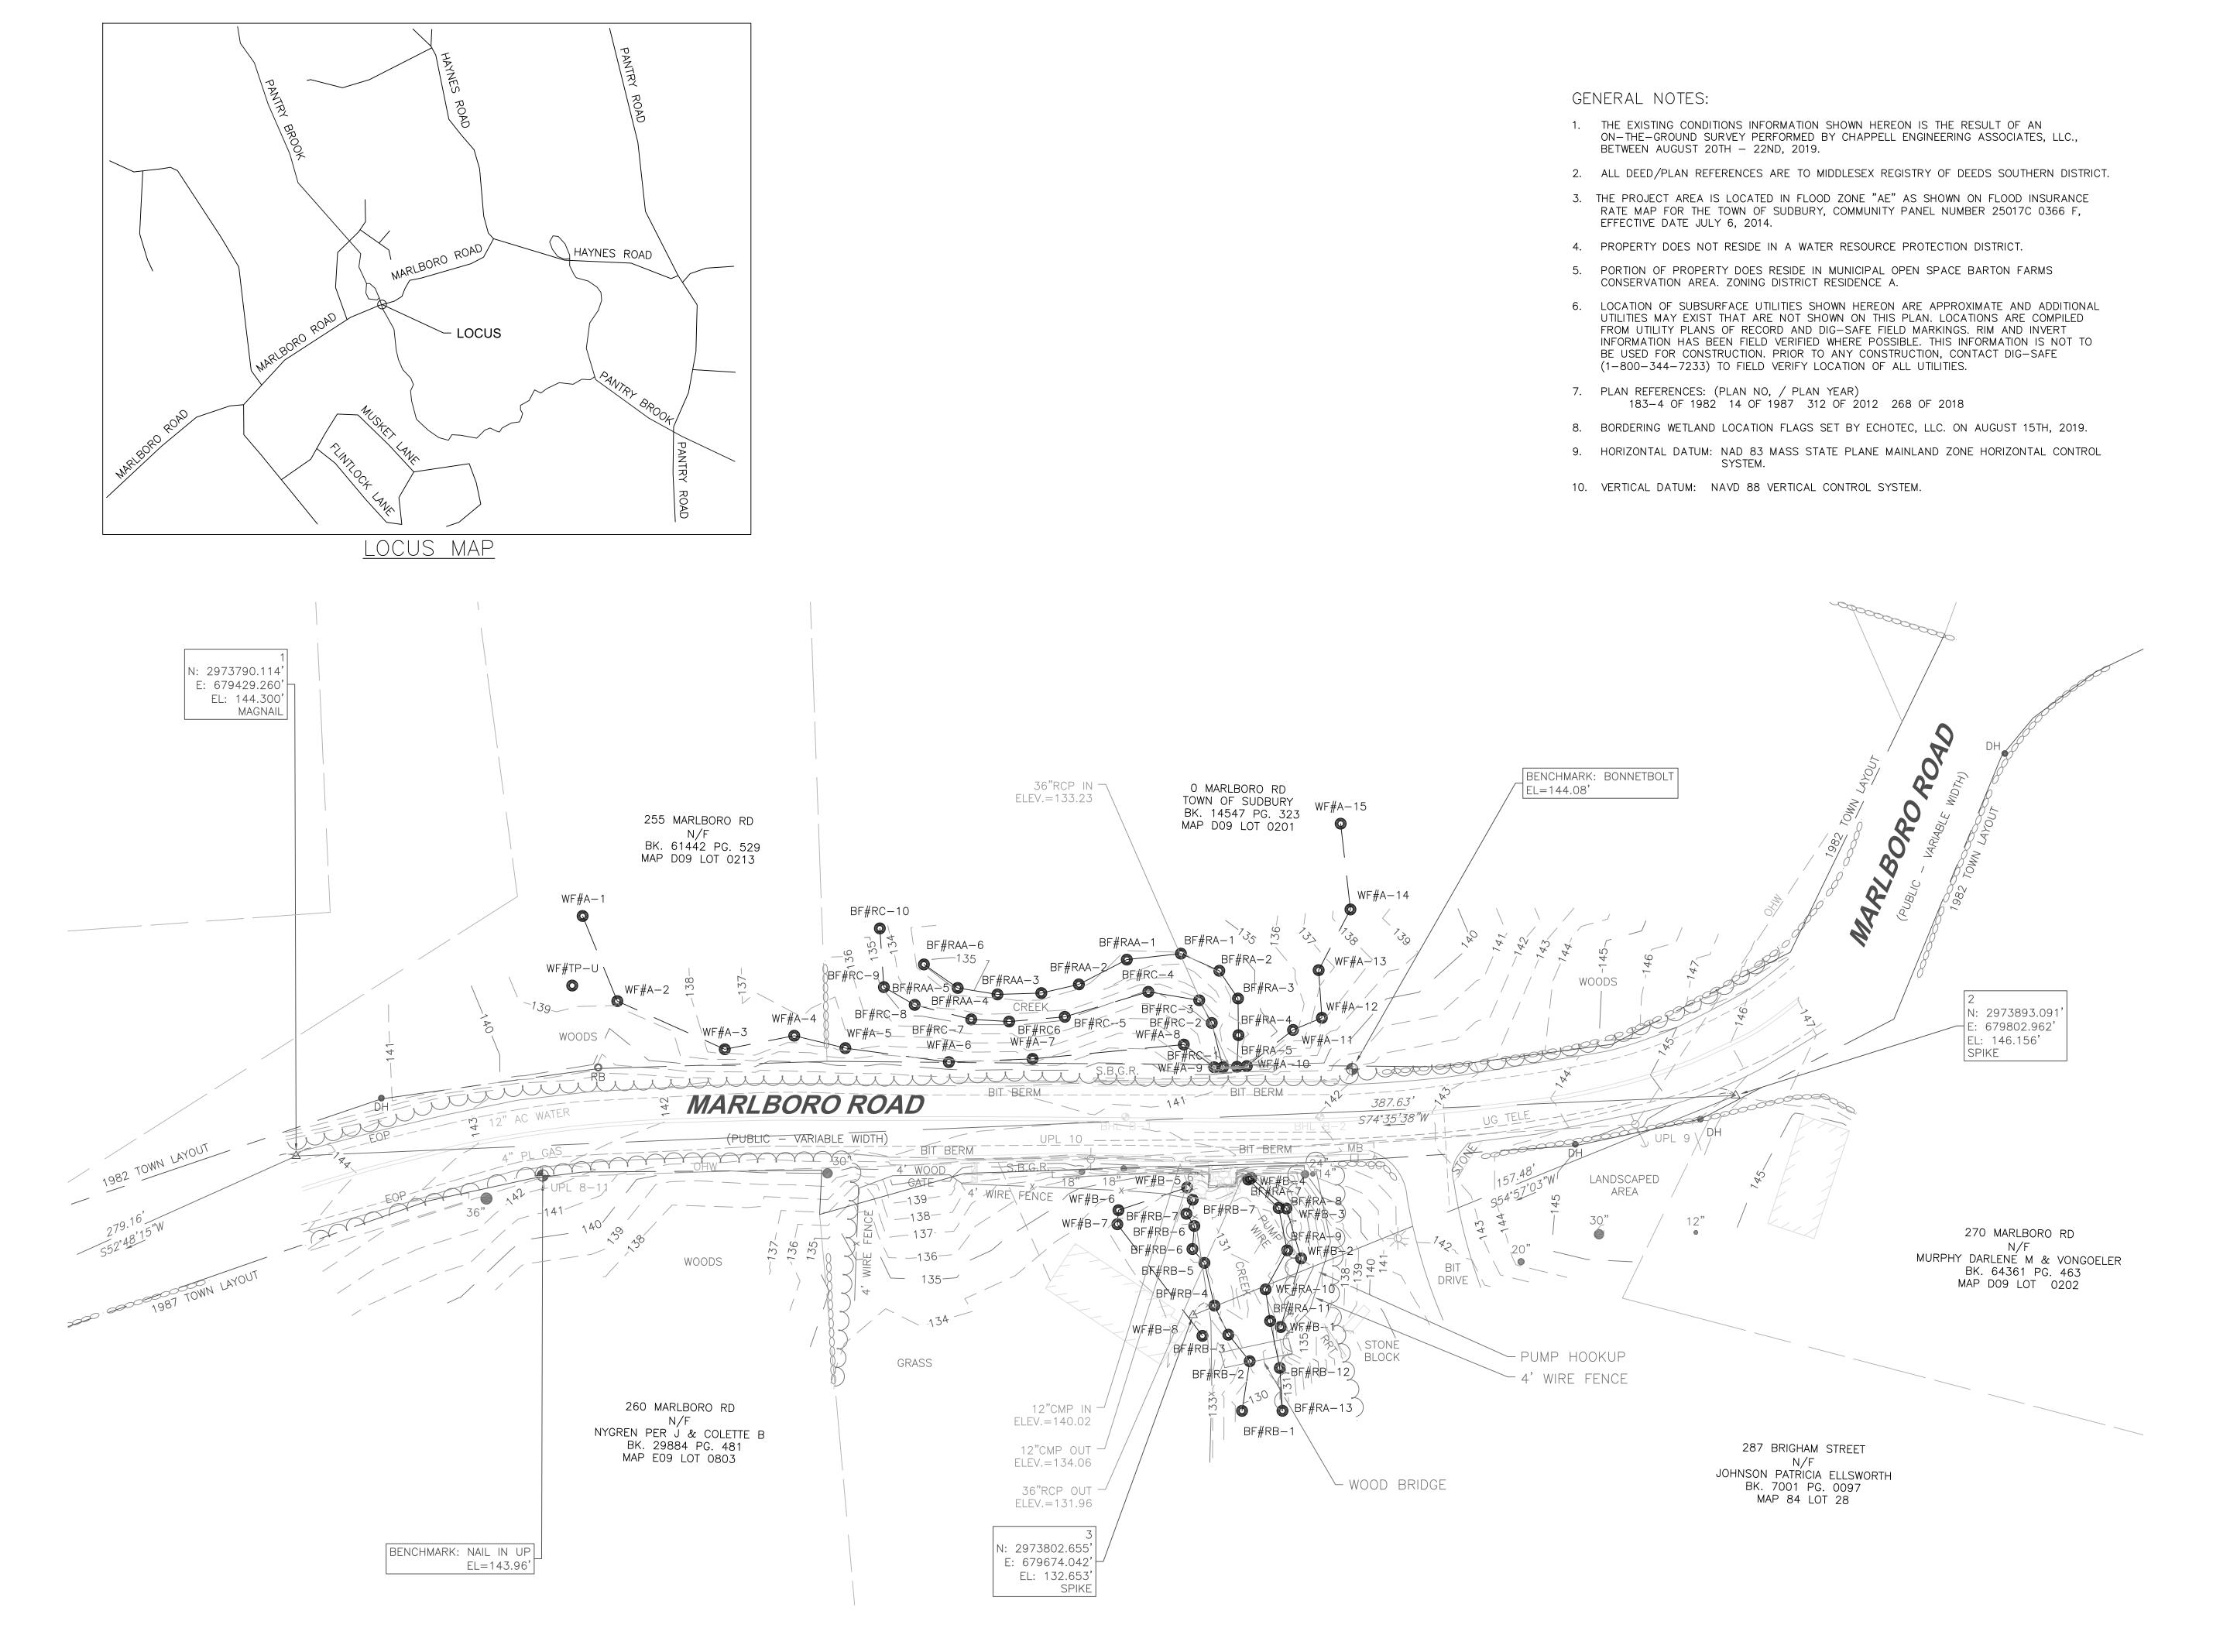
## ATTACHMENT A: EXISTING CONDITIONS SURVEY

EXISTING CONDITIONS SURVEY

An existing conditions survey of the site was performed by Chappell Engineering Associates on September 17, 2019. The existing culvert pipe is 29.8 feet long, flowing north to south beneath Marlboro Road. The downstream pipe end is located on private property. Survey is included as Attachment A.
