**APPENDIX B WILDLIFE HABITAT
EVALUATION REPORT FOR CULVERT 4**
Bruce Freeman Rail Trail, Sudbury,
Massachusetts

February 4, 2022

Prepared for:
Massachusetts Department of Transportation

Prepared by:
Stantec Consulting Services Inc.

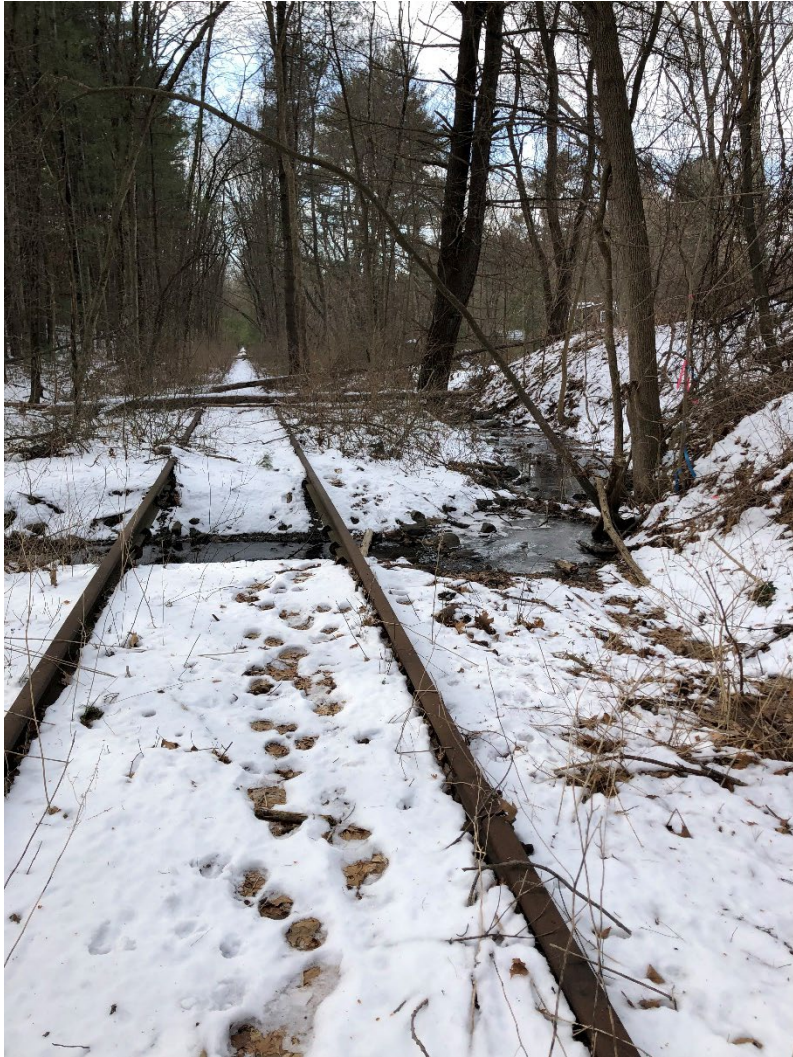
Photo 1. Existing railroad tracks leading to Culvert 4

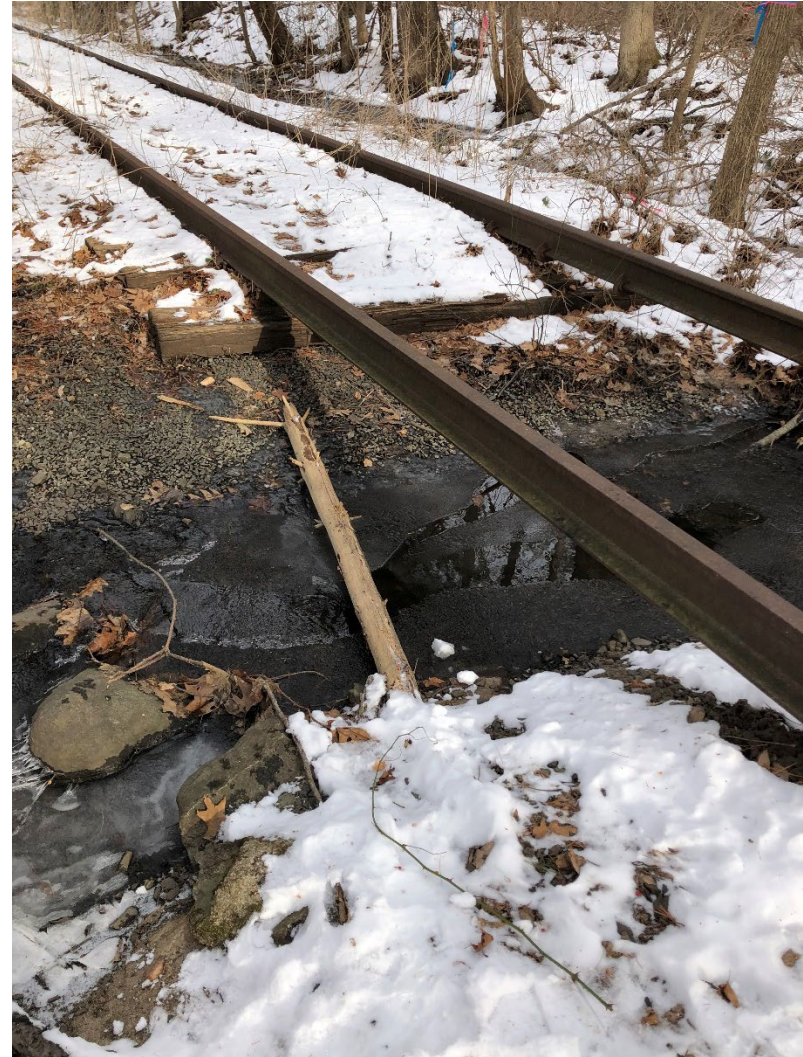
Photo 2. Overview of railroad tracks over tributary to Hop Brook within proposed work area at Culvert 4

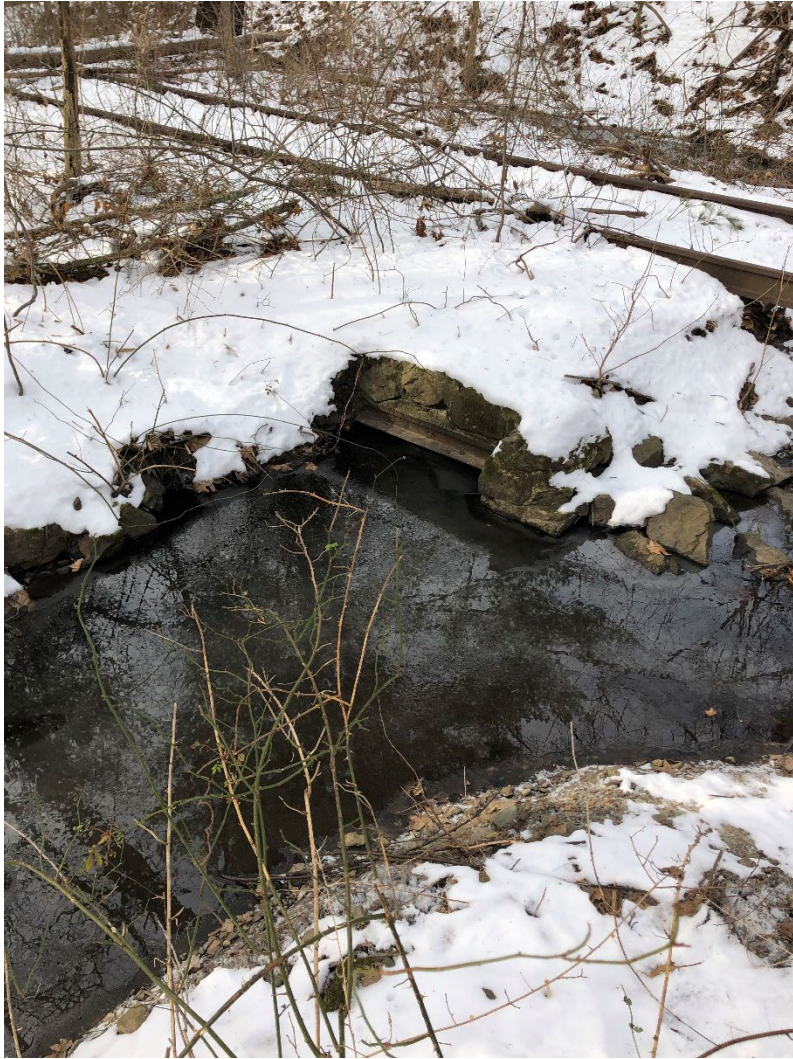
Based on information in the Fuss & O'Neill NOI (December 22, 2021), we understand that Culvert 4, a mortared stone box culvert with clay pipes has collapsed and the outlet is buried. As a result, the

Photo 3. Mortared stone box culvert (#4) near Station 167 + 20 to be replaced

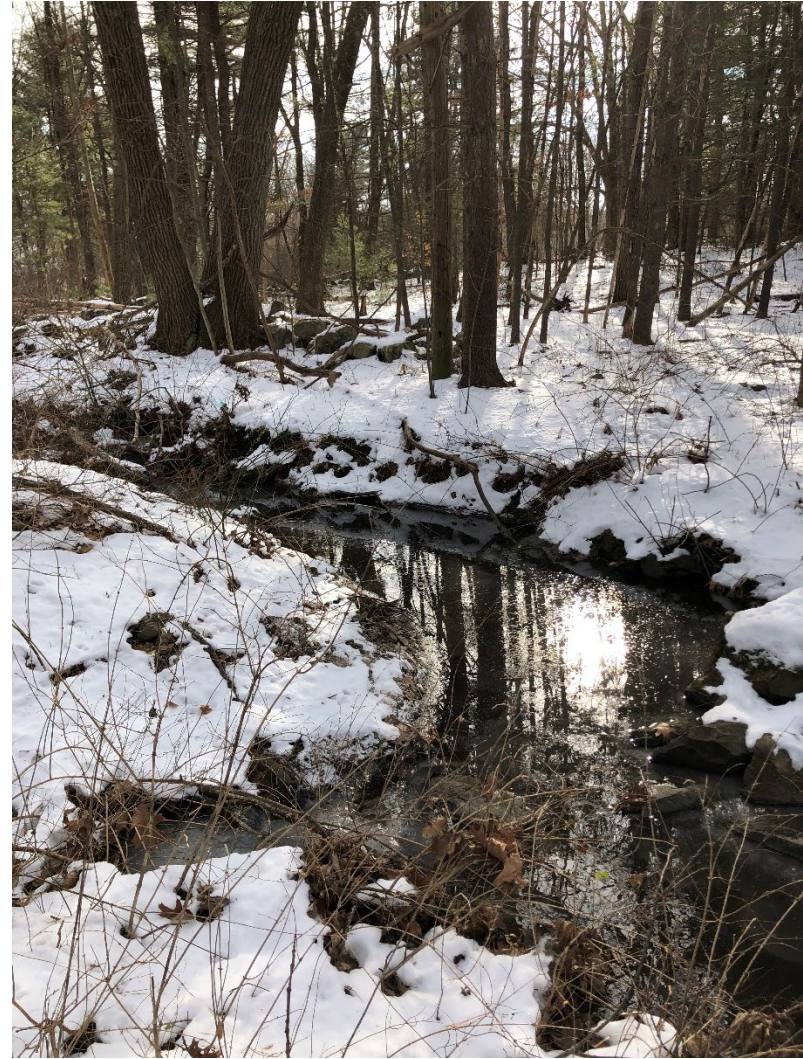
Mud flats (freshwater): There is a marginal area of exposed mud within the existing stream channel that is approximately 2 feet wide by 3 feet long. It is located at the confluence of the unnamed stream to Hop Brook and the BF#30 series jurisdictional stream under the Sudbury Wetlands Bylaw at the railroad track crossing. This area is not classified as a “Freshwater Mud Flat Community” and likely only serves as marginal habitat value due to its size. (Photo 4)

Photo 4. Unnamed tributary to Hop Brook within work footprint

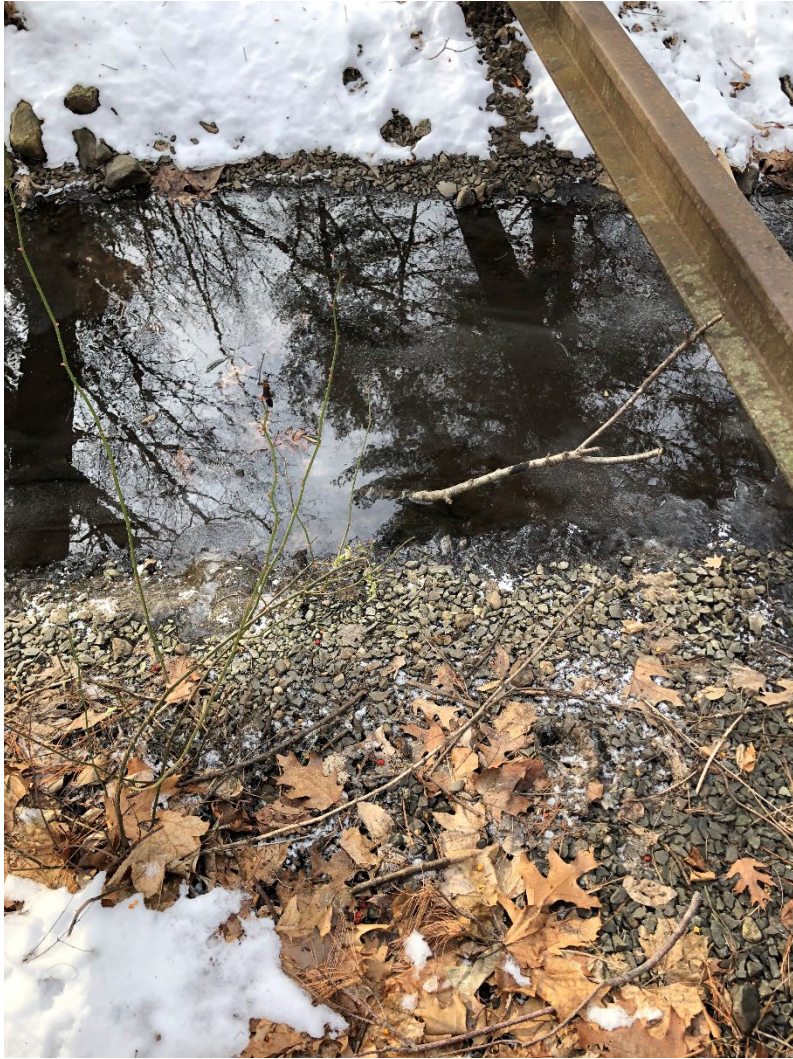
Photo 5. A portion of the Bank *within* limit of work is comprised of small stone and gravel and has washed into the stream

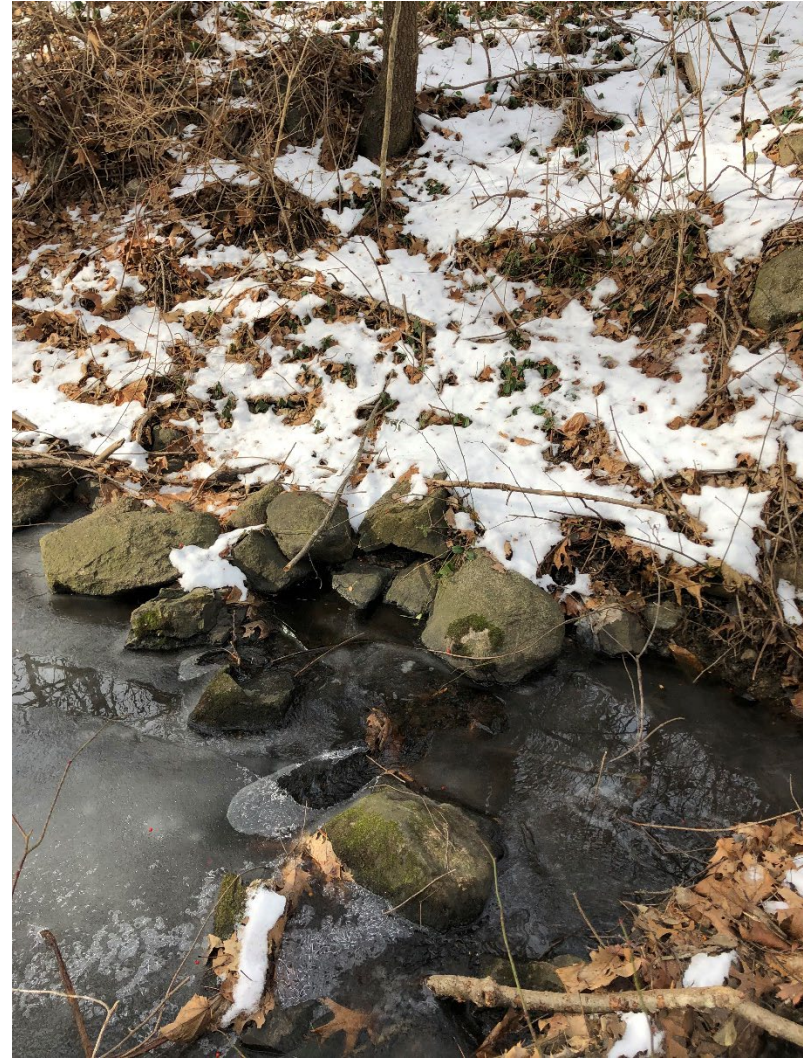
Photo 6. Rocks and boulders are common within the stream

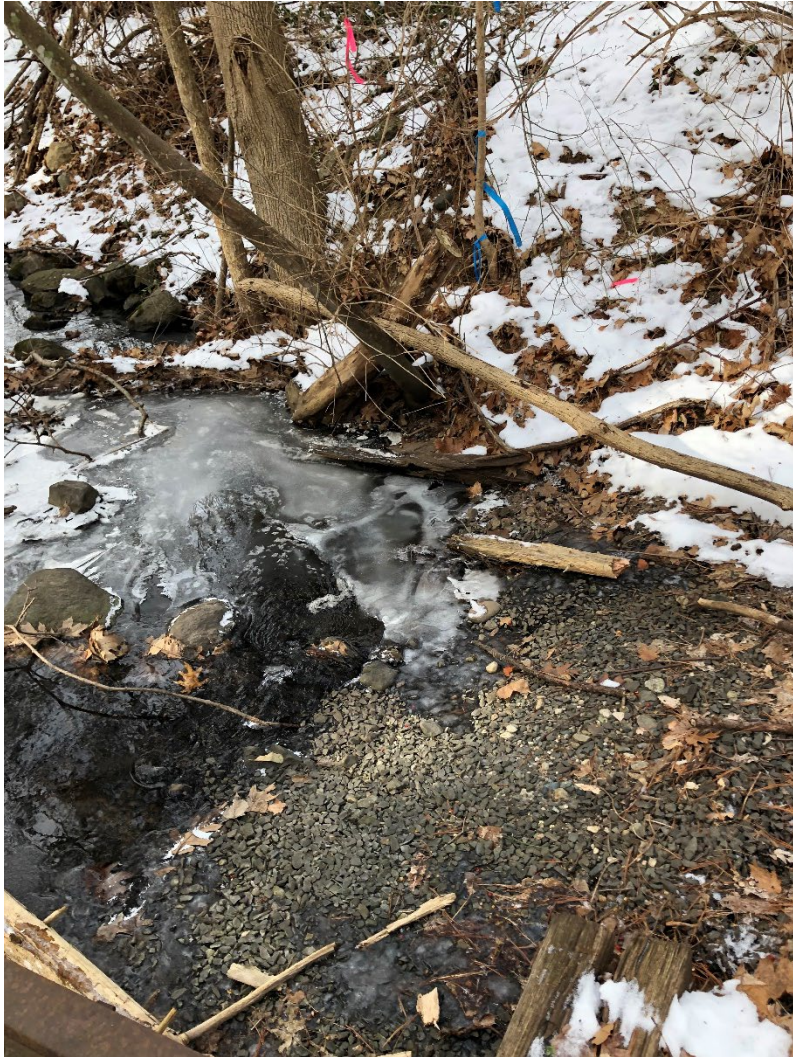
unnamed tributary to Hop Brook has cut around the collapsed culvert and washed through the existing rail embankment (Photo 7). The culvert will be removed and replaced with 48" diameter reinforced concrete pipe buried 2' with a natural stream channel bottom. The stream alignment will be restored to the former culvert location. There are an estimated 100 LF of permanent impact and 15 LF of temporary impact to Inland Bank associated with this work. The Appendix B Wildlife Habitat Evaluation was performed because the impact to Inland Bank at Culvert 4 is greater than 2 times the threshold for Bank (> 50 LF). The Culvert 4 replacement work is part of a larger project and, for the purposes of this WHE, only the area within 50' of the limit of work was evaluated for this effort.

Flat rocks and logs on Bank: The Bank in this portion of the unnamed tributary to Hop Brook is steep but not high and contains both cut and fallen logs that could potentially serve as cover for stream salamanders. (Photo 7)

Photo 7. Bank below the railroad track at crossing; stream has cut around the collapsed culvert

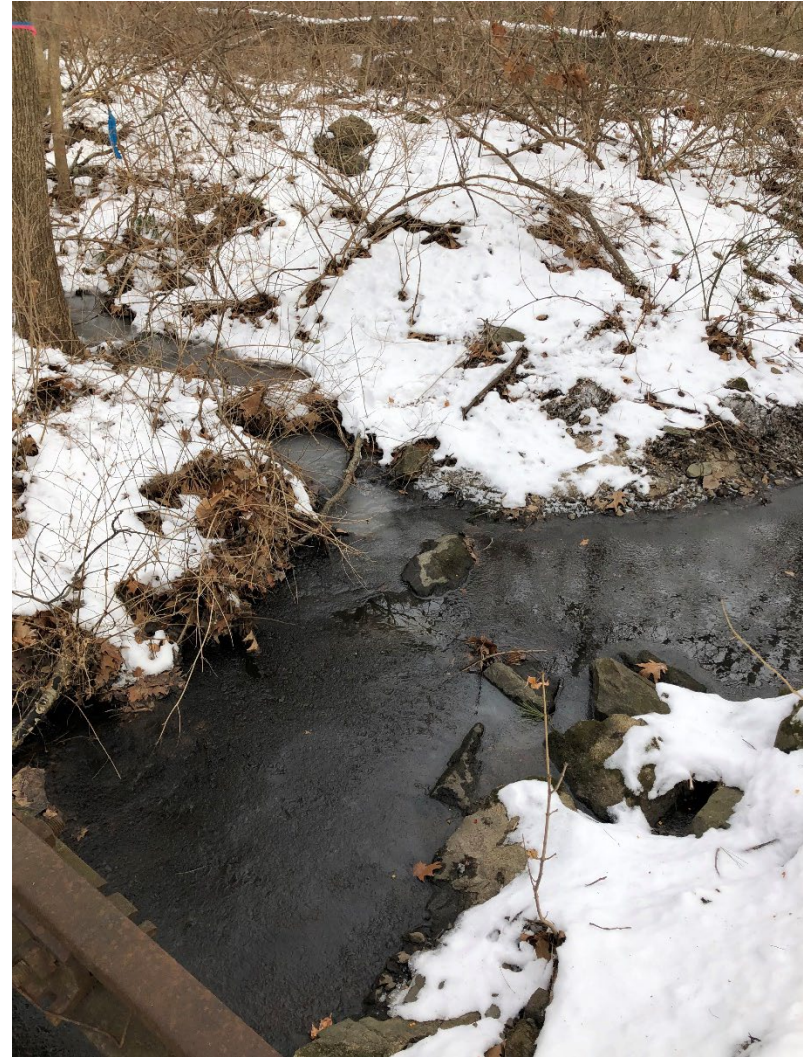
Medium to large flat rocks within the stream: There are a number of flat rocks, greater than 6” within the limit of work that could potentially provide cover for stream salamanders and nesting habitat for spring salamander (*Gyrinophilus porphyriticus*) and northern two-lined salamanders (*Eurycea bislineata*); however, spring salamanders may not occur in eastern Massachusetts. (Photo 8).

Photo 8. Stream has a number of >6" flat stones that would be suitable cover for 2-lined salamanders

1. Preserve larger rocks, especially flat stones from the stream and strategically place back into stream post-construction.
2. Avoid or minimize installation of physical barriers that would create impassable conditions across the trail for some smaller wildlife species.

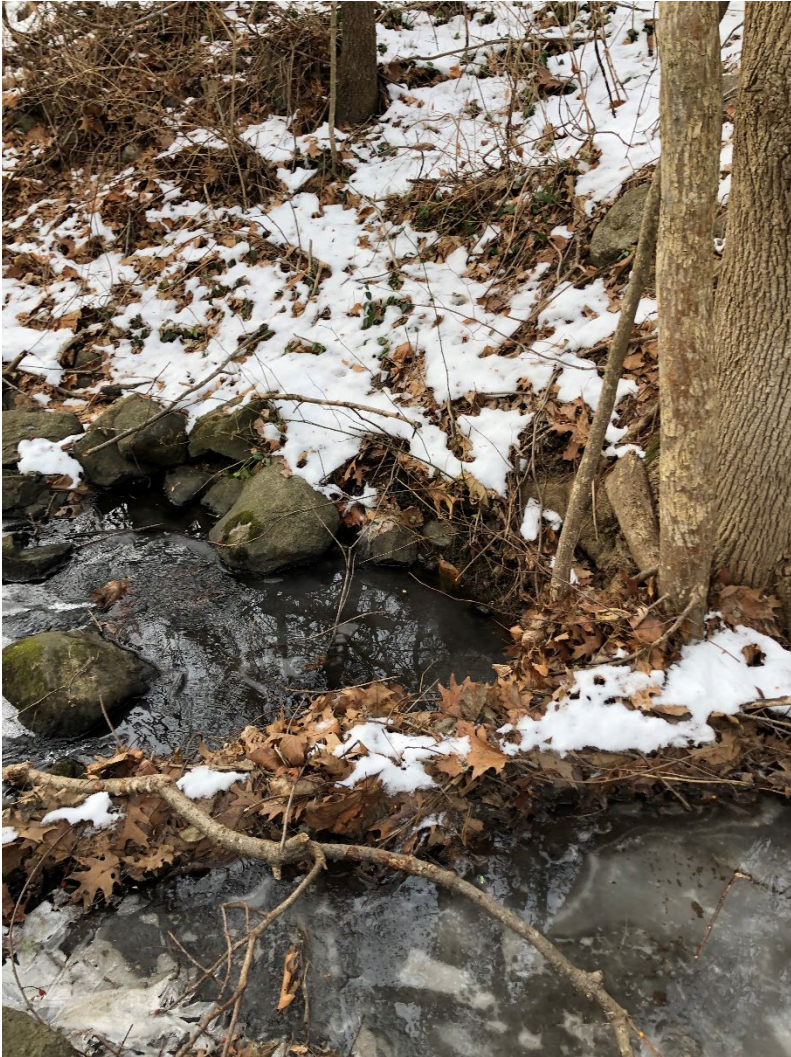
Photo 9. Coarse woody debris is present in the stream

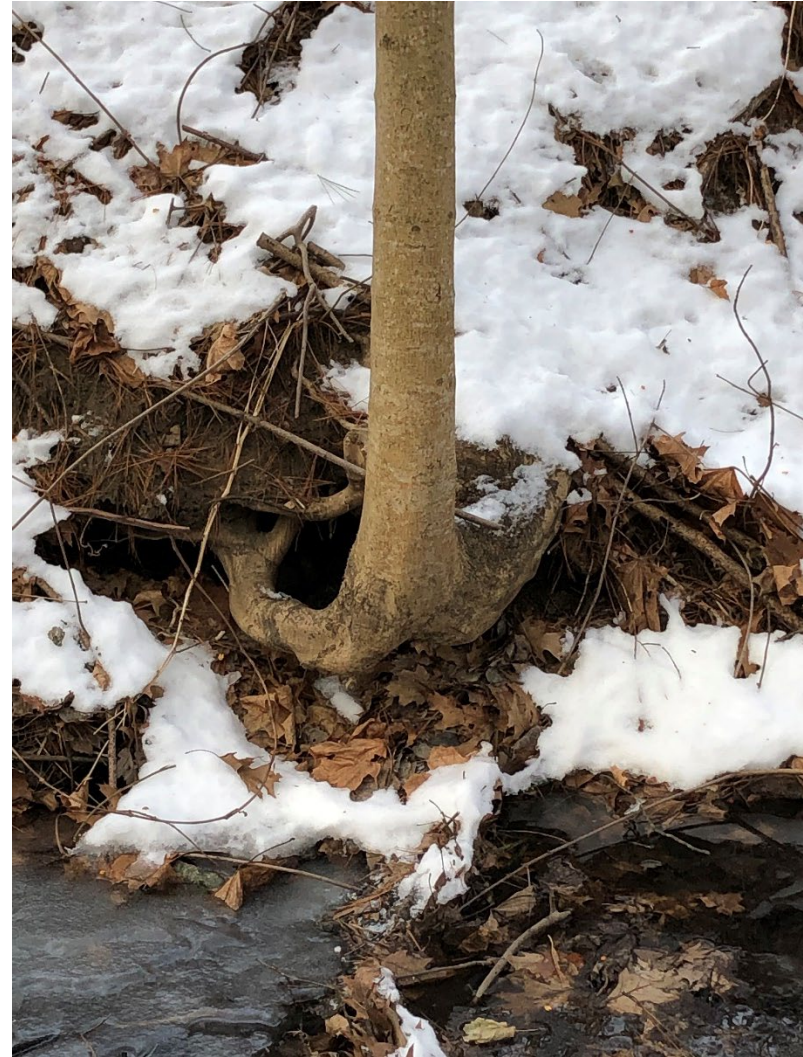
Undercut or Overhanging Banks with crevices: There are a number of small areas of Bank within the study area where the Banks have eroded and are undercut, providing potential habitat for small mammals. (Photo 10 and Photo 12)

Photo 10. A number of undercut banks and tree hollows formed by roots exist along the Bank

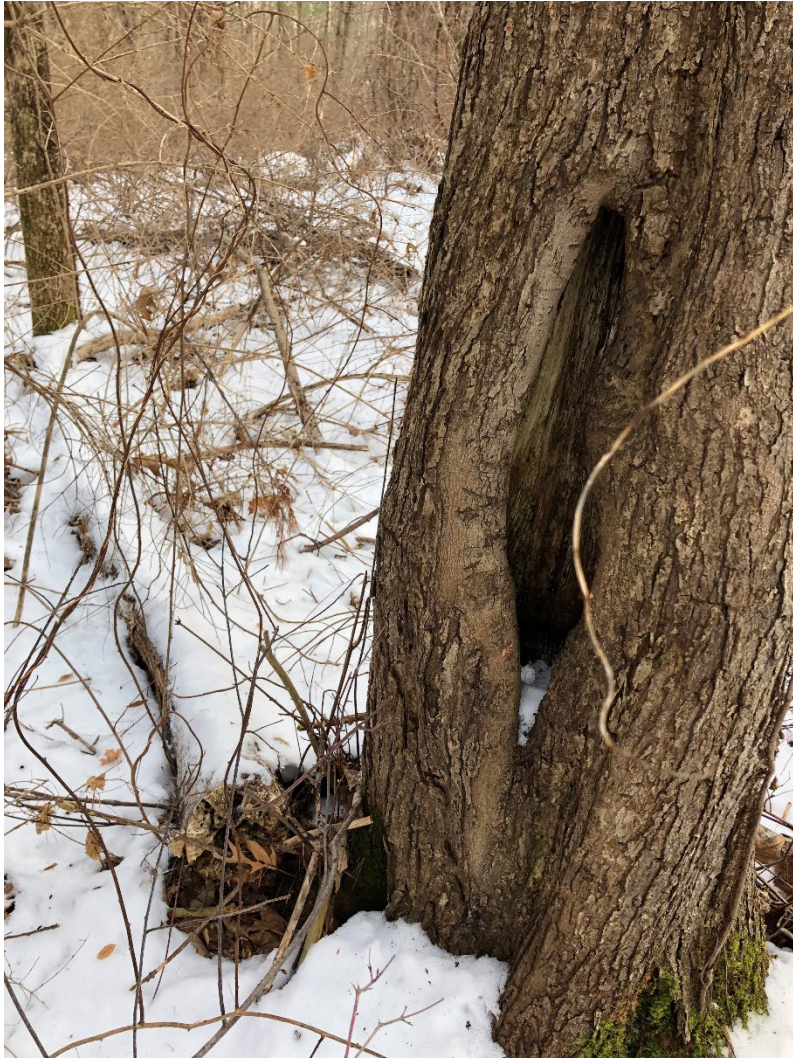
Photo 11. Limited cavities observed in trees near limit of work but none suitable for species such as tree swallows, saw whet owls, screech owls, bluebirds, etc., as they are not high enough in the tree

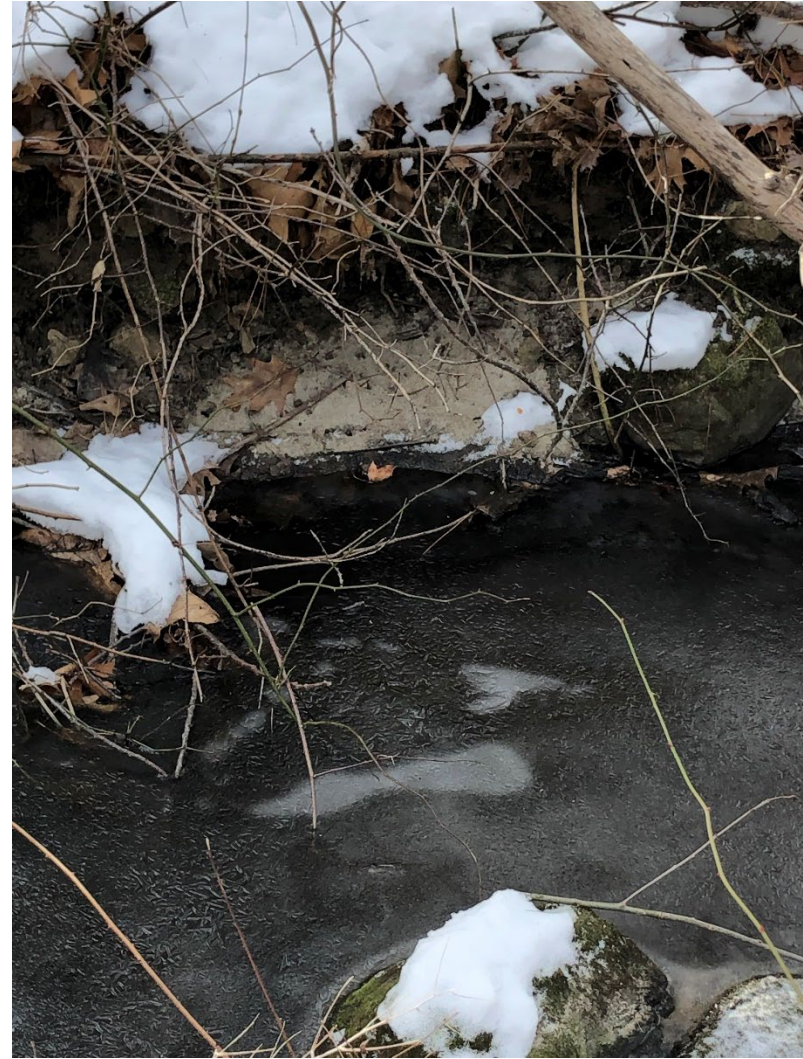
Photo 12. Patch of sand along the Bank of the intermittent stream not large enough or topographically well-positioned to offer turtle nesting habitat
