Re: Great Meadows (Sudbury River), Sudbury/Wayland, MA – 2022 Year End Summary Report

It is our pleasure to present a year end summary report to US Fish and Wildlife Service regarding the 2022 aquatic management program at Great Meadows (pictured in Figure 1 to the right). Great Meadows is a portion of the Sudbury River that extends from Sherman's Bridge Road (to the north of the area) and Route 27 (at the southern point of Great Meadows). This portion of the River is located both Sudbury and Wayland, MA. Great Meadows is primarily surrounded by dense woodlands and wetlands with very little developed property abutting the Wildlife Refuge. Access to Great Meadows is gained from a boat launch at Sherman's Bridge Landing, which consists of a pull-off along Sherman's Bridge Road. Several families of waterfowl were noted during each site visit during the 2022 season. Great Meadows is a popular recreational are for activities such as fishing, bird watching, and boating (primarily kayaking and canoeing).

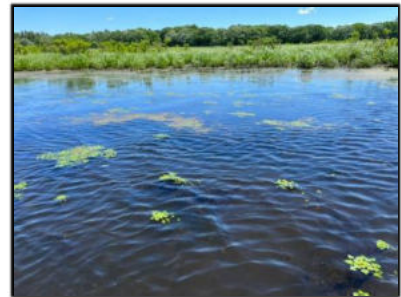
Figure 2: Water chestnut and various pondweeds within Great Meadows

Sudbury River that is located between Sherman’s Bridge Road and Route 27 (pictured in Figure 1). The boat was launched at Sherman’s Bridge Landing. There were several invasive species documented throughout the survey, which include water chestnut (noted in Figure 2), curly-leaf pondweed, fanwort, and Eurasian milfoil. The most prominent invasive species was Eurasian milfoil, as it was noted in moderate to dense densities (pictured in the background of Figures 2, 3, and 5). It was found in the majority of the management area, primarily noted close to both shorelines. Half of the population appeared dead/decaying while the other half appeared actively growing, close to forming “mats” at the surface. Curly-leaf pondweed, fanwort, and water chestnut were observed scattered throughout the survey area, and specifically throughout the Eurasian milfoil areas. These species were found in trace to moderate densities. The majority of the water chestnut had reached the surface, although portions of the water chestnut population was documented still growing within the water column. Water chestnut seeds (Figure 4) were also noted scattered, floating on the surface. Water chestnut became more dense/less scattered as we traveled south on the River towards Route 27. A handful of native species were documented throughout the survey including thin-leaf

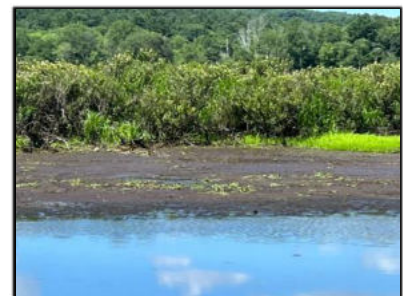
Figure 8: Very shallow conditions due to the drought; water chestnut noted on the shoreline

advance of treatment, and conditions were similar to the previous survey; however, the water level had significantly dropped since the last survey (illustrated in Figure 8). As a result of lower water levels, some of the water chestnut was seen out of the water, drying out (water chestnut on the shoreline within Figure 8 below), but was still sprayed by the herbicide in an effort to stop any seed production. The water chestnut was also observed scattered throughout the River in similar densities to those observed during the pre-management survey.

As planned, and based on the survey, a treatment was conducted for the control of water chestnut (see Figure 6). The liquid herbicide, Clearcast (imazamox), was paired with a non-ionic surfactant. The surfactant helps the herbicide stick to the target water chestnut plants and also increases penetration through the plant. The herbicide mixture was applied using an airboat equipped with a calibrated spray system (see Figure 6 above), which we utilized to spread the product by the foliar application method. This methodology ensures the herbicide is evenly spread in treatment areas and applied on the surface of the leaves. It also helps minimize/negate non-target impacts. Prior to treatment, two MA DEP signs were posted, one at Sherman’s Bridge Launch, and one at the bridge on Route 27 (Figure 7). Neon orange signs noting the treatment and any affiliated water-use restrictions were also posted (pictured in Figure 7). The property owned by the town of Sudbury, as instructed, was not treated. Additional fulfilled requirements included providing MA-DEP permits, contact information, and pre-treatment survey data to both the Wayland and Sudbury Conservation Commissions. A newspaper was also placed prior to treatment to fulfill the condition within the Wayland OOC. Lastly, weather was closely monitored prior to treatment to ensure a day without precipitation or high winds. Overall, the weather was ideal for the foliar treatment.

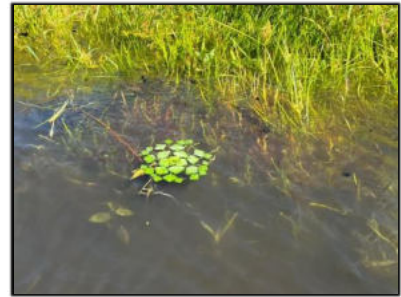
Figure 11: Water chestnut plant found within Great Meadows

Overall, this portion of the River looked great as the treatment worked very well. Minimal water chestnut was documented as it was noted in trace densities (see Figure 11). When observed, the water chestnut was typically found as just one individual plant (shown in Figure 11). Other invasive species documented included Eurasian milfoil, curly-leaf pondweed, and fanwort. Eurasian milfoil was the most prevalent invasive species documented. Native species observed were duckweed, watermeal, ribbonleaf pondweed, waterlilies, watershield, coontail, snailseed, thin-leaf pondweed, and caliitriche (*Callitriche*). The water level had significantly increased since the previous site visit (the northeast region of the US had recently experienced a heavy rain event days prior to the survey).

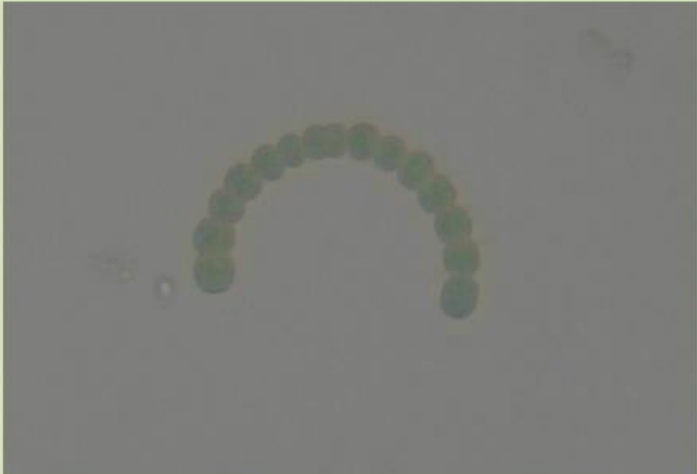
<i>Algae ID Results</i> Great Meadows			
Identification	Classification	Description	Density/Biomass (cells/mL)
<i>Aulacoseria sp.</i>	Bacillariophyta- Diatoms	Filamentous, planktonic	< 40
<i>Dolichospermum sp.</i>	Cyanophyta- Blue-green algae	Filamentous, scum-former, planktonic, taste/odor producer, toxin producer	< 40
<i>Synedra sp.</i>	Bacillariophyta- Diatoms	Single-celled, planktonic	< 40
<i>Ceratium sp.</i>	Dinophyta- Dinoflagellates	Single-celled, flagellated, planktonic	< 40

The algae sample resulted in great results as there was nothing concerning regarding the results. Blue-green algae / cyanobacteria occur in aquatic ecosystems and have the ability to produce toxins. These toxins can pose a risk to human and animal health. The Massachusetts Department of Public Health (MA DPH) recommends an advisory when cell counts exceed 70,000 per ml of water. Dense blooms and scums can contain millions of cells/ml and toxin levels in the parts per million. They can form near embankments and in areas suitable for swimming and other forms of recreation. They can also move around in the water

body and grow quickly, making management of them difficult. The sample resulted in well below both the 70,000 cell/ml threshold set by MA DPH, and the 20,000 cells/ml which would be a concerning threshold. The only potential toxin producing species documented in the algae sample resulted in less than 40 cells per ml.

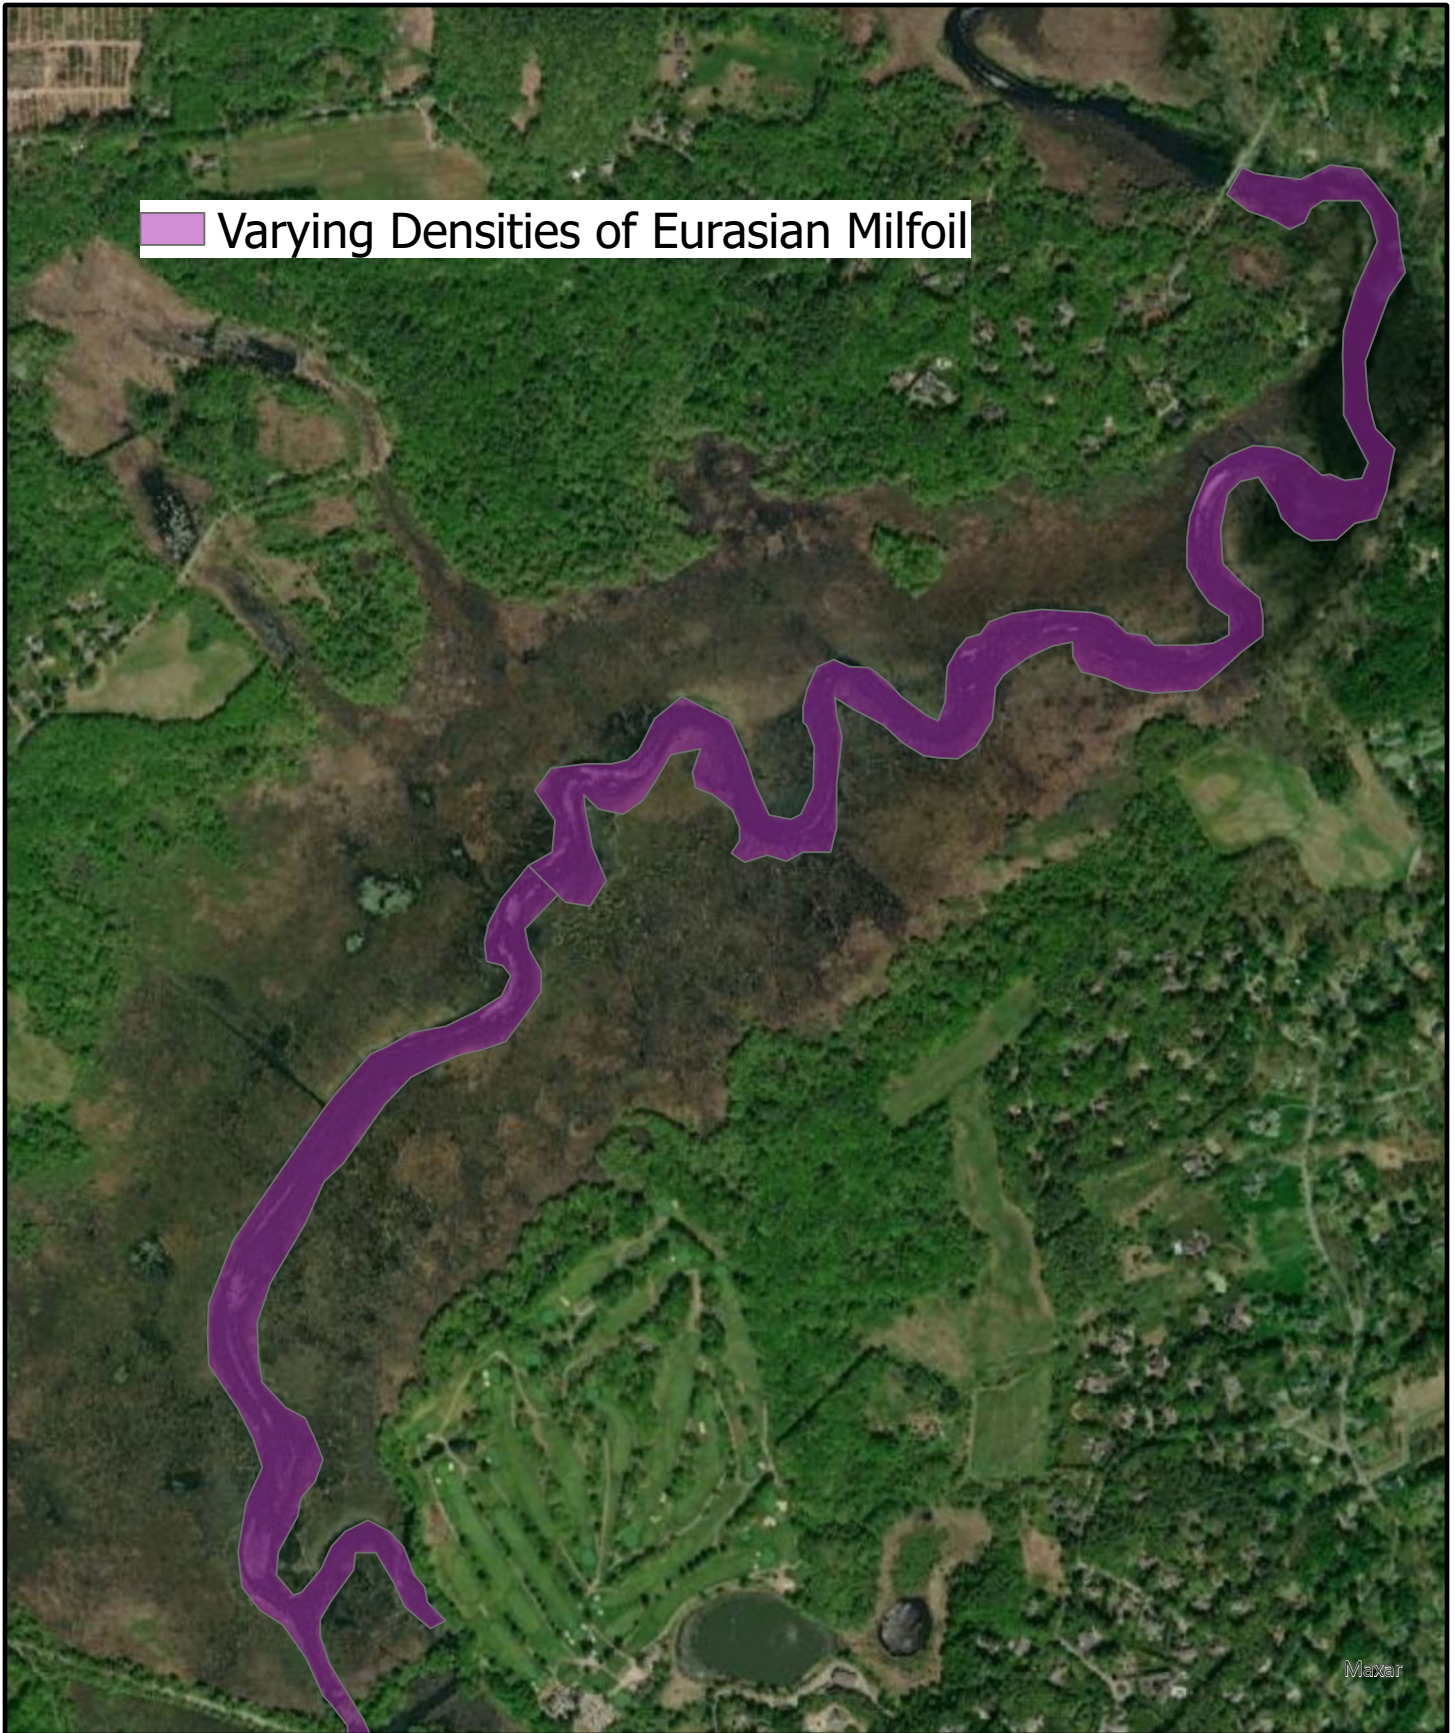
Varying Densities of Eurasian Milfoil

Several things were learned this year through survey data collection. The most noticeable takeaway is that this stretch of River contains several invasive species, with a population dominated by Eurasian milfoil. This is best seen in our pre-treatment survey maps. Invasive species other than water chestnut were not a target for treatment, nor were they impacted by the 2022 management program. The post-treatment survey map of the water chestnut notes several points where water chestnut was present. It is important to note that these GPS points typically contained 1-2 plants, so overall 99%+ of the water chestnut was controlled through the 2022 effort. Other invasive species' cover and densities were similar to that in the pre-treatment maps. Please refer to the post-treatment survey dialogue.

Based on the above alternatives analysis, we would recommend targeting Eurasian milfoil with ProcettaCOR herbicide. This herbicide has been used in Wayland in the past. ProcettaCOR is a highly selective systemic herbicide used for the management of freshwater aquatic vegetation. ProcettaCOR' selectivity allows for impacts milfoil with minimal impact to native pondweeds. While ProcettaCOR provides multiple year systemic control of milfoil, it also acts much like a contact herbicide in that it makes spot-treatment possible, yet also has a very short half-life in water (roughly 9 hours). Usage of ProcettaCOR allows for less product in the water. Due to its selective formulation, ProcettaCOR can be applied at very low concentrations. This effort would come at a fairly significant cost and may be best suited following another one to two seasons of water chestnut control. We are happy to discuss this approach more at any time.
