November 30, 2022

**Re: Hop Brook Ponds (Stearns Millpond, Carding Millpond, and Grist Millpond), Sudbury, MA – 2022 Year End Report (DEP File #301-1283)**

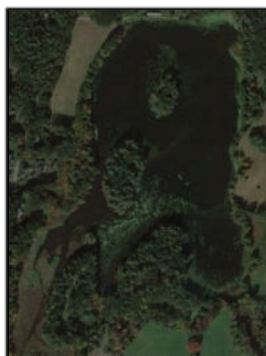
*Figure 2: Carding Millpond - Sudbury, MA*

Carding Millpond is found in the middle of Grist Millpond and Stearns Millpond. This waterbody is south of Stearns Millpond, and northeast of Grist Millpond. Carding Millpond is approximately 42.8 acres, including two islands within the middle of the Pond. The northern island is roughly 0.85 acres while the southern island (the larger island) is about 2.4 acres. Access to Carding Millpond was gained from a boat launch on the northern shoreline. The road to the boat launch is found off of Dutton Road, which runs along the western shoreline. The Pond is surrounded by sparse woodlands with a handful of developed properties/fields mixed noted on each shoreline. Two inlets are noted within the Pond, one in each southern basin. The primary inlet is found within the southwestern basin. The outlet within the Pond is along the northern shoreline, which flows into Hop Brook.

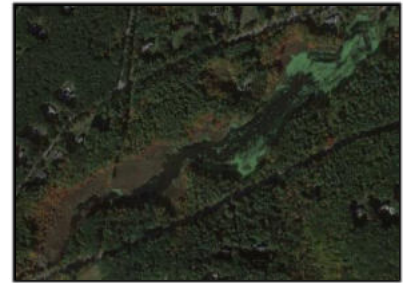
Figure 3: Grist Millpond - Sudbury, MA

Grist Millpond is found north of Route 20 (Boston Post Road) and south of Wayside Inn Road. This waterbody is approximately 12.9 acres and is surrounded by woodlands and wetlands, with a small number of developed properties along the northern shoreline. The Wayside Inn Grist Mill is located downstream of the Pond. Access to the Pond was gained from the northeastern point of the waterbody,

adjacent to the outlet. Water flows from the west (inlet at the western point) to east within Grist Millpond. Due to lack of proper boat access, a crane was utilized to assist with launching the airboat for each treatment. The outlet to the Pond is a small culvert that is noted underneath a walking path. There are walking paths observed around portions of the perimeter of this waterbody. Grist Millpond is a well-known historical site in addition to a popular location for outdoor recreational activities such as hiking, fishing, walking dogs, and bird watching. There is public parking off of Wayside Inn Road for both the Grist Millpond area as well as the Wayside Inn Grist Mill.

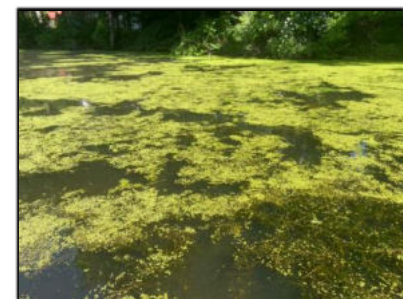
Figure 4: A mix of pondweeds and algae within Stearns Millpond

Maps/external GPS. Stearns Millpond was the first pond surveyed. Throughout the Pond, both native and invasive species (illustrated in Figure 4) were observed, ranging from trace to dense densities. The native species noted were moderate to dense densities of thin-leaf pondweed (*Potamogeton pusillus*), dense densities of mixed duckweed (*Lemnoideae*) and watermeal (*Wolffia*) along the entire shoreline, and scattered in the middle of the Pond, dense densities of coontail, which can sometimes be mistaken for milfoil. This has 100% been documented as native coontail (*Ceratophyllum demersum*) and not invasive milfoil (*Myriophyllum humile*). There were also sparse densities of elodea (*Elodea*) observed. As for the invasive species, there were dense densities of curly-leaf pondweed (*Potamogeton crispus*) throughout the water column, as well as surfacing, and flowering. Some of the curly-leaf pondweed also had epiphytic algae covering it, which is an indication that the plant is decaying. Curly-leaf pondweed is a colder water invasive species that typically starts to die off naturally around this time of year. There were also scattered patches of water chestnut in trace to moderate (primarily trace to sparse densities), with floating seeds, a majority was surfaced, but some was growing throughout the water column. The densest area was the eastern portion of the Pond, and as you travel to the west, it becomes more scattered. Along the shoreline there were scattered patches of invasive phragmites (*Phragmites australis*).

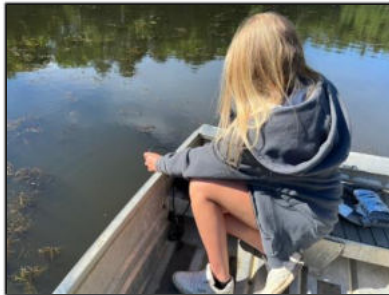
Figure 5: Field Assistant, Grace Adams, collecting water quality data

While on-site, basic water quality was collected using calibrated meters (see Figure 5 above). The pH was 7.0, which is within the standard range for freshwater and considered neutral. The water temperature was consistent with other similar waterbodies we manage in the area, and the dissolved oxygen was sufficient to support fish and wildlife. The water clarity was also assessed, and deemed as above average, as visibility was to the bottom of the Pond, although the Pond is fairly shallow throughout.

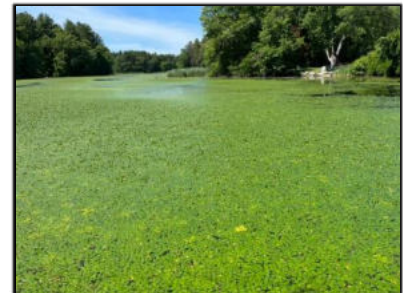
Figure 6: Dense water chestnut noted at Grist Millpond

The next waterbody surveyed was Grist Millpond. Since the waterbody was so heavily populated with water chestnut, a motor was not able to make it through, therefore the 12' jon boat was rowed throughout the Pond. The Grist Millpond was roughly 90-100 percent covered with water chestnut (pictured in Figure 6 above, and in the background of Figure 7), as well as watermeal, and algae. Several rake tosses also revealed elodea, a native species, that was under all the surfaced water chestnut. Lastly, moderate to dense curly leaf pondweed (invasive) was documented throughout the majority of the Pond, as shown in the attached map.

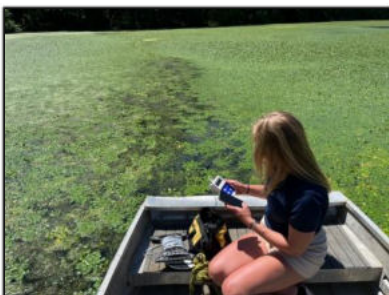
Figure 7: Dense water chestnut resulting in difficult conditions to navigate throughout the Pond; Water quality data collected

The pH was 7.3, which is within standard range for freshwater and considered neutral (Grace Adams collecting water quality data in Figure 7). The water temperature was consistent with other similar waterbodies we manage in the area, and the dissolved oxygen was sufficient to support fish and aquatic organisms. The water clarity was difficult to assess, due to the large amount of vegetation on the

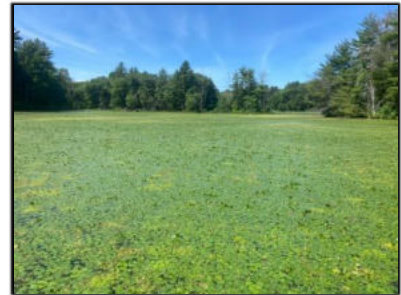
Carding Millpond was the final waterbody that was surveyed. Throughout the Pond, both native and invasive species were observed at varying densities. The native species noted were moderate densities of thin-leaf pondweed, dense densities of duckweed and watermeal along the entire shoreline and scattered in the middle of the Pond, dense densities of coontail. There were also moderate to dense densities of elodea observed. As for the invasive species, there were dense densities of curly-leaf pondweed throughout the water column, as well as surfacing, and flowering. Some of the curly-leaf pondweed also had epiphytic algae covering it. The water chestnut (see Figures 8 and 9) was present in dense densities in the southwestern section of the Pond (pictured in Figure 8), as well as around the island, with filamentous algae mixed in around it. The rest of the water chestnut was in moderate densities throughout the entire Pond, with some areas of sparse densities.

Figure 8: Water chestnut pictured in the southern basin at Carding Millpond

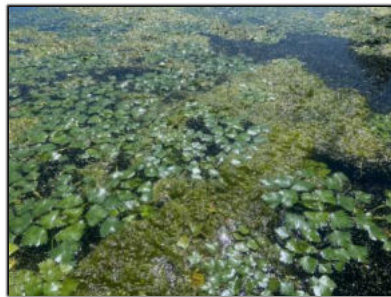
Figure 9: A mix of water chestnut, coontail, and filamentous algae

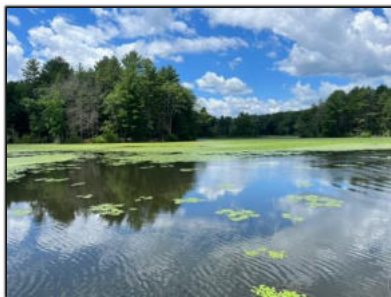
*Figure 11: Water chestnut documented within Carding Millpond during the treatment*

As planned, a treatment was conducted for the control of invasive water chestnut. Clearcast (imazamox), the approved herbicide under the Order of Conditions issued by Sudbury Conservation Commission, and the MA-DEP WM04 permit, was paired with a non-ionic surfactant. The mixture was applied to all water chestnut within the three Ponds via foliar application using low-volume calibrated spray equipment. This methodology, which is approved under the Order of Conditions, allows for even coverage and distribution to the target water chestnut, while limiting any non-target impacts. Weather was also closely monitored prior to treatment to ensure a treatment date without rain or high winds. Conditions for the treatment were perfect. Grist Millpond was accessed by a crane provided by Astro Crane (see Figure 10 above). This was scheduled several weeks in advance of the treatment. The crane lifted the airboat into the Pond, where it was then used for the treatment. Carding Millpond was also treated by airboat but did not require a crane as there is a suitable launch (treatment at Carding Millpond pictured in Figure 11). While on-site, crew leader, Colin Gosselin, assessed the density and distribution of the water chestnut

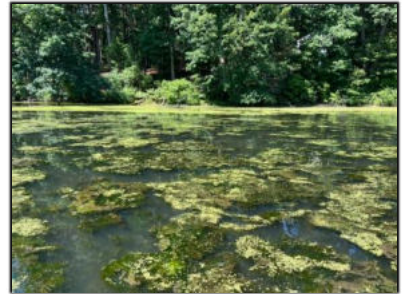
*Figure 12: Moderate to dense pondweeds and filamentous algae within Stearns Millpond*

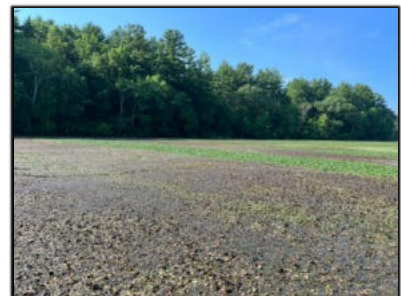
*Figure 13: Lanes of dead and living water chestnut formed from the previous treatment at Grist Millpond*

Upon arrival, brief interim surveys of each Pond were conducted using visual observation and a throw-rake. Strips/lanes of dead/dying water chestnut were noticeably visible in all areas previously treated within all three Ponds (lanes created from the previous treatment documented in Figures 13-16). This is consistent with what we'd hope to see following the initial treatment. As you'll see in the photos, some of the water chestnut had already fallen from the water column, while much of it was brown/dead but had not fallen from the water column yet. The dead chestnut plants eventually dropped from the water column. Prior to this treatment, several live water

Overall, the weather conditions for both treatments were ideal. The results from the first treatment were desirable (illustrated in Figures 13-16), and the second treatment was performed without issue. Excellent coverage was achieved during both treatments, and we were confident that the desired level of control would be achieved. Continued browning of the water chestnut plants treated during this follow-up

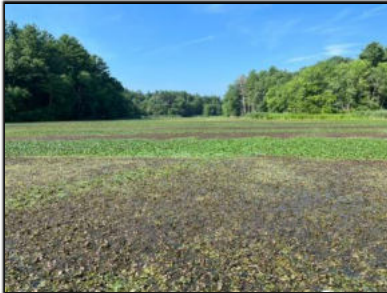
*Figure 14: Grist Millpond post the initial treatment; Lanes formed throughout the waterbody*

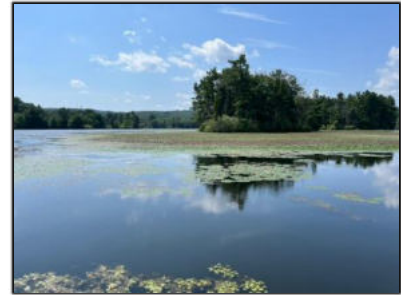
*Figure 15: Carding Millpond after the initial treatment*

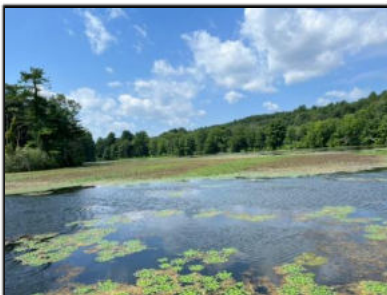
*Figure 16: Areas of water chestnut dropping out of the water column around the island at Carding Millpond*

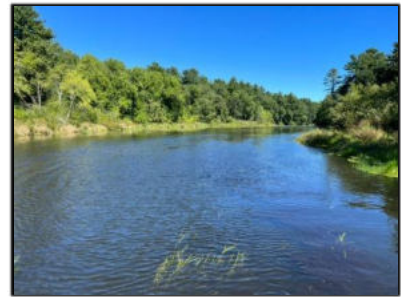
*Figure 17: Great results documented at Stearns Pond from the 2022 treatment program*

Upon arrival, surveys were conducted using visual observation paired with a standard throw-rake and handheld GPS/ArcGIS Field Maps, as applicable. The overall health and conditions of Stearns Mill Pond had improved drastically since the first treatment. The Pond looked great as the treatments worked very well (conditions noted in Figure 17).

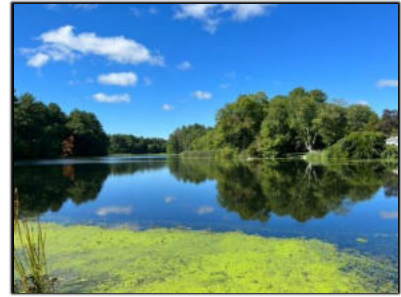
Grist Millpond was the second waterbody surveyed during the site visit. Overall, the Pond had greatly improved since the series of treatments (illustrated in Figure 19). The water chestnut population had significantly decreased as great control was achieved. Water chestnuts were still documented, but at trace to moderate densities scattered around the Pond. Water chestnut was primarily documented against the shoreline, with a few small patches scattered throughout the middle of the western half of the Pond. The majority of the eastern half of the Pond was open water. A large percentage of the small areas of remaining water chestnut did not appear healthy looking, as the plants were no longer rooted, discolored in appearance, or covered in epiphytic/filamentous algae. Filamentous algae was primarily found in the western half of

Figure 19: Overlooking Grist Millpond post-treatment

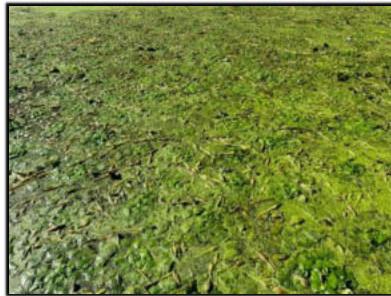
Figure 20: Floating water chestnut fragments, watermeal, and duckweed pictured on the surface of Grist Millpond

the western half of the Pond, in proximity of dead water chestnut and dense watermeal/duckweed (see Figures 20 and 21). This was typically found on the surface, although benthic filamentous algae was noted throughout the Pond (see Figure 20), but primarily contained within the western point of the Pond. Other native species noted include Elodea, coontail, duckweed, watermeal, and ribbon-leaf pondweed (*Potamogeton epihydrus*). Duckweed and watermeal were the most prevalent and dominant species documented throughout the Pond. Duckweed and watermeal were observed as very dense throughout the western 2/3's of the Pond (pictured in Figure 21). In the eastern half, it was more scattered at trace to sparse densities. The densest areas of duckweed and watermeal in the eastern half of the Pond were areas where water chestnut was also located. Cattails (*Typha sp.*) were noted scattered around the perimeter of the Pond in sparse to dense densities. Also documented throughout the survey were floating fragments of water chestnut plants and water chestnut seeds. The gate was shut and tied closed with the rope while leaving the site.

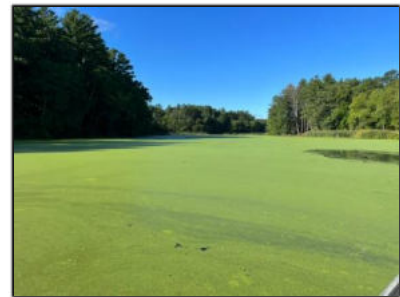
Figure 21: Dense duckweed and watermeal at Grist Millpond

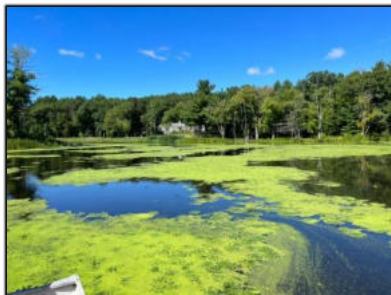
Figure 22: Dense coontail and algae noted at Carding Millpond

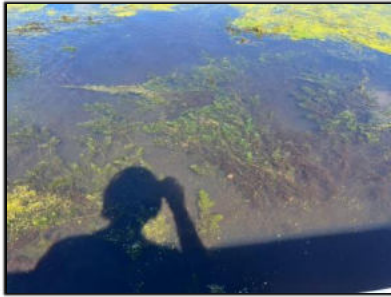
Figure 23: Scattered water chestnut mixed throughout the duckweed, watermeal, coontail and algae at Carding Millpond

was noted as more scattered trace to sparse densities within the middle areas of the Pond. This is where individual plants to very small, isolated patches were located. The southern coves significantly improved from the previous pre-treatment conditions. Water chestnut fragments and seeds were documented floating on the surface throughout the Pond. There were a few areas of open water, including portions of the northwestern corner, middle/eastern-middle of the Pond, and within the southwestern coves. Other species notes included waterlilies, coontail, elodea, watermeal, duckweed, thin-leaf pondweed, and cattails (mix of mentioned species in Figures 22 and 23). The most prominent species throughout the Pond included watermeal, duckweed, and coontail as these species were documented at moderate to dense (see Figures 22 and 23). The coontail made traveling throughout the Pond very difficult as it was surfacing throughout the majority of the Pond. Elodea, waterlilies, and thin-leaf pondweed were documented at trace densities. The southwestern coves were extremely shallow. Filamentous algae and epiphytic algae were noted, with filamentous algae being the primary algae documented (noted in both Figures 22 and 23). Filamentous algae was observed scattered on the surface mixed throughout the vegetation. It was primarily found on the surface, but occasionally documented on the bottom. Epiphytic algae was noted on a small percentage of the vegetation, which indicates that the plant is dying/decaying. The gate was closed and locked while leaving the site.

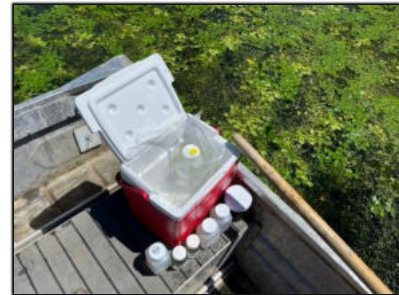
Figure 24: Water and Wetland collecting water quality

As required by the special orders (within the order of conditions), during the June 14<sup>th</sup> and September 8<sup>th</sup> survey events, water samples (see Figure 24 to the right) were collected to analyze specific water quality within Grist Millpond, Stearns Millpond, and Carding Millpond. Samples were collected from the middle of the Ponds, preserved, and immediately taken to a State certified laboratory where they were analyzed for the specific contracted parameters. As noted above, the samples were analyzed for turbidity, true color, apparent color, total alkalinity, ammonia nitrogen, nitrate nitrogen, total kjeldahl nitrogen, total phosphorus, soluble phosphorus, and E. coli. All samples collected were “surface grabs.” Dissolved oxygen, pH, and temperature were measured using a calibrated meter during each site visit.

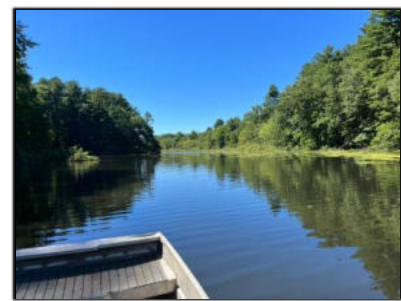
*Figure 26: Stearns Millpond post-treatment; The treatments proved very effective*

Based on the above narrative, we recommend continuing with a similar approach to water chestnut management in 2023. From an application perspective we may start slightly earlier in the season in 2023 which will help us gain even better coverage as dense water chestnut virtually grows on top of itself, leaving some plants less susceptible to herbicide cover. This additional time will also allow us to add a potential small third treatment in Carding Millpond and/or Grist Millpond. If access allows us to eliminate the need for a crane, we will have additional flexibility as we will need not rely on the crane company's schedule and lead times. We will keep both Hop Brook Protection Association and Sudbury Conservation Commission up to date throughout the season, as we did in 2022. This will allow us to adjust as needed, including starting slightly earlier and adding a possible third Clearcast application. In conclusion, the water chestnut treatment program works extremely well as designed, and slight adjustments to timing and the number of applications can make the program even more efficient and effective.

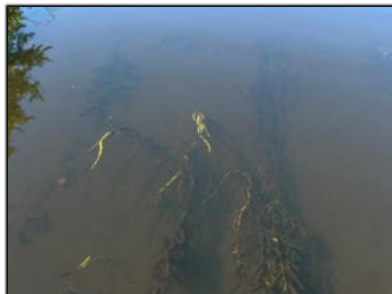
*Figure 27: Curly-leaf Pondweed*

Aside from the water chestnut, some thought should be put towards management of other nuisance and/or invasive species. Especially for Grist Millpond and Carding Millpond, many areas where water chestnut was controlled were replaced by dense watermeal and duckweed covering the surface. Although watermeal and duckweed are both native species, their dense cover also has the ability to limit oxygen exchange and biodiversity. Additionally, these ponds specifically have additional dense species including coontail and/or elodea. Lastly, curly-leaf pondweed (invasive) was documented in all three waterbodies. Luckily, milfoil was not documented in any of the three ponds. In an effort to create open-water habitat in the ponds, some consideration should be given to treatment with Sonar (fluridone), particularly at Carding Millpond and Grist Millpond. Sonar is an aquatic herbicide that was initially registered with the Environmental Protection Agency (EPA) in 1986 and has been used throughout Massachusetts and the United States for decades. The herbicide inhibits the photosynthesis process by stopping plants from making a protective pigment that keeps chlorophyll from breaking down in the sunlight. Fluridone moves quickly throughout a waterbody and is therefore usually applied as a whole lake/basin treatment, as would be recommended for Grist Millpond and Carding Millpond. Sonar is also one of the few herbicides approved for use in drinking water, which speaks volumes to the safety of the

product. This approach requires maintenance of approximately 10-20 parts per billion of fluridone for a period of 45-60+ days, so an initial treatment and at least follow-up application would be recommended. We recommend this approach in an effort to create more open-water habitat in the ponds, specifically Grist Millpond and Carding Millpond.
