## 4 Southwest Circle Sudbury, Ma Landscape Restoration Plan

Submitted for Hearing on February 5, 2024

Karen Sebastian LLC

Landscape Architecture

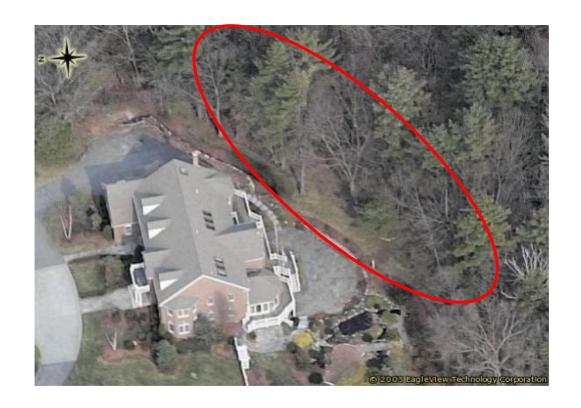
Condition of rear yard, area of concern, April 18, 2003

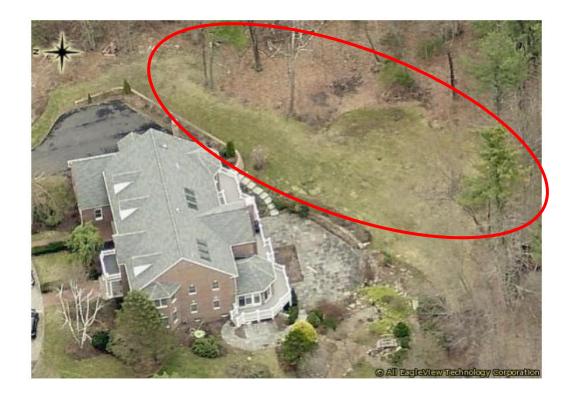
Condition of rear yard, area of concern, April 18, 2019 showing encroachment on resource area.

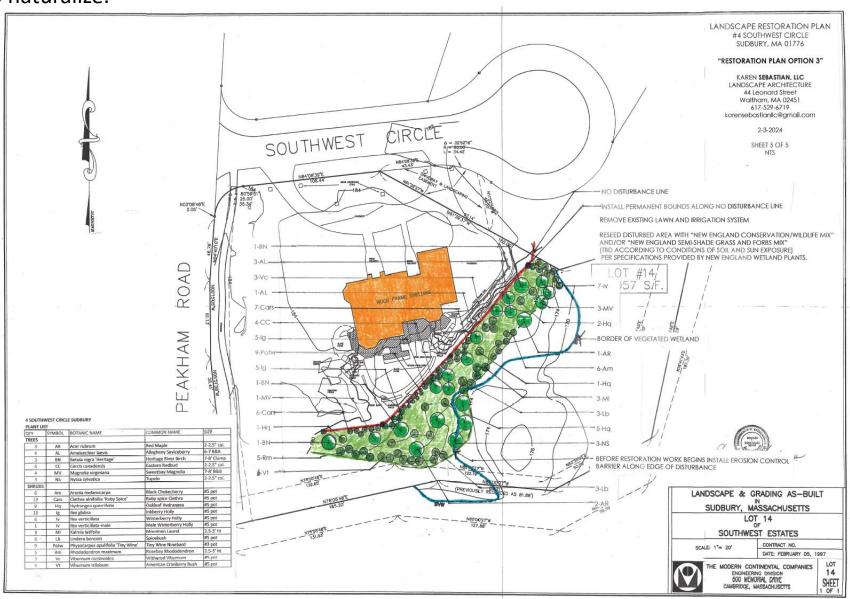
"RESTORATION PLAN OPTION 3". Proposed Restoration of Disturbed Area-Install Permanent Bounds to indicate new "LIMIT OF MOWING", remove Existing Lawn and Irrigation System, Install Native Trees and Shrubs per plan, Re-seed area with Native Seed Mix suitable to site conditions supplied by New England Wetland Plants to stabilize disturbed soil. Allow area to naturalize.
