**Environmental Monitor Construction Site Inspection Report  
MassDOT Project #608164 Construction Contract # 119678  
EM Report #2**

Project Description: Bruce Freeman Rail Trail Right-of-Way  
Permit Description(s): Order of Conditions (MGL Chapter 131, Section 40 and 310 CMR 10.00, Mass DEP File No. 301-1362); 2022 EPA NPDES General Permit for Discharges from Construction Areas; U.S. Army Corps of Engineers Permit No NAE-2021-01975.

Project Name: Bruce Freeman Rail Trail - Phase 2d - Sudbury  
Date of Inspections: 5/16/2024  
Bi Weekly/ Monthly Period Covered: May Weekly Inspection #2  
Inspector's Name(s): Douglas Beach  
Inspectors' Contact Information: [dbeach@beta-inc.com](mailto:dbeach@beta-inc.com)

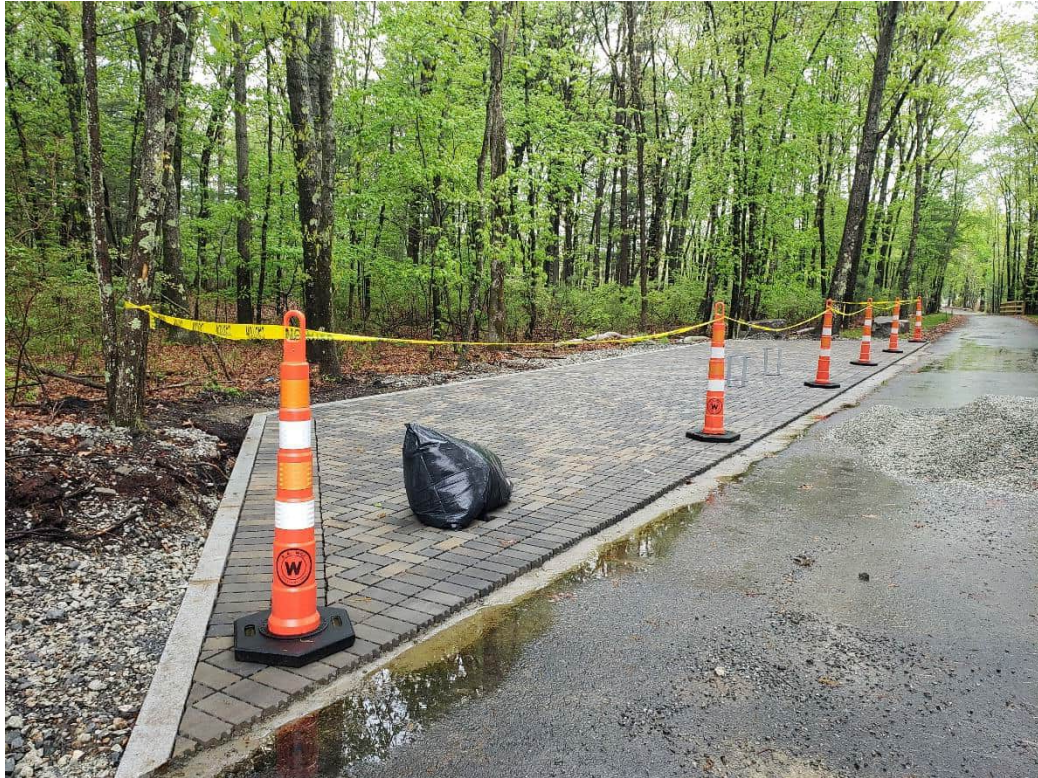
**Photo No. 1**    **Date:**  
5/16/2024

View of trash at the newly constructed rest area near Station 101+00 per Compliance Action Item 29.

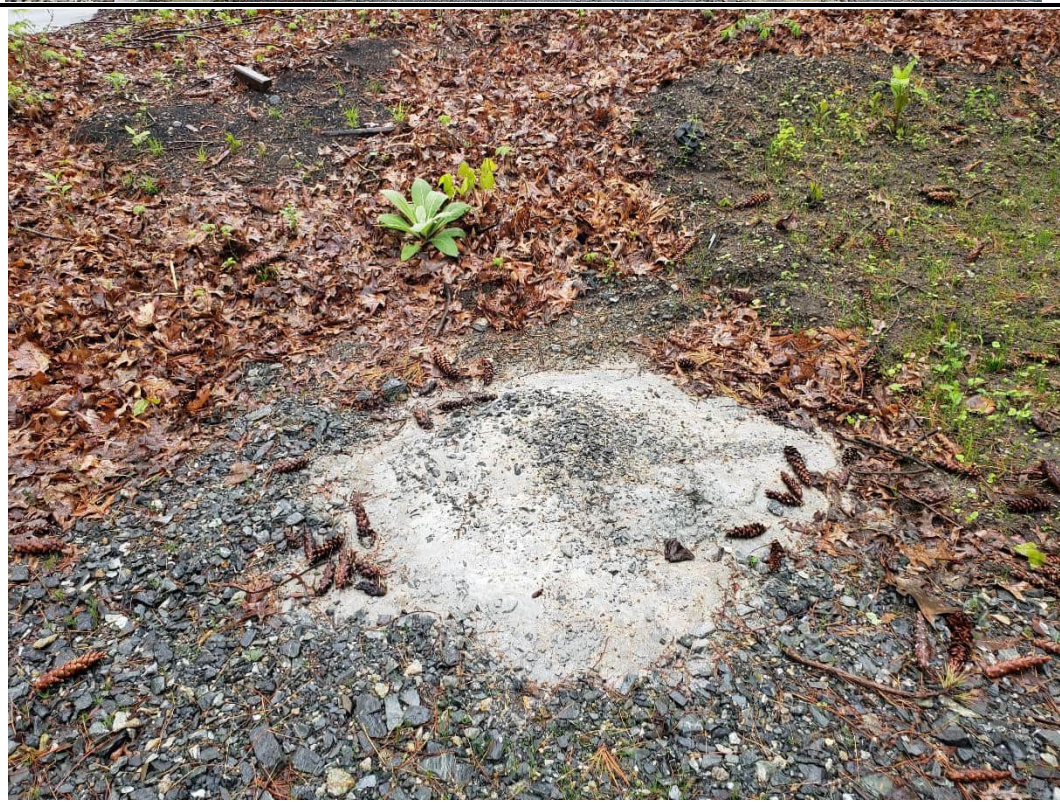
**Photo No. 2**    **Date:**  
5/16/2024

Typical view of dried concrete and cement washout at Station 143+50 per Compliance Action Items 1, 2, 4, 7, 11, 28, and 30.

Item	Location/ Description	Observation Date	Resolution Due Date	Recommended Resolution / Resolution Date	Comments/Updates
31	Stabilize loam recently placed between Stations 256+00 and 292+00 <b>Priority: High</b>	5/16/2024	5/23/2024	Apply seed and straw for stabilization.	
30	Concrete pile improperly disposed of at Station 101+00 <b>Priority: Low</b>	5/16/2024	5/23/2024	Remove concrete pile from the area.	
29	Trash has been left on the rest area pad at Station 101+00 <b>Priority: Low</b>	5/16/2024	5/23/2024	Remove the trash in a proper manner.	
1	Trash and concrete improperly disposed of around Stations 125+50 through 126+00 <b>Priority: Low</b>	5/8/2024	5/15/2024	Pick up loose trash and remove concrete pile from the area in accordance with the SWPPP.	5/16/2024 - Observation remains.
2	Concrete pile requiring disposal at Station 143+50 <b>Priority: Low</b>	5/8/2024	5/15/2024	Remove concrete pile from the area.	5/16/2024 - Observation remains.

7	Concrete pile improperly disposed of at Station 181+50 <b>Priority: Low</b>	5/8/2024	5/15/2024	Remove concrete pile from the area.	5/16/2024 - Observation remains.

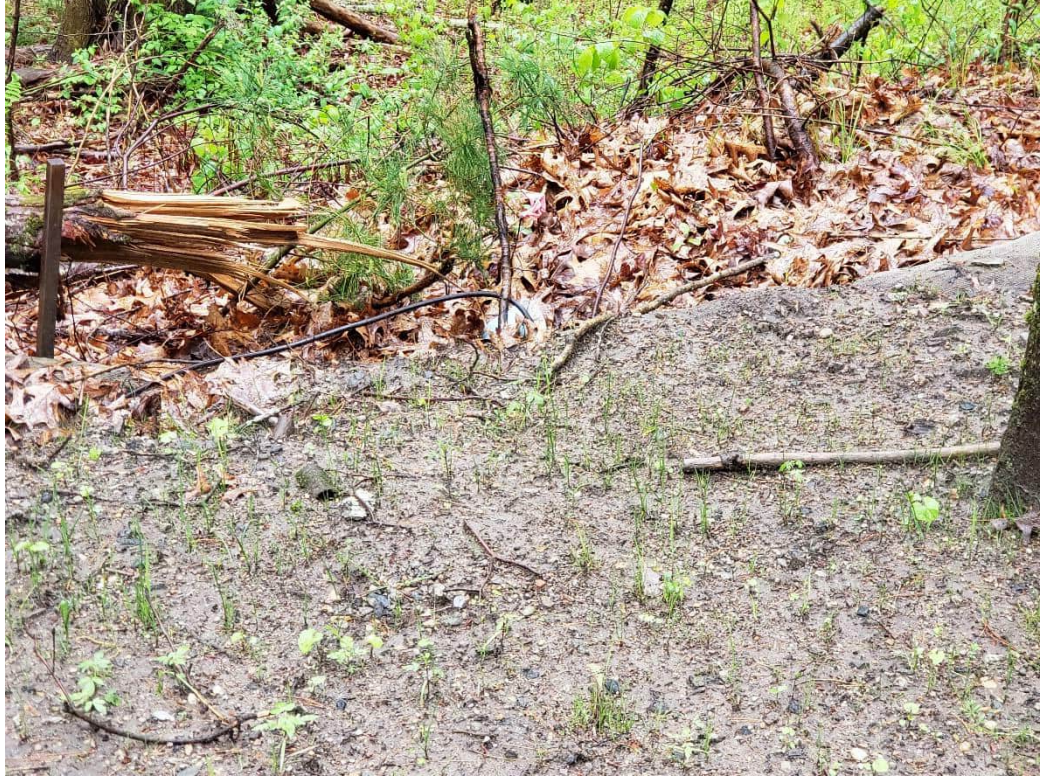
**Photo No. 3**    **Date:** 5/16/2024

Typical view of washout between Stations 155+00 through 162+00 per Compliance Action Item 3.

3	Sediment washout over the slope and existing erosion controls at Stations 155+00 to 162+50 <b>Priority: Low</b>	5/8/2024	5/15/2024	Replace decomposed and damaged compost filter tubes in the areas necessary to contain sediment washout until stabilization measures are completed.	5/16/2024 - Observation remains.
4	Concrete pile improperly disposed of at Station 163+00 <b>Priority: Low</b>	5/8/2024	5/15/2024	Remove concrete pile from the area.	5/16/2024 - Observation remains.
5	Turbid water in swale at Stations 167+00 through 172+00 <b>Priority: High</b>	5/8/2024	5/15/2024	Stabilize all contributing areas to the swale and implement stabilization measures over exposed soils within the swale itself once water recedes. It is recommended that the contractor coordinate with MassDOT on stabilization within the swale, which may require jute netting and seed.	5/16/2024 - Observation remains.
6	Exposed sediment slope at Station 172+00 to 175+00 <b>Priority: High</b>	5/8/2024	5/15/2024	Install temporary sediment controls along the slope such as jute netting and/or straw following the application of seed.	5/16/2024 - Observation remains.

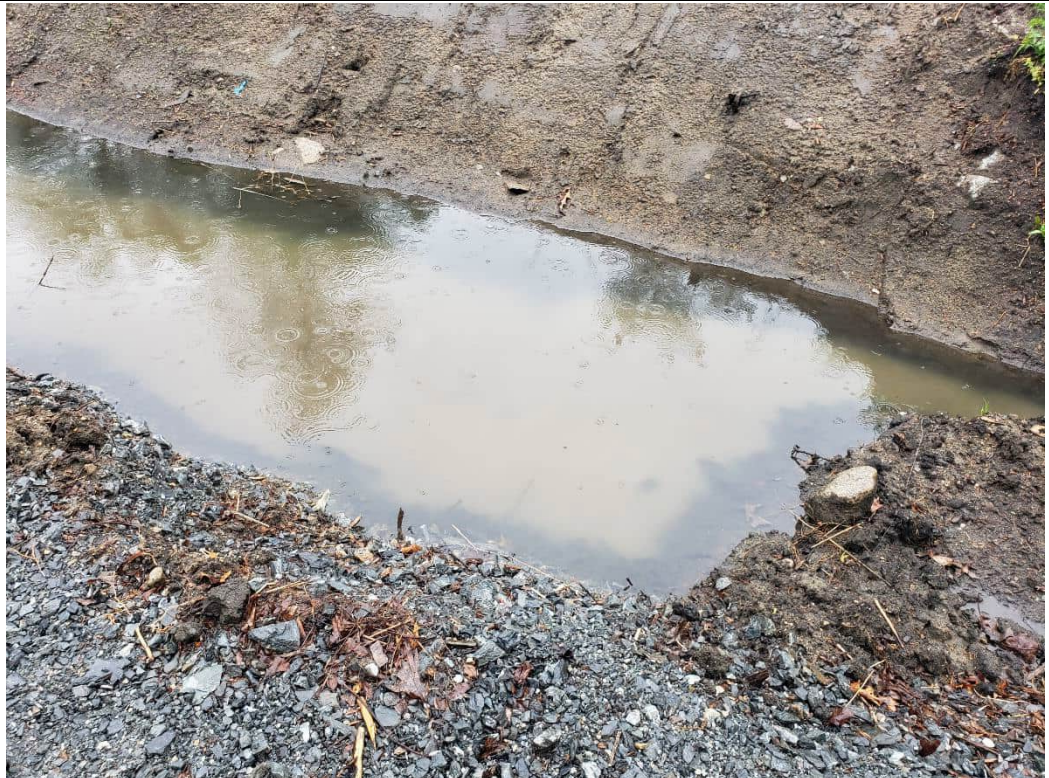
**Photo No. 4**    **Date:** 5/16/2024

View of turbid water within a channel near Stations 167+00 through 172+00 per Compliance Action Item 5.

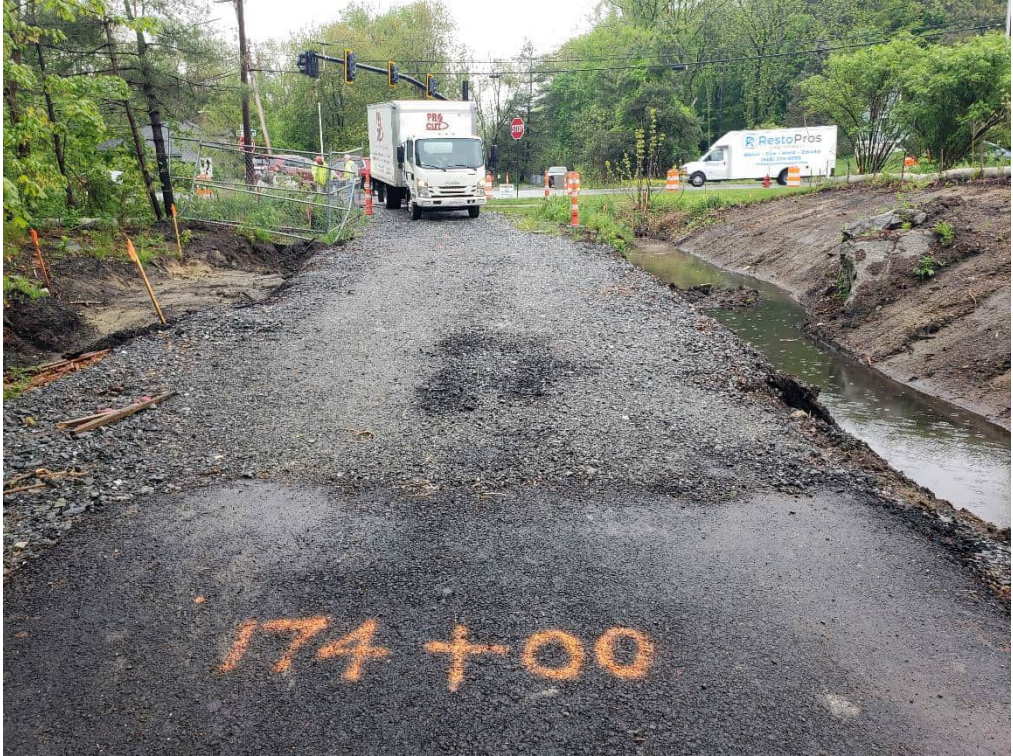
**Photo No. 5**    **Date:** 5/16/2024

View of exposed soils requiring stabilization along the east side of trail near Stations 172+00 through to 175+00 per Compliance Action Item 6.

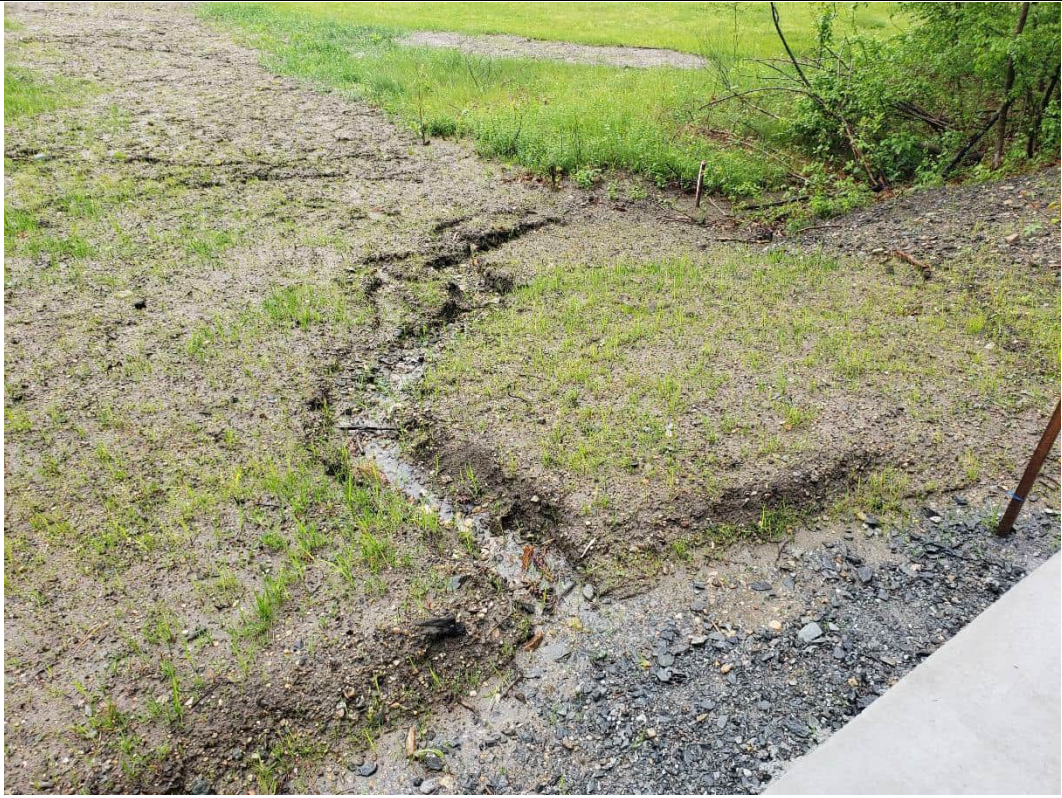
**Photo No. 6**    **Date:** 5/16/2024

View of rill erosion along a slope at the intersection of Stations 184+50 and 1003+00 per Compliance Action Item 9.

9	Rill erosion resulting in offsite sediment migration at Station 1003+00 <b>Priority: Low</b>	5/8/2024	5/15/2024	Fill in rills and apply seed to stabilize the area. Temporary stabilization measures such as straw and/or jute netting may be required.	5/16/2024 - Observation remains.
11	Concrete pile improperly disposed of at Station 185+00 <b>Priority: Low</b>	5/8/2024	5/15/2024	Remove concrete pile from the area.	5/16/2024 - Observation remains.
13	Rill erosion is occurring along the west side of the trail at Stations 201+50 to 204+00 <b>Priority: Low</b>	5/8/2024	5/15/2024	Fill in rills and apply seed to stabilize the area. Temporary stabilization measures such as straw and/or jute netting may be required.	5/16/2024 - Observation remains.
14	Sediment-laden runoff is being discharged into a stream from the new parking lot at Station 216+50 <b>Priority: High</b>	5/8/2024	5/15/2024	Replace compost filter tubes around the stream and develop a method of redirecting runoff from the parking lot at the source.	5/16/2024 - New compost filter tubes have been installed but were observed to be undermined. In addition, a new earthen slope was observed to be constructed in this area and requires stabilization.

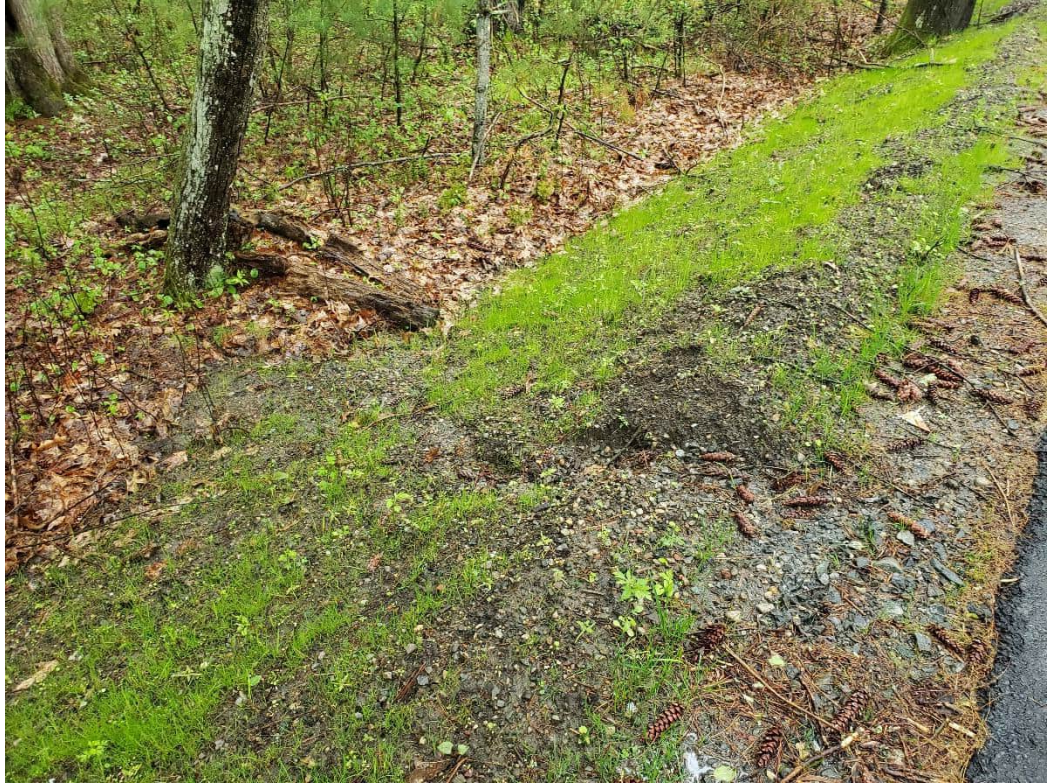
**Photo No. 7**    **Date:**  
5/16/2024

View of typical rill erosion and sediment runoff along the west side of the trail from Stations 201+00 through 204+00 per Compliance Action Item 13.

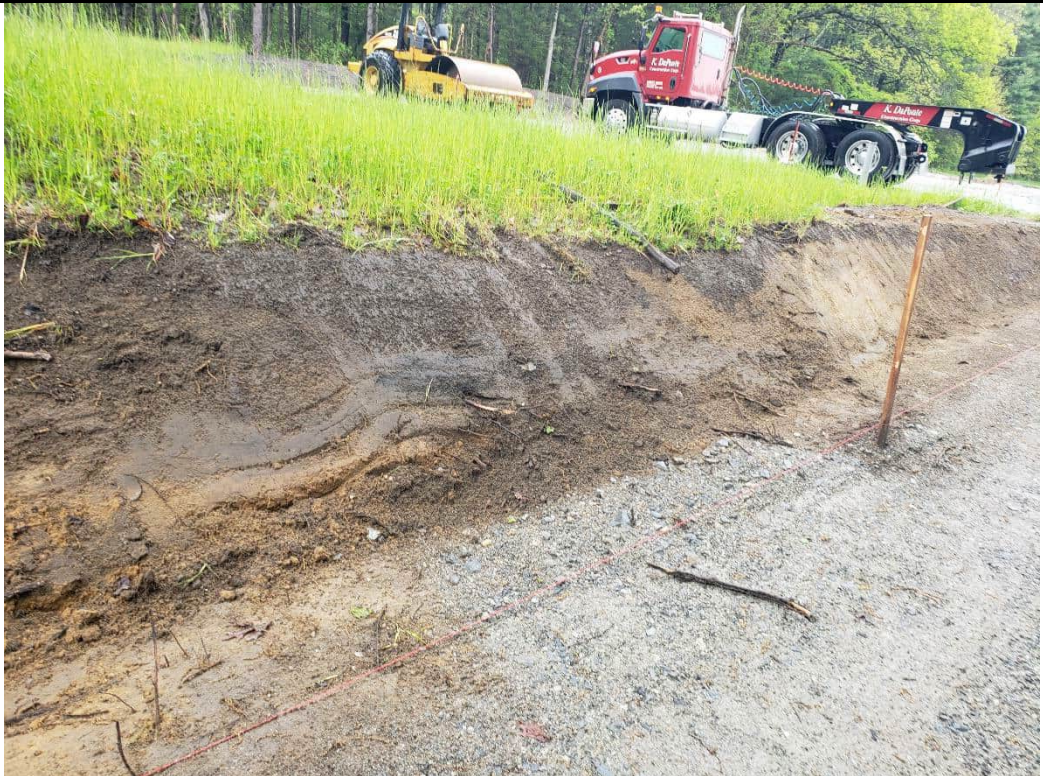
**Photo No. 8**    **Date:**  
5/16/2024

View of exposed soils along a newly graded slope near the parking lot at Station 216+50 per Compliance Action Item 14.

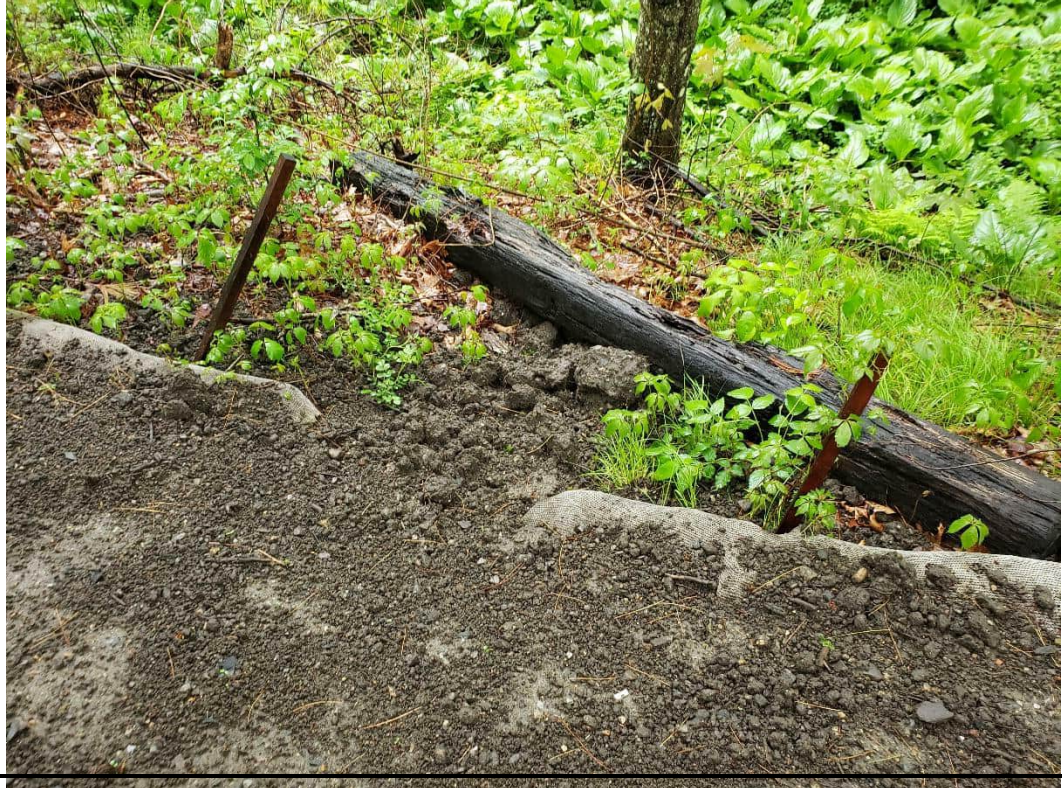
**Photo No. 11** **Date:** 5/16/2024

View of washout overtopping compost filter tubes at Station 231+00 per Compliance Action Item 16.

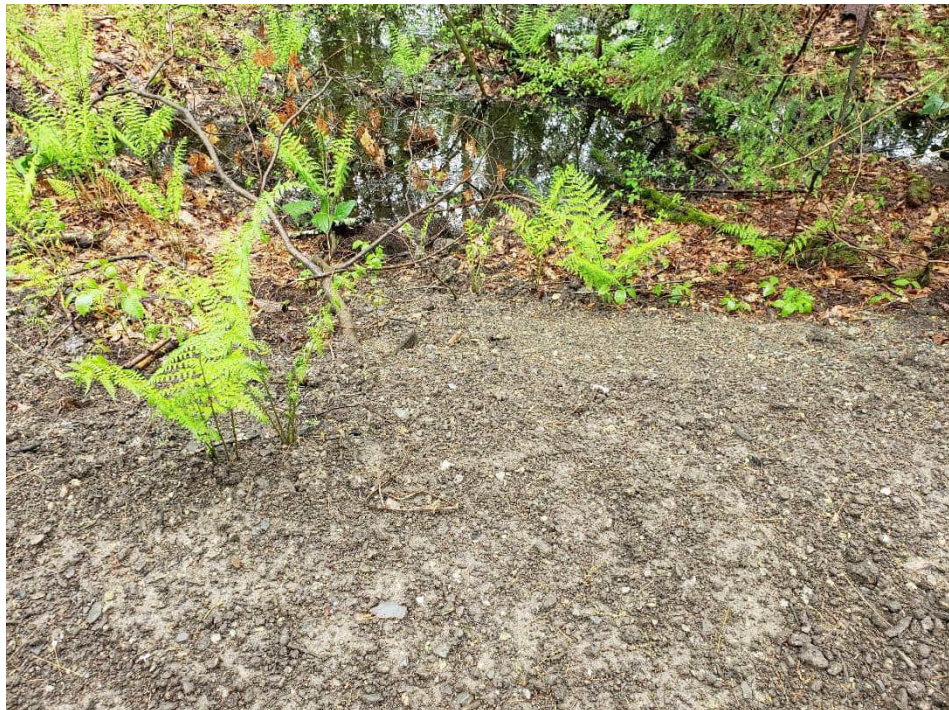
**Photo No. 12** **Date:** 5/16/2024

View of washout overtopping compost filter tubes resulting in sediment/soil accumulation within the wetland along the east side of the trail between Stations 236+00 and 238+00 per Compliance Action Item 17.

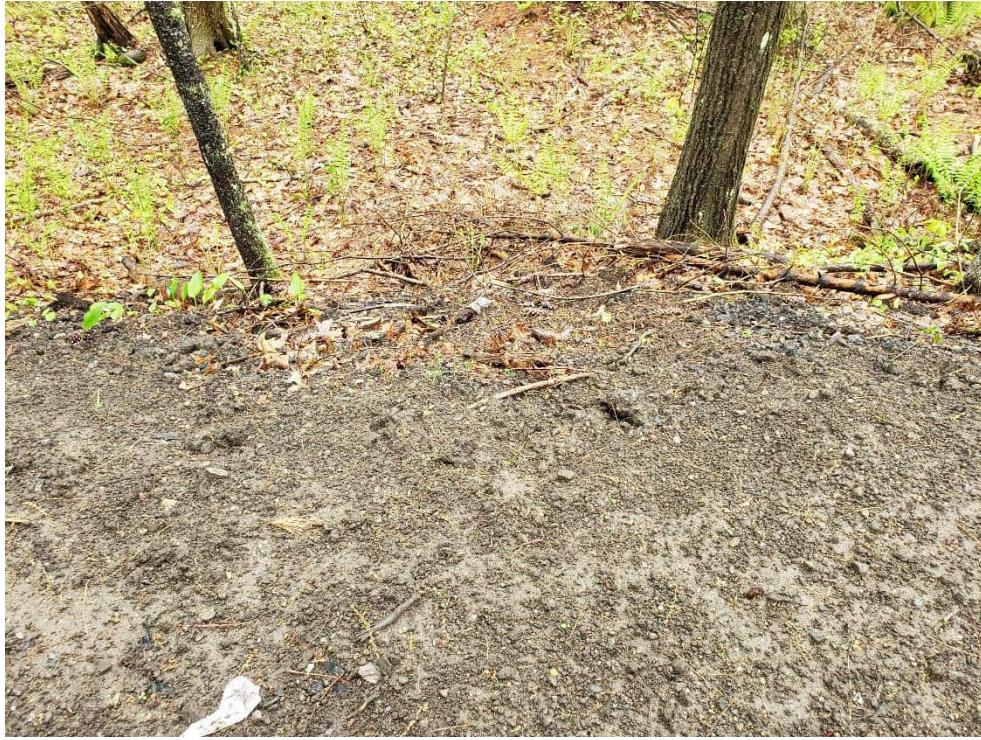
**Photo No. 13** **Date:** 5/16/2024

View of washout overtopping compost filter tubes near Stations 238+00 and 241+00 per Compliance Action Item 18.

18	Sediment migration beyond the limits of work at Stations 238+00 to 241+00 <b>Priority: Medium</b>	5/8/2024	5/15/2024	Stabilize steep slopes with jute netting or compost filter tubes to prevent additional land movement and erosion.	5/16/2024 - Observation remains.
19	Sediment migration into the stream at Station 247+00 <b>Priority: High</b>	5/8/2024	5/15/2024	Install compost filter tubes to prevent further sedimentation of the stream. If dry conditions are present, evaluate whether sediment removal is feasible.	5/16/2024 - Observation remains.
20	Rill erosion moving offsite on the West side of the trail at Stations 252+00 to 253+00 <b>Priority: Low</b>	5/8/2024	5/15/2024	Add or replace compost filter tubes or straw wattles to stabilize the immediate area until grass grows in.	5/16/2024 - Observation remains.
21	Washout and erosion issues on the east side of trail at Stations 255+50 to 256+00 <b>Priority: Low</b>	5/8/2024	5/15/2024	Remove material that has eroded offsite and add additional erosion control such as straw wattles, jute netting, or compost filter tubes.	5/16/2024 - Observation remains.

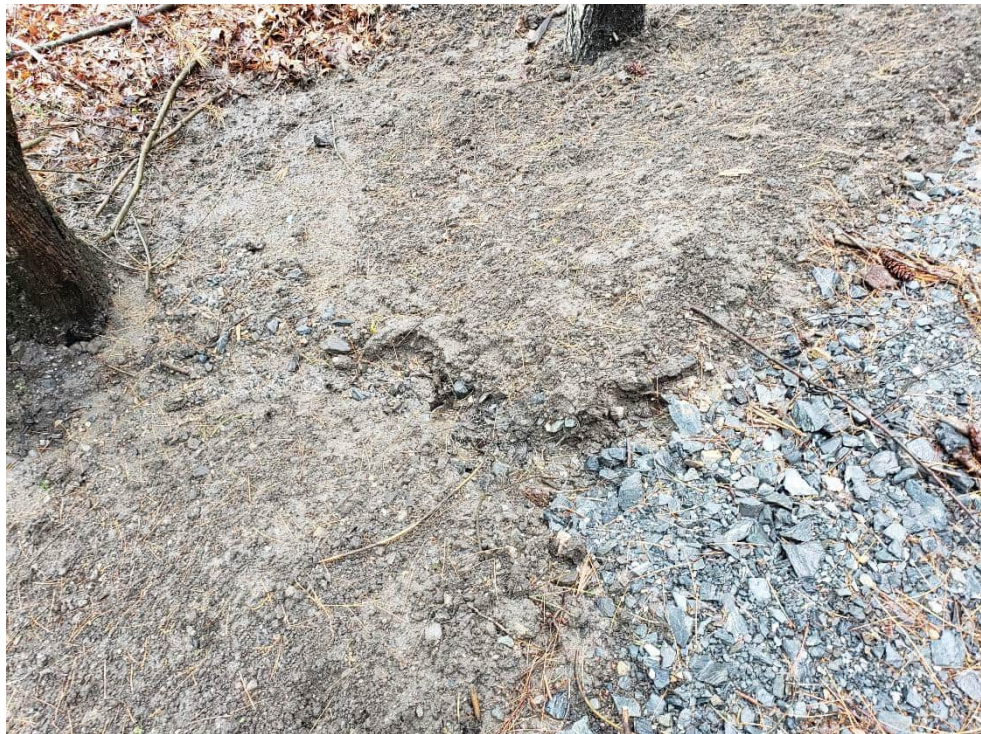
**Photo No. 14** **Date:** 5/16/2024

View of rill erosion along exposed soils near Station 252+00 per Compliance Action Item 20.
