Re: Hop Brook Ponds (Stearns Millpond, Carding Millpond, and Grist Millpond), Sudbury, MA (DEP#301-1283) – 2025 Year End Report

It is our pleasure to present a year-end summary report to The Hop Brook Protection Association regarding the 2025 aquatic management program at the Hop Brook Ponds. The Hop Brook waterbodies include Stearns Millpond, Carding Millpond, and Grist Millpond, all located in Sudbury, MA.

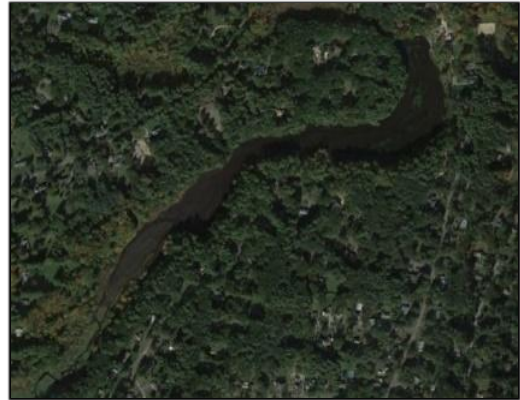
Figure 3: Stearns Millpond - Sudbury, MA

Stearns Millpond (Figure 3) is the northernmost waterbody of the three Hop Brook Ponds and is approximately 16.8 acres. This pond is primarily surrounded by woodlands with developed properties scattered on both the northern and southern shorelines. The inlet (which is Hop Brook) to Stearns Millpond is found along the southwestern point. Water flows from west to east within the waterbody, with the outlet noted at the northeastern point (adjacent to the public parking lot). This outlet is a constructed dam that flows back into Hop Brook. The pond is fairly shallow, with an average depth of roughly 2.5-3 feet. Access to this waterbody is gained from the public parking lot off of Dutton Road.

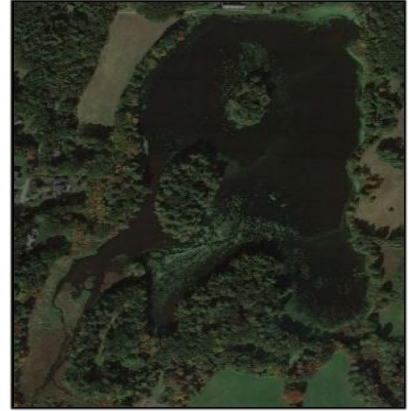
Figure 7: Carding Millpond - Sudbury, MA

Carding Millpond (Figure 8) is found between Grist Millpond and Stearns Millpond. This waterbody is south of Stearns Millpond, and northeast of Grist Millpond. Carding Millpond is approximately 42.8 acres, including two islands within the middle of the pond. The northern island is roughly 0.85 acres while the southern island (the larger island) is about 2.4 acres. Access to Carding Millpond was gained from a boat launch on the northern shoreline. The road to the boat launch is found off Dutton Road, which runs along the western shoreline. The pond is surrounded by sparse woodlands with a handful of developed properties/fields mixed noted on each shoreline. Two inlets are noted within the pond, one in each southern basin. The primary inlet is found within the southwestern basin. The outlet within the pond is along the northern shoreline, which flows into Hop Brook.

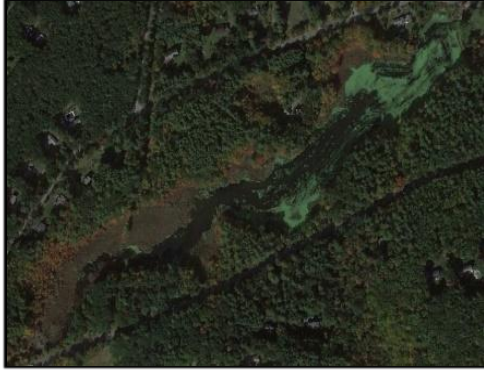
Figure 11: Grist Millpond - Sudbury, MA

Grist Millpond (pictured in Figure 13) is found north of Route 20 (Boston Post Road) and south of Wayside Inn Road. This waterbody is approximately 12.9 acres and is surrounded by woodlands and wetlands, with a small number of developed properties along the northern shoreline. The Wayside Inn Grist Mill is located downstream of the pond. Access to the pond was gained from the northeastern point of the waterbody, adjacent to the outlet. Water flows from the west (inlet at the western point) to east within Grist Millpond. The outlet to the pond is a small culvert that is noted underneath a walking path. There are walking paths observed around portions of the perimeter of this waterbody. Grist Millpond is
