WETLAND DETERMINATION DATA FORM – Northcentral and Northeast Region

Project/Site: Sudbury-Hudson City/County: Hudson/ Middlesex Sampling Date: 10-16-17
Applicant/Owner: Eversource Energy State: MA Sampling Point: Wet DW-476
Investigator(s): K. Kinsella, J. Vieira Section, Township, Range: _____
Landform (hillside, terrace, etc.): Depression Local relief (concave, convex, none): None Slope %: 0
Subregion (LRR or MLRA): LRR R Lat: 42°23'35.992 N Long: 71°30'49.0263 W Datum: NAD83
Soil Map Unit Name: _____ NWI classification: PFO
Are climatic / hydrologic conditions on the site typical for this time of year? Yes X No _____ (If no, explain in Remarks.)
Are Vegetation _____, Soil _____, or Hydrology _____ significantly disturbed? Are "Normal Circumstances" present? Yes _____ No X
Are Vegetation _____, Soil _____, or Hydrology _____ naturally problematic? (If needed, explain any answers in Remarks.)

New underground electric transmission line and rail trail within the same inactive railroad corridor.

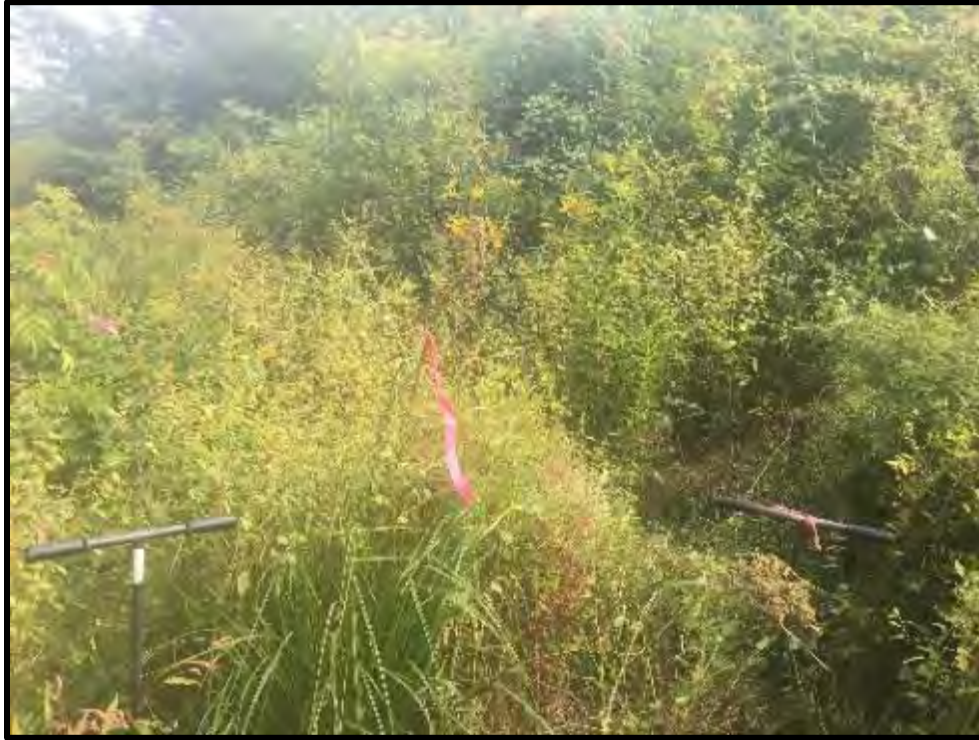
Photo 1 View of emergent Wetland 3 on the south side of the existing rail bed.

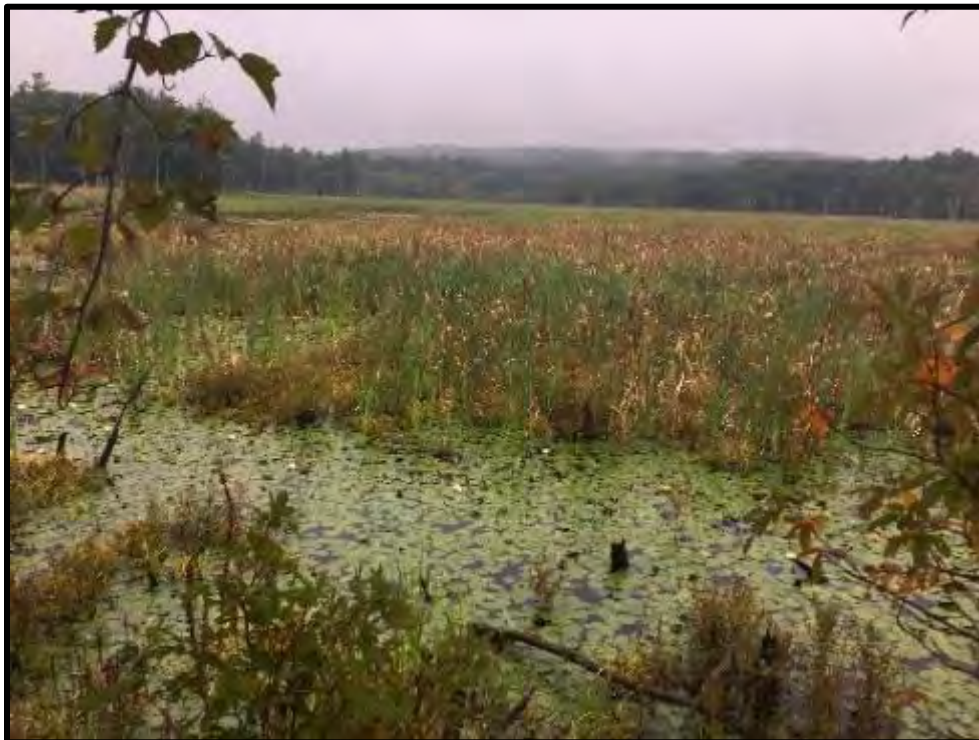
Photo 2 View of emergent marsh and aquatic bed component of Wetland 6 on the south side of the existing rail bed.

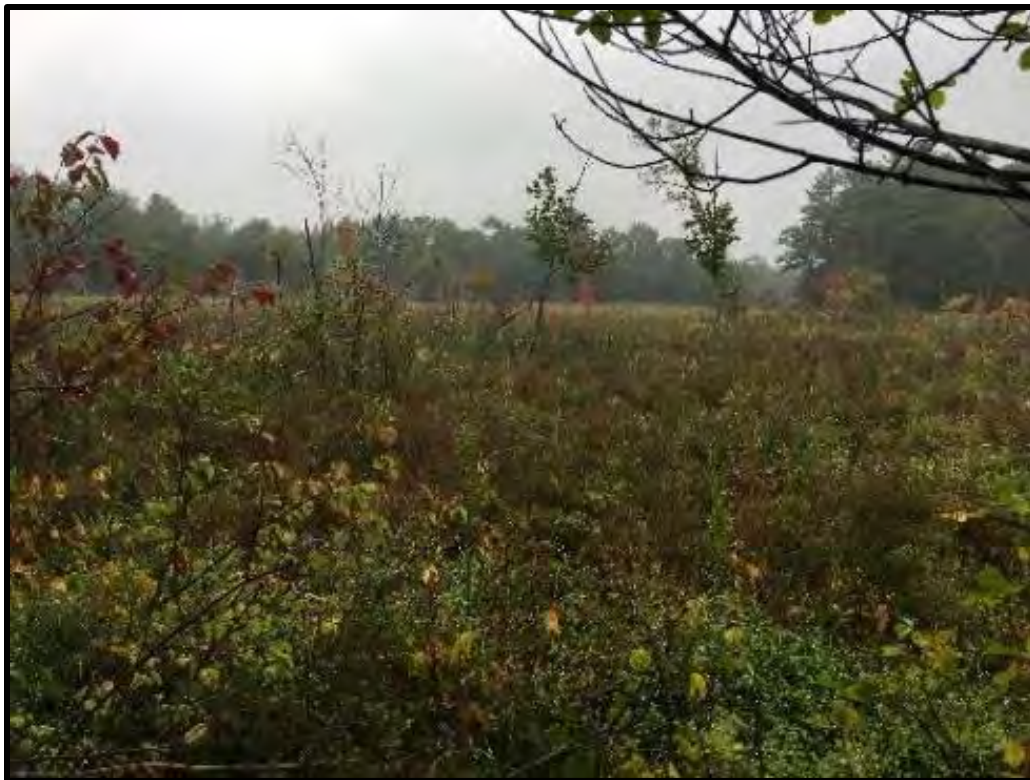
Photo 3 Emergent marsh part of Wetland 7 on the north side of the existing rail bed.

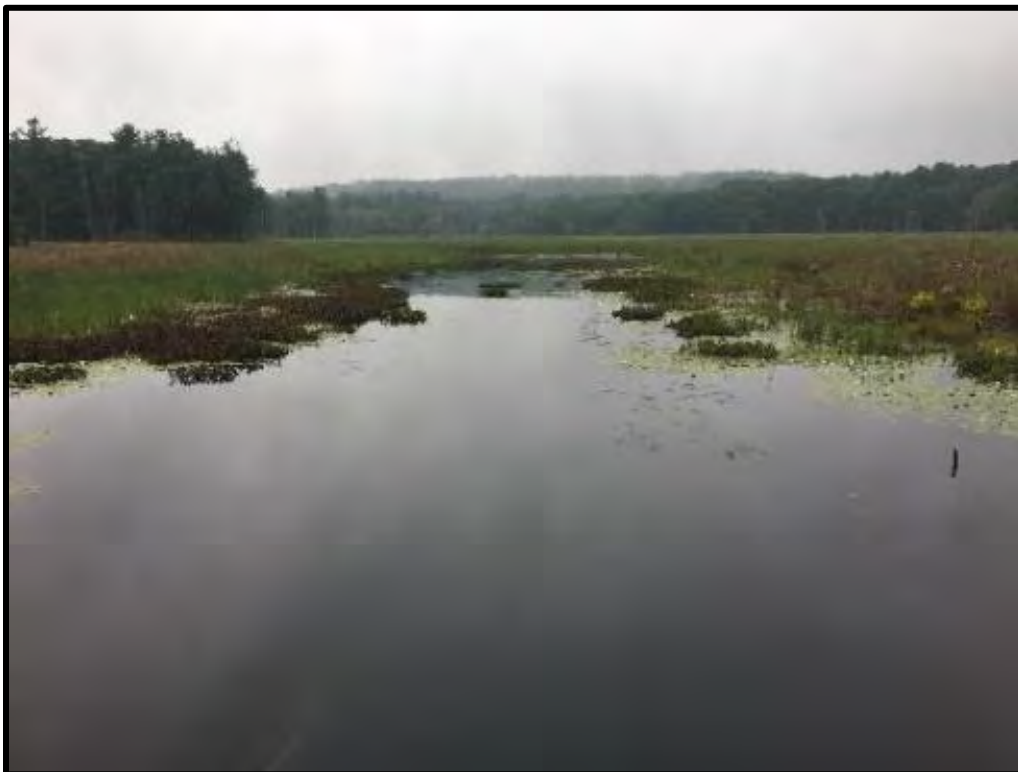
Photo 4 View of Fort Meadow Brook at the existing rail bed crossing.

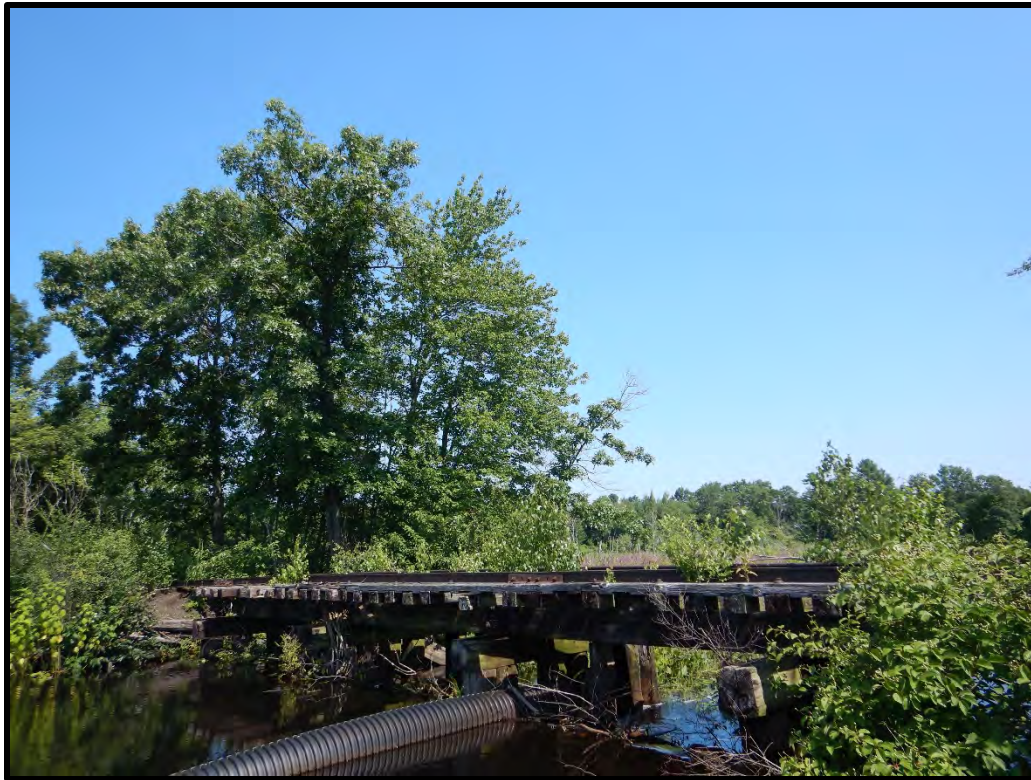
Photo 5 View of Bridge 130 across Fort Meadow Brook.

Current bridge design drawings indicate that modification, including abutment changes, and addition of exterior duct banks to bridges #128 and #130 referenced above are proposed. Plate girder style Bridge #127 is proposed to be demolished and replaced with a new truss design. The proposed modification and/or demolition of the bridges do not appear to be developed in accordance with the Secretary of the Interior's Standards and Guidelines for Rehabilitation (36 CFR 67), as previously requested in the MHC's June 30, 2017 comments on the ENF.

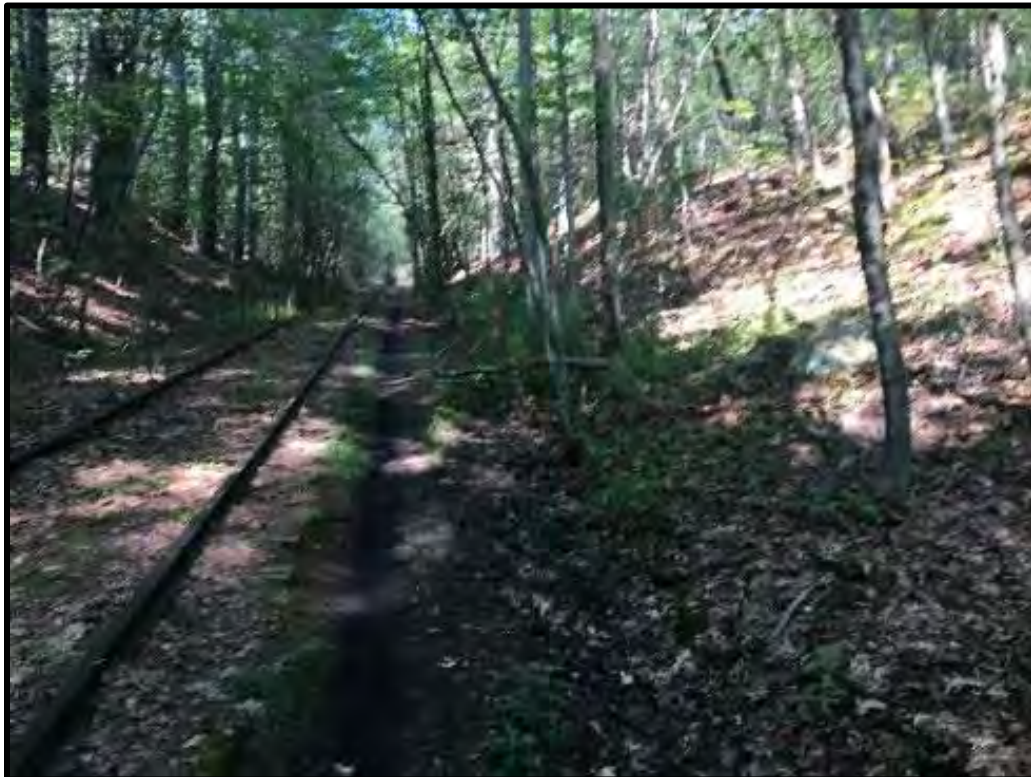
Photo 6 View of Wetland 12, a narrow feature in a slight rail ditch depression between the rail bed and a steep slope.

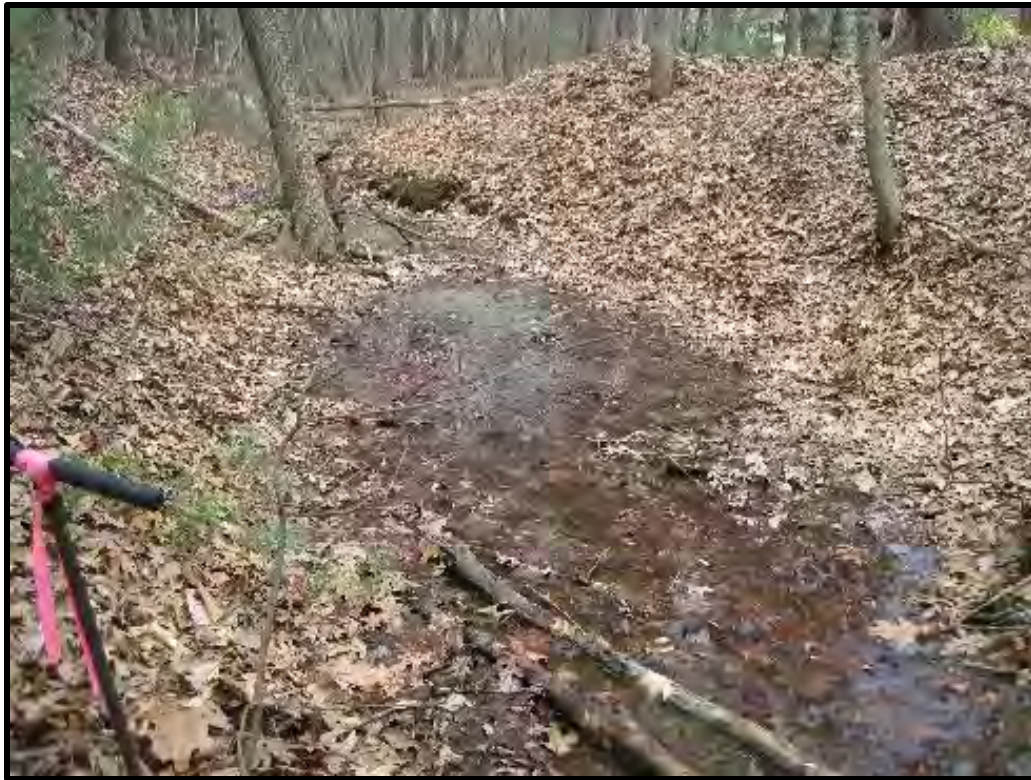
Photo 7 View of Wetland 21 with standing water.

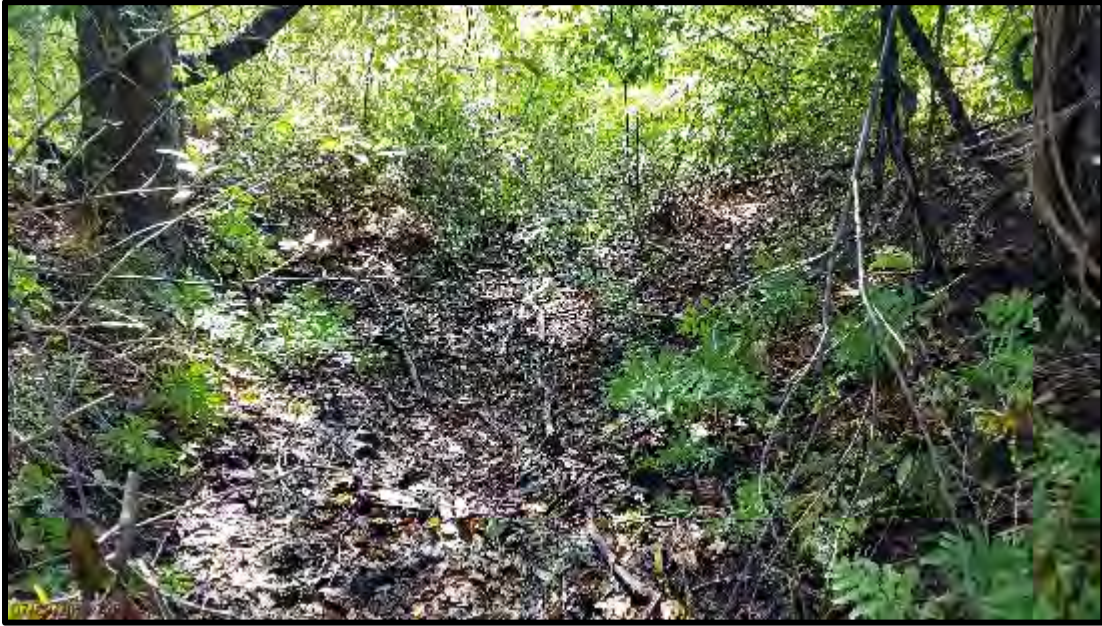
Photo 8 View of Wetland 4 located on the south side of the rail bed near flag CW-2.

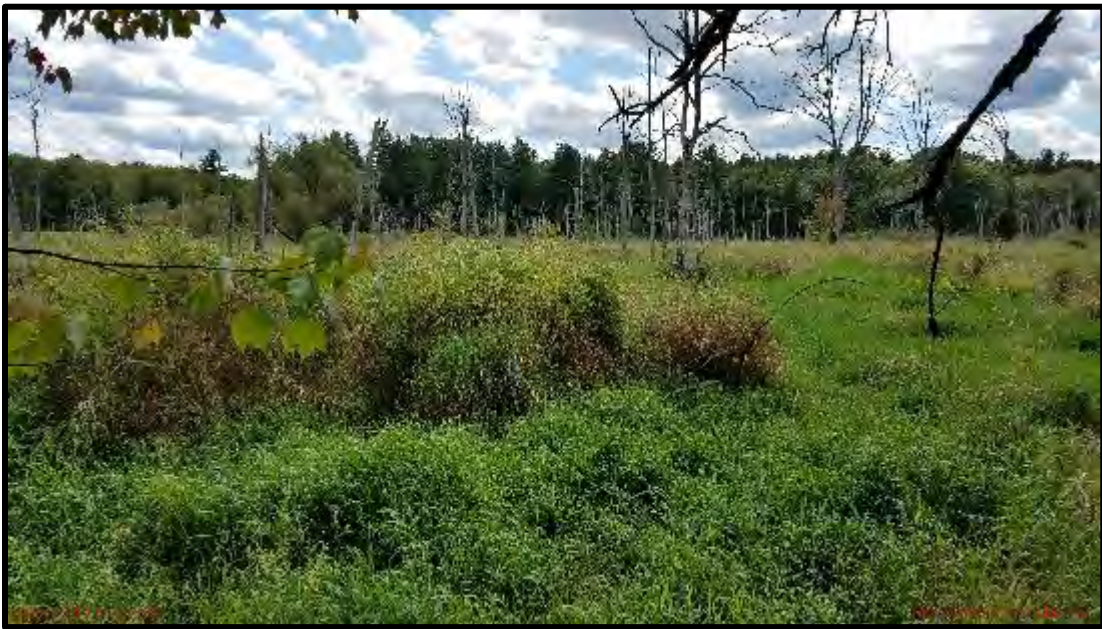
Photo 9 View of Wetland 12 associated with the Hop Brook marsh system to the south of the rail bed near flag CW-23.

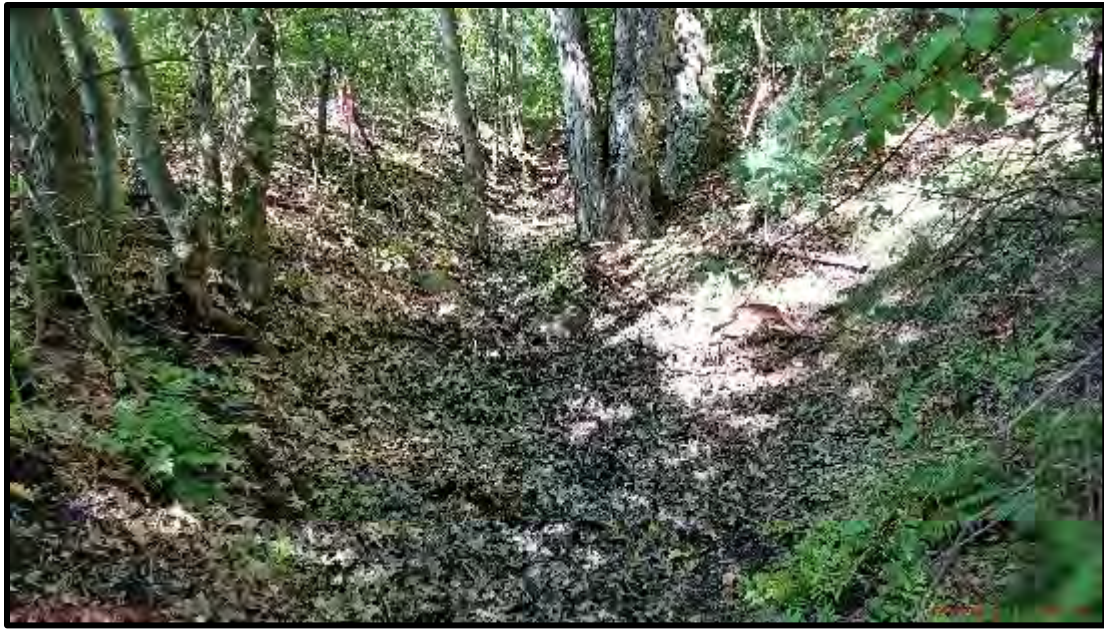
Photo 10 View of Wetland 13 to the north of the rail bed near flag DW-73.

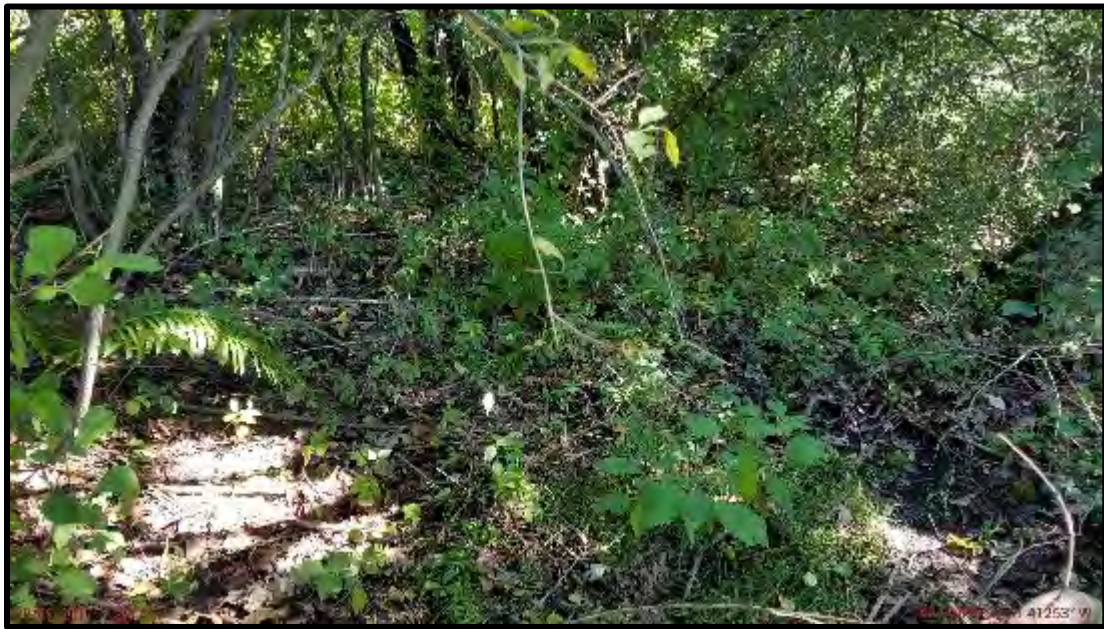
Photo 11 View of the PFO portion of Wetland 14 to the north of the rail bed near flag DW-86.

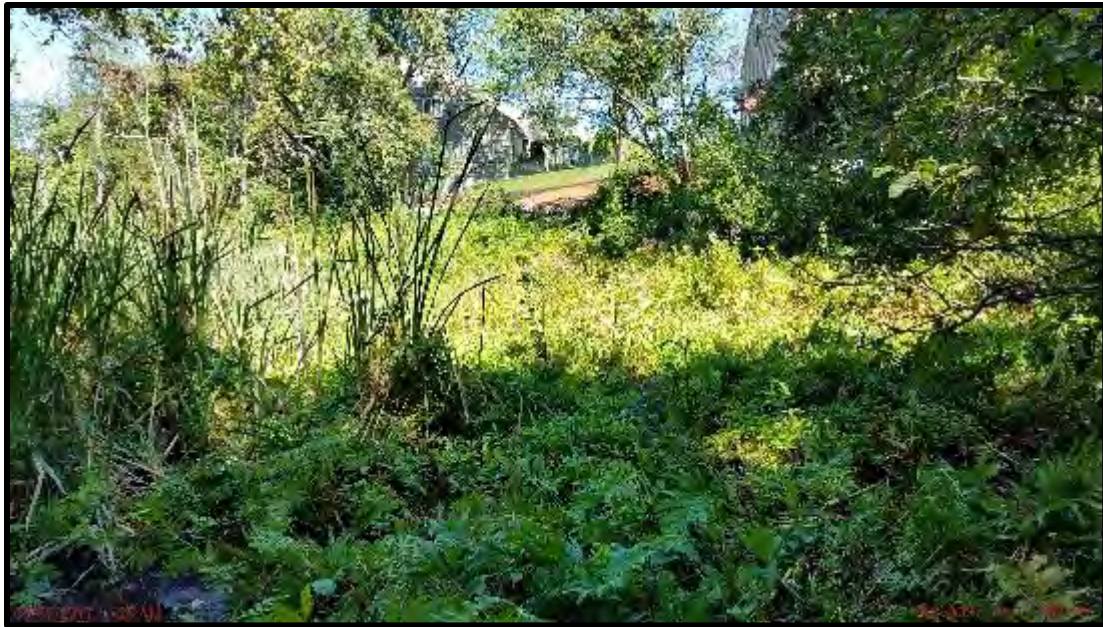
Photo 12 View of the PEM portion of Wetland 14 to the north of the rail bed near flag DW-89.

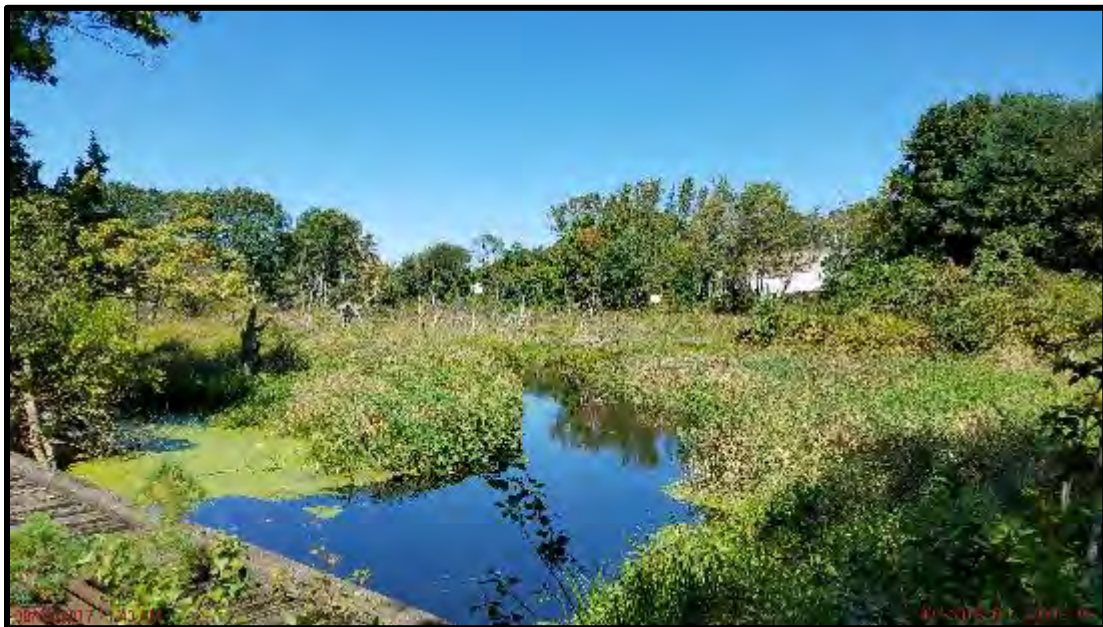
Photo 13 View of Hop Brook (Bridge 127) to the north of the railroad bridge near flags DW-94/DB-13.

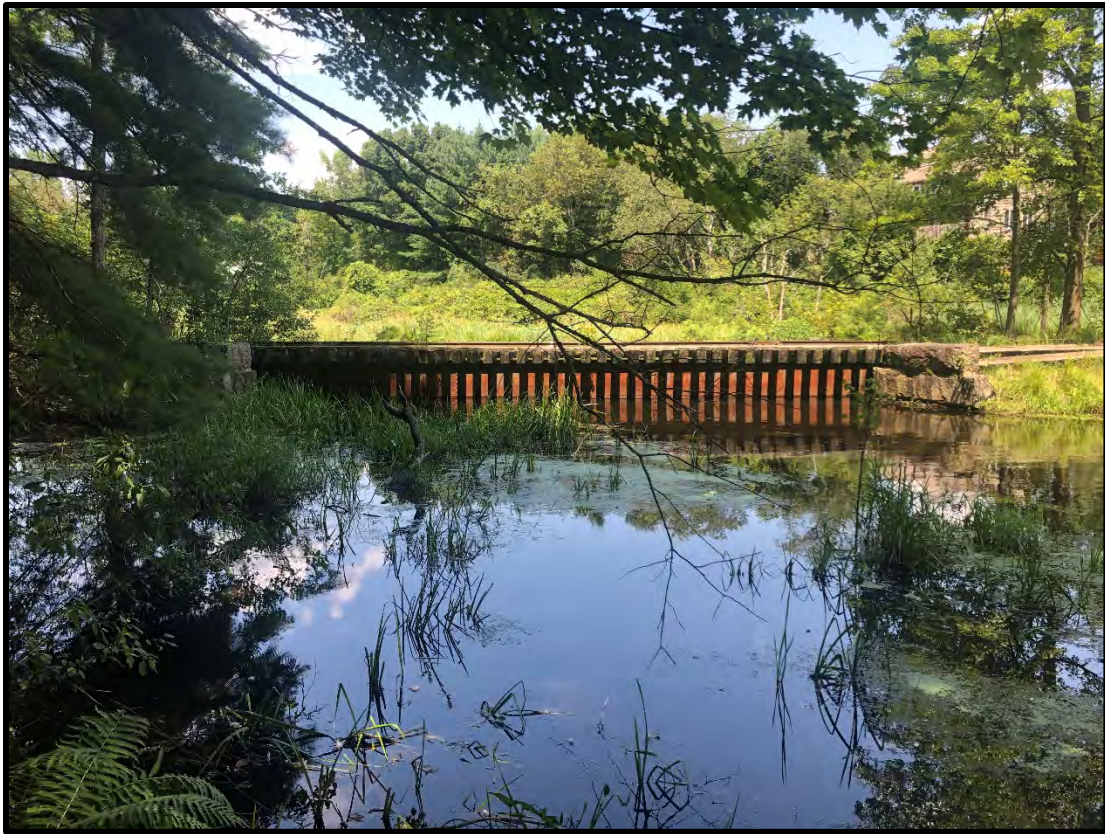
Photo 14 View of Bridge 127 over Hop Brook.

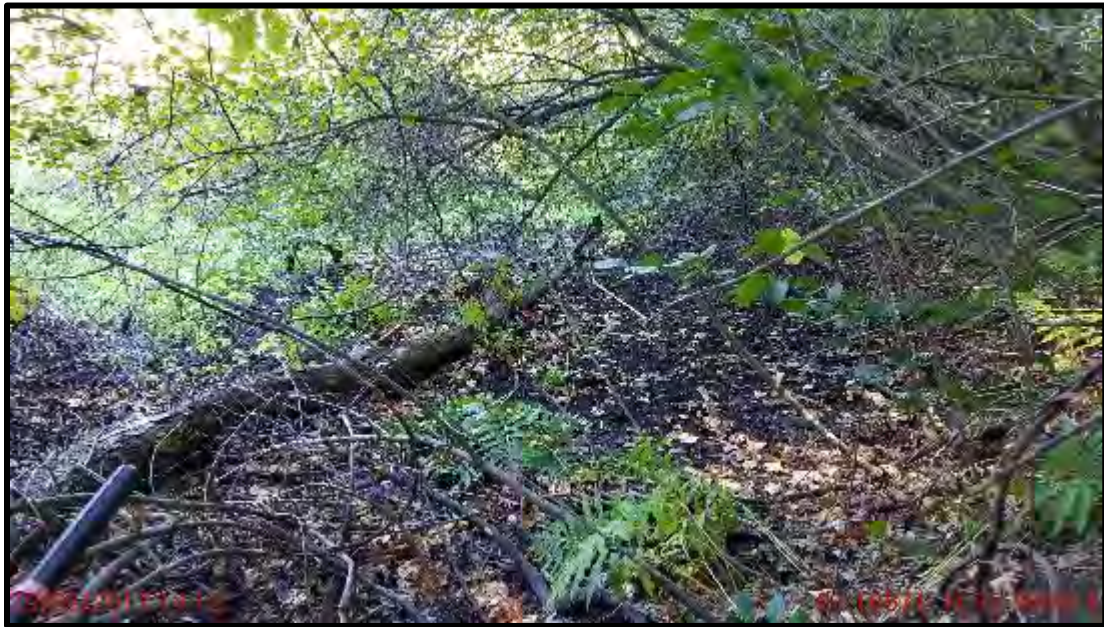
Photo 15 View of Wetland 15 to the north of the rail bed near flag CW-190.

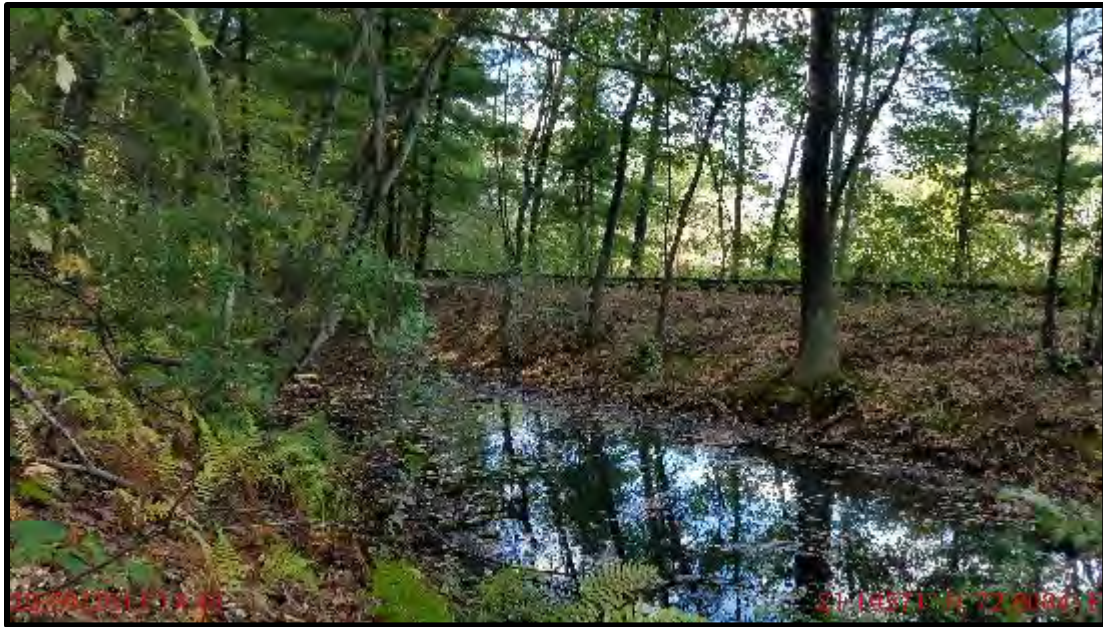
Photo 16 View of Wetland 16 to the south of the rail bed near flag DW-264.

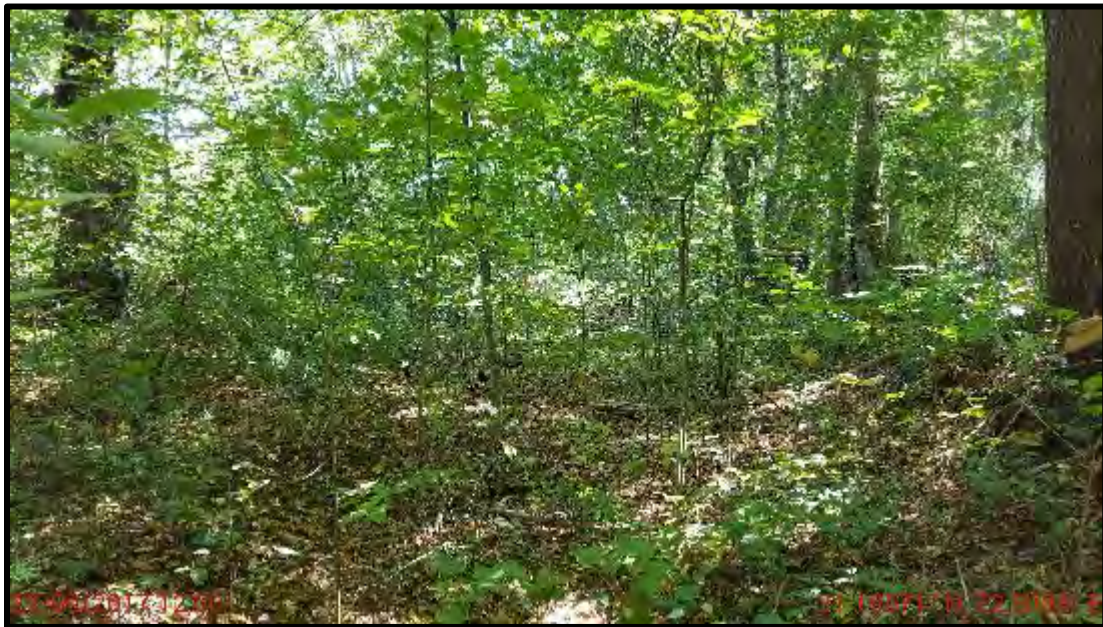
Photo 17 View of Wetland 18 to the north of the rail bed near flag CW-163.

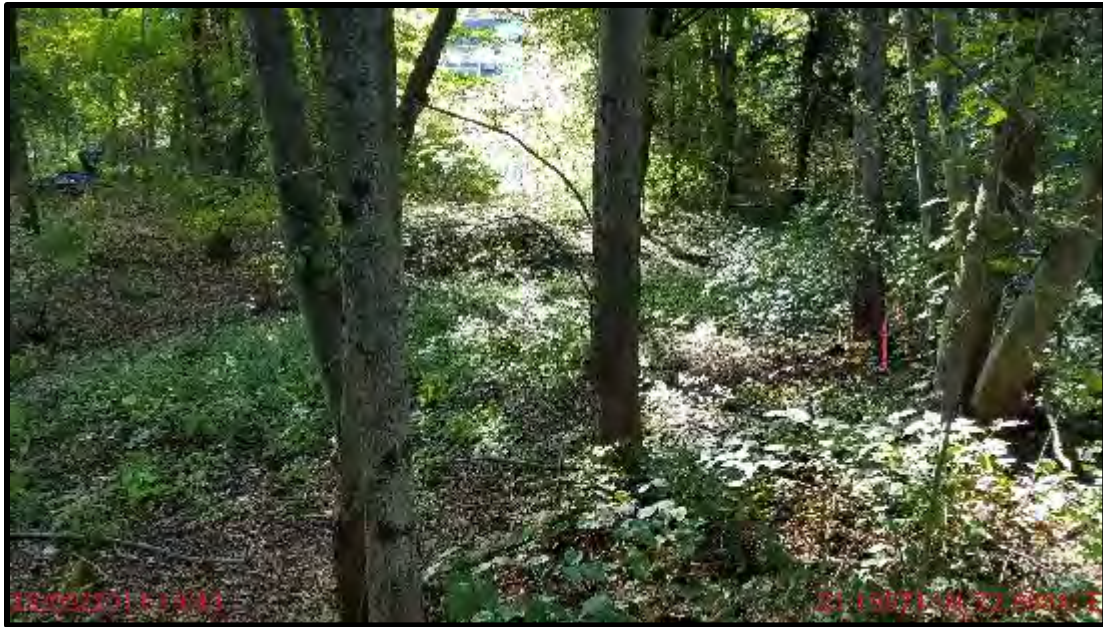
Photo 18 View of Wetland 19 to the south of the rail bed near flag DW-244.

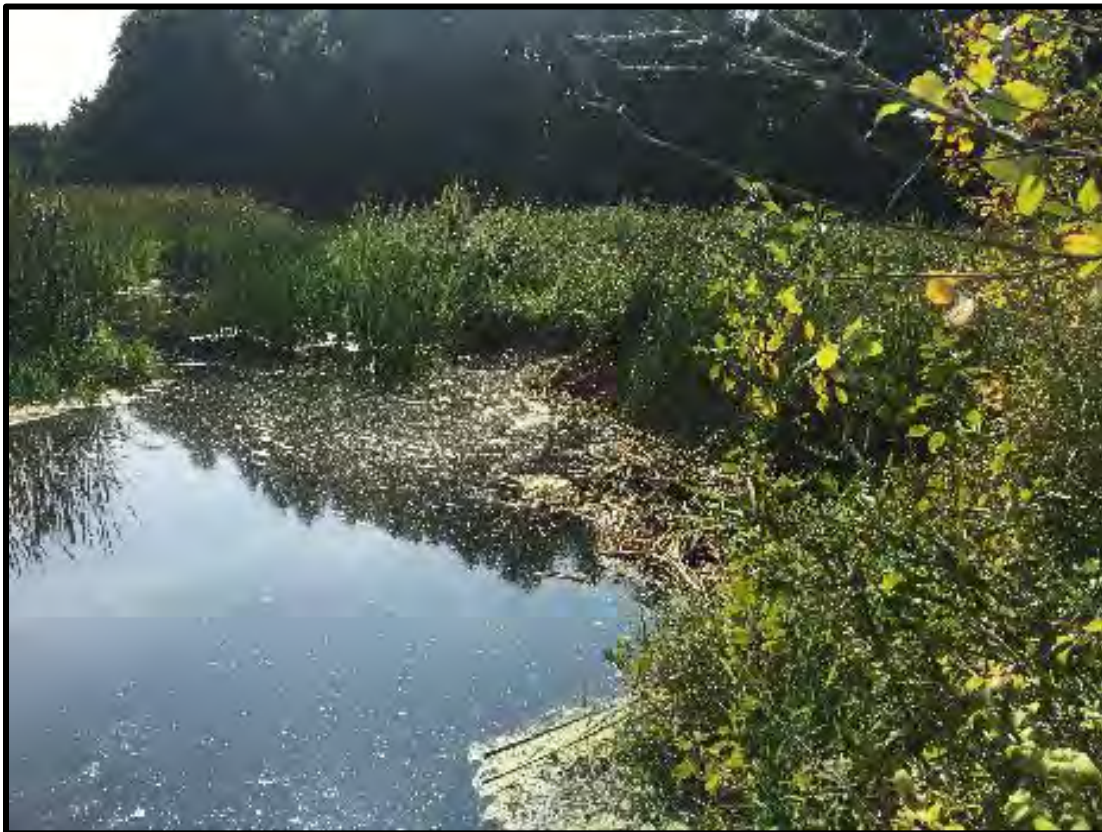
Photo 19 View of Hop Brook (Bridge 128) to the south of the rail bed near flag AB-34.

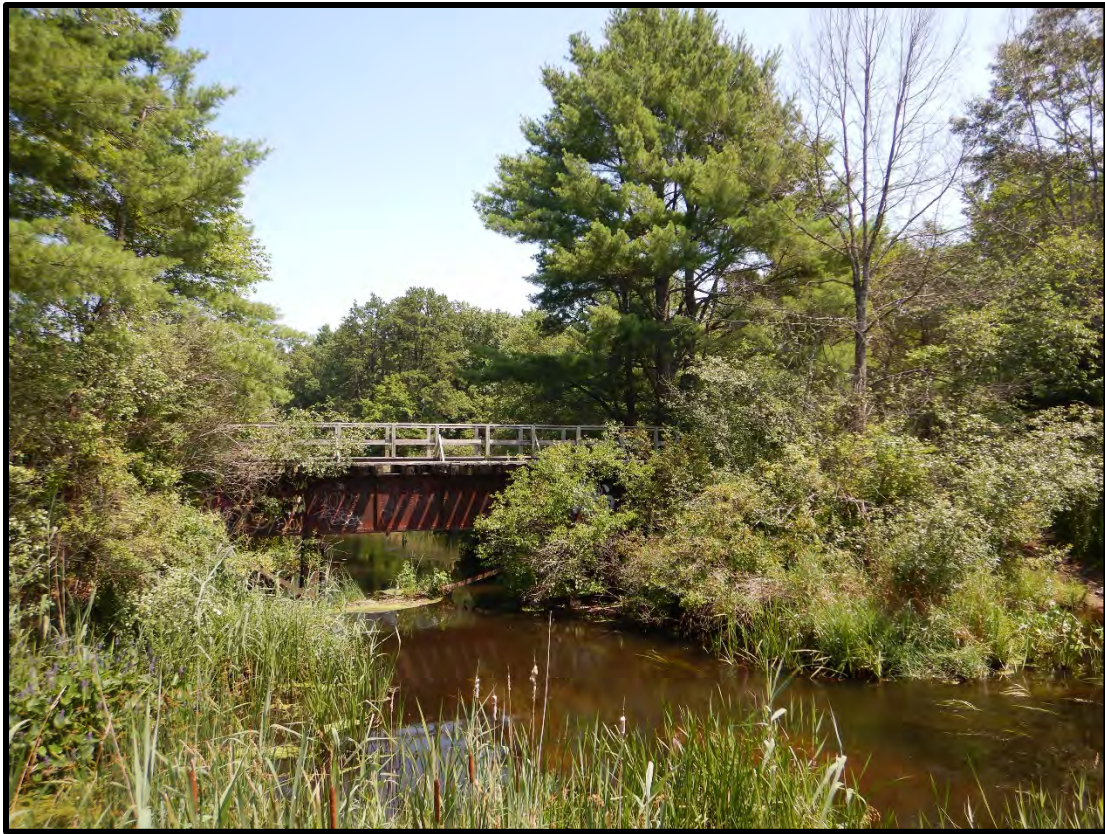
Photo 20 View of Bridge 127 over Hop Brook.
