# FORM A - AREA

**Name of Area:** Central Massachusetts Railroad Corridor  
(Boston & Maine Railroad Corridor)

# INVENTORY FORM A CONTINUATION SHEET

CENTRAL MASSACHUSETTS  
RR CORRIDOR

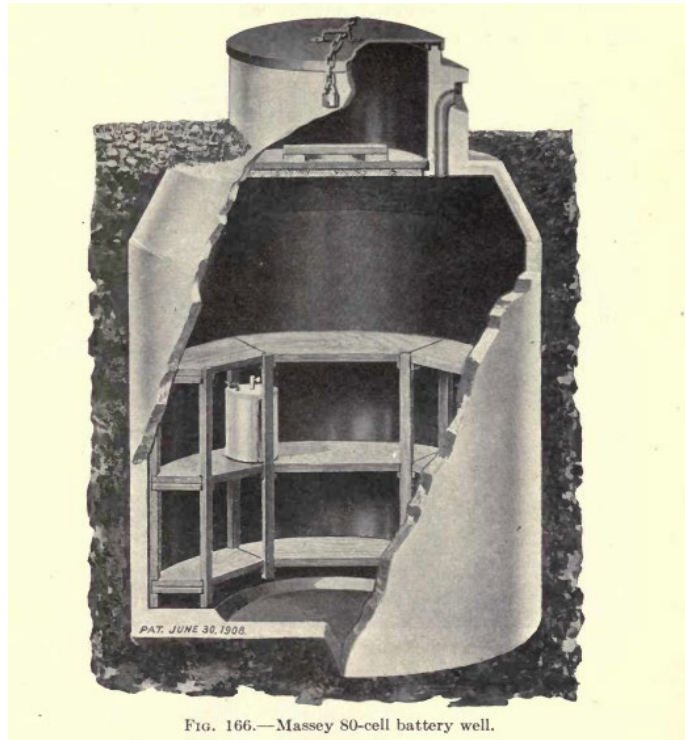
FIG. 166.—Massey 80-cell battery well.

metal hatch visible above ground. The wells are typically "4 or 5 feet in diameter and from 4 to 8 feet in depth. Tiers of wooden shelves are provided around the wall of the well to support the battery cells."<sup>44</sup>

Typical battery well from 1908. As illustrated in SUD.R and King 1921: 161.

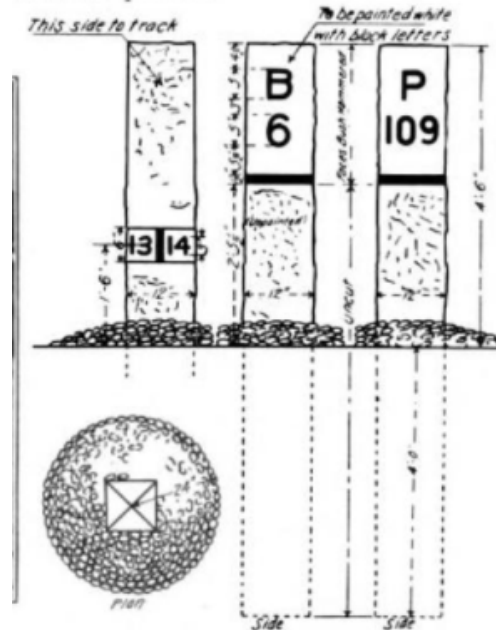
Fig. 469.—Granite Mile Post,  
Boston & Maine R. R.

Typical milepost, as illustrated in SUD.R and Camp 1904: 898.

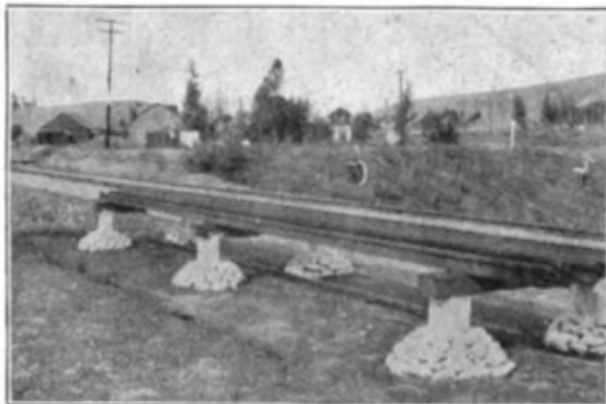
Although a different style from the flat, flared profile used by the B&MRR, the rail rests shown here illustrate how they were utilized on the rail corridor. From Camp 1904: 574.<sup>46</sup>

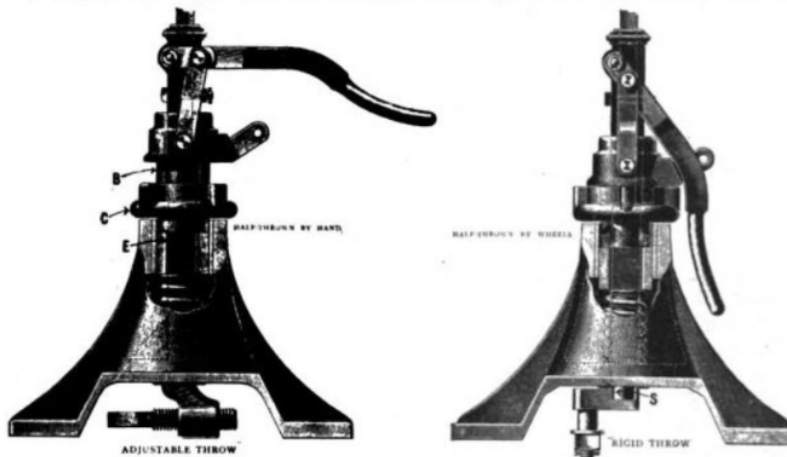
**Fig. 152.—Ramapo Automatic Switch Stand.**

Track switch stands such as the extant one located on this portion of the corridor (MP 28.80; Photos 41-43) were pieces of pivoting equipment, manually or automatically operated by a lever. Among the most popular products was the Ramapo automatic switch stand found on the CMRR/B&MRR corridor.<sup>47</sup>

The Ramapo automatic switch stand, as illustrated in Camp 1904: 396.

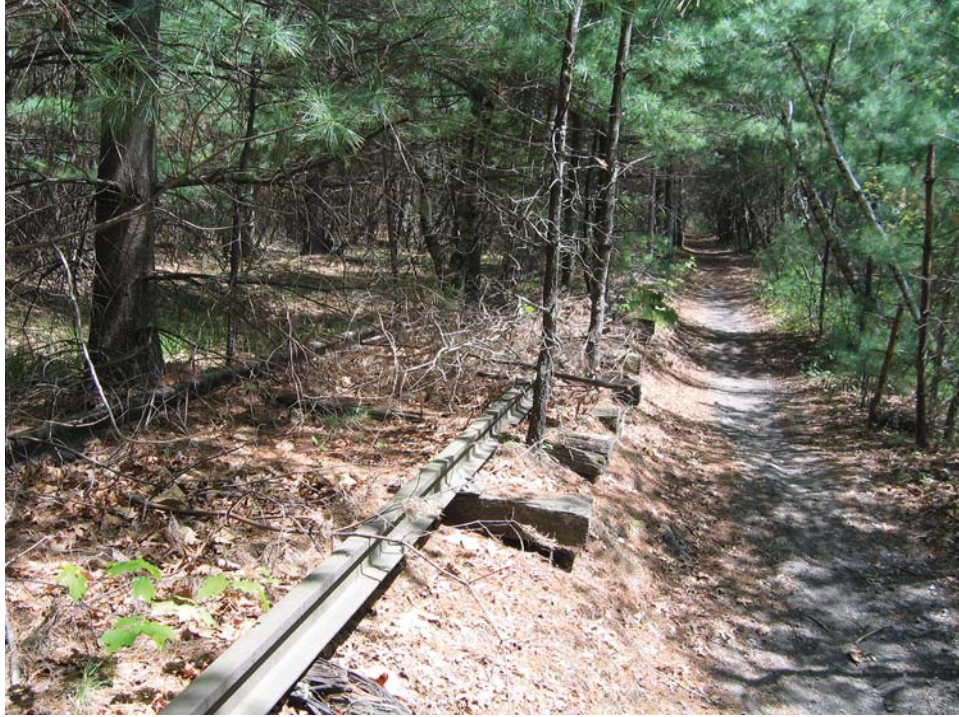
**Photo # 1: (front cover)** Filled rail bed across wetlands at Fort Meadow Brook, view southeast

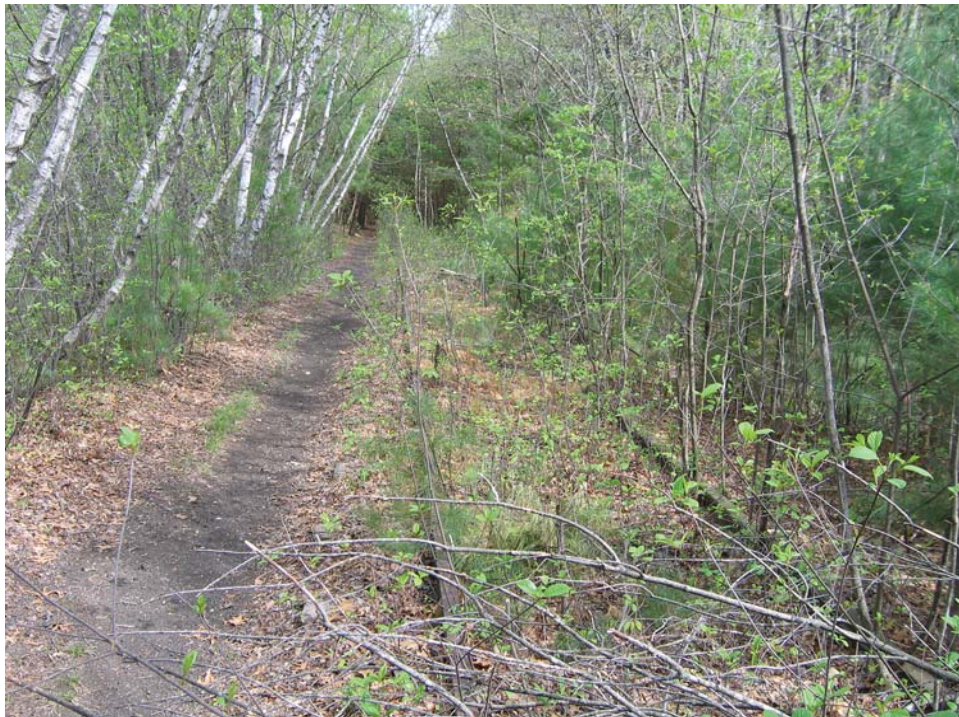
**Photo # 3** Raised rail bed through wetlands east of Parmenter Road, view southeast

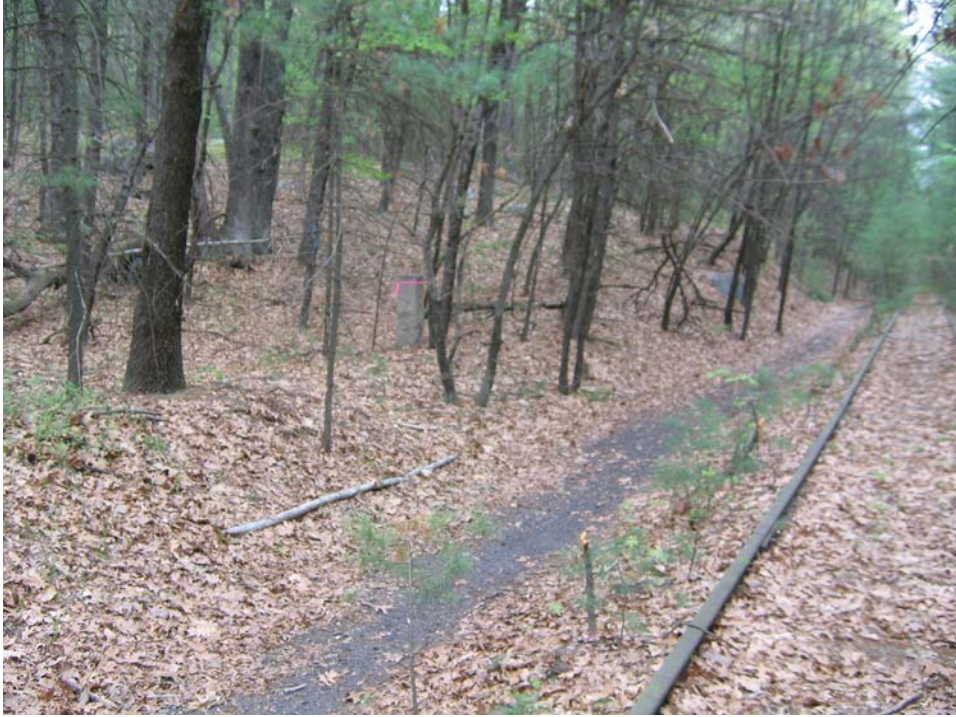
**Photo # 4** Rail bed and knoll east of Parmenter Road, mile marker 23 visible on left (pink tag), view northeast

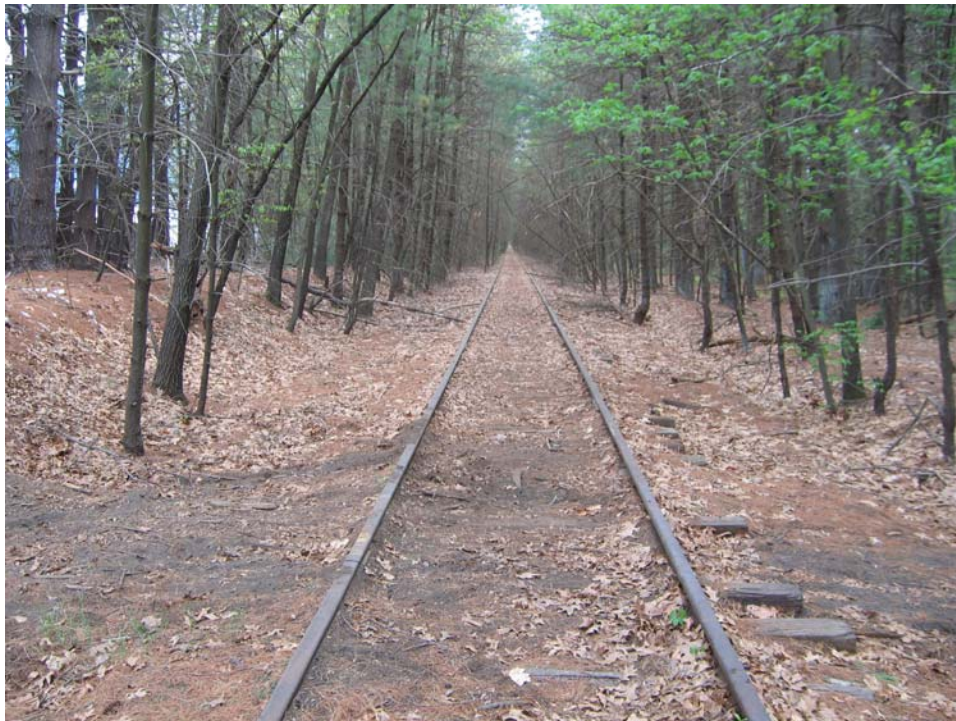
**Photo # 5** Cut and fill of corridor through wooded terrain east of Main Street, view southeast

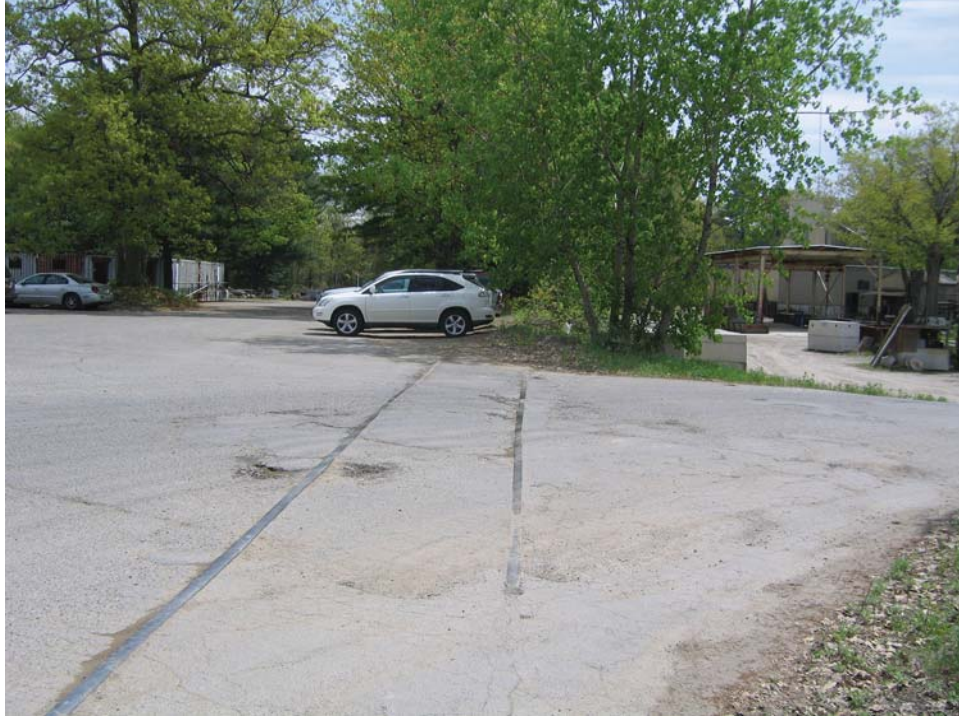
The tracks and rails remain largely extant, except in localized areas where bridge structures have been removed (see above discussion). Although the 1914 valuation maps for the line indicate an occasional siding stemming off toward an adjacent (presumably industrial) property, only the main line was observed to be extant. **SUD.R** notes the similarity of the track structure in Sudbury to that of Wayland; the same is true of the structure in Hudson:

**Photo # 6** Crossing at paved access road west of Main Street showing extant rails, view southeast

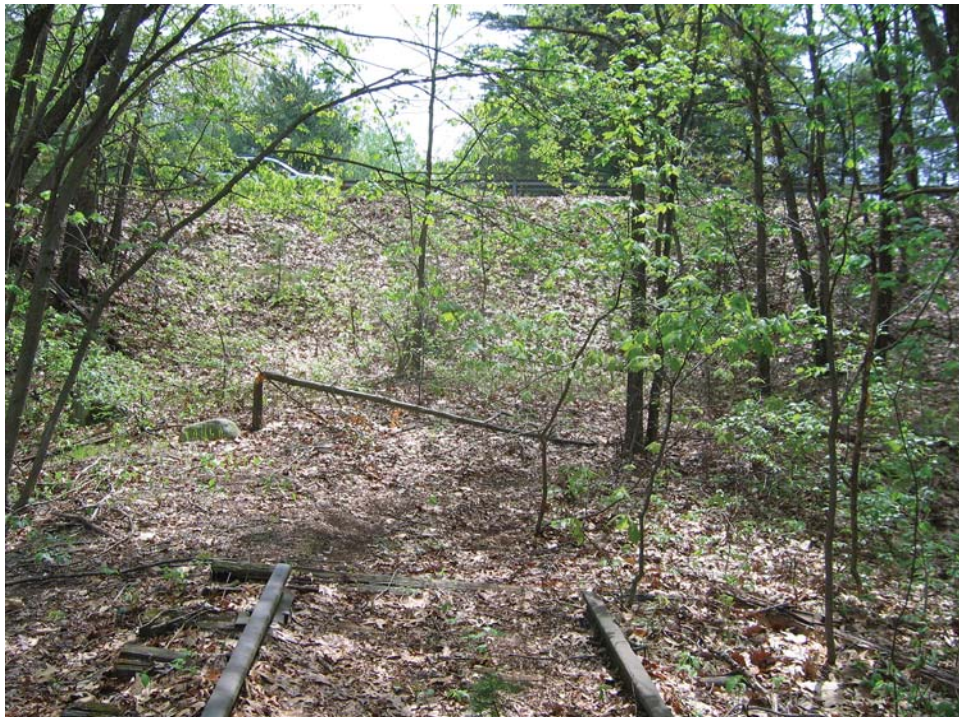
**Photo # 7** Filled site of former Bridge 131, under Chestnut Street, view east

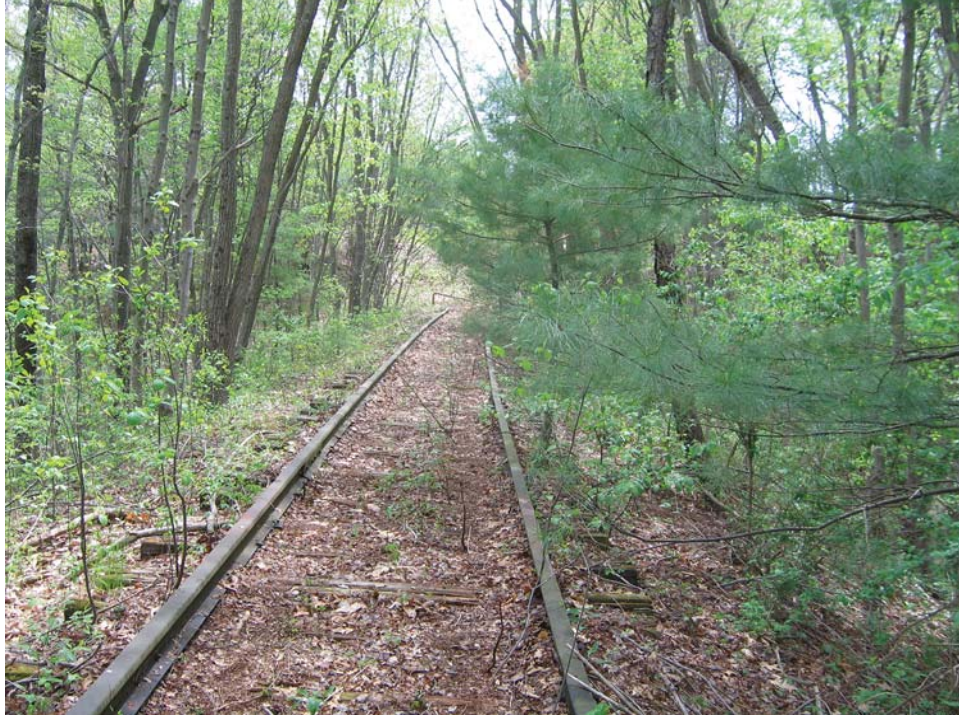
**Photo # 8** Raised rail bed approaching Chestnut Street, view east

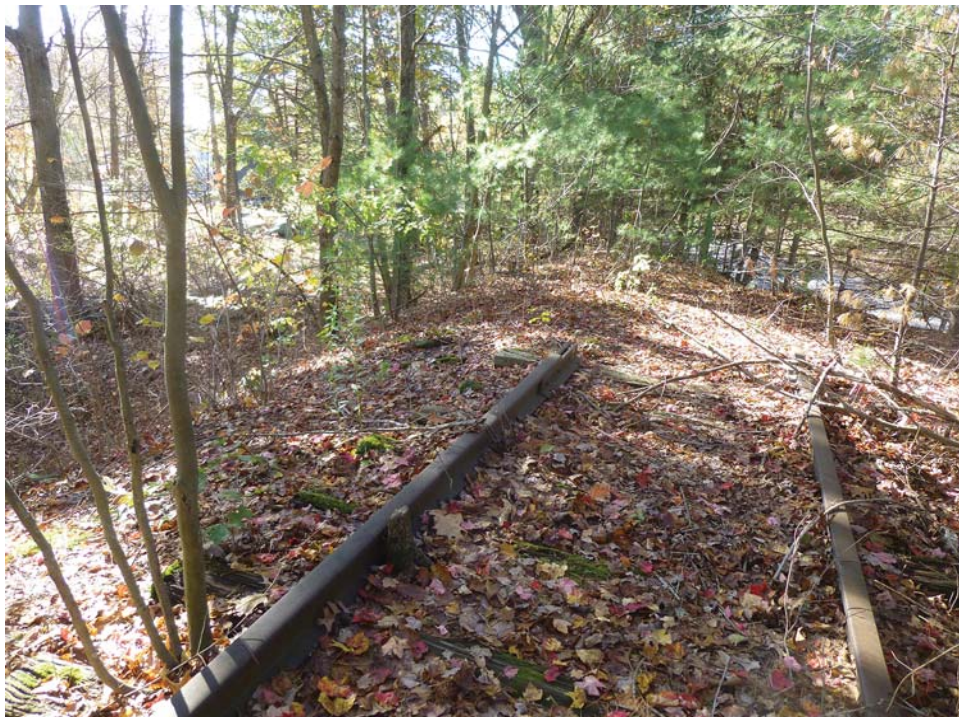
**Photo # 9** Raised rail bed east of Wilkins Street, view east

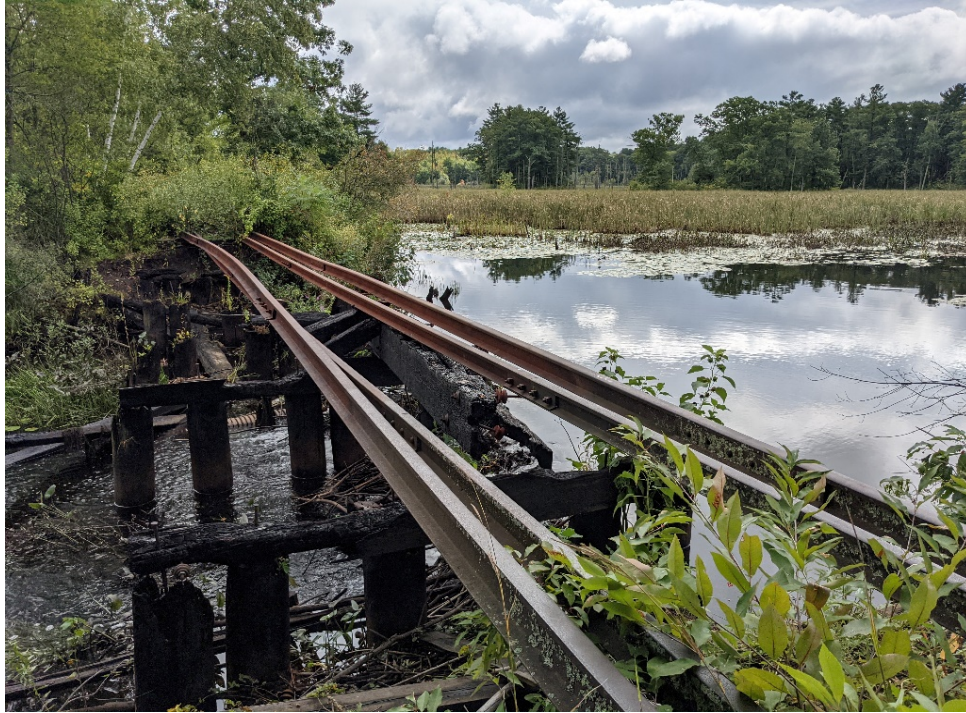
Bridge 130 across Fort Meadow Brook (MP 25.37; Photos 10-11), **HUD.908** is a timber pile structure constructed in 1939, replacing an earlier structure at this location that was similarly identified as a pile trestle in the 1914 valuation map. The four-span bridge carries a single track across the brook, with a length of just over 49 feet and a width of 12 feet. At the time the 1987, HUD.908 form was prepared, it was noted that the trestle was an example of a common bridge type of the time period, and that Bridge 130 was the shortest of five pile trestles in the corridor between Waltham and Hudson.<sup>6</sup> In 2019, a major fire occurred at the structure causing moderate damage and diminishing the integrity and condition of this structure. However, the rails along the deck remain intact and the piles are still recognizable as the bridge

Photo # 10 Bridge 130 at MP 25.37, view northwest

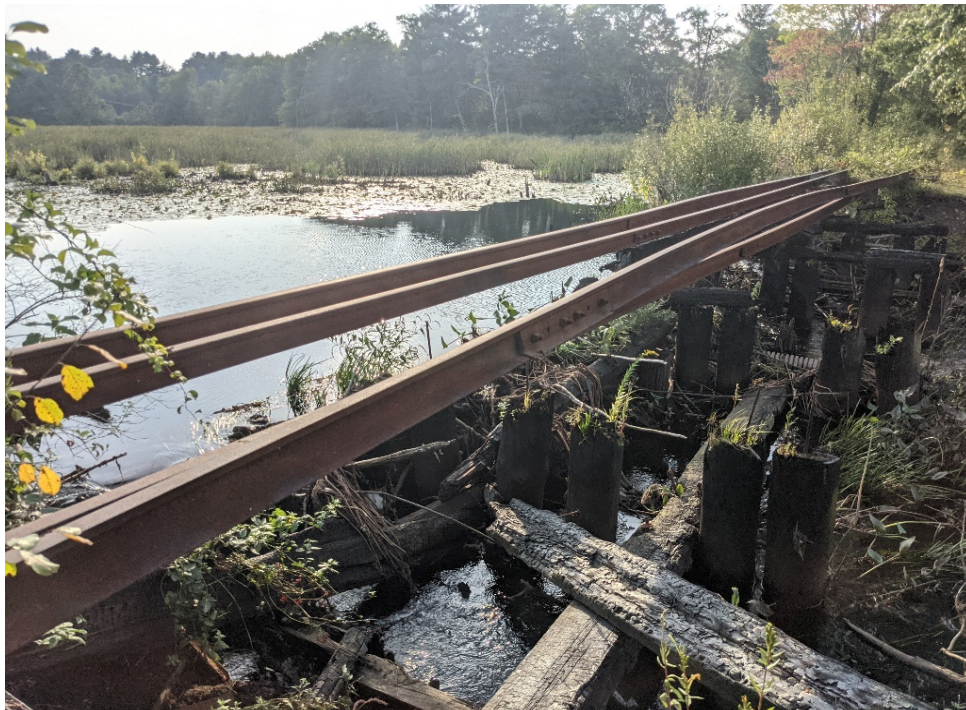
Photo # 11 Bridge 130 at MP 25.37, view southeast

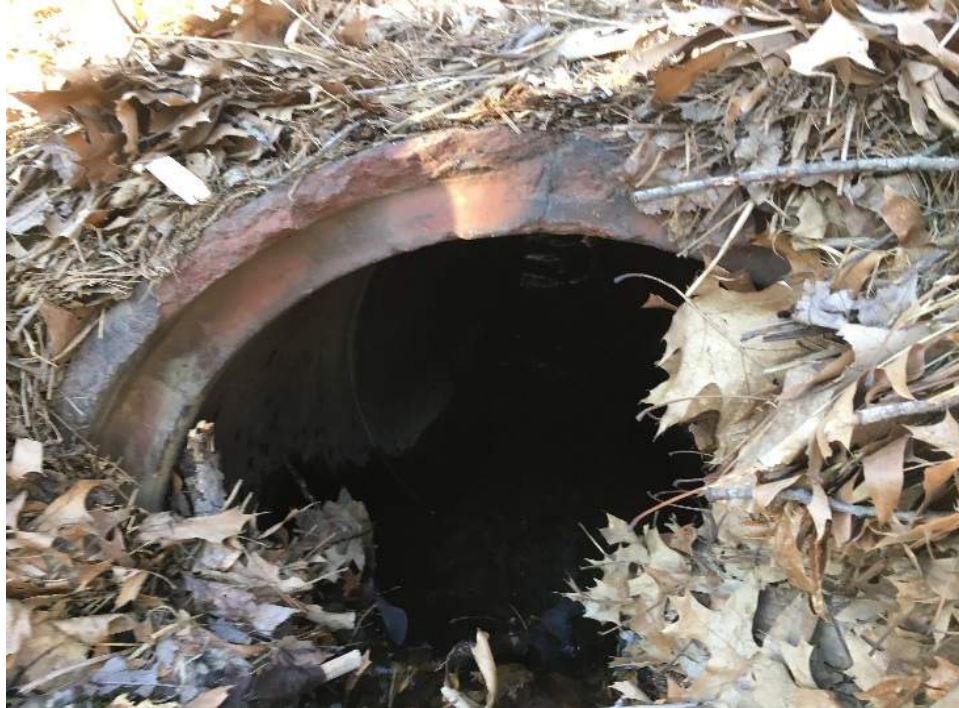
Culvert 129C (MP 24.30; Photo 12) is a 24-inch tile pipe, approximately 39 feet long. It is topped by approximately 5 feet of cover. A field inspection notes that the pipe is cracked at the north end, likely due to a tree growing atop the northeast corner.<sup>8</sup>

**Photo # 12** Culvert 129C at MP 24.30, south end inlet, view north

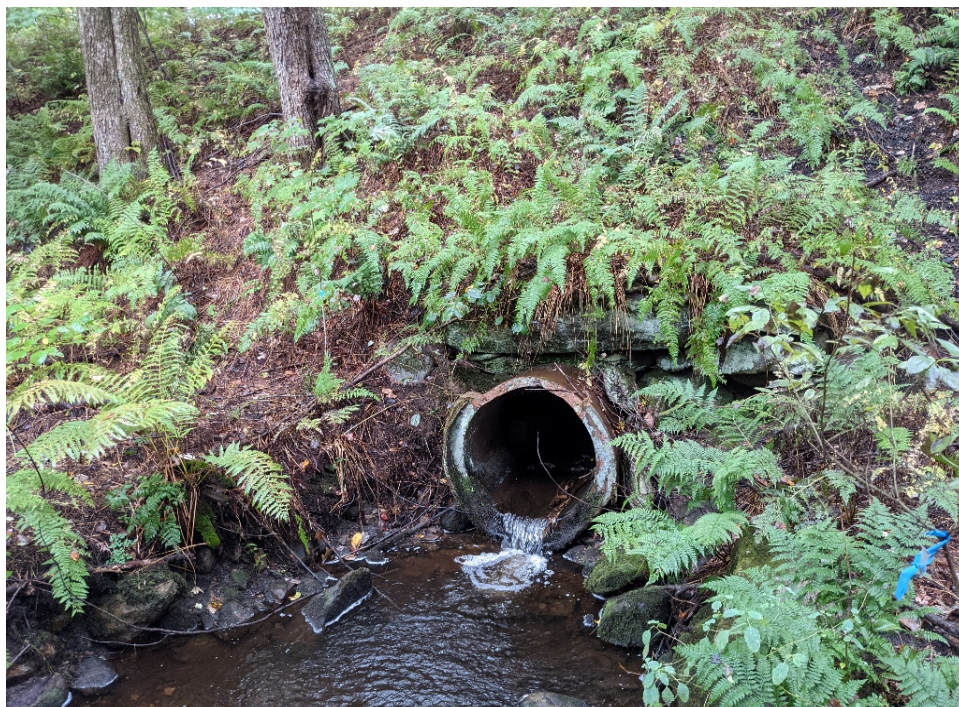
Only two of the four culverts indicated on the 1914 valuation map were located during the survey (129C and 132A); the other two have presumably been filled and no water flow was observed in their former locations (129B and 129E). Both of the extant culverts are in fair to good condition.

**Photo # 13** Culvert 132A at MP 26.12, south end and embankment, view south

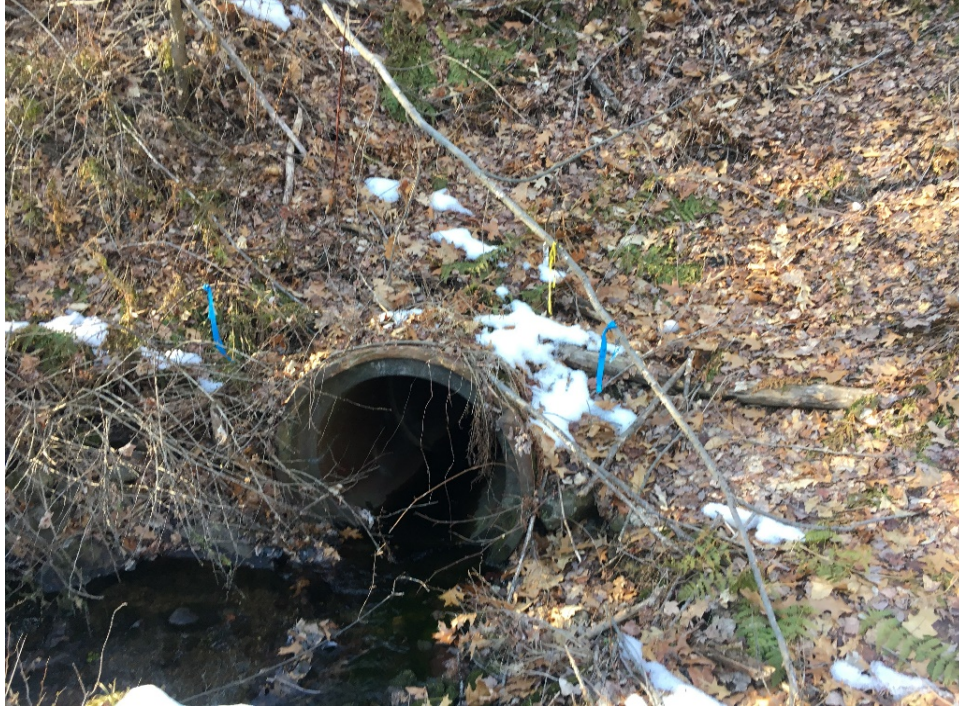
**Photo # 14** Culvert 132A at MP 26.12, north end with collapsed headwall, view north

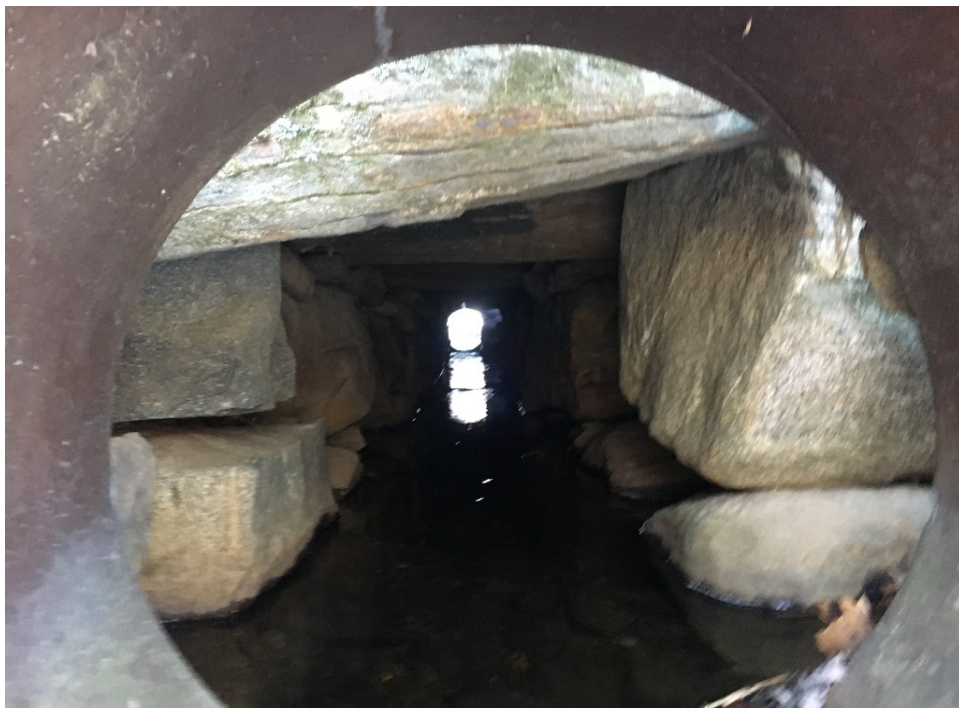
**Photo # 15** Culvert 132A at MP 26.12, stone box in center of culvert, view south

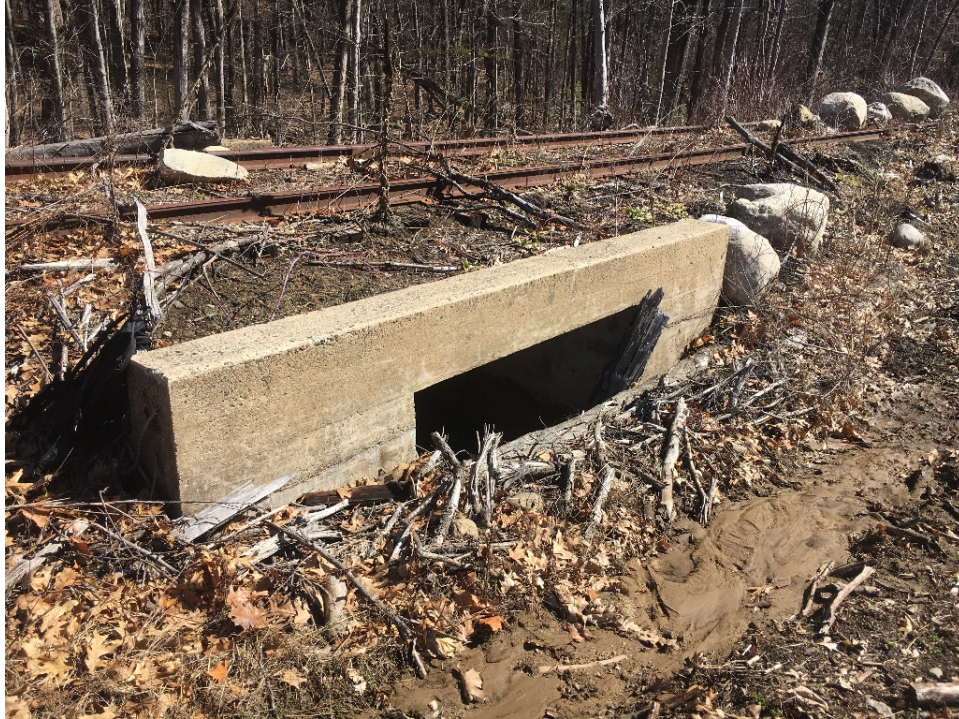
Bridge 132/Cattle Pass (MP 25.83; Photos 16-18) is a six-foot-by-six-foot concrete structure, which was in place by 1914. The structure has concrete headwalls and a concrete roof, with stone ashlar abutments on each side. The surface is buried below the existing ballast and the corridor running on top of the structure is approximately 18 feet wide between each 12-inch-thick headwall. It is in fair condition, exhibiting some concrete spalling and delamination and a temporary mud and debris dam at the south opening have covered all but the top third of the opening.<sup>7</sup>

Photo # 16 Cattle pass at MP 25.83, south side, notice mud and debris dam that has formed, covering most of the opening, view north

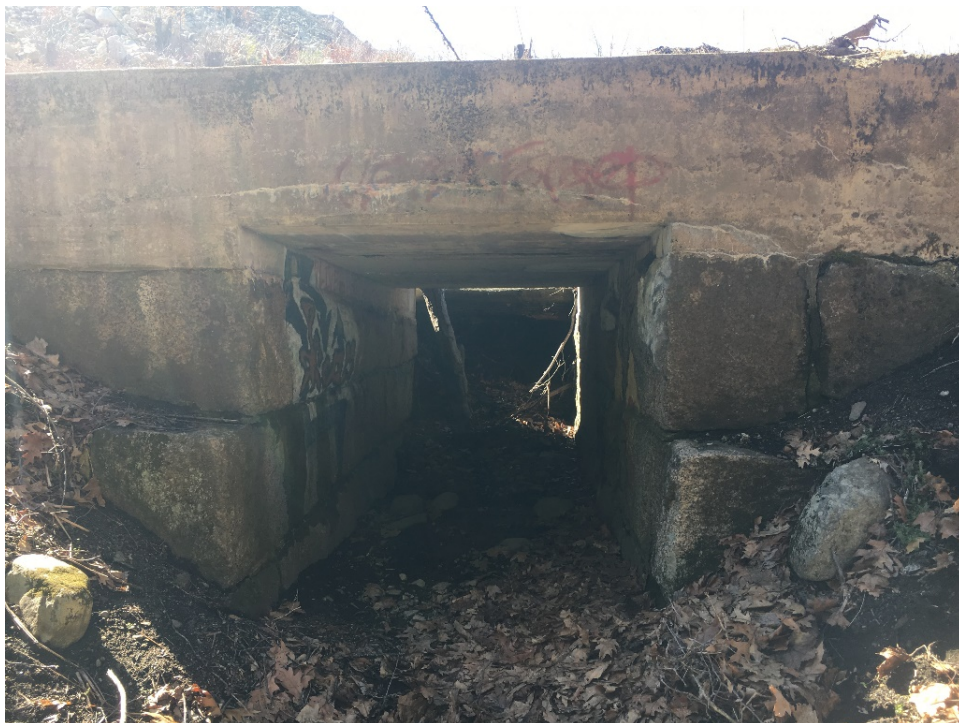
Photo # 17 Cattle Pass at MP 25.83, north side, view south

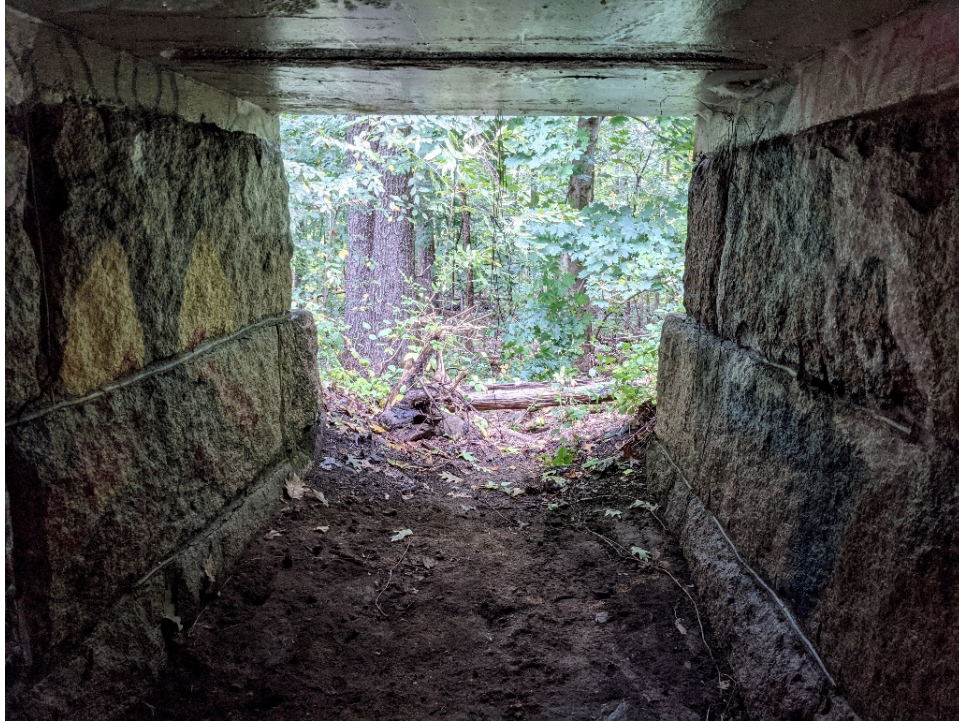
**Photo # 18** Cattle Pass at MP 25.83, view of the interior of the cattle pass toward the north side opening, view north

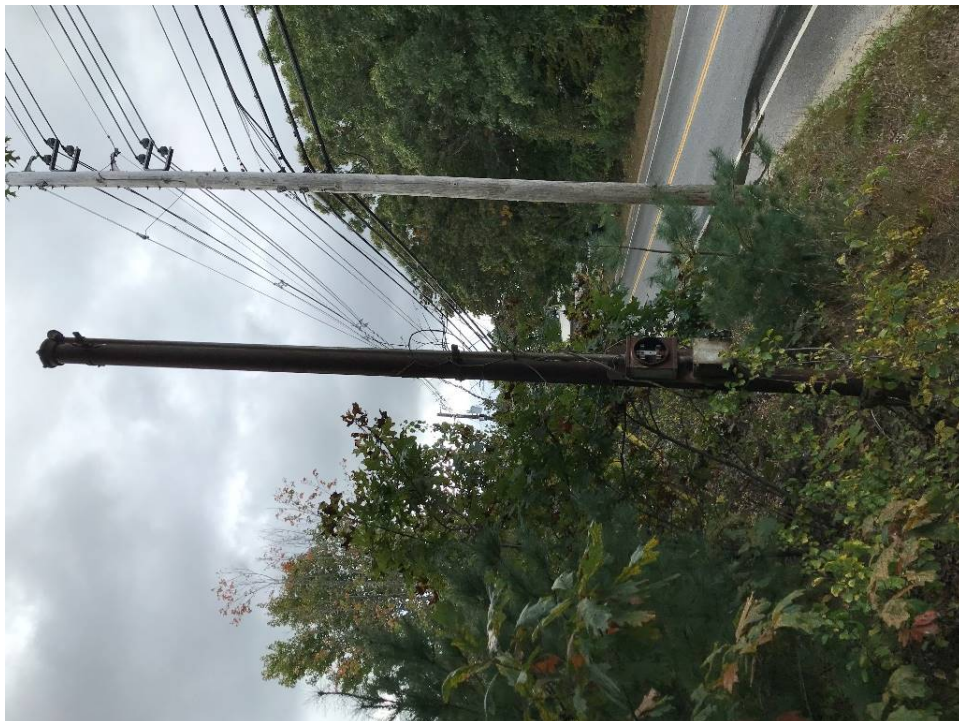
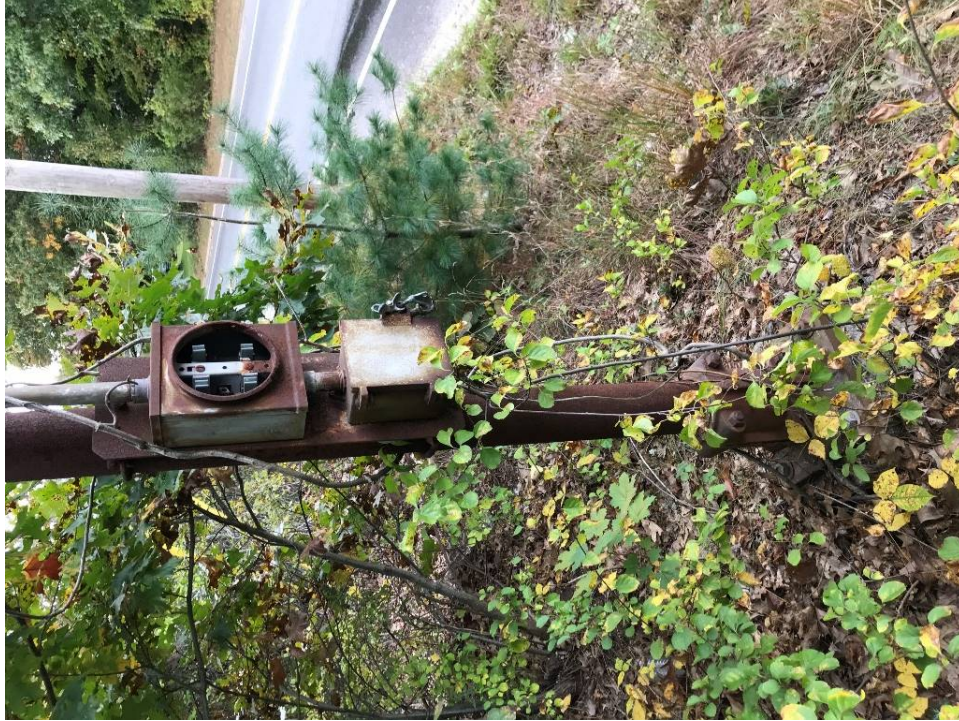
The presence of a concrete battery well (MP 24.36; Photo 23), and features associated with the Main Street crossing such as the wood signposts and a rail-related utility pole (MP 24.72-24.78; Photos 19-20, 45-46) all speak to the complicated signaling systems along the line. As described and illustrated in **SUD.R**:

**Photo # 19** Utility Pole at MP 24.76, view south

**Photo # 20** Utility Pole at MP 24.76, view south

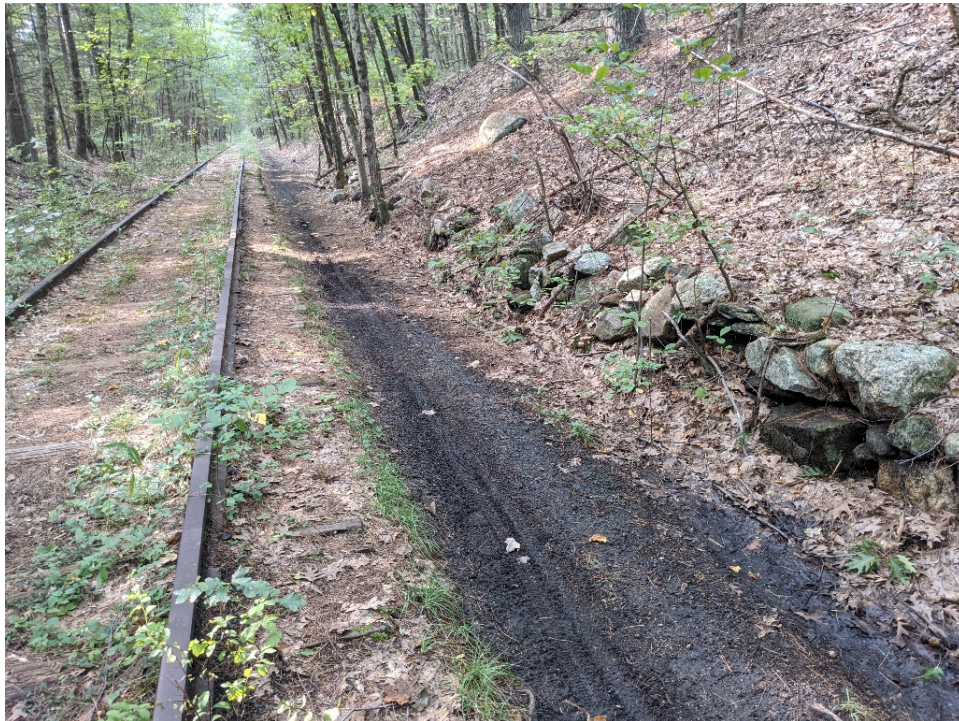
A Stone Wall (MP 23.95; Photo 21) is extant along approximately 50 feet of the corridor. The four-course dry-laid fieldstone retaining wall is approximately 2 ½ feet tall.

**Photo # 21** Stone retaining wall at MP 23.95 along the north side of the rail corridor, view west

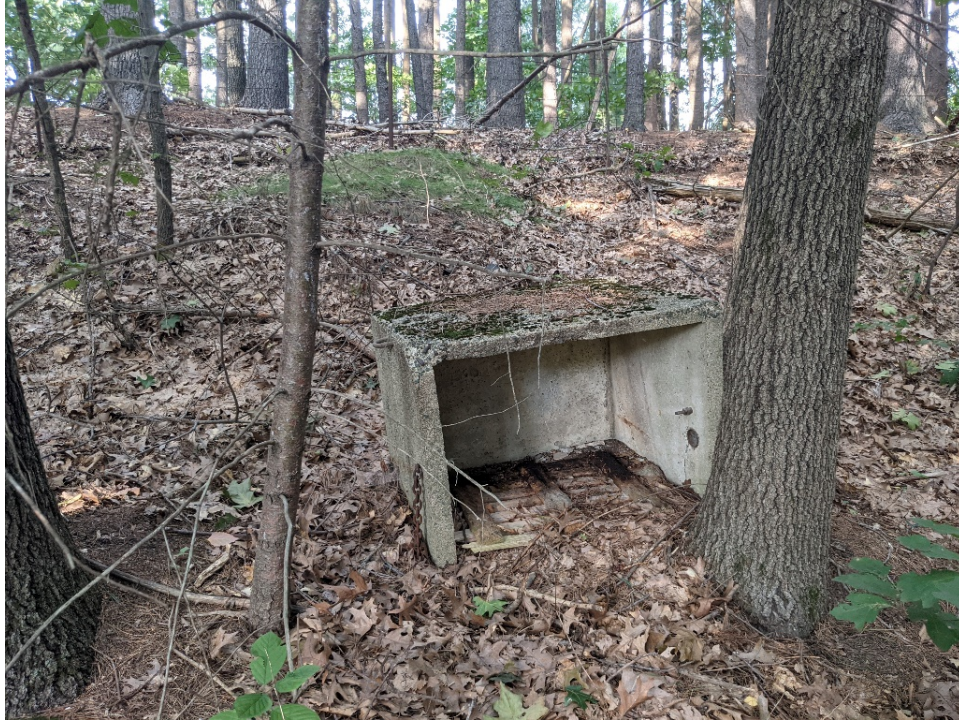
An isolated Concrete Box (MP 24.89; Photo 22) may also have been historically associated with a signal structure. Although the 1914 valuation map indicates a whistle post near this location, the hollow concrete box (or base) does not resemble the known whistle posts in Hudson or Sudbury. It is possible the box is a remnant of a signal added after 1914 in association with the industry siding located east of this location.

**Photo # 22** Concrete mechanical/electric box at MP 24.89, view north

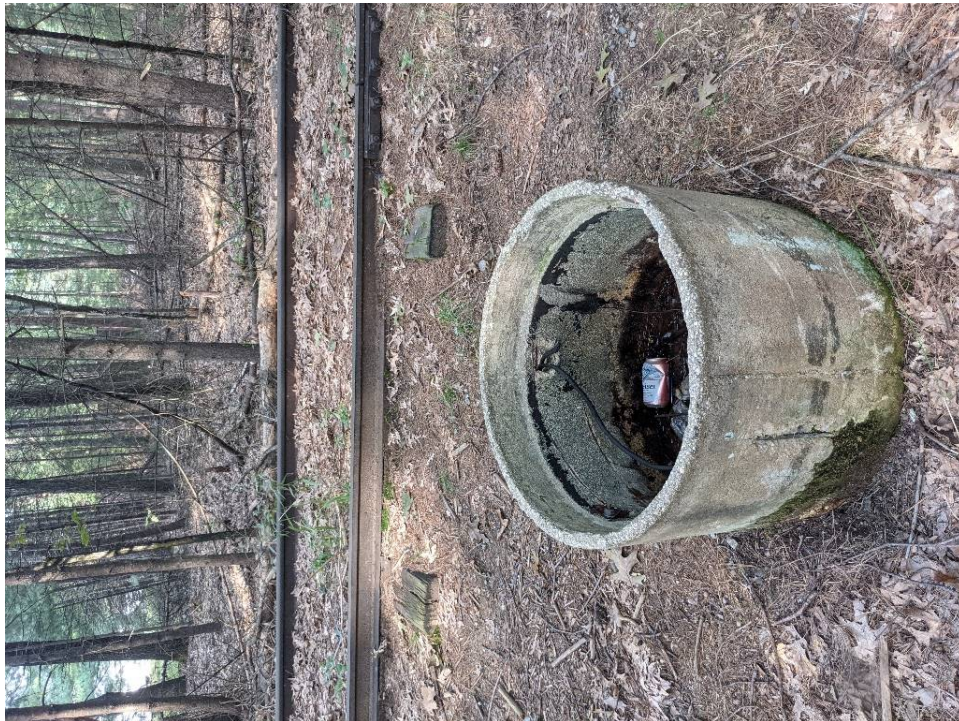
An isolated concrete Battery Base Well (MP 24.36; Photo 23) was likely originally associated with a signal structure, but the structure is not extant. There is no signal noted on the 1914 valuation map at this location, suggesting it may have been added later.

**Photo # 23** Concrete base well at MP 24.36, view north

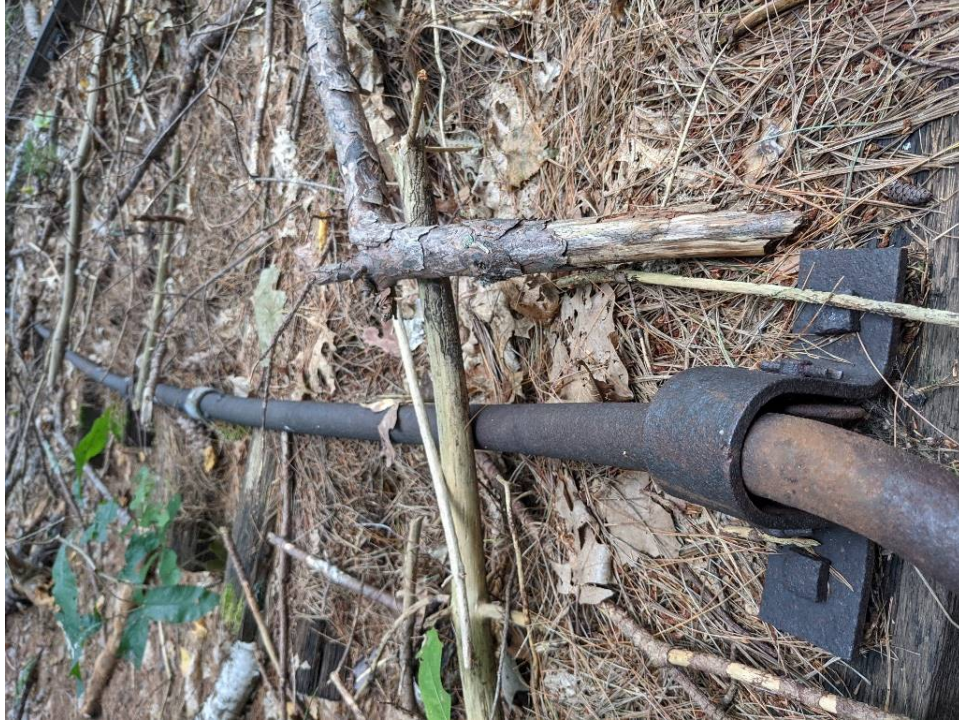
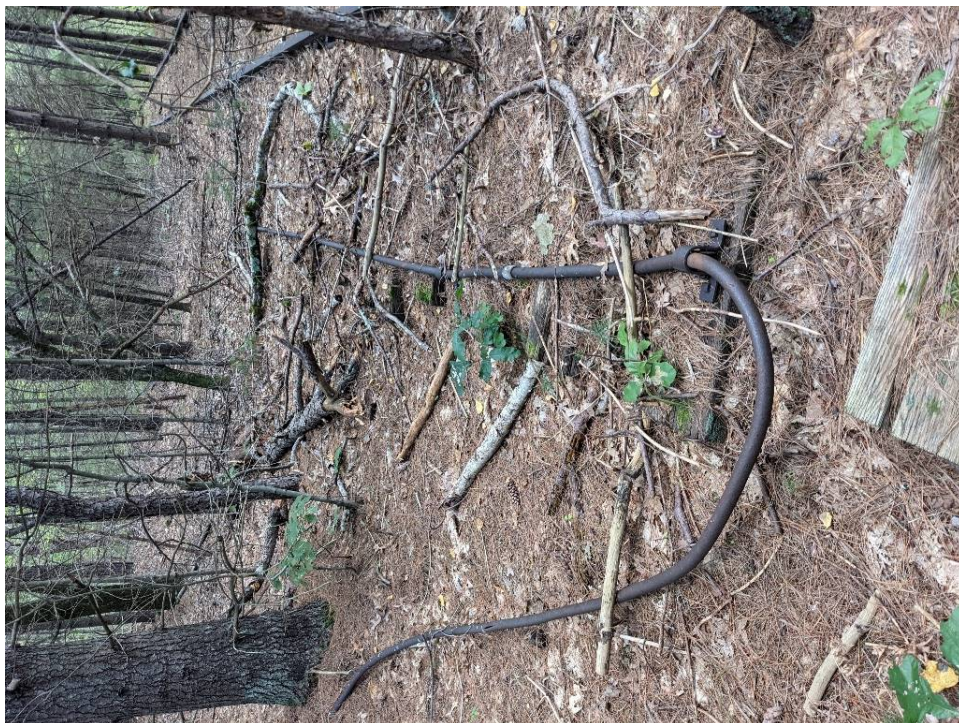
Photo # 24 Conduit for pipe-connected derail switch at MP 23.33, view east

Photo # 25 Conduit for pipe-connected derail switch at MP 23.33, view east

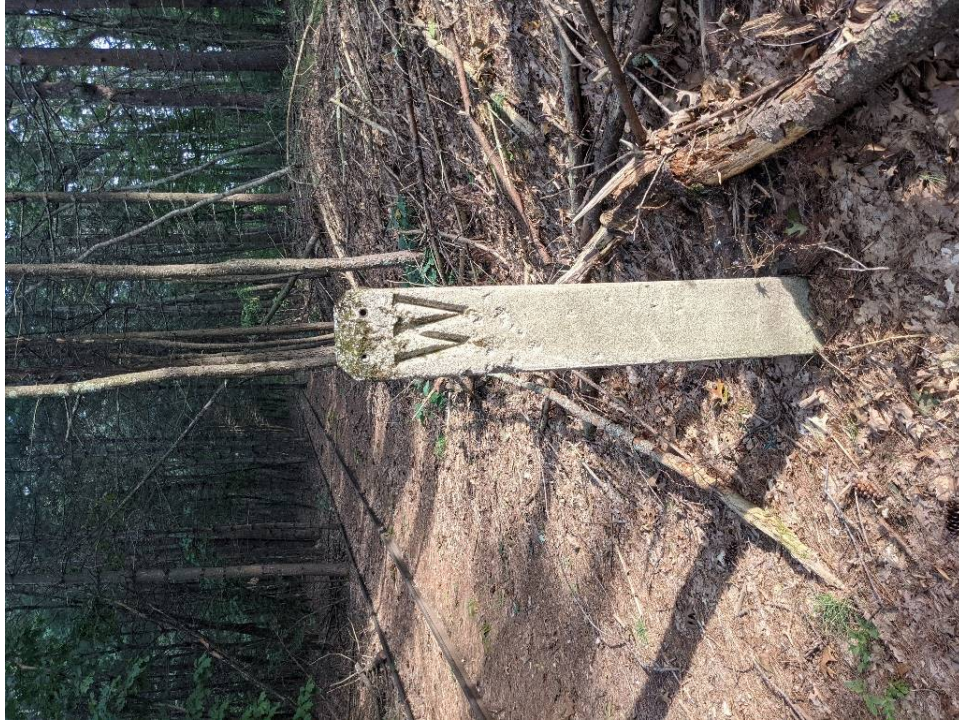
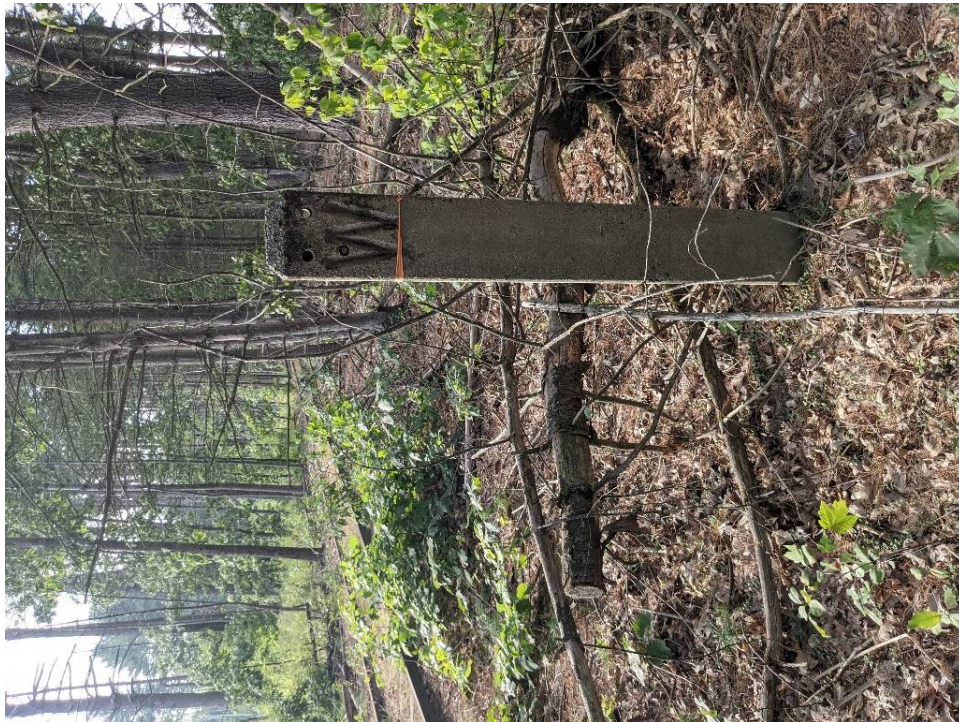
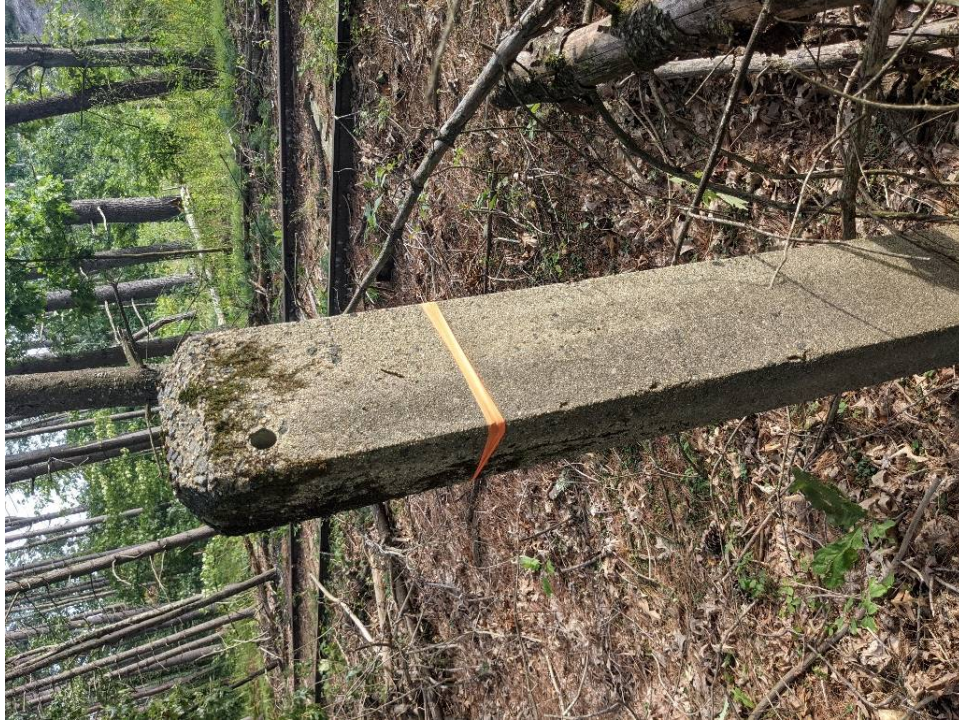
There are two extant concrete whistle posts in this portion of the rail corridor, alongside the north and south side of the tracks east of the Main Street crossing (MP 24.40 and 24.50). As noted on the **SUD.R.** form:

Both whistle posts are in good condition.

**Photo # 26** Whistle Post, south side of track at MP 24.4, view east

**Photo # 27** Whistle Post, north side of track at MP 24.5, view west

**Photo # 28** Whistle Post, north side of track at MP 24.50, view southeast
