# FORM A - AREA

**Name of Area:** Central Massachusetts Railroad Corridor  
(Boston & Maine Railroad Corridor)

# INVENTORY FORM A CONTINUATION SHEET

CENTRAL MASSACHUSETTS  
RR CORRIDOR

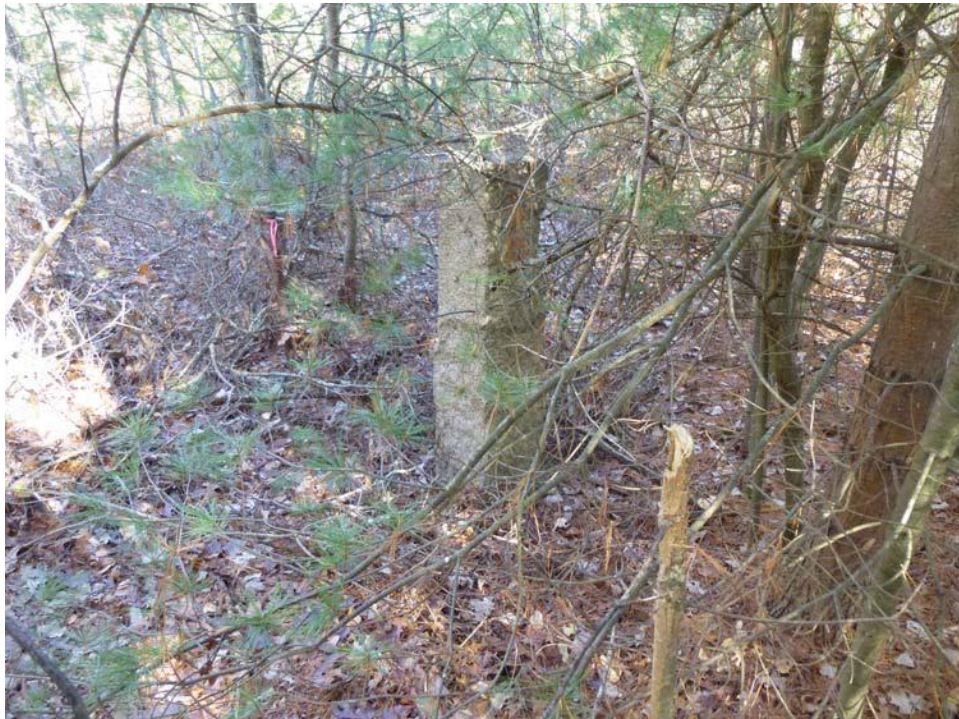
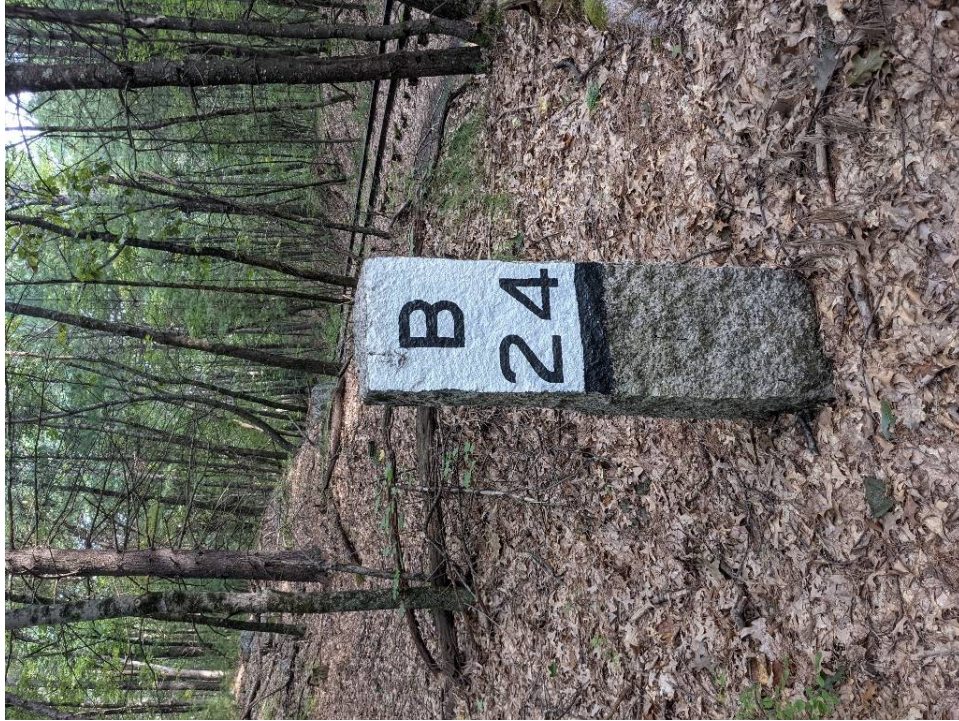
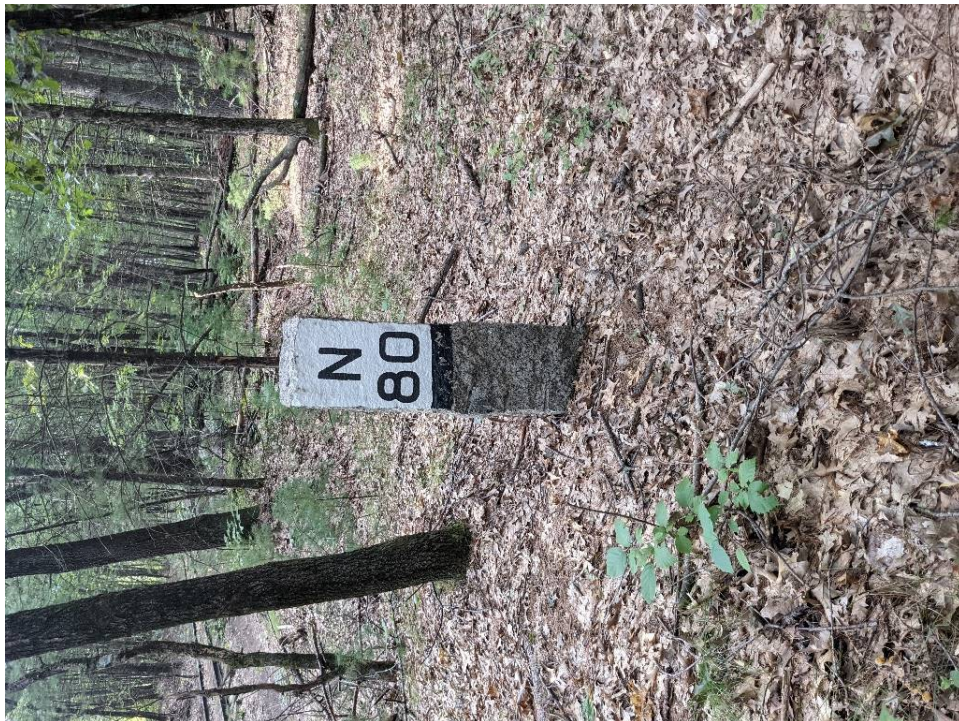
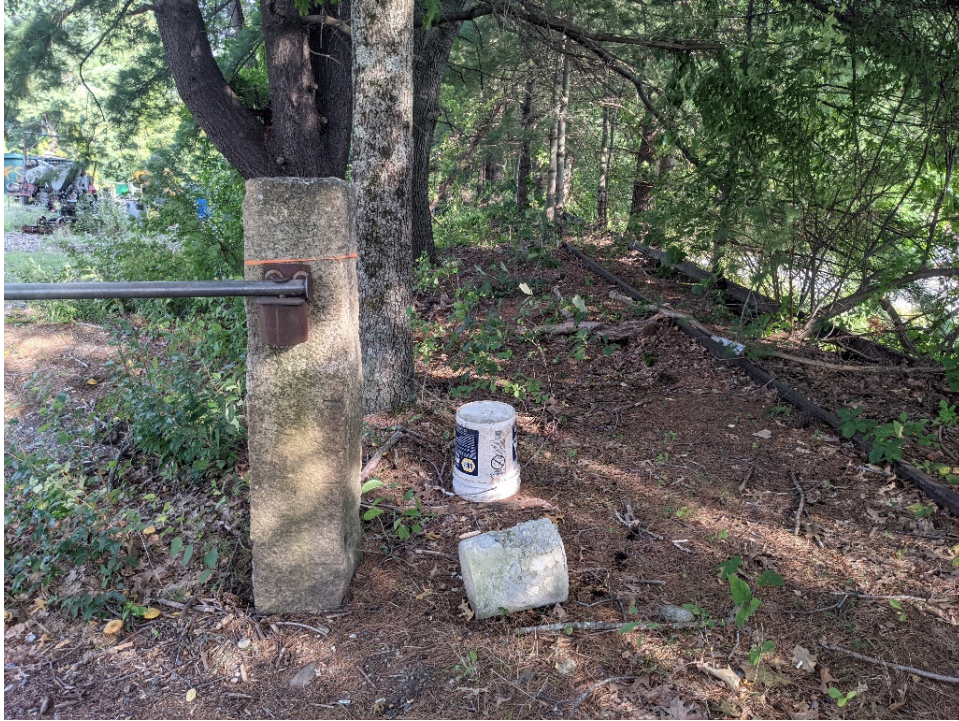
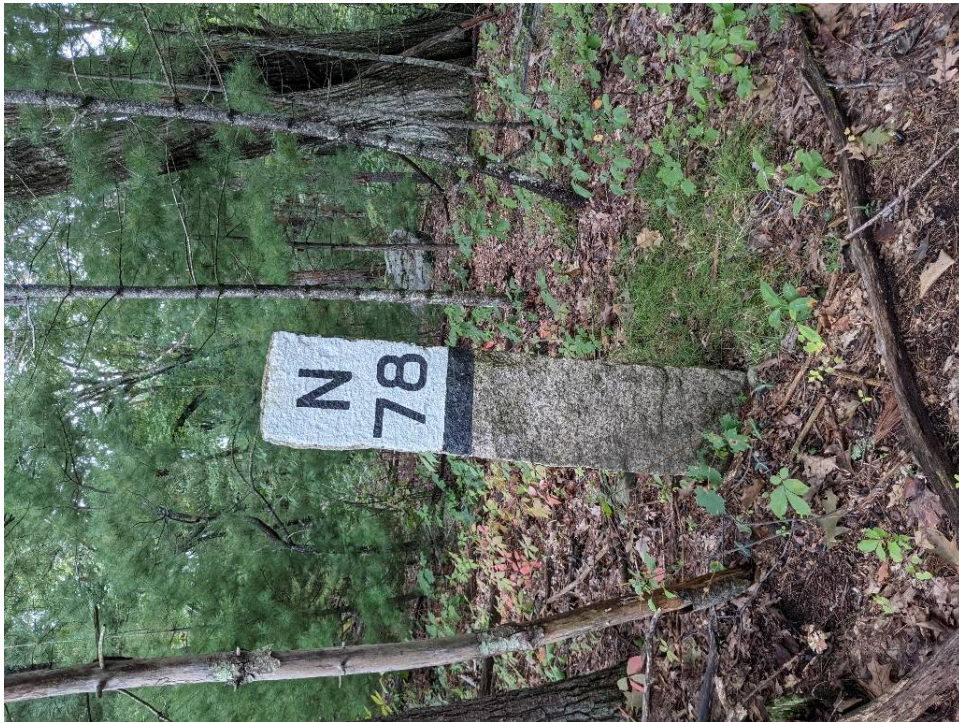
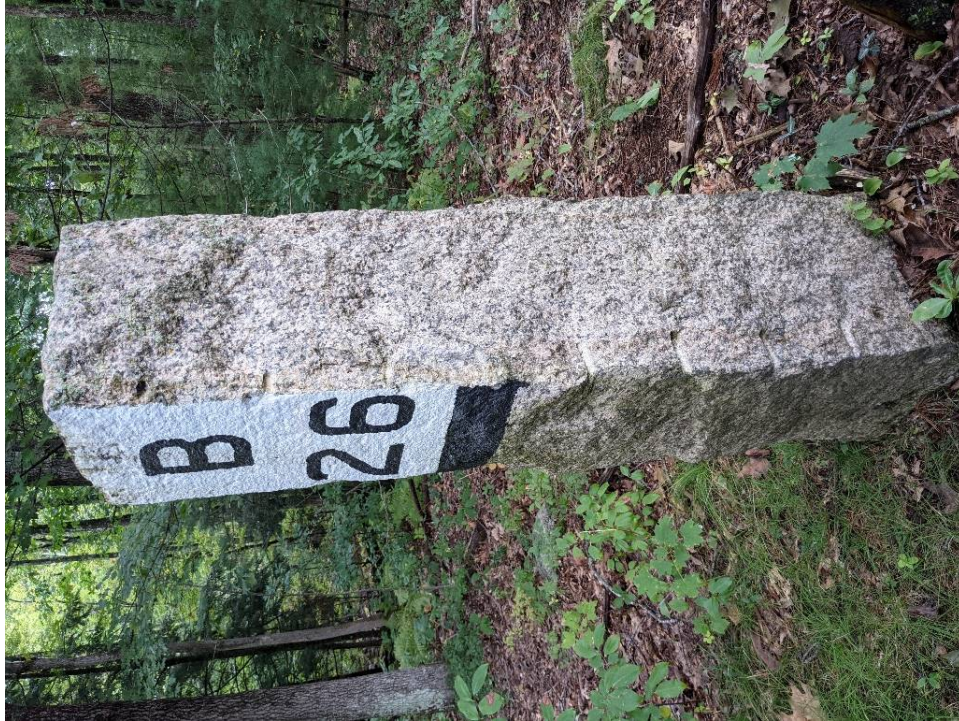
There are four mileposts located in the rail corridor in the project area (MPs 23-26). They are present on the 1914 valuation map and may date to the original 1881 opening of the railroad; alternatively, they may have been erected by the B&MRR in the early twentieth century to replace the original posts. Similar to those in **SUD.R**:

The posts for mile markers 24, 25, and 26 are painted, showing the mileage to Boston on the inbound side, and the mileage to Northampton on the outbound side. All of the mileposts are in good condition.

**Photo # 29** Milepost 23, view southwest

Photo # 30 Milepost 24, view east

Photo # 31 Milepost 24, view west

Photo # 32 Milepost 25, view east

Photo # 33 Milepost 26, view west

**Photo # 34** Milepost 26, view northwest

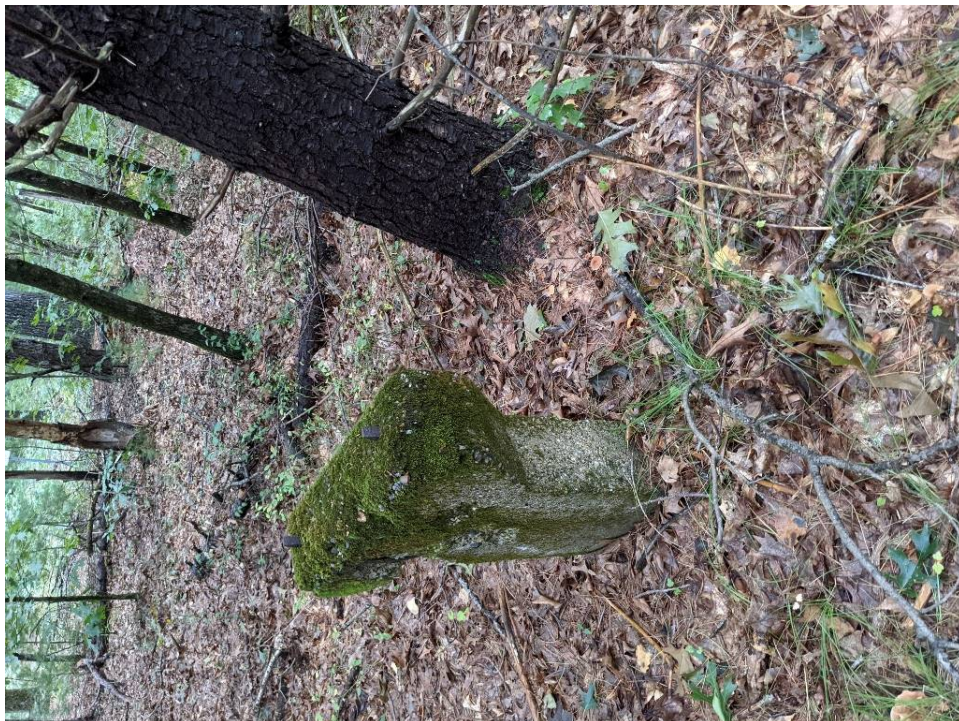
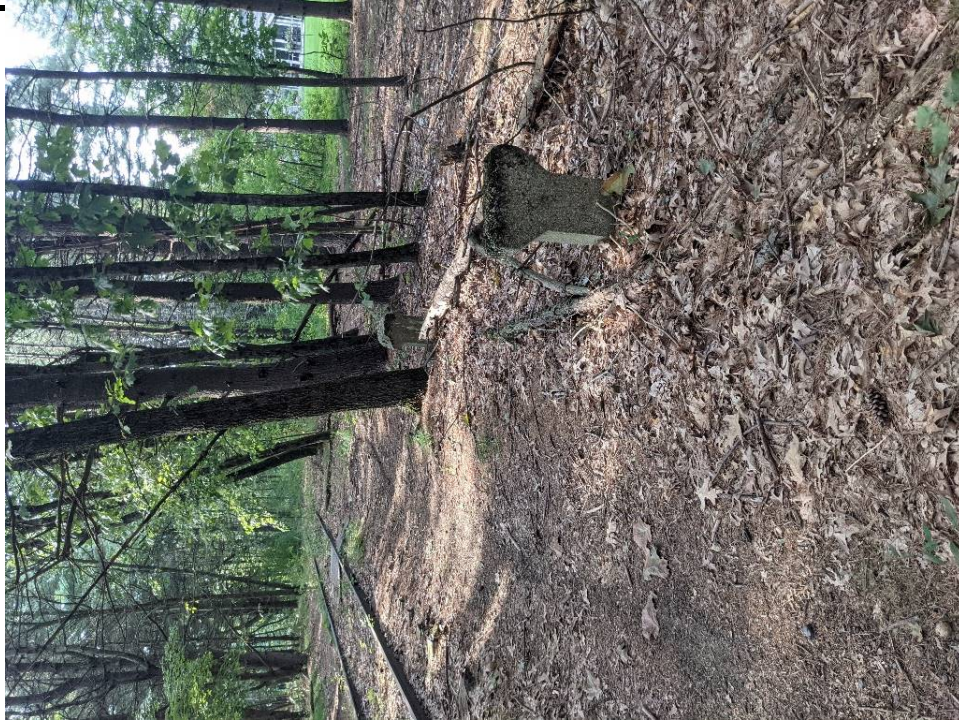
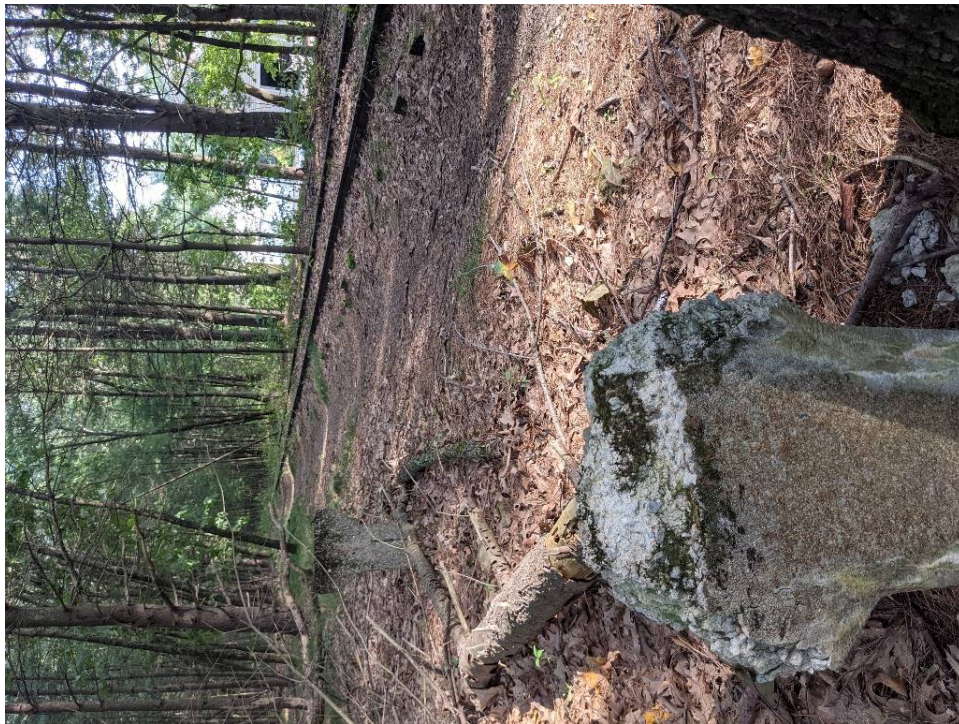
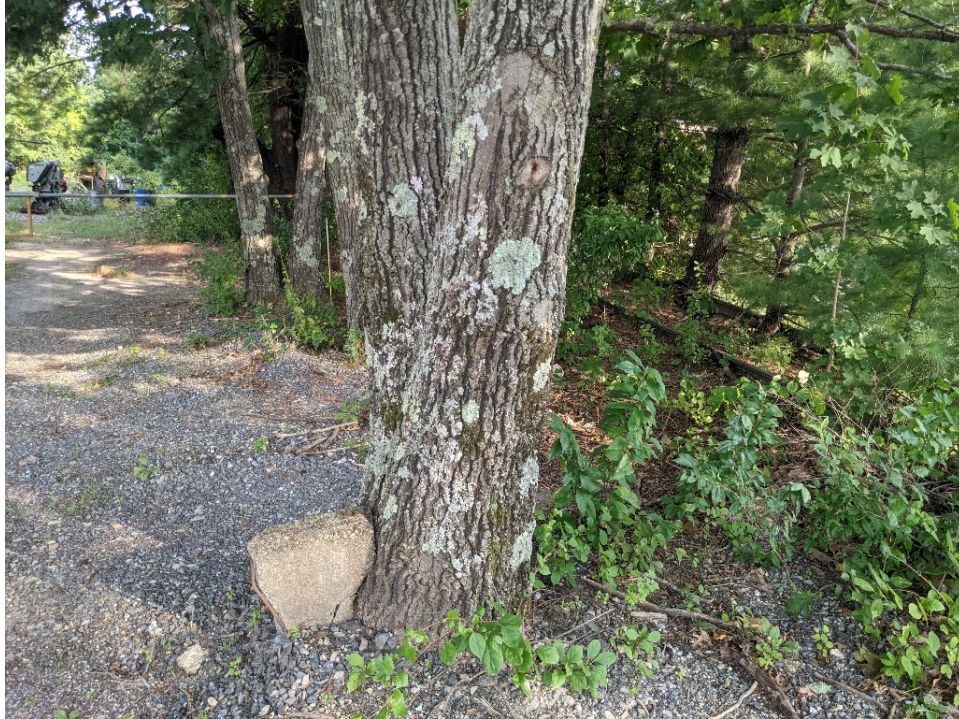
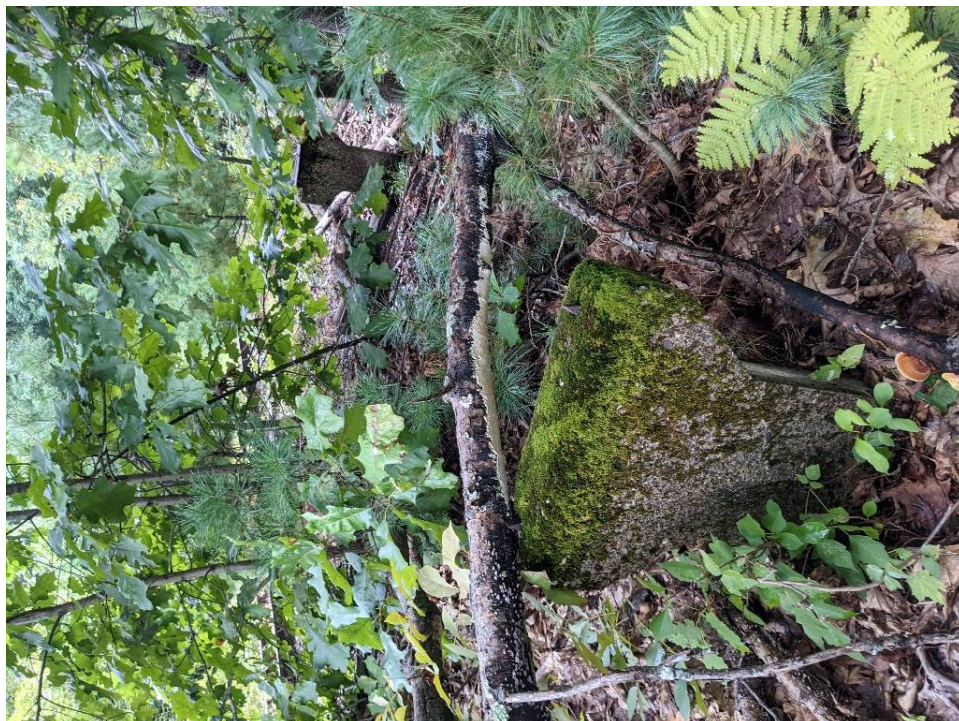
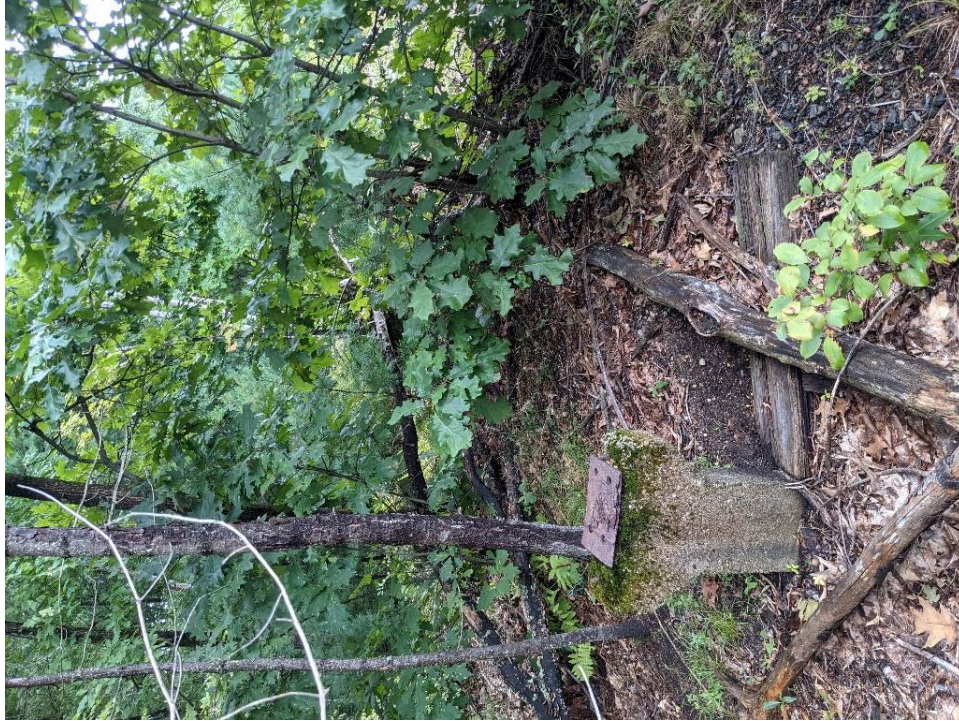
All four rail rests noted in this portion of the corridor on the 1914 valuation map are extant, though in varying conditions. As with Sudbury, the current iterations likely date from the 1929-1930 upgrade of the corridor. **SUD.R** notes, "In this corridor, rail rests are located on the engineer's side, outbound movement, and as near as possible to the mileposts, as per B&MRR specifications." As constructed, "Each rail rest consists of a set of three reinforced cast concrete posts with flared heads placed approximately 15 feet apart. The pair of inverted metal track spikes set into the top surface of each post served to hold the rail sections in place. The posts measure 5'-0" H x 6" deep. The posts are 10" wide at the base and 1'-6" at the top."

Although constructed in sets of three, only three of the locations retain all three of their original posts. The rail rest associated with milepost 23 exhibits the most intact condition, with the shape and flared profile highly visible. In contrast, at milepost 25, only one post was relocated. It is fragmented and is leaning heavily due to its location immediate to a mature tree and its roots.

**Photo # 35** Rail rest at MP 23.05, view southwest

**Photo # 36** Rail rest at MP 24.09, view west

**Photo # 37** Rail rest at MP 24.09, view east

**Photo # 38** Rail rest at MP 25.00, view east

**Photo # 39** Rail rest at MP 26.00, view west

**Photo # 40** Rail rest at MP 26.00, view east

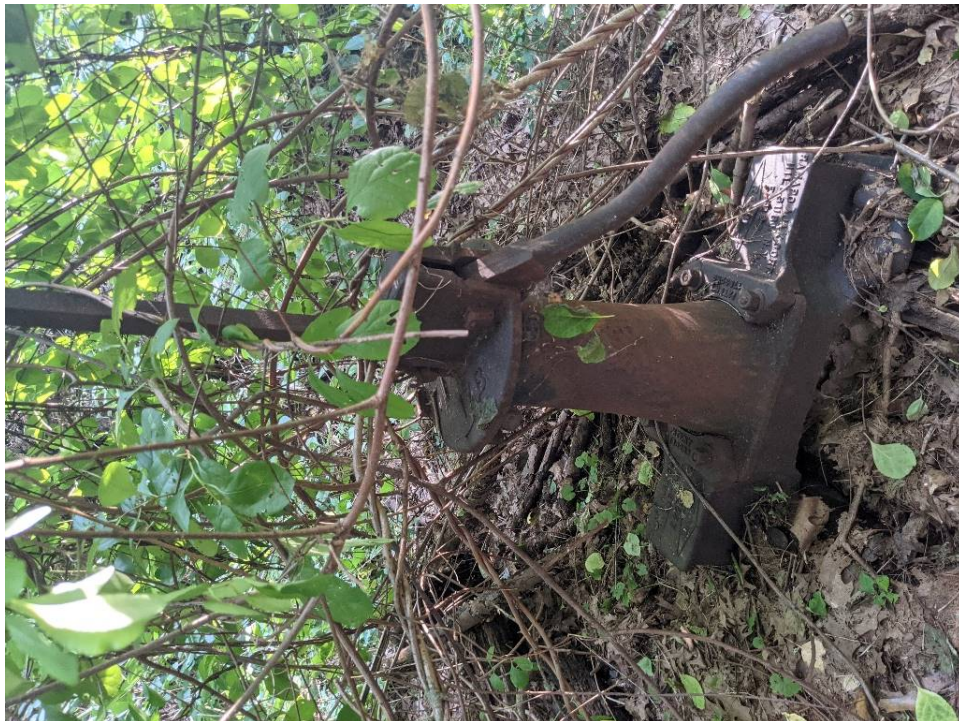
A Track Switch Stand with Electrical Box (MP 24.80; Photos 41-43) is located west of the Main Street crossing. The cast-steel Switch Stand is a Model No. 17 B manufactured by Ramapo Ajax Corp. of Huntington, NY. This is the same type found in Sudbury, and as described in SUD.R, "Each switch stand consists of a rectangular cast steel base that supports a round, tapered steel pivot post. A curvilinear locking handle is connected to the post with bolts. A sheet steel day target is bolted to a steel rod that extends from the top of the pivot." The nearby electrical box, manufactured by the General Railway Signal Company, may have serviced an electric switch stand lamp. The switch is noted on the 1914 valuation map but based on the patent date embossed on the electrical box, the latter was installed after 1932.

**Photo # 41** Switch Stand and Electrical Box at MP 24.80, view east

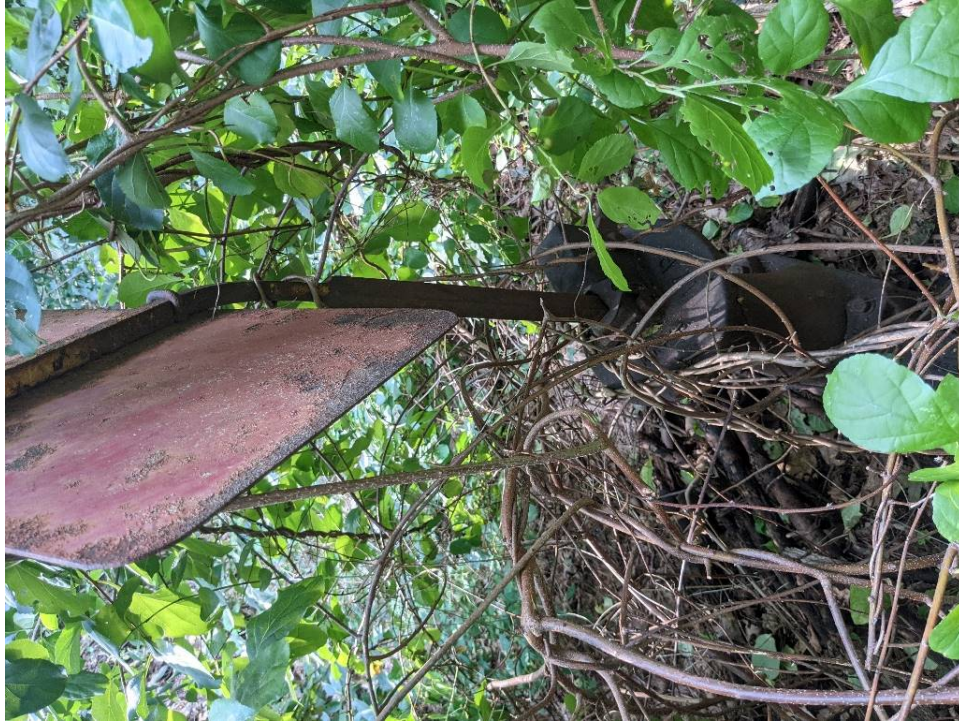
**Photo # 42** Switch Stand and Electrical Box at MP 24.80, view south

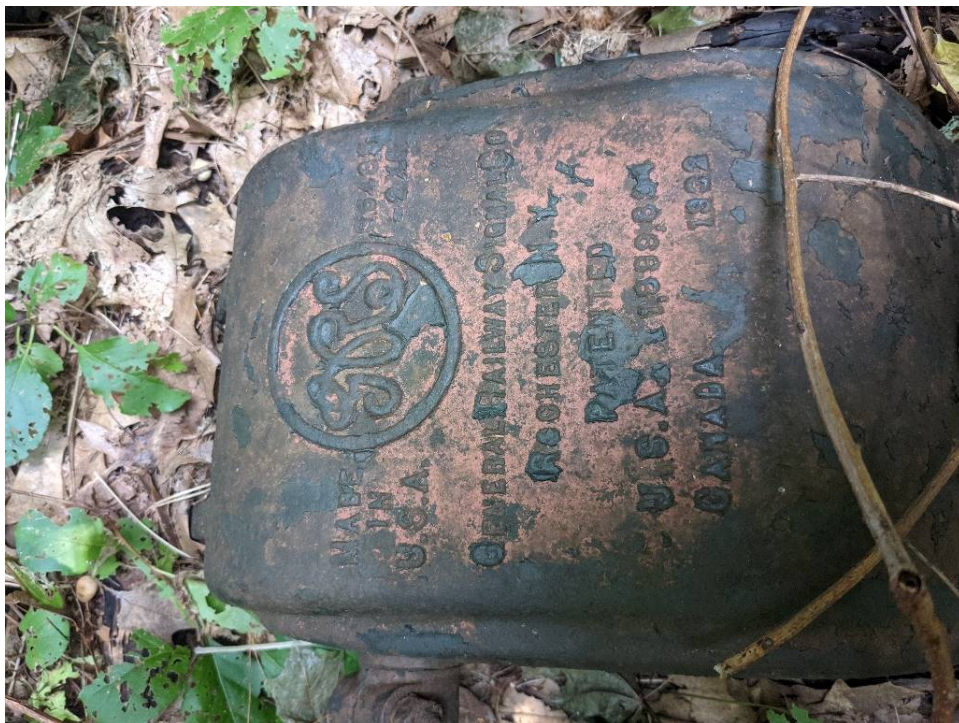
**Photo # 43** Closeup of Electrical Box cover at MP 24.80

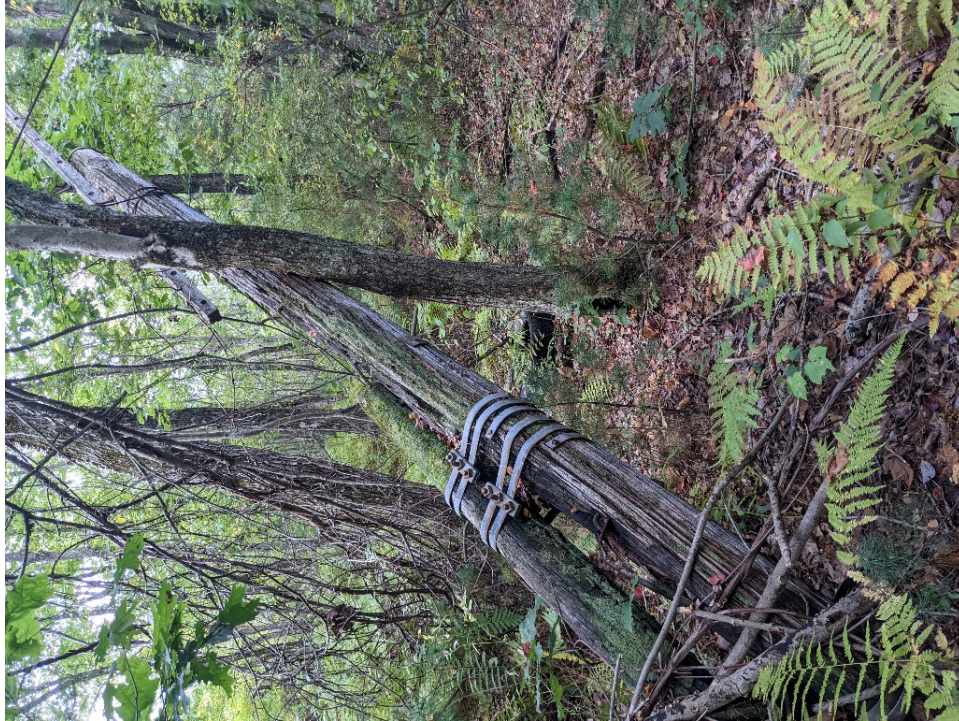
Only one telegraph pole (MP 23.06) was relocated in this portion of the corridor through Hudson. It was in fair condition, and tipped over partially on its side with the cross post askew.

Photo # 44 Telegraph Pole at MP 23.06, view S

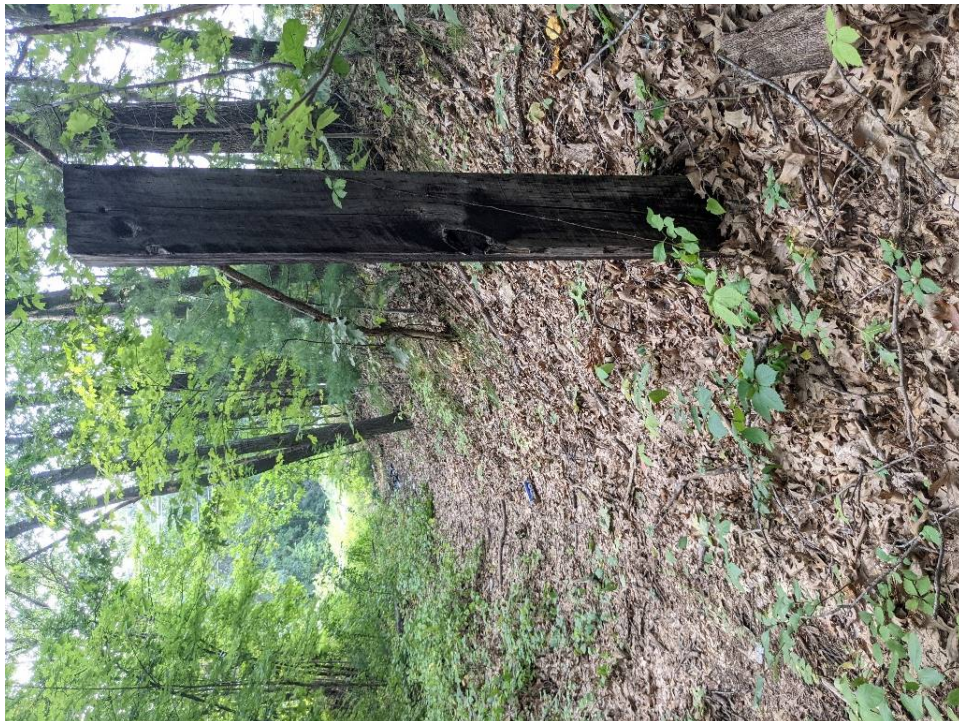
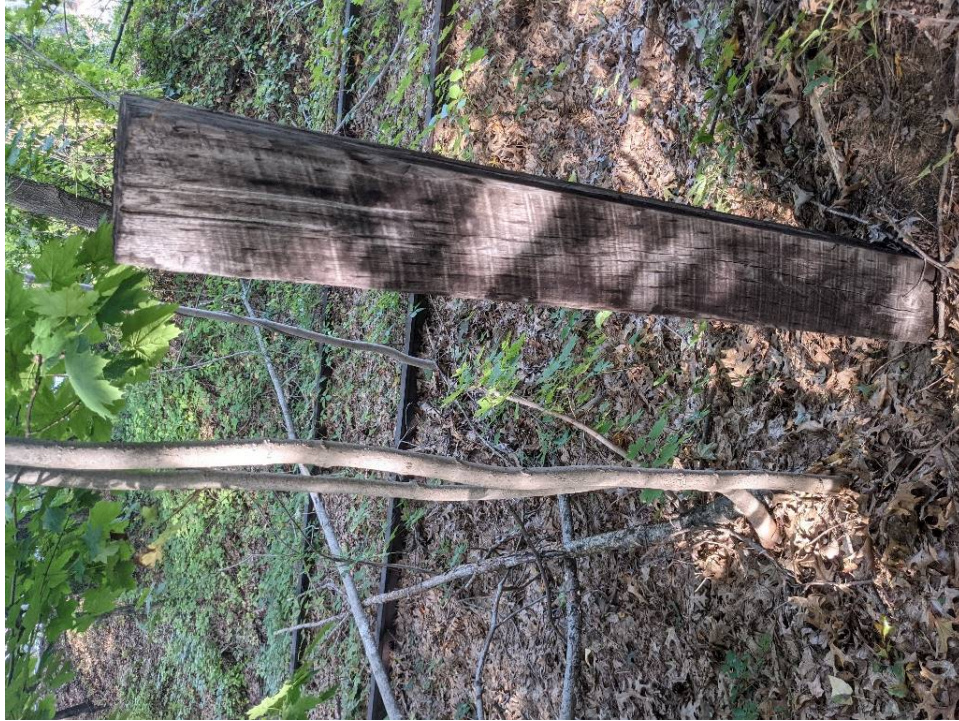
Two squared wood posts were observed, one on each side of the railroad crossing at Main Street and are likely to have been associated with one or more of the crossing-related features noted on the 1914 valuation map (MP 24.72 and 24.78). Crossing signs, highway flashers, and a wig wag were marked at this location, and the posts may indicate the former locations of the crossing signs. The posts are in fair to good condition, but associated elements that could confirm their original use have been lost.

The presence of a concrete battery well (MP 24.36; Photo 23), and features associated with the Main Street crossing such as the wood signposts and a rail-related utility pole (MP 24.72-24.78; Photos 19-20, 45-46) all speak to the complicated signaling systems along the line. As described and illustrated in **SUD.R**:

Photo # 45 Wood post at MP 24.72, view west

**Photo # 46** Wood post at MP 24.78, looking north

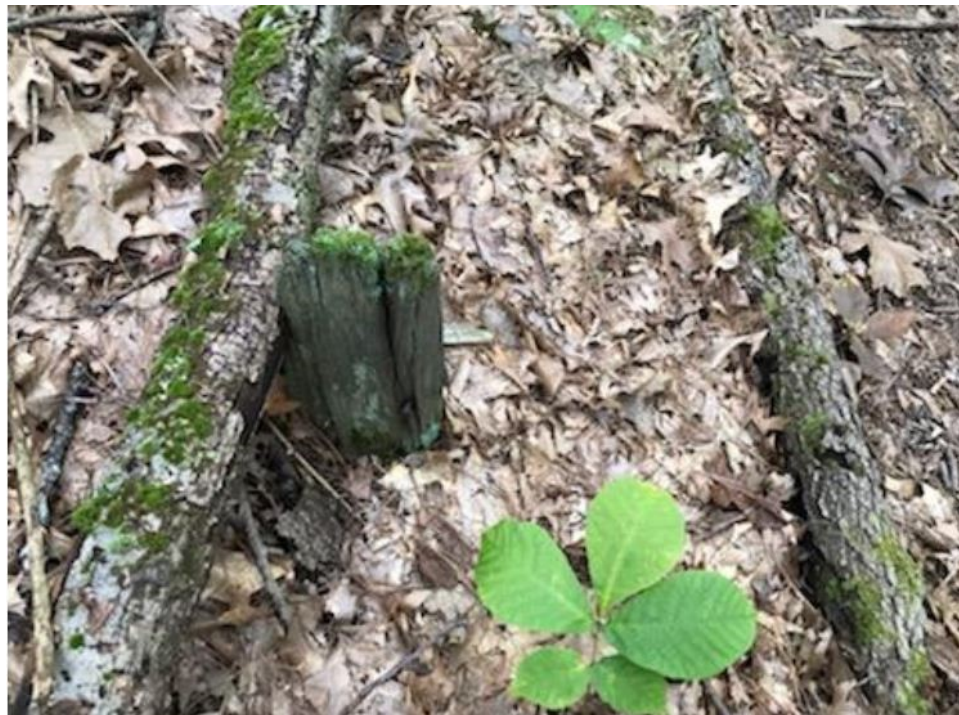
## Section Post (Photo 47)

**Photo # 47** Section post stump at MP 24.00, view west
