Re: Phase I Environmental Site Assessment with Subsurface Investigation

Raytheon Facility, 528 Boston Post Road

Sudbury, Massachusetts

RTN 3-27243

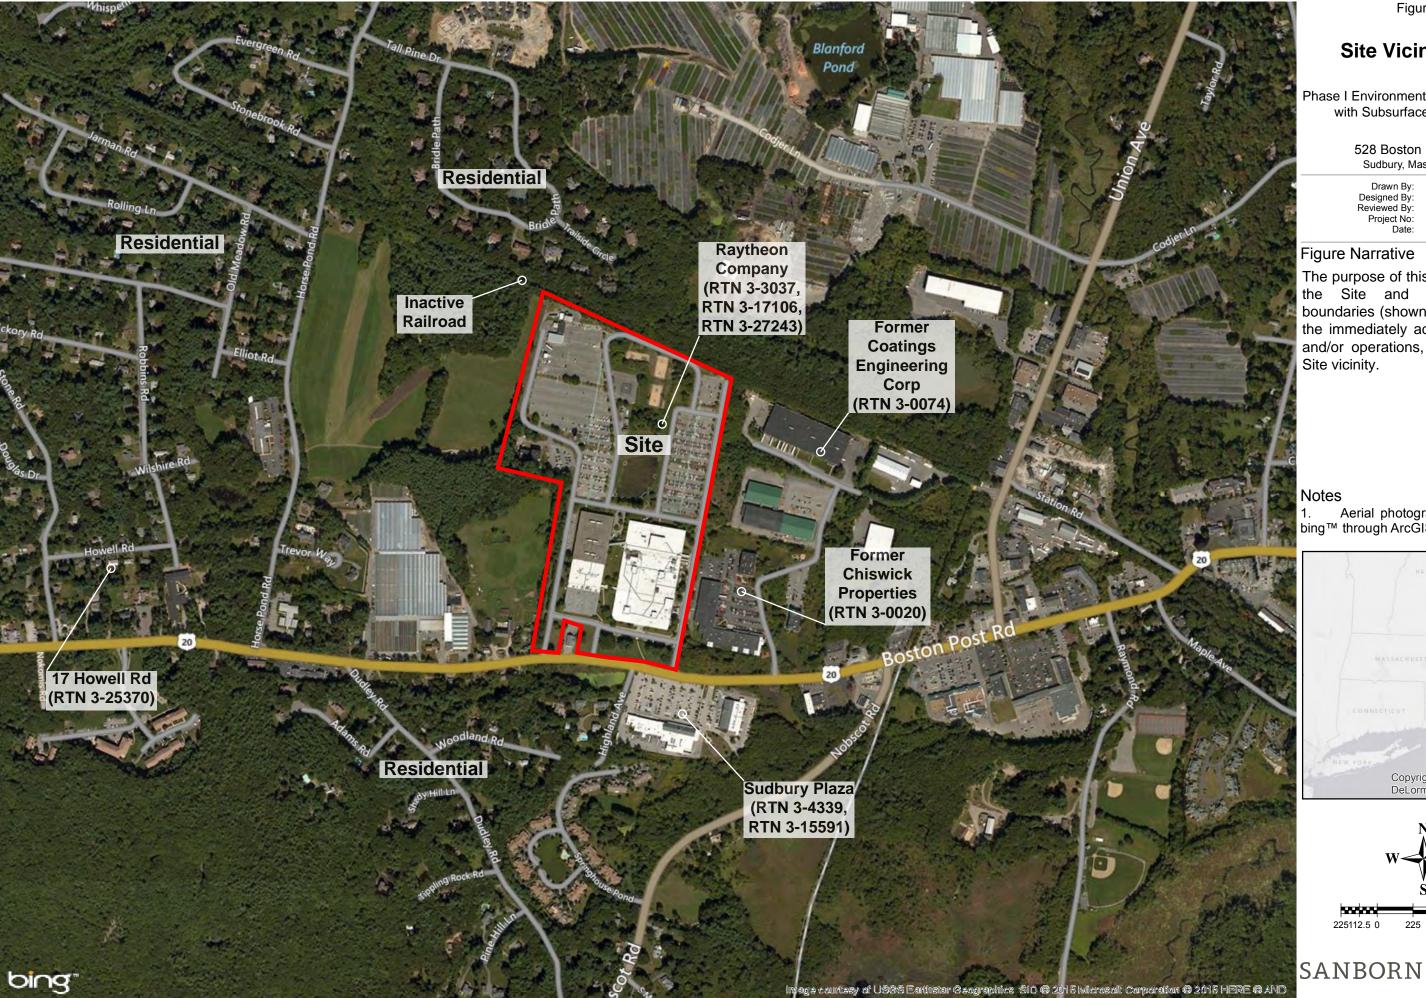
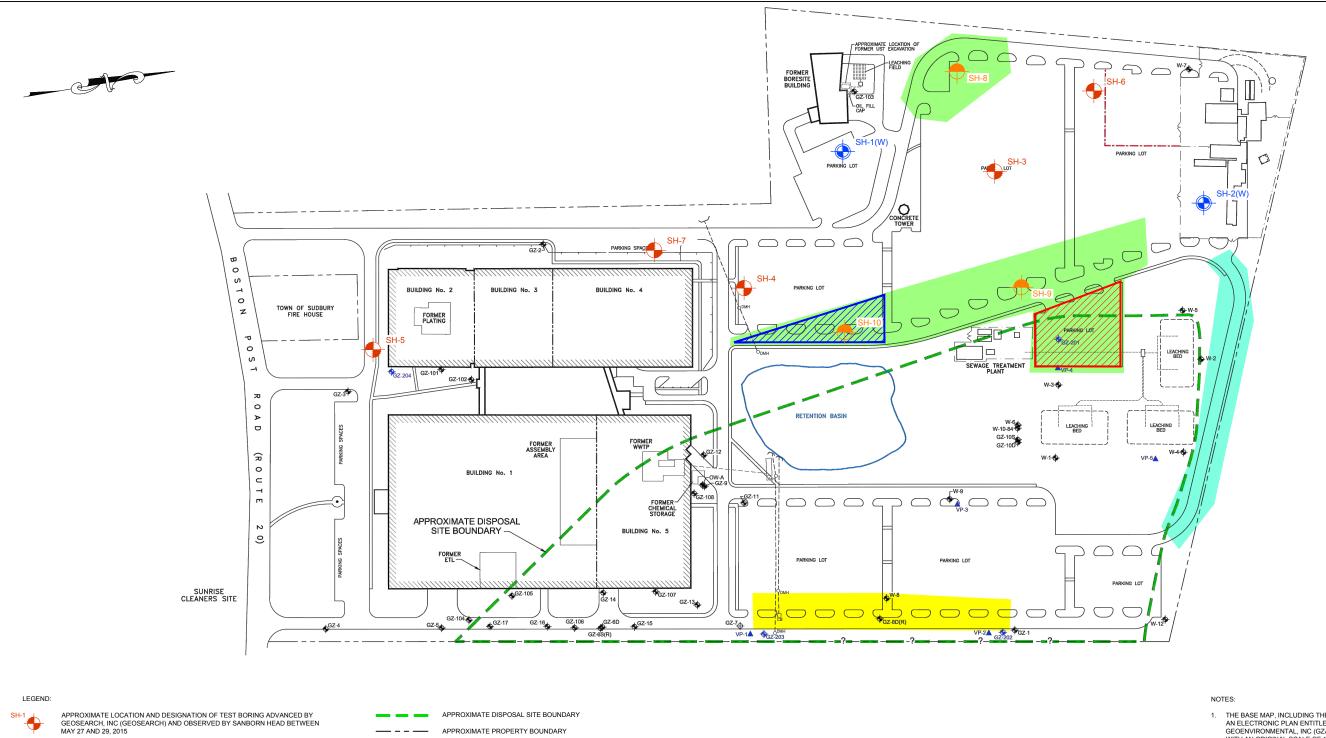
APPROXIMATE LOCATION AND DESIGNATION OF SHALLOW TEST BORING ADVANCED BY GEOSEARCH AND OBSERVED BY SANBORN HEAD ON MAY 29,

APPROXIMATE LOCATIONG AND DESIGNATION OF TEST BORING COMPLETED AS A MONITORING WELL ADVANCED BY GEOSEARCH AND OBSERVED BY SANBORN HEAD BETWEEN MAY 27 AND 28, 2015

APPROXIMATE LOCATION OF POTENTIALLY BURIED TRASH AND DEBRIS AS NOTED BY THE

- EXPLORATIONS DESIGNATED SH-1 THROUGH SH-10 WERE ADVANCED BY GEOSEARCH, INC (GEOSEARCH) OF FITCHBURG, MA BETWEEN MAY 27 AND 29, 2015 AND WERE OBSERVED BY SANBORN HEAD.

- 3. APPROXIMATE LOCATIONS OF EXPLORATIONS OBSERVED BY SANBORN HEAD ARE BASED ON TAPED MEASUREMENTS MADE IN THE FIELD RELATIVE FROM PROMINENT SITE FEATURES. THIS DATA SHOULD BE CONSIDERED ACCURATE ONLY TO THE DEGREE IMPLIED BY THE METHOD USED.
