Sudbury Bruce Freeman Rail Trail Task Force Meeting *March 9, 2021*

Concepts for Discussion

BIKE PATH CONSTRUCTION (BRUCE FREEMAN RAIL TRAIL) SUDBURY, MASSACHUSETTS

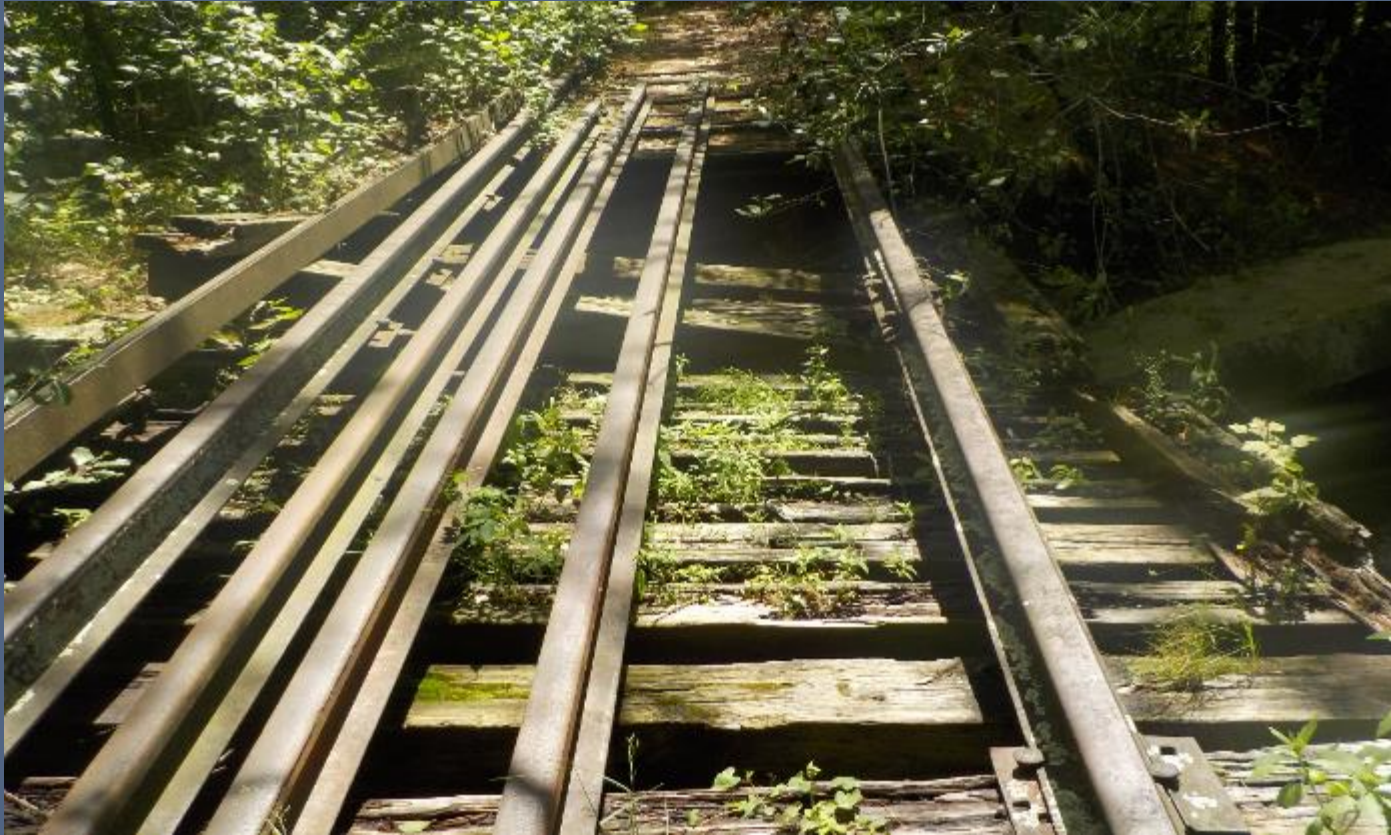
EXISTING PANTRY BROOK BRIDGE DECK

Existing Conditions - Pantry Brook

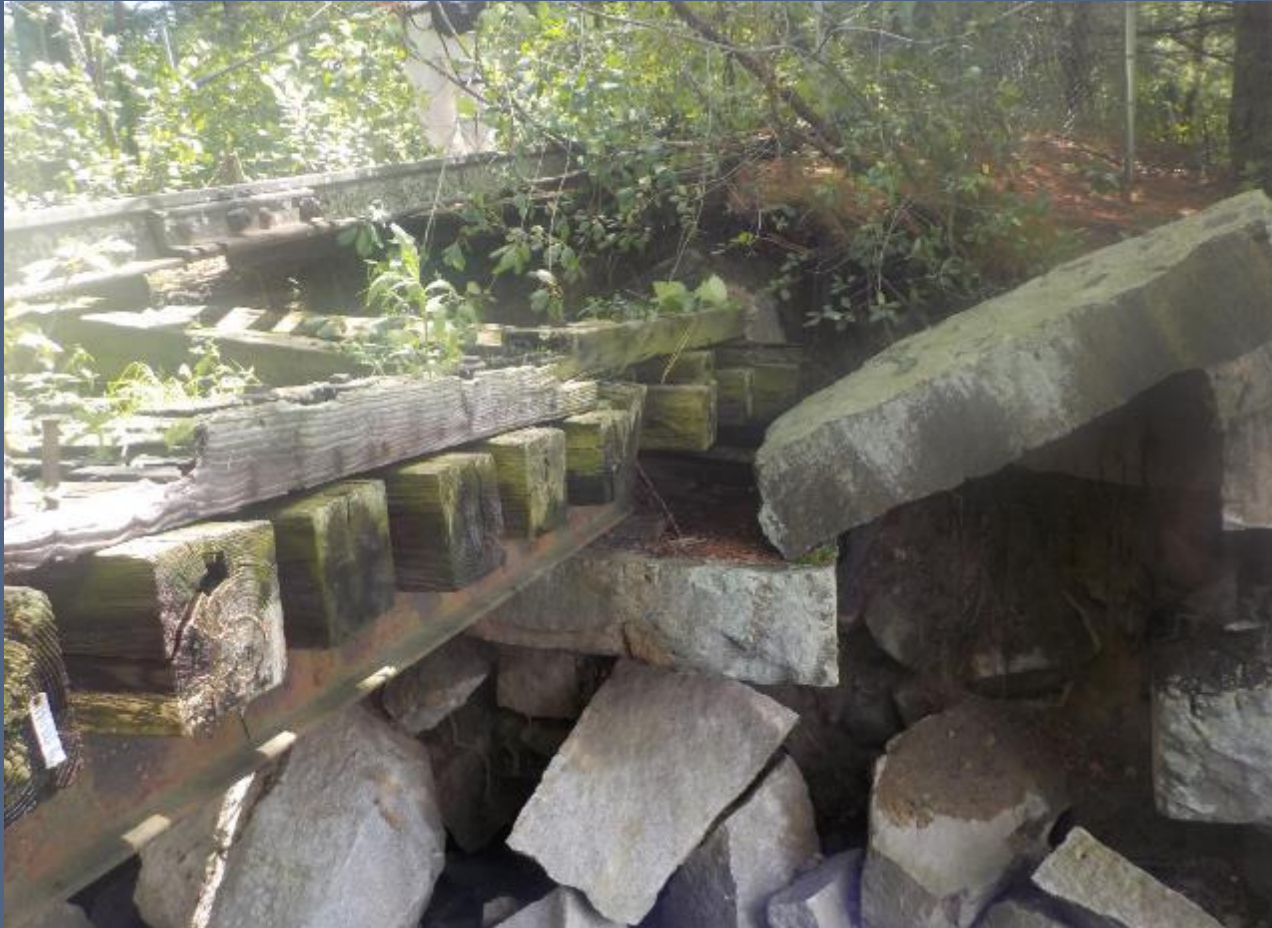
EXISTING PANTRY SOUTH ABUTMENT

Existing Conditions - Pantry Brook

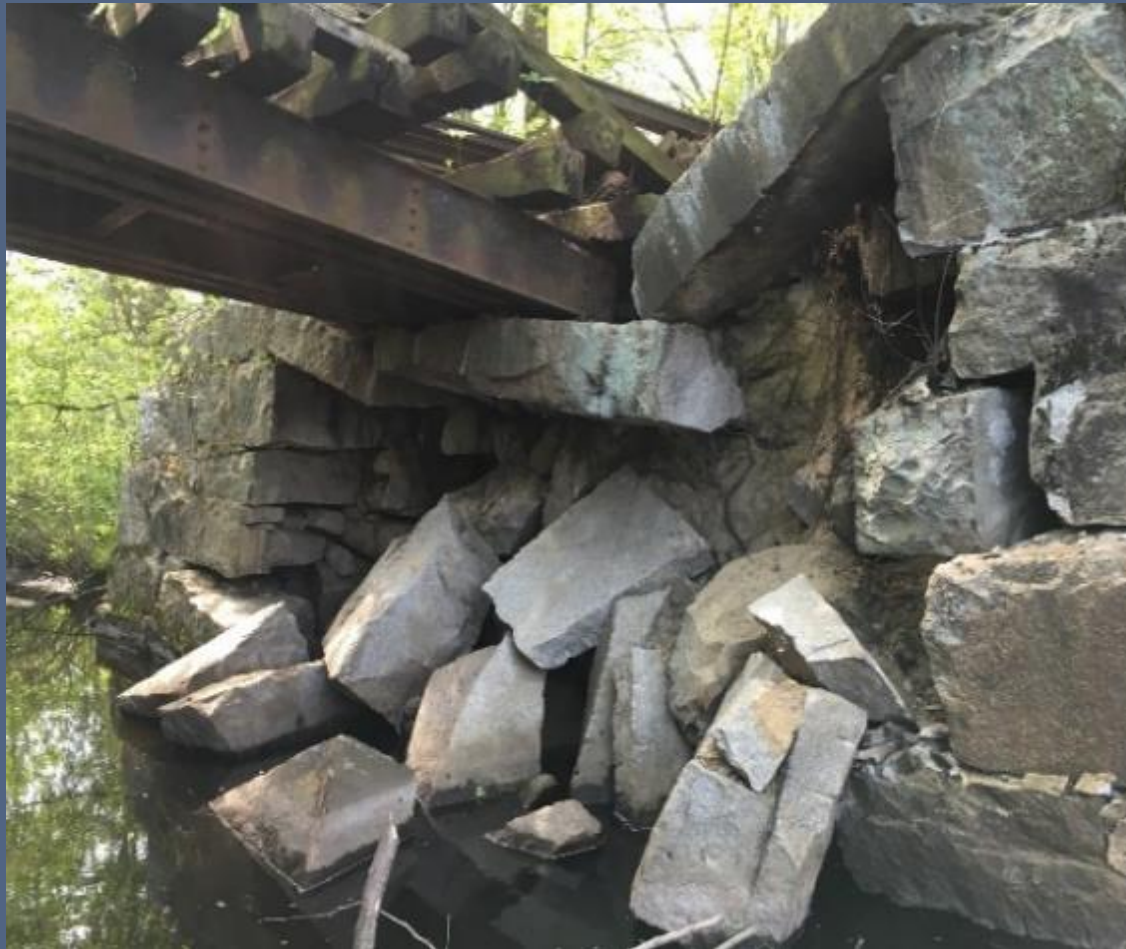
EXISTING PANTRY SOUTH ABUTMENT

Existing Conditions - Pantry Brook

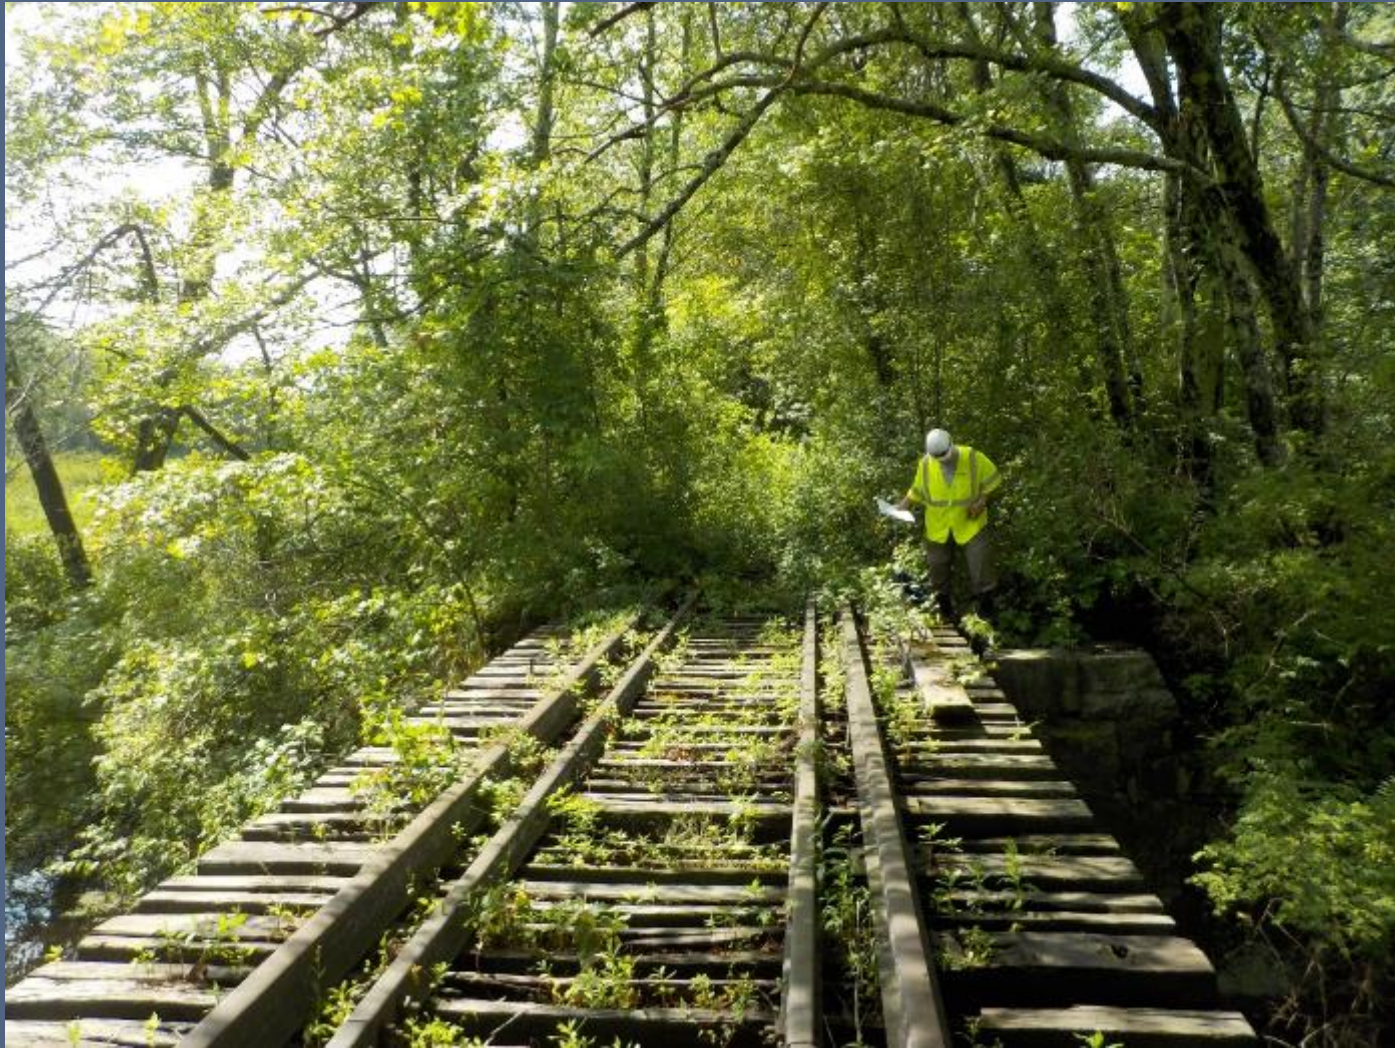
The diagram illustrates a cross-section of a bridge structure. Key components and labels include:

- BRG. SOUTH ABUTMENT** and **BRG. NORTH ABUTMENT**: The existing bridge abutments.
- 27'-7"±**: The span length between the abutments.
- PROP. TIMBER DECK** and **PROP. TIMBER FLOORBEAM (TYP.)**: The proposed new deck and floorbeams.

- 0.24%**: The proposed deck slope.
- PROP. GRADE**: The proposed ground level on the right side.
- APPROX. EXIST. GROUND**: The existing ground level on the right side.

- PROPOSED CONCRETE CAP (TYP.)**: The proposed concrete cap on the left abutment.
- EXIST. STEEL GIRDER TO REMAIN**: The existing steel girders supporting the deck.

- EXIST. GRANITE ABUTMENT TO REMAIN**: The existing granite abutments.
- CLEAN & PAINT EXIST. GIRDER**: The existing girders to be maintained.
- TOP PORTION OF EXIST. GRANITE ABUTMENT TO BE REMOVED (TYP.)**: The portion of the existing granite abutment to be removed.

- W.S. 6/3/2016 EL. 131.45**: The water surface elevation.
- APPROX. -XIST. STREAMBED**: The existing streambed.
- APPROXIMATE TOP OF EXIST. FTG. EL.**: The approximate top of the existing footing elevation.

- Reuse existing steel superstructure
- Clean and repaint existing beams
- Replace decking with pressure treated timber
- Detailed investigation and design shows lack of depth for bridge deck that matches proposed trail surface grade

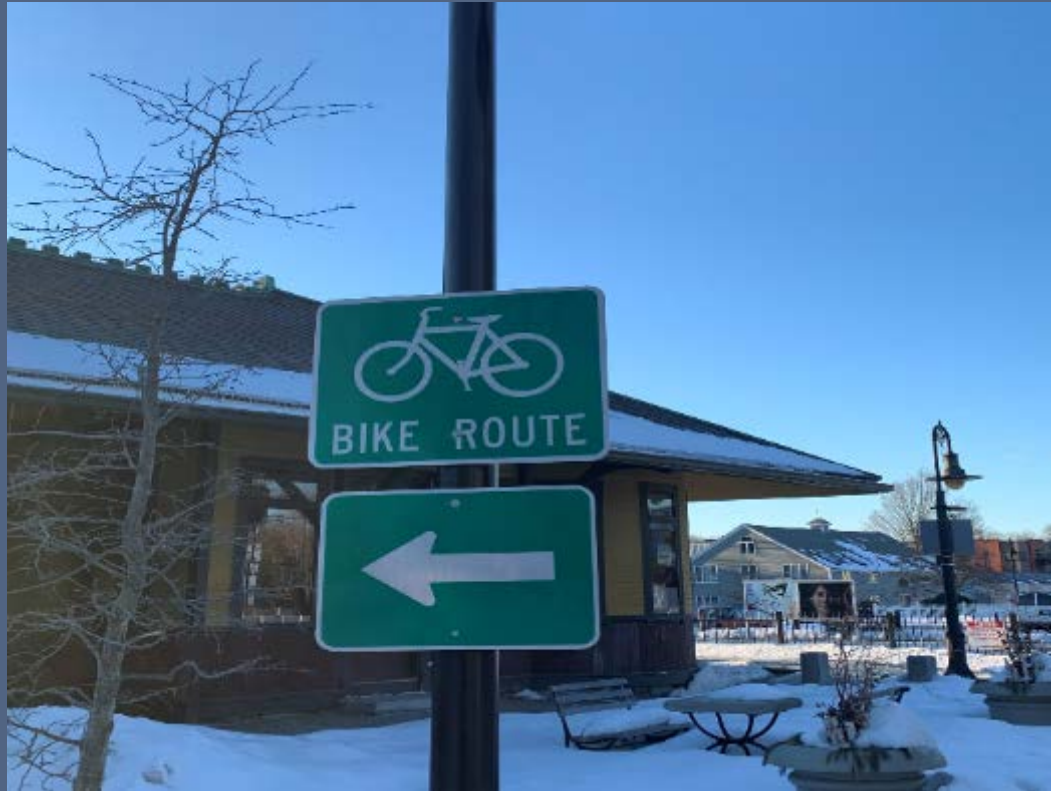
Wayfinding Signage – To Route

- Entry to Town of Sudbury
- Road crossings
- Stream crossings
- Nearby destinations

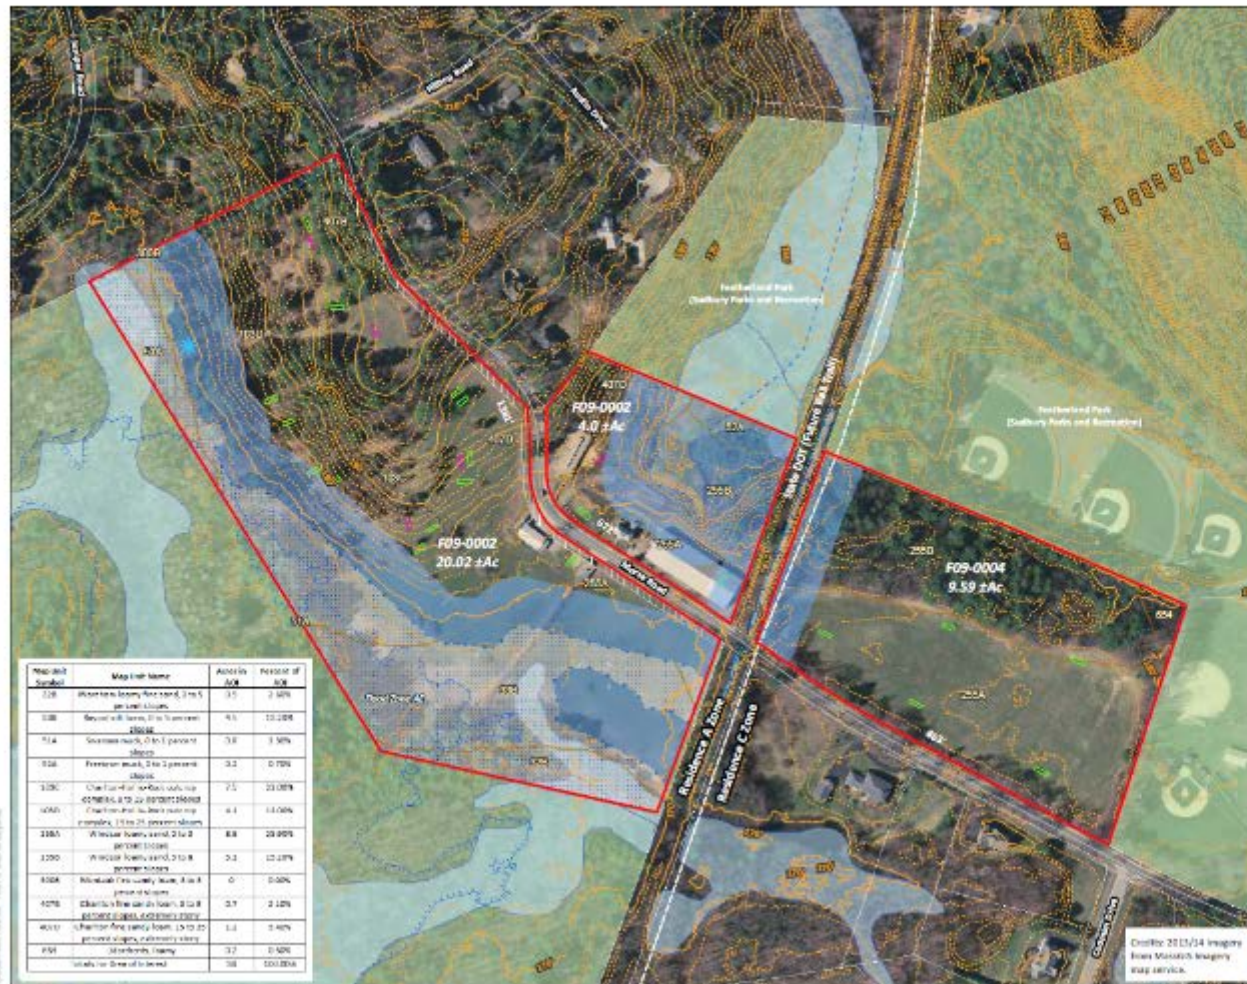
Broadacres Farm
Sudbury, MA

Site Analysis Plan

- Subject Property - 33.61 ±Ac
- Drainage Easement - 20' Wide
- Sidewalk Easement - 15' Wide
- Passing Soil Test Areas (2018)
- Not Observed / Abandoned Soil Test Areas (2018)
- Adjacent Properties
- Protected Land
- Delineated Wetlands
- Open Water
- Wetlands (DGP)
- Perennial Streams
- Intermittent Streams
- Contours (ft)
- Soil Types
- 100 Year Flood Zone
- 100' Wetlands Setback
- Vernal Pool
