Curtis Middle School

Town of Sudbury ADA Transition Plan

January 2021

**Town of Sudbury
Curtis Middle School**

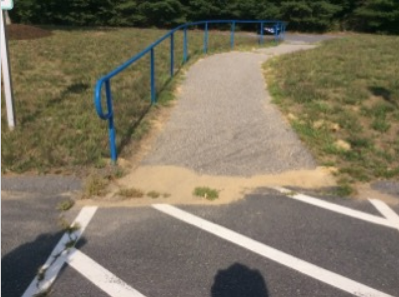
ID	Location	Floor	Room	Element	Type	Photo	Issues	Current Measure	Recommendations	Quantity	Price	Cost Estimation
Approach and Entrance												
Exterior Access Route												
1	Parking 1 Lower Level A Opposite Main Entrance	Ext.		Exterior Access Route	Walkway

Running slope > 1:20 (5%)	12.4%	Reduce running slope to be no steeper than 1:20 (5%). (Cost based on adding asphalt to reduce slope at base of walkway.)	1	480	\$480
2	Parking 1 Lower Level B	Ext.		Exterior Access Route	Walkway

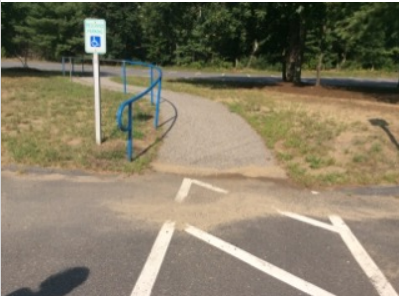
Running slope > 1:20 (5%)	15.7%	Reduce running slope to be no steeper than 1:20 (5%). (Cost based on adding asphalt to reduce slope at base of walkway.)	1	480	\$480
3	Egress Door 13	Ext.		Exterior Access Route	Walkway

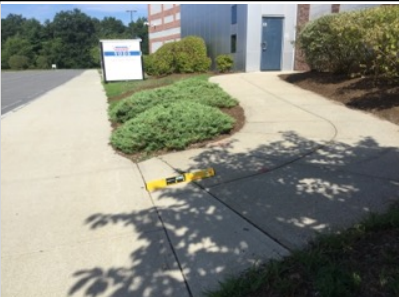
Running slope > 1:20 (5%)	12%	Reduce running slope to be no steeper than 1:20 (5%). (Cost for adding concrete to correct pathway running slope.)	1	240	\$240
4	Egress Door 10	Ext.		Exterior Access Route	Exterior

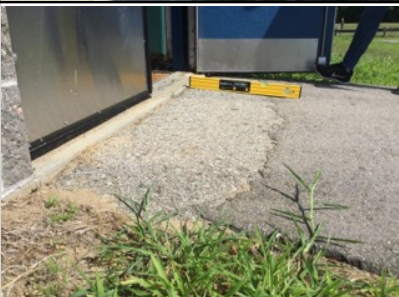
Running slope > 1:20 (5%)	6.3%	Reduce running slope to 1;50 (2.00%) max. at door landing. (Cost for adding asphalt to correct pathway running slope.)	1	240	\$240

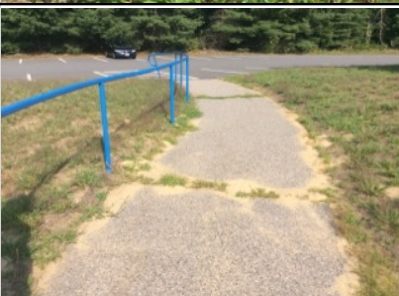
5	Parking 1 Opposite Main Entrance	Ext.		Exterior Access Route	Walkway

Route not maintained in operable working condition	-	Ensure the accessible route is maintained in operable working condition.	1	Labor	\$0

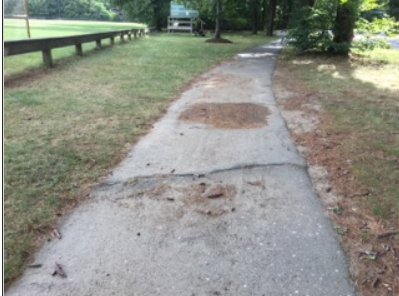
ID	Location	Floor	Room	Element	Type	Photo	Issues	Current Measure	Recommendations	Quantity	Price	Cost Estimation
6	Path Leading to Sitting Area at the Softball Field	Ext.		Exterior Access Route	Walkway

Route not maintained in operable working condition	-	Ensure the accessible route is maintained in operable working condition.	1	Labor	\$0
7	Main Entrance-Fire Box	Ext.		Exterior Access Route	Exterior

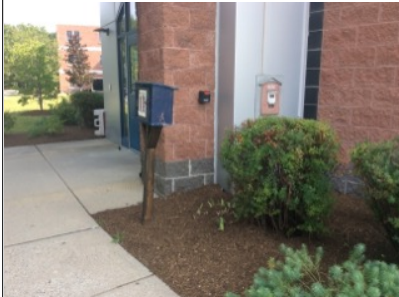
Accessible route not provided	-	Ensure an accessible route is provided. (Cost based on a 4' wide min. x 6' concrete route to fire box.)	1	384	\$384
8	Bike Racks	Ext.		Exterior Access Route	Walkway

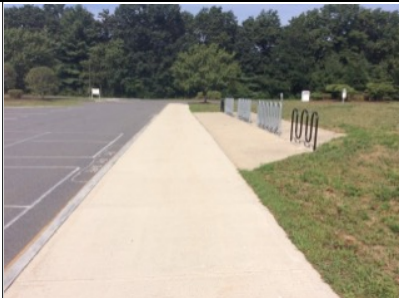
Accessible route not provided	7.9%	Ensure an accessible route is provided. Reduce running slope at bike rack to 1:50 (2.00%) in all directions. (Cost based on adding concrete at bike rack to reduce slope.)	1	240	\$240
Off-Street Parking Lot or Garage												
9	Parking 1 Lower Level A Opposite Main Entrance	Ext.		Off-Street Parking Lot or Garage	N/A

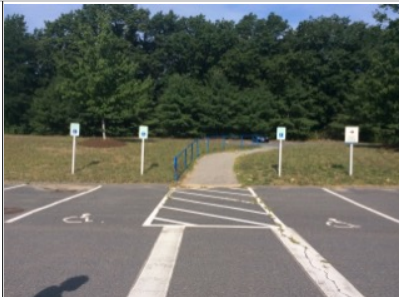
Total # of parking Total # of designated accessible parking spaces Total # of designated van accessible spaces Sign does not have the designation "Van Accessible" Sign bottom < 60" above finished grade	225 3 1 - 53"	Add the designation "Van Accessible" to the sign located at the van accessible space. Locate sign with the bottom of the sign 60" above the ground.	1	500	\$500

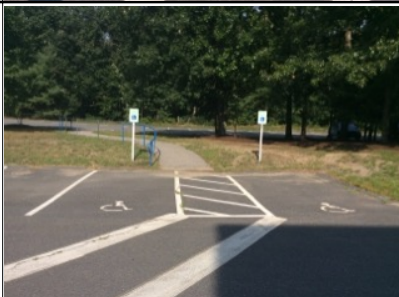
10	Parking 1 Lower Level B	Ext.		Off-Street Parking Lot or Garage	N/A

Total # of designated accessible parking spaces Total # of designated van accessible spaces Sign does not have the designation "Van Accessible" Sign bottom < 60" above finished grade	1 1 - 54"	Add the designation "Van Accessible" to the sign located at the van accessible space. Locate sign with the bottom of the sign 60" above the ground.	1	500	\$500

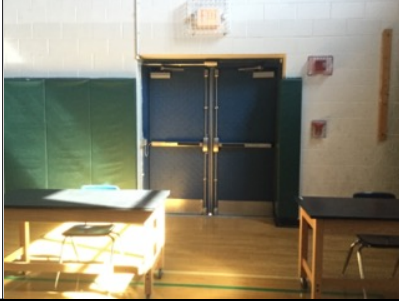
ID	Location	Floor	Room	Element	Type	Photo	Issues	Current Measure	Recommendations	Quantity	Price	Cost Estimation
Emergency Exit												
11	Egress Door 9	1		Emergency Exit	N/A

Tactile sign not provided at emergency exit Tactile sign not provided at exit	-	Provide tactile exit signs with raised characters and braille at exit doors. Mount signs between 48"- 60" above the finished floor located on the latch side of the door.	1	232	\$232
12	Egress Door 5	1		Emergency Exit	N/A

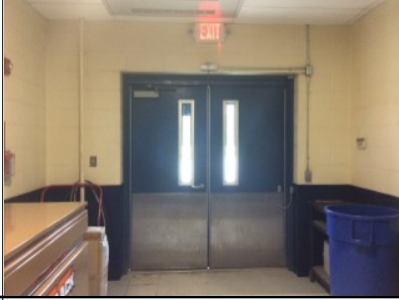
Tactile sign not provided at exit	-	Provide tactile exit signs with raised characters and braille at exit doors. Mount signs between 48"- 60" above the finished floor located on the latch side of the door.	1	232	\$232
13	Main Entrance - Egress Door 1	1		Emergency Exit	N/A

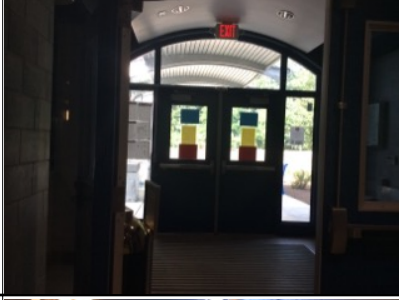
Tactile sign not provided at exit Illuminated Int. Symbol of Acc. not provided (MAAB)	- -	Provide tactile exit signs with raised characters and braille at exit doors. Mount signs between 48"- 60" above the finished floor located on the latch side of the door. Provide an illuminated sign with the International Symbol of Accessibility.	1	432	\$432

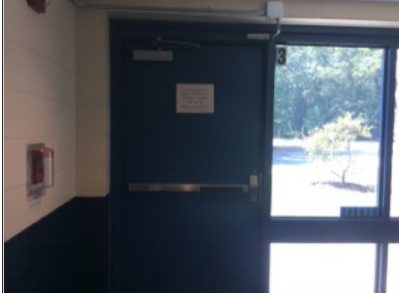
Tactile exit sign not provided	-	Ensure tactile exit signs with raised characters and braille are provided at exit doors. Mount signs between 48"- 60" above the finished floor located on the latch side of the door.	1	232	\$232

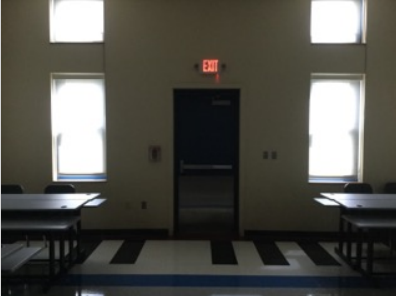
ID	Location	Floor	Room	Element	Type	Photo	Issues	Current Measure	Recommendations	Quantity	Price	Cost Estimation
16	Music Lab/ Electronic Room	1	175	Means of Egress	N/A

Tactile exit sign not provided	-	Ensure tactile exit signs with raised characters and braille are provided at exit doors. Mount signs between 48"- 60" above the finished floor located on the latch side of the door.	1	232	\$232
17	Egress Door 15	1		Means of Egress	N/A

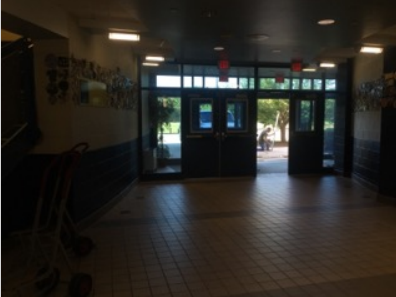
Tactile exit sign not provided Illuminated ISA symbol not provided (MAAB)	- -	Ensure tactile exit signs with raised characters and braille are provided at exit doors. Mount signs between 48"- 60" above the finished floor located on the latch side of the door. Provide an illuminated sign with the International Symbol of Accessibility.	1	432	\$432
18	Auditorium Egress Door 14	1	1320	Means of Egress	N/A

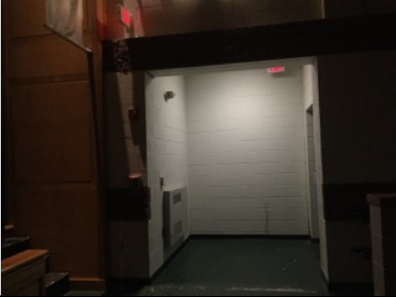
Tactile exit sign not provided Illuminated ISA symbol not provided (MAAB)	- -	Ensure tactile exit signs with raised characters and braille are provided at exit doors. Mount signs between 48"- 60" above the finished floor located on the latch side of the door. Provide an illuminated sign with the International Symbol of Accessibility.	1	432	\$432

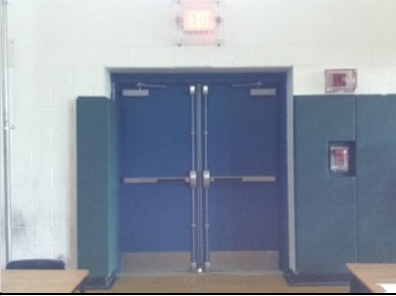
19	Egress Door 8	1		Means of Egress	N/A

Tactile exit sign not provided Illuminated ISA symbol not provided (MAAB)	- -	Ensure tactile exit signs with raised characters and braille are provided at exit doors. Mount signs between 48"- 60" above the finished floor located on the latch side of the door. Provide an illuminated sign with the International Symbol of Accessibility.	1	432	\$432
20	Egress Door 11	1		Means of Egress	N/A

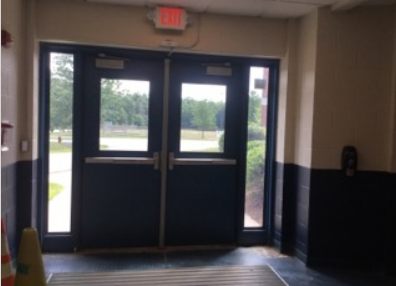
Tactile exit sign not provided Illuminated ISA symbol not provided (MAAB)	- -	Ensure tactile exit signs with raised characters and braille are provided at exit doors. Mount signs between 48"- 60" above the finished floor located on the latch side of the door. Provide an illuminated sign with the International Symbol of Accessibility	1	432	\$432

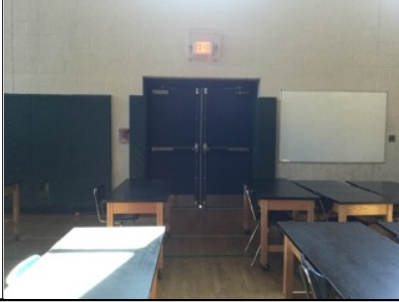
ID	Location	Floor	Room	Element	Type	Photo	Issues	Current Measure	Recommendations	Quantity	Price	Cost Estimation
21	Egress Door 10	1		Means of Egress	N/A

Tactile exit sign not provided Illuminated ISA symbol not provided (MAAB)	- - -	Ensure tactile exit signs with raised characters and braille are provided at exit doors. Mount signs between 48"- 60" above the finished floor located on the latch side of the door. Provide an illuminated sign with the International Symbol of Accessibility.	1	432	\$432
Interior Access Route												
22	Technology Center	2		Interior Access Route	N/A

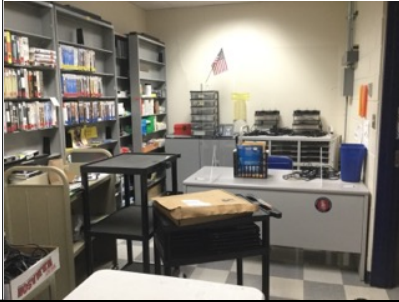
Route < 36" wide	-	Ensure that a clear width of 36" min. is maintained at the accessible route.	1	Labor	\$0
23	Corridor Leading to More Counselor's Offices	2		Interior Access Route	N/A

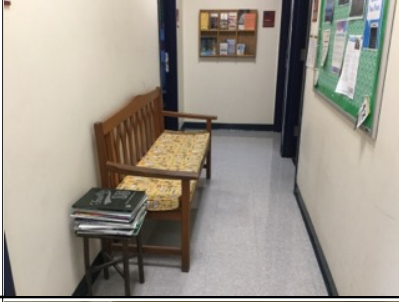
Route < 36" wide	33"	Ensure that a clear width of 36" min. is maintained at the accessible route.	1	Labor	\$0
24	Auditorium	1	1320	Interior Access Route	N/A

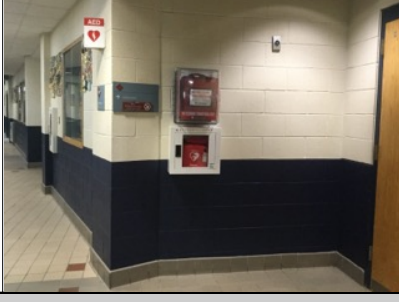
Obstructed by protruding objects	36"	Relocate defibrillator or provide a cane-detectable barrier.	1	306	\$306

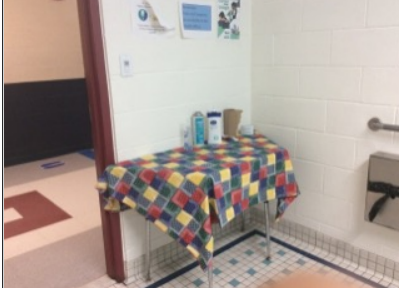
Doors, Doorways, & Gates												
25	Single-User Toilet Room	1		Doors, Doorways, & Gates	Toilet Room

Maneuvering clearance(s) not provided	-	Remove the table to provide 18" min. pull-side maneuvering clearance at door.	1	Labor	\$0

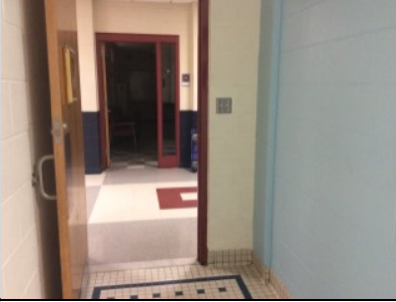
ID	Location	Floor	Room	Element	Type	Photo	Issues	Current Measure	Recommendations	Quantity	Price	Cost Estimation
26	Men's Toilet Room	1		Doors, Doorways, & Gates	Toilet Room

Maneuvering clearance(s) not provided	14.75"	Provide an automatic door opener.	1	3060	\$3060
27	Principal's Office	1		Doors, Doorways, & Gates	Office

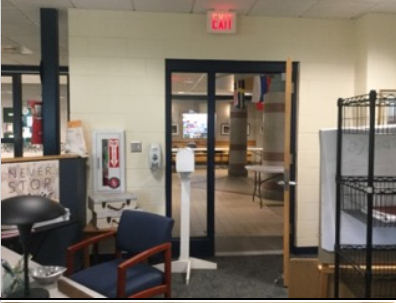
Maneuvering clearance(s) not provided	-	Remove the mailbox to provide 18" min. pull-side maneuvering clearance at door.	1	Labor	\$0
28	Stair 2	2		Doors, Doorways, & Gates	Circulation

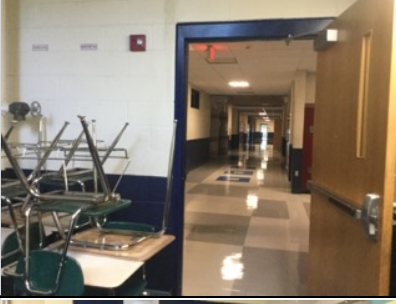
Maneuvering clearance(s) not provided	-	Remove stored items to provide 18" min. pull side maneuvering clearance at door.	1	Labor	\$0
29	Grade 7 Technology Engineering	2	260	Doors, Doorways, & Gates	Classroom

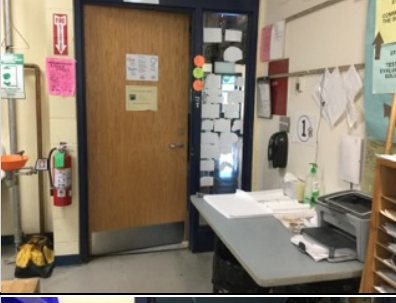
Maneuvering clearance(s) not provided	-	Remove the desk to provide maneuvering clearance.	1	Labor	\$0
30	Grade 6 Guidance Councilor	2		Doors, Doorways, & Gates	Office

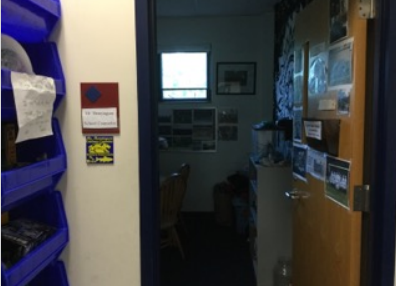
Maneuvering clearance(s) not provided	13.75"	Remove shelves to provide 18" min. pull-side maneuvering clearance at door.	1	Labor	\$0

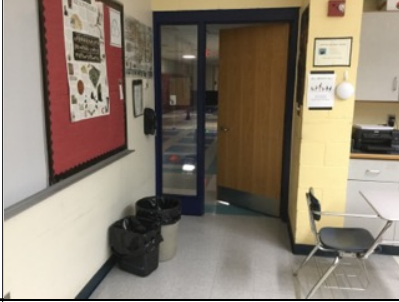
ID	Location	Floor	Room	Element	Type	Photo	Issues	Current Measure	Recommendations	Quantity	Price	Cost Estimation
31	Grade 7 SS	2	215	Doors, Doorways, & Gates	Classroom

Maneuvering clearance(s) not provided	-	Remove trash can to provide 12" min. push-side maneuvering clearance at door.	1	Labor	\$0
32	Music Band	1	184	Doors, Doorways, & Gates	Classroom

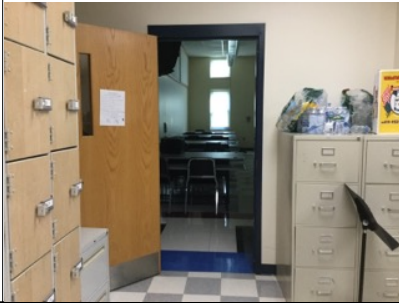
Maneuvering clearance(s) not provided	-	Remove file cabinet to provide 18" min. pull-side maneuvering clearance.	1	Labor	\$0
33	Reception	1		Doors, Doorways, & Gates	Other

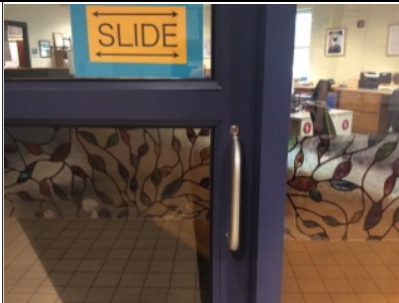
Hardware not operable with a closed fist	2"	Provide hardware that can be operable with one hand and not require tight grasping, pinching, or twisting of the wrist. Note: Adding an additional handle to the horizontal metal portion of the door above the existing hardware could result in a door opening solution that could be used without requiring tight grasping, pinching or twisting of the wrist.)	1	484	\$484

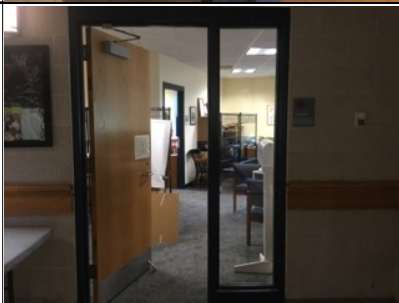
Door requires > 5 lbs. of force to open	10 lbs.	Adjust closers so doors do not require more than 5 pounds of force to open.	1	Labor	\$0
35	Reception	1		Doors, Doorways, & Gates	Other

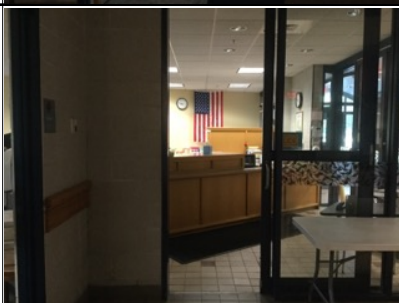
Door requires > 5 lbs. of force to open	11 lbs.	Adjust closers so doors do not require more than 5 pounds of force to open.	1	Labor	\$0

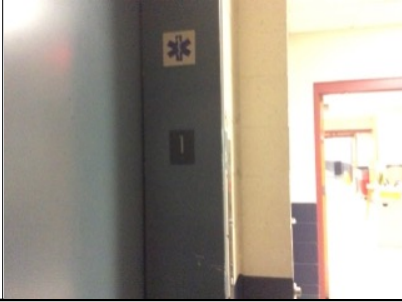
ID	Location	Floor	Room	Element	Type	Photo	Issues	Current Measure	Recommendations	Quantity	Price	Cost Estimation
Elevator												
36	Elevator	1		Elevator	Interior

Tactile stars not provided at main entry level	-	Provide a tactile star on both sides of jambs at main floor. At other floors, provide appropriate number. Provide a tactile star at the main floor on the control panel within the car.	2	96	\$192
Signage												
37	Cafeteria	1		Signage	Designation

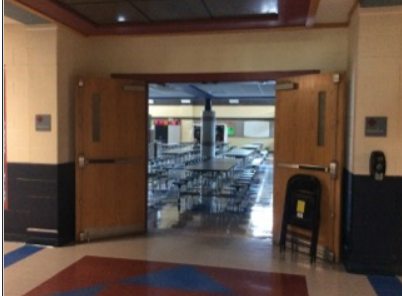
Raised characters not provided on sign Braille not provided on sign	- -	Provide text with raised characters duplicated in braille on sign.	1	232	\$232
38	Auditorium/ Gymnasium Doorway	1		Signage	Designation

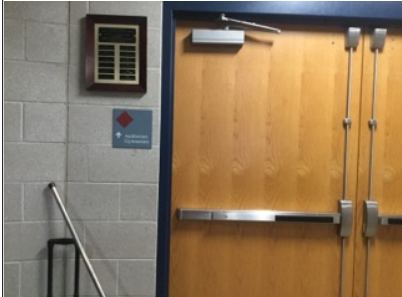
Raised characters not provided on sign Braille not provided on sign	- -	Provide text with raised characters duplicated in braille on sign.	1	232	\$232
39	Technology Center	2		Signage	Designation

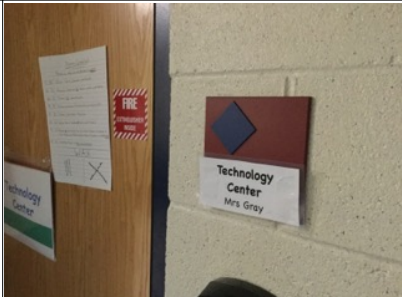
Raised characters not provided on sign Braille not provided on sign	- -	Provide text with raised characters duplicated in braille on sign. (Ensure signs are up-to-date and that accurate raised characters and braille are provided.)	1	232	\$232

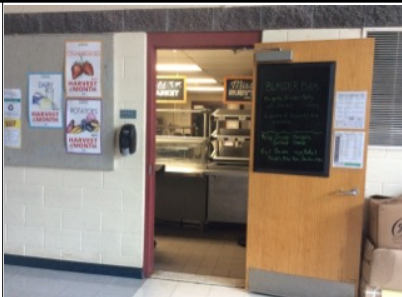
40	Kitchen	1		Signage	Designation

Braille not provided on sign	-	Provide braille on sign.	1	232	\$232

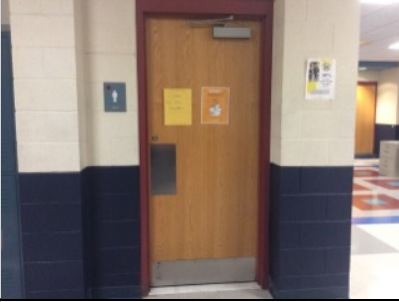
ID	Location	Floor	Room	Element	Type	Photo	Issues	Current Measure	Recommendations	Quantity	Price	Cost Estimation
41	Men's Toilet Room	1		Signage	Designation

Braille not provided on sign	-	Provide braille on sign.	1	232	\$232
42	Custodian	1		Signage	Designation

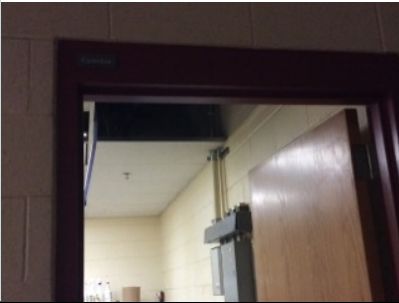
Sign not located on the latch side of the door	-	Locate sign at permanent rooms alongside the door on the latch side.	1	Labor	\$0
43	Grade 8 Bridges Program	1	106	Signage	Designation

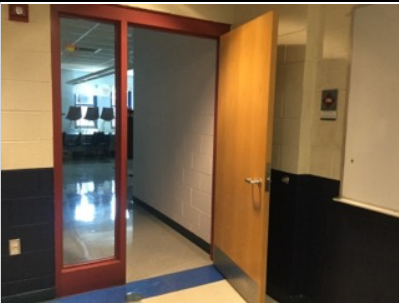
Sign not located on the latch side of the door	-	Locate sign at permanent rooms alongside the door on the latch side.	1	Labor	\$0
44	Grade 8 Green SS	1	115	Signage	Designation

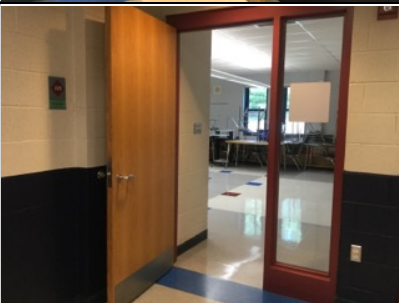
Sign not located on the latch side of the door	-	Locate sign at permanent rooms alongside the door on the latch side.	1	Labor	\$0
45	Grade 7 SpED LEAP	2	206	Signage	Designation

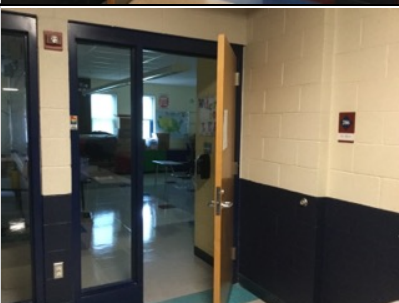
Sign not located on the latch side of the door	-	Locate sign at permanent rooms alongside the door on the latch side.	1	Labor	\$0

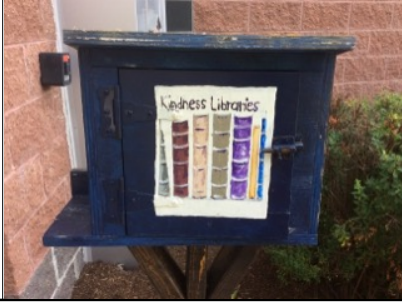
ID	Location	Floor	Room	Element	Type	Photo	Issues	Current Measure	Recommendations	Quantity	Price	Cost Estimation
Operable Parts												
46	Main Entrance - Library Book Return	Ext.		Operable Parts	Other

Not operable with a closed fist	-	Provide hardware that can be operable with one hand and not require tight grasping, pinching, or twisting of the wrist.	1	200	\$200
Dining or Work Surfaces												
47	Cafeteria	1		Dining or Work Surfaces	Dining Surface

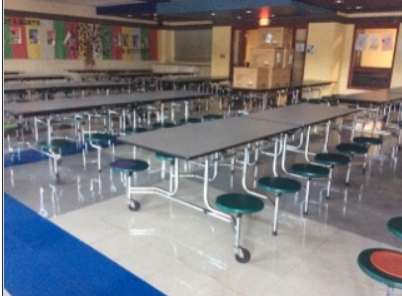
At least one or 5% accessible tables not provided	-	Ensure that at least 5% of dining or work surfaces are accessible.(Cost based on three accessible dining surfaces.)	3	1100	\$3300
48	Grade 8 Special Ed Skills	1	147	Dining or Work Surfaces	Work Surface

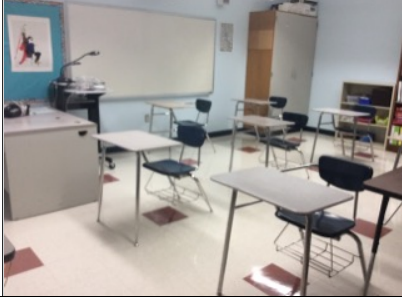
At least one or 5% accessible tables not provided	-	Ensure that at least one work surface is accessible.	1	700	\$700
49	Grade 6 SS Class	3	309	Dining or Work Surfaces	Work Surface

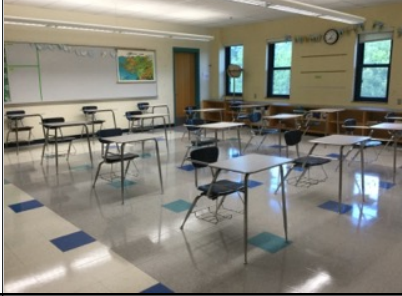
At least one or 5% accessible tables not provided	-	Ensure that at least one work surface is accessible.	1	700	\$700

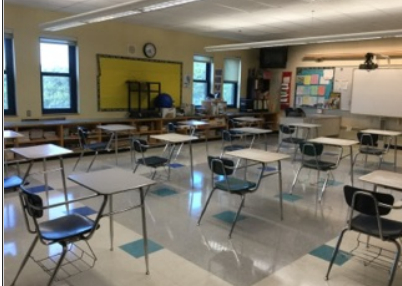
50	Grade 6 Science Class	3	306	Dining or Work Surfaces	Work Surface

At least one or 5% accessible tables not provided	-	Ensure that at least one work surface is accessible.	1	700	\$700

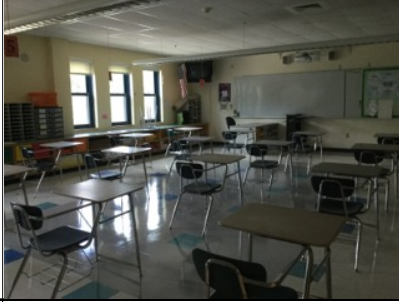
ID	Location	Floor	Room	Element	Type	Photo	Issues	Current Measure	Recommendations	Quantity	Price	Cost Estimation
51	Grade 6 ELA Class	3	318	Dining or Work Surfaces	Work Surface

At least one or 5% accessible tables not provided	-	Ensure that at least one work surface is accessible.	1	700	\$700
52	Computer Lab	2	269	Dining or Work Surfaces	Work Surface

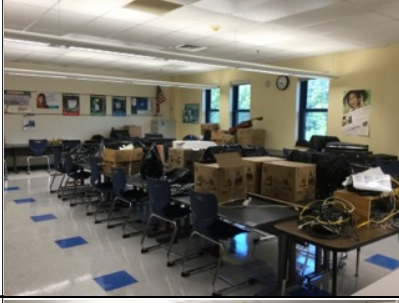
At least one or 5% accessible tables not provided	25.5"	Ensure that at least one work surface is accessible.	1	700	\$700
53	Grade 7 SpED LEAP	2	206	Dining or Work Surfaces	Work Surface

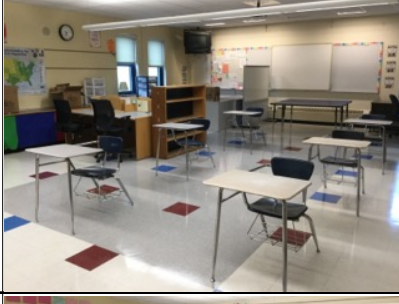
At least one or 5% accessible tables not provided	-	Ensure that at least one work surface is accessible.	1	700	\$700
54	Grade 7 ELA	2	212	Dining or Work Surfaces	Work Surface

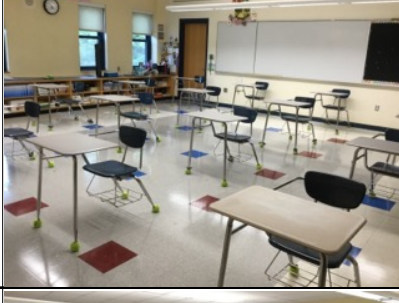
At least one or 5% accessible tables not provided	-	Ensure that at least one work surface is accessible.	1	700	\$700
55	Grade 7 SS	2	215	Dining or Work Surfaces	Work Surface

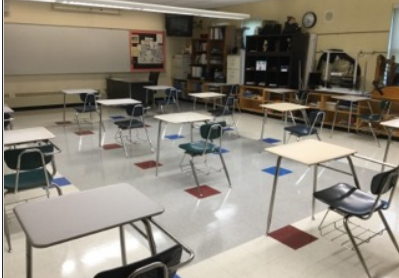
At least one or 5% accessible tables not provided	-	Ensure that at least one work surface is accessible.	1	700	\$700

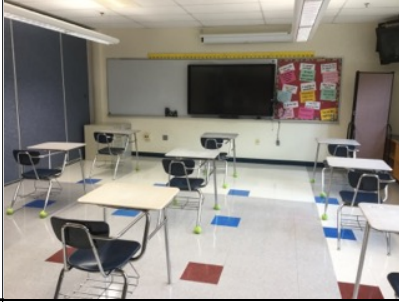
ID	Location	Floor	Room	Element	Type	Photo	Issues	Current Measure	Recommendations	Quantity	Price	Cost Estimation
56	Learning Center	2	221	Dining or Work Surfaces	Work Surface

At least one or 5% accessible tables not provided	-	Ensure that at least one work surface is accessible.	1	700	\$700
57	Music Lab/ Electronic Room	1	175	Dining or Work Surfaces	Work Surface

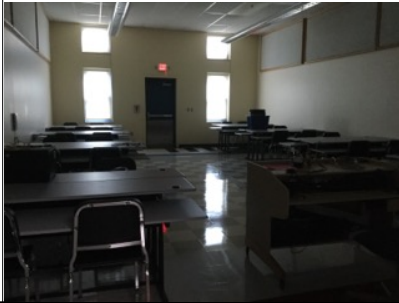
At least one or 5% accessible tables not provided	26"	Ensure that at least one work surface is accessible.	1	700	\$700
Assembly Area												
58	Auditorium	1	1320	Assembly Area	N/A

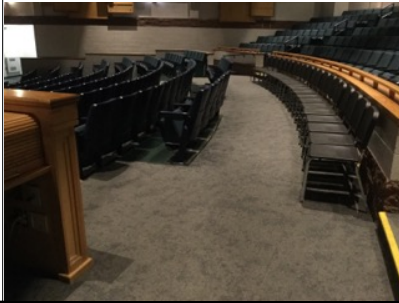
Assistive listening devices not provided	-	If audible communication is integral to the use of the space, provide an assistive listening system.	1	1214	\$1214
59	Library	2		Assembly Area	N/A

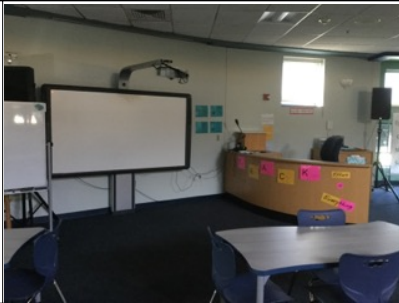
Assistive listening devices not provided	-	If audible communication is integral to the use of the space, provide an assistive listening system.	1	1214	\$1214

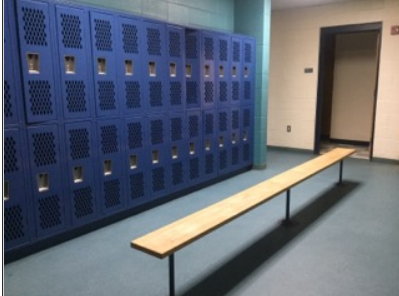
ID	Location	Floor	Room	Element	Type	Photo	Issues	Current Measure	Recommendations	Quantity	Price	Cost Estimation
61	Men's Locker Room	1		Locker Room	Men's

Back support not provided at bench	-	Provide at least one bench with back support or that is affixed to a wall with room on the side to transfer.	1	200	\$200
62	Women's Locker Room	1		Locker Room	Women's

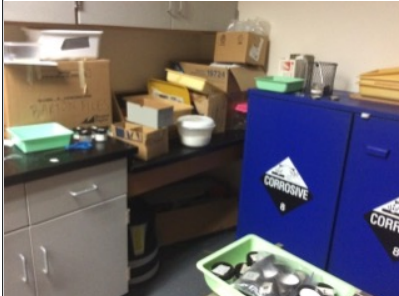
At least one (or 5%) acc. work surface not provided	24.25"	Alter so that 5% of work surfaces (at least one) are 28"- 34" above the floor with knee and toe clearance positioned for a forward approach.	1	880	\$880
64	Science Room	1		Laboratory	Other

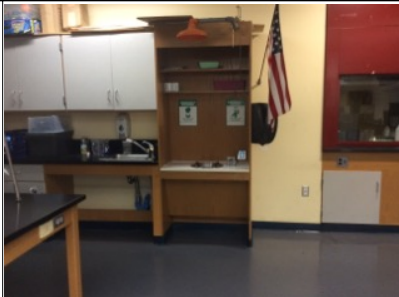
Emergency shower out of reach range	-	Lower the shower pull to 48" max. above the floor.	1	Labor	\$0

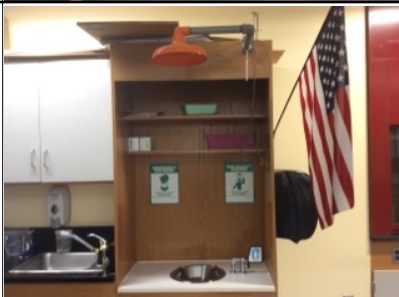
65	Science Room	1		Laboratory	Other

Emergency shower out of reach range	56"	Lower the shower pull to 48" max. above the floor.	1	Labor	\$0

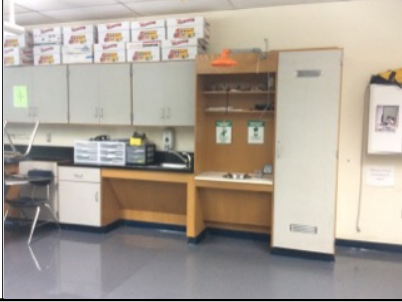
ID	Location	Floor	Room	Element	Type	Photo	Issues	Current Measure	Recommendations	Quantity	Price	Cost Estimation
66	Grade 8 Green Science	1	127	Laboratory	Other

Emergency shower out of reach range	58.75"	Lower the shower pull to 48" max. above the floor.	1	Labor	\$0
Picnic Tables												
67	Main Entrance	Ext.		Picnic Tables	N/A

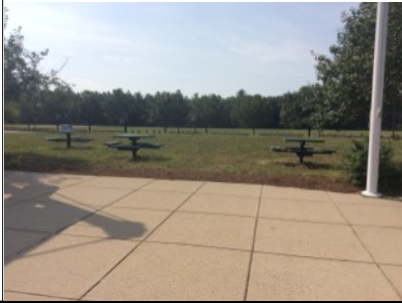
At least 5% accessible spaces not provided Picnic table not on an accessible route	- -	Ensure that at least 5% (minimum one) of picnic tables are accessible. Ensure that the accessible picnic table is connected to an accessible route.	1	1400	\$1400
Exterior Benches												
68	Bench at Bike Rack	Ext.		Exterior Benches	N/A

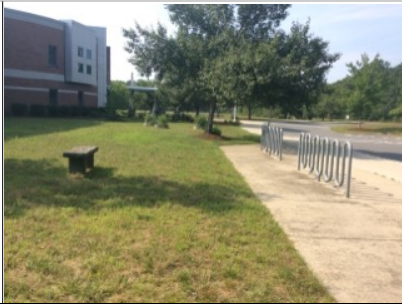
No accessible route to one bench in area	-	Relocate bench to an accessible route.	1	Labor	\$0
Toilet & Bathing Rooms												
Lavatory												
69	Women's Toilet Room Near Cafeteria and Locker Rooms	1		Lavatory	N/A

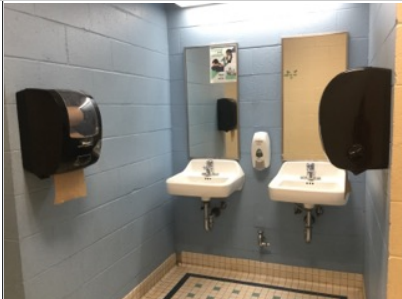
Clear floor space not provided at lavatory	-	Provide at least one lavatory with a 30" min. by 48" min. clear floor space positioned for a forward approach. (Relocate the paper towel dispenser out of the clear floor space in front of the lavatory that is made accessible.)	1	353	\$353

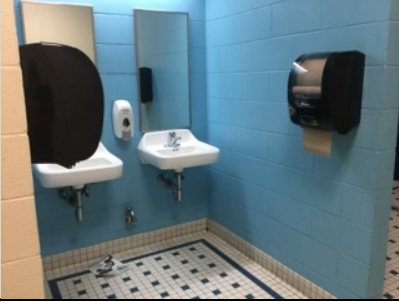
ID	Location	Floor	Room	Element	Type	Photo	Issues	Current Measure	Recommendations	Quantity	Price	Cost Estimation
70r	Men's Toilet Room Near Cafeteria and Locker Rooms	1		Lavatory	N/A

Clear floor space not provided at lavatory	- -	Provide at least one lavatory with a 30" min. by 48" min. clear floor space positioned for a forward approach. (Relocate the paper towel dispenser out of the clear floor space in front of the lavatory that is made accessible.)	1	353	\$353
71	Men's Toilet Room	1		Lavatory	N/A

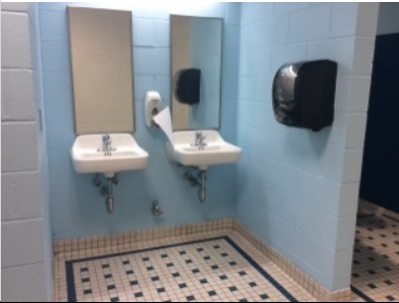
Plumbing underneath is exposed	-	Insulate or otherwise configure pipes to prevent contact for at least one lavatory.	1	92	\$92
72	Men's Locker Room	1		Lavatory	N/A

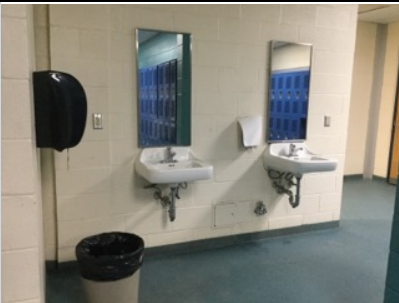
Plumbing underneath is exposed	-	Insulate or otherwise configure pipes to prevent contact for at least one lavatory.	1	92	\$92
73	Women's Locker Room	1		Lavatory	N/A

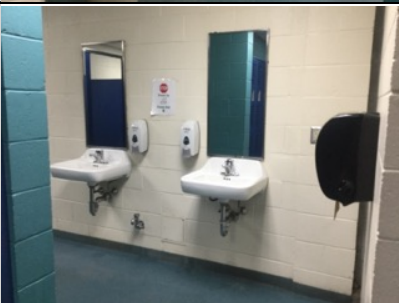
Plumbing underneath is exposed	-	Insulate or otherwise configure pipes to prevent contact for at least one lavatory.	1	92	\$92

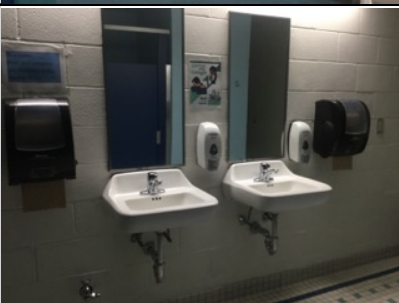
Plumbing underneath is exposed	-	Insulate or otherwise configure pipes to prevent contact for at least one lavatory.	1	92	\$92

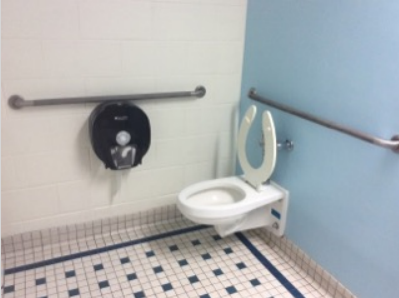
ID	Location	Floor	Room	Element	Type	Photo	Issues	Current Measure	Recommendations	Quantity	Price	Cost Estimation
Single-User Toilet												
75	Lavatory - Health Office	1		Single-User Toilet	N/A

Flush control not on open side	-	Relocate the flush control to the open side.	1	374	\$374
76	Single-User Toilet Room	1		Single-User Toilet	N/A

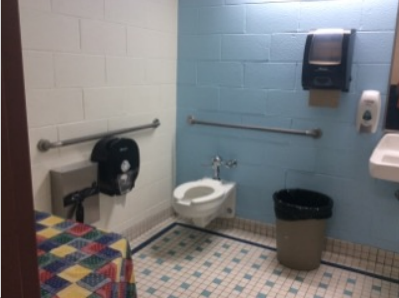
Flush control not on open side	-	Relocate the flush control to the open side.	1	374	\$374
77	Toilet Room 2 Section A	1		Single-User Toilet	N/A

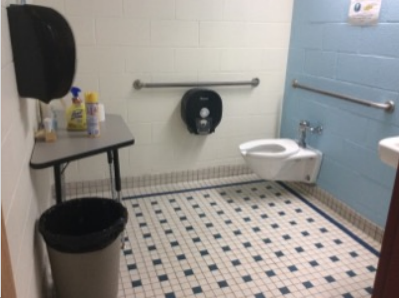
Flush control not on open side	-	Relocate the flush control to the open side.	1	374	\$374
78	Single-User Toilet Room	1		Single-User Toilet	N/A

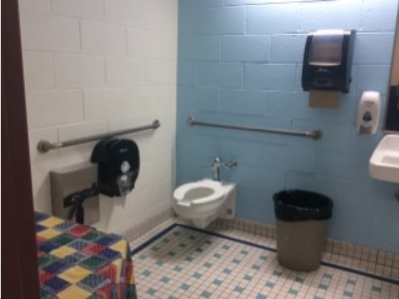
Non-compliant paper towel dispenser.		Relocate dispenser from above grab bar.	1	353	\$353
Toilet Compartment												
79	Men's Toilet Room	1		Toilet Compartment	Accessible Compartment

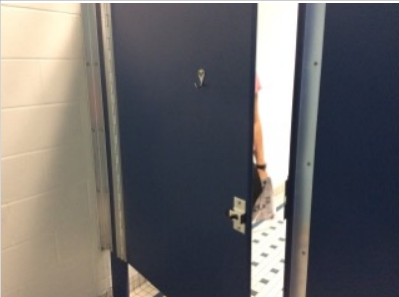
Door has malfunctioning self-closing hinge	-	Repair hinge.	1	Labor	\$0

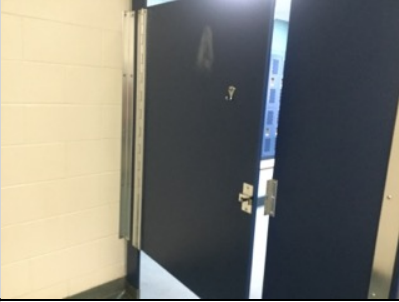
ID	Location	Floor	Room	Element	Type	Photo	Issues	Current Measure	Recommendations	Quantity	Price	Cost Estimation
80	Men's Locker Room Accessible Compartment	1		Toilet Compartment	Accessible Compartment

Door has malfunctioning self-closing hinge	-	Repair hinge.	1	Labor	\$0
81	Women's Toilet Room Near Cafeteria and Locker Rooms	1		Toilet Compartment	Accessible Compartment

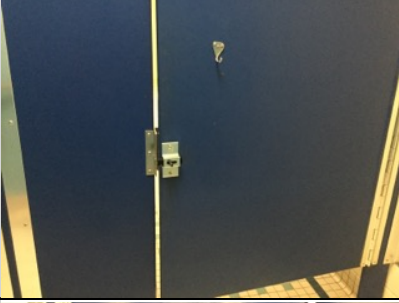
Door has malfunctioning self-closing hinge	-	Repair hinge.	1	Labor	\$0
82	Men's Toilet Room Near Cafeteria and Locker Rooms	1		Toilet Compartment	Accessible Compartment

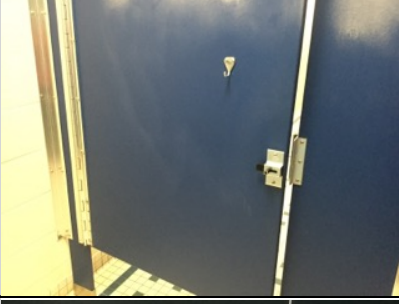
Door has malfunctioning self-closing hinge	-	Repair hinge.	1	Labor	\$0
83	Women's Toilet Room Section A	1		Toilet Compartment	Accessible Compartment

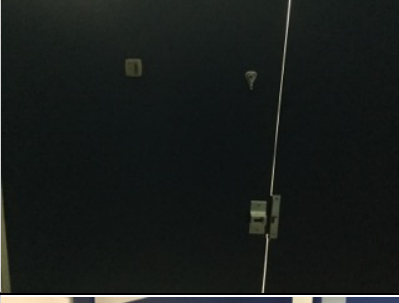
Door has malfunctioning self-closing hinge	-	Repair hinge.	1	Labor	\$0
84	Men's Toilet Room	3		Toilet Compartment	Accessible Compartment

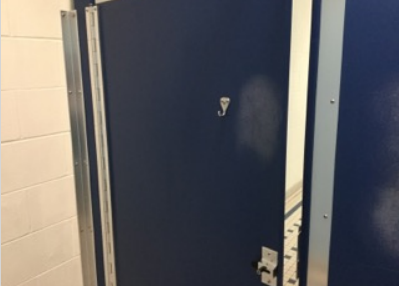
Door has malfunctioning self-closing hinge	-	Repair hinge.	1	Labor	\$0

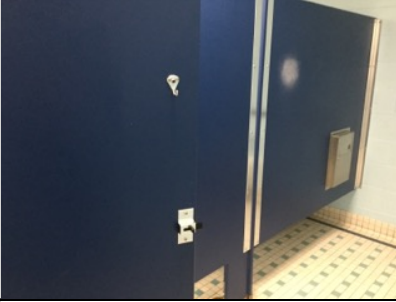
ID	Location	Floor	Room	Element	Type	Photo	Issues	Current Measure	Recommendations	Quantity	Price	Cost Estimation
85	Women's Toilet Room	3		Toilet Compartment	Accessible Compartment

Door has malfunctioning self-closing hinge	-	Repair hinge.	1	Labor	\$0
86	Women's Toilet Room	2		Toilet Compartment	Accessible Compartment

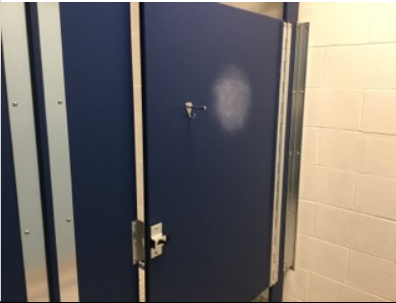
Door has malfunctioning self-closing hinge	-	Repair hinge.	1	Labor	\$0
87	Men's Toilet Room	2		Toilet Compartment	Accessible Compartment

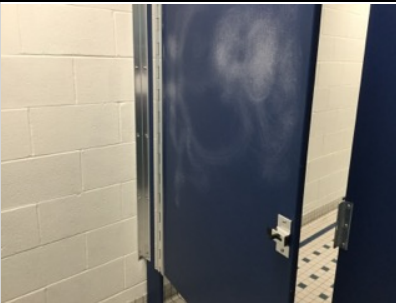
Door has malfunctioning self-closing hinge	-	Repair hinge.	1	Labor	\$0
88	Men's Toilet Room	2		Toilet Compartment	Accessible Compartment

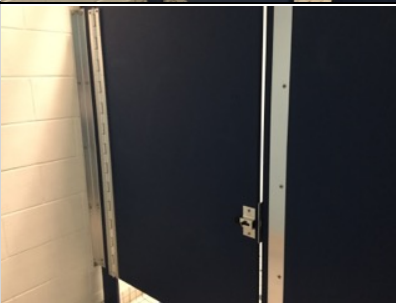
Door has malfunctioning self-closing hinge	-	Repair hinge.	1	Labor	\$0
89	Women's Toilet Room	2		Toilet Compartment	Accessible Compartment

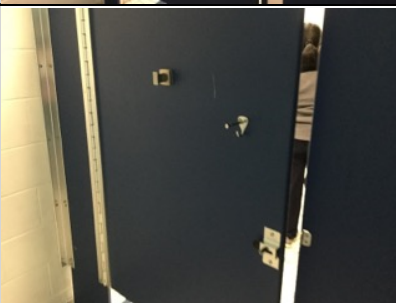
Door has malfunctioning self-closing hinge	-	Repair hinge.	1	Labor	\$0

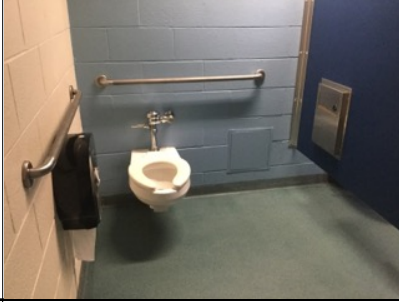
ID	Location	Floor	Room	Element	Type	Photo	Issues	Current Measure	Recommendations	Quantity	Price	Cost Estimation
90	Women's Locker Room	1		Toilet Compartment	Accessible Compartment

Flush control not on open side	-	Provide the flush control on the open side of the toilet (transfer side).	1	374	\$374
91	Women's Toilet Room Near Cafeteria and Locker Rooms	1		Toilet Compartment	Accessible Compartment

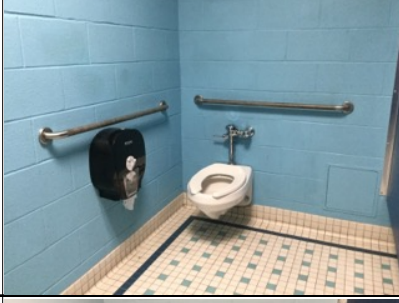
Flush control not on open side	-	Provide the flush control on the open side of the toilet (transfer side).	1	374	\$374
92	Women's Toilet Room	2		Toilet Compartment	Accessible Compartment

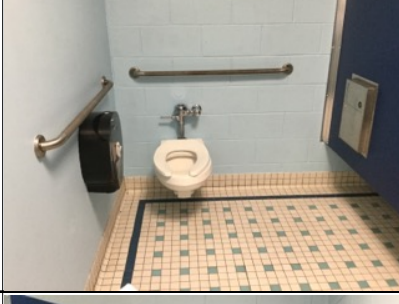
Flush control not on open side	-	Provide the flush control on the open side of the toilet (transfer side).	1	374	\$374
93	Women's Toilet Room	3		Toilet Compartment	Accessible Compartment

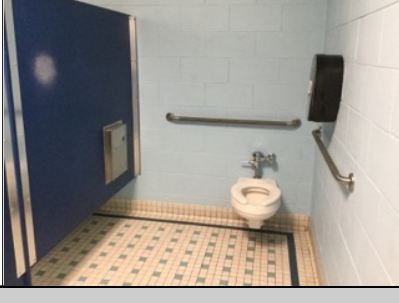
Non-compliant toilet paper dispenser	-	Relocate toilet paper so that it is 24" min. high, located under the grab bar, and between 7" and 9" from the front of the toilet./Replace dispenser as it does not allow continuous paper flow.	1	353	\$353

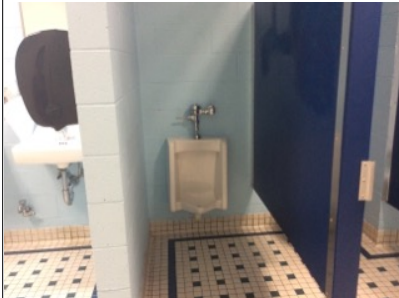
Urinal recessed > 24" has > 36" clear width	33"	If urinal is recessed greater than 24" ensure there is a clear width of 36".	1	353	\$353

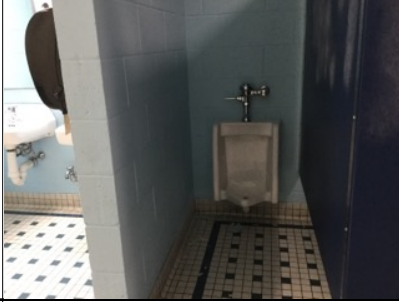
ID	Location	Floor	Room	Element	Type	Photo	Issues	Current Measure	Recommendations	Quantity	Price	Cost Estimation
95	Men's Toilet Room	3		Urinal	N/A

Urinal recessed > 24" has > 36" clear width	30.25"	If urinal is recessed greater than 24" ensure there is a clear width of 36".	1	353	\$353
96	Men's Toilet Room	2		Urinal	N/A

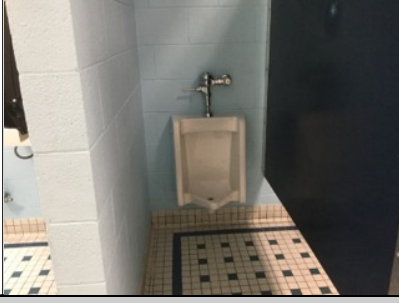
Urinal recessed > 24" has > 36" clear width	31.25"	If urinal is recessed greater than 24" ensure there is a clear width of 36".	1	353	\$353
Dispensers												
97	Grade 7 Technology Engineering	2	260	Dispensers	Paper Towel Dispenser

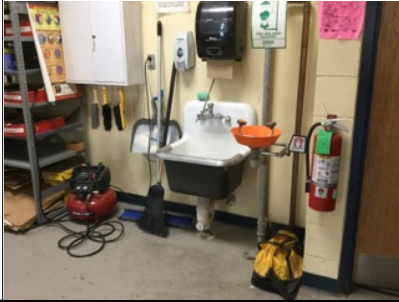
Controls > 42" high	50"	If it is used by students, relocate paper towel dispenser so the operable part is 42" max. above the finished floor.	1	256	\$256
98	Single-User Toilet Room	1		Dispensers	Paper Towel Dispenser

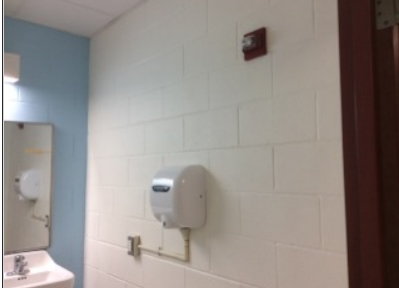
99	Single-User Toilet Room	1		Dispensers	Hand Dryer

Dispenser acts as a protruding object	-	Relocate dispenser out of the circulation path or provide a cane-detectible barrier under the dispenser.	1	306	\$306

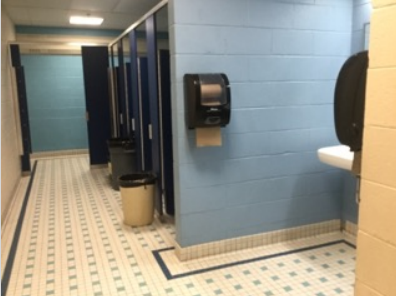
ID	Location	Floor	Room	Element	Type	Photo	Issues	Current Measure	Recommendations	Quantity	Price	Cost Estimation
100	Women's Toilet Room Near Cafeteria and Locker Rooms	1		Dispensers	Paper Towel Dispenser

Dispenser acts as a protruding object	-	Relocate dispenser out of the circulation path or provide a cane-detectible barrier.	1	306	\$306
101	Men's Toilet Room Near Cafeteria and Locker Rooms	1		Dispensers	Paper Towel Dispenser

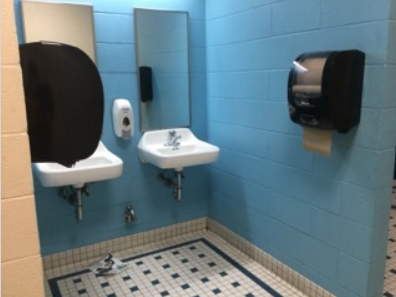
Dispenser acts as a protruding object	-	Relocate dispenser out of the circulation path or provide a cane-detectible barrier.	1	306	\$306
102	Men's Toilet Room	3		Dispensers	Paper Towel Dispenser

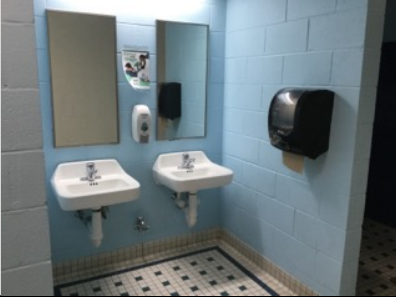
Dispenser acts as a protruding object	-	Relocate dispenser out of the circulation path or provide a cane-detectible barrier.	1	306	\$306
103	Women's Toilet Room	2		Dispensers	Paper Towel Dispenser

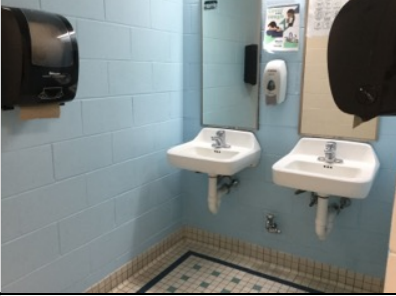
Dispenser acts as a protruding object	-	Relocate paper towel dispenser out of the circulation path or provide a cane-detectible barrier.	1	306	\$306

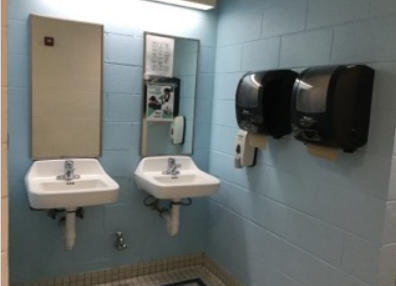
104	Men's Toilet Room	2		Dispensers	Paper Towel Dispenser

Dispenser acts as a protruding object	-	Relocate paper towel dispenser out of the circulation path or provide a cane-detectible barrier.	1	306	\$306

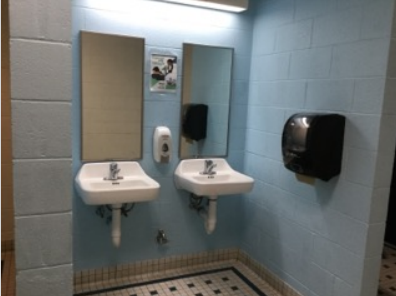
ID	Location	Floor	Room	Element	Type	Photo	Issues	Current Measure	Recommendations	Quantity	Price	Cost Estimation
105	Men's Toilet Room	2		Dispensers	Paper Towel Dispenser

Dispenser acts as a protruding object	-	Relocate paper towel dispenser out of the circulation path or provide a cane-detectible barrier.	1	306	\$306
106	Men's Toilet Room	1		Dispensers	Paper Towel Dispenser

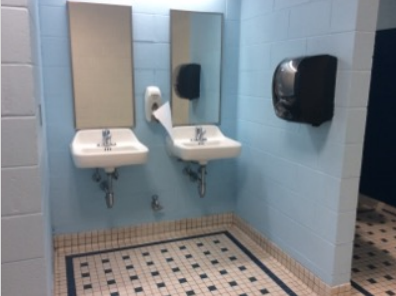
Dispenser acts as a protruding object	-	Relocate dispenser out of the circulation path or provide a cane-detectible barrier under the dispenser.	1	306	\$306
Shower Compartment												
107	Women's Locker Room	1		Shower Compartment	Roll-In Type

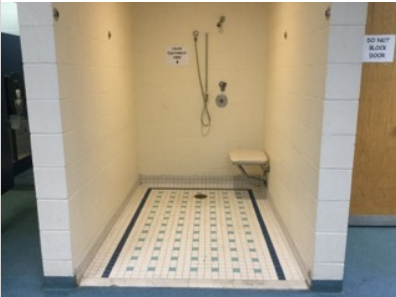
Grab bars not provided	-	Provide compliant grab bars. For a roll-in shower with a seat, grab bars shall be provided on the back wall and side wall opposite the seat.	1	898	\$898
108	Men's Locker Room	1		Shower Compartment	Roll-In Type

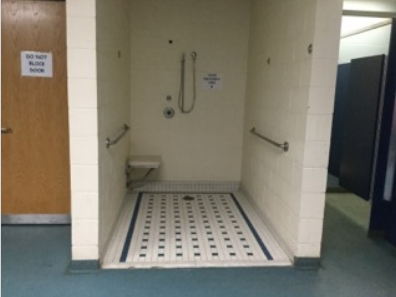
Grab bars not provided Grab bars mounted in wrong location	- -	Provide grab bar on back wall. Ensure grab bars are not provided over the seat. For a roll-in shower with a seat, grab bars shall be provided on the back wall and side wall opposite the seat.	1	1154	\$1154

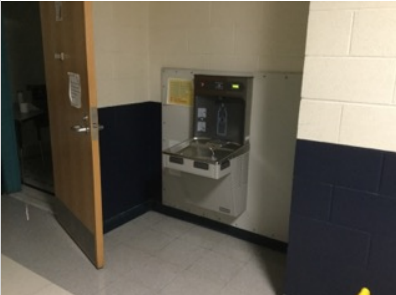
Additional Access												
Drinking Fountains												
109	Drinking Fountain Next to 301	3		Drinking Fountains	Low

No drinking fountain provided for standing users Knee or toe clearance not provided	- 25"	Provide an additional drinking fountain for standing users or install a Hi-Lo drinking fountain. Provide knee and toe clearance, 27" min. high at drinking fountain for seated users. (Cost based on a new Hi-Lo fountain.)	1	4216	\$4216

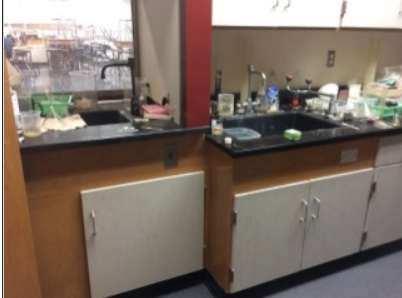
ID	Location	Floor	Room	Element	Type	Photo	Issues	Current Measure	Recommendations	Quantity	Price	Cost Estimation
Sink												
110	Science Prep	1		Sink	Lab

Toe and knee clearances not provided	-	If the sinks in this area are used by students, ensure there is a 27" knee clearance positioned for a forward approach at at least one sink in the lab.	1	1686	\$1686
111	Grade 7 Technology Engineering	2	260	Sink	Classroom

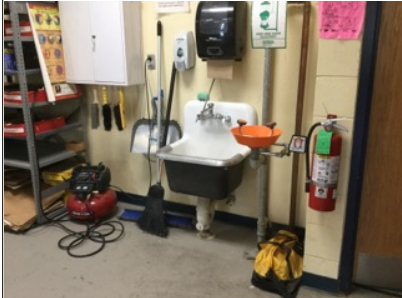
Toe and knee clearances not provided	-	If the sink in this area is used by students, ensure there is a 27" knee clearance positioned for a forward approach.	1	1686	\$1686
Play and Sport Areas												
Field												
112	Baseball Team Seating 1	Ext.		Field	Baseball

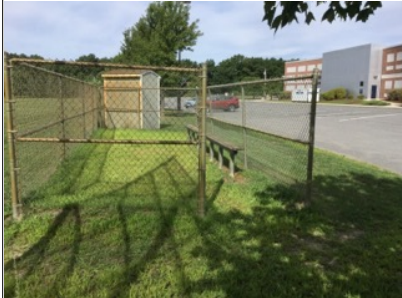
Accessible spaces not provided at team seating	-	Provide a firm, stable and slip resistant path and surface 48" wide min. to the baseball field team seating and at a 36" x 48" clear floor space by the team seating. (Cost based on an asphalt path and patch by the bench positioned to allow shoulder alignment with a person seated at the bench for someone using a wheeled mobility device.)	1	360	\$360

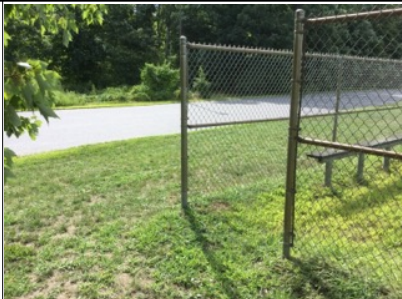
113	Baseball Team Seating 2	Ext.		Field	Baseball

Accessible spaces not provided at team seating	-	Provide a firm, stable and slip resistant path and surface 48" wide min. to the baseball field team seating and at a 36" x 48" clear floor space by the team seating. (Cost based on an asphalt path and patch by the bench positioned to allow shoulder alignment with a person seated at the bench for someone using a wheeled mobility device.)	1	360	\$360
114	Team Seating 1 at Softball Field	Ext.		Field	Softball

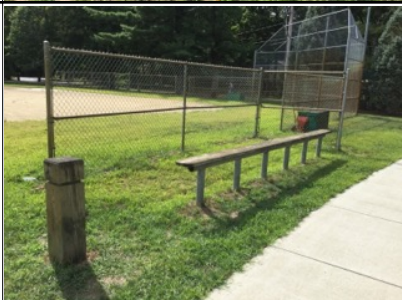
Accessible spaces not provided at team seating	-	Provide a firm, stable and slip resistant path and surface 48" wide min. to the softball field team seating and at a 36" x 48" clear floor space by the team seating. (Cost based on an asphalt path and patch by the bench positioned to allow shoulder alignment with a person seated at the bench for someone using a wheeled mobility device.)	1	360	\$360

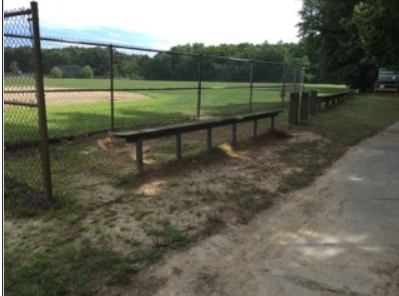
ID	Location	Floor	Room	Element	Type	Photo	Issues	Current Measure	Recommendations	Quantity	Price	Cost Estimation
115	Team Seating 2 at Softball Field	Ext.		Field	Softball

Accessible spaces not provided at team seating	-	Provide a firm, stable and slip resistant path and surface 48" wide min. to the softball field team seating and at a 36" x 48" clear floor space by the team seating. (Cost based on an asphalt path and patch by the bench positioned to allow shoulder alignment with a person seated at the bench for someone using a wheeled mobility device.)	1	360	\$360
116	Softball Field Entrance by Team Seating 2	Ext.		Field	Softball

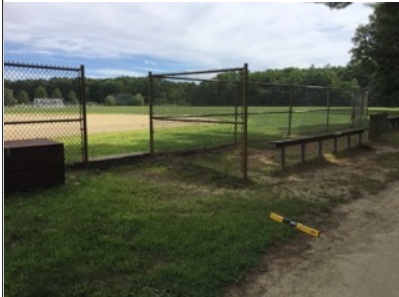
Field not connected to an accessible route	17.9%	Provide an accessible route to the edge of sport activity at the softball field. Provide a firm, stable and slip resistant surface 48" wide min. with a max. running slope of 1:20 (5.00%) and a max. cross slope of 1:50 (2.00%).	1	480	\$480

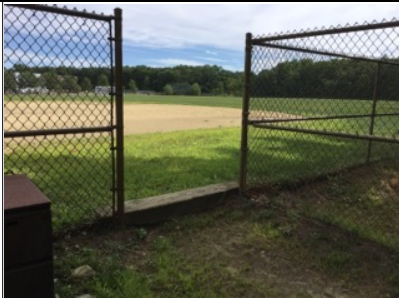
117	Softball Field Entrance by Team Seating 2	Ext.		Field	Softball

Field not connected to an accessible route	8.25"	Reduce change in level to 1/2" max.	1	Labor	\$0
Play and Sport Areas												
Field												
118	Team Seating at the Soccer Field	Ext.		Field	Soccer

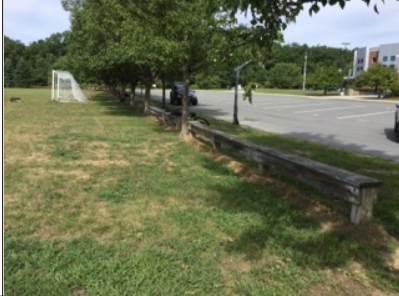
Accessible spaces not provided at team seating	-	Provide a firm, stable and slip resistant path and surface 48" wide min. to the soccer field team seating and at a 36" x 48" clear floor space by the team seating. (Cost based on an asphalt path and patch by the bench positioned to allow shoulder alignment with a person seated at the bench for someone using a wheeled mobility device.)	1	360	\$360
119	Open Field Entrance	Ext.		Field	Soccer

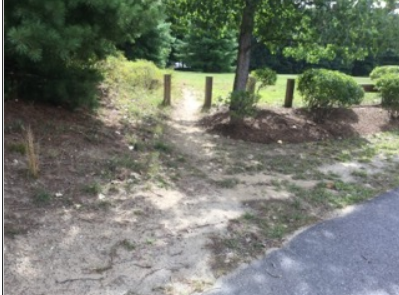
Field not connected to an accessible route	6.8%	Provide an accessible route to the edge of sport activity at the soccer field. Provide a firm, stable and slip resistant surface 48" wide min. with a max. running slope of 1:20 (5.00%) and a max. cross slope of 1:50 (2.00%).	1	480	\$480

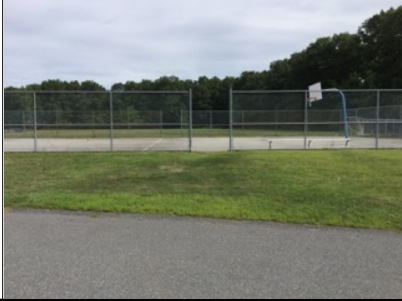
ID	Location	Floor	Room	Element	Type	Photo	Issues	Current Measure	Recommendations	Quantity	Price	Cost Estimation
Court												
120	Basketball Court	Ext.		Court	Basketball

Court is not connected to an accessible route	10.4%	Provide an accessible route to the edge of sport activity at the basketball court. Provide a firm, stable and slip resistant surface 48" wide min. with a max. running slope of 1:20 (5.00%) and a max. cross slope of 1:50 (2.00%).	1	480	\$480
Best Practice												
Egress Walkway												
121	Egress Door 9	1		Egress Walkway	N/A
