Curtis Middle School

Town of Sudbury ADA Transition Plan

January 2021

**Town of Sudbury
Curtis Middle School**

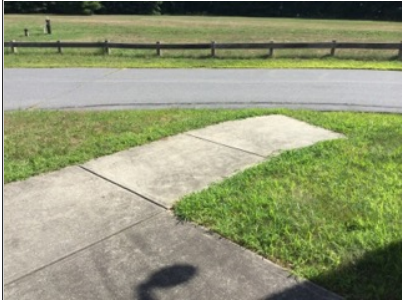
Recommend extending walkway from egress door to paved surface.	1	-	\$0
122	Egress Door 6 - 9	Ext.		Egress Walkway	N/A

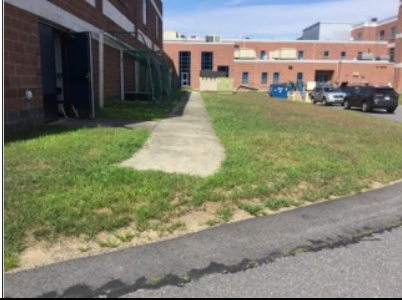
Recommend extending walkway from egress door to paved surface.	1	-	\$0
Podium												
123	Auditorium	1	1320	Podium	N/A

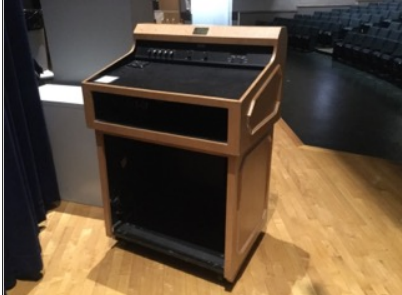
Recommend providing an adjustable height podium with knee and toe clearance.	1	-	\$0
