Fairbank Community Center

Town of Sudbury ADA Transition Plan

December 2020

Institute for Human Centered Design

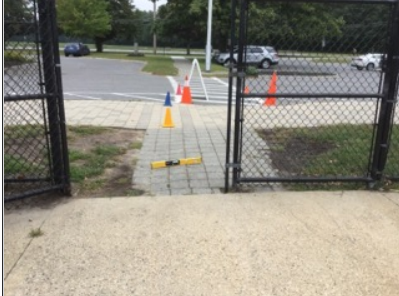
Cross slope > 1:50 (2.00%) Does not prevent accumulation of water	10.7% -	Reduce cross slope to be no steeper than 1:50 (2.00%) and ensure that running slope is no greater than 1:50 (2.00%) at the gate. Repair surface so that it does not accumulate water. (Cost estimate for a 10' long by 4' wide asphalt route.)	1	400	\$400
2	Basketball Court Northeast Walkway	Ext.		Exterior Access Route	Walkway

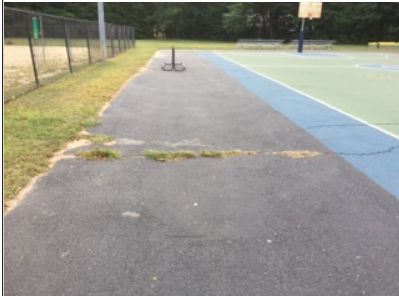
Surface is not stable, firm, and slip-resistant	-	Patch and repair asphalt surface.	1	160	\$160
Off-Street Parking Lot or Garage												
3	West Parking Lot	Ext.		Off-Street Parking Lot or Garage	Visitor

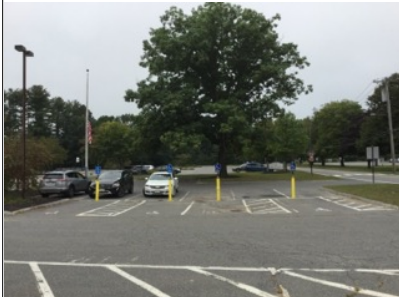
Total # of parking Total # of designated accessible parking spaces Total # of designated van accessible spaces Running or cross slope at space > 1:50 (2.00%)	107 4 1 6.4%	Reduce running or cross slope at north accessible parking space to be no steeper than 1:50 (2.00%).	1	1440	\$1440

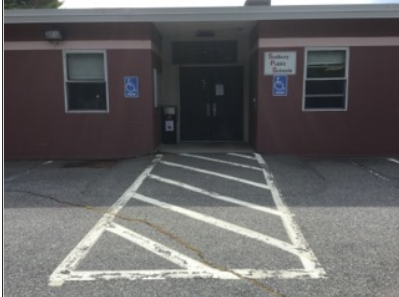
4	Parking Lot on Northeast Side	Ext.		Off-Street Parking Lot or Garage	Visitor

Total # of parking Total # of designated accessible parking spaces Total # of designated van accessible spaces Running or cross slope at space > 1:50 (2.00%) Sign does not have the designation "Van Accessible" Sign bottom < 60" above finished grade	92 5 0 6.5% - 56"	Provide one van accessible space. Add the designation "Van Accessible" to the sign at the larger van accessible parking space. Reduce running or cross slope to be no steeper than 1:50 (2.00%). Locate signs with the bottom of the sign 60" min. above the ground.	1	1940 Labor	\$1940

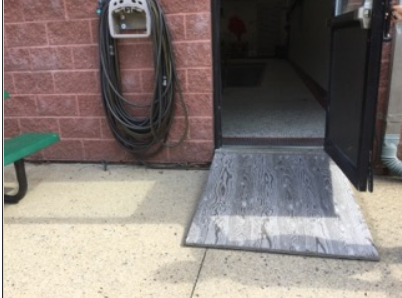
Running slope > 1:12 (8.3%) Handrails not provided at both sides if rise is > 6" Surface is not stable, firm, and slip-resistant	13.5% 7" -	Install a temporary metal ramp to provide an accessible route. (Cost is for a 7' perforated metal ramp with a 5' x 5' platform courtesy of Amramp.)	1	2800	\$2800
Emergency Exit												
6	Pool Egress With Step by the Gate	1		Emergency Exit	N/A

At the door between the pool and the picnic area, there is a non-compliant wood ramp that is not securely attached. It is lacking proper handrails and does not allow for maneuvering clearance at the door. In addition, the slope of this ramp exceeds what is allowed.

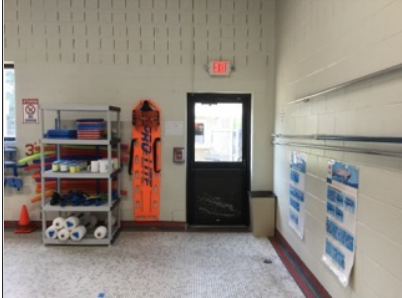
Tactile sign not provided at exit Directional sign to accessible emergency exit not provided	- - -	Provide tactile exit signs with raised characters and braille at exit doors. Mount signs between 48"- 60" above the finished floor located on the latch side of the door. Provide a directional sign indicating the location of the nearest accessible emergency exit.	1	464	\$464

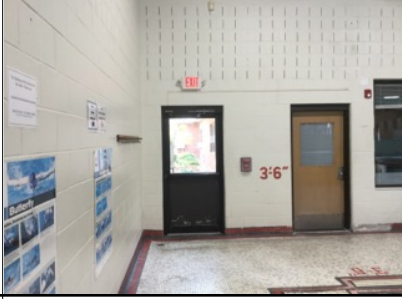
Tactile sign not provided at exit Directional sign to accessible emergency exit not provided	- -	Provide tactile exit signs with raised characters and braille at exit doors. Mount signs between 48"- 60" above the finished floor located on the latch side of the door. Provide a directional sign indicating the location of the nearest accessible emergency exit.	1	464	\$464
8	Egress by Pool Locker Rooms to Senior Center Parking Lot	1		Emergency Exit	N/A

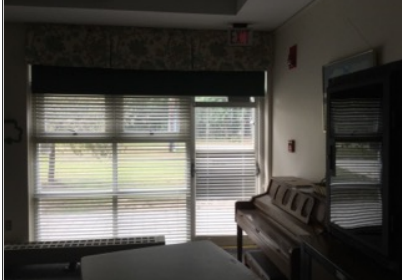
Tactile sign not provided at exit Directional sign to accessible emergency exit not provided	- -	Provide tactile exit signs with raised characters and braille at exit doors. Mount signs between 48"- 60" above the finished floor located on the latch side of the door. Provide a directional sign indicating the location of the nearest accessible emergency exit.	1	464	\$464

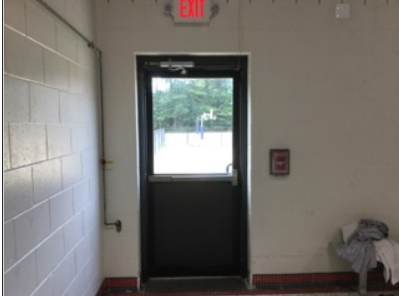
Tactile sign not provided at exit Illuminated Int. Symbol of Acc. not provided (MAAB)	- -	Provide tactile exit signs with raised characters and braille at exit doors. Mount signs between 48"- 60" above the finished floor located on the latch side of the door. Provide an illuminated sign with the International Symbol of Accessibility.	1	432	\$432
11	Egress Next to Gym/Stage	1		Emergency Exit	N/A

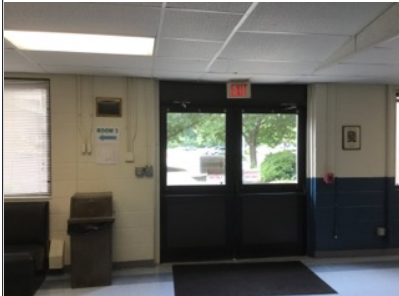
Tactile sign not provided at exit Illuminated Int. Symbol of Acc. not provided (MAAB)		Provide tactile exit signs with raised characters and braille at exit doors. Mount signs between 48"- 60" above the finished floor located on the latch side of the door. Provide an illuminated sign with the International Symbol of Accessibility.	1	432	\$432

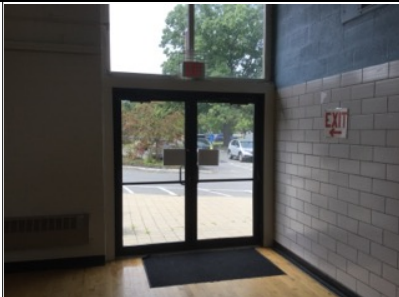
12	Gym/Stage Egress	1		Emergency Exit	N/A

Tactile sign not provided at exit Illuminated Int. Symbol of Acc. not provided (MAAB)	- -	Provide tactile exit signs with raised characters and braille at exit doors. Mount signs between 48"- 60" above the finished floor located on the latch side of the door. Provide an illuminated sign with the International Symbol of Accessibility.	1	432	\$432
13	Main Entrance to Pool	1		Emergency Exit	N/A

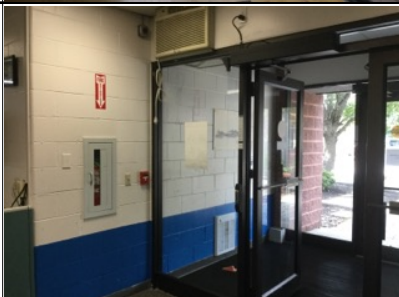
Tactile sign not provided at exit Illuminated Int. Symbol of Acc. not provided (MAAB)	- -	Provide tactile exit signs with raised characters and braille at exit doors. Mount signs between 48"- 60" above the finished floor located on the latch side of the door. Provide an illuminated sign with the International Symbol of Accessibility.	1	432	\$432
14	Egress Next to Toilet Rooms in the Senior Center	1		Emergency Exit	N/A

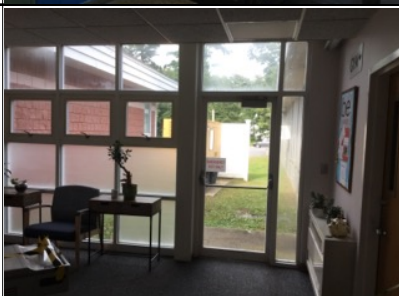
Tactile sign not provided at exit Illuminated Int. Symbol of Acc. not provided (MAAB)	- -	Provide tactile exit signs with raised characters and braille at exit doors. Mount signs between 48"- 60" above the finished floor located on the latch side of the door. Provide an illuminated sign with the International Symbol of Accessibility.	1	1116	\$1116

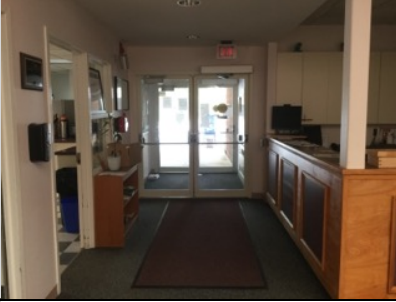
Tactile sign not provided at exit Illuminated Int. Symbol of Acc. not provided (MAAB)	- -	Provide tactile exit signs with raised characters and braille at exit doors. Mount signs between 48"- 60" above the finished floor located on the latch side of the door. Provide an illuminated sign with the International Symbol of Accessibility.	2	432	\$864
16	Egress Through Kitchen	1		Emergency Exit	N/A

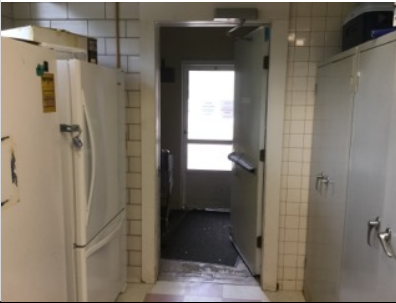
Tactile sign not provided at exit Illuminated Int. Symbol of Acc. not provided (MAAB) Maneuvering clearance(s) not provided	- - -	Provide tactile exit signs with raised characters and braille at exit doors. Mount signs between 48"- 60" above the finished floor located on the latch side of the door. Provide an illuminated sign with the International Symbol of Accessibility. Relocate refrigerator to provide 12 inches clear on the latch side of the door,	1	1116 Labor	\$1116

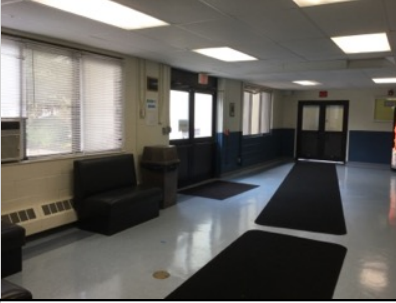
Surface not stable, firm, and slip-resistant	2	Secure mats.	1	Labor	\$0
18	Director of Student Services	1		Interior Access Route	N/A

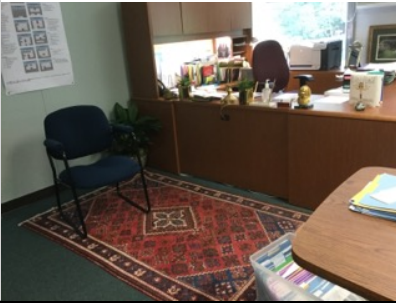
Surface not stable, firm, and slip-resistant	-	Secure carpet.	1	Labor	\$0
19	Human Resources	1		Interior Access Route	N/A

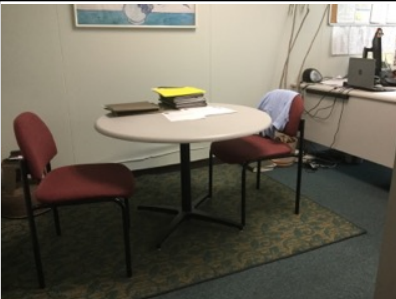
Surface not stable, firm, and slip-resistant	-	Secure carpet.	1	Labor	\$0

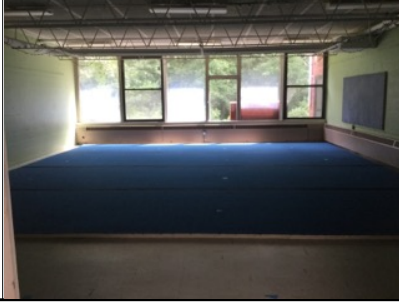
Accessible route not provided	2"	Provide a portable ramp at 2" level change.	1	500	\$500
Doors, Doorways, & Gates												
21	Secondary Entrance to Pool	1		Doors, Doorways, & Gates	Circulation

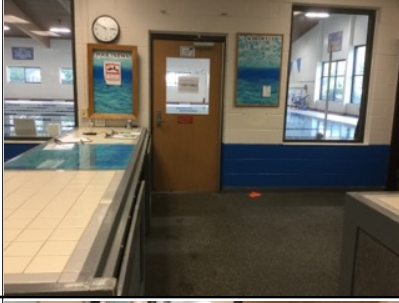
Maneuvering clearance(s) not provided	-	Provide an automatic door opener.	1	3060	\$3060
22	Director's and First Aid Office by Pool	1		Doors, Doorways, & Gates	Office

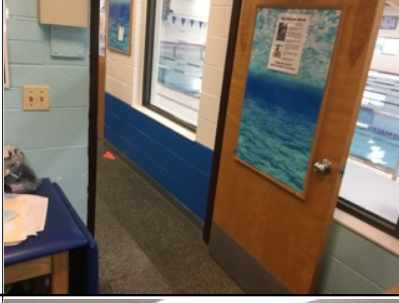
Hardware not operable with a closed fist	-	Provide hardware that can be operable with one hand and not require tight grasping, pinching, or twisting of the wrist.	1	484	\$484
23	Teen Room	1		Doors, Doorways, & Gates	Meeting Room

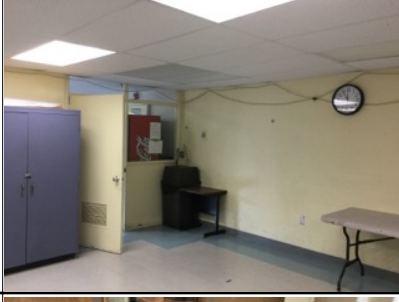
Hardware not operable with a closed fist	-	Provide hardware that can be operable with one hand and not require tight grasping, pinching, or twisting of the wrist.	1	484	\$484

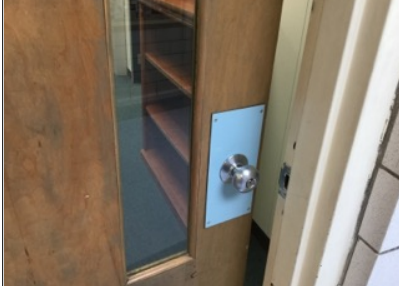
24	Business Office	1		Doors, Doorways, & Gates	Office

Hardware not operable with a closed fist	-	Provide hardware that can be operable with one hand and not require tight grasping, pinching, or twisting of the wrist.	1	484	\$484

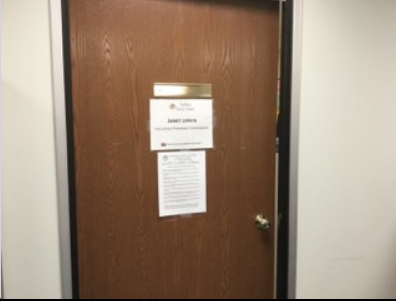
Hardware not operable with a closed fist	-	Provide hardware that can be operable with one hand and not require tight grasping, pinching, or twisting of the wrist.	1	484	\$484
26	Room 3 Game Room by Parks and Recreation	1		Doors, Doorways, & Gates	Meeting Room

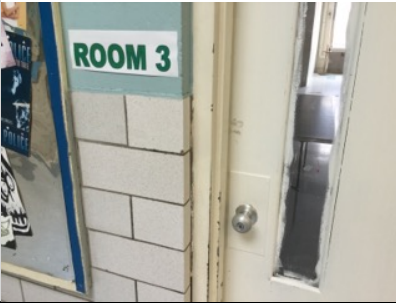
Hardware not operable with a closed fist	-	Provide hardware that can be operable with one hand and not require tight grasping, pinching, or twisting of the wrist.	1	484	\$484
27	Pre-school Room by Parks and Recreation	1		Doors, Doorways, & Gates	Classroom

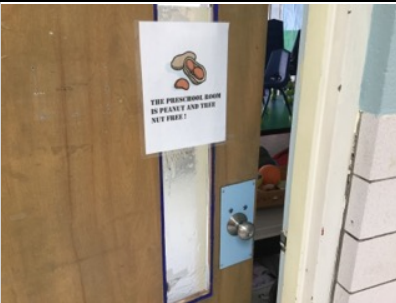
Hardware not operable with a closed fist	-	Provide hardware that can be operable with one hand and not require tight grasping, pinching, or twisting of the wrist.	1	484	\$484
28	Social Worker for District	1		Doors, Doorways, & Gates	Office

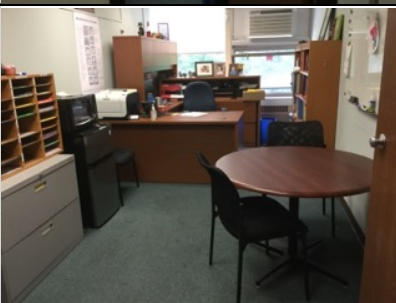
29	Assistant Director of Student Services	1		Doors, Doorways, & Gates	Office

Hardware not operable with a closed fist	-	Provide hardware that can be operable with one hand and not require tight grasping, pinching, or twisting of the wrist.	1	484	\$484

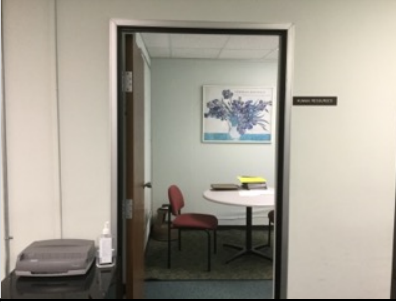
Hardware not operable with a closed fist	-	Provide hardware that can be operable with one hand and not require tight grasping, pinching, or twisting of the wrist.	1	484	\$484
31	Pool Entrance	1		Doors, Doorways, & Gates	Circulation

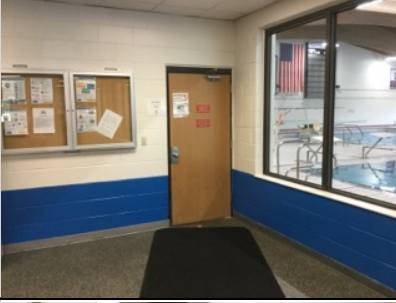
Hardware not operable with a closed fist Door requires > 5 lbs. of force to open	- 17 lbs	Provide hardware that can be operable with one hand and not require tight grasping, pinching, or twisting of the wrist. Adjust closers so doors do not require more than 5 pounds of force to open.	1	484 Labor	\$484
32	Secondary Entrance to Pool	1		Doors, Doorways, & Gates	Circulation

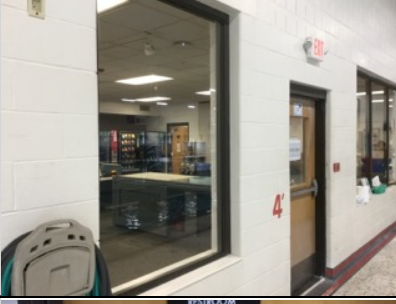
Door requires > 5 lbs. of force to open	16 lbs	Adjust closers so doors do not require more than 5 pounds of force to open.	1	Labor	\$0

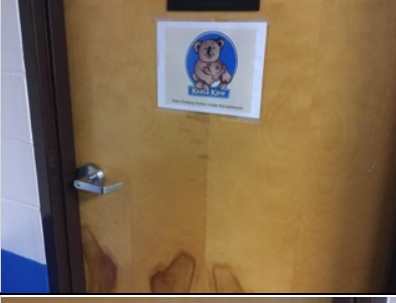
33	All Gender Toilet Room by Locker Rooms (West Side)	1		Doors, Doorways, & Gates	Toilet Room

Door requires > 5 lbs. of force to open	16 lbs	Adjust closers so doors do not require more than 5 pounds of force to open.	1	Labor	\$0
34	All Gender Toilet Room by Locker Rooms (East Side)	1		Doors, Doorways, & Gates	Toilet Room

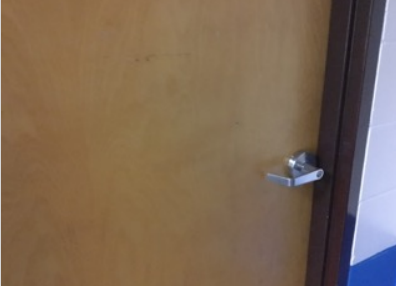
Door requires > 5 lbs. of force to open	12 lbs	Adjust closers so doors do not require more than 5 pounds of force to open.	1	Labor	\$0

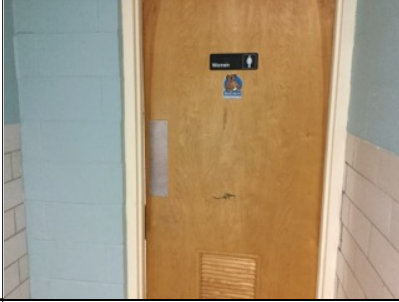
Door requires > 5 lbs. of force to open	9 lbs	Adjust closers so doors do not require more than 5 pounds of force to open.	1	Labor	\$0
36	Men's/Boys' Toilet Room by Human Resources	1		Doors, Doorways, & Gates	Toilet Room

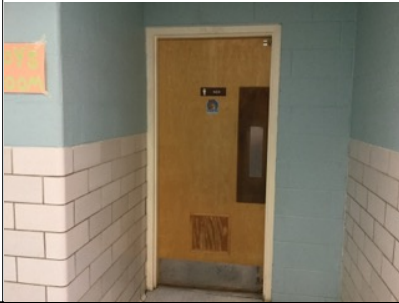
Door requires > 5 lbs. of force to open	17 lbs	Adjust closers so doors do not require more than 5 pounds of force to open.	1	Labor	\$0
Signage												
37	Pool - Men's Locker Room	1		Signage	Designation

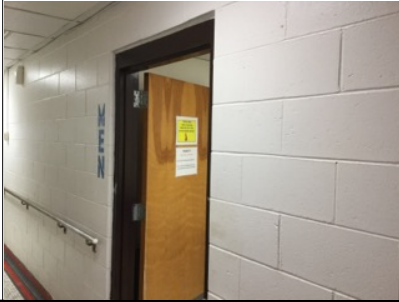
Raised characters not provided on sign Braille not provided on sign	- -	Provide text with raised characters duplicated in braille on sign.	1	232	\$232
38	Pool - Women's Locker Room Access From the Reception	1		Signage	Designation

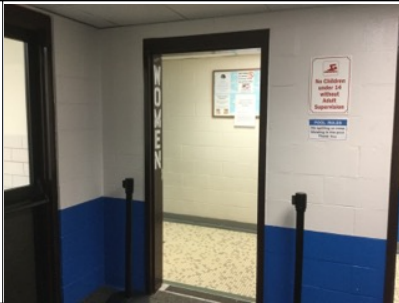
Raised characters not provided on sign Braille not provided on sign	- -	Provide text with raised characters duplicated in braille on sign.	1	232	\$232

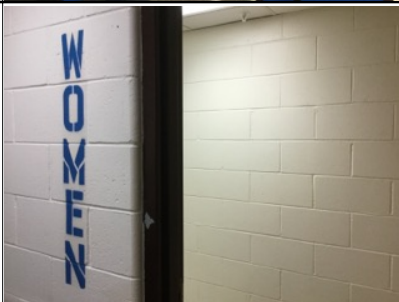
Raised characters not provided on sign Braille not provided on sign	- -	Provide text with raised characters duplicated in braille on sign.	1	232	\$232

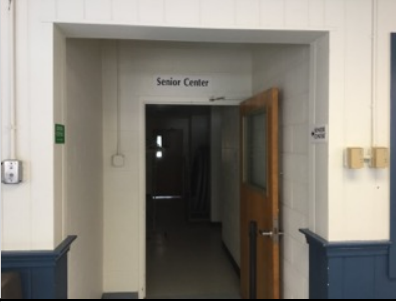
Raised characters not provided on sign Braille not provided on sign	- -	Provide text with raised characters duplicated in braille on sign.	1	232	\$232
41	Assistant Superintendent and Superintendent	1		Signage	Designation

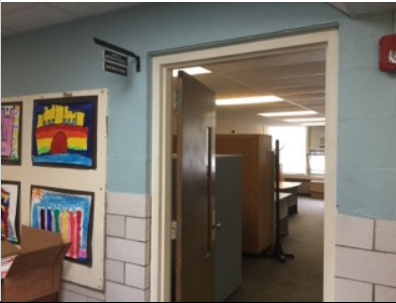
Raised characters not provided on sign Braille not provided on sign	- -	Provide text with raised characters duplicated in braille on sign.	2	232	\$464
42	Student Services	1		Signage	Designation

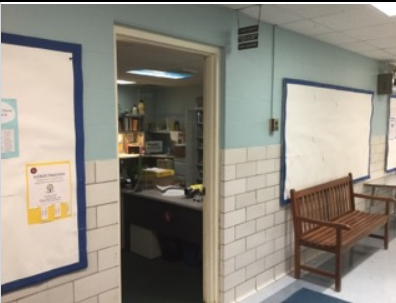
Raised characters not provided on sign Braille not provided on sign	- -	Provide text with raised characters duplicated in braille on sign.	1	232	\$232
43	Social Worker for District	1		Signage	Designation

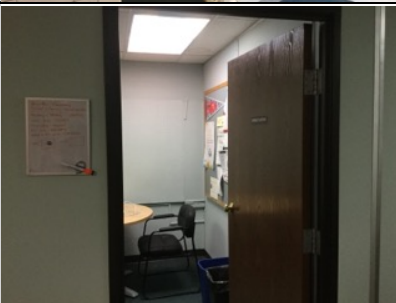
Raised characters not provided on sign Braille not provided on sign	- -	Provide text with raised characters duplicated in braille on sign.	1	232	\$232

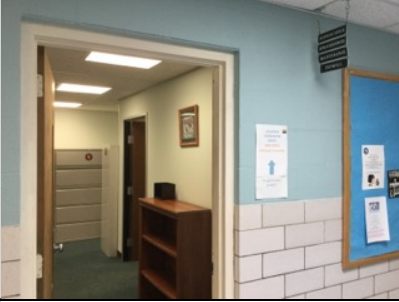
Raised characters not provided on sign Braille not provided on sign	- -	Provide text with raised characters duplicated in braille on sign.	1	232	\$232
46	Human Resources	1		Signage	Designation

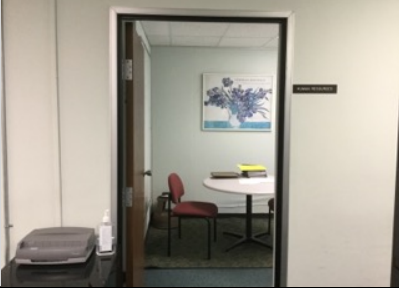
Raised characters not provided on sign Braille not provided on sign	- -	Provide text with raised characters duplicated in braille on sign.	1	232	\$232
47	Room 3 Game Room by Parks and Recreation	1		Signage	Designation

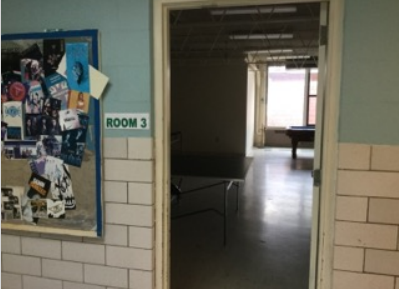
Raised characters not provided on sign Braille not provided on sign	- -	Provide text with raised characters duplicated in braille on sign.	1	232	\$232
48	Senior Center Volunteer Program Coordinator	1		Signage	Designation

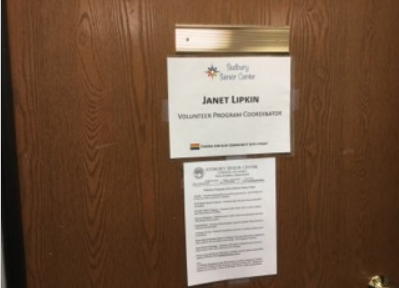
Raised characters not provided on sign Braille not provided on sign Sign not located on the latch side of the door	- - -	Provide text with raised characters duplicated in braille on sign. Locate sign at permanent rooms alongside the door on the latch side.	1	232	\$232

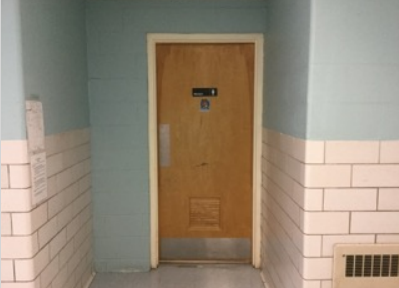
49	Women's/ Girls' Toilet Room by Human Resources	1	30	Signage	Designation

Raised characters not provided on sign Braille not provided on sign Sign not located on the latch side of the door	- - -	Provide text with raised characters duplicated in braille on sign. Locate sign at permanent rooms alongside the door on the latch side.	1	232	\$232

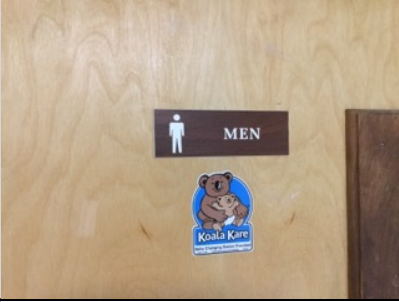
Raised characters not provided on sign Braille not provided on sign Sign not located on the latch side of the door	- - -	Provide text with raised characters duplicated in braille on sign. Locate sign at permanent rooms alongside the door on the latch side.	1	232	\$232
51	Senior Center, M. Van Houten Room	1		Signage	Designation

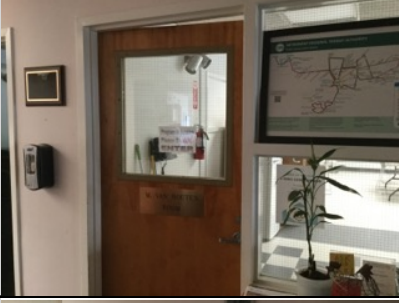
Raised characters not provided on sign Braille not provided on sign Sign not located on the latch side of the door	- - -	Provide text with raised characters duplicated in braille on sign. Locate sign at permanent rooms alongside the door on the latch side.	1	232	\$232
52	Senior Center, Sudbury Pines Room	1		Signage	Designation

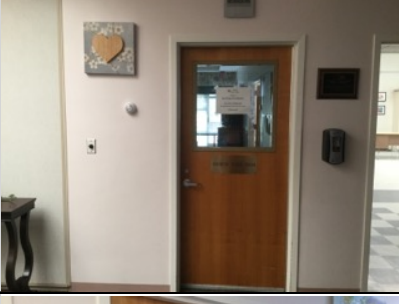
Raised characters not provided on sign Braille not provided on sign Sign not located on the latch side of the door	- - -	Provide text with raised characters duplicated in braille on sign. Locate sign at permanent rooms alongside the door on the latch side.	1	232	\$232

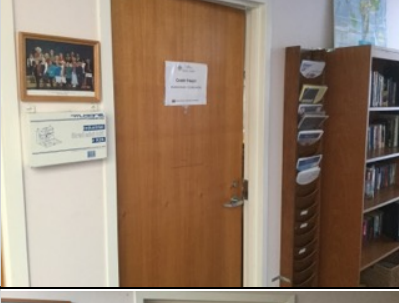
Raised characters not provided on sign Braille not provided on sign Sign not located on the latch side of the door	- - -	Provide text with raised characters duplicated in braille on sign. Locate sign at permanent rooms alongside the door on the latch side.	1	232	\$232
54	Senior Center, Program Coordinator	1		Signage	Designation

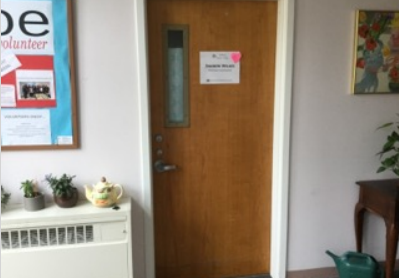
Raised characters not provided on sign Braille not provided on sign Sign not located on the latch side of the door	- - -	Provide text with raised characters duplicated in braille on sign. Locate sign at permanent rooms alongside the door on the latch side.	1	232	\$232

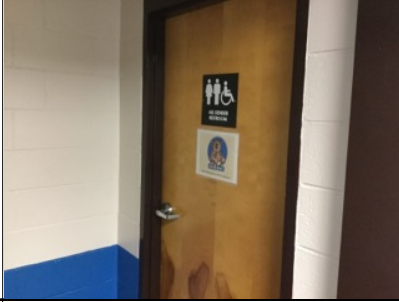
Sign not located on the latch side of the door	-	Locate sign at permanent rooms alongside the door on the latch side.	1	Labor	\$0
56	All Gender Toilet Room by Locker Rooms (East Side)	1		Signage	Designation

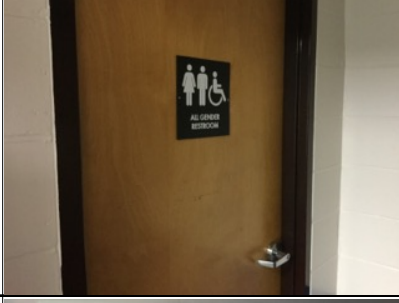
Sign not located on the latch side of the door	-	Locate sign at permanent rooms alongside the door on the latch side.	1	Labor	\$0
57	Senior Center, Women's and Men's Toilet Rooms	1		Signage	Designation

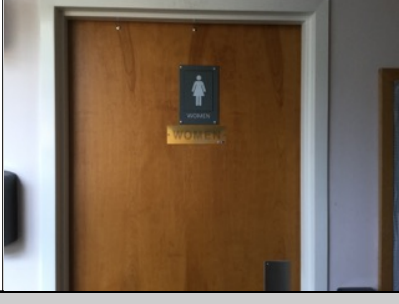
Sign not located on the latch side of the door	-	Locate sign at permanent rooms alongside the door on the latch side.	2	Labor	\$0
Service Counter												
58	Senior Center Main Reception	1		Service Counter	N/A

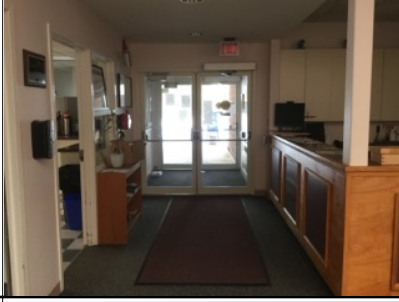
Counter > 36" high	42.5"	Provide a counter that is 36" max. above the ground or finished floor.	1	880	\$880

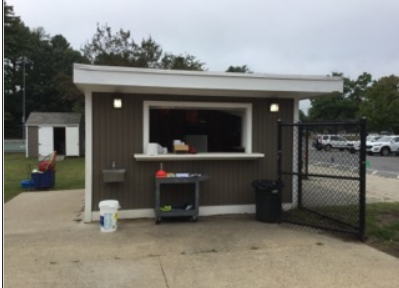
59	Concession Stand at Kids Summer Camp (Interior of Fence)	Ext.		Service Counter	N/A

Counter > 36" high	47"	Provide a counter that is 36" max. above the ground or finished floor.	1	880	\$880

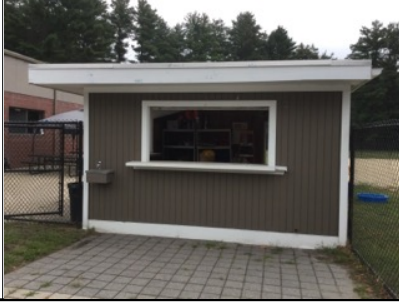
Counter > 36" high	47"	Provide a counter that is 36" max. above the ground or finished floor.	1	880	\$880
Operable Parts												
61	Pool - Main Entrance	1		Operable Parts	Other

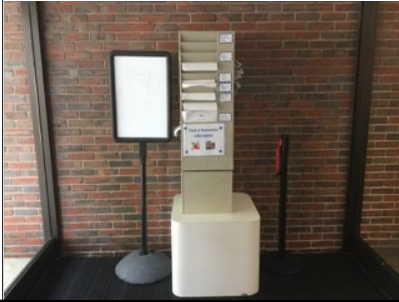
Reach < 15" or > 48"(forward/side approach)	66"	Ensure that one of each type of form is located no higher than 48" above the finished floor.	1	Labor	\$0
62	Diving Pool Coat Hooks	1		Operable Parts	Clothes Rod/Hooks

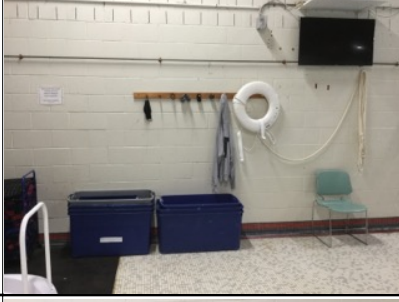
Side reach > 54"	69"	Provide one hook at 48" max. above the finished floor.	1	150	\$150
63	Swimming Pool Coat Hooks	1		Operable Parts	Clothes Rod/Hooks

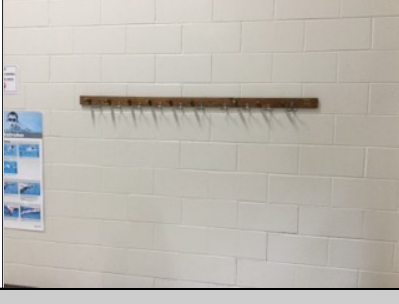
Side reach > 54"	62.5"	Provide one hook at 48" max. above the finished floor.	1	150	\$150
Children's Reach Ranges												
64	Pre-school Multipurpose Room	1		Children's Reach Ranges	N/A

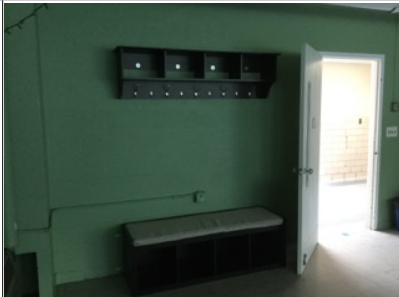
Reach < 20" or > 36" (Ages 3 - 4)	66.25"	Provide one storage hook and shelf that is between 20" and 36" above the finished floor.	1	Labor	\$0

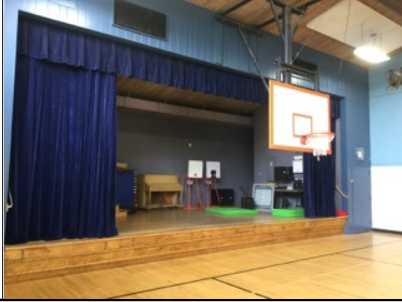
Accessible route to stage not provided	-	Provide an interior lift to the stage.	1	21660	\$21660
Locker Room												
66	Pool - Women's Locker Room Changing Rooms	1		Locker Room	Women's

An accessible route is not provided to the stage in the gym.

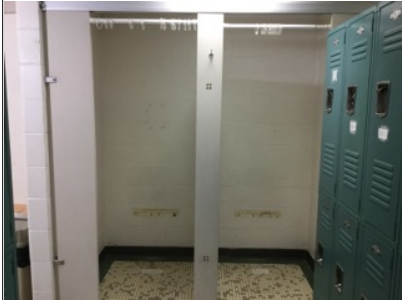
Room is < 78" x 72" Bench < 24" deep Bench < 48" long	46" 38.5" - -	Provide an accessible changing room that is 78" by 72" minimum. Provide a bench that is 24" deep and 48" long with room on the side to transfer.	1	5866	\$5866
67	Pool - Women's Locker Room	1		Locker Room	Women's

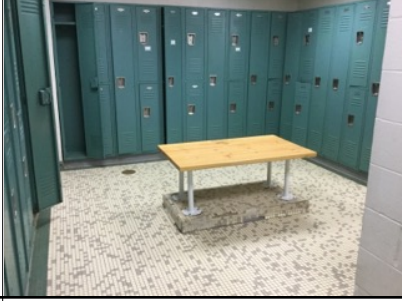
Back support not provided at bench Bench is not 17"-19" high Bench < 24" deep Bench < 48" long	- 22.5" 27" -	Provide at least one bench with back support or that is affixed to a wall with room on the side to transfer. Install a bench with the top of the seat between 17"- 19" above the finished floor. Provide a bench that is 24" deep and 48" long.	1	200	\$200

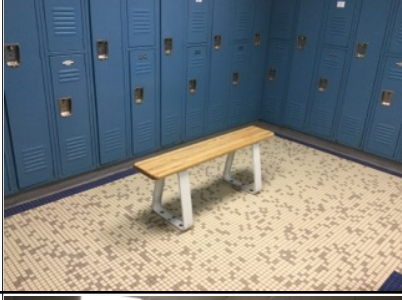
Back support not provided at bench Bench < 24" deep Bench < 48" long	- 9" -	Provide at least one bench with back support or that is affixed to a wall with room on the side to transfer. Provide a bench that is 24" deep and 48" long.	1	200	\$200
69	Pool - Men's Locker Room	1		Locker Room	Men's

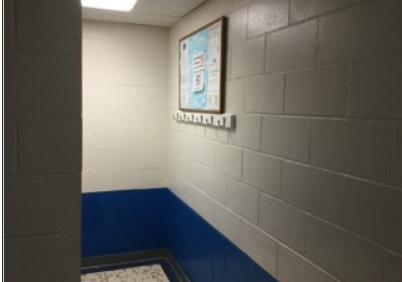
Hook > 48" high	58"	Locate one hook no higher than 48" above the finished floor.	1	150	\$150

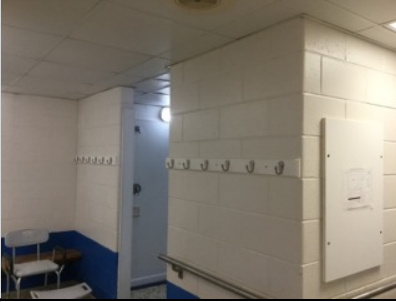
Hook > 48" high	62.5"	Locate one hook no higher than 48" above the finished floor.	2	150	\$300
71	Pool - Women's Locker Room	1		Locker Room	Women's

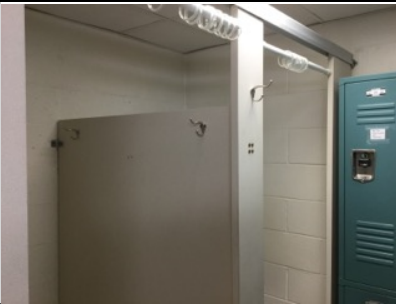
Hook > 48" high	66.25"	Locate one hook no higher than 48" above the finished floor.	1	150	\$150
73	Pool - Women's Locker Room	1		Locker Room	Women's

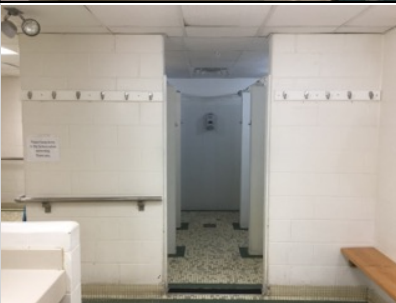
Hook > 48" high	66.25"	Locate one hook no higher than 48" above the finished floor.	1	150	\$150
Picnic Tables												
74	Picnic Table Next to Northeast Parking Lot Accessible Parking by Street	Ext.		Picnic Tables	N/A

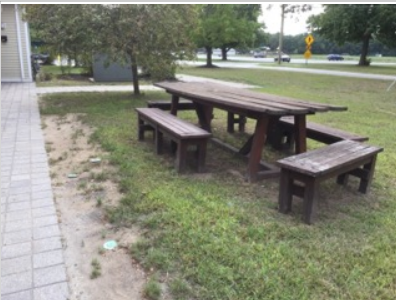
Toe or knee clearance at tables not provided Picnic table not on an accessible route	- -	Provide at least 1 picnic table in this area with toe and knee clearance. Ensure that the picnic table is connected to an accessible route.	1	1400	\$1400

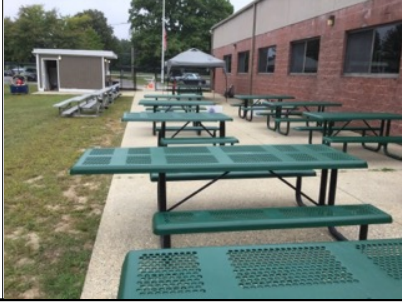
Picnic table not on an accessible route	-	Ensure that the accessible space at the picnic tables are connected to an accessible route.	2	Labor	\$0
Kitchens and Kitchenettes												
76	Senior Center, M. Van Houten Room	1		Kitchens and Kitchenettes	Other

An accessible picnic table is not provided on the northeast side of the building. Two accessible picnic tables in the picnic area south of the pool are located so that the accessible portion of the table is not located on an accessible route.

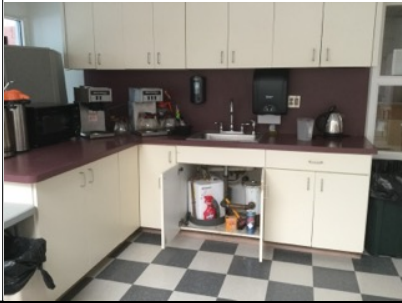
Knee/toe clearance not provided at sink Sink > 34" high	- 36.5"	Provide a sink with knee and toe clearance positioned for a forward approach. Ensure the sink is no higher than 34" above the finished floor.	1	4780	\$4780
Toilet & Bathing Rooms												
Overall Access												
77	Senior Center, Women's and Men's Toilet Rooms	1		Overall Access	Toilet Room

The sink in the M. Van Houten Room and the teen room are located higher than 34 inches above the finished floor and lack knee and toe clearance.

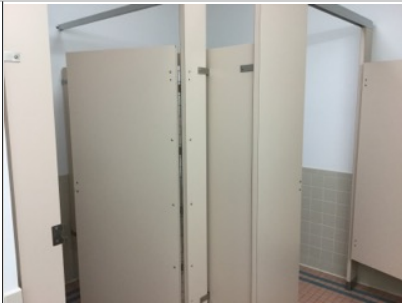
Audible and visible alarms not provided	-	When fire system is updated, ensure that a visible and audible fire alarm is installed.	2	-	\$0

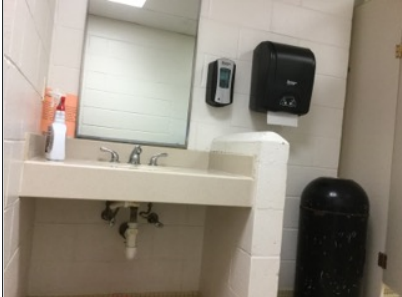
78	All Gender Toilet Room (West Side)	1		Overall Access	Toilet Room

Audible and visible alarms not provided	-	When fire system is updated, ensure that a visible and audible fire alarm is installed.	1	-	\$0

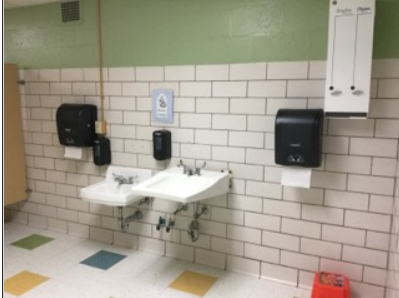
Plumbing underneath is exposed	-	Insulate or otherwise configure pipes to prevent contact at lavatory with knee and toe clearance.	1	92	\$92
80	All Gender Toilet Room by Locker Rooms (East Side)	1		Lavatory	N/A

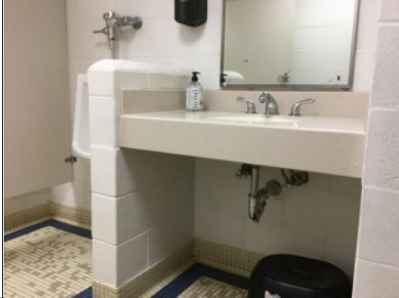
Plumbing underneath is exposed	-	Insulate or otherwise configure pipes to prevent contact at lavatory.	1	92	\$92
81	Pool - Men's Locker Room	1		Lavatory	N/A

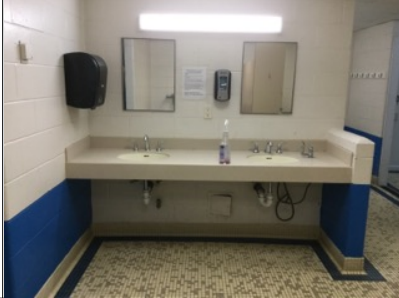
Plumbing underneath is exposed Mirror above lavatory w/reflective surface > 40" Dispensers not within reach range	- 46.25" 50", 52.5"	Insulate or otherwise configure pipes to prevent contact for at least one lavatory. Lower mirror so that the bottom surface is at 40" max. above the finished floor. Lower soap and paper towel dispensers to 42" max. above the floor.	1	860	\$860

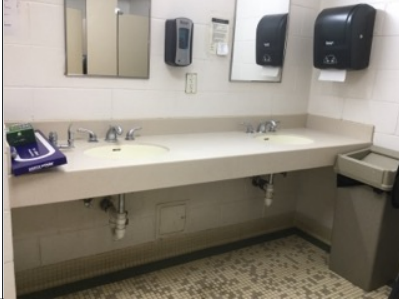
82	Pool - Women's Locker Room	1		Lavatory	N/A

Plumbing underneath is exposed Mirror above lavatory w/reflective surface > 40" Dispensers not within reach range	- 46" 50", 52"	Insulate or otherwise configure pipes to prevent contact for at least one lavatory. Lower mirror so that the bottom surface is at 40" max. above the finished floor. Lower soap and paper towel dispensers to 42" max. above the floor.	1	860	\$860
83	Senior Center, Men's Toilet Room	1		Lavatory	N/A

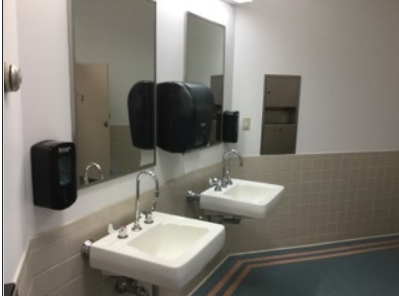
Plumbing underneath is exposed Mirror above lavatory w/reflective surface > 40" Dispensers not within reach range	- 44.25" 49.25", 54.5"	Insulate or otherwise configure pipes to prevent contact for at least one lavatory. Lower mirror so that the bottom surface is at 40" max. above the finished floor. Lower sanitary napkin disposal bag dispenser and paper towel dispenser to 42" max. above the floor.	1	860	\$860

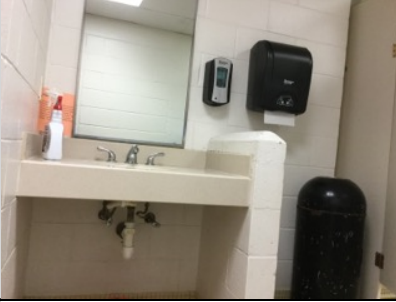
Plumbing underneath is exposed Dispensers not within reach range	- 48.8"	Insulate or otherwise configure pipes to prevent contact at lavatory. Lower paper towel dispenser to 42" max. above the floor.	1	348	\$348
85	Senior Center, Women's Toilet Room	1		Lavatory	N/A

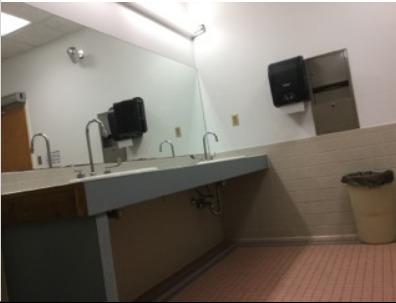
Plumbing underneath is exposed Dispensers not within reach range	- 47.25"	Insulate or otherwise configure pipes to prevent contact for at least one lavatory. Lower soap and paper towel dispensers to 42" max. above the floor.	1	604	\$604
86	Men's/Boys' Toilet Room	1		Lavatory	N/A

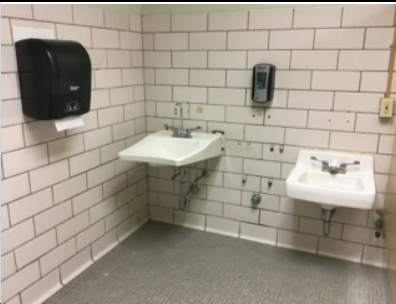
Plumbing underneath is exposed Dispensers not within reach range	- 46"	Insulate or otherwise configure pipes to prevent contact at lavatory with knee and toe clearance. Lower soap dispenser to 42" max. above the floor.	1	445	\$445

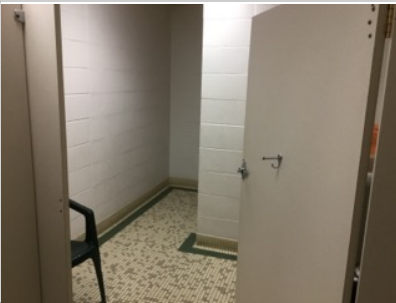
Door has non-compliant hardware Door has malfunctioning self-closing hinge	- -	Provide hardware that can be operable with one hand and not require tight grasping, pinching, or twisting of the wrist. Repair hinge.	1	70 Labor	\$70
88	All Gender Toilet Room by Locker Rooms (East Side)	1		Toilet Compartment	Accessible Compartment

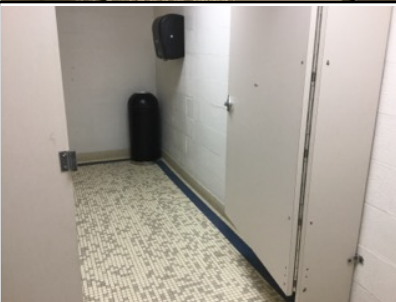
Door has non-compliant hardware Door has malfunctioning self-closing hinge	- -	Provide hardware that can be operable with one hand and not require tight grasping, pinching, or twisting of the wrist. Repair hinge.	1	70 Labor	\$70

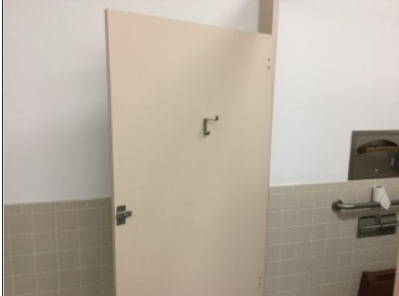
Door has non-compliant hardware Door has malfunctioning self-closing hinge	- - 54.5"	Provide hardware that can be operable with one hand and not require tight grasping, pinching, or twisting of the wrist. Repair hinge.	1	70 Labor	\$70
90	Pool - Men's Locker Room	1		Toilet Compartment	Accessible Compartment

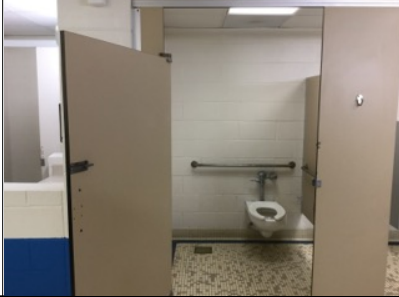
Door has non-compliant hardware Door has malfunctioning self-closing hinge Coat hook > 48"	- - 60.75"	Provide hardware that can be operable with one hand and not require tight grasping, pinching, or twisting of the wrist. Repair hinge. Lower coat hook so that it is no higher than 48".	1	220 Labor	\$220
91	Senior Center, Women's Toilet Room	1		Toilet Compartment	Accessible Compartment

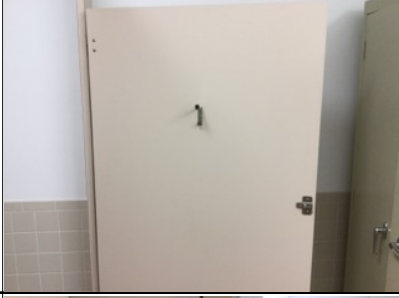
Door has non-compliant hardware Door has malfunctioning self-closing hinge Coat hook > 48"	- - 55.25"	Provide hardware that can be operable with one hand and not require tight grasping, pinching, or twisting of the wrist. Repair hinge. Lower coat hook so that it is no higher than 48".	1	220 Labor	\$220

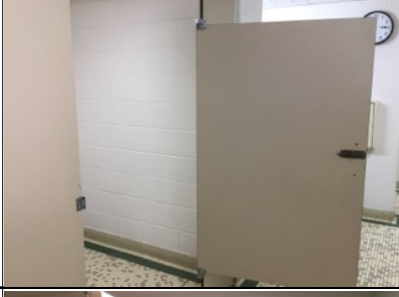
Door has malfunctioning self-closing hinge	-	Repair hinge.	1	Labor	\$0
93	Men's/Boys' Toilet Room by Human Resources	1		Toilet Compartment	Accessible Compartment

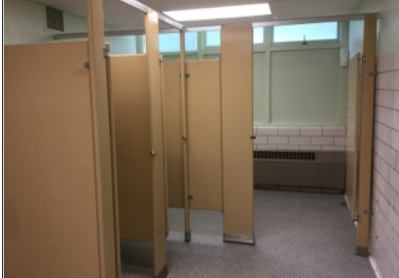
Door has malfunctioning self-closing hinge	-	Repair hinge.	1	Labor	\$0

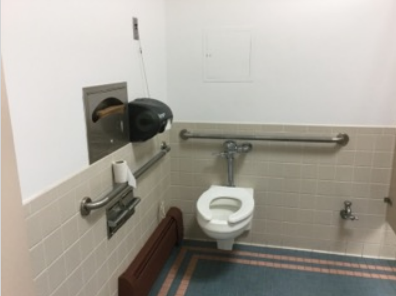
ID	Location	Floor	Room	Element	Type	Photo	Issues	Current Measure	Recommendations	Quantity	Price	Cost Estimation
94	Senior Center, Men's Toilet Room	1		Toilet Compartment	Accessible Compartment

Side or rear grab bar < 33" or >36" high Flush control not on open side Non-compliant toilet paper dispenser	30.5" - -	Locate side grab bar between 33"- 36" above the finished floor. Provide the flush control on the open side of the toilet (transfer side). Relocate toilet paper so that it is 24" min. high, located under the grab bar, and between 7" and 9" from the front of the toilet.	1	1123	\$1123
95	Senior Center, Women's Toilet Room	1		Toilet Compartment	Accessible Compartment

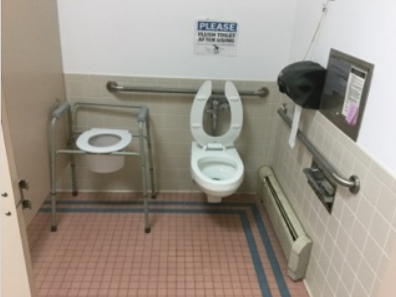
Side or rear grab bar < 33" or >36" high Non-compliant toilet paper dispenser	30.5" -	Locate side grab bar between 33"- 36" above the finished floor. Relocate toilet paper so that it is 24" min. high, located under the grab bar, and between 7" and 9" from the front of the toilet.	1	749	\$749

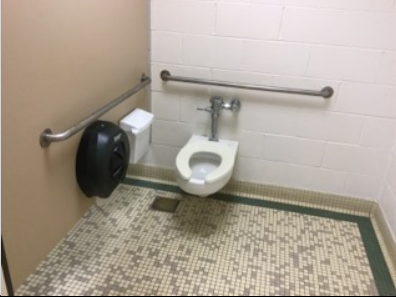
96	Pool - Women's Locker Room	1		Toilet Compartment	Accessible Compartment

Flush control not on open side	-	Provide the flush control on the open side of the toilet (transfer side).	1	374	\$374
97	All Gender Toilet Room by Locker Rooms (East Side)	1		Toilet Compartment	Accessible Compartment

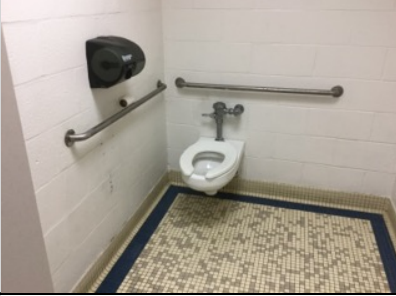
Flush control not on open side Non-compliant toilet paper dispenser	- -	Provide the flush control on the open side of the toilet (transfer side). Relocate toilet paper so that it is 24" min. high, located under the grab bar, and between 7" and 9" from the front of the toilet.	1	630	\$630
98	All Gender Toilet Room by Locker Rooms (West Side)	1		Toilet Compartment	Accessible Compartment

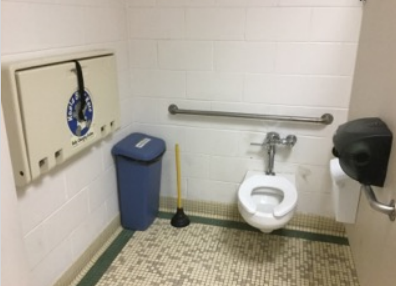
Non-compliant toilet paper dispenser	-	Relocate toilet paper so that it is 24" min. high, located under the grab bar, and between 7" and 9" from the front of the toilet.	1	256	\$256

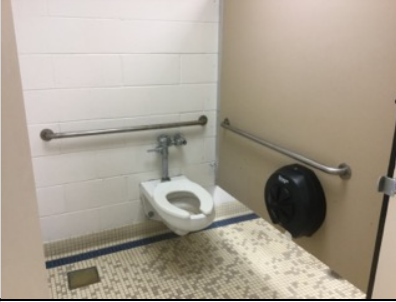
ID	Location	Floor	Room	Element	Type	Photo	Issues	Current Measure	Recommendations	Quantity	Price	Cost Estimation
99	Pool - Men's Locker Room	1		Toilet Compartment	Accessible Compartment

Clearance at toilet < 72" clear depth (MAAB)	68"	Provide a wheelchair accessible compartment that is 60" wide and 72" deep.	1	6182	\$6182
100	Pool - Women's Locker Room	1		Toilet Compartment	Accessible Compartment

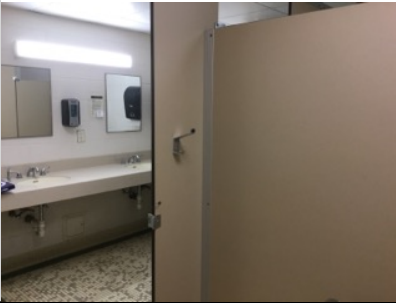
Coat hook > 48"	56"	Lower coat hook so that it is no higher than 48".	1	150	\$150
Urinal												
101	Men's/Boys' Toilet Room by Human Resources	1		Urinal	N/A

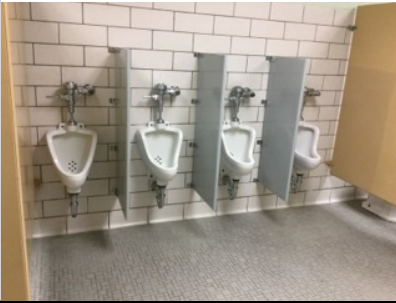
Rim > 17" high Clear floor space not provided at urinal	24.5" 29"	Provide at least one urinal with the rim no higher than 17" above the finished floor. Remove partition to provide a 30" min. by 48" min. clear floor space positioned for a forward approach.	1	3601	\$3601
102	All Gender Toilet Room by Locker Rooms (East Side)	1		Urinal	N/A

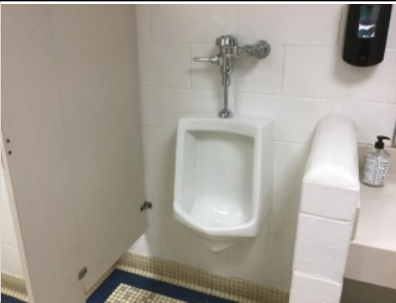
Rim > 17" high Flush control too high or not properly located	25" 51"	Provide at least one urinal with the rim no higher than 17" above the finished floor. Mount flush control at 44" max. above the finished floor.	1	3622	\$3622

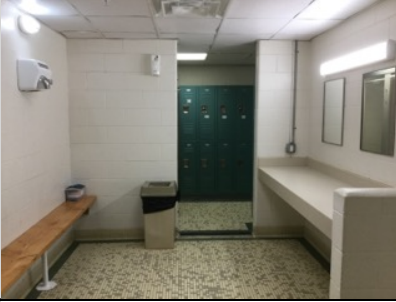
ID	Location	Floor	Room	Element	Type	Photo	Issues	Current Measure	Recommendations	Quantity	Price	Cost Estimation
104	Pool - Women's Locker Room	1		Dispensers	Hand Dryer

Controls > 42" high Clear floor space not provided at accessory	70" -	Relocate one hand dryer so the operable part is 42" max. above the finished floor and there is a 30" min. by 48" min. clear floor space.	1	256	\$256
105	All Gender Toilet Room by Locker Rooms (East Side)	1		Dispensers	Paper Towel Dispenser

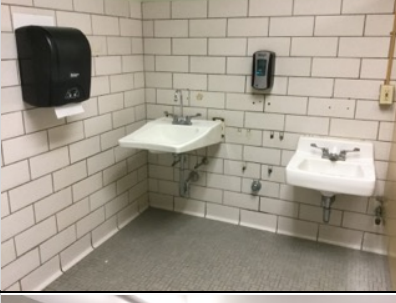
Controls > 42" high Dispenser acts as a protruding object	43.75" -	Relocate paper towel dispenser so the operable part is 42" max. above the finished floor, and out of the circulation path.	1	353	\$353

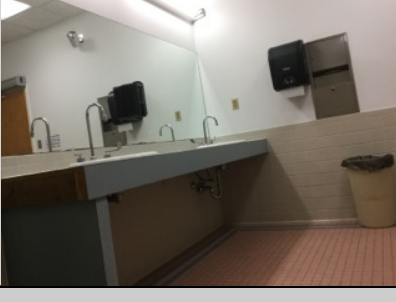
107	Senior Center, Women's Toilet Room	1		Dispensers	Paper Towel Dispenser

Controls > 42" high Dispenser acts as a protruding object	49" -	Relocate paper towel dispenser so the operable part is 42" max. above the finished floor, and out of the circulation path.	1	256	\$256
Shower Compartment												
108	Pool - Women's Showers	1		Shower Compartment	Transfer Type

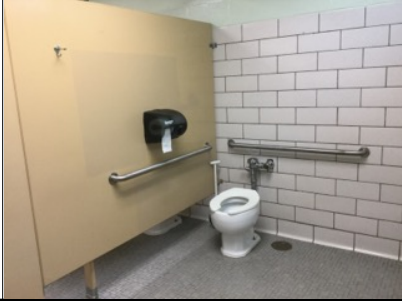
ID	Location	Floor	Room	Element	Type	Photo	Issues	Current Measure	Recommendations	Quantity	Price	Cost Estimation
Toilet Compartment (Children)												
109	Men's/Boys' Toilet Room by Human Resources	1		Toilet Compartment (Children)	Accessible Compartment

Flush control not on open side Non-compliant toilet paper dispenser	- -	Provide the flush control on the open side of the toilet (transfer side), no higher than 44". Relocate toilet paper dispenser so that it is between 14"- 19" above the floor and between 7"- 9" in front of the toilet. Ensure dispensers and other devices are not mounted above grab bars.	1	630	\$630
110	Women's/ Girls' Toilet Room by Human Resources	1	30	Toilet Compartment (Children)	Accessible Compartment

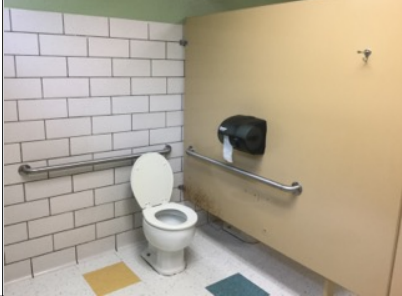
Non-compliant toilet paper dispenser Coat hook not within reach range	- 59.25"	Relocate toilet paper dispenser so that it is between 14"- 19" above the floor and between 7"- 9" in front of the toilet. Ensure dispensers and other devices are not mounted above grab bars. Lower hook so that it is no higher than 36" high for children ages 3-4.	1	406	\$406

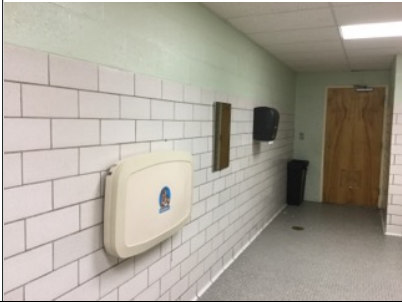
Dispensers (Children)												
111	Men's/Boys' Toilet Room by Human Resources	1		Dispensers (Children)	Paper Towel Dispenser

Dispenser controls > 42" high Dispenser is a protruding object	49.5" 9.5"	Relocate paper towel dispenser so the operable part is 42" max. above the finished floor, and out of the circulation path.	1	353	\$353
Additional Access												
Drinking Fountains												
112	Meeting Room by Pool	1		Drinking Fountains	Low

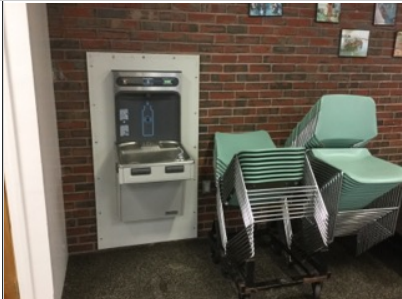
No drinking fountain provided for standing users	-	Provide an additional drinking fountain for standing users.	1	4028	\$4028

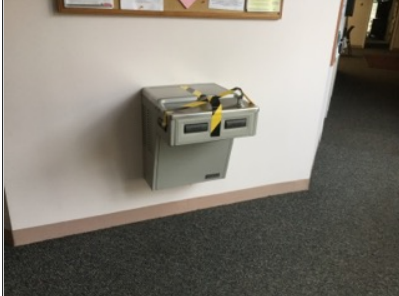
ID	Location	Floor	Room	Element	Type	Photo	Issues	Current Measure	Recommendations	Quantity	Price	Cost Estimation
113	Senior Center, Drinking Fountain Next to Toilet Rooms	1		Drinking Fountains	Low

No drinking fountain provided for standing users	-	Install a Hi-Lo drinking fountain.	1	4216	\$4216
114	Concession Stand	Ext.		Drinking Fountains	High

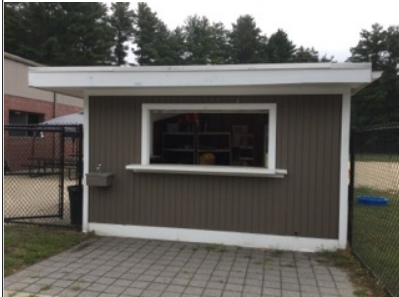
No drinking fountain provided for seated users	-	Provide an additional drinking fountain for seated users.	1	4028	\$4028
115	Drinking Fountain at Concession Stand (Interior of Fence)	Ext.		Drinking Fountains	High

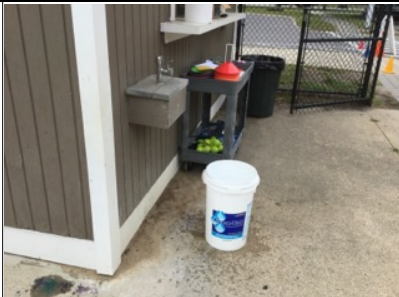
No drinking fountain provided for seated users Standing height fountain does not have cane protection	- -	Provide an additional drinking fountain for seated users. Provide a cane-detectable barrier skirt under the high unit.	1	4918	\$4918
Sink												
116	Teen Room	1		Sink	Kitchenette

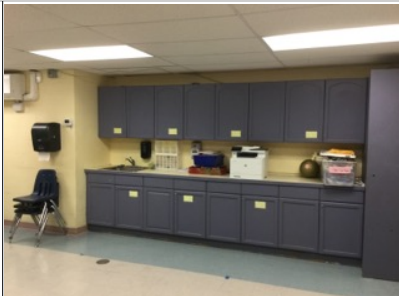
Toe and knee clearances not provided Rim or counter > 34"	- 36.5"	Ensure there is a 27" knee clearance positioned for a forward approach. Relocate sink with the front of the rim or counter no higher than 34".	1	4780	\$4780

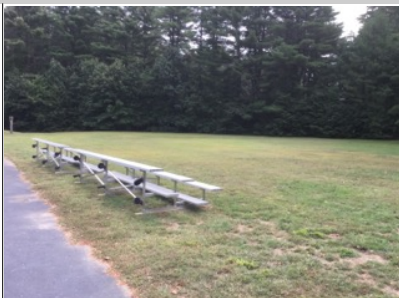
Play and Sport Areas												
Field												
117	Open Field	Ext.		Field	Soccer

Accessible spaces not provided at sidelines seating	-	Provide a 36" x 48" clear floor space at sidelines seating on each side of the bleachers. (Cost estimate for two 3' x 4' asphalt areas.)	2	120	\$240

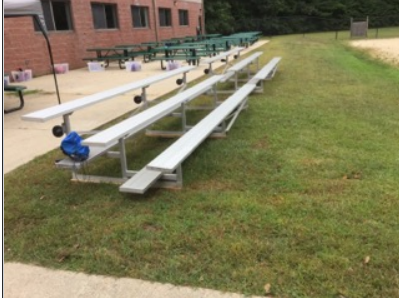
ID	Location	Floor	Room	Element	Type	Photo	Issues	Current Measure	Recommendations	Quantity	Price	Cost Estimation
Court												
118	Volleyball Court	Ext.		Court	Volleyball

Accessible spaces are not provided at sidelines seating	-	Provide a 36" x 48" clear floor space at sidelines seating on each side of the bleachers. (Cost estimate for two 3' x 4' concrete areas.)	2	192	\$384
119	Gaga Ball Court	Ext.		Court

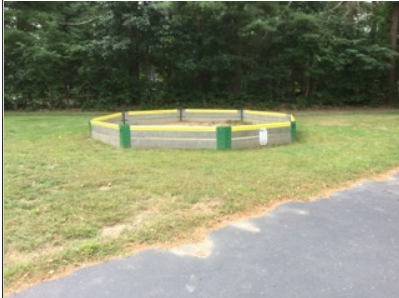
Court is not connected to an accessible route	-	Provide an accessible route to the court and an ADA compliant doorway to the court. (Cost estimate for a hinged doorway at court and 10' long 4' wide asphalt route to the court.)	1	750	\$750
Best Practice												
120	Pool - Main Entrance	1

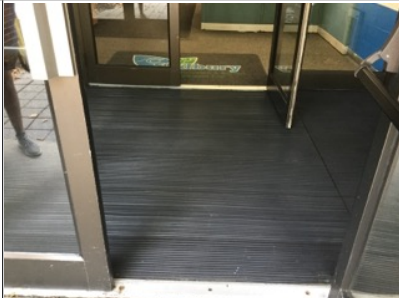
This is a good example of a recessed floor mat.	1	-	\$0
121	Pre-school Multipurpose Room	1
