Fairbank Community Center

Town of Sudbury ADA Transition Plan

December 2020

Institute for Human Centered Design

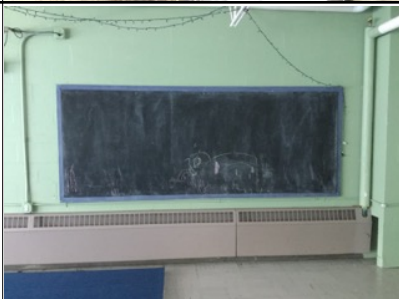
For children aged 3-4 under the ADA the recommendations for reach ranges are between 20" and 36" high, and this blackboard is located near the top of that reach range at 33" above the finished floor. Recommend providing a lower blackboard.	1	-	\$0

- For children aged 3-4 years under the ADA the recommendations for reach ranges are between 20" and 36" high, and the blackboard in the pre-school room is located near the top of that reach range at 33" above the finished floor. Recommend providing a lower blackboard.
- Recommend providing an adjustable height podium in the senior center.
- Recommend applying glass manifestation to the large expanse of clear glass by the entrance to the pool, in order to make the glass visible, preventing injury through collision.

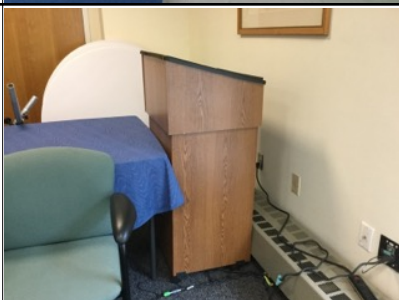
Recommend providing an adjustable height podium.	1	-	\$0

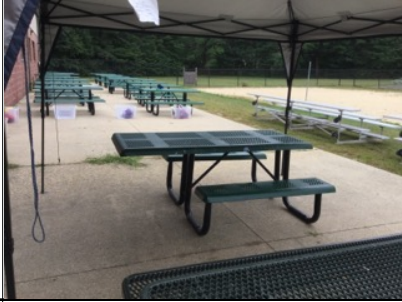
ID	Location	Floor	Room	Element	Type	Photo	Issues	Current Measure	Recommendations	Quantity	Price	Cost Estimation
123	Kids Summer Camp Picnic Area	Ext.

This is a good example of an accessible picnic table.	1	-	\$0
124	Pool - Main Entrance	Ext.

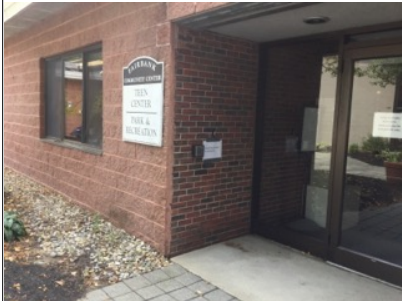
Recommend applying glass manifestation to large expanse of clear glass, in order to make the glass visible, preventing injury through collision.	1	-	\$0
