Fire Department Station 3

Town of Sudbury ADA Transition Plan

October 2020

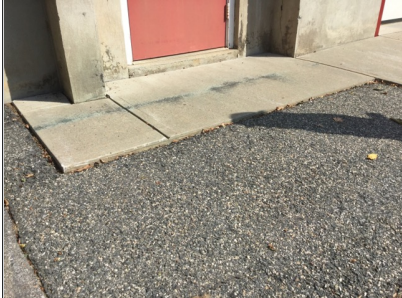
- There is a change in level greater than allowed on the exterior route to the main entrance.

Level changes > 1/4"	1"	Alter change in level to be 1/4" high max. (See ID #2 for cost.)	1	-	\$0
Entrance												
2	Main Entrance	Ext.		Entrance	Main Entrance

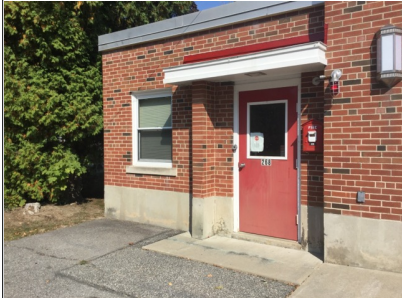
The main entrance door has a threshold that is greater than allowed and has door hardware that requires tight grasping, pinching, or twisting of the wrist.

Threshold > 1/2" high Hardware not operable with a closed fist	3" -	Alter threshold to be 1/2" high max. Provide hardware that can be operable with one hand and not require tight grasping, pinching, or twisting of the wrist. (Cost estimate is for compliant hardware and providing a level (2% slope max.) concrete 60" wide by 60" deep area at the door and a sloped walkway (max. slope of 8.33%) to the landing.)	1	1204	\$1204
Emergency Exit												
3	Main Entrance	1		Emergency Exit	N/A

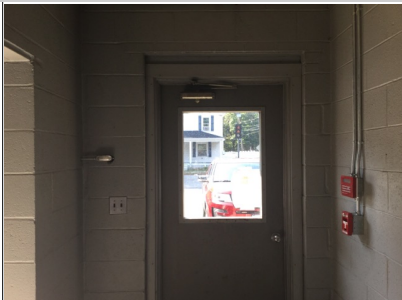
The main entrance is lacking signage with raised characters and braille on the latch side of the exit door. In addition, after the route is made compliant, signage with an illuminated International Symbol of Accessibility (ISA) should be added over the door.

Tactile sign not provided at exit Illuminated Int. Symbol of Acc. not provided (MAAB)	- -	Provide tactile exit signs with raised characters and braille at exit doors. Mount signs between 48"- 60" above the finished floor located on the latch side of the door. Provide an illuminated sign with the International Symbol of Accessibility.	1	1116	\$1116

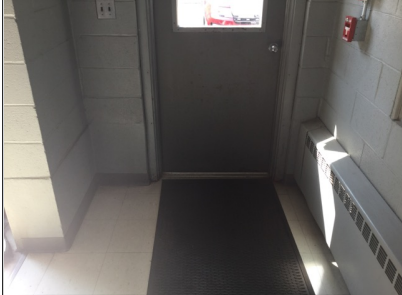
4	Main Entrance	1		Emergency Exit	N/A

The exit door that the public uses is lacking maneuvering clearance, and an automatic door opener is required. In addition, the mat by the door is not secured.

Maneuvering clearance(s) not provided Mat not securely attached	7" -	Provide an automatic door opener. Secure the mat.	1	3060 Labor	\$3060
