Haynes Elementary School

Town of Sudbury ADA Transition Plan

January 2021

Institute for Human Centered Design

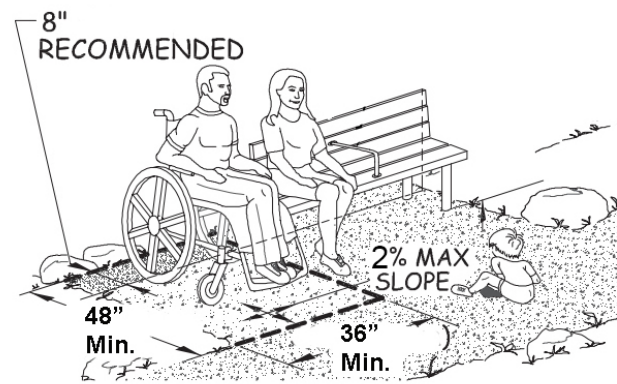
- Recommend providing a 36" x 48" space alongside one bench positioned so that a person using a wheelchair can sit shoulder to shoulder with someone seated on the bench. See following image:

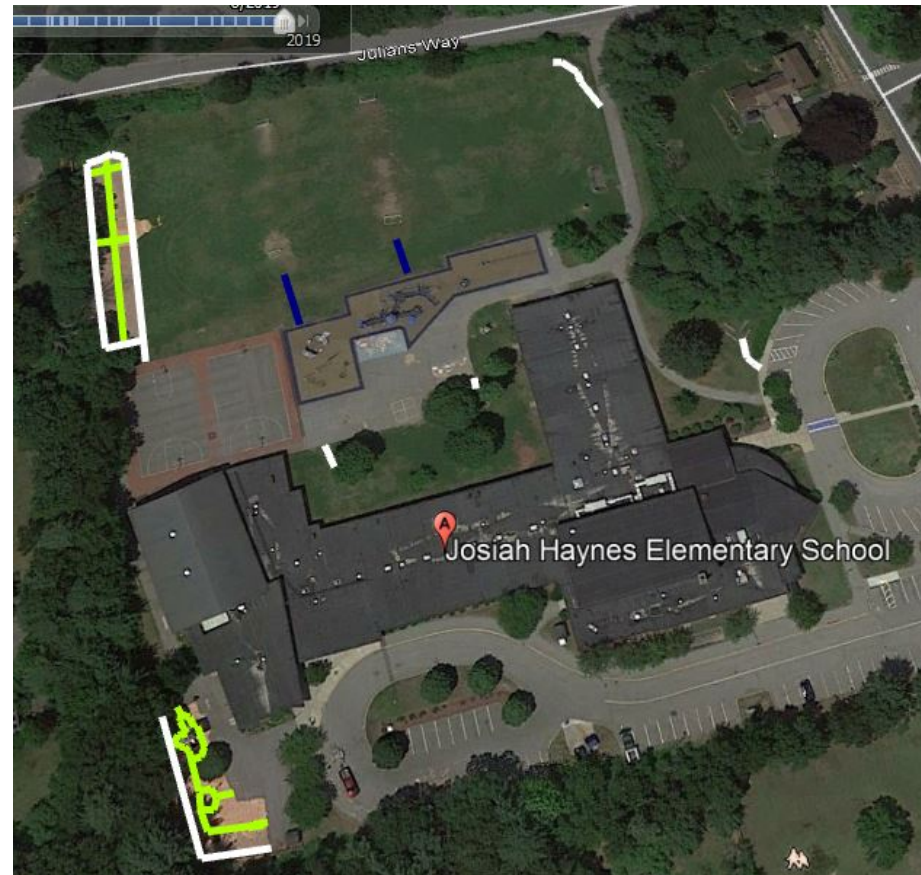
Figure 1: Lines in the following aerial view represent a recommended layout of exterior accessible routes that are required at Haynes Elementary School. White lines represent asphalt routes, yellow lines represent poured-in-place rubber routes within playgrounds and blue lines represent stone dust walkways to areas of sport activity.

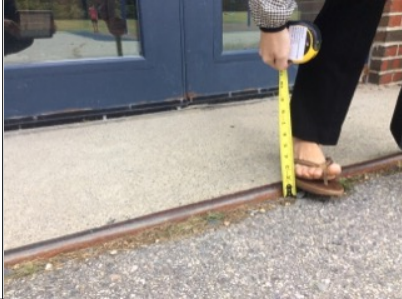
ID	Location	Floor	Room	Element	Type	Photo	Issues	Current Measure	Recommendations	Quantity	Price	Cost Estimation
Approach and Entrance												
Exterior Access Route												
1	Exit From Corridor by Rooms 22 and 23	Ext.		Exterior Access Route	Walkway

Surface openings > 1/2" Level changes > 1/4"	1.75" 1"	Alter change in level to be 1/4" high max. and ensure that surface openings are no greater than 1/2". (Cost estimate for asphalt.)	1	320	\$320
2	Walkway by Exit Door 3	Ext.		Exterior Access Route	Walkway

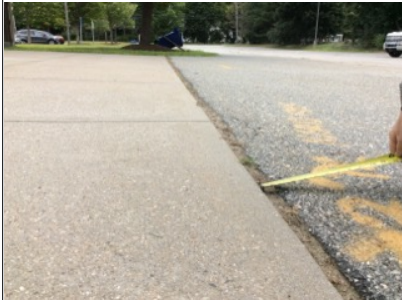
Surface openings > 1/2" Surface is not stable, firm, and slip-resistant	1.5" -	Repair gaps in surface.	1	160	\$160
3	Rear Southwest Parking Lot Accessible Parking Space	Ext.		Exterior Access Route	Sidewalk

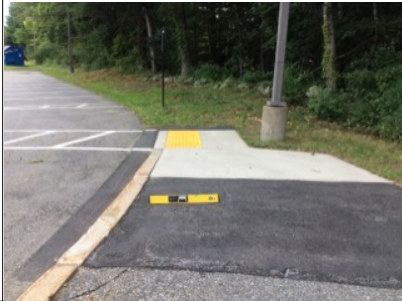
Cross slope > 1:50 (2.00%)	9.4%	Reduce cross slope to be no steeper than 1:50 (2.00%). (Cost for 10' long by 5' wide asphalt area.)	1	500	\$500
4	Walkway by Exit Door 6	Ext.		Exterior Access Route	Exterior

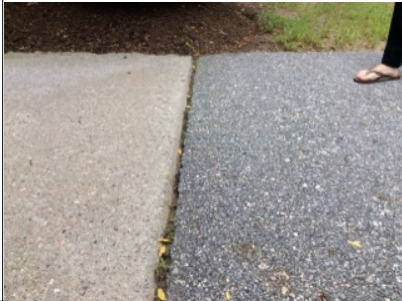
Level changes > 1/4"	-	Alter change in level to be 1/4" high max.	1	160	\$160

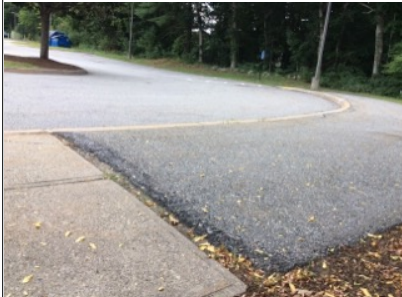
5	Sidewalk by Exit Door 9 to Accessible Parking Space in Rear Lot	Ext.		Exterior Access Route	Sidewalk

Level changes > 1/4"	1"	Alter change in level to be 1/4" high max. (Cost estimate for asphalt.)	1	160	\$160

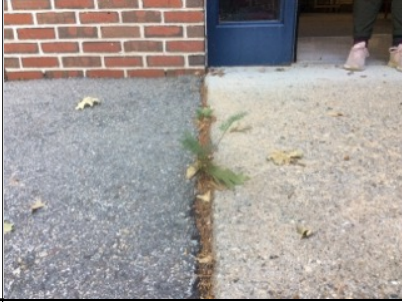
Surface is not stable, firm, and slip-resistant	-	Repair surface.	1	160	\$160
7	Walkway by Exit From Corridor by Rooms 22 and 23	Ext.		Exterior Access Route	Walkway

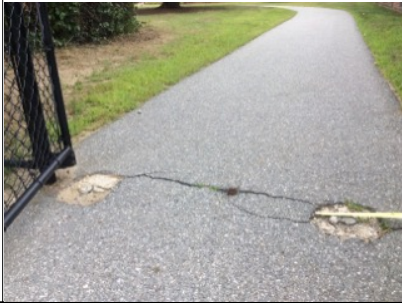
Surface is not stable, firm, and slip-resistant	-	Repair surface at gate.	1	160	\$160
8	Exit Door 10 From Partners Program (Grades 3-5)	Ext.	8	Exterior Access Route	Walkway

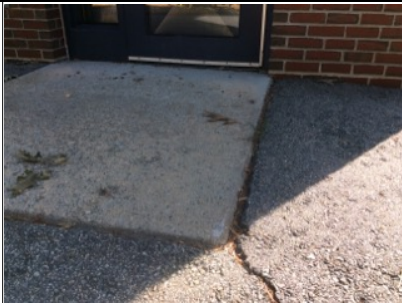
Surface is not stable, firm, and slip-resistant	-	Repair surface at transition between concrete and asphalt.	1	160	\$160
9	Bike Rack by Exit Door 3	Ext.		Exterior Access Route	Walkway

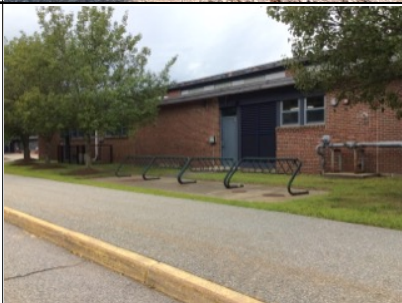
Accessible route not provided	-	Ensure an accessible route is provided to the bike rack. (Cost estimate for a 6' long 4' wide asphalt route.)	1	240	\$240
10	Picnic Table and Bench Area	Ext.		Exterior Access Route	Exterior

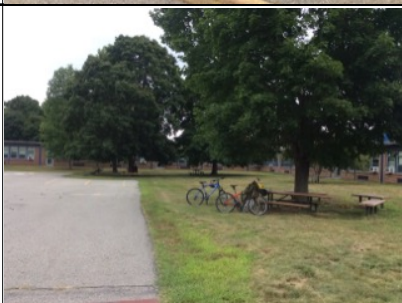
Accessible route not provided	-	Provide an accessible route to one picnic table and one bench in this area. (Cost estimate for 20' long 4' wide asphalt route.)	1	800	\$800

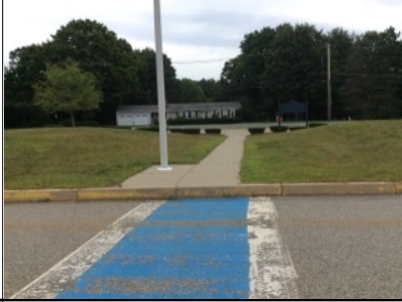
Curb ramp not provided	-	Provide a curb ramp at this intersection and at the end of the walkway on the east. (Cost estimate for a concrete curb ramp.)	2	2800	\$5600
12	Northeast Parking Lot	Ext.		Curb Ramp	N/A

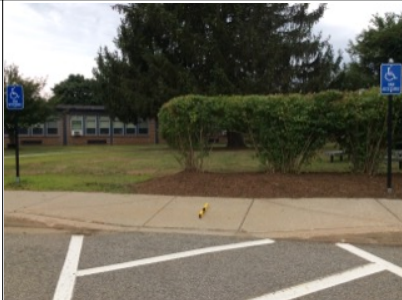
Landing not provided at top of curb ramp	-	Provide landing at top of curb ramp or reconfigure ramp. (Cost estimate for new concrete curb ramp.)	1	2800	\$2800
13	East Crosswalk by Main Entrance	Ext.		Curb Ramp	N/A

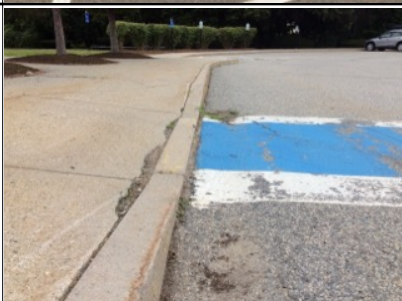
Surface not stable, firm and slip-resistant	-	Repair surface for gaps and changes in level.	1	144	\$144
14	Curb Ramp by Exit Door 6	Ext.		Curb Ramp	N/A

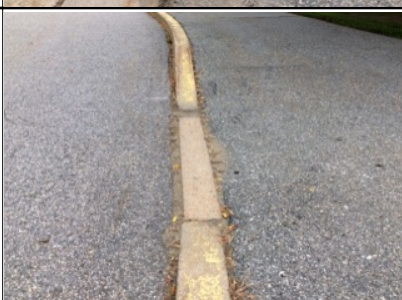
Surface not stable, firm and slip-resistant	2.25"	Repair surface for gaps and changes in level.	1	144	\$144
15	Curb Ramp by Exit Door 9	Ext.		Curb Ramp	N/A

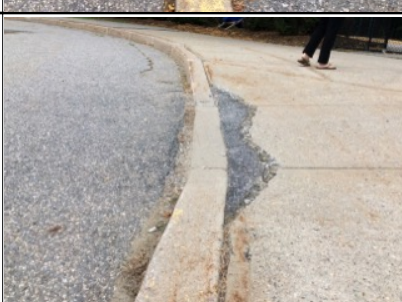
Surface not stable, firm and slip-resistant	-	Repair surface for gaps and changes in level.	1	144	\$144

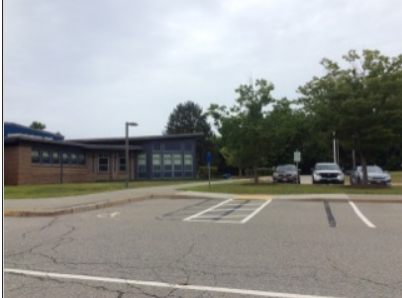
Total # of parking Total # of designated accessible parking spaces Total # of designated van accessible spaces Sign does not have the designation "Van Accessible" Sign bottom < 60" above finished grade	48 0 1 - 51.5"	Provide one additional car accessible parking space. Add the designation "Van Accessible" to the sign located at the van accessible space. Locate sign with the bottom of the sign 60" above the ground.	1	2350 Labor	\$2350
17	Rear Southwest Parking Lot Accessible Parking Space	Ext.		Off-Street Parking Lot or Garage	Visitor

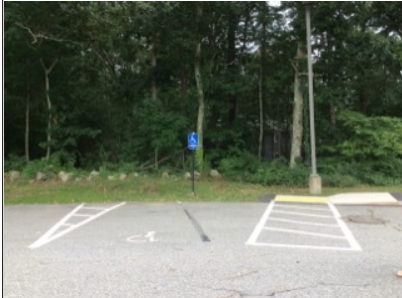
Total # of parking Total # of designated accessible parking spaces Total # of designated van accessible spaces Sign does not have the designation "Van Accessible"	18 1 0 -	Add the designation "Van Accessible" to the sign located at the accessible space.	1	500	\$500

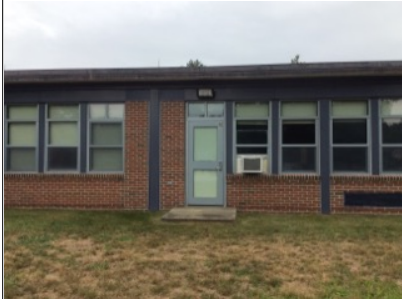
Emergency Exit												
18	Exit Door 16	Ext.		Emergency Exit

Recommend providing accessible routes from all exit doors.	1	-	\$0
19	Learning Center for Grades 4-5 Exit Door 17	1	15	Emergency Exit	N/A

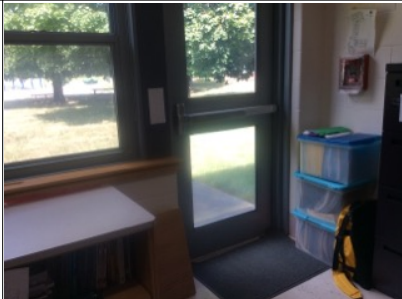
Tactile sign not provided at exit Directional sign to accessible emergency exit not provided	- -	Provide tactile exit signs with raised characters and braille at exit doors. Mount signs between 48"- 60" above the finished floor located on the latch side of the door. Provide a directional sign indicating the location of the nearest accessible emergency exit.	1	464	\$464
20	Exit Door 18	1	16	Emergency Exit	N/A

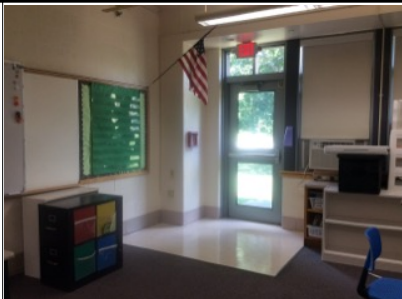
Tactile sign not provided at exit Directional sign to accessible emergency exit not provided	- -	Provide tactile exit signs with raised characters and braille at exit doors. Mount signs between 48"- 60" above the finished floor located on the latch side of the door. Provide a directional sign indicating the location of the nearest accessible emergency exit.	1	464	\$464

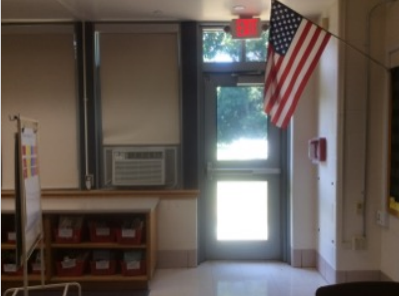
Tactile sign not provided at exit Directional sign to accessible emergency exit not provided	- -	Provide tactile exit signs with raised characters and braille at exit doors. Mount signs between 48"- 60" above the finished floor located on the latch side of the door. Provide a directional sign indicating the location of the nearest accessible emergency exit.	2	464	\$928
22	Exit Doors From Classrooms	1	21 22	Emergency Exit	N/A

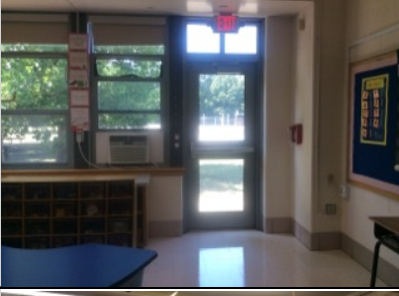
Tactile sign not provided at exit Directional sign to accessible emergency exit not provided	- -	Provide tactile exit signs with raised characters and braille at exit doors. Mount signs between 48"- 60" above the finished floor located on the latch side of the door. Provide a directional sign indicating the location of the nearest accessible emergency exit.	2	464	\$928

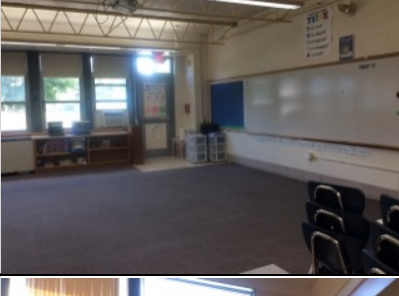
23	Grade 4 Exit Door 16	1	13	Emergency Exit	N/A

Tactile sign not provided at exit Directional sign to accessible emergency exit not provided Maneuvering clearance(s) not provided	- - -	Provide tactile exit signs with raised characters and braille at exit doors. Mount signs between 48"- 60" above the finished floor located on the latch side of the door. Provide a directional sign indicating the location of the nearest accessible emergency exit. Relocate the table that is blocking the door.	1	464 Labor	\$464
24	Front Lobby	1		Emergency Exit	N/A

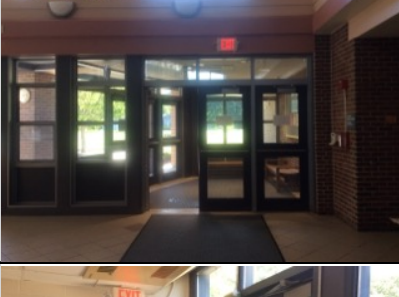
Tactile sign not provided at exit Illuminated Int. Symbol of Acc. not provided (MAAB)	- -	Provide tactile exit signs with raised characters and braille at exit doors. Mount signs between 48"- 60" above the finished floor located on the latch side of the door. Provide an illuminated sign with the International Symbol of Accessibility.	1	432	\$432

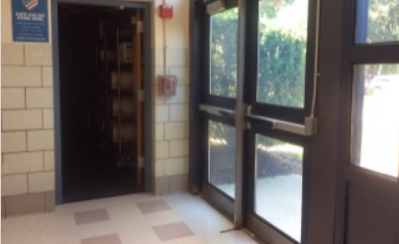
25	Exit Door 6 by ESL	1		Emergency Exit	N/A

Tactile sign not provided at exit Illuminated Int. Symbol of Acc. not provided (MAAB)	- -	Provide tactile exit signs with raised characters and braille at exit doors. Mount signs between 48"- 60" above the finished floor located on the latch side of the door. Provide an illuminated sign with the International Symbol of Accessibility.	1	432	\$432

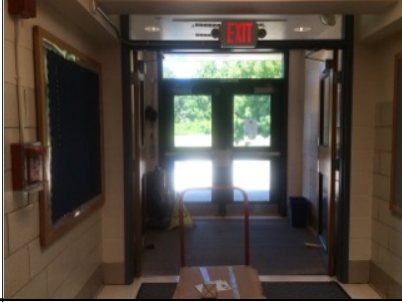
Tactile sign not provided at exit Illuminated Int. Symbol of Acc. not provided (MAAB)	- -	Provide tactile exit signs with raised characters and braille at exit doors. Mount signs between 48"- 60" above the finished floor located on the latch side of the door. Provide an illuminated sign with the International Symbol of Accessibility.	1	432	\$432
27	Exit Door 15 by Art Classroom	1		Emergency Exit	N/A

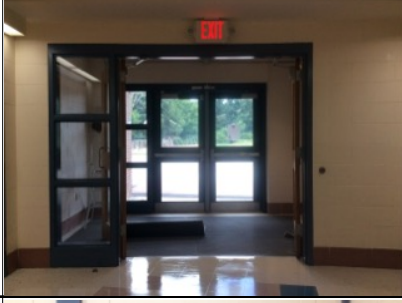
Tactile sign not provided at exit Illuminated Int. Symbol of Acc. not provided (MAAB)	- -	Provide tactile exit signs with raised characters and braille at exit doors. Mount signs between 48"- 60" above the finished floor located on the latch side of the door. Provide an illuminated sign with the International Symbol of Accessibility.	1	432	\$432

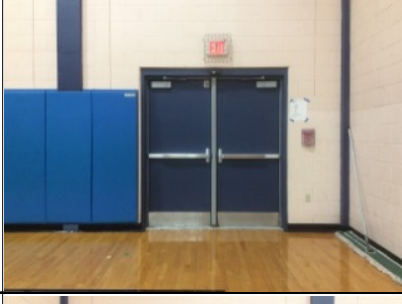
28	Exit Door 14 From Gym	1		Emergency Exit	N/A

Tactile sign not provided at exit Illuminated Int. Symbol of Acc. not provided (MAAB)	- -	Provide tactile exit signs with raised characters and braille at exit doors. Mount signs between 48"- 60" above the finished floor located on the latch side of the door. Provide an illuminated sign with the International Symbol of Accessibility.	1	432	\$432
29	Exit Door 13 From Gym	1		Emergency Exit	N/A

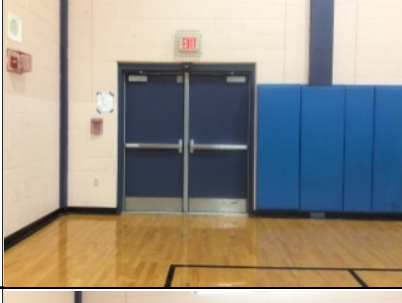
Tactile sign not provided at exit Illuminated Int. Symbol of Acc. not provided (MAAB)	- -	Provide tactile exit signs with raised characters and braille at exit doors. Mount signs between 48"- 60" above the finished floor located on the latch side of the door. Provide an illuminated sign with the International Symbol of Accessibility.	1	432	\$432
30	Exit Door 12 From Gym	1		Emergency Exit	N/A

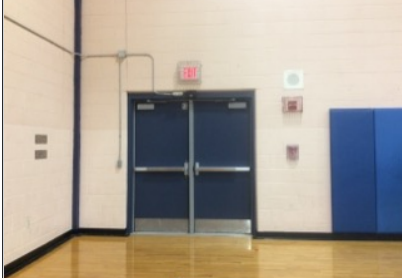
Tactile sign not provided at exit Illuminated Int. Symbol of Acc. not provided (MAAB)	- -	Provide tactile exit signs with raised characters and braille at exit doors. Mount signs between 48"- 60" above the finished floor located on the latch side of the door. Provide an illuminated sign with the International Symbol of Accessibility.	1	432	\$432

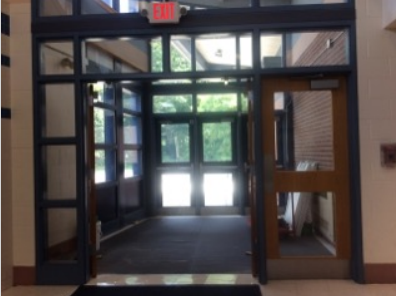
Tactile sign not provided at exit Illuminated Int. Symbol of Acc. not provided (MAAB)	- -	Provide tactile exit signs with raised characters and braille at exit doors. Mount signs between 48"- 60" above the finished floor located on the latch side of the door. Provide an illuminated sign with the International Symbol of Accessibility.	1	432	\$432
32	Exit Door 7	1	6	Emergency Exit	N/A

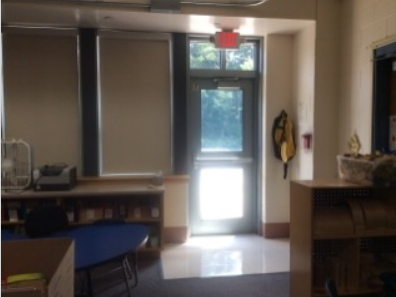
Tactile sign not provided at exit Illuminated Int. Symbol of Acc. not provided (MAAB)	- -	Provide tactile exit signs with raised characters and braille at exit doors. Mount signs between 48"- 60" above the finished floor located on the latch side of the door. Provide an illuminated sign with the International Symbol of Accessibility.	1	432	\$432
33	Exit Door 8	1	7	Emergency Exit	N/A

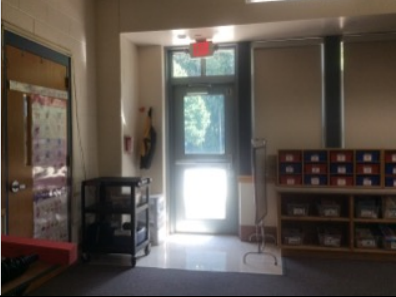
Tactile sign not provided at exit Illuminated Int. Symbol of Acc. not provided (MAAB)	- -	Provide tactile exit signs with raised characters and braille at exit doors. Mount signs between 48"- 60" above the finished floor located on the latch side of the door. Provide an illuminated sign with the International Symbol of Accessibility.	1	432	\$432

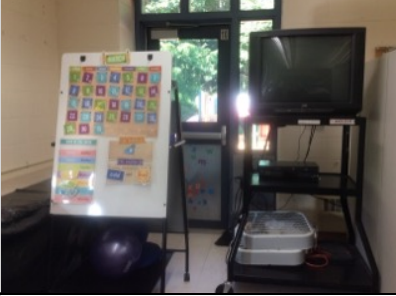
34	Partners Program (Grades 3-5) Egress Door 10	1	8	Emergency Exit	N/A

Tactile sign not provided at exit Illuminated Int. Symbol of Acc. not provided (MAAB)	- -	Provide tactile exit signs with raised characters and braille at exit doors. Mount signs between 48"- 60" above the finished floor located on the latch side of the door. Provide an illuminated sign with the International Symbol of Accessibility.	1	432	\$432
35	Partners Program (Grades K-2) Exit Door 11	1	9	Emergency Exit	N/A

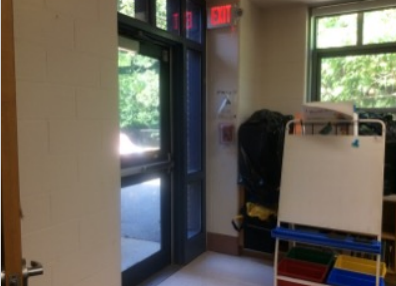
Tactile sign not provided at exit Illuminated Int. Symbol of Acc. not provided (MAAB) Maneuvering clearance(s) not provided	- - -	Provide tactile exit signs with raised characters and braille at exit doors. Mount signs between 48"- 60" above the finished floor located on the latch side of the door. Provide an illuminated sign with the International Symbol of Accessibility. Relocate furniture.	1	432 Labor	\$432

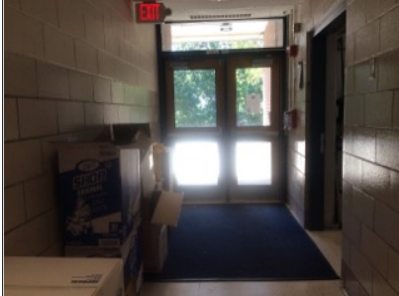
Tactile sign not provided at exit Illuminated Int. Symbol of Acc. not provided (MAAB) Mat not securely attached	- - -	Provide tactile exit signs with raised characters and braille at exit doors. Mount signs between 48"- 60" above the finished floor located on the latch side of the door. Provide an illuminated sign with the International Symbol of Accessibility. Secure the mat.	1	432 Labor	\$432
37	Partners Program (Grades 3-5) Egress Door 10	1	8	Emergency Exit	N/A

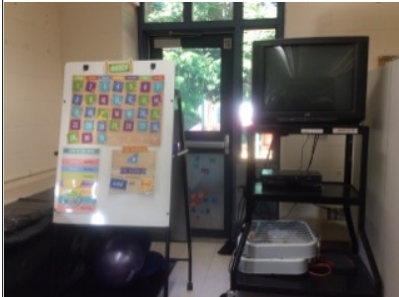
Maneuvering clearance(s) not provided	-	Relocate furniture that blocks access to the emergency exit.	1	Labor	\$0
Access to Goods and Services												
Interior Access Route												
38	Library	1		Interior Access Route	N/A

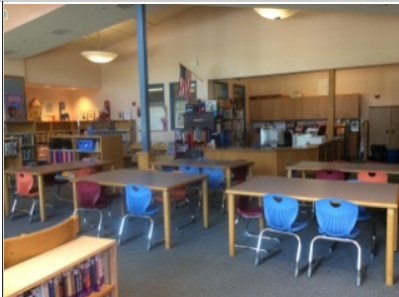
Route < 36" wide	24.5"	Ensure that a clear width of 36" min. is maintained at the accessible route. Note: Route can narrow to 32" for 24" of depth.	1	Labor	\$0

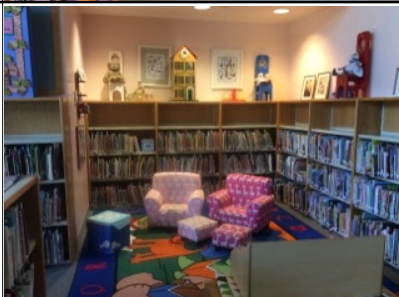
39	Library	1		Interior Access Route	N/A

Route < 36" wide	24"	Ensure that a clear width of 36" min. is maintained at the accessible route. Note: Route can narrow to 32" for 24" of depth.	1	Labor	\$0
40	Library	1		Interior Access Route	N/A

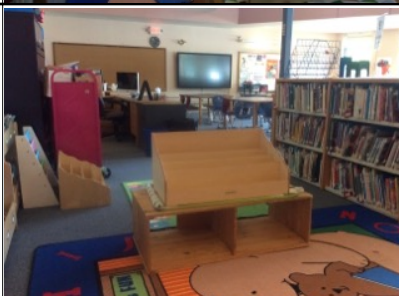
Route < 36" wide	30"	Ensure that a clear width of 36" min. is maintained at the accessible route. Note: Route can narrow to 32" for 24" of depth.	1	Labor	\$0

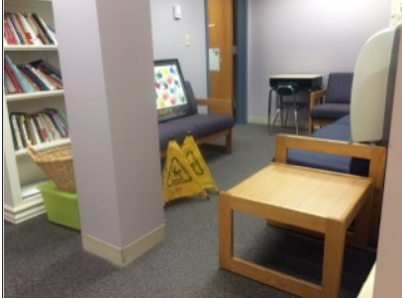
Route < 36" wide	18"	Ensure that a clear width of 36" min. is maintained at the accessible route. Note: Route can narrow to 32" for 24" of depth.	1	Labor	\$0
42	Speech Language & Counseling Waiting Area	1		Interior Access Route	N/A

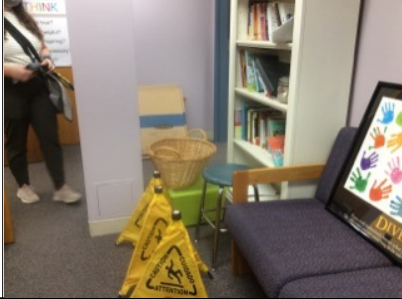
Route < 36" wide	27.25"	Ensure that a clear width of 36" min. is maintained at the accessible route. Note: Route can narrow to 32" for 24" of depth.	1	Labor	\$0
43	Partners Program (Grades 3-5)	1	8	Interior Access Route	N/A

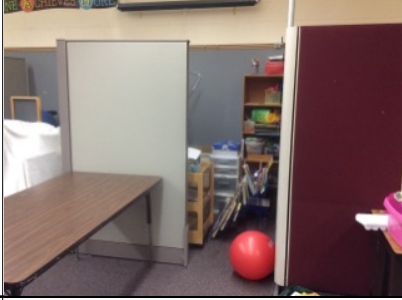
Route < 36" wide	27"	Ensure that a clear width of 36" min. is maintained at the accessible route. Route is able to narrow to 32" for 24" min. deep.	1	Labor	\$0
44	Girls' Toilet Room Across From Auditorium	1		Interior Access Route	N/A

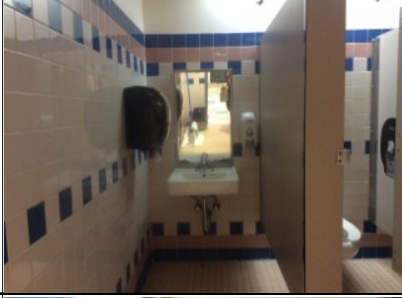
Route < 36" wide Obstructed by protruding objects	25.75" 10"	Ensure that a clear width of 36" min. is maintained at the accessible route. Relocate paper towel dispenser so that it does not obstruct the clear width and does not act as a protruding object.	1	353	\$353

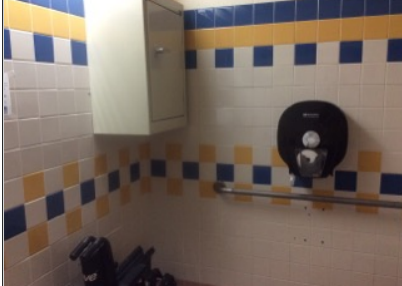
45	Health Office Toilet Room	1		Interior Access Route	N/A

Obstructed by protruding objects	12"	Relocate white storage box. It acts as a protruding object and projects into the clear space required at the toilet.	1	353	\$353

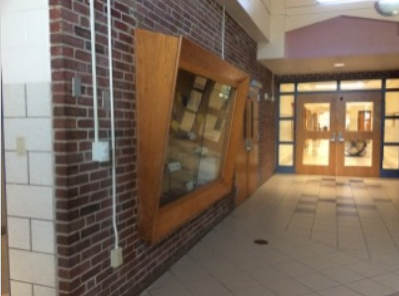
Obstructed by protruding objects	17"	Provide a cane-detectable barrier along each side.	2	306	\$612
47	Auditorium/ Cafeteria	1		Interior Access Route	N/A

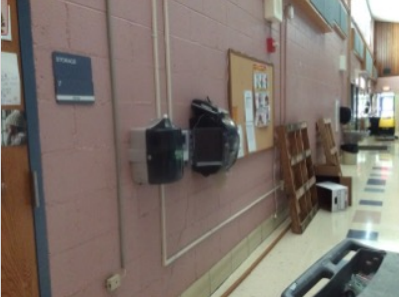
Obstructed by protruding objects	8"	Relocate paper towel dispenser and cleansing wipe dispenser out of the circulation path.	2	256	\$512
48	Grade 2 Grade 1	1	19 21	Interior Access Route	614

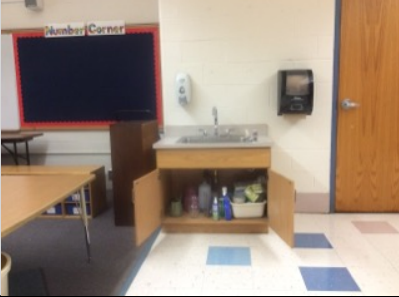
Obstructed by protruding objects	9"	Relocate paper towel dispensers out of the circulation path.	2	256	\$512
49	Library	1		Interior Access Route	N/A	 	Surface not stable, firm, and slip-resistant	-	Secure the mat.	1	Labor	\$0
50	Library	1		Interior Access Route	N/A	 	Surface not stable, firm, and slip-resistant	-	Secure the mat.	1	Labor	\$0

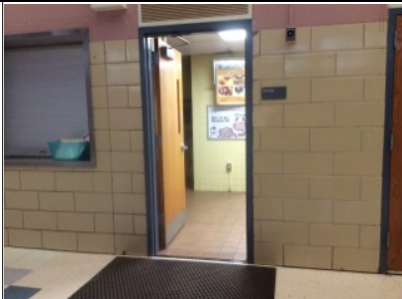
Surface not stable, firm, and slip-resistant	-	Secure the mat.	1	Labor	\$0
53	Kitchen	1		Interior Access Route	N/A

Surface not stable, firm, and slip-resistant	-	Secure the mat.	1	Labor	\$0
54	Women's Toilet Room	1		Interior Access Route	N/A

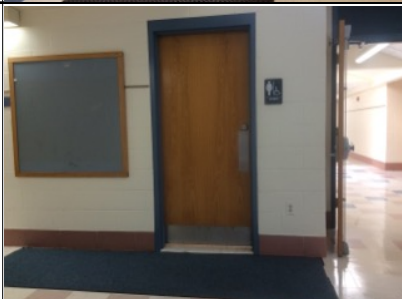
Surface not stable, firm, and slip-resistant	-	Secure the mat.	1	Labor	\$0
55	Men's Toilet Room	1		Interior Access Route	N/A

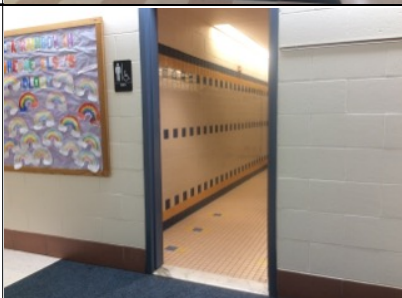
Surface not stable, firm, and slip-resistant	-	Secure the mat.	1	Labor	\$0

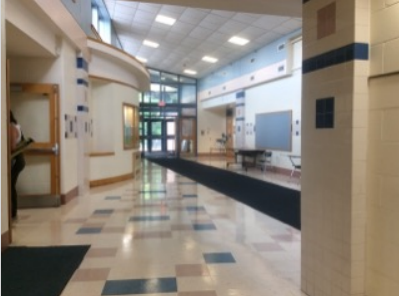
Surface not stable, firm, and slip-resistant	-	Secure the mat.	1	Labor	\$0
57	Grade 1	1	21	Interior Access Route	N/A

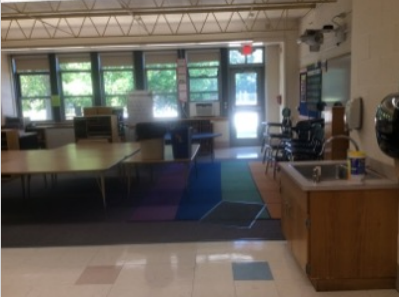
Surface not stable, firm, and slip-resistant	-	Secure rainbow colored mat.	1	Labor	\$0
58	Spanish	1	23	Interior Access Route	N/A

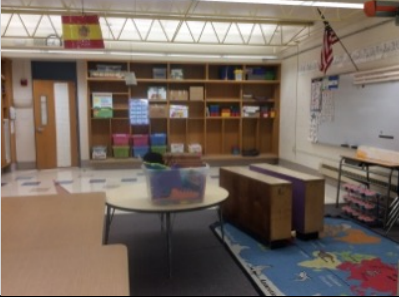
Surface not stable, firm, and slip-resistant	-	Secure the carpet with the map on it.	1	Labor	\$0
59	Corridor by Spanish	1	23	Interior Access Route	N/A

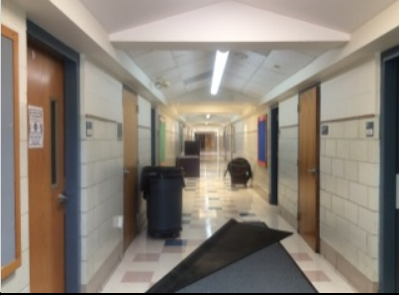
Surface not stable, firm, and slip-resistant	-	Secure the mat.	1	Labor	\$0
60	Kindergarten	1	6	Interior Access Route	N/A

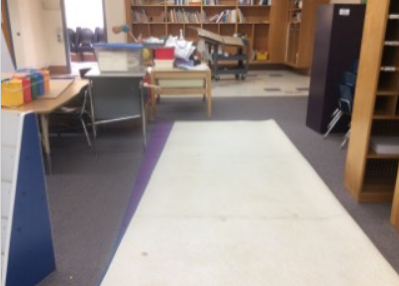
Surface not stable, firm, and slip-resistant	-	Secure the mat.	1	Labor	\$0

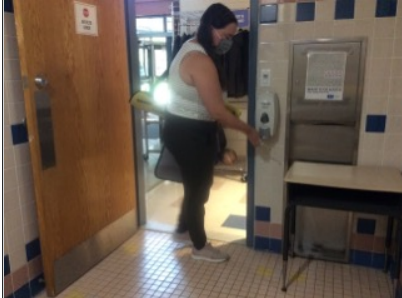
Maneuvering clearance(s) not provided	12"	Relocate desk.	1	Labor	\$0
62	ESL/LLI	1		Doors, Doorways, & Gates	Classroom

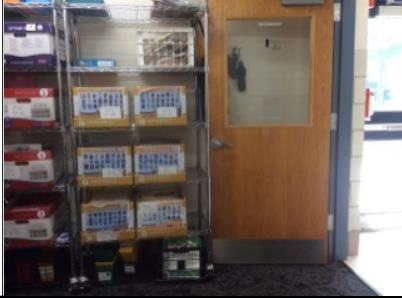
Maneuvering clearance(s) not provided	42"	Relocate shelving unit that is by the door.	1	Labor	\$0
63	Speech Language & Counseling	1		Doors, Doorways, & Gates	Classroom

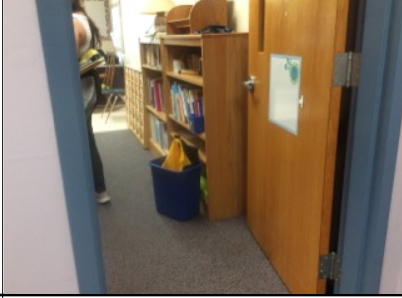
Maneuvering clearance(s) not provided		Relocate bookshelf to provide 60" min deep clear at door.	1	Labor	\$0
64	Speech Language & Counseling Waiting Room	1		Doors, Doorways, & Gates	Classroom

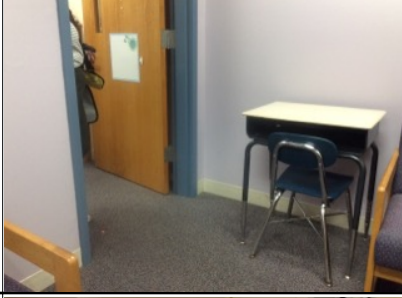
Maneuvering clearance(s) not provided	30.5"	Relocate desk to provide maneuvering clearance at door.	1	Labor	\$0
65	Partners Program (Grades 3-5) Classroom Door	1	8	Doors, Doorways, & Gates	Classroom

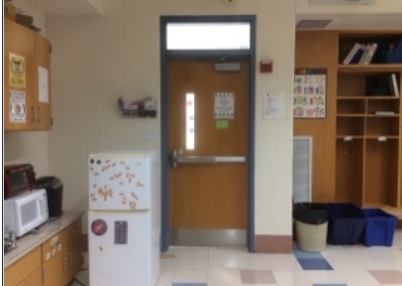
Maneuvering clearance(s) not provided	-	Relocate fridge.	1	Labor	\$0

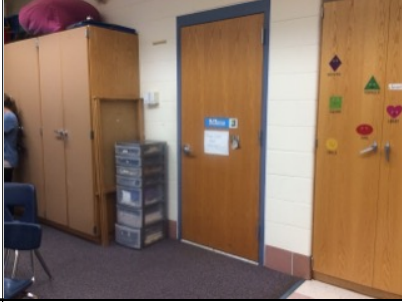
Maneuvering clearance(s) not provided	9"	Relocate storage boxes.	1	Labor	\$0
67	Psychologist Office Exit to Corridor	1		Doors, Doorways, & Gates	Office

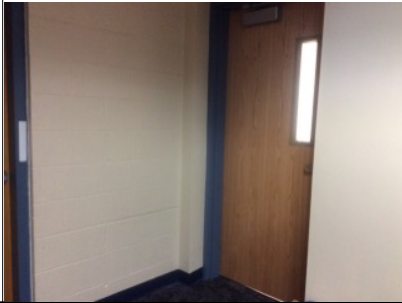
Maneuvering clearance not provided at recess > 6"	8.5"	Install an automatic door opener.	1	3060	\$3060
Stairways												
68	Library	1		Stairways	Other

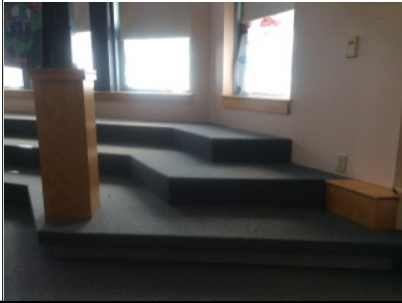
Handrail not provided on both sides	-	Provide handrails on both sides.	1	1320	\$1320
69	Auditorium/ Cafeteria	1		Stairways	Other

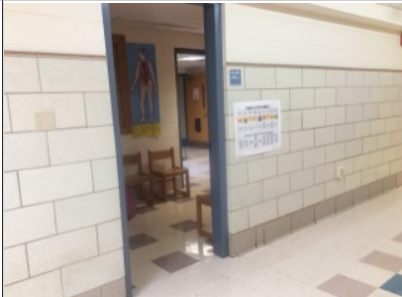
Raised characters not provided on sign Braille not provided on sign	- -	Provide text with raised characters duplicated in braille on sign.	1	232	\$232

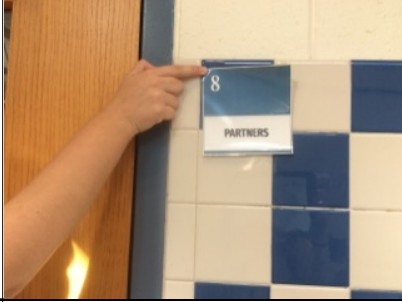
Raised characters not provided on sign Braille not provided on sign	- -	Provide text with raised characters duplicated in braille on sign.	1	232	\$232
72	Principal's Office	1		Signage	Designation

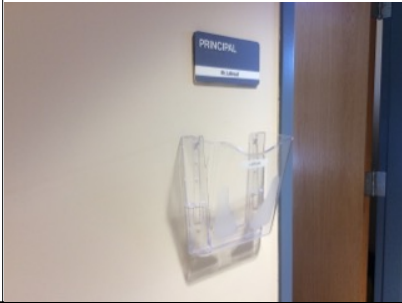
Sign lacks 18" min. by 18" min. clear floor space	-	Relocate folder storage.	1	Labor	\$0
Dining or Work Surfaces												
73	Principal's Office	1		Dining or Work Surfaces	Work Surface

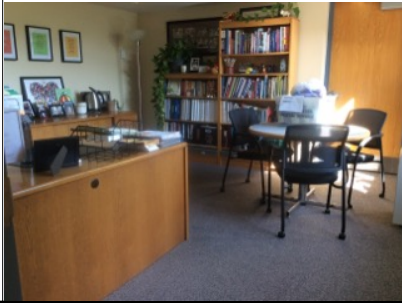
Knee or toe clearance not provided	-	Provide at least 1 work surface with 27" min. knee and toe clearance. Table lacks toe clearance.	1	700	\$700
74	Vice Principal's Office	1		Dining or Work Surfaces	Work Surface

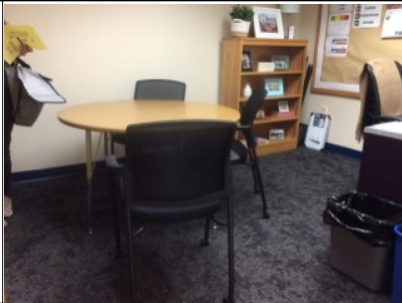
Knee or toe clearance not provided	23" wide	Provide at least 1 work surface with 27" min. knee and toe clearance that is 30" wide, min.	1	700	\$700

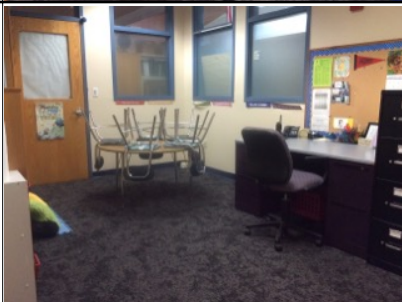
75	Psychologist Office	1		Dining or Work Surfaces	Work Surface

Knee or toe clearance not provided	23" wide	Provide at least 1 work surface that has a clear width of 30" min. and a clear height of 24" min.	1	700	\$700

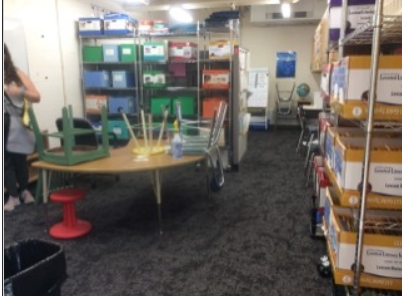
Knee or toe clearance not provided	22.5"	Ensure that 1 work surface is adjusted to provide 24" min. knee and toe clearance.	1	Labor	\$0
77	Speech Language & Counseling	1		Dining or Work Surfaces	Work Surface

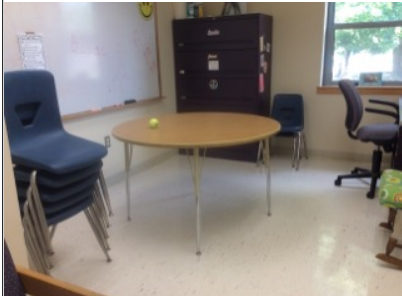
Knee or toe clearance not provided	23" wide	Provide at least 1 work surface with 27" min. knee and toe clearance that is 30" wide min.	1	700	\$700
78	OT/PT	1		Dining or Work Surfaces	Work Surface

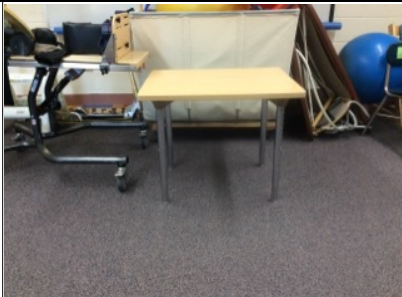
Knee or toe clearance not provided	21" wide	Provide at least 1 work surface with 24" high min. knee and toe clearance that is 30" wide min.	1	200	\$200
79	Grade 2	1	19	Dining or Work Surfaces	Work Surface

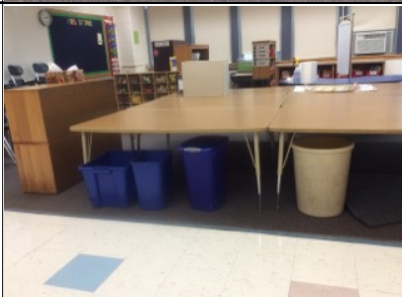
Knee or toe clearance not provided	22.75"	Ensure that 1 work surface is adjusted to provide 24" high min. knee and toe clearance.	1	Labor	\$0

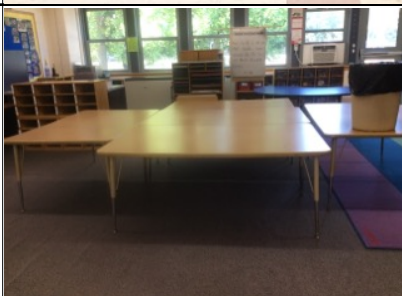
80	Grade 1	1	21	Dining or Work Surfaces	Work Surface

Knee or toe clearance not provided	22.75"	Ensure that 1 work surface is adjusted to provide 24" high min. knee and toe clearance.	1	Labor	\$0

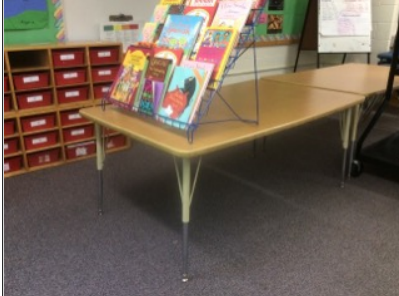
Knee or toe clearance not provided	23.5"	Ensure that 1 work surface is adjusted to provide 24" high min. knee and toe clearance.	1	Labor	\$0
82	Learning Center for K-3	1	27	Dining or Work Surfaces	Work Surface

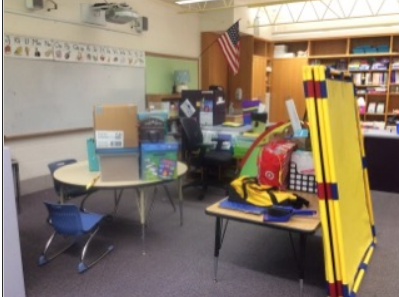
Knee or toe clearance not provided	21" wide	Provide at least 1 work surface with knee clearance that is 30" wide min.	1	200	\$200
83	Learning Center for K-3	1	27	Dining or Work Surfaces	Work Surface

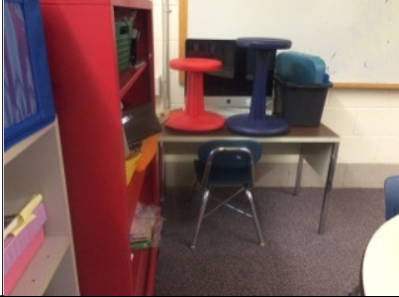
Knee or toe clearance not provided	22"	Provide at least 1 dining or work surface with 24" high min. knee and toe clearance.	1	200	\$200
84	Kindergarten	1	6	Dining or Work Surfaces	Work Surface

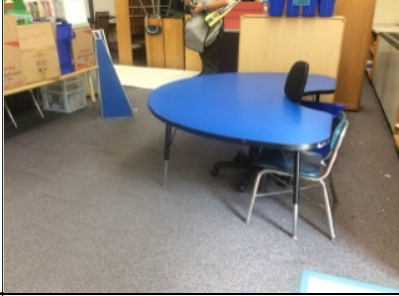
Knee or toe clearance not provided	20"	Ensure that 1 work surface is adjusted to provide 24" high min. knee and toe clearance.	1	Labor	\$0

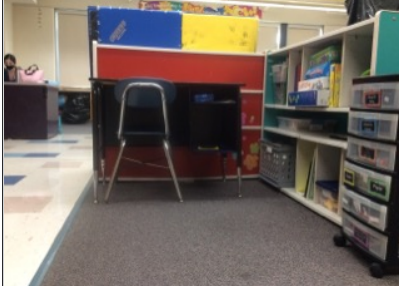
85	Partners Program (Grades 3-5)	1	8	Dining or Work Surfaces	Work Surface

Knee or toe clearance not provided	20" wide	Provide at least 1 work surface with 24" high min. knee and toe clearance that is 30" wide min.	1	200	\$200

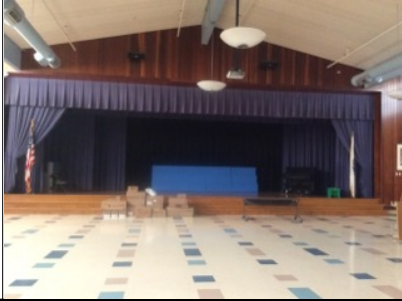
Assistive listening devices not provided	-	If audible communication is integral to the use of the space, provide an assistive listening system. (Cost estimate for 600 people.)	1	6250	\$6250
Picnic Tables												
87	Picnic Table and Bench Area	Ext.		Picnic Tables	N/A

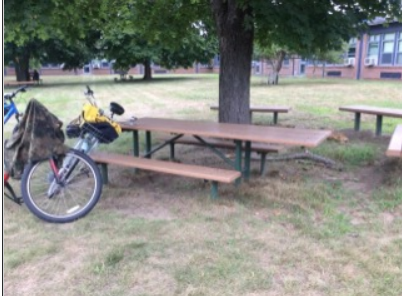
Toe or knee clearance at tables not provided	- 21.5"	Provide at least 1 dining surface (or ensure that 5% of dining surfaces) have toe and knee clearance.	1	1400	\$1400
88	Picnic Table with Chess Board	Ext.		Picnic Tables	N/A

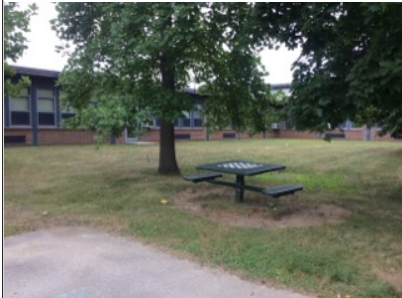
Picnic table not on an accessible route	-	Ensure that the accessible picnic table is connected to an accessible route. (Cost estimate for a 6' long by 4' wide asphalt route.)	1	240	\$240
Exterior Benches

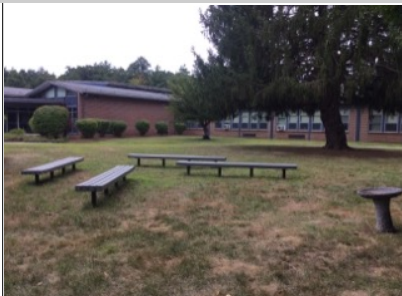
89	Seating Area by Birdbath on Northeast Side by the Main Entrance	Ext.		Exterior Benches	N/A

No accessible route to one bench in area	-	Provide an accessible route to one bench in this area. (Cost estimate for 30' long, 4' wide asphalt route.)	1	1200	\$1200
Toilet & Bathing Rooms

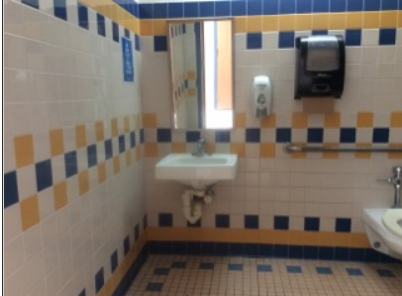
Toe or knee clearances not provided	23"	Provide at least one lavatory with knee and toe clearance positioned for a forward approach. As the rest of this toilet room is built to adult dimensions, 27" min. knee clearance is recommended at the lavatory.	1	1686	\$1686
91	Kindergarten Toilet Room	1	6	Lavatory	N/A

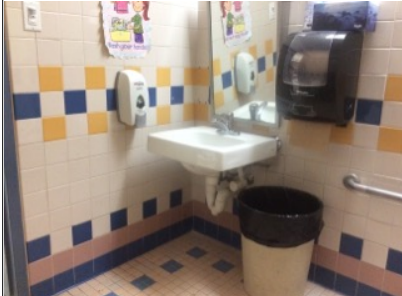
Toe or knee clearances not provided	21.5"	Provide at least one lavatory with knee and toe clearance positioned for a forward approach.	1	1686	\$1686
92	Men's Toilet Room	1		Lavatory	N/A

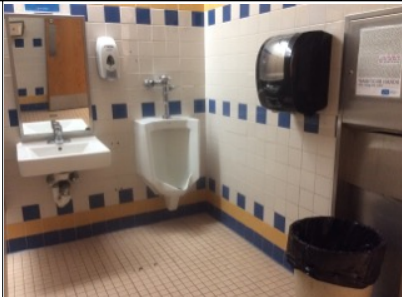
Plumbing underneath is exposed	-	Insulate or otherwise configure pipes to prevent contact for at least one lavatory.	1	92	\$92
Single-User Toilet												
93	Accessible Toilet Room	1		Single-User Toilet	N/A

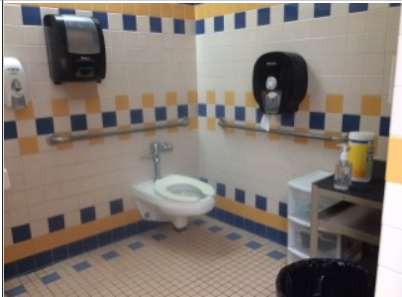
Clearance at toilet < 72" clear depth Toilet paper dispenser is not compliant Paper towel mounted over grab bar	- -	Relocate shelving and storage. Relocate toilet paper so that it is 24" min. high, located under the grab bar, and between 7" and 9" from the front of the toilet. Relocate the paper towel dispenser so that it is not mounted above the grab bar.	2	353	\$706

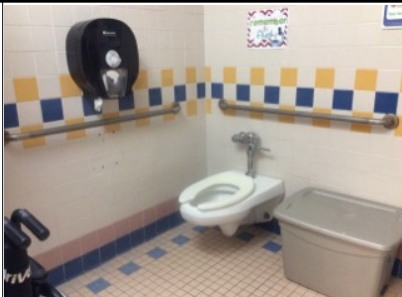
94	Health Office Toilet Room	1		Single-User Toilet	N/A

Toilet paper dispenser is not compliant Clearance at toilet < 60" clear width	- -	Relocate storage bin. Relocate toilet paper so that it is 24" min. high, located under the grab bar, and between 7" and 9" from the front of the toilet.	1	353	\$353

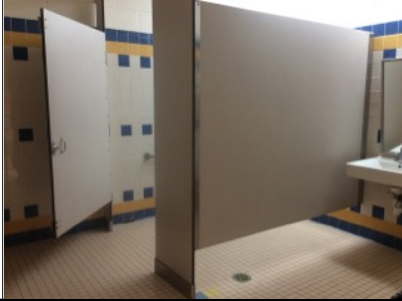
Door has malfunctioning self-closing hinge	-	Repair hinge.	1	Labor	\$0
Dispensers												
96	Health Office Toilet Room	1		Dispensers	Paper Towel Dispenser

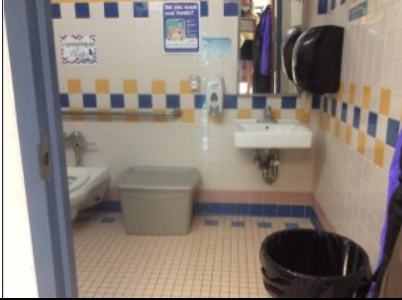
Dispenser acts as a protruding object	9"	Relocate dispenser out of the circulation path.	1	353	\$353
97	Women's Toilet Room by Lobby and Library and Men's Toilet Room	1		Dispensers	Paper Towel Dispenser

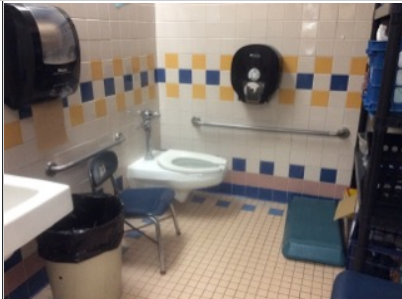
Clearance at toilet < 72" clear deep	-	Relocate stored items so that there is 72" clear deep at the toilet.	1	Labor	\$0

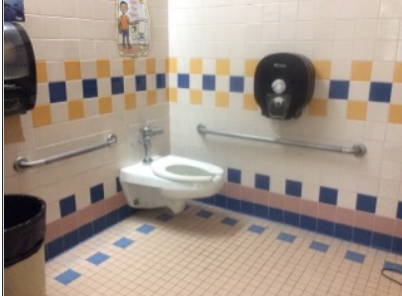
Non-compliant toilet paper dispenser	-	Relocate toilet paper dispenser so that it is between 14"- 19" above the floor and between 7"- 9" in front of the toilet. Ensure dispensers and other devices are not mounted above grab bars.	1	353	\$353
100	Health Office Toilet Room	1		Single-User Toilet (Children)	N/A

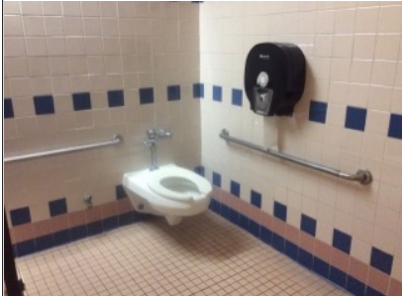
Non-compliant toilet paper dispenser	-	Relocate toilet paper dispenser so that it is between 14"- 19" above the floor and between 7"- 9" in front of the toilet. Ensure dispensers and other devices are not mounted above grab bars.	1	353	\$353

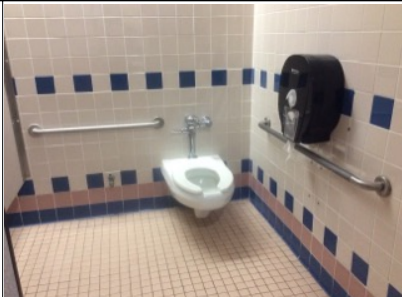
102	Women's Toilet Room by Lobby and Library	1		Toilet Compartment (Children)	Accessible Compartment

Non-compliant toilet paper dispenser Coat hook not within reach range	- 51"	Relocate toilet paper dispenser so that it is between 14"- 19" above the floor and between 7"- 9" in front of the toilet. Ensure dispensers and other devices are not mounted above grab bars. Lower hook so that it is no higher than 44" for children ages 9-12. The other dimensions in the toilet room are built for this age range.	1	503	\$503
103	Men's Toilet Room	1		Toilet Compartment (Children)	Accessible Compartment

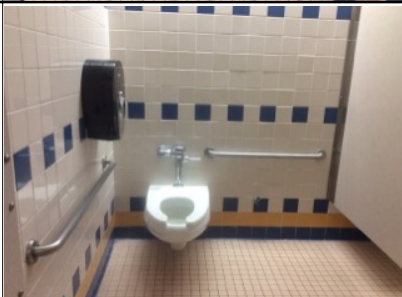
Non-compliant toilet paper dispenser Coat hook not within reach range	- 49"	Relocate toilet paper dispenser so that it is between 14"- 19" above the floor and between 7"- 9" in front of the toilet. Ensure dispensers and other devices are not mounted above grab bars. Lower hook so that it is no higher than 44" for children ages 9-12. The other dimensions in the toilet room are built for this age range.	1	503	\$503

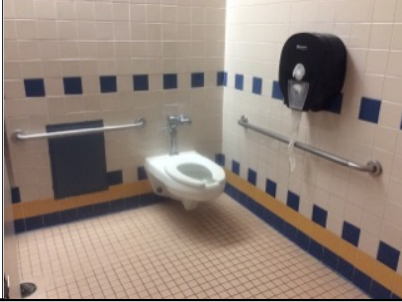
Non-compliant toilet paper dispenser Coat hook not within reach range	- 50"	Relocate toilet paper dispenser so that it is between 14"- 19" above the floor and between 7"- 9" in front of the toilet. Ensure dispensers and other devices are not mounted above grab bars. Lower hook so that it is no higher than 44" for children ages 9-12. The rest of the dimensions in this toilet room are for this age group.	1	503	\$503
Lavatory (Children)												
105	Partners Program (Grades 3-5) Toilet Room	1	8	Lavatory (Children)	N/A

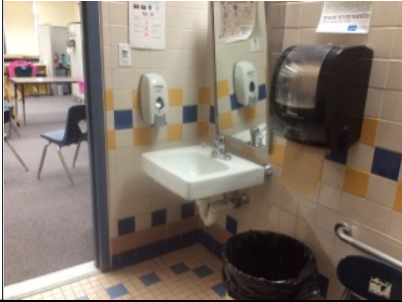
Toe or knee clearances not provided	23"	Provide at least one lavatory with 25" min. knee clearance positioned for a forward approach.	1	1686	\$1686
106	Partners Program (Grades K-2) Toilet Room	1	9	Lavatory (Children)	N/A

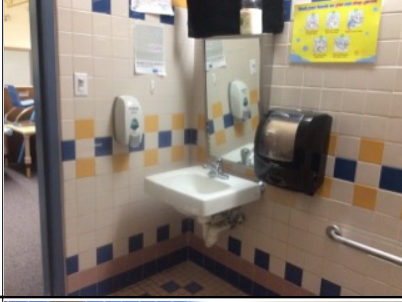
Toe or knee clearances not provided	22"	Provide at least one lavatory with 25" min. knee clearance positioned for a forward approach.	1	1686	\$1686

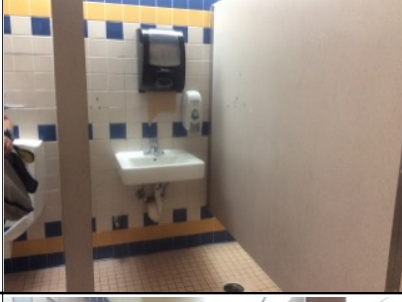
107	Boys' Toilet Room by Health Office	1		Lavatory (Children)	N/A

Exposed plumbing underneath	-	Insulate or otherwise configure pipes to prevent contact at lavatory.	1	92	\$92
108	Girls' Toilet Room Across From Auditorium	1		Lavatory (Children)	N/A

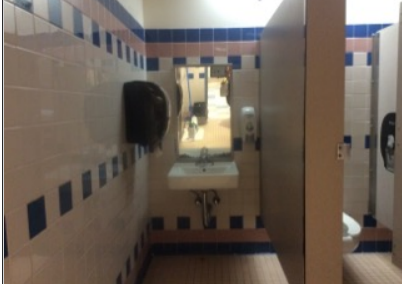
Exposed plumbing underneath	-	Insulate or otherwise configure pipes to prevent contact at lavatory.	1	92	\$92

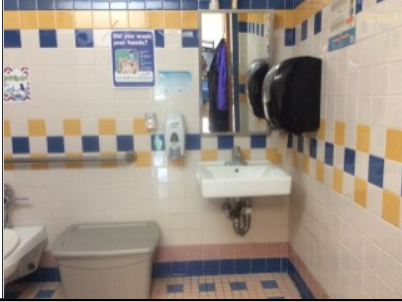
Exposed plumbing underneath Mirror above lavatory w/reflective surface > 31"	- 38"	Insulate or otherwise configure pipes to prevent contact at lavatory. Lower mirror so that the bottom surface is at 31" above finished floor.	1	348	\$348
Dispensers (Children)												
110	Boys' Toilet Room by Health Office	1		Dispensers (Children)	Paper Towel Dispenser

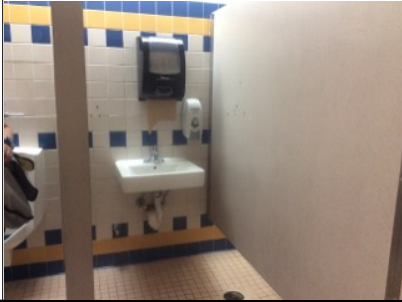
Dispenser controls > 42" high	50"	Relocate so the operable part is 42" max. above the finished floor.	1	353	\$353
Urinal (Children)												
111	Boys' Toilet Room by Health Office	1		Urinal (Children)

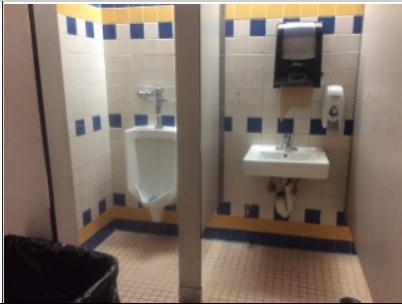
Urinal has < 30" clear width Urinal recessed > 24" deep has > 36" clear width	26" 34"	Remove partition to provide a 30" min. by 48" min. clear floor space positioned for a forward approach. Provide a partition that is less than 24" deep.	1	353	\$353

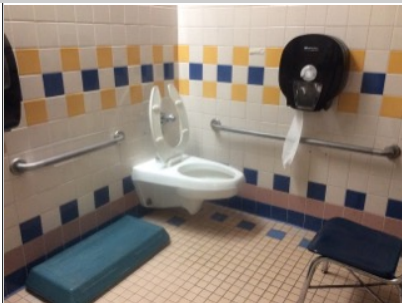
Controls < 14" or > 17" (Ages 5 - 8) Dispenser located above grab bar	- -	Relocate toilet paper dispenser so the operable part is between 14" and 17" above the finished floor. Relocate dispenser 1.5" minimum underneath the grab bar.	1	353	\$353
113	Partners Program (Grades 3-5) Toilet Room	1	8	Toilet Paper Dispensers (Children)	N/A

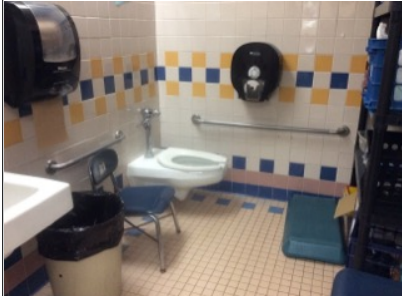
Controls < 17" or > 19" (Ages 9 - 12) Dispenser located above grab bar	- -	Relocate toilet paper dispenser so the operable part is between 14" and 17" above the finished floor. Relocate dispenser 1.5" minimum underneath the grab bar.	1	353	\$353

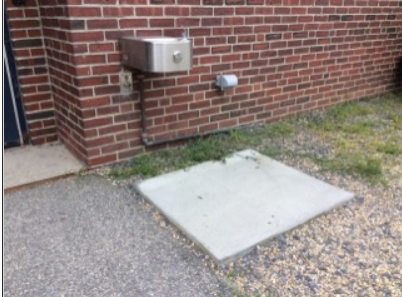
Clear floor space not provided Operable parts malfunctioning No drinking fountain provided for standing users	- - -	Provide a 30" by 48" clear floor space positioned for a forward approach. (Cost estimate for 3' by 4' asphalt area.) Repair or replace drinking fountain to ensure operable parts are functioning. Provide an additional drinking fountain for standing users on an accessible route.	1	4148 Labor	\$4148
115	Drinking Fountain	1		Drinking Fountains	Low

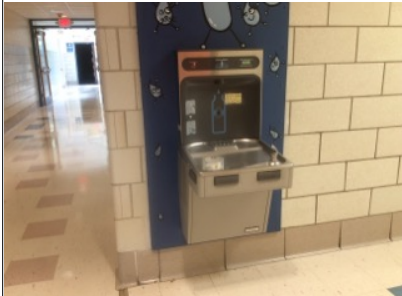
No drinking fountain provided for standing users	-	Provide an additional drinking fountain for standing users.	1	4028	\$4028
116	Drinking Fountain by Gym	1		Drinking Fountains	Low

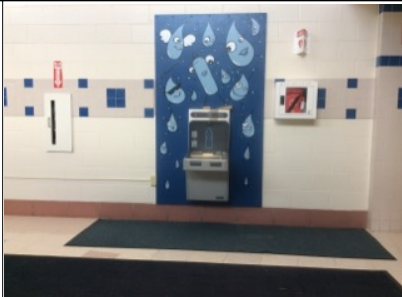
No drinking fountain provided for standing users	-	Provide an additional drinking fountain for standing users.	1	4028	\$4028

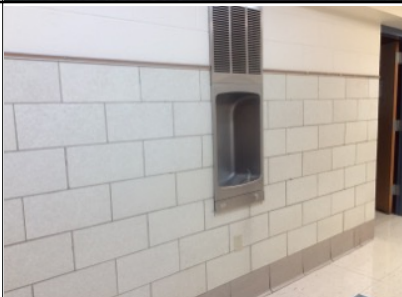
117	Drinking Fountain	1		Drinking Fountains	Low

No drinking fountain provided for standing users Knee or toe clearance not provided	- -	Install a Hi-Lo drinking fountain.	1	4216	\$4216
118	Drinking Fountain by Women's Toilet Room	1		Drinking Fountains	Hi-Lo

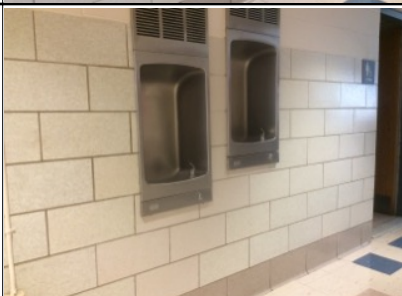
Knee or toe clearance not provided	-	Provide a drinking fountain with knee and toe clearance, 27" min. high at drinking fountain for seated users. (Cost for a new low drinking fountain.)	1	4028	\$4028

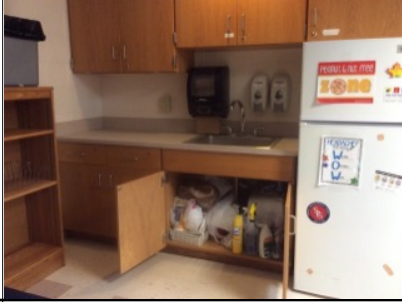
Toe and knee clearances not provided Exposed plumbing underneath sink	26"	Ensure there is a 27" knee clearance positioned for a forward approach. Insulate or otherwise configure pipes at sink.	1	1778	\$1778
120	Learning Lab	1		Sink	Lab
