Haynes Elementary School

Town of Sudbury ADA Transition Plan

January 2021

Institute for Human Centered Design

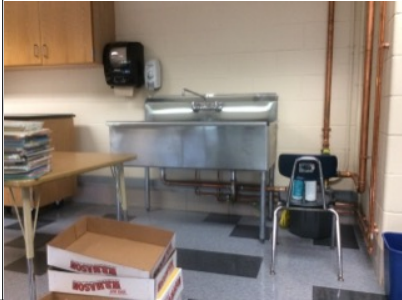
Toe and knee clearances not provided Exposed plumbing underneath sink Dispenser not within reach range	- - 48"	Ensure there is a 27" knee clearance positioned for a forward approach. Insulate or otherwise configure pipes at sink. Relocate paper towel dispenser 44" max. above the finished floor or ground.	1	2034	\$2034
Sinks for Children's Use												
121	OT/PT	1		Sinks for Children's Use	Other

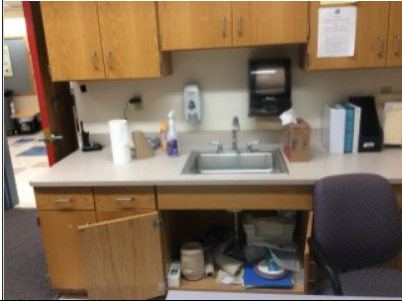
Exposed plumbing underneath Knee or toe clearance not provided	- 25.75"	Insulate or otherwise configure pipes to prevent contact at sink. Provide at least one sink with 24" high knee and toe clearance positioned for a forward approach.	1	1778	\$1778

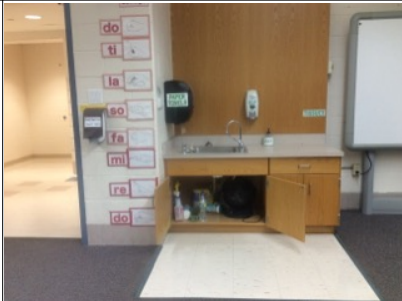
122	Music Room	1	1	Sinks for Children's Use	Classroom

Exposed plumbing underneath Knee or toe clearance not provided	- 22.5"	Insulate or otherwise configure pipes to prevent contact at sink. Provide at least one sink with 24" high knee and toe clearance positioned for a forward approach.	1	1778	\$1778
123	Grade 4	1	13	Sinks for Children's Use	Classroom

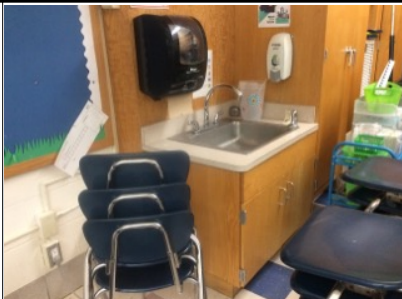
Exposed plumbing underneath Knee or toe clearance not provided	- 22"	Insulate or otherwise configure pipes to prevent contact at sink. Provide at least one sink with 24" high knee and toe clearance positioned for a forward approach.	1	1778	\$1778

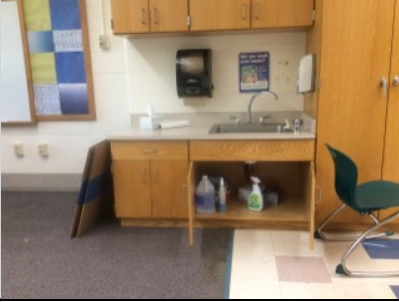
Exposed plumbing underneath Knee or toe clearance not provided	- 22.5"	Insulate or otherwise configure pipes to prevent contact at sink. Provide at least one sink with 24" high knee and toe clearance positioned for a forward approach.	1	1778	\$1778
125	Grade 5	1	16	Sinks for Children's Use	Classroom

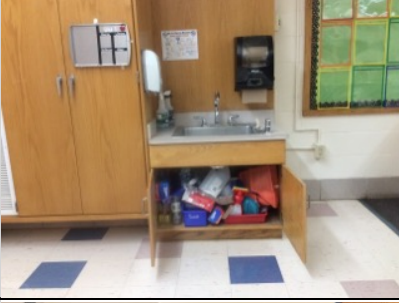
Exposed plumbing underneath Knee or toe clearance not provided	- 22"	Insulate or otherwise configure pipes to prevent contact at sink. Provide at least one sink with 24" high knee and toe clearance positioned for a forward approach.	1	1778	\$1778
126	Grade 2	1	19	Sinks for Children's Use	Classroom

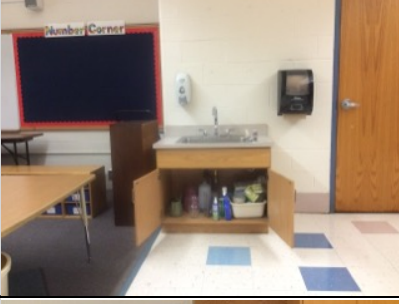
Exposed plumbing underneath Knee or toe clearance not provided	- 22"	Insulate or otherwise configure pipes to prevent contact at sink. Provide at least one sink with 24" high knee and toe clearance positioned for a forward approach.	1	1778	\$1778

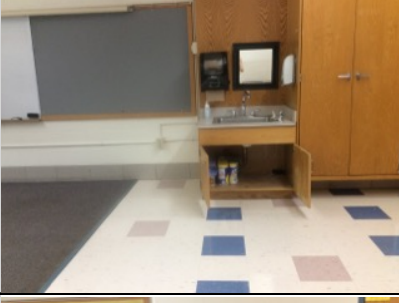
127	Grade 3	1	2	Sinks for Children's Use	Classroom

Exposed plumbing underneath Knee or toe clearance not provided	- 22"	Insulate or otherwise configure pipes to prevent contact at sink. Provide at least one sink with 24" high knee and toe clearance positioned for a forward approach.	1	1778	\$1778
128	Grade 1	1	21	Sinks for Children's Use	Classroom

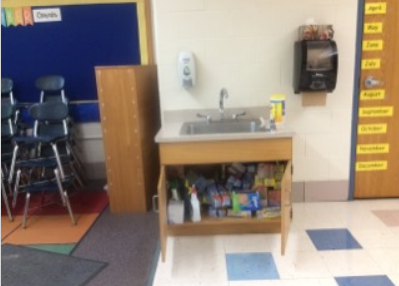
Exposed plumbing underneath Knee or toe clearance not provided	- 22"	Insulate or otherwise configure pipes to prevent contact at sink. Provide at least one sink with 24" high knee and toe clearance positioned for a forward approach.	1	1778	\$1778

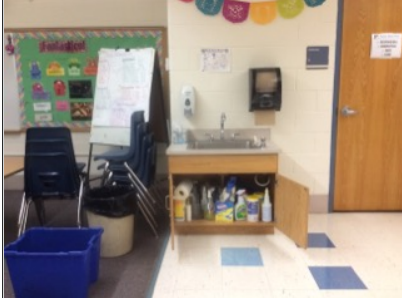
Exposed plumbing underneath Knee or toe clearance not provided	- 22"	Insulate or otherwise configure pipes to prevent contact at sink. Provide at least one sink with 24" high knee and toe clearance positioned for a forward approach.	1	1778	\$1778
130	Steps Room	1	25	Sinks for Children's Use	Classroom

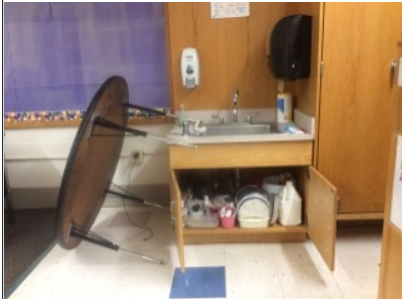
Exposed plumbing underneath Knee or toe clearance not provided	- 22"	Insulate or otherwise configure pipes to prevent contact at sink. Provide at least one sink with 24" high knee and toe clearance positioned for a forward approach.	1	1778	\$1778
131	Learning Center for K-3	1	27	Sinks for Children's Use	Classroom

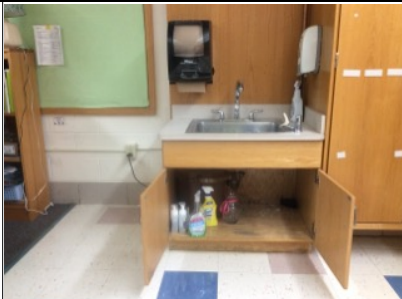
Exposed plumbing underneath Knee or toe clearance not provided	- 22"	Insulate or otherwise configure pipes to prevent contact at sink. Provide at least one sink with 24" high knee and toe clearance positioned for a forward approach.	1	1778	\$1778

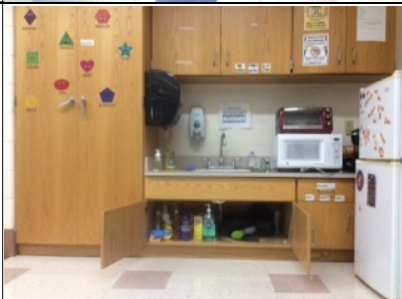
132	Partners Program (Grades 3-5)	1	8	Sinks for Children's Use	Classroom

Exposed plumbing underneath Knee or toe clearance not provided	- -	Insulate or otherwise configure pipes to prevent contact at sink. Provide at least one sink with 24" high knee and toe clearance positioned for a forward approach.	1	1778	\$1778
133	Partners Program (Grades K-2)	1	9	Sinks for Children's Use	Classroom

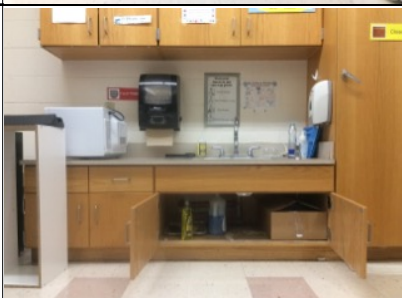
Exposed plumbing underneath Knee or toe clearance not provided	- -	Insulate or otherwise configure pipes to prevent contact at sink. Provide at least one sink with 24" high knee and toe clearance positioned for a forward approach.	1	1778	\$1778

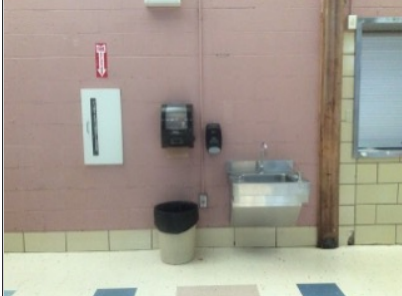
Knee or toe clearance not provided	23"	Provide at least one sink with 24" high knee and toe clearance positioned for a forward approach.	1	1686	\$1686
135	Art Classroom	1	11	Sinks for Children's Use	Classroom

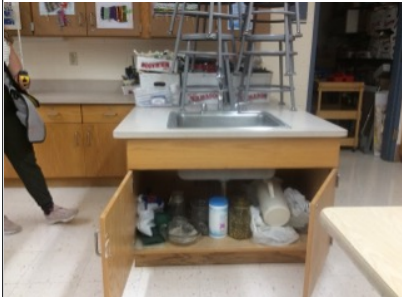
Knee or toe clearance not provided	18.5"	Provide at least one sink with 24" high knee and toe clearance positioned for a forward approach.	1	1686	\$1686
136	Kindergarten	1	6	Sinks for Children's Use	Classroom

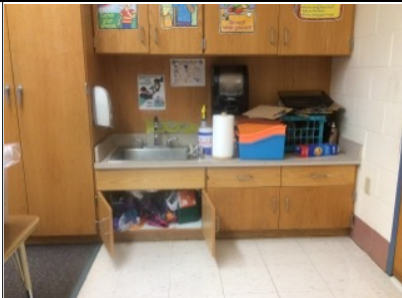
Knee or toe clearance not provided	16.75"	Provide at least one sink with 24" high knee and toe clearance positioned for a forward approach.	1	1686	\$1686
Play and Sport Areas												
Play Areas												
137	Swing Sets North of the Basketball Court	Ext.		Play Areas	N/A

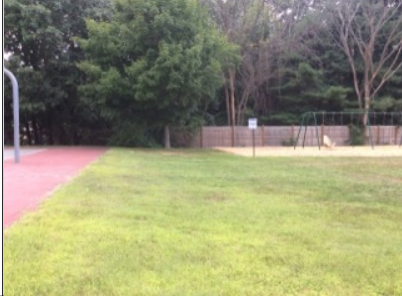
Accessible route not provided to playground Accessible route not provided around playground Accessible route not provided to play components	- - -	Install an accessible route to and around the playground. (Cost estimate for 430' long, 4' wide asphalt route.) Provide a compliant impact-attenuating surface to and around the play components. (Cost estimate for 1,380 sq. ft. of poured in place rubber surface.)	1	36520	\$36520

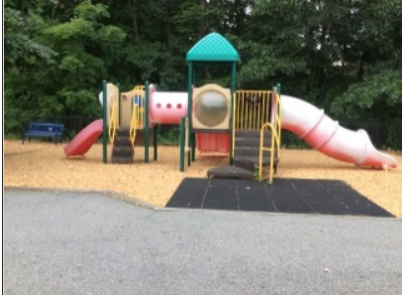
138	Southwest Playground	Ext.		Play Areas	N/A

Accessible route not provided around playground Accessible route not provided to play components	- -	Provide an accessible route around the play area. (Cost estimate for 144' long 4' wide asphalt route, including a route to the bench.) Provide a compliant impact-attenuating surface to and around the play components. (Cost estimate for 1,344 sq. ft. of poured in place rubber surface.)	1	24576	\$24576

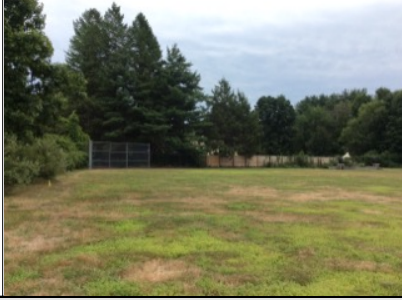
Field not connected to an accessible route	-	Provide an accessible route to the field. (Cost estimate for 60' long, 4' wide asphalt route.)	1	2400	\$2400
Overall Review												
141	Accessible Shower Across From Health Office	1	14

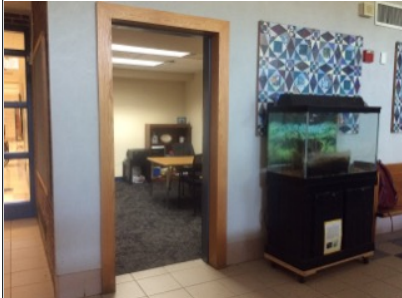
Recommend providing a sign at all permanent rooms where a sign is not provided.	3	-	\$0

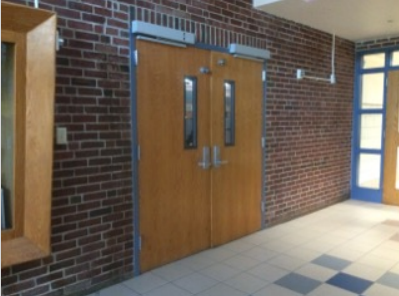
Recommend providing a sign at all permanent rooms where a sign is not provided.	1	-	\$0
144	Corridor Stairs to Stage	1

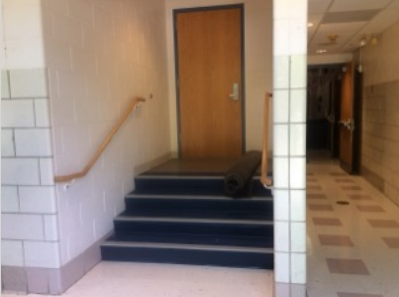
Recommend providing designation signage with raised characters and braille at all permanent rooms lacking signage. Recommend providing directional signage to the accessible route to the stage.	1	-	\$0
145	Stage Ramp Door Across From Music Room	1

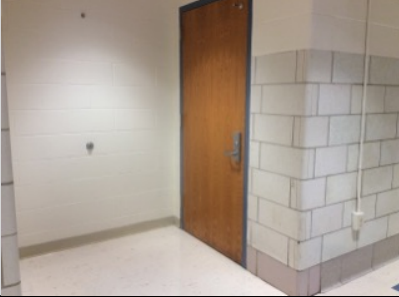
Recommend providing designation signage with raised characters and braille at all permanent rooms lacking signage.	1	-	\$0
146	ESL/LLI	1

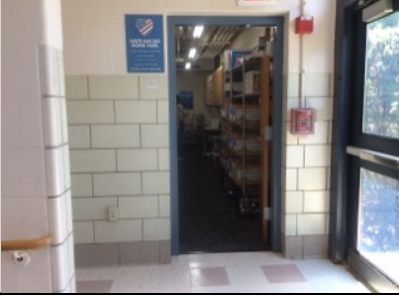
Recommend providing designation signage with raised characters and braille at all permanent rooms lacking signage.	1	-	\$0
147	Corridor	1

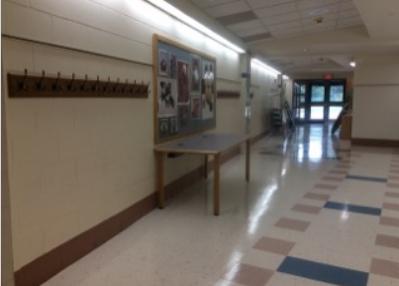
Recommend locating some hooks in the main corridor within recommended children's reach ranges between 40" and 44" high for students in the kindergarten through the fifth grade.	1	-	\$0

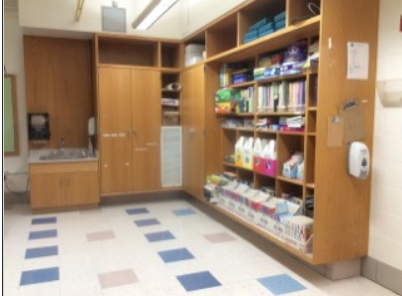
It is good example to see height adjustable shelving.	1	-	\$0
149	Partners Program (Grades 3-5)	1	8

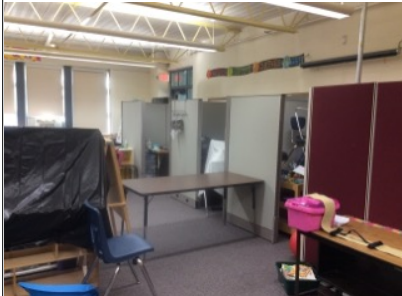
Individual workspaces for children can fold down behind cubicle walls. This feature is very useful for students with learning disabilities.	1	-	\$0
150	Exit Door 16	Ext.	13

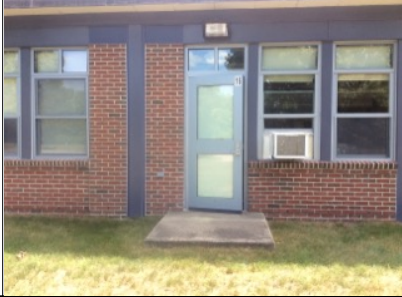
Recommend providing an accessible walkway from each ground level classroom exit door.	1	-	\$0
151	Southwest Playground Gate	Ext.

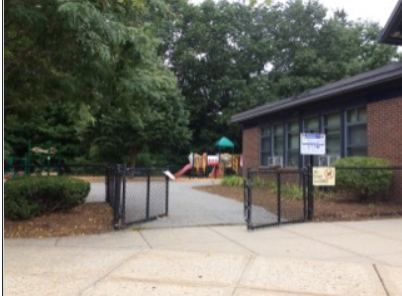
Recommend providing a 10" high solid surface kickplate on the push side of the gate to the southwest playground.	1	-	\$0
152	Swing Sets North of the Basketball Court	Ext.

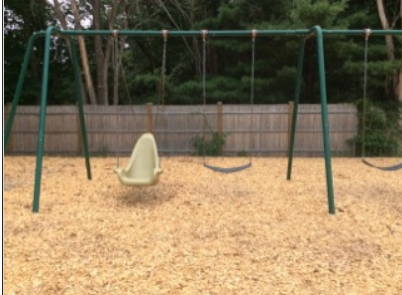
Good example to see a variety of swings in this swingset area.	1	-	\$0

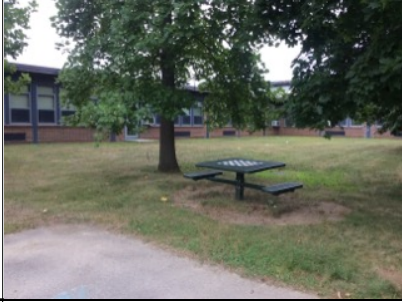
-	Recommend providing a 48" wide accessible route around entire picnic table at each accessible picnic table.	1	-	\$0
154	Seating Area by Birdbath on Northeast Side by the Main Entrance	Ext.

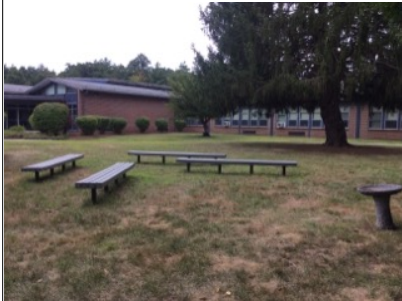
-	Recommend providing a 36" x 48" space alongside one bench positioned so that a person using a wheelchair can sit shoulder to shoulder with someone seated on the bench. Recommend providing a variety of benches, including benches with backs and armrests.	1	-	\$0
