Nixon Elementary School

Town of Sudbury ADA Transition Plan

January 2021

Institute for Human Centered Design

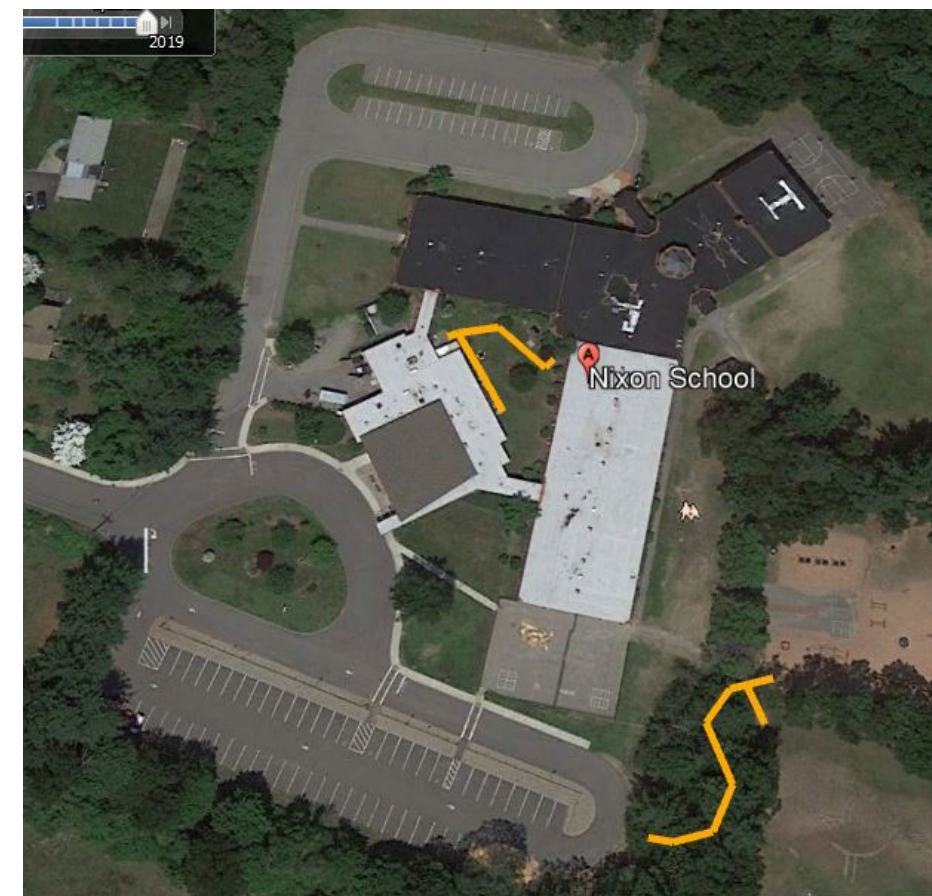
Figure 1: In the following image, orange lines show recommended stone dust routes in the courtyard, to the soccer field and between the playground and front parking lot:

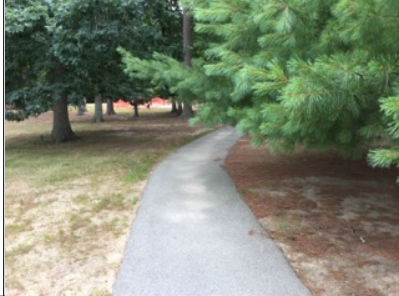
ID	Location	Floor	Room	Element	Type	Photo	Issues	Current Measure	Recommendations	Quantity	Price	Cost Estimation
Approach and Entrance												
Exterior Access Route												
1	Path to Basketball Court From Back Entrance	Ext.		Exterior Access Route	Walkway

Obstructed by protruding objects	-	Trim low hanging branches in trees.	1	200	\$200
2	Back Road From Playground to Front Parking	Ext.		Exterior Access Route	Walkway

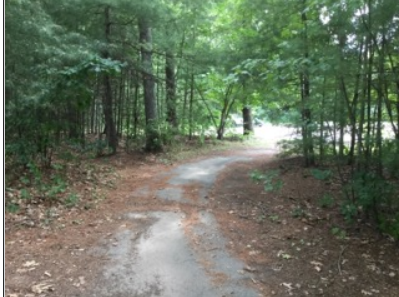
Surface openings > 1/2" Level changes > 1/4" Surface is not stable, firm, and slip-resistant	1" -	Alter change in level to be 1/4" high max. Repair surface. (Cost estimate for a 188' long, 4' wide stone dust route.)	1	6016	\$6016
3	Path to Basketball Court From Back Entrance	Ext.		Exterior Access Route	Exterior

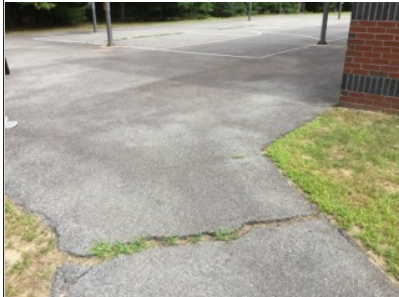
Surface openings > 1/2" Route not maintained in operable working condition	2"	Repair asphalt so that openings are 1/2" max. Ensure the accessible route is maintained in operable working condition. (Cost estimate for 6' long by 4' wide area of asphalt.)	1	240	\$240

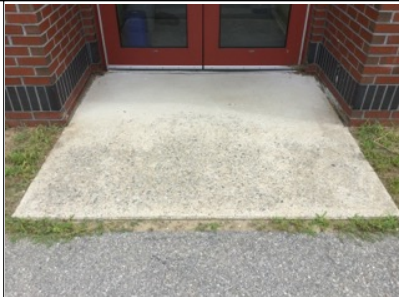
4	Egress Door 7	Ext.		Exterior Access Route	Exterior

Level changes > 1/4"	1"	Alter change in level to be 1/4" high max.	1	160	\$160
5	Path to Football Field and New Playground	Ext.		Exterior Access Route	Walkway

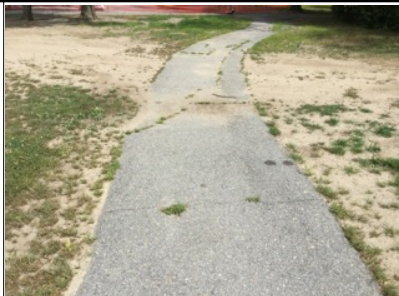
Surface is not stable, firm, and slip-resistant Route not maintained in operable working condition	- -	Repair surface. Ensure the accessible route is maintained in operable working condition. (Cost estimate for 30' long 4' wide of asphalt.)	1	1200	\$1200

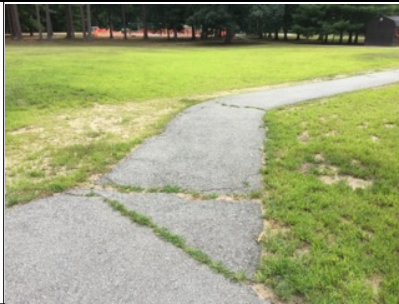
ID	Location	Floor	Room	Element	Type	Photo	Issues	Current Measure	Recommendations	Quantity	Price	Cost Estimation
6	Path to Basketball Court From Back Entrance	Ext.		Exterior Access Route	Walkway

Surface is not stable, firm, and slip-resistant Route not maintained in operable working condition	- -	Repair surface. Ensure the accessible route is maintained in operable working condition. (Cost estimate for 10' long by 4' wide area of asphalt.)	1	400	\$400
7	Path to Basketball Court From Back Entrance	Ext.		Exterior Access Route	Walkway

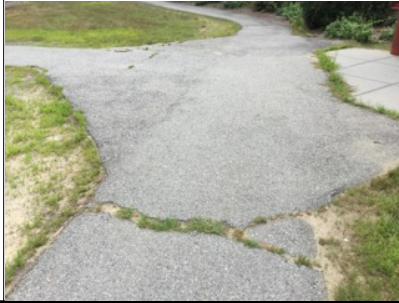
Surface is not stable, firm, and slip-resistant Route not maintained in operable working condition	- -	Repair surface. Ensure the accessible route is maintained in operable working condition. (Cost estimate for 10' long by 4' wide area of asphalt.)	1	400	\$400
8	Corridor Exit 12 by Office 19	1	19	Exterior Access Route	Walkway

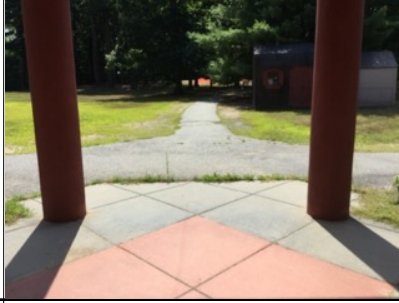
Route not maintained in operable working condition	-	Ensure the accessible route is maintained in operable working condition. (Cost estimate for 4' x 4' asphalt area.)	1	160	\$160

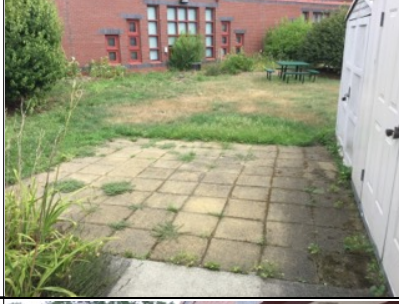
9	Courtyard Patio	Ext.		Exterior Access Route	Exterior

Route not maintained in operable working condition	-	Ensure the accessible route is maintained in operable working condition.	1	Labor	\$0
10	Egress Door 13 Route	Ext.		Exterior Access Route	Exterior

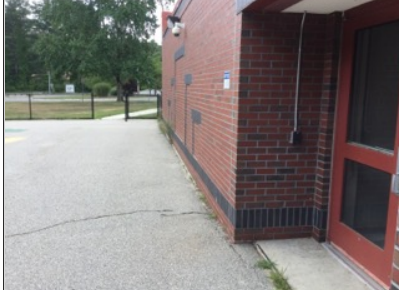
Route not maintained in operable working condition	-	Ensure the accessible route is maintained in operable working condition.	1	160	\$160

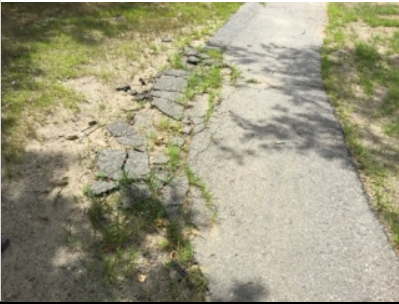
ID	Location	Floor	Room	Element	Type	Photo	Issues	Current Measure	Recommendations	Quantity	Price	Cost Estimation
11	Path to Soccer Field and New Playground	Ext.		Exterior Access Route	Walkway

Route not maintained in operable working condition Surface is not stable, firm, and slip-resistant	- -	Repair surface. Ensure the accessible route is maintained in operable working condition. (Cost estimate for 10' long 4' wide of asphalt.)	1	400	\$400
12	Path to Basketball Court From Back Entrance	Ext.		Exterior Access Route	Walkway

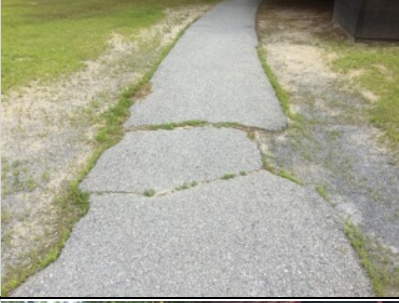
Route not maintained in operable working condition Surface is not stable, firm, and slip-resistant	- -	Repair surface. Ensure the accessible route is maintained in operable working condition. (Cost estimate for 6' long by 4' wide area of asphalt.)	1	240	\$240
13	Courtyard Garden Beds and Bench	Ext.		Exterior Access Route	Exterior

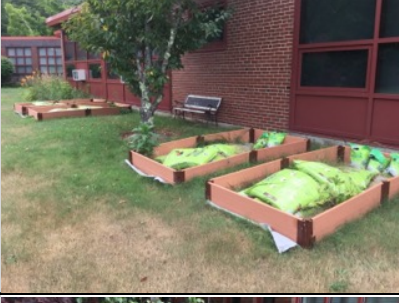
Accessible route not provided	-	Ensure an accessible route is provided to the garden beds and one bench in the courtyard. (Cost estimate for a 83' long by 4' wide stone dust walkway.)	1	2656	\$2656

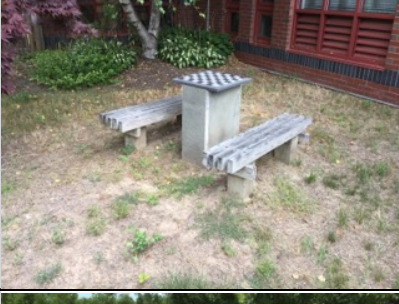
14	Courtyard Chess Table	Ext.		Exterior Access Route	Exterior

Accessible route not provided	-	Provide an accessible route to the chess board. (Cost estimate for a 10' long by 4' wide stone dust walkway.)	1	320	\$320
15	Bike Rack on Left Side of Entrance	Ext.		Exterior Access Route	Walkway

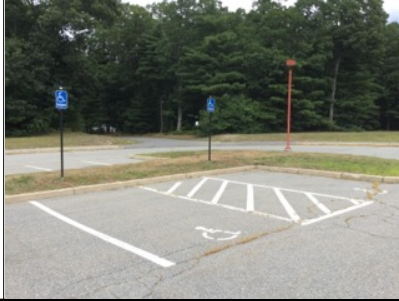
ID	Location	Floor	Room	Element	Type	Photo	Issues	Current Measure	Recommendations	Quantity	Price	Cost Estimation
Off-Street Parking Lot or Garage												
16	Back Parking Lot	Ext.		Off-Street Parking Lot or Garage	Visitor

Total # of parking Total # of designated accessible parking spaces Total # of designated van accessible spaces Sign does not have the designation "Van Accessible"	37 2 0 -	Add the designation "Van Accessible" to one parking space.	1	500	\$500
17	Front Parking Lot	Ext.		Off-Street Parking Lot or Garage	Visitor

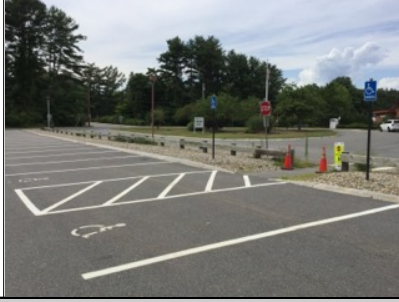
Total # of parking Total # of designated accessible parking spaces Total # of designated van accessible spaces Sign does not have the designation "Van Accessible"	60 3 0 -	Add the designation "Van Accessible" to one of the accessible parking spaces.	1	500	\$500
Emergency Exit												
18	Egress Door 6	1		Emergency Exit	N/A

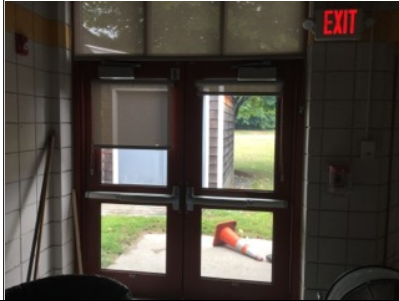
19	Main Entrance Door 1 (Egress)	1		Emergency Exit	N/A

Tactile sign not provided at exit Directional sign to accessible emergency exit not provided	- -	Provide tactile exit signs with raised characters and braille at exit doors. Mount signs between 48"- 60" above the finished floor located on the latch side of the door. Provide a directional sign indicating the location of the nearest accessible emergency exit.	1	464	\$464

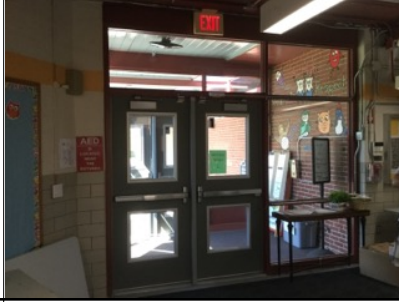
Tactile sign not provided at exit Illuminated Int. Symbol of Acc. not provided (MAAB)	- -	Provide tactile exit signs with raised characters and braille at exit doors. Mount signs between 48"- 60" above the finished floor located on the latch side of the door. Provide an illuminated sign with the International Symbol of Accessibility.	1	432	\$432
20	Egress Door 7	1		Emergency Exit	N/A

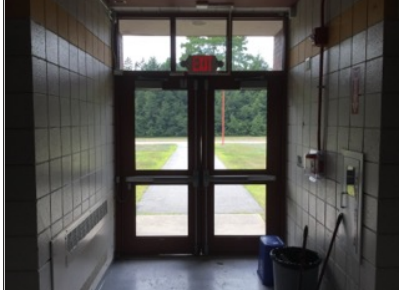
Tactile sign not provided at exit Illuminated Int. Symbol of Acc. not provided (MAAB)	- -	Provide tactile exit signs with raised characters and braille at exit doors. Mount signs between 48"- 60" above the finished floor located on the latch side of the door. Provide an illuminated sign with the International Symbol of Accessibility.	1	432	\$432

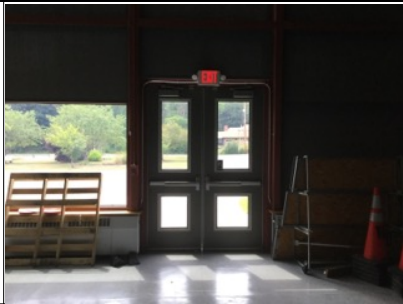
ID	Location	Floor	Room	Element	Type	Photo	Issues	Current Measure	Recommendations	Quantity	Price	Cost Estimation
21	Egress Door 2	1		Emergency Exit	N/A

Tactile sign not provided at exit Illuminated Int. Symbol of Acc. not provided (MAAB)	- -	Provide tactile exit signs with raised characters and braille at exit doors. Mount signs between 48"- 60" above the finished floor located on the latch side of the door. Provide an illuminated sign with the International Symbol of Accessibility.	1	432	\$432
22	Egress Door 13	1		Emergency Exit	N/A

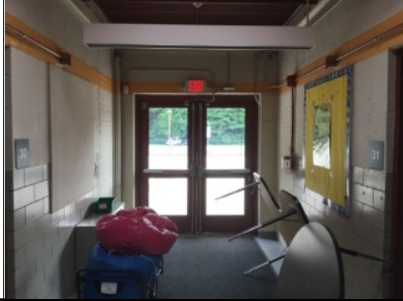
Tactile sign not provided at exit Illuminated Int. Symbol of Acc. not provided (MAAB)	- -	Provide tactile exit signs with raised characters and braille at exit doors. Mount signs between 48"- 60" above the finished floor located on the latch side of the door. Provide an illuminated sign with the International Symbol of Accessibility.	1	432	\$432
23	Egress Door 8	1		Emergency Exit	N/A

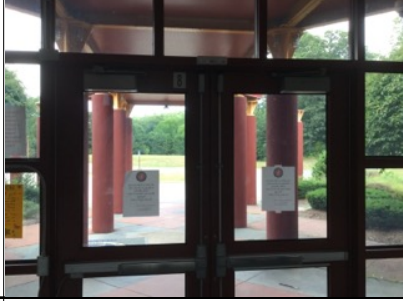
Tactile sign not provided at exit Illuminated Int. Symbol of Acc. not provided (MAAB)	- -	Provide tactile exit signs with raised characters and braille at exit doors. Mount signs between 48"- 60" above the finished floor located on the latch side of the door. Provide an illuminated sign with the International Symbol of Accessibility.	1	432	\$432

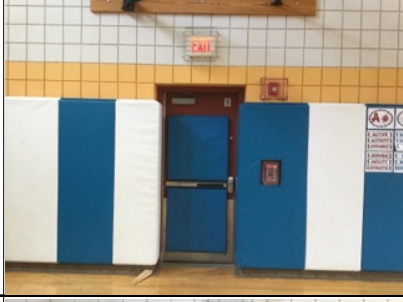
Tactile sign not provided at exit Illuminated Int. Symbol of Acc. not provided (MAAB)	- -	Provide tactile exit signs with raised characters and braille at exit doors. Mount signs between 48"- 60" above the finished floor located on the latch side of the door. Provide an illuminated sign with the International Symbol of Accessibility.	1	432	\$432
25	Gym Egress Door 10	1	16	Emergency Exit	N/A

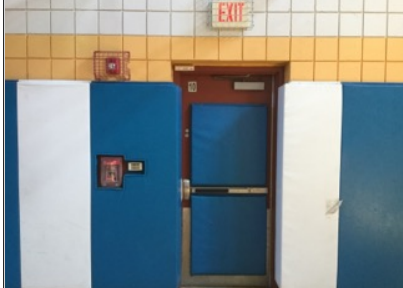
Tactile sign not provided at exit Illuminated Int. Symbol of Acc. not provided (MAAB)	- -	Provide tactile exit signs with raised characters and braille at exit doors. Mount signs between 48"- 60" above the finished floor located on the latch side of the door. Provide an illuminated sign with the International Symbol of Accessibility.	1	432	\$432

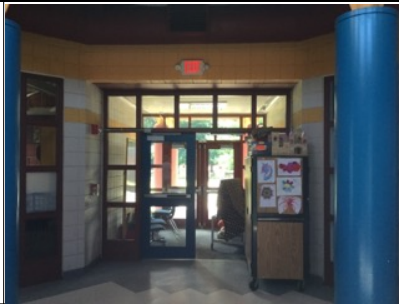
ID	Location	Floor	Room	Element	Type	Photo	Issues	Current Measure	Recommendations	Quantity	Price	Cost Estimation
26	Corridor Exit 12 by Office 19	1	19	Emergency Exit	N/A

Tactile sign not provided at exit Illuminated Int. Symbol of Acc. not provided (MAAB)	- -	Provide tactile exit signs with raised characters and braille at exit doors. Mount signs between 48"- 60" above the finished floor located on the latch side of the door. Provide an illuminated sign with the International Symbol of Accessibility.	1	432	\$432
27	Corridor Exit 12 by Office 19	1	19	Emergency Exit	N/A

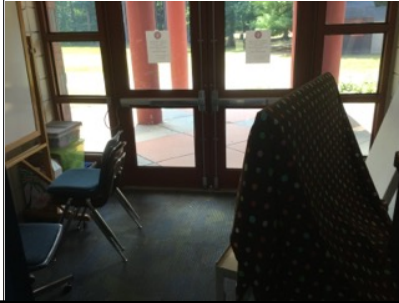
Door requires > 15 lbs. of force to open	20 lbs	Adjust closers of exterior doors so doors do not require more than 15 pounds of force.	1	Labor	\$0
28	Egress Door 8	Ext.		Emergency Exit	N/A

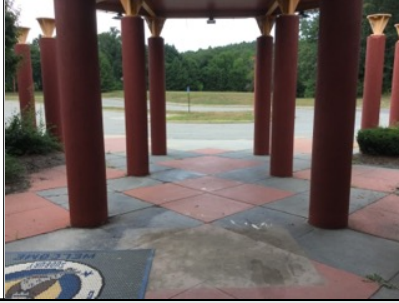
Door requires > 15 lbs. of force to open	18lbs	Adjust closers of exterior doors so doors do not require more than 15 pounds of force.	1	Labor	\$0

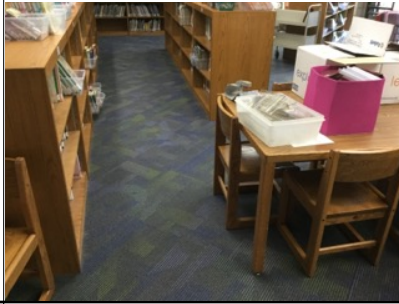
Route < 36" wide	34.5"	Ensure that a clear width of 36" min. is maintained at the accessible route.	1	Labor	\$0
30	Tray Drop by Kitchen Area	1		Interior Access Route	N/A

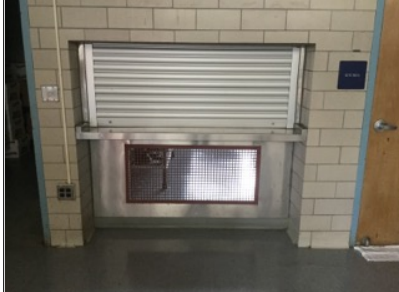
Obstructed by protruding objects	12"	Provide a cane-detectable barrier at each side of the tray drop.	2	306	\$612

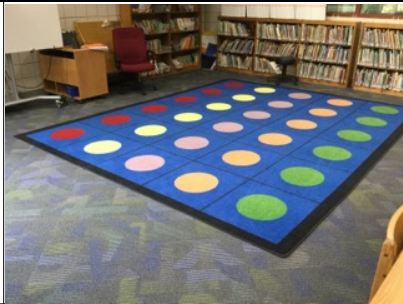
ID	Location	Floor	Room	Element	Type	Photo	Issues	Current Measure	Recommendations	Quantity	Price	Cost Estimation
31	Library Media Center	1	1	Interior Access Route	N/A

Surface not stable, firm, and slip-resistant	-	Secure the mat.	1	Labor	\$0
32	Spanish Class	1	14	Interior Access Route	N/A

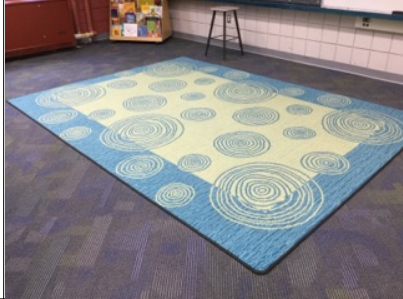
Surface not stable, firm, and slip-resistant	-	Secure the mat.	1	Labor	\$0
Doors, Doorways, & Gates												
33	Office	1	20	Doors, Doorways, & Gates	Office

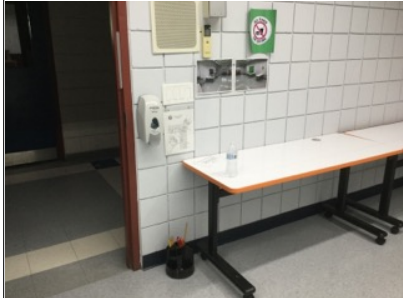
Maneuvering clearance(s) not provided	13"	Relocate the table out of the door maneuvering clearance.	1	Labor	\$0
35	Grade 3 Classroom	1	25	Doors, Doorways, & Gates	Classroom

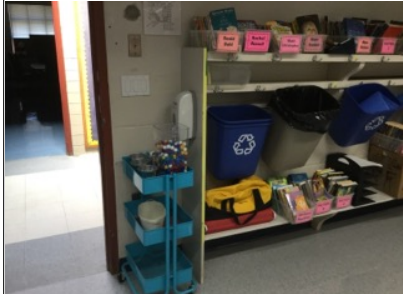
Maneuvering clearance(s) not provided	-	Relocate blue storage cart.	1	Labor	\$0

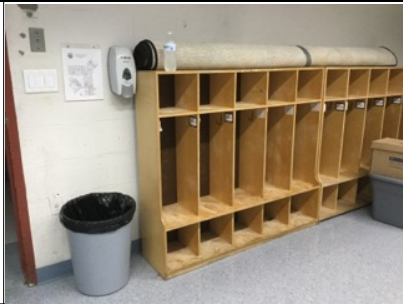
ID	Location	Floor	Room	Element	Type	Photo	Issues	Current Measure	Recommendations	Quantity	Price	Cost Estimation
36	Grade 1 Classroom	1	27	Doors, Doorways, & Gates	Classroom

Maneuvering clearance(s) not provided	-	Relocate trash bin.	1	Labor	\$0
37	Counselor's Office	1	35	Doors, Doorways, & Gates	Office

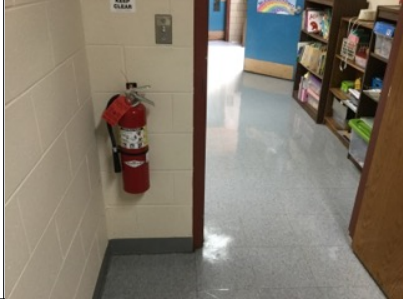
Maneuvering clearance(s) not provided	-	Relocate fire extinguisher out of door maneuvering clearance.	1	Labor	\$0
Ramps												
38	Accessible Stage Access	1		Ramps	Interior

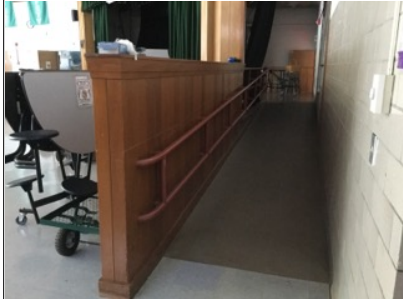
Handrails not provided at both sides if rise is > 6"	-	Provide handrails on both sides.	1	2640	\$2640
Signage												
39	Gym	1	16	Signage	Designation

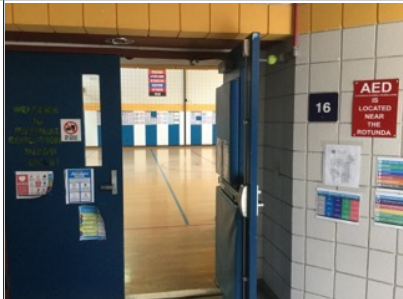
Raised characters < 48" or > 60" above ground	63"	Mount signs so that the baseline of the lowest tactile character is 48" min. above finished floor and the baseline of the highest tactile character is 60" max. above the finished floor.	1	Labor	\$0
40	Cafeteria	1		Signage	Designation

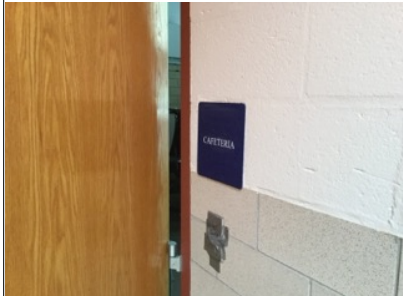
Sign not located on the latch side of the door	-	Locate sign at permanent rooms alongside the door on the latch side.	1	Labor	\$0

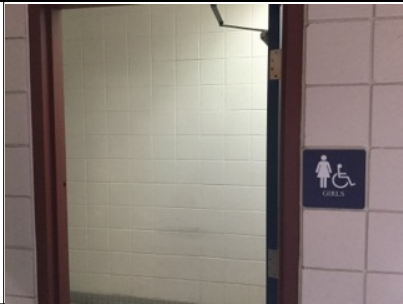
ID	Location	Floor	Room	Element	Type	Photo	Issues	Current Measure	Recommendations	Quantity	Price	Cost Estimation
41	Girls' Toilet Room Near the Gym	1		Signage	Designation

Sign not located on the latch side of the door	-	Locate sign at permanent rooms alongside the door on the latch side.	1	Labor	\$0
Service Counter												
42	Reception	1		Service Counter	N/A

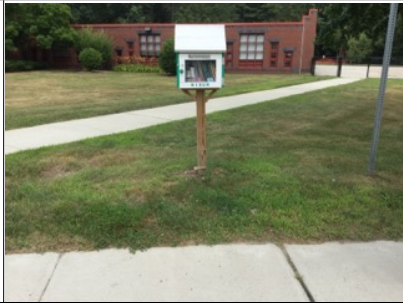
Element not on an accessible route Not operable with a closed fist	- -	Ensure the library box is located on an accessible route. Provide hardware that can be operable with one hand and not require tight grasping, pinching, or twisting of the wrist. (Cost estimate for a 6' long by 4' wide stone dust route.)	1	442	\$442
44	Learning Studio	1	22	Operable Parts	Other

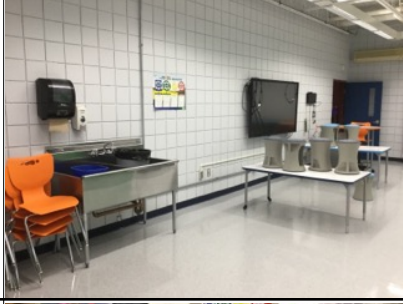
Forward reach if obstruction > 20"- 25" deep is > 44" high	57", 53"	Ensure that the controls for the paper towel dispenser and the soap dispenser are not higher than 44" above the finished floor.	2	256	\$512

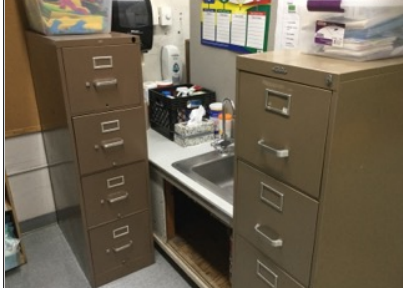
45	Math and Literacy	1	28	Operable Parts	Other

Side reach if obstruction > 24" deep is > 46" high	50" high 32" deep	Ensure that control of the paper towel dispenser is not located any deeper than 24" and any higher than 46" above the finished floor. Relocate file cabinet.	1	Labor 256	\$256

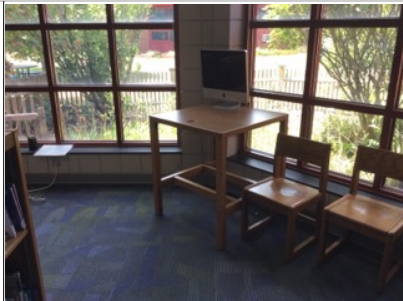
ID	Location	Floor	Room	Element	Type	Photo	Issues	Current Measure	Recommendations	Quantity	Price	Cost Estimation
Dining or Work Surfaces												
46	Library Media Center Computer Terminal	1	1	Dining or Work Surfaces	Work Surface

Knee or toe clearance not provided	8" deep	Provide at least 1 work surface with 24" min. high knee and toe clearance that has 30" min. clear width.	1	200	\$200
47	Grade 4 Classroom	1	12	Dining or Work Surfaces	Work Surface

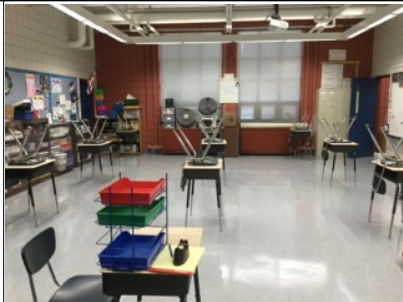
Knee or toe clearance not provided	23.5"	Provide at least 1 work surface with 24" min. high knee and toe clearance that has 30" min. clear width.	1	200	\$200
48	Grade 3 Classroom	1	25	Dining or Work Surfaces	Work Surface

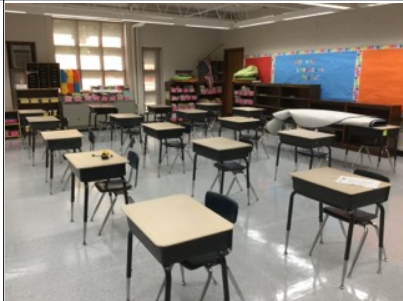
Knee or toe clearance not provided	21" wide	Provide at least 1 work surface with 24" min. high knee and toe clearance that has 30" min. clear width.	1	200	\$200
49	Grade 2 Classroom	1	26	Dining or Work Surfaces	Work Surface

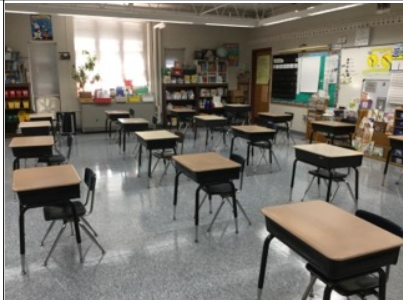
Knee or toe clearance not provided	-	Provide at least 1 work surface with 24" min. high knee and toe clearance that has 30" min. clear width.	1	200	\$200

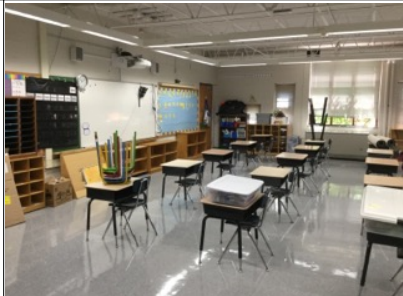
50	Grade 1 Classroom	1	27	Dining or Work Surfaces	Work Surface

Knee or toe clearance not provided	-	Provide at least 1 work surface with 24" min. high knee and toe clearance that has 30" min. clear width.	1	200	\$200

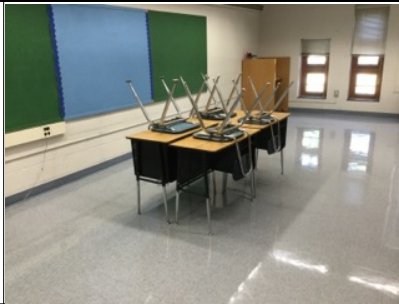
ID	Location	Floor	Room	Element	Type	Photo	Issues	Current Measure	Recommendations	Quantity	Price	Cost Estimation
51	Special Room	1	31	Dining or Work Surfaces	Work Surface

Knee or toe clearance not provided	-	Provide at least 1 work surface with 24" min. high knee and toe clearance that has 30" min. clear width.	1	200	\$200
52	Special Room	1	33	Dining or Work Surfaces	Work Surface

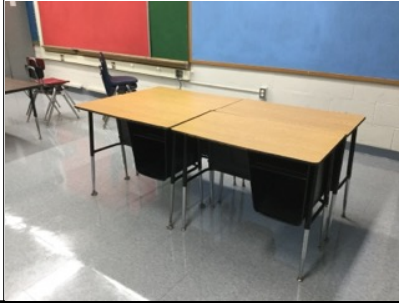
Knee or toe clearance not provided	18" wide	Provide at least 1 work surface with 24" min. high knee and toe clearance that has 30" min. clear width.	1	200	\$200
53	Grade 5 Classroom	1	8	Dining or Work Surfaces	Work Surface

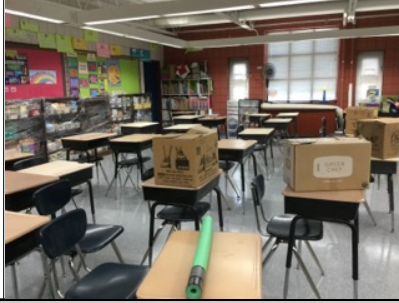
Knee or toe clearance not provided	18.5" wide	Provide at least 1 work surface with 24" min. high knee and toe clearance that has 30" min. clear width.	1	200	\$200
Assembly Area												
54	Music Room	1	18	Assembly Area	N/A

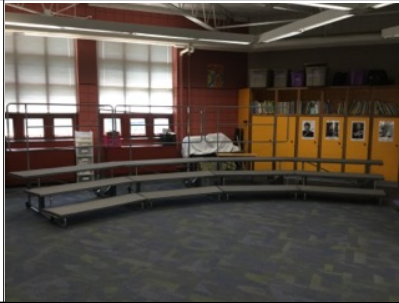
Minimum # wheelchair spaces not provided	-	Provide integrated wheelchair spaces in the bleachers based on ADA 2010 Standards 221.2.1.1.	1	-	\$0

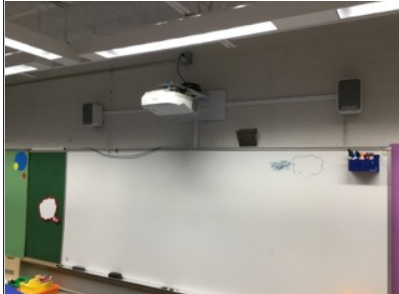
55	Special Room	1	33	Assembly Area	N/A

Assistive listening devices not provided	-	If audible communication is integral to the use of the space, provide an assistive listening system.	1	1214	\$1214

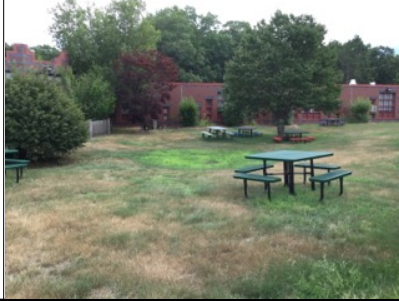
ID	Location	Floor	Room	Element	Type	Photo	Issues	Current Measure	Recommendations	Quantity	Price	Cost Estimation
Picnic Tables												
56	Courtyard Picnic Area	Ext.		Picnic Tables	N/A

Toe or knee clearance at tables not provided Picnic table not on an accessible route	- -	Provide at least one picnic table has toe and knee clearance. Ensure that the picnic table is connected to an accessible route. (Cost estimate for a 50' long by 4' wide stone dust route and an accessible picnic table.)	1	3000	\$3000
57	Picnic Tables by New Playground	Ext.		Picnic Tables	N/A

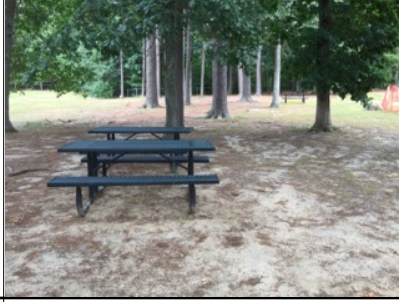
Toe or knee clearance at tables not provided Picnic table not on an accessible route	- -	Provide one accessible picnic table in this area and provide an accessible route to it. (Cost estimate for an accessible picnic table and a 30' long by 4' wide asphalt route to it).	1	2600	\$2600
58	Chess Picnic Table by the New Playground	Ext.		Picnic Tables	N/A

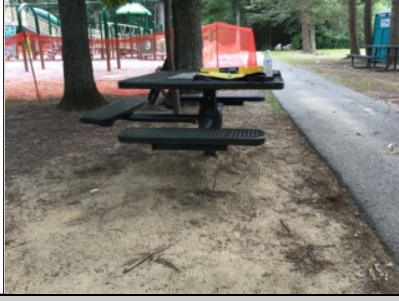
Picnic table not on an accessible route	- -	Provide an accessible route to one picnic table in this area. (Cost estimate for a 6' long by 4' wide asphalt route.)	1	240	\$240

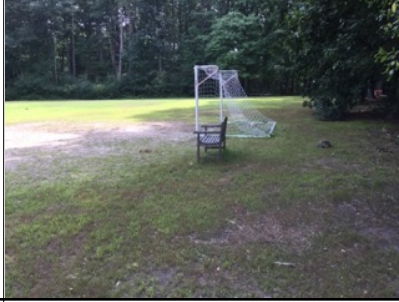
Exterior Benches												
59	Soccer Field Bench	Ext.		Exterior Benches

No accessible route to one bench in area		Locate one bench in this area on an accessible route.	1	Labor	\$0
60	Bench by the New Playground	Ext.		Exterior Benches	N/A

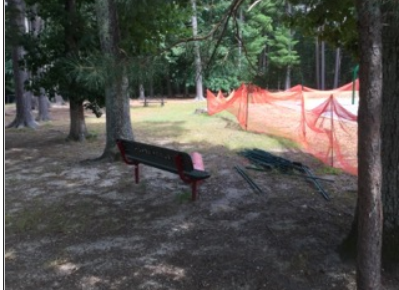
No accessible route to one bench in area		Provide an accessible route to one bench in this area. (Cost estimate for a 30' long, 4' wide asphalt route.)	1	1200	\$1200

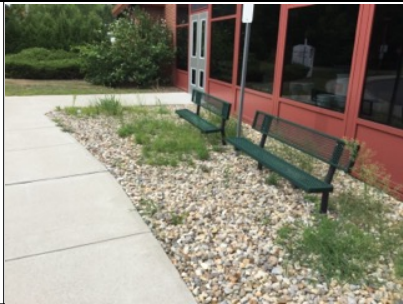
ID	Location	Floor	Room	Element	Type	Photo	Issues	Current Measure	Recommendations	Quantity	Price	Cost Estimation
61	Benches in Front of Cafeteria	Ext.		Exterior Benches	N/A

No accessible route to one bench in area	-	Provide an accessible route to one bench. (Cost estimate for a 6' long 4' wide stone dust walkway.)	1	192	\$192
Toilet & Bathing Rooms												
Overall Access												
62	Girls' Toilet Room by Room 27	1		Overall Access	Toilet Room

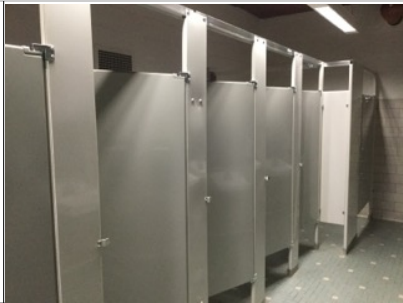
6 fixtures, but no ambulatory compartment provided	-	Provide one ambulatory accessible compartment.	1	3012	\$3012
63	Girls' Toilet Room by the Gym	1		Overall Access	Toilet Room

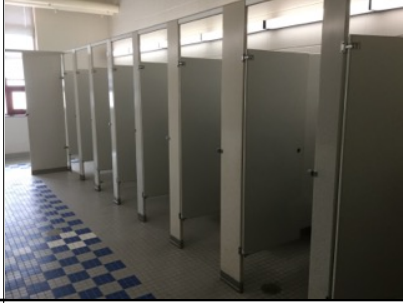
6 fixtures, but no ambulatory compartment provided	-	Provide one ambulatory accessible compartment.	1	3012	\$3012
64	Girls' Toilet Room Near Classroom 8	1		Overall Access	Toilet Room

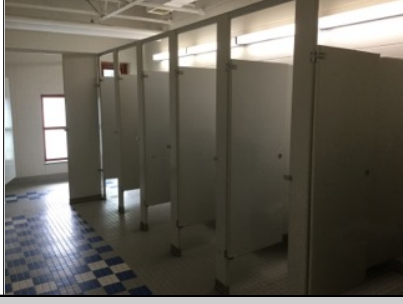
6 fixtures, but no ambulatory compartment provided	-	Provide one ambulatory accessible compartment.	1	3012	\$3012

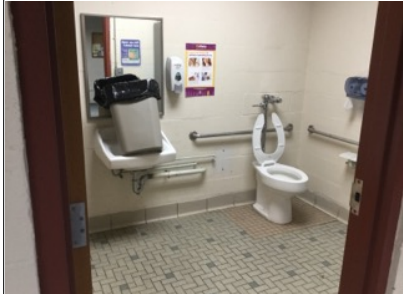
Lavatory												
65	Health Office Toilet Room	1		Lavatory	N/A

Toe or knee clearances not provided Plumbing underneath is exposed	24" -	Provide at least one lavatory with 27" knee and toe clearance positioned for a forward approach. Insulate or otherwise configure pipes to prevent contact at lavatory.	1	1778	\$1778

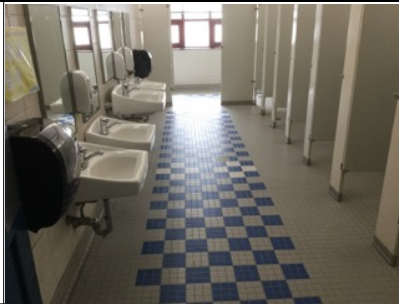
ID	Location	Floor	Room	Element	Type	Photo	Issues	Current Measure	Recommendations	Quantity	Price	Cost Estimation
66	Girls' and Boys' Toilet Rooms by the Gym	1		Lavatory	N/A

Plumbing underneath is exposed	-	Insulate or otherwise configure pipes to prevent contact for at least one lavatory at the high lavatory.	2	92	\$184
67	Boys' Toilet Room Near Classroom 8	1		Lavatory	N/A

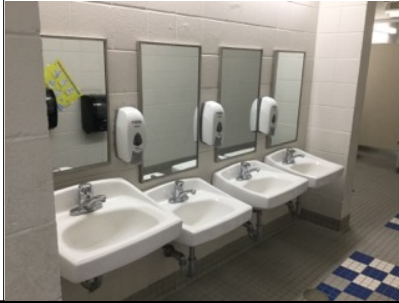
Plumbing underneath is exposed	-	Insulate or otherwise configure pipes to prevent contact for at least one lavatory (the high lavatory).	1	92	\$92
68	Girls' Toilet Room Near Classroom 8	1		Lavatory	N/A

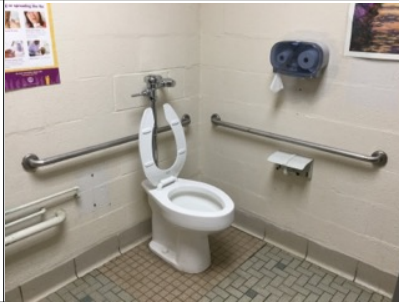
Centerline < or > 18" (MAAB) Side or rear grab bar < 33" or > 36" high Toilet paper dispenser is not compliant	20.5" 30.5" -	Relocate toilet so that the centerline is 18" from the side wall. Mount grab bars 33"- 36" above the floor. Relocate toilet paper so that it is 24" min. high, located under the grab bar, and between 7" and 9" from the front of the toilet. Ensure it is not mounted over the grab bars.	1	3973	\$3973

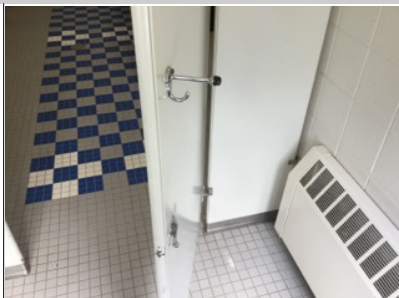
Door has non-compliant hardware Door has malfunctioning self-closing hinge	- -	Provide hardware that can be operable with one hand and not require tight grasping, pinching, or twisting of the wrist. Repair hinge.	1	70 Labor	\$70

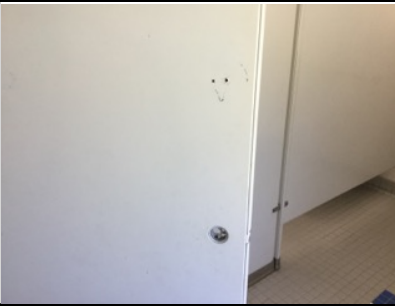
ID	Location	Floor	Room	Element	Type	Photo	Issues	Current Measure	Recommendations	Quantity	Price	Cost Estimation
71	Boys' Toilet Room by the Gym	1		Toilet Compartment	Accessible Compartment

Door has malfunctioning self-closing hinge		Repair hinge.	1	Labor	\$0
72	Girls' Toilet Room Near Classroom 8	1		Toilet Compartment	Accessible Compartment

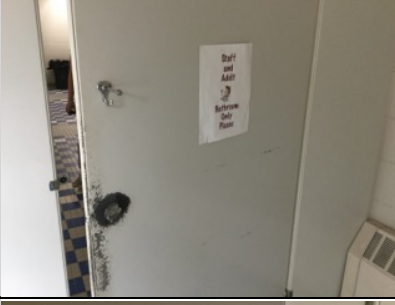
Door has malfunctioning self-closing hinge	-	Repair hinge.	1	Labor	\$0
73	Boys' Toilet Room Near Classroom 8	1		Toilet Compartment	Accessible Compartment

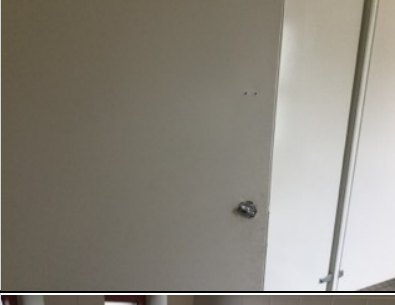
Door has malfunctioning self-closing hinge	-	Repair hinge.	1	Labor	\$0
74	Girls' Toilet Room Near Classroom 8	1		Toilet Compartment	Accessible Compartment

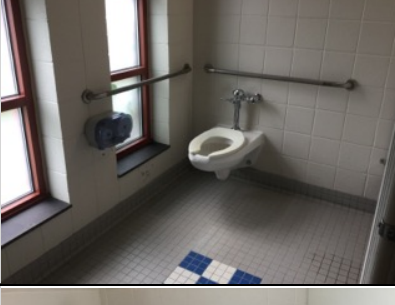
Flush control not on open side	-	Provide the flush control on the open side of the toilet (transfer side).	1	374	\$374
75	Girls' Toilet Room by the Gym	1		Toilet Compartment	Accessible Compartment

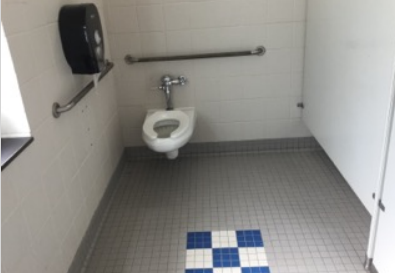
Flush control not on open side Non-compliant toilet paper dispenser	- -	Provide the flush control on the open side of the toilet (transfer side). Relocate toilet paper so that it is 24" min. high, located under the grab bar, and between 7" and 9" from the front of the toilet.	1	630	\$630

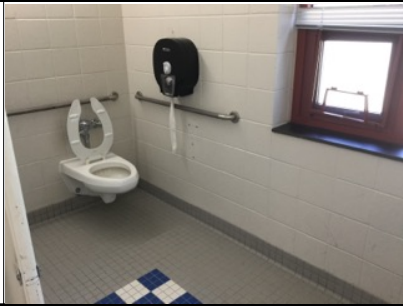
ID	Location	Floor	Room	Element	Type	Photo	Issues	Current Measure	Recommendations	Quantity	Price	Cost Estimation
76	Boys' Toilet Room by the Gym	1		Toilet Compartment	Accessible Compartment

Non-compliant toilet paper dispenser		Relocate toilet paper so that it is 24" min. high, located under the grab bar, and between 7" and 9" from the front of the toilet.	1	256	\$256
Dispensers												
77	Health Office	1		Dispensers	Paper Towel Dispenser

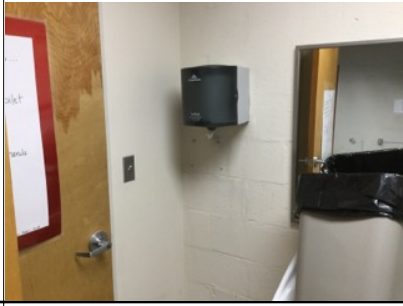
Controls > 42" high Dispenser acts as a protruding object	54.5" -	Relocate paper towel dispenser so the operable part is 42" max. above the finished floor. Relocate dispenser out of the circulation path.	1	256	\$256
78	Boys' and Girls' Toilet Rooms by Room 27	1		Dispensers	Paper Towel Dispenser

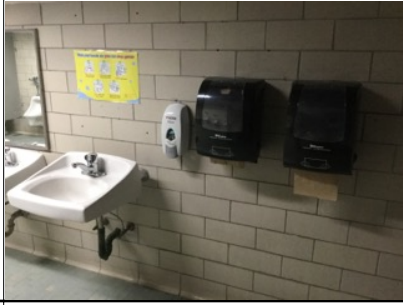
Dispenser acts as a protruding object	-	Relocate paper towel dispensers out of the circulation path.	4	353	\$1412
79	Girls' Toilet Room Near Classroom 8	1		Dispensers	Paper Towel Dispenser

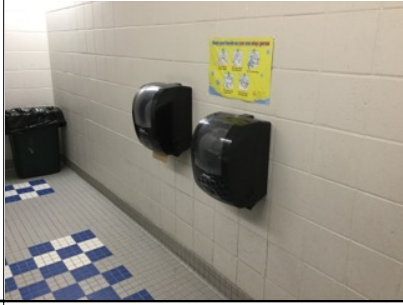
Dispenser acts as a protruding object	10"	Relocate higher paper towel dispenser out of the circulation path. Alternatively, lower it so that the bottom edge is at 27" max.	1	256	\$256

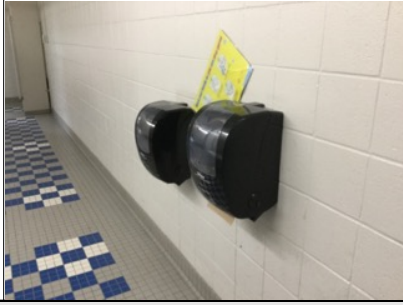
Dispenser acts as a protruding object	-	Relocate dispensers out of the circulation path. Alternatively, lower them so that the bottom edge is at 27" max.	2	256	\$512
Toilet Rooms for Children

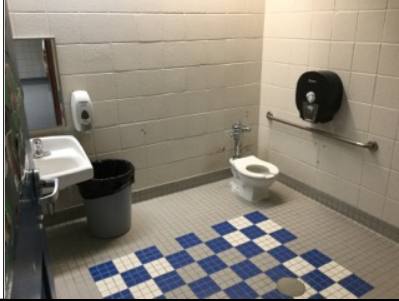
ID	Location	Floor	Room	Element	Type	Photo	Issues	Current Measure	Recommendations	Quantity	Price	Cost Estimation
Single-User Toilet (Children)												
81	Kindergarten Toilet Room	1		Single-User Toilet (Children)	N/A

Toilet seat < 12" or > 15" high (K - 3) Side or rear grab bar < 42" long Non-compliant toilet paper dispenser	10.5" 0 -	Install a toilet with a seat between 12"- 15" high above the finished floor. Provide a rear wall grab bar that is 42" long located 6" max. from the interior corner. Relocate toilet paper dispenser so that it is between 14"- 19" above the floor and between 7"- 9" in front of the toilet. Ensure dispensers and other devices are not mounted above grab bars.	1	3417	\$3417
Toilet Compartment (Children)												
82	Boys' Toilet Room by Room 27	1		Toilet Compartment (Children)	Accessible Compartment

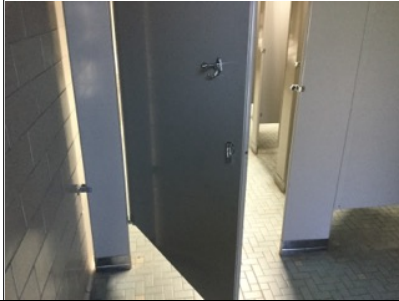
Door with non-compliant hardware Coat hook not within reach range	- 51"	Provide hardware that can be operable with one hand and not require tight grasping, pinching, or twisting of the wrist. Lower hook so that it is no higher than 44" for children ages 9-12.	1	220	\$220

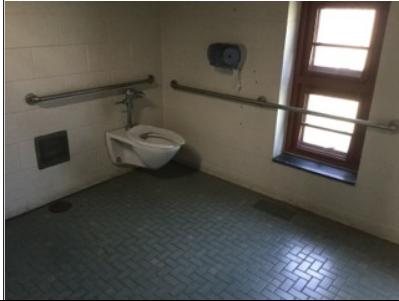
83	Boys' Toilet Room by Room 27	1		Toilet Compartment (Children)	Accessible Compartment

Side or rear grab bar < 25" or > 27" high (Ages 9 - 12) Non-compliant toilet paper dispenser	32.5" 30" -	Relocate both grab bars to 25"- 27" above the floor. Relocate toilet paper dispenser so that it is between 14"- 19" above the floor and between 7"- 9" in front of the toilet. Ensure dispensers and other devices are not mounted above grab bars.	1	768	\$768
84	Girls' Toilet Room by Room 27	1		Toilet Compartment (Children)	Accessible Compartment

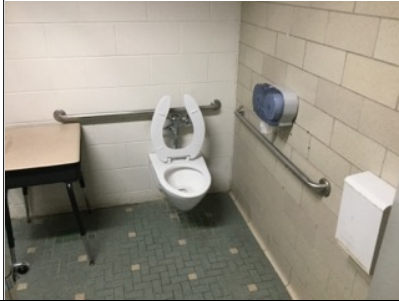
Non-compliant toilet paper dispenser Clearance at toilet < 60" clear width	- -	Relocate toilet paper dispenser so that it is between 14"- 19" above the floor and between 7"- 9" in front of the toilet. Ensure dispensers and other devices are not mounted above grab bars. Remove desk.	1	353	\$353
Lavatory (Children)												
85	Boys' Toilet Room by Room 27	1		Lavatory (Children)	N/A

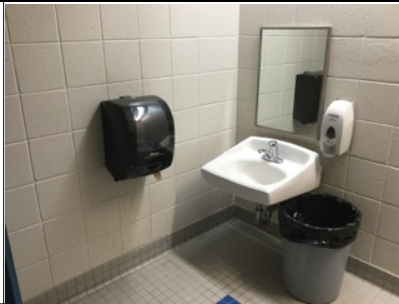
ID	Location	Floor	Room	Element	Type	Photo	Issues	Current Measure	Recommendations	Quantity	Price	Cost Estimation
86	Kindergarten Toilet Room	1		Lavatory (Children)	N/A

Exposed plumbing underneath		Insulate or otherwise configure pipes to prevent contact at lavatory.	1	92	\$92
87	Girls' Toilet Room by Room 27	1		Lavatory (Children)	N/A

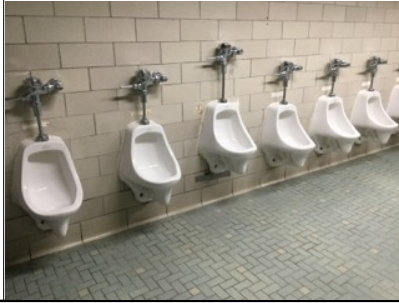
Rim > 15" high (MAAB)	18"	Provide at least one urinal with the rim no higher than 15" above the finished floor.	1	3248	\$3248
Additional Access												
Drinking Fountains												
89	Drinking Fountain Next to Boys' Toilet Room by Room 27	1		Drinking Fountains	Low

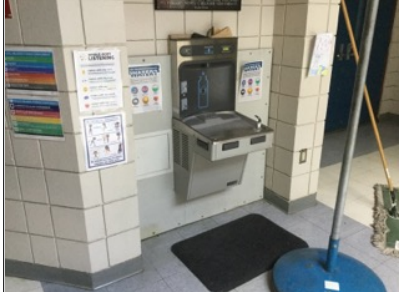
90	Fountain Next to Gym	1		Drinking Fountains	Low

No drinking fountain provided for standing users	-	Provide an additional drinking fountain for standing users.	1	4028	\$4028

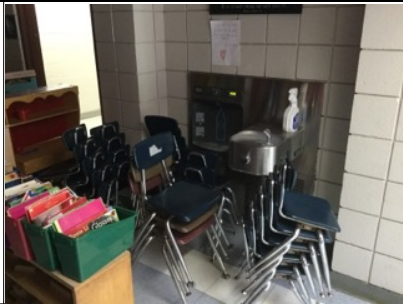
ID	Location	Floor	Room	Element	Type	Photo	Issues	Current Measure	Recommendations	Quantity	Price	Cost Estimation
91	Drinking Fountain Between Toilet Rooms Near Classroom 8	1		Drinking Fountains	Low

No drinking fountain provided for standing users		Provide an additional drinking fountain for standing users.	1	4028	\$4028
92	Fountain Next to Cafeteria	1		Drinking Fountains	Low

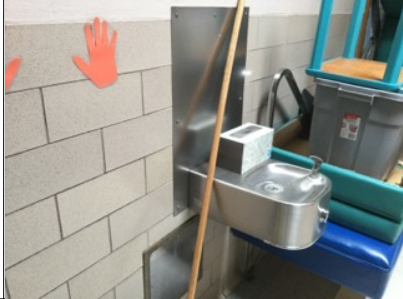
No drinking fountain provided for standing users	-	Provide an additional drinking fountain for standing users.	1	4028	\$4028
93	Drinking Fountain by Kitchen Area	1		Drinking Fountains	Low

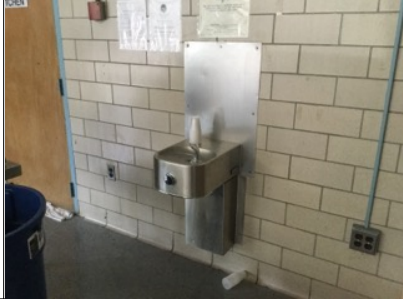
No drinking fountain provided for standing users	-	Install a Hi-Lo drinking fountain.	1	4216	\$4216
94	Drinking Fountain at Playground	Ext.		Drinking Fountains	Low

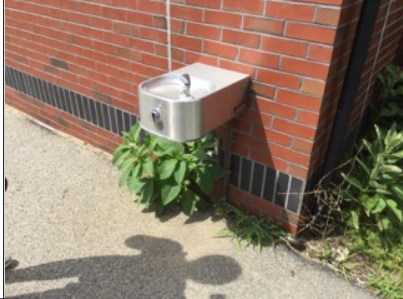
No drinking fountain provided for standing users	-	Provide an additional drinking fountain for standing users.	1	4028	\$4028
Sink												
95	Health Office	1		Sink	Other

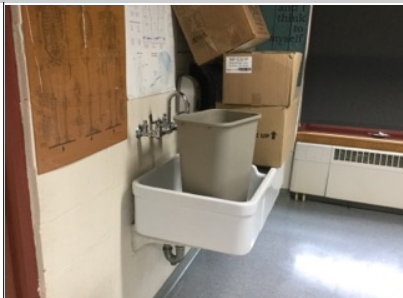
Exposed plumbing underneath sink	-	Insulate or otherwise configure pipes at sink.	1	92	\$92

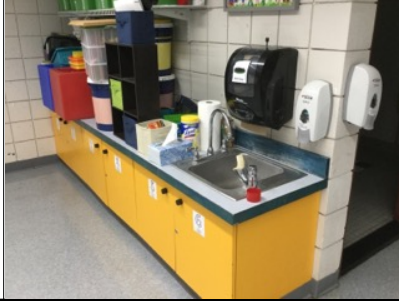
Non-compliant or malfunctioning faucet Exposed plumbing underneath Knee or toe clearance not provided	- - -	Provide a faucet that can be operable with one hand and not require tight grasping, pinching or twisting of the wrist for at least one sink. Insulate or otherwise configure pipes to prevent contact at the sink. Provide at least one sink with 24" high knee and toe clearance positioned for a forward approach.	1	2764	\$2764
97	Grade 4 Classroom	1	12	Sinks for Children's Use	Classroom

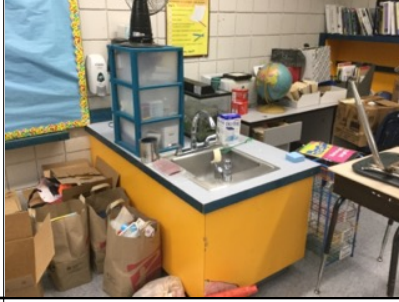
Non-compliant or malfunctioning faucet Exposed plumbing underneath Knee or toe clearance not provided	- - -	Provide a faucet that can be operable with one hand and not require tight grasping, pinching or twisting of the wrist for at least one sink. Insulate or otherwise configure pipes to prevent contact at the sink. Provide at least one sink with 24" high knee and toe clearance positioned for a forward approach.	1	2764	\$2764

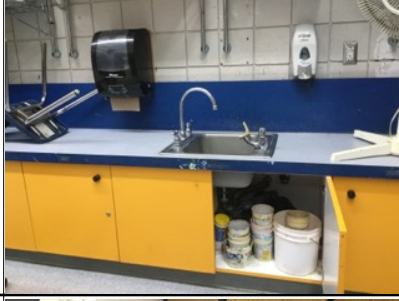
98	Art Room	1	13	Sinks for Children's Use	Classroom

Non-compliant or malfunctioning faucet Exposed plumbing underneath Knee or toe clearance not provided	- - -	Provide a faucet that can be operable with one hand and not require tight grasping, pinching or twisting of the wrist for at least one sink. Insulate or otherwise configure pipes to prevent contact at the sink. Provide at least one sink with 24" high knee and toe clearance positioned for a forward approach.	1	2764	\$2764
99	Learning Center	1	21	Sinks for Children's Use	Classroom

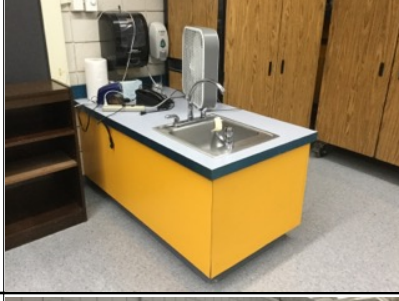
Non-compliant or malfunctioning faucet Exposed plumbing underneath Knee or toe clearance not provided	- - -	Provide a faucet that can be operable with one hand and not require tight grasping, pinching or twisting of the wrist for at least one sink. Insulate or otherwise configure pipes to prevent contact at the sink. Provide at least one sink with 24" high knee and toe clearance positioned for a forward approach.	1	2764	\$2764

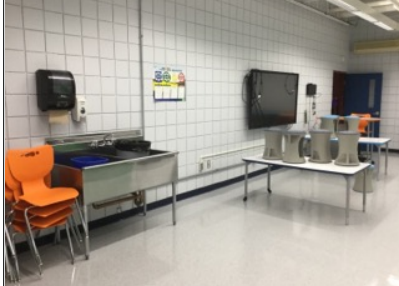
100	Learning Studio	1	22	Sinks for Children's Use	Classroom

Non-compliant or malfunctioning faucet Exposed plumbing underneath Knee or toe clearance not provided	- - -	Provide a faucet that can be operable with one hand and not require tight grasping, pinching or twisting of the wrist for at least one sink. Insulate or otherwise configure pipes to prevent contact at the sink. Provide at least one sink with 24" high knee and toe clearance positioned for a forward approach.	1	2764	\$2764

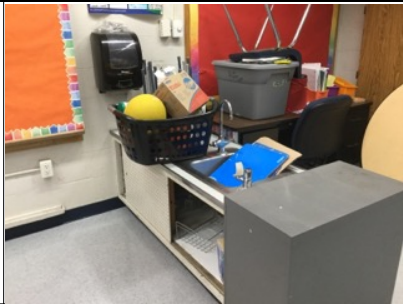
Non-compliant or malfunctioning faucet Exposed plumbing underneath Knee or toe clearance not provided	- - -	Provide a faucet that can be operable with one hand and not require tight grasping, pinching or twisting of the wrist for at least one sink. Insulate or otherwise configure pipes to prevent contact at the sink. Provide at least one sink with 24" high knee and toe clearance positioned for a forward approach.	1	2764	\$2764
102	Grade 2 Classroom	1	26	Sinks for Children's Use	Classroom

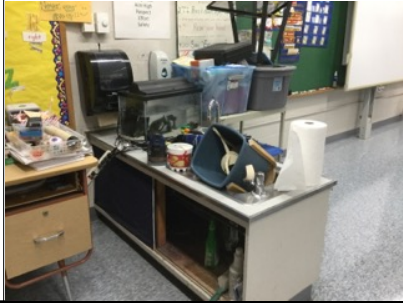
Non-compliant or malfunctioning faucet Exposed plumbing underneath Knee or toe clearance not provided	- - -	Provide a faucet that can be operable with one hand and not require tight grasping, pinching or twisting of the wrist for at least one sink. Insulate or otherwise configure pipes to prevent contact, for at least one sink. Provide at least one sink with 24" high knee and toe clearance positioned for a forward approach.	1	2764	\$2764

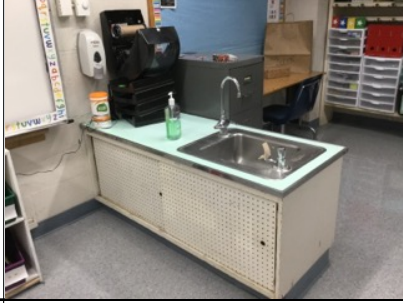
103	Grade 1 Classroom	1	27	Sinks for Children's Use	Classroom

Non-compliant or malfunctioning faucet Exposed plumbing underneath Knee or toe clearance not provided	- - -	Provide a faucet that can be operable with one hand and not require tight grasping, pinching or twisting of the wrist for at least one sink. Insulate or otherwise configure pipes to prevent contact at the sink. Provide at least one sink with 24" high knee and toe clearance positioned for a forward approach.	1	2764	\$2764
104	Math and Literacy	1	28	Sinks for Children's Use	Other

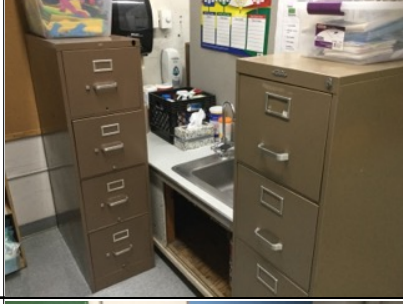
Non-compliant or malfunctioning faucet Exposed plumbing underneath Knee or toe clearance not provided	- - -	Provide a faucet that can be operable with one hand and not require tight grasping, pinching or twisting of the wrist for at least one sink. Insulate or otherwise configure pipes to prevent contact, for at least one sink. Provide at least one sink with 24" high knee and toe clearance positioned for a forward approach.	1	2764	\$2764

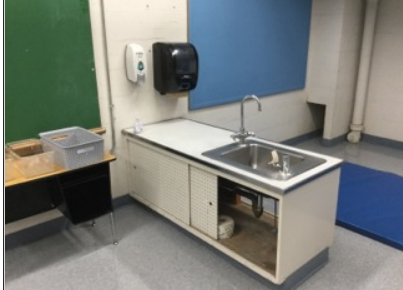
105	Special Room	1	31	Sinks for Children's Use	Classroom

Non-compliant or malfunctioning faucet Exposed plumbing underneath Knee or toe clearance not provided	- - -	Provide a faucet that can be operable with one hand and not require tight grasping, pinching or twisting of the wrist for at least one sink. Insulate or otherwise configure pipes to prevent contact at the sink. . Provide at least one sink with 24" high knee and toe clearance positioned for a forward approach.	1	2764	\$2764

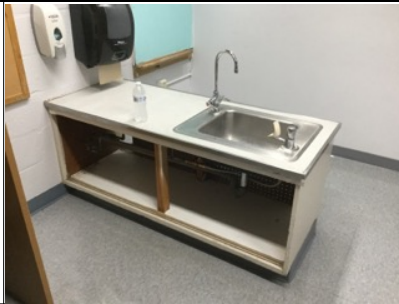
Non-compliant or malfunctioning faucet Exposed plumbing underneath Knee or toe clearance not provided	- - -	Provide a faucet that can be operable with one hand and not require tight grasping, pinching or twisting of the wrist for at least one sink. Insulate or otherwise configure pipes to prevent contact, for at least one sink. Provide at least one sink with 24" high knee and toe clearance positioned for a forward approach.	1	2764	\$2764
107	Special Room	1	33	Sinks for Children's Use	Other

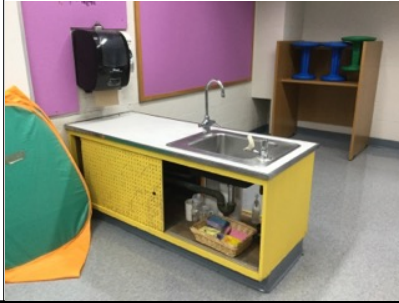
Non-compliant or malfunctioning faucet Exposed plumbing underneath Knee or toe clearance not provided	- - -	Provide a faucet that can be operable with one hand and not require tight grasping, pinching or twisting of the wrist for at least one sink. Insulate or otherwise configure pipes to prevent contact at the sink. Provide at least one sink with 24" high knee and toe clearance positioned for a forward approach.	1	2764	\$2764

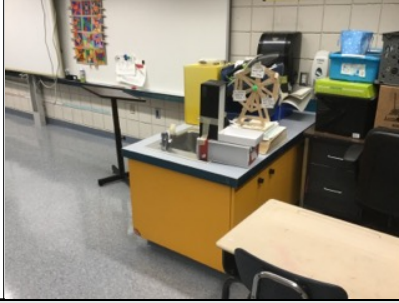
108	Grade 5 Classroom	1	8	Sinks for Children's Use	Classroom

Non-compliant or malfunctioning faucet Exposed plumbing underneath Knee or toe clearance not provided	- - -	Provide a faucet that can be operable with one hand and not require tight grasping, pinching or twisting of the wrist for at least one sink. Insulate or otherwise configure pipes to prevent contact, for at least one sink. Provide at least one sink with 24" high knee and toe clearance positioned for a forward approach.	1	2764	\$2764
Play and Sport Areas												
Field												
109	Soccer Field	Ext.		Field	Soccer

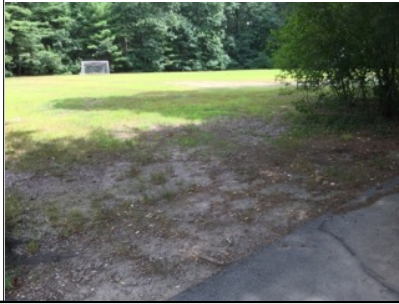
Field not connected to an accessible route	-	Provide an accessible route to the field. (Cost estimate for 30' long by 4' wide stone dust walkway.)	1	960	\$960
Overall Review												
110	New Playground	Ext.

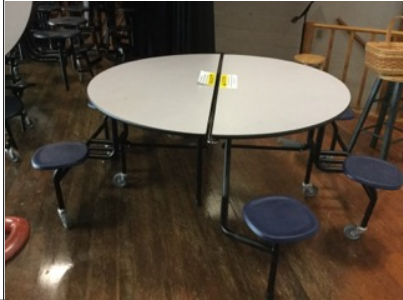
ID	Location	Floor	Room	Element	Type	Photo	Issues	Current Measure	Recommendations	Quantity	Price	Cost Estimation
Best Practice												
111	Cafeteria, Accessible Table	1

This is a good example of a table with knee and toe clearance.	1	-	\$0
112	Stage Steps	1
