Nixon Elementary School

Town of Sudbury ADA Transition Plan

January 2021

Institute for Human Centered Design

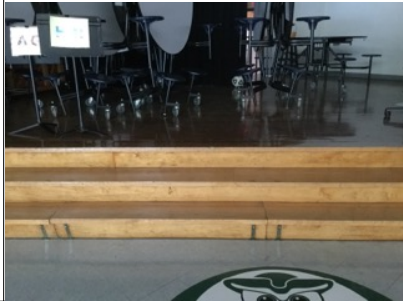
-	Recommend providing handrails on each side.	1	-	\$0
113	Principal's Office	1

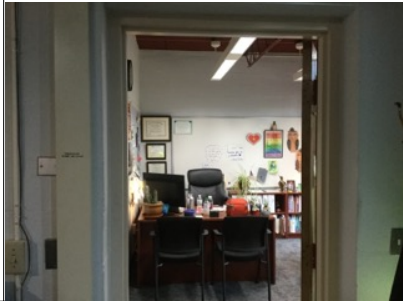
Recommend providing signs with raised characters and braille at permanent rooms where no sign is present.	1	-	\$0
114	Playground	Ext.

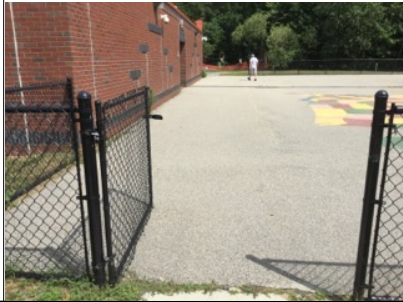
Recommend providing a 10" high solid surface (kickplate) on the push side of the gate.	1	-	\$0
115	Chess Picnic Table by the New Playground	Ext.

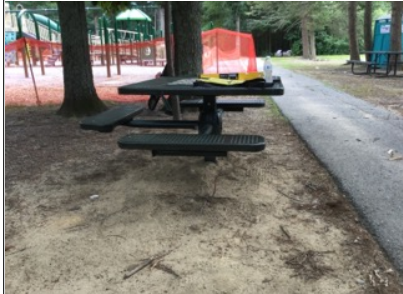
-	Recommend providing a 48" wide accessible route around the accessible picnic table.	1	-	\$0

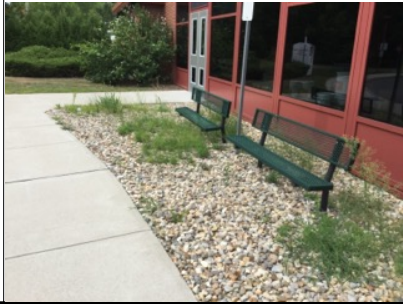
ID	Location	Floor	Room	Element	Type	Photo	Issues	Current Measure	Recommendations	Quantity	Price	Cost Estimation
116	Benches in Front of Cafeteria	Ext.

-	Recommend providing a 36" x 48" space alongside one bench positioned so that a person using a wheelchair can sit shoulder to shoulder with someone seated on the bench. Recommend providing a variety of benches, including benches with backs and armrests.	1	-	\$0
