Curtis Middle School

Town of Sudbury ADA Transition Plan

January 2021

Institute for Human Centered Design

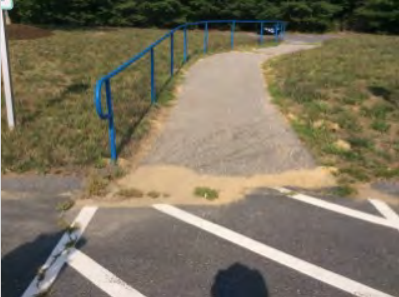
ID	Location	Floor	Room	Element	Type	Photo	Issues	Current Measure	Recommendations	Quantity	Price	Cost Estimation
Approach and Entrance												
Exterior Access Route												
1	Parking 1 Lower Level A Opposite Main Entrance	Ext.		Exterior Access Route	Walkway

Running slope > 1:20 (5%)	12.4%	Reduce running slope to be no steeper than 1:20 (5%). (Cost based on adding asphalt to reduce slope at base of walkway.)	1	480	\$480
2	Parking 1 Lower Level B	Ext.		Exterior Access Route	Walkway

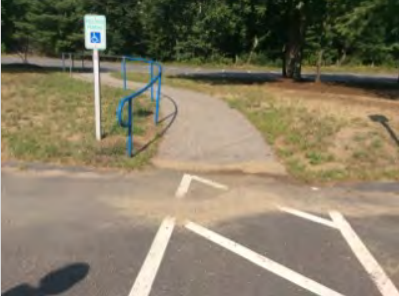
Running slope > 1:20 (5%)	15.7%	Reduce running slope to be no steeper than 1:20 (5%). (Cost based on adding asphalt to reduce slope at base of walkway.)	1	480	\$480
3	Egress Door 13	Ext.		Exterior Access Route	Walkway

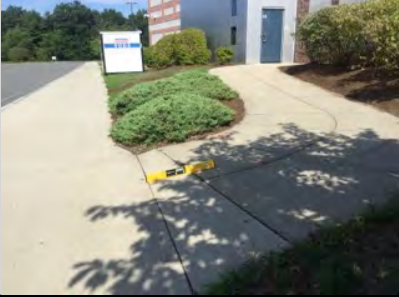
Running slope > 1:20 (5%)	12%	Reduce running slope to be no steeper than 1:20 (5%). (Cost for adding concrete to correct pathway running slope.)	1	240	\$240
4	Egress Door 10	Ext.		Exterior Access Route	Exterior

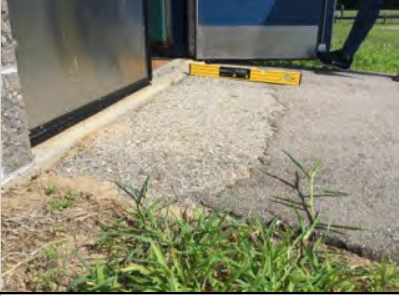
Running slope > 1:20 (5%)	6.3%	Reduce running slope to 1;50 (2.00%) max. at door landing. (Cost for adding asphalt to correct pathway running slope.)	1	240	\$240

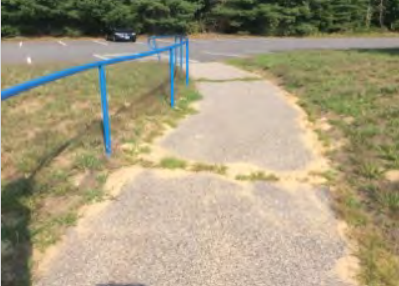
5	Parking 1 Opposite Main Entrance	Ext.		Exterior Access Route	Walkway

Route not maintained in operable working condition	-	Ensure the accessible route is maintained in operable working condition.	1	Labor	\$0

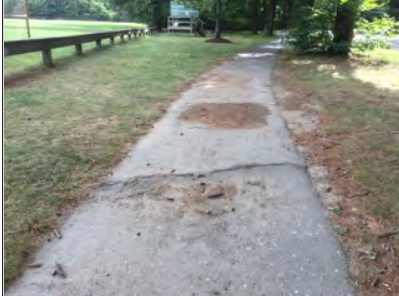
ID	Location	Floor	Room	Element	Type	Photo	Issues	Current Measure	Recommendations	Quantity	Price	Cost Estimation
6	Path Leading to Sitting Area at the Softball Field	Ext.		Exterior Access Route	Walkway

Route not maintained in operable working condition	-	Ensure the accessible route is maintained in operable working condition.	1	Labor	\$0
7	Main Entrance-Fire Box	Ext.		Exterior Access Route	Exterior

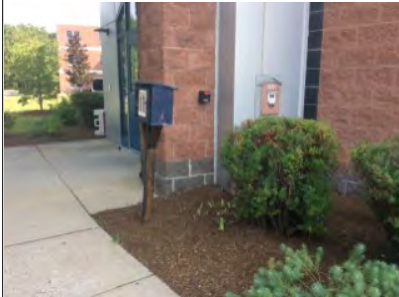
Accessible route not provided	-	Ensure an accessible route is provided. (Cost based on a 4' wide min. x 6' concrete route to fire box.)	1	384	\$384
8	Bike Racks	Ext.		Exterior Access Route	Walkway

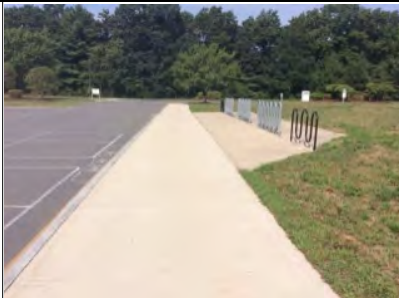
Accessible route not provided	7.9%	Ensure an accessible route is provided. Reduce running slope at bike rack to 1:50 (2.00%) in all directions. (Cost based on adding concrete at bike rack to reduce slope.)	1	240	\$240
Off-Street Parking Lot or Garage												
9	Parking 1 Lower Level A Opposite Main Entrance	Ext.		Off-Street Parking Lot or Garage	N/A

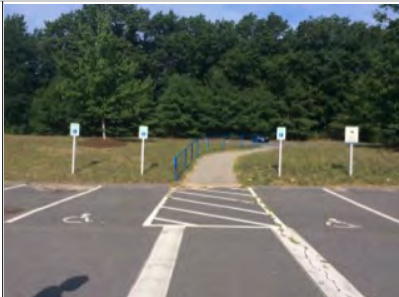
Total # of parking Total # of designated accessible parking spaces Total # of designated van accessible spaces Sign does not have the designation "Van Accessible" Sign bottom < 60" above finished grade	225 3 1 - 53"	Add the designation "Van Accessible" to the sign located at the van accessible space. Locate sign with the bottom of the sign 60" above the ground.	1	500	\$500

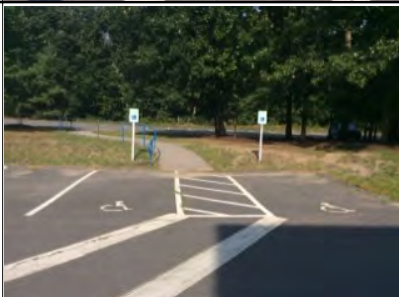
10	Parking 1 Lower Level B	Ext.		Off-Street Parking Lot or Garage	N/A

Total # of designated accessible parking spaces Total # of designated van accessible spaces Sign does not have the designation "Van Accessible" Sign bottom < 60" above finished grade	1 1 - 54"	Add the designation "Van Accessible" to the sign located at the van accessible space. Locate sign with the bottom of the sign 60" above the ground.	1	500	\$500

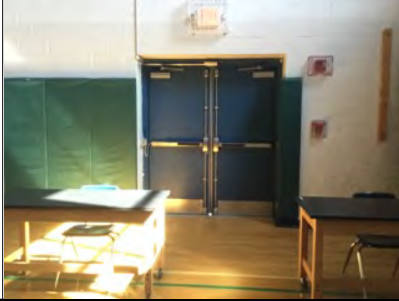
ID	Location	Floor	Room	Element	Type	Photo	Issues	Current Measure	Recommendations	Quantity	Price	Cost Estimation
Emergency Exit												
11	Egress Door 9	1		Emergency Exit	N/A

Tactile sign not provided at emergency exit Tactile sign not provided at exit	-	Provide tactile exit signs with raised characters and braille at exit doors. Mount signs between 48"- 60" above the finished floor located on the latch side of the door.	1	232	\$232
12	Egress Door 5	1		Emergency Exit	N/A

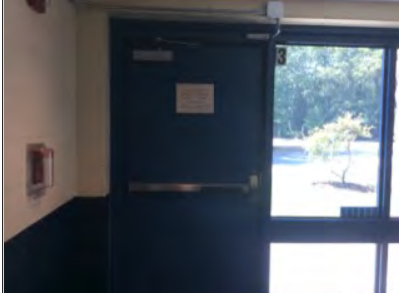
Tactile exit sign not provided	-	Ensure tactile exit signs with raised characters and braille are provided at exit doors. Mount signs between 48"- 60" above the finished floor located on the latch side of the door.	1	232	\$232

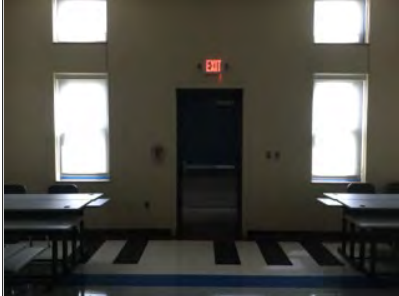
ID	Location	Floor	Room	Element	Type	Photo	Issues	Current Measure	Recommendations	Quantity	Price	Cost Estimation
16	Music Lab/ Electronic Room	1	175	Means of Egress	N/A

Tactile exit sign not provided	-	Ensure tactile exit signs with raised characters and braille are provided at exit doors. Mount signs between 48"- 60" above the finished floor located on the latch side of the door.	1	232	\$232
17	Egress Door 15	1		Means of Egress	N/A

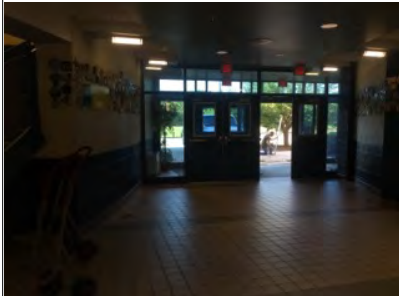
Tactile exit sign not provided Illuminated ISA symbol not provided (MAAB)	- -	Ensure tactile exit signs with raised characters and braille are provided at exit doors. Mount signs between 48"- 60" above the finished floor located on the latch side of the door. Provide an illuminated sign with the International Symbol of Accessibility.	1	432	\$432
18	Auditorium Egress Door 14	1	1320	Means of Egress	N/A

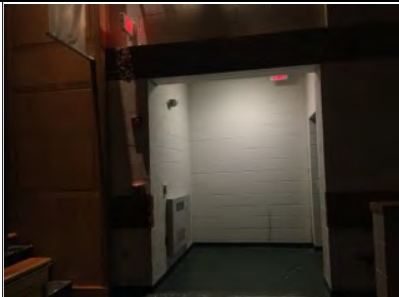
Tactile exit sign not provided Illuminated ISA symbol not provided (MAAB)	- -	Ensure tactile exit signs with raised characters and braille are provided at exit doors. Mount signs between 48"- 60" above the finished floor located on the latch side of the door. Provide an illuminated sign with the International Symbol of Accessibility.	1	432	\$432

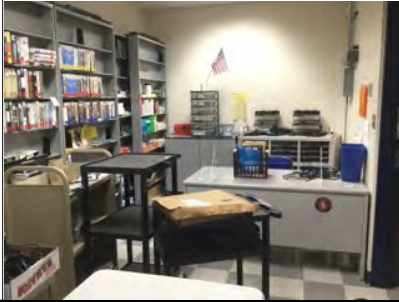
Route < 36" wide	-	Ensure that a clear width of 36" min. is maintained at the accessible route.	1	Labor	\$0
23	Corridor Leading to More Counselor's Offices	2		Interior Access Route	N/A

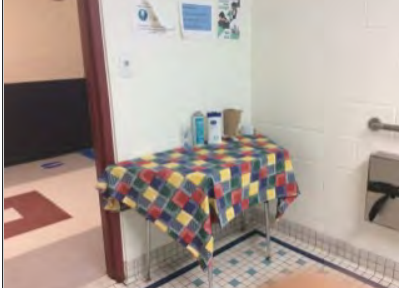
Doors, Doorways, & Gates												
25	Single-User Toilet Room	1		Doors, Doorways, & Gates	Toilet Room

Maneuvering clearance(s) not provided	-	Remove the table to provide 18" min. pull-side maneuvering clearance at door.	1	Labor	\$0

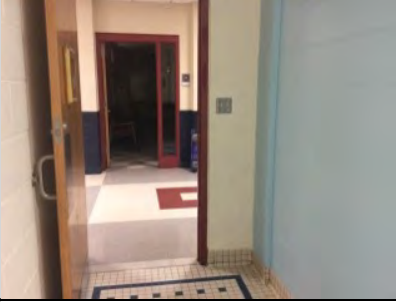
ID	Location	Floor	Room	Element	Type	Photo	Issues	Current Measure	Recommendations	Quantity	Price	Cost Estimation
26	Men's Toilet Room	1		Doors, Doorways, & Gates	Toilet Room

Maneuvering clearance(s) not provided	14.75"	Provide an automatic door opener.	1	3060	\$3060
27	Principal's Office	1		Doors, Doorways, & Gates	Office

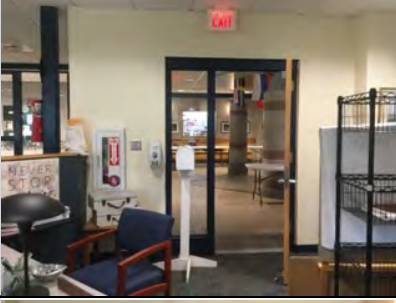
Maneuvering clearance(s) not provided	-	Remove the mailbox to provide 18" min. pull-side maneuvering clearance at door.	1	Labor	\$0
28	Stair 2	2		Doors, Doorways, & Gates	Circulation

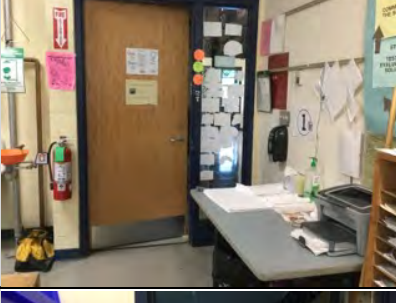
Maneuvering clearance(s) not provided	-	Remove the desk to provide maneuvering clearance.	1	Labor	\$0
30	Grade 6 Guidance Councilor	2		Doors, Doorways, & Gates	Office

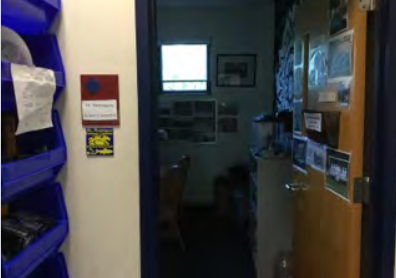
Maneuvering clearance(s) not provided	13.75"	Remove shelves to provide 18" min. pull-side maneuvering clearance at door.	1	Labor	\$0

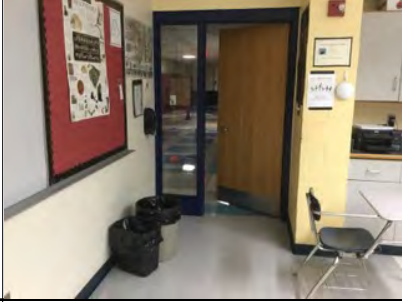
Maneuvering clearance(s) not provided	-	Remove trash can to provide 12" min. push-side maneuvering clearance at door.	1	Labor	\$0
32	Music Band	1	184	Doors, Doorways, & Gates	Classroom

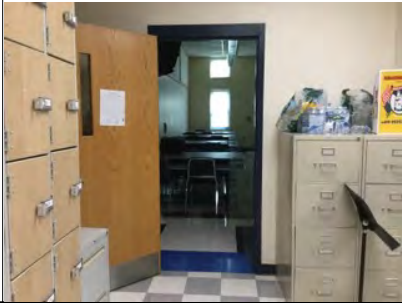
Maneuvering clearance(s) not provided	-	Remove file cabinet to provide 18" min. pull-side maneuvering clearance.	1	Labor	\$0
33	Reception	1		Doors, Doorways, & Gates	Other

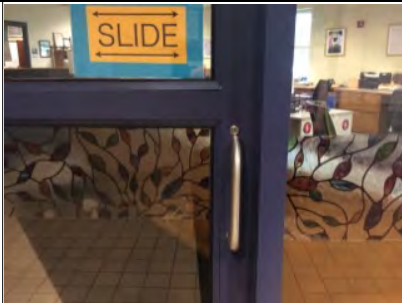
Hardware not operable with a closed fist	2"	Provide hardware that can be operable with one hand and not require tight grasping, pinching, or twisting of the wrist. Note: Adding an additional handle to the horizontal metal portion of the door above the existing hardware could result in a door opening solution that could be used without requiring tight grasping, pinching or twisting of the wrist.)	1	484	\$484

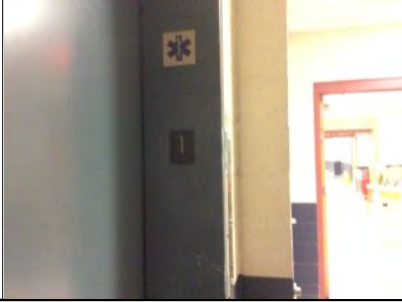
Tactile stars not provided at main entry level	-	Provide a tactile star on both sides of jambs at main floor. At other floors, provide appropriate number. Provide a tactile star at the main floor on the control panel within the car.	2	96	\$192
Signage												
37	Cafeteria	1		Signage	Designation

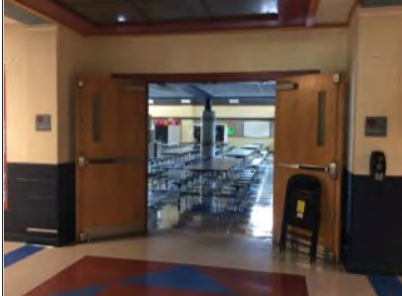
Raised characters not provided on sign Braille not provided on sign	- -	Provide text with raised characters duplicated in braille on sign.	1	232	\$232
38	Auditorium/ Gymnasium Doorway	1		Signage	Designation

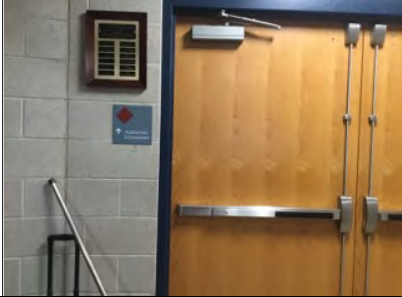
Raised characters not provided on sign Braille not provided on sign	- -	Provide text with raised characters duplicated in braille on sign.	1	232	\$232
39	Technology Center	2		Signage	Designation

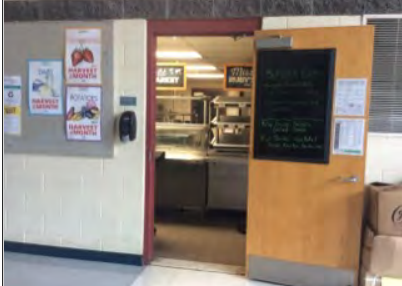
40	Kitchen	1		Signage	Designation

Braille not provided on sign	-	Provide braille on sign.	1	232	\$232

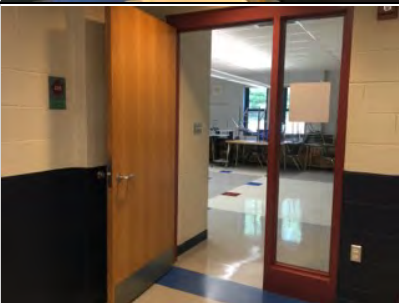
Sign not located on the latch side of the door	-	Locate sign at permanent rooms alongside the door on the latch side.	1	Labor	\$0
45	Grade 7 SpED LEAP	2	206	Signage	Designation

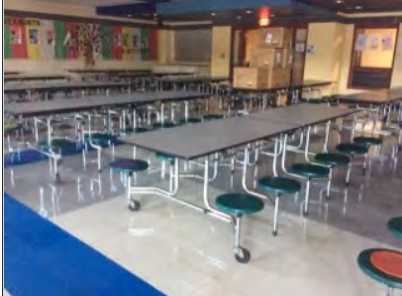
At least one or 5% accessible tables not provided	-	Ensure that at least 5% of dining or work surfaces are accessible.(Cost based on three accessible dining surfaces.)	3	1100	\$3300
48	Grade 8 Special Ed Skills	1	147	Dining or Work Surfaces	Work Surface

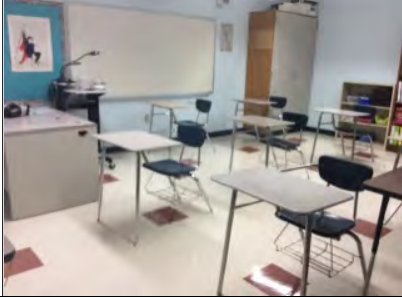
At least one or 5% accessible tables not provided	-	Ensure that at least one work surface is accessible.	1	700	\$700
49	Grade 6 SS Class	3	309	Dining or Work Surfaces	Work Surface

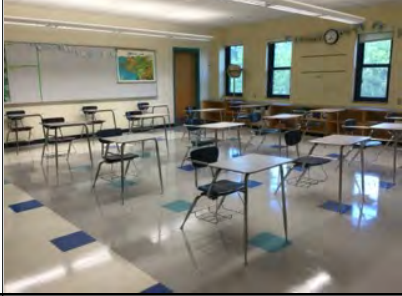
At least one or 5% accessible tables not provided	-	Ensure that at least one work surface is accessible.	1	700	\$700

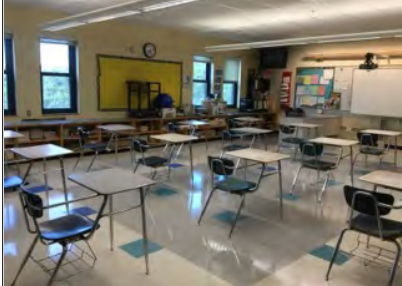
50	Grade 6 Science Class	3	306	Dining or Work Surfaces	Work Surface

At least one or 5% accessible tables not provided	-	Ensure that at least one work surface is accessible.	1	700	\$700

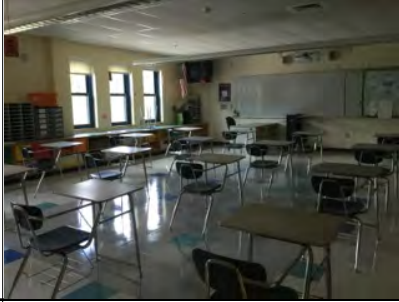
ID	Location	Floor	Room	Element	Type	Photo	Issues	Current Measure	Recommendations	Quantity	Price	Cost Estimation
51	Grade 6 ELA Class	3	318	Dining or Work Surfaces	Work Surface

At least one or 5% accessible tables not provided	-	Ensure that at least one work surface is accessible.	1	700	\$700
52	Computer Lab	2	269	Dining or Work Surfaces	Work Surface

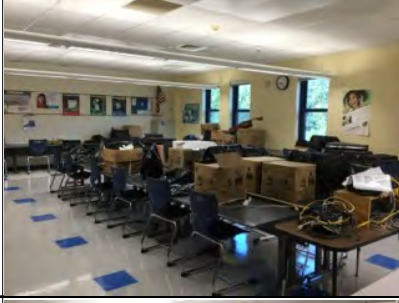
At least one or 5% accessible tables not provided	25.5"	Ensure that at least one work surface is accessible.	1	700	\$700
53	Grade 7 SpED LEAP	2	206	Dining or Work Surfaces	Work Surface

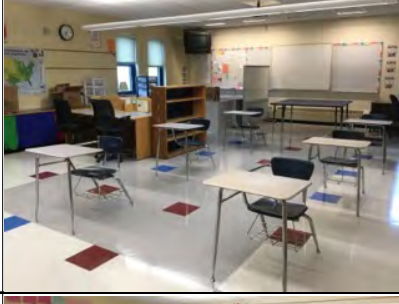
At least one or 5% accessible tables not provided	-	Ensure that at least one work surface is accessible.	1	700	\$700
54	Grade 7 ELA	2	212	Dining or Work Surfaces	Work Surface

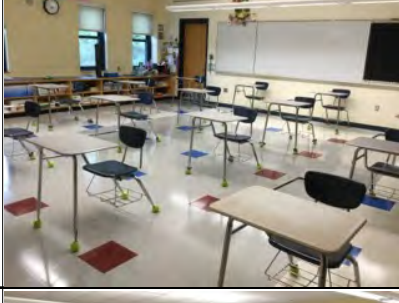
At least one or 5% accessible tables not provided	-	Ensure that at least one work surface is accessible.	1	700	\$700
55	Grade 7 SS	2	215	Dining or Work Surfaces	Work Surface

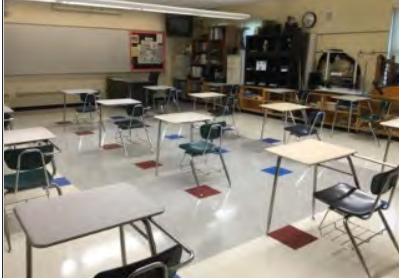
At least one or 5% accessible tables not provided	-	Ensure that at least one work surface is accessible.	1	700	\$700

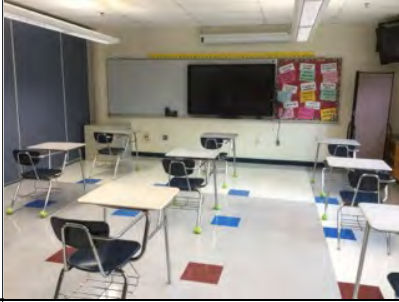
ID	Location	Floor	Room	Element	Type	Photo	Issues	Current Measure	Recommendations	Quantity	Price	Cost Estimation
56	Learning Center	2	221	Dining or Work Surfaces	Work Surface

At least one or 5% accessible tables not provided	-	Ensure that at least one work surface is accessible.	1	700	\$700
57	Music Lab/ Electronic Room	1	175	Dining or Work Surfaces	Work Surface

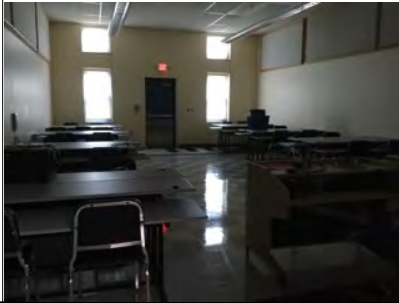
At least one or 5% accessible tables not provided	26"	Ensure that at least one work surface is accessible.	1	700	\$700
Assembly Area												
58	Auditorium	1	1320	Assembly Area	N/A

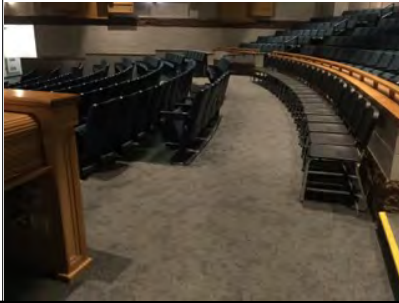
Assistive listening devices not provided	-	If audible communication is integral to the use of the space, provide an assistive listening system.	1	1214	\$1214
59	Library	2		Assembly Area	N/A

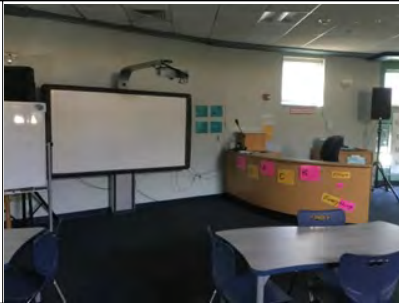
Assistive listening devices not provided	-	If audible communication is integral to the use of the space, provide an assistive listening system.	1	1214	\$1214

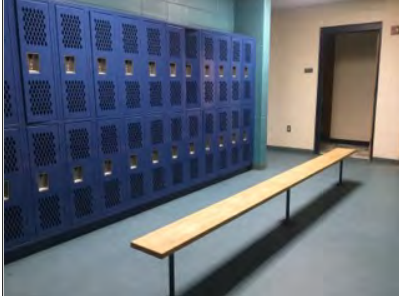
ID	Location	Floor	Room	Element	Type	Photo	Issues	Current Measure	Recommendations	Quantity	Price	Cost Estimation
61	Men's Locker Room	1		Locker Room	Men's

Back support not provided at bench	-	Provide at least one bench with back support or that is affixed to a wall with room on the side to transfer.	1	200	\$200
62	Women's Locker Room	1		Locker Room	Women's

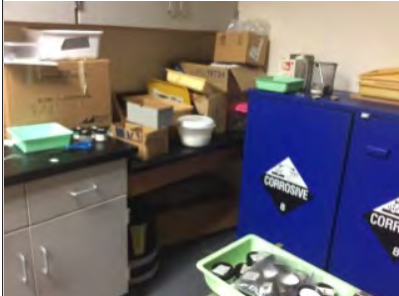
At least one (or 5%) acc. work surface not provided	24.25"	Alter so that 5% of work surfaces (at least one) are 28"- 34" above the floor with knee and toe clearance positioned for a forward approach.	1	880	\$880
64	Science Room	1		Laboratory	Other

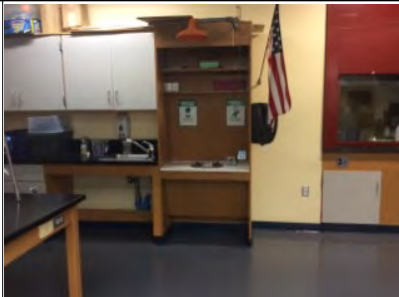
Emergency shower out of reach range	-	Lower the shower pull to 48" max. above the floor.	1	Labor	\$0

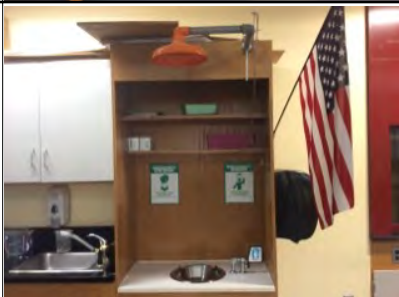
65	Science Room	1		Laboratory	Other

Emergency shower out of reach range	56"	Lower the shower pull to 48" max. above the floor.	1	Labor	\$0

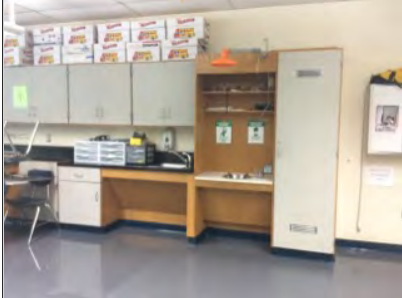
ID	Location	Floor	Room	Element	Type	Photo	Issues	Current Measure	Recommendations	Quantity	Price	Cost Estimation
66	Grade 8 Green Science	1	127	Laboratory	Other

Emergency shower out of reach range	58.75"	Lower the shower pull to 48" max. above the floor.	1	Labor	\$0
Picnic Tables												
67	Main Entrance	Ext.		Picnic Tables	N/A

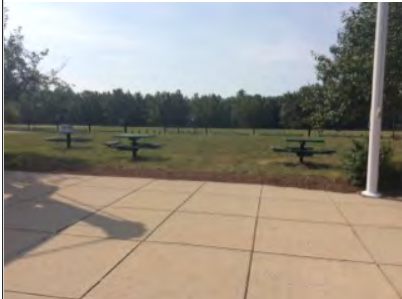
At least 5% accessible spaces not provided Picnic table not on an accessible route	- -	Ensure that at least 5% (minimum one) of picnic tables are accessible. Ensure that the accessible picnic table is connected to an accessible route.	1	1400	\$1400
Exterior Benches												
68	Bench at Bike Rack	Ext.		Exterior Benches	N/A

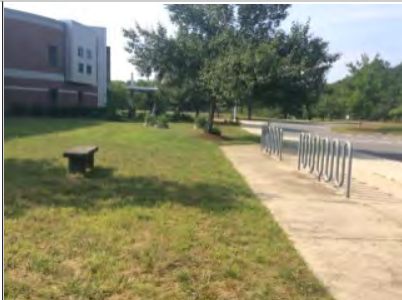
No accessible route to one bench in area	-	Relocate bench to an accessible route.	1	Labor	\$0
Toilet & Bathing Rooms												
Lavatory												
69	Women's Toilet Room Near Cafeteria and Locker Rooms	1		Lavatory	N/A

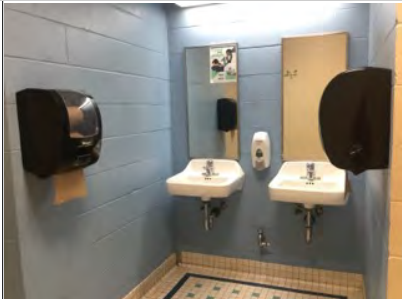
Clear floor space not provided at lavatory	-	Provide at least one lavatory with a 30" min. by 48" min. clear floor space positioned for a forward approach. (Relocate the paper towel dispenser out of the clear floor space in front of the lavatory that is made accessible.)	1	353	\$353

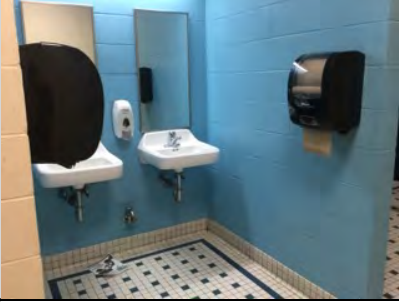
ID	Location	Floor	Room	Element	Type	Photo	Issues	Current Measure	Recommendations	Quantity	Price	Cost Estimation
70r	Men's Toilet Room Near Cafeteria and Locker Rooms	1		Lavatory	N/A

Clear floor space not provided at lavatory	- -	Provide at least one lavatory with a 30" min. by 48" min. clear floor space positioned for a forward approach. (Relocate the paper towel dispenser out of the clear floor space in front of the lavatory that is made accessible.)	1	353	\$353
71	Men's Toilet Room	1		Lavatory	N/A

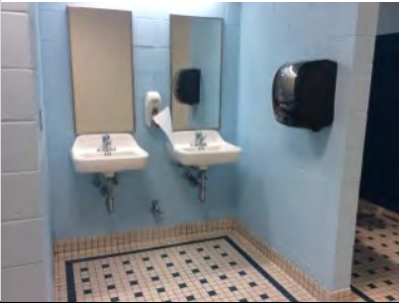
Plumbing underneath is exposed	-	Insulate or otherwise configure pipes to prevent contact for at least one lavatory.	1	92	\$92
72	Men's Locker Room	1		Lavatory	N/A

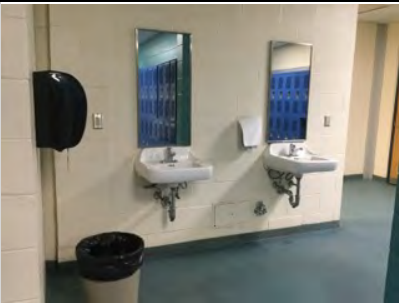
Plumbing underneath is exposed	-	Insulate or otherwise configure pipes to prevent contact for at least one lavatory.	1	92	\$92
73	Women's Locker Room	1		Lavatory	N/A

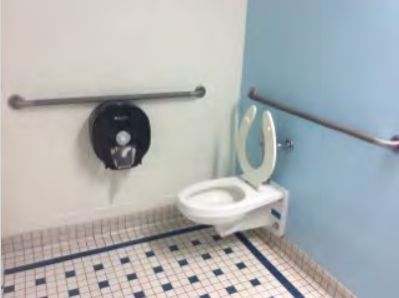
ID	Location	Floor	Room	Element	Type	Photo	Issues	Current Measure	Recommendations	Quantity	Price	Cost Estimation
Single-User Toilet												
75	Lavatory - Health Office	1		Single-User Toilet	N/A

Flush control not on open side	-	Relocate the flush control to the open side.	1	374	\$374
76	Single-User Toilet Room	1		Single-User Toilet	N/A

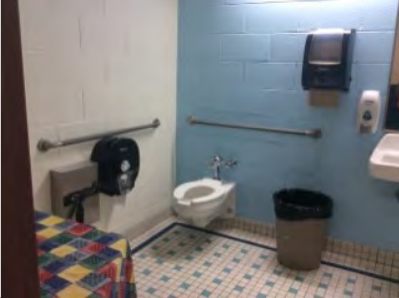
Flush control not on open side	-	Relocate the flush control to the open side.	1	374	\$374
77	Toilet Room 2 Section A	1		Single-User Toilet	N/A

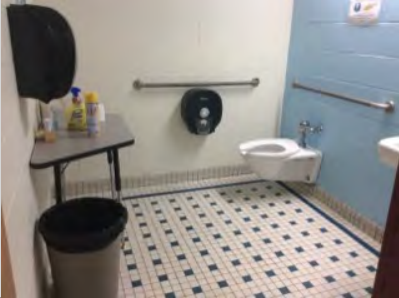
Flush control not on open side	-	Relocate the flush control to the open side.	1	374	\$374
78	Single-User Toilet Room	1		Single-User Toilet	N/A

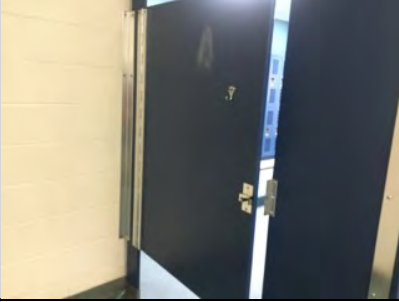
ID	Location	Floor	Room	Element	Type	Photo	Issues	Current Measure	Recommendations	Quantity	Price	Cost Estimation
80	Men's Locker Room Accessible Compartment	1		Toilet Compartment	Accessible Compartment

Door has malfunctioning self-closing hinge	-	Repair hinge.	1	Labor	\$0
81	Women's Toilet Room Near Cafeteria and Locker Rooms	1		Toilet Compartment	Accessible Compartment

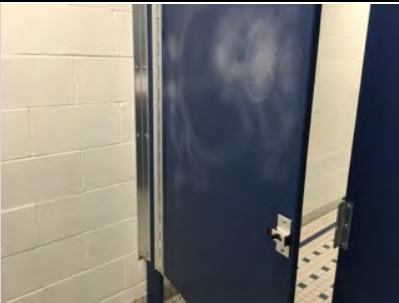
Door has malfunctioning self-closing hinge	-	Repair hinge.	1	Labor	\$0
88	Men's Toilet Room	2		Toilet Compartment	Accessible Compartment

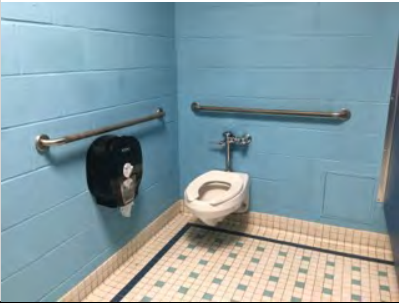
Flush control not on open side	-	Provide the flush control on the open side of the toilet (transfer side).	1	374	\$374
92	Women's Toilet Room	2		Toilet Compartment	Accessible Compartment

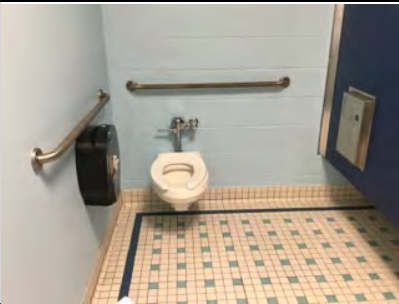
Flush control not on open side	-	Provide the flush control on the open side of the toilet (transfer side).	1	374	\$374
93	Women's Toilet Room	3		Toilet Compartment	Accessible Compartment

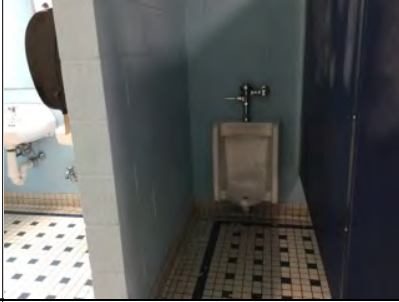
ID	Location	Floor	Room	Element	Type	Photo	Issues	Current Measure	Recommendations	Quantity	Price	Cost Estimation
95	Men's Toilet Room	3		Urinal	N/A

Urinal recessed > 24" has > 36" clear width	30.25"	If urinal is recessed greater than 24" ensure there is a clear width of 36".	1	353	\$353
96	Men's Toilet Room	2		Urinal	N/A

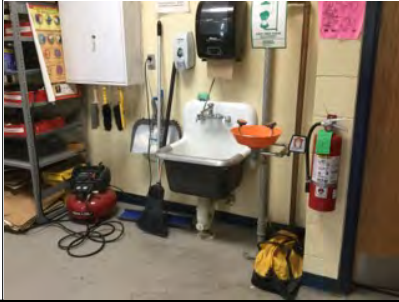
Controls > 42" high	50"	If it is used by students, relocate paper towel dispenser so the operable part is 42" max. above the finished floor.	1	256	\$256
98	Single-User Toilet Room	1		Dispensers	Paper Towel Dispenser

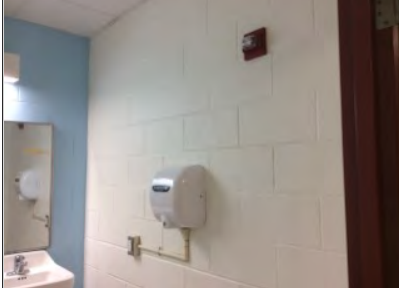
99	Single-User Toilet Room	1		Dispensers	Hand Dryer

Dispenser acts as a protruding object	-	Relocate dispenser out of the circulation path or provide a cane-detectible barrier under the dispenser.	1	306	\$306

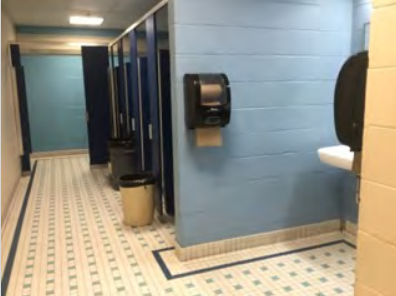
ID	Location	Floor	Room	Element	Type	Photo	Issues	Current Measure	Recommendations	Quantity	Price	Cost Estimation
100	Women's Toilet Room Near Cafeteria and Locker Rooms	1		Dispensers	Paper Towel Dispenser

Dispenser acts as a protruding object	-	Relocate dispenser out of the circulation path or provide a cane-detectible barrier.	1	306	\$306
101	Men's Toilet Room Near Cafeteria and Locker Rooms	1		Dispensers	Paper Towel Dispenser

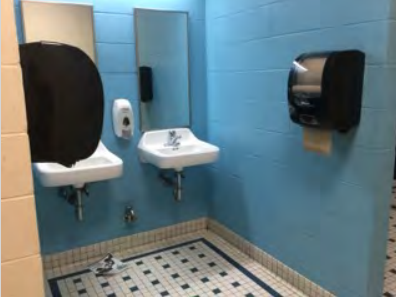
Dispenser acts as a protruding object	-	Relocate dispenser out of the circulation path or provide a cane-detectible barrier.	1	306	\$306
102	Men's Toilet Room	3		Dispensers	Paper Towel Dispenser

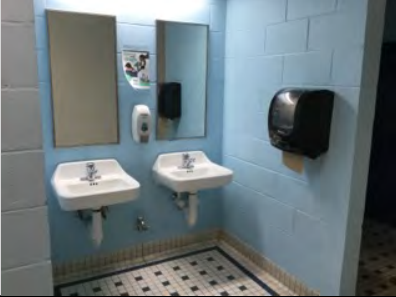
Dispenser acts as a protruding object	-	Relocate dispenser out of the circulation path or provide a cane-detectible barrier.	1	306	\$306
103	Women's Toilet Room	2		Dispensers	Paper Towel Dispenser

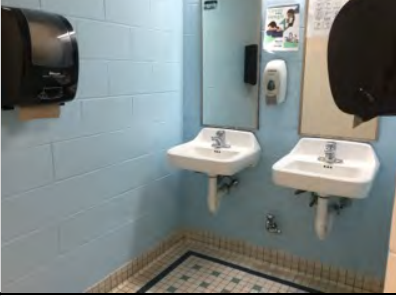
Dispenser acts as a protruding object	-	Relocate paper towel dispenser out of the circulation path or provide a cane-detectible barrier.	1	306	\$306

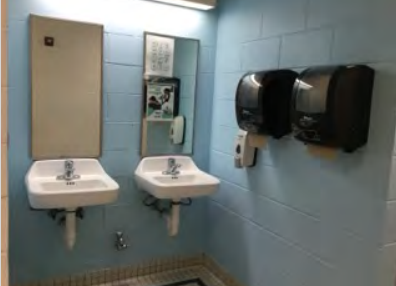
104	Men's Toilet Room	2		Dispensers	Paper Towel Dispenser

Dispenser acts as a protruding object	-	Relocate paper towel dispenser out of the circulation path or provide a cane-detectible barrier.	1	306	\$306

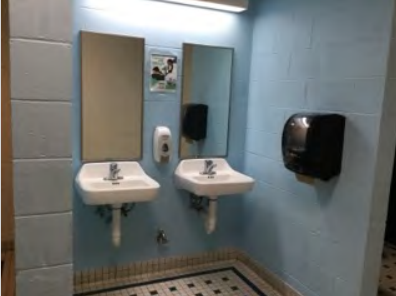
ID	Location	Floor	Room	Element	Type	Photo	Issues	Current Measure	Recommendations	Quantity	Price	Cost Estimation
105	Men's Toilet Room	2		Dispensers	Paper Towel Dispenser

Dispenser acts as a protruding object	-	Relocate paper towel dispenser out of the circulation path or provide a cane-detectible barrier.	1	306	\$306
106	Men's Toilet Room	1		Dispensers	Paper Towel Dispenser

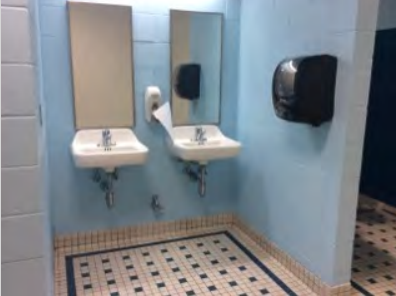
Dispenser acts as a protruding object	-	Relocate dispenser out of the circulation path or provide a cane-detectible barrier under the dispenser.	1	306	\$306
Shower Compartment												
107	Women's Locker Room	1		Shower Compartment	Roll-In Type

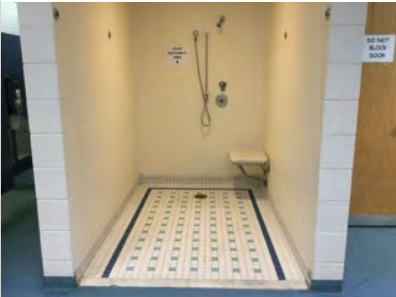
Grab bars not provided	-	Provide compliant grab bars. For a roll-in shower with a seat, grab bars shall be provided on the back wall and side wall opposite the seat.	1	898	\$898
108	Men's Locker Room	1		Shower Compartment	Roll-In Type

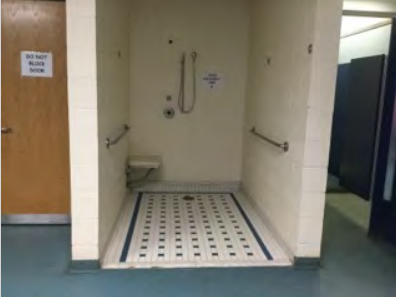
Grab bars not provided Grab bars mounted in wrong location	- -	Provide grab bar on back wall. Ensure grab bars are not provided over the seat. For a roll-in shower with a seat, grab bars shall be provided on the back wall and side wall opposite the seat.	1	1154	\$1154

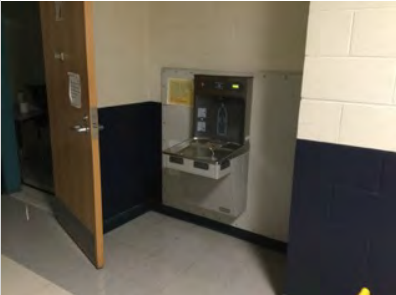
Additional Access												
Drinking Fountains												
109	Drinking Fountain Next to 301	3		Drinking Fountains	Low

No drinking fountain provided for standing users Knee or toe clearance not provided	- 25"	Provide an additional drinking fountain for standing users or install a Hi-Lo drinking fountain. Provide knee and toe clearance, 27" min. high at drinking fountain for seated users. (Cost based on a new Hi-Lo fountain.)	1	4216	\$4216

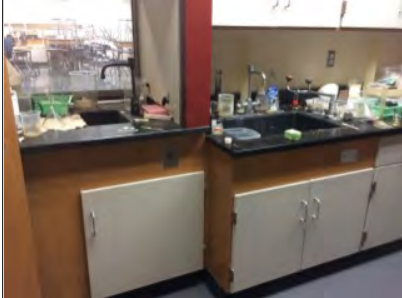
ID	Location	Floor	Room	Element	Type	Photo	Issues	Current Measure	Recommendations	Quantity	Price	Cost Estimation
Sink												
110	Science Prep	1		Sink	Lab

Toe and knee clearances not provided	-	If the sinks in this area are used by students, ensure there is a 27" knee clearance positioned for a forward approach at at least one sink in the lab.	1	1686	\$1686
111	Grade 7 Technology Engineering	2	260	Sink	Classroom

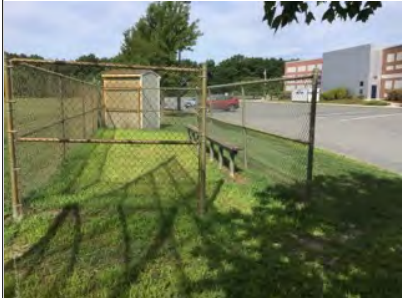
Accessible spaces not provided at team seating	-	Provide a firm, stable and slip resistant path and surface 48" wide min. to the baseball field team seating and at a 36" x 48" clear floor space by the team seating. (Cost based on an asphalt path and patch by the bench positioned to allow shoulder alignment with a person seated at the bench for someone using a wheeled mobility device.)	1	360	\$360

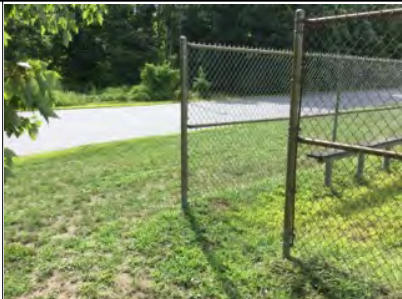
113	Baseball Team Seating 2	Ext.		Field	Baseball

Accessible spaces not provided at team seating	-	Provide a firm, stable and slip resistant path and surface 48" wide min. to the baseball field team seating and at a 36" x 48" clear floor space by the team seating. (Cost based on an asphalt path and patch by the bench positioned to allow shoulder alignment with a person seated at the bench for someone using a wheeled mobility device.)	1	360	\$360
114	Team Seating 1 at Softball Field	Ext.		Field	Softball

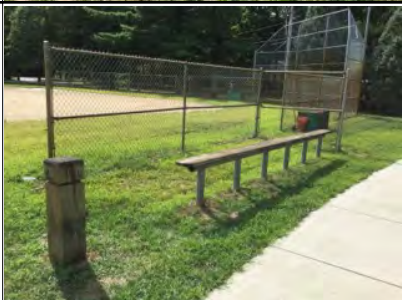
Accessible spaces not provided at team seating	-	Provide a firm, stable and slip resistant path and surface 48" wide min. to the softball field team seating and at a 36" x 48" clear floor space by the team seating. (Cost based on an asphalt path and patch by the bench positioned to allow shoulder alignment with a person seated at the bench for someone using a wheeled mobility device.)	1	360	\$360

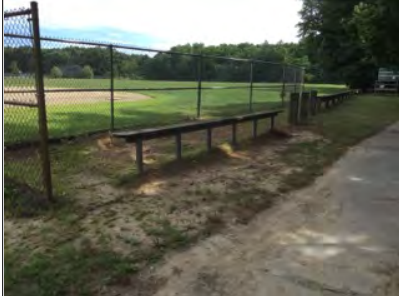
ID	Location	Floor	Room	Element	Type	Photo	Issues	Current Measure	Recommendations	Quantity	Price	Cost Estimation
115	Team Seating 2 at Softball Field	Ext.		Field	Softball

Accessible spaces not provided at team seating	-	Provide a firm, stable and slip resistant path and surface 48" wide min. to the softball field team seating and at a 36" x 48" clear floor space by the team seating. (Cost based on an asphalt path and patch by the bench positioned to allow shoulder alignment with a person seated at the bench for someone using a wheeled mobility device.)	1	360	\$360
116	Softball Field Entrance by Team Seating 2	Ext.		Field	Softball

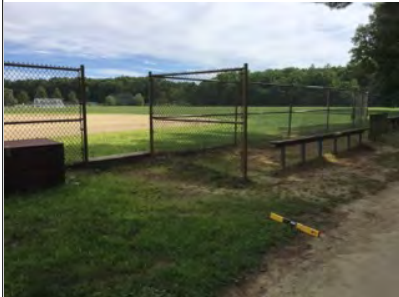
Field not connected to an accessible route	17.9%	Provide an accessible route to the edge of sport activity at the softball field. Provide a firm, stable and slip resistant surface 48" wide min. with a max. running slope of 1:20 (5.00%) and a max. cross slope of 1:50 (2.00%).	1	480	\$480

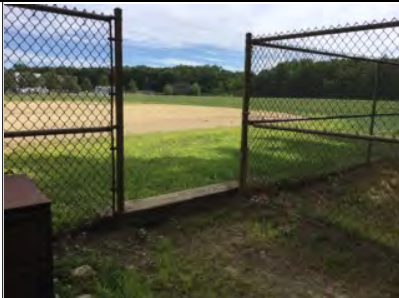
117	Softball Field Entrance by Team Seating 2	Ext.		Field	Softball

Field not connected to an accessible route	8.25"	Reduce change in level to 1/2" max.	1	Labor	\$0
Play and Sport Areas												
Field												
118	Team Seating at the Soccer Field	Ext.		Field	Soccer

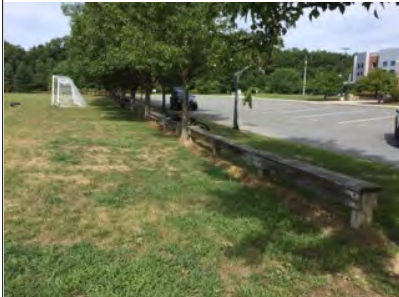
Accessible spaces not provided at team seating	-	Provide a firm, stable and slip resistant path and surface 48" wide min. to the soccer field team seating and at a 36" x 48" clear floor space by the team seating. (Cost based on an asphalt path and patch by the bench positioned to allow shoulder alignment with a person seated at the bench for someone using a wheeled mobility device.)	1	360	\$360
119	Open Field Entrance	Ext.		Field	Soccer

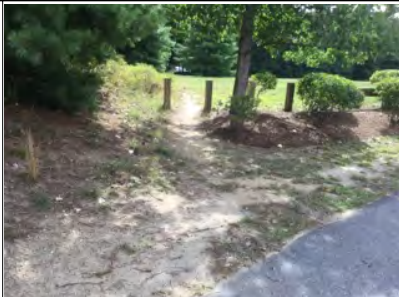
Field not connected to an accessible route	6.8%	Provide an accessible route to the edge of sport activity at the soccer field. Provide a firm, stable and slip resistant surface 48" wide min. with a max. running slope of 1:20 (5.00%) and a max. cross slope of 1:50 (2.00%).	1	480	\$480

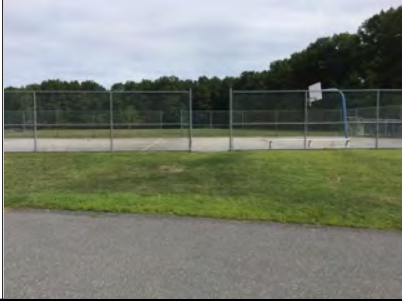
ID	Location	Floor	Room	Element	Type	Photo	Issues	Current Measure	Recommendations	Quantity	Price	Cost Estimation
Court												
120	Basketball Court	Ext.		Court	Basketball

Court is not connected to an accessible route	10.4%	Provide an accessible route to the edge of sport activity at the basketball court. Provide a firm, stable and slip resistant surface 48" wide min. with a max. running slope of 1:20 (5.00%) and a max. cross slope of 1:50 (2.00%).	1	480	\$480
Best Practice												
Egress Walkway												
121	Egress Door 9	1		Egress Walkway	N/A

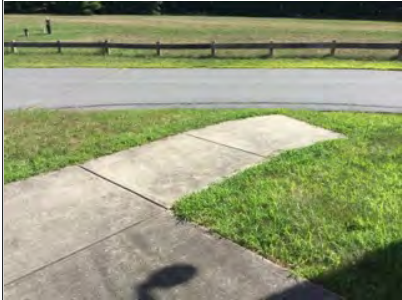
Recommend extending walkway from egress door to paved surface.	1	-	\$0
122	Egress Door 6 - 9	Ext.		Egress Walkway	N/A

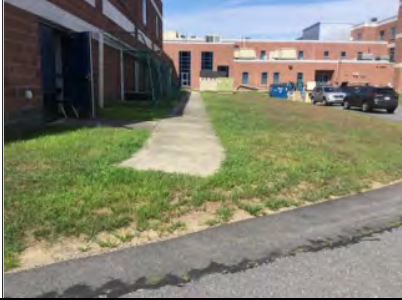
Recommend extending walkway from egress door to paved surface.	1	-	\$0
Podium												
123	Auditorium	1	1320	Podium	N/A

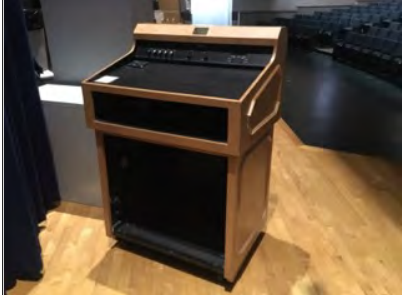
Recommend providing an adjustable height podium with knee and toe clearance.	1	-	\$0

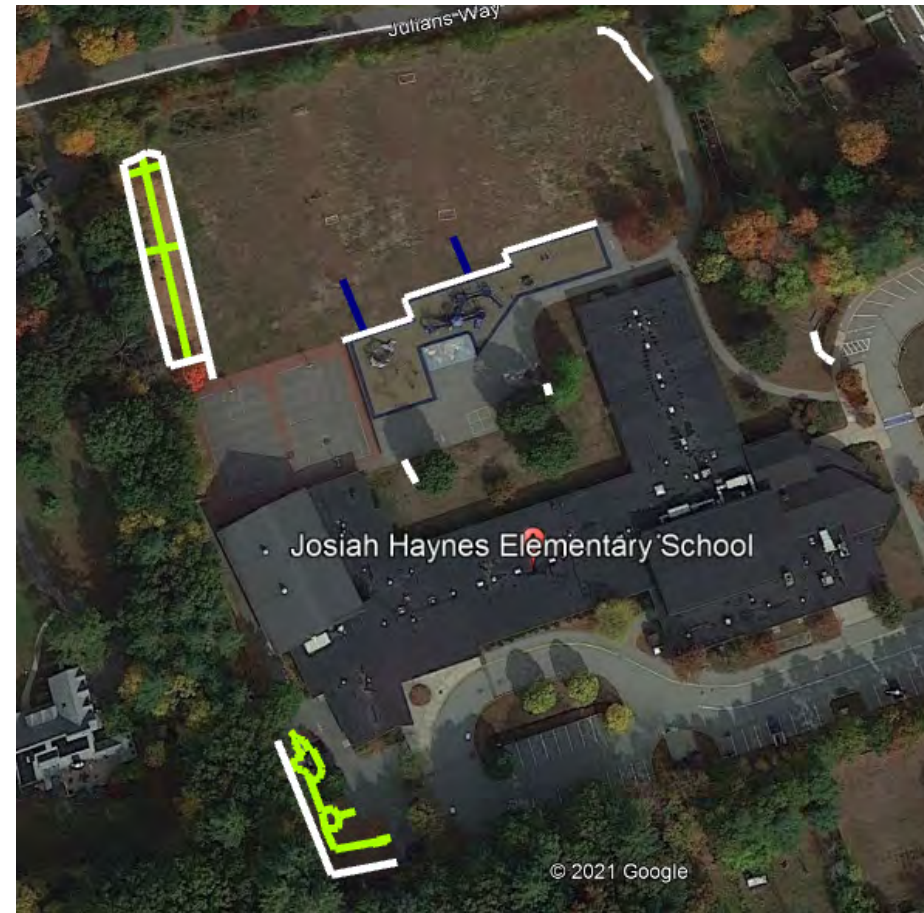
Figure 1: Lines in the following aerial view represent a recommended layout of exterior accessible routes that are required at Haynes Elementary School. White lines represent asphalt routes, yellow lines represent poured-in-place rubber routes within playgrounds and blue lines represent stone dust walkways to areas of sport activity.

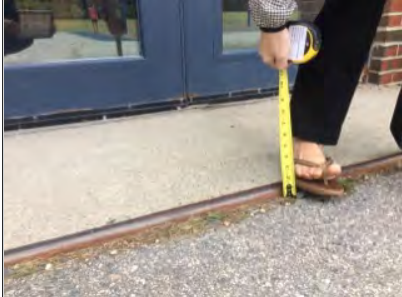
ID	Location	Floor	Room	Element	Type	Photo	Issues	Current Measure	Recommendations	Quantity	Price	Cost Estimation
Approach and Entrance												
Exterior Access Route												
1	Exit From Corridor by Rooms 22 and 23	Ext.		Exterior Access Route	Walkway

Surface openings > 1/2" Level changes > 1/4"	1.75" 1"	Alter change in level to be 1/4" high max. and ensure that surface openings are no greater than 1/2". (Cost estimate for asphalt.)	1	320	\$320
2	Walkway by Exit Door 3	Ext.		Exterior Access Route	Walkway

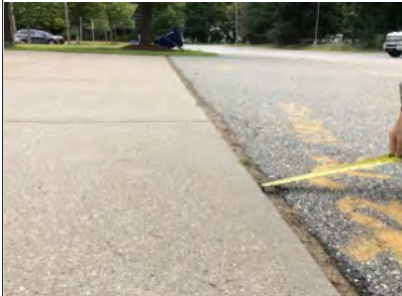
Surface openings > 1/2" Surface is not stable, firm, and slip-resistant	1.5" -	Repair gaps in surface.	1	160	\$160
3	Rear Southwest Parking Lot Accessible Parking Space	Ext.		Exterior Access Route	Sidewalk

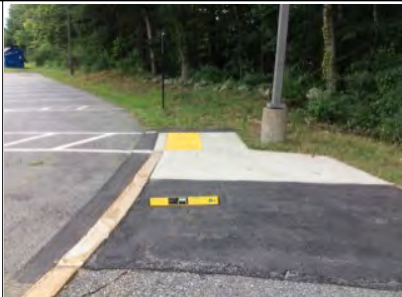
Cross slope > 1:50 (2.00%)	9.4%	Reduce cross slope to be no steeper than 1:50 (2.00%). (Cost for 10' long by 5' wide asphalt area.)	1	500	\$500
4	Walkway by Exit Door 6	Ext.		Exterior Access Route	Exterior

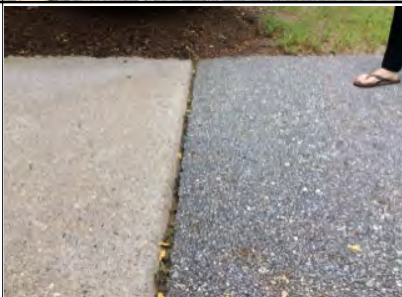
Level changes > 1/4"	-	Alter change in level to be 1/4" high max.	1	160	\$160

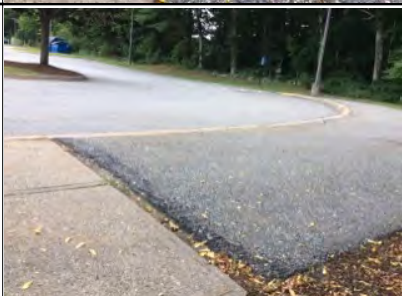
5	Sidewalk by Exit Door 9 to Accessible Parking Space in Rear Lot	Ext.		Exterior Access Route	Sidewalk

Level changes > 1/4"	1"	Alter change in level to be 1/4" high max. (Cost estimate for asphalt.)	1	160	\$160

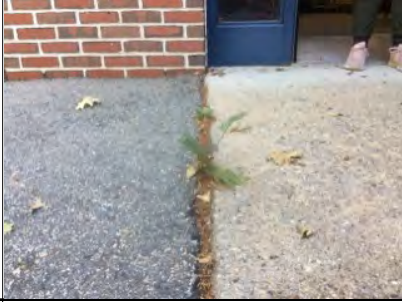
Surface is not stable, firm, and slip-resistant	-	Repair surface.	1	160	\$160
7	Walkway by Exit From Corridor by Rooms 22 and 23	Ext.		Exterior Access Route	Walkway

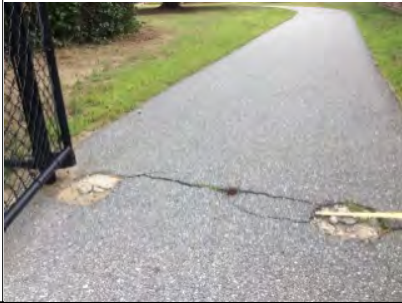
Surface is not stable, firm, and slip-resistant	-	Repair surface at gate.	1	160	\$160
8	Exit Door 10 From Partners Program (Grades 3-5)	Ext.	8	Exterior Access Route	Walkway

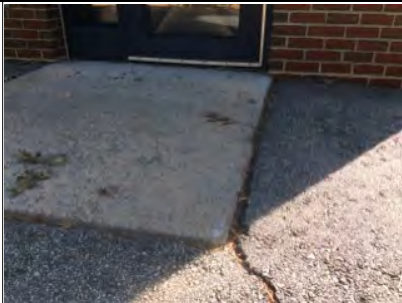
Surface is not stable, firm, and slip-resistant	-	Repair surface at transition between concrete and asphalt.	1	160	\$160
9	Bike Rack by Exit Door 3	Ext.		Exterior Access Route	Walkway

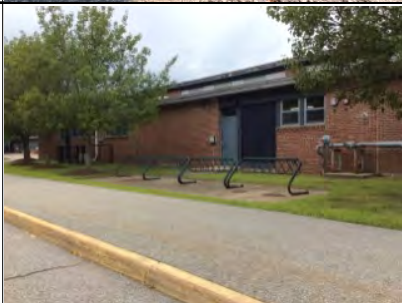
Accessible route not provided	-	Ensure an accessible route is provided to the bike rack. (Cost estimate for a 6' long 4' wide asphalt route.)	1	240	\$240
10	Picnic Table and Bench Area	Ext.		Exterior Access Route	Exterior

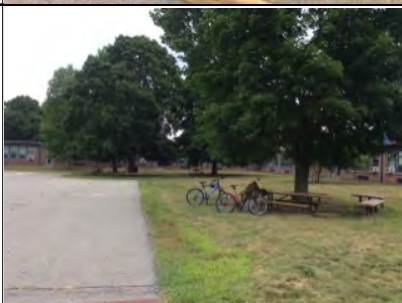
Accessible route not provided	-	Provide an accessible route to one picnic table and one bench in this area. (Cost estimate for 20' long 4' wide asphalt route.)	1	800	\$800

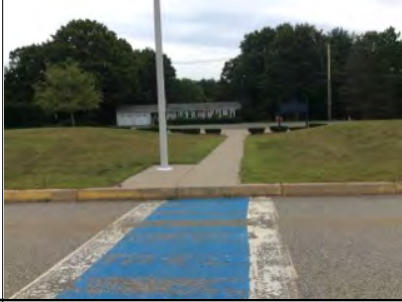
ID	Location	Floor	Room	Element	Type	Photo	Issues	Current Measure	Recommendations	Quantity	Price	Cost Estimation
Curb Ramp												
11	East Crosswalk	Ext.		Curb Ramp	N/A

Curb ramp not provided	-	Provide a curb ramp at this intersection and at the end of the walkway on the east. (Cost estimate for a concrete curb ramp.)	2	2800	\$5600
12	Northeast Parking Lot	Ext.		Curb Ramp	N/A

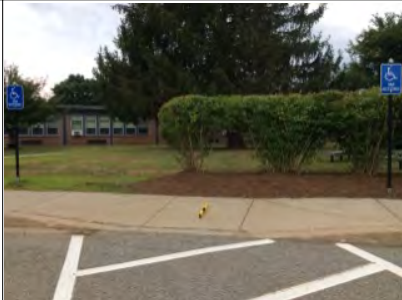
Landing not provided at top of curb ramp	-	Provide landing at top of curb ramp or reconfigure ramp. (Cost estimate for new concrete curb ramp.)	1	2800	\$2800
13	East Crosswalk by Main Entrance	Ext.		Curb Ramp	N/A

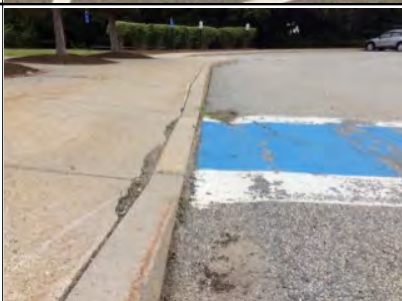
Surface not stable, firm and slip-resistant	-	Repair surface for gaps and changes in level.	1	144	\$144
14	Curb Ramp by Exit Door 6	Ext.		Curb Ramp	N/A

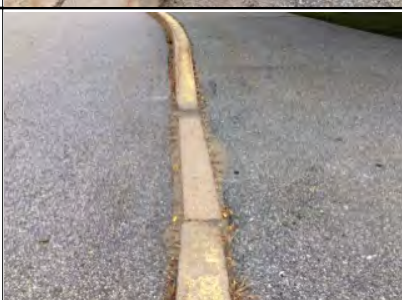
Surface not stable, firm and slip-resistant	2.25"	Repair surface for gaps and changes in level.	1	144	\$144
15	Curb Ramp by Exit Door 9	Ext.		Curb Ramp	N/A

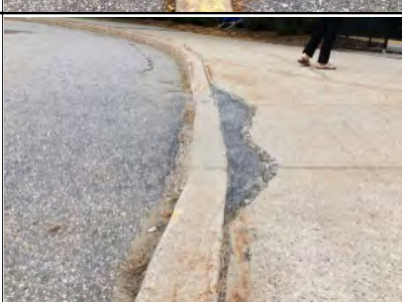
Surface not stable, firm and slip-resistant	-	Repair surface for gaps and changes in level.	1	144	\$144

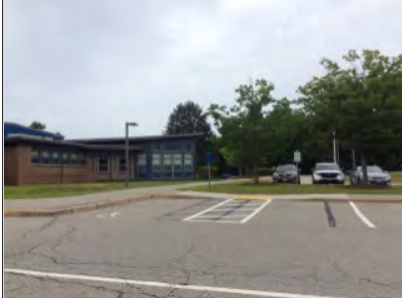
ID	Location	Floor	Room	Element	Type	Photo	Issues	Current Measure	Recommendations	Quantity	Price	Cost Estimation
Off-Street Parking Lot or Garage												
16	Southeast Parking Lot	Ext.		Off-Street Parking Lot or Garage	Visitor

Total # of parking Total # of designated accessible parking spaces Total # of designated van accessible spaces Sign does not have the designation "Van Accessible" Sign bottom < 60" above finished grade	48 0 1 - 51.5"	Provide one additional car accessible parking space. Add the designation "Van Accessible" to the sign located at the van accessible space. Locate sign with the bottom of the sign 60" above the ground.	1	2350 Labor	\$2350
17	Rear Southwest Parking Lot Accessible Parking Space	Ext.		Off-Street Parking Lot or Garage	Visitor

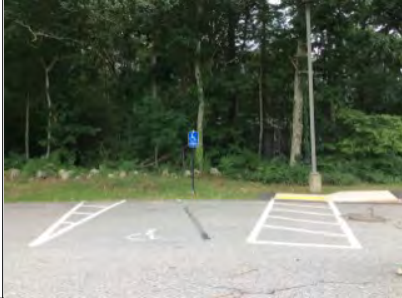
Total # of parking Total # of designated accessible parking spaces Total # of designated van accessible spaces Sign does not have the designation "Van Accessible"	18 1 0 -	Add the designation "Van Accessible" to the sign located at the accessible space.	1	500	\$500

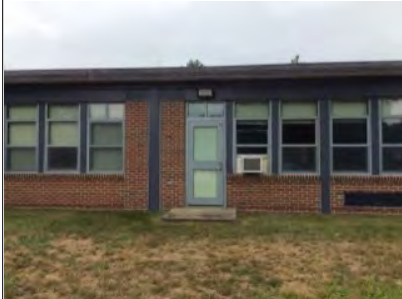
Emergency Exit												
18	Exit Door 16	Ext.		Emergency Exit

Recommend providing accessible routes from all exit doors.	1	-	\$0
19	Learning Center for Grades 4-5 Exit Door 17	1	15	Emergency Exit	N/A

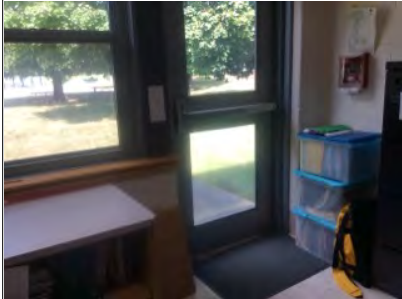
Tactile sign not provided at exit Directional sign to accessible emergency exit not provided	- -	Provide tactile exit signs with raised characters and braille at exit doors. Mount signs between 48"- 60" above the finished floor located on the latch side of the door. Provide a directional sign indicating the location of the nearest accessible emergency exit.	1	464	\$464
20	Exit Door 18	1	16	Emergency Exit	N/A

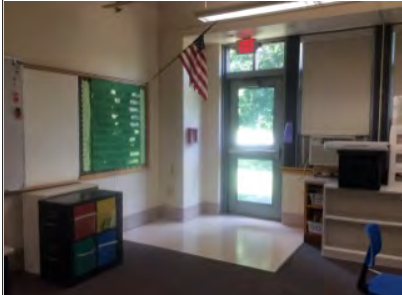
Tactile sign not provided at exit Directional sign to accessible emergency exit not provided	- -	Provide tactile exit signs with raised characters and braille at exit doors. Mount signs between 48"- 60" above the finished floor located on the latch side of the door. Provide a directional sign indicating the location of the nearest accessible emergency exit.	1	464	\$464

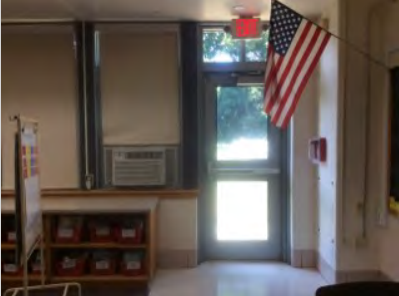
ID	Location	Floor	Room	Element	Type	Photo	Issues	Current Measure	Recommendations	Quantity	Price	Cost Estimation
21	Exit Doors From Classrooms	1	19 20	Emergency Exit	N/A

Tactile sign not provided at exit Directional sign to accessible emergency exit not provided	- -	Provide tactile exit signs with raised characters and braille at exit doors. Mount signs between 48"- 60" above the finished floor located on the latch side of the door. Provide a directional sign indicating the location of the nearest accessible emergency exit.	2	464	\$928
22	Exit Doors From Classrooms	1	21 22	Emergency Exit	N/A

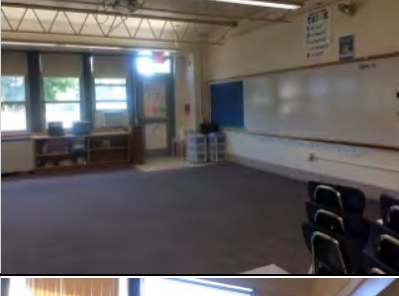
23	Grade 4 Exit Door 16	1	13	Emergency Exit	N/A

Tactile sign not provided at exit Directional sign to accessible emergency exit not provided Maneuvering clearance(s) not provided	- - -	Provide tactile exit signs with raised characters and braille at exit doors. Mount signs between 48"- 60" above the finished floor located on the latch side of the door. Provide a directional sign indicating the location of the nearest accessible emergency exit. Relocate the table that is blocking the door.	1	464 Labor	\$464
24	Front Lobby	1		Emergency Exit	N/A

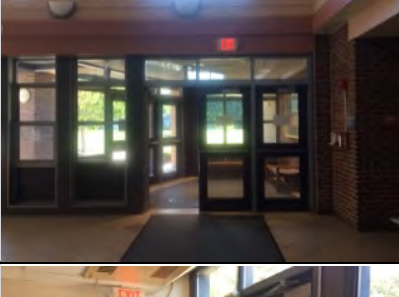
Tactile sign not provided at exit Illuminated Int. Symbol of Acc. not provided (MAAB)	- -	Provide tactile exit signs with raised characters and braille at exit doors. Mount signs between 48"- 60" above the finished floor located on the latch side of the door. Provide an illuminated sign with the International Symbol of Accessibility.	1	432	\$432

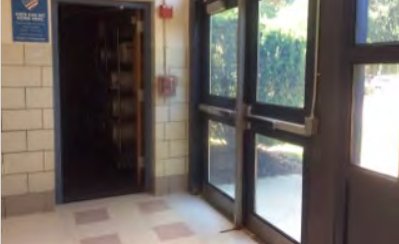
25	Exit Door 6 by ESL	1		Emergency Exit	N/A

Tactile sign not provided at exit Illuminated Int. Symbol of Acc. not provided (MAAB)	- -	Provide tactile exit signs with raised characters and braille at exit doors. Mount signs between 48"- 60" above the finished floor located on the latch side of the door. Provide an illuminated sign with the International Symbol of Accessibility.	1	432	\$432
