Curtis Middle School

Town of Sudbury ADA Transition Plan

January 2021

Institute for Human Centered Design

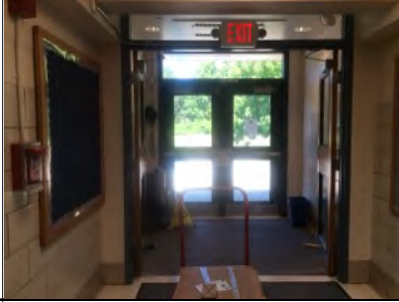
ID	Location	Floor	Room	Element	Type	Photo	Issues	Current Measure	Recommendations	Quantity	Price	Cost Estimation
26	Exit From Corridor by Rooms 22 and 23	1		Emergency Exit	N/A

Tactile sign not provided at exit Illuminated Int. Symbol of Acc. not provided (MAAB)	- -	Provide tactile exit signs with raised characters and braille at exit doors. Mount signs between 48"- 60" above the finished floor located on the latch side of the door. Provide an illuminated sign with the International Symbol of Accessibility.	1	432	\$432
27	Exit Door 15 by Art Classroom	1		Emergency Exit	N/A

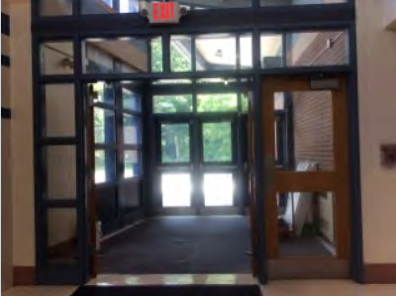
ID	Location	Floor	Room	Element	Type	Photo	Issues	Current Measure	Recommendations	Quantity	Price	Cost Estimation
31	Exit Door 9	1		Emergency Exit	N/A

Tactile sign not provided at exit Illuminated Int. Symbol of Acc. not provided (MAAB)	- -	Provide tactile exit signs with raised characters and braille at exit doors. Mount signs between 48"- 60" above the finished floor located on the latch side of the door. Provide an illuminated sign with the International Symbol of Accessibility.	1	432	\$432
32	Exit Door 7	1	6	Emergency Exit	N/A

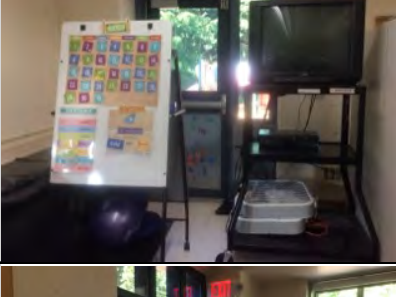
34	Partners Program (Grades 3-5) Egress Door 10	1	8	Emergency Exit	N/A

Tactile sign not provided at exit Illuminated Int. Symbol of Acc. not provided (MAAB)	- -	Provide tactile exit signs with raised characters and braille at exit doors. Mount signs between 48"- 60" above the finished floor located on the latch side of the door. Provide an illuminated sign with the International Symbol of Accessibility.	1	432	\$432
35	Partners Program (Grades K-2) Exit Door 11	1	9	Emergency Exit	N/A

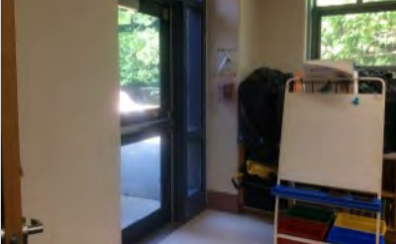
Tactile sign not provided at exit Illuminated Int. Symbol of Acc. not provided (MAAB) Maneuvering clearance(s) not provided	- - -	Provide tactile exit signs with raised characters and braille at exit doors. Mount signs between 48"- 60" above the finished floor located on the latch side of the door. Provide an illuminated sign with the International Symbol of Accessibility. Relocate furniture.	1	432 Labor	\$432

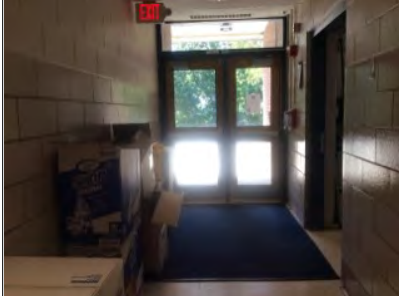
ID	Location	Floor	Room	Element	Type	Photo	Issues	Current Measure	Recommendations	Quantity	Price	Cost Estimation
36	Exit Door 3 to the Parking Lot on the Side of the School	1		Emergency Exit	N/A

Tactile sign not provided at exit Illuminated Int. Symbol of Acc. not provided (MAAB) Mat not securely attached	- - -	Provide tactile exit signs with raised characters and braille at exit doors. Mount signs between 48"- 60" above the finished floor located on the latch side of the door. Provide an illuminated sign with the International Symbol of Accessibility. Secure the mat.	1	432 Labor	\$432
37	Partners Program (Grades 3-5) Egress Door 10	1	8	Emergency Exit	N/A

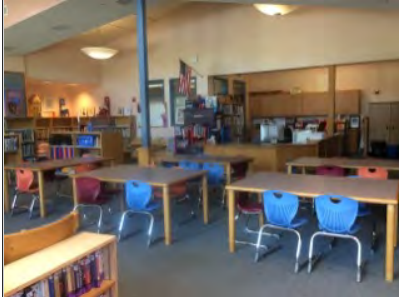
Route < 36" wide	24.5"	Ensure that a clear width of 36" min. is maintained at the accessible route. Note: Route can narrow to 32" for 24" of depth.	1	Labor	\$0

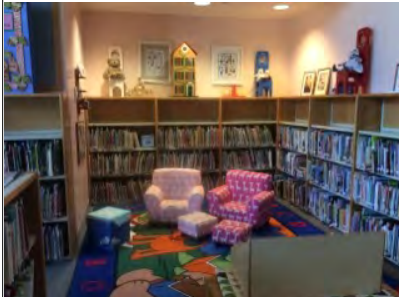
39	Library	1		Interior Access Route	N/A

Route < 36" wide	24"	Ensure that a clear width of 36" min. is maintained at the accessible route. Note: Route can narrow to 32" for 24" of depth.	1	Labor	\$0
40	Library	1		Interior Access Route	N/A

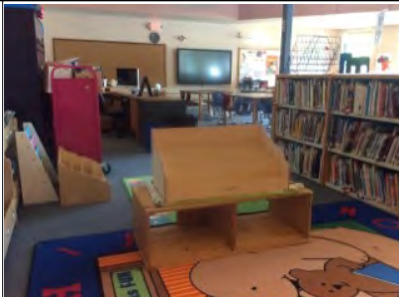
Route < 36" wide	30"	Ensure that a clear width of 36" min. is maintained at the accessible route. Note: Route can narrow to 32" for 24" of depth.	1	Labor	\$0

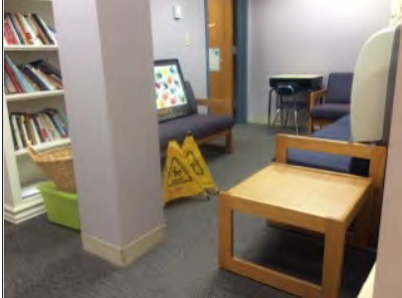
ID	Location	Floor	Room	Element	Type	Photo	Issues	Current Measure	Recommendations	Quantity	Price	Cost Estimation
41	Speech Language & Counseling Waiting Area	1		Interior Access Route	N/A

Route < 36" wide	18"	Ensure that a clear width of 36" min. is maintained at the accessible route. Note: Route can narrow to 32" for 24" of depth.	1	Labor	\$0
42	Speech Language & Counseling Waiting Area	1		Interior Access Route	N/A

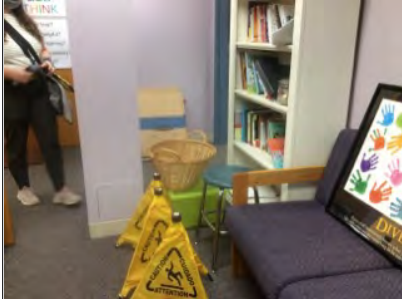
Route < 36" wide	27.25"	Ensure that a clear width of 36" min. is maintained at the accessible route. Note: Route can narrow to 32" for 24" of depth.	1	Labor	\$0
43	Partners Program (Grades 3-5)	1	8	Interior Access Route	N/A

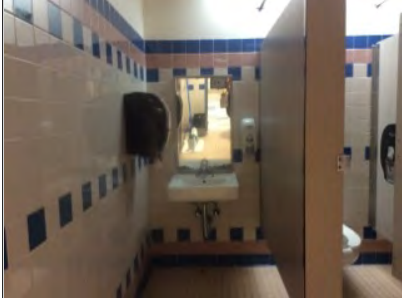
Route < 36" wide Obstructed by protruding objects	25.75" 10"	Ensure that a clear width of 36" min. is maintained at the accessible route. Relocate paper towel dispenser so that it does not obstruct the clear width and does not act as a protruding object.	1	353	\$353

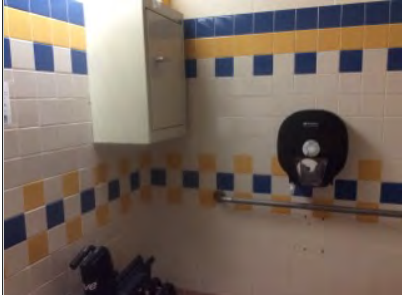
45	Health Office Toilet Room	1		Interior Access Route	N/A

Obstructed by protruding objects	12"	Relocate white storage box. It acts as a protruding object and projects into the clear space required at the toilet.	1	353	\$353

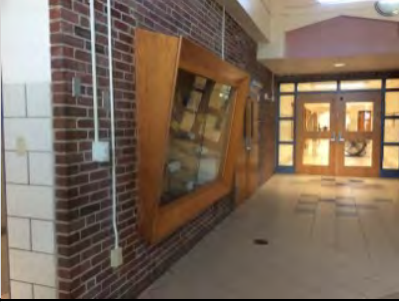
ID	Location	Floor	Room	Element	Type	Photo	Issues	Current Measure	Recommendations	Quantity	Price	Cost Estimation
46	Lobby	1		Interior Access Route	N/A

Obstructed by protruding objects	17"	Provide a cane-detectable barrier along each side.	2	306	\$612
47	Auditorium/ Cafeteria	1		Interior Access Route	N/A

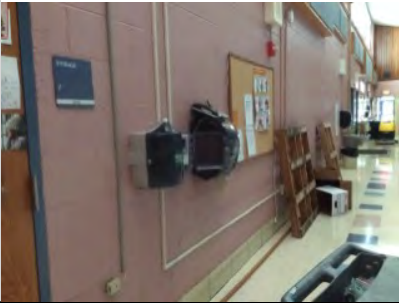
Obstructed by protruding objects	8"	Relocate paper towel dispenser and cleansing wipe dispenser out of the circulation path.	2	256	\$512
48	Grade 2 Grade 1	1	19 21	Interior Access Route	614

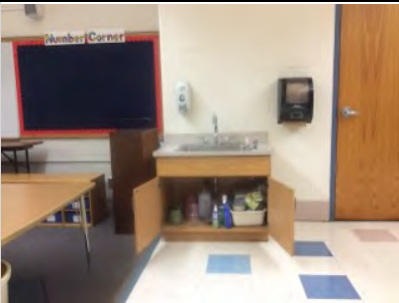
Obstructed by protruding objects	9"	Relocate paper towel dispensers out of the circulation path.	2	256	\$512
49	Library	1		Interior Access Route	N/A

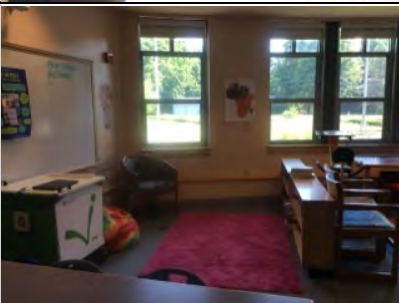
Surface not stable, firm, and slip-resistant	-	Secure the mat.	1	Labor	\$0
50	Library	1		Interior Access Route	N/A

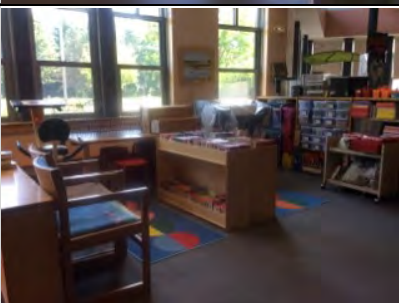
Surface not stable, firm, and slip-resistant	-	Secure the mat.	1	Labor	\$0

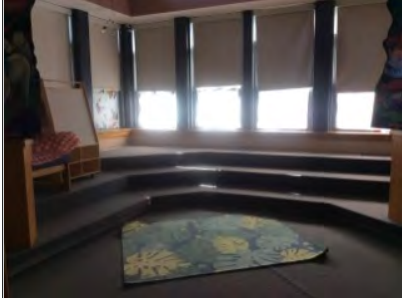
ID	Location	Floor	Room	Element	Type	Photo	Issues	Current Measure	Recommendations	Quantity	Price	Cost Estimation
51	Library	1		Interior Access Route	N/A

Surface not stable, firm, and slip-resistant	-	Secure the mat.	1	Labor	\$0
52	Library	1		Interior Access Route	N/A

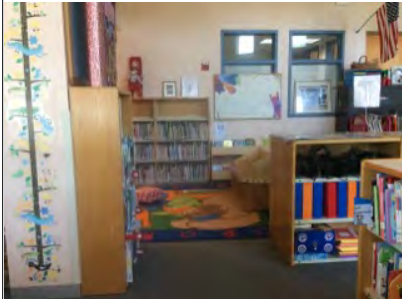
Surface not stable, firm, and slip-resistant	-	Secure the mat.	1	Labor	\$0
53	Kitchen	1		Interior Access Route	N/A

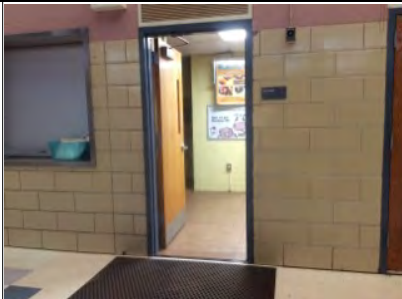
Surface not stable, firm, and slip-resistant	-	Secure the mat.	1	Labor	\$0
54	Women's Toilet Room	1		Interior Access Route	N/A

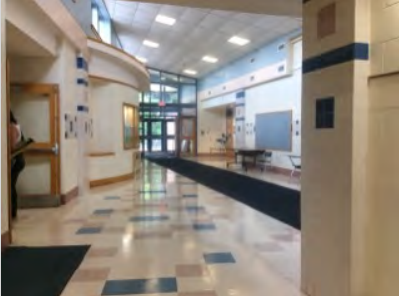
ID	Location	Floor	Room	Element	Type	Photo	Issues	Current Measure	Recommendations	Quantity	Price	Cost Estimation
56	Corridor by Gym	1		Interior Access Route	N/A

Surface not stable, firm, and slip-resistant	-	Secure the mat.	1	Labor	\$0
57	Grade 1	1	21	Interior Access Route	N/A

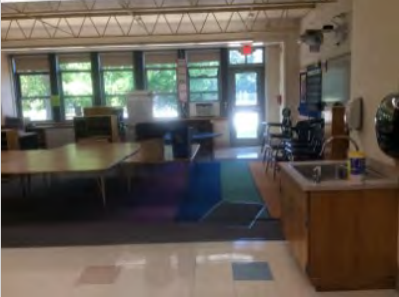
Surface not stable, firm, and slip-resistant	-	Secure rainbow colored mat.	1	Labor	\$0
58	Spanish	1	23	Interior Access Route	N/A

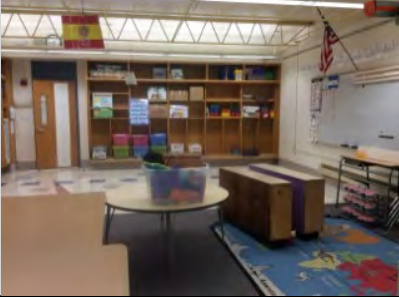
Surface not stable, firm, and slip-resistant		Secure the carpet with the map on it.	1	Labor	\$0
59	Corridor by Spanish	1	23	Interior Access Route	N/A

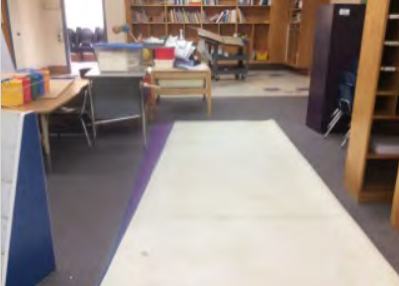
Surface not stable, firm, and slip-resistant	-	Secure the mat.	1	Labor	\$0

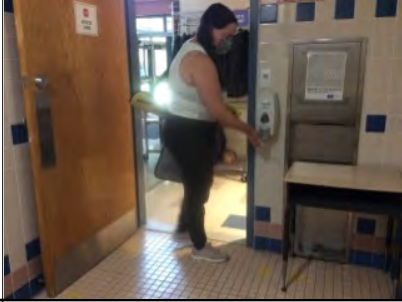
ID	Location	Floor	Room	Element	Type	Photo	Issues	Current Measure	Recommendations	Quantity	Price	Cost Estimation
Doors, Doorways, & Gates												
61	Women's Toilet Room by Lobby and Library	1		Doors, Doorways, & Gates	Toilet Room

Maneuvering clearance(s) not provided	12"	Relocate desk.	1	Labor	\$0
62	ESL/LLI	1		Doors, Doorways, & Gates	Classroom

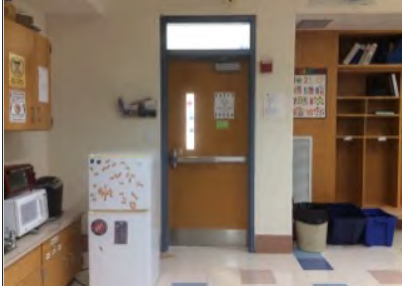
Maneuvering clearance(s) not provided	-	Relocate fridge.	1	Labor	\$0

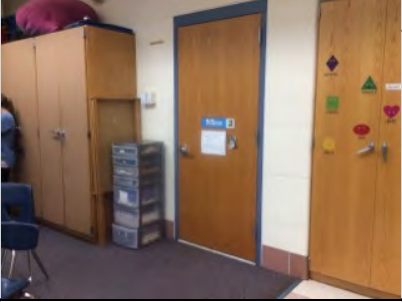
ID	Location	Floor	Room	Element	Type	Photo	Issues	Current Measure	Recommendations	Quantity	Price	Cost Estimation
66	Partners Program (Grades 3-5) Toilet Room	1	8	Doors, Doorways, & Gates	Toilet Room

Maneuvering clearance(s) not provided	9"	Relocate storage boxes.	1	Labor	\$0
67	Psychologist Office Exit to Corridor	1		Doors, Doorways, & Gates	Office

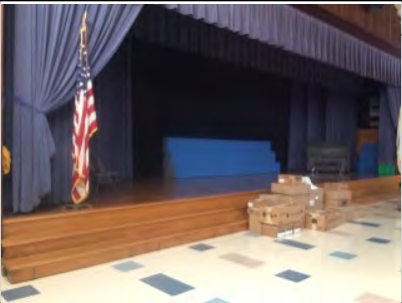
Handrail not provided on both sides	-	Provide handrails on both sides.	1	880	\$880
Signage												
70	Health Office Lobby From Corridor	1		Signage	Designation

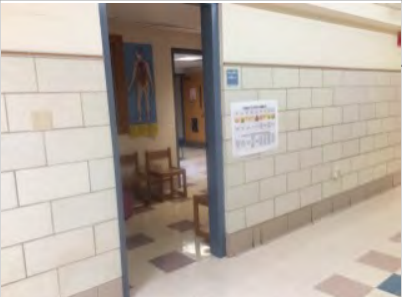
Raised characters not provided on sign Braille not provided on sign	- -	Provide text with raised characters duplicated in braille on sign.	1	232	\$232

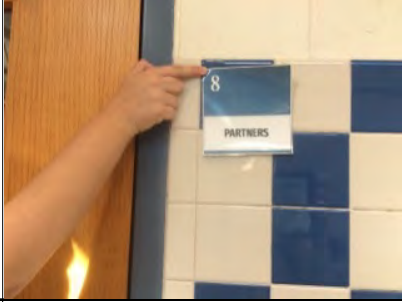
ID	Location	Floor	Room	Element	Type	Photo	Issues	Current Measure	Recommendations	Quantity	Price	Cost Estimation
71	Partners Program (Grades 3-5)	1	8	Signage	Designation

Raised characters not provided on sign Braille not provided on sign	- -	Provide text with raised characters duplicated in braille on sign.	1	232	\$232
72	Principal's Office	1		Signage	Designation

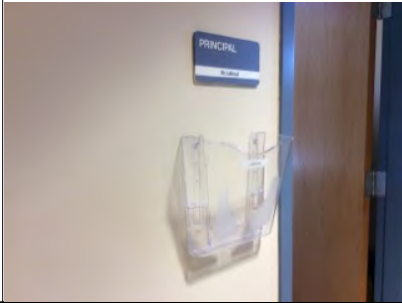
Sign lacks 18" min. by 18" min. clear floor space	-	Relocate folder storage.	1	Labor	\$0
Dining or Work Surfaces												
73	Principal's Office	1		Dining or Work Surfaces	Work Surface

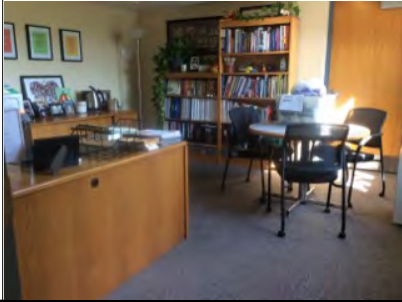
Knee or toe clearance not provided	-	Provide at least 1 work surface with 27" min. knee and toe clearance. Table lacks toe clearance.	1	700	\$700
74	Vice Principal's Office	1		Dining or Work Surfaces	Work Surface

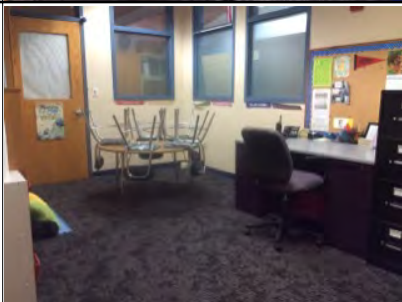
75	Psychologist Office	1		Dining or Work Surfaces	Work Surface

Knee or toe clearance not provided	23" wide	Provide at least 1 work surface that has a clear width of 30" min. and a clear height of 24" min.	1	700	\$700

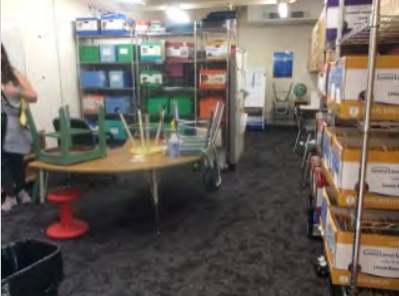
ID	Location	Floor	Room	Element	Type	Photo	Issues	Current Measure	Recommendations	Quantity	Price	Cost Estimation
76	ESL/LLI	1		Dining or Work Surfaces	Work Surface

Knee or toe clearance not provided	22.5"	Ensure that 1 work surface is adjusted to provide 24" min. knee and toe clearance.	1	Labor	\$0
77	Speech Language & Counseling	1		Dining or Work Surfaces	Work Surface

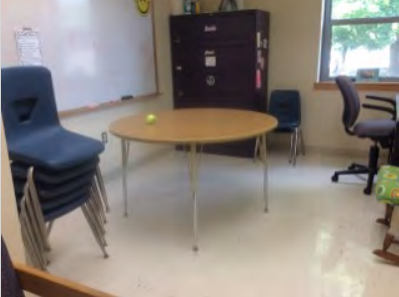
Knee or toe clearance not provided	23" wide	Provide at least 1 work surface with 27" min. knee and toe clearance that is 30" wide min.	1	700	\$700
78	OT/PT	1		Dining or Work Surfaces	Work Surface

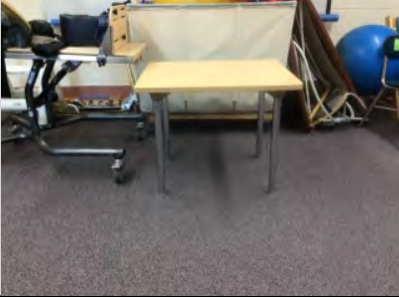
Knee or toe clearance not provided	21" wide	Provide at least 1 work surface with 24" high min. knee and toe clearance that is 30" wide min.	1	200	\$200
79	Grade 2	1	19	Dining or Work Surfaces	Work Surface

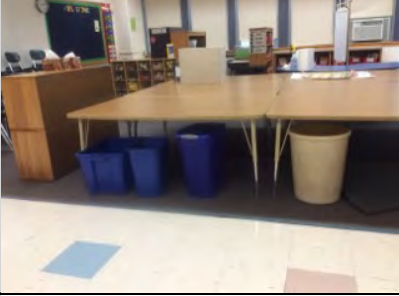
Knee or toe clearance not provided	22.75"	Ensure that 1 work surface is adjusted to provide 24" high min. knee and toe clearance.	1	Labor	\$0

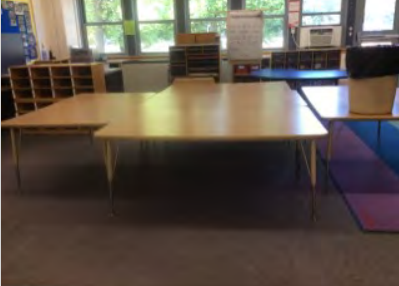
80	Grade 1	1	21	Dining or Work Surfaces	Work Surface

Knee or toe clearance not provided	22.75"	Ensure that 1 work surface is adjusted to provide 24" high min. knee and toe clearance.	1	Labor	\$0

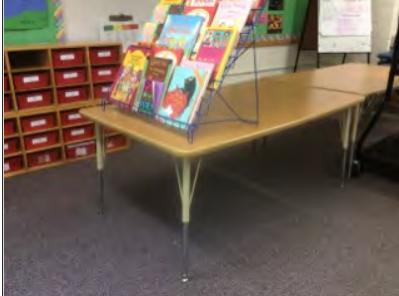
ID	Location	Floor	Room	Element	Type	Photo	Issues	Current Measure	Recommendations	Quantity	Price	Cost Estimation
81	Spanish	1	23	Dining or Work Surfaces	Work Surface

Knee or toe clearance not provided	23.5"	Ensure that 1 work surface is adjusted to provide 24" high min. knee and toe clearance.	1	Labor	\$0
82	Learning Center for K-3	1	27	Dining or Work Surfaces	Work Surface

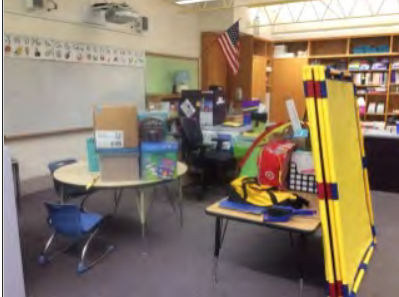
Knee or toe clearance not provided	21" wide	Provide at least 1 work surface with knee clearance that is 30" wide min.	1	200	\$200
83	Learning Center for K-3	1	27	Dining or Work Surfaces	Work Surface

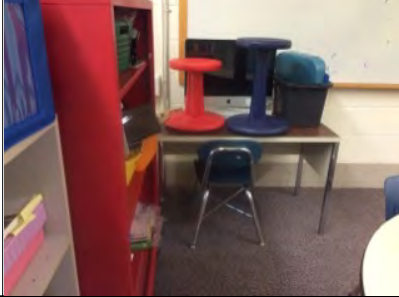
Knee or toe clearance not provided	22"	Provide at least 1 dining or work surface with 24" high min. knee and toe clearance.	1	200	\$200
84	Kindergarten	1	6	Dining or Work Surfaces	Work Surface

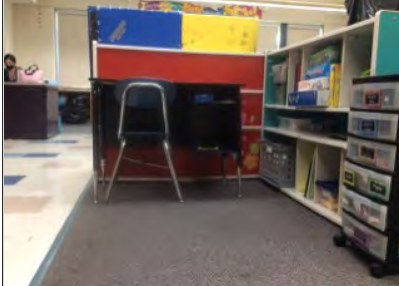
85	Partners Program (Grades 3-5)	1	8	Dining or Work Surfaces	Work Surface

Knee or toe clearance not provided	20" wide	Provide at least 1 work surface with 24" high min. knee and toe clearance that is 30" wide min.	1	200	\$200

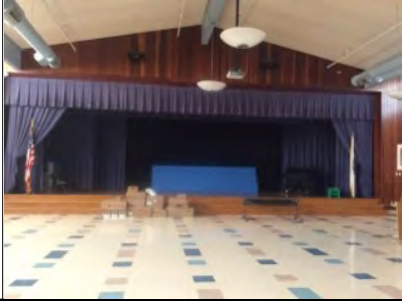
ID	Location	Floor	Room	Element	Type	Photo	Issues	Current Measure	Recommendations	Quantity	Price	Cost Estimation
Assembly Area												
86	Auditorium/ Cafeteria	1		Assembly Area	N/A

Assistive listening devices not provided	-	If audible communication is integral to the use of the space, provide an assistive listening system. (Cost estimate for 600 people.)	1	6250	\$6250
Picnic Tables												
87	Picnic Table and Bench Area	Ext.		Picnic Tables	N/A

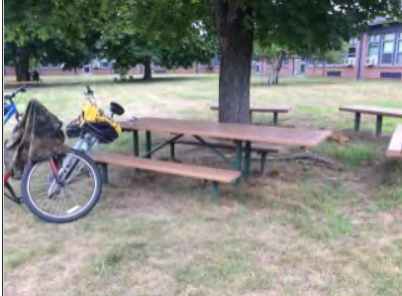
Toe or knee clearance at tables not provided	- 21.5"	Provide at least 1 dining surface (or ensure that 5% of dining surfaces) have toe and knee clearance.	1	1400	\$1400
88	Picnic Table with Chess Board	Ext.		Picnic Tables	N/A

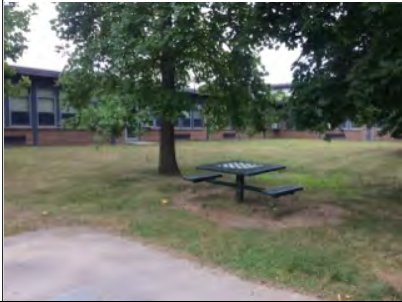
Picnic table not on an accessible route	-	Ensure that the accessible picnic table is connected to an accessible route. (Cost estimate for a 6' long by 4' wide asphalt route.)	1	240	\$240
Exterior Benches

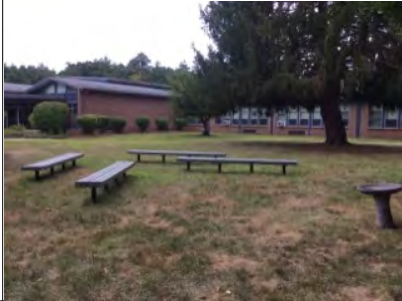
89	Seating Area by Birdbath on Northeast Side by the Main Entrance	Ext.		Exterior Benches	N/A

No accessible route to one bench in area	-	Provide an accessible route to one bench in this area. (Cost estimate for 30' long, 4' wide asphalt route.)	1	1200	\$1200
Toilet & Bathing Rooms

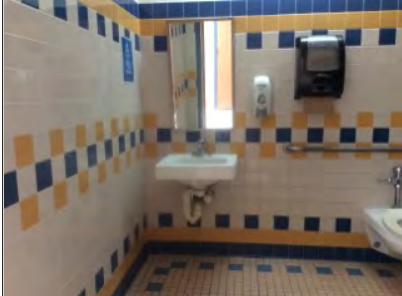
ID	Location	Floor	Room	Element	Type	Photo	Issues	Current Measure	Recommendations	Quantity	Price	Cost Estimation
Lavatory												
90	Accessible Toilet Room	1		Lavatory	N/A

Toe or knee clearances not provided	23"	Provide at least one lavatory with knee and toe clearance positioned for a forward approach. As the rest of this toilet room is built to adult dimensions, 27" min. knee clearance is recommended at the lavatory.	1	1686	\$1686
91	Kindergarten Toilet Room	1	6	Lavatory	N/A

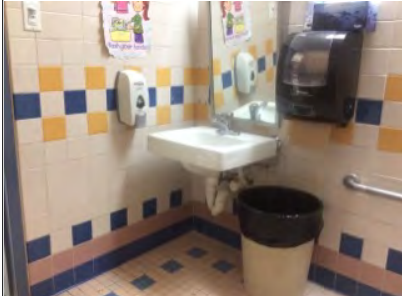
Toe or knee clearances not provided	21.5"	Provide at least one lavatory with knee and toe clearance positioned for a forward approach.	1	1686	\$1686
92	Men's Toilet Room	1		Lavatory	N/A

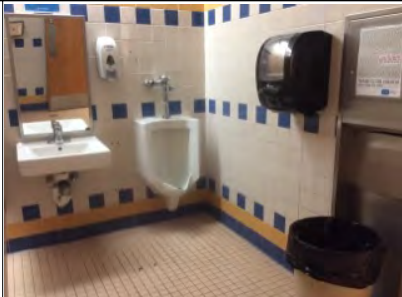
Plumbing underneath is exposed	-	Insulate or otherwise configure pipes to prevent contact for at least one lavatory.	1	92	\$92
Single-User Toilet												
93	Accessible Toilet Room	1		Single-User Toilet	N/A

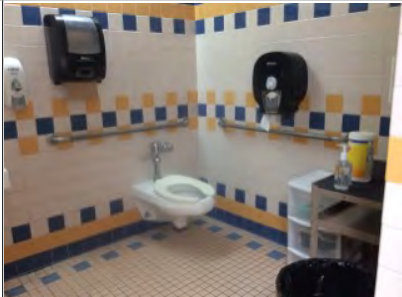
Clearance at toilet < 72" clear depth Toilet paper dispenser is not compliant Paper towel mounted over grab bar	- -	Relocate shelving and storage. Relocate toilet paper so that it is 24" min. high, located under the grab bar, and between 7" and 9" from the front of the toilet. Relocate the paper towel dispenser so that it is not mounted above the grab bar.	2	353	\$706

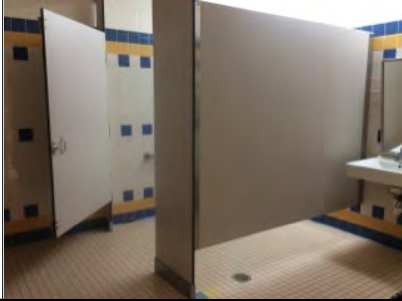
ID	Location	Floor	Room	Element	Type	Photo	Issues	Current Measure	Recommendations	Quantity	Price	Cost Estimation
Toilet Compartment												
95	Men's Toilet Room	1		Toilet Compartment	Accessible Compartment

Door has malfunctioning self-closing hinge	-	Repair hinge.	1	Labor	\$0
Dispensers												
96	Health Office Toilet Room	1		Dispensers	Paper Towel Dispenser

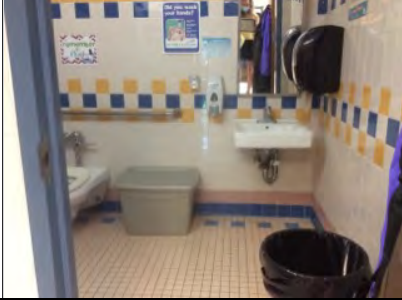
Dispenser acts as a protruding object	9"	Relocate dispenser out of the circulation path.	1	353	\$353
97	Women's Toilet Room by Lobby and Library and Men's Toilet Room	1		Dispensers	Paper Towel Dispenser

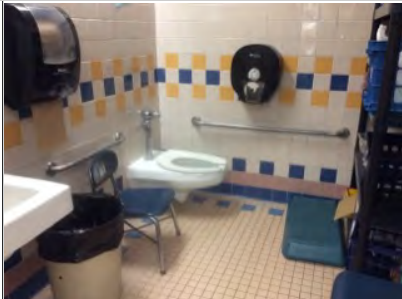
Clearance at toilet < 72" clear deep	-	Relocate stored items so that there is 72" clear deep at the toilet.	1	Labor	\$0

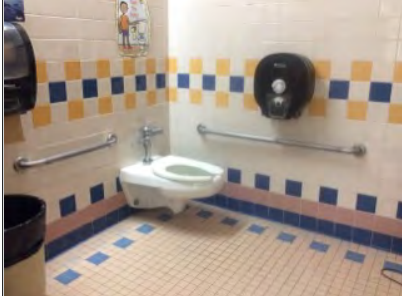
ID	Location	Floor	Room	Element	Type	Photo	Issues	Current Measure	Recommendations	Quantity	Price	Cost Estimation
99	Kindergarten Toilet Room	1	6	Single-User Toilet (Children)	N/A

Non-compliant toilet paper dispenser	-	Relocate toilet paper dispenser so that it is between 14"- 19" above the floor and between 7"- 9" in front of the toilet. Ensure dispensers and other devices are not mounted above grab bars.	1	353	\$353
100	Health Office Toilet Room	1		Single-User Toilet (Children)	N/A

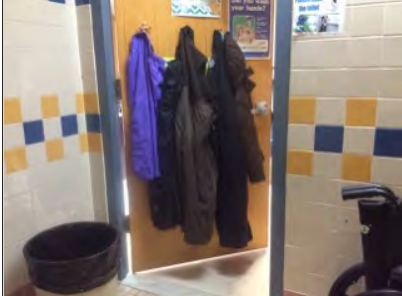
Coat hook not within reach range	56"	Lower hook so that it is no higher than 40" above the floor.	1	150	\$150
Toilet Compartment (Children)												
101	Girls' Toilet Room Across From Auditorium	1		Toilet Compartment (Children)	Accessible Compartment

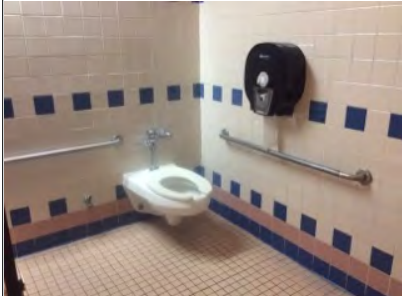
Non-compliant toilet paper dispenser	-	Relocate toilet paper dispenser so that it is between 14"- 19" above the floor and between 7"- 9" in front of the toilet. Ensure dispensers and other devices are not mounted above grab bars.	1	353	\$353

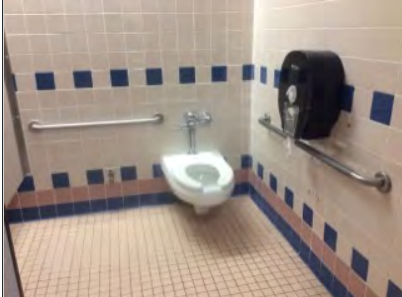
102	Women's Toilet Room by Lobby and Library	1		Toilet Compartment (Children)	Accessible Compartment

Non-compliant toilet paper dispenser Coat hook not within reach range	- 51"	Relocate toilet paper dispenser so that it is between 14"- 19" above the floor and between 7"- 9" in front of the toilet. Ensure dispensers and other devices are not mounted above grab bars. Lower hook so that it is no higher than 44" for children ages 9-12. The other dimensions in the toilet room are built for this age range.	1	503	\$503
103	Men's Toilet Room	1		Toilet Compartment (Children)	Accessible Compartment

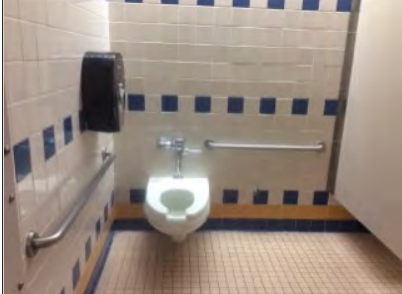
Non-compliant toilet paper dispenser Coat hook not within reach range	- 49"	Relocate toilet paper dispenser so that it is between 14"- 19" above the floor and between 7"- 9" in front of the toilet. Ensure dispensers and other devices are not mounted above grab bars. Lower hook so that it is no higher than 44" for children ages 9-12. The other dimensions in the toilet room are built for this age range.	1	503	\$503

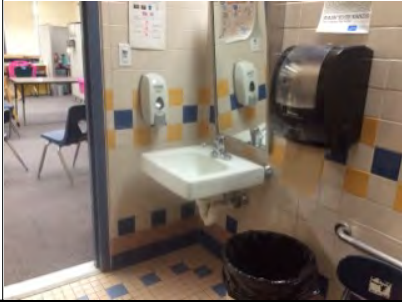
Toe or knee clearances not provided	23"	Provide at least one lavatory with 25" min. knee clearance positioned for a forward approach.	1	1686	\$1686
106	Partners Program (Grades K-2) Toilet Room	1	9	Lavatory (Children)	N/A

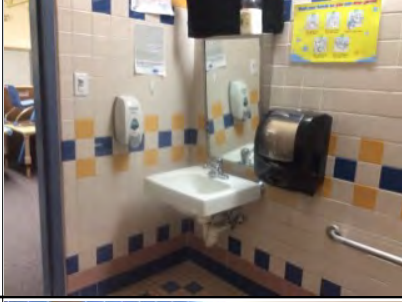
Toe or knee clearances not provided	22"	Provide at least one lavatory with 25" min. knee clearance positioned for a forward approach.	1	1686	\$1686

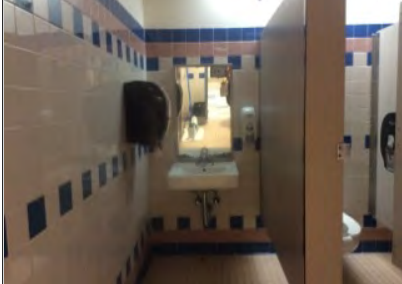
Exposed plumbing underneath	-	Insulate or otherwise configure pipes to prevent contact at lavatory.	1	92	\$92

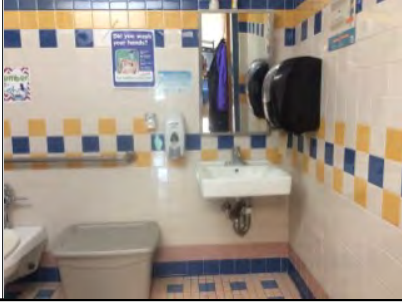
ID	Location	Floor	Room	Element	Type	Photo	Issues	Current Measure	Recommendations	Quantity	Price	Cost Estimation
109	Health Office Toilet Room	1		Lavatory (Children)	N/A

Exposed plumbing underneath Mirror above lavatory w/reflective surface > 31"	- 38"	Insulate or otherwise configure pipes to prevent contact at lavatory. Lower mirror so that the bottom surface is at 31" above finished floor.	1	348	\$348
Dispensers (Children)												
110	Boys' Toilet Room by Health Office	1		Dispensers (Children)	Paper Towel Dispenser

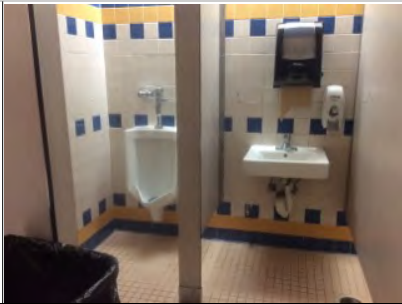
Urinal has < 30" clear width Urinal recessed > 24" deep has > 36" clear width	26" 34"	Remove partition to provide a 30" min. by 48" min. clear floor space positioned for a forward approach. Provide a partition that is less than 24" deep.	1	353	\$353

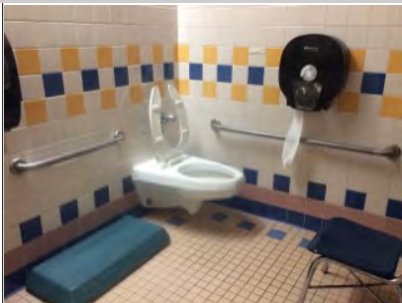
Toilet Paper Dispensers (Children)												
112	Partners Program (Grades K-2) Toilet Room	1	9	Toilet Paper Dispensers (Children)	N/A

Controls < 14" or > 17" (Ages 5 - 8) Dispenser located above grab bar	- -	Relocate toilet paper dispenser so the operable part is between 14" and 17" above the finished floor. Relocate dispenser 1.5" minimum underneath the grab bar.	1	353	\$353
113	Partners Program (Grades 3-5) Toilet Room	1	8	Toilet Paper Dispensers (Children)	N/A

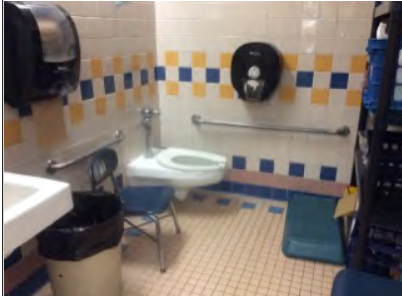
Controls < 17" or > 19" (Ages 9 - 12) Dispenser located above grab bar	- -	Relocate toilet paper dispenser so the operable part is between 14" and 17" above the finished floor. Relocate dispenser 1.5" minimum underneath the grab bar.	1	353	\$353

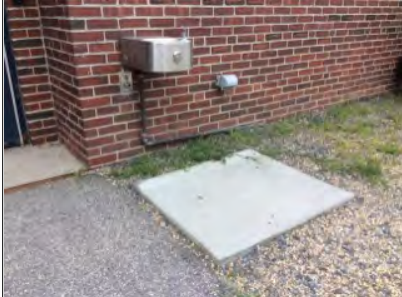
ID	Location	Floor	Room	Element	Type	Photo	Issues	Current Measure	Recommendations	Quantity	Price	Cost Estimation
Additional Access												
Drinking Fountains												
114	Exit From Corridor by Rooms 22 and 23	Ext.		Drinking Fountains	Low

Clear floor space not provided Operable parts malfunctioning No drinking fountain provided for standing users	- - -	Provide a 30" by 48" clear floor space positioned for a forward approach. (Cost estimate for 3' by 4' asphalt area.) Repair or replace drinking fountain to ensure operable parts are functioning. Provide an additional drinking fountain for standing users on an accessible route.	1	4148 Labor	\$4148
115	Drinking Fountain	1		Drinking Fountains	Low

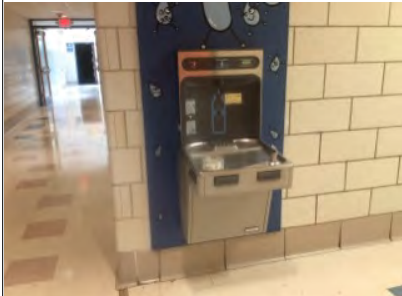
No drinking fountain provided for standing users	-	Provide an additional drinking fountain for standing users.	1	4028	\$4028
116	Drinking Fountain by Gym	1		Drinking Fountains	Low

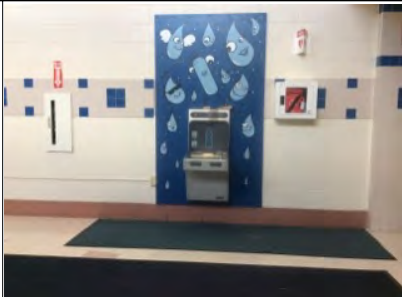
No drinking fountain provided for standing users	-	Provide an additional drinking fountain for standing users.	1	4028	\$4028

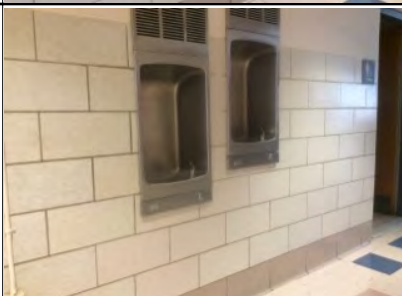
Knee or toe clearance not provided	-	Provide a drinking fountain with knee and toe clearance, 27" min. high at drinking fountain for seated users. (Cost for a new low drinking fountain.)	1	4028	\$4028

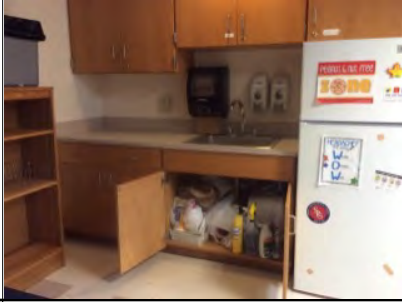
ID	Location	Floor	Room	Element	Type	Photo	Issues	Current Measure	Recommendations	Quantity	Price	Cost Estimation
Sink												
119	Health Office	1		Sink	Other

Toe and knee clearances not provided Exposed plumbing underneath sink	26"	Ensure there is a 27" knee clearance positioned for a forward approach. Insulate or otherwise configure pipes at sink.	1	1778	\$1778
120	Learning Lab	1		Sink	Lab

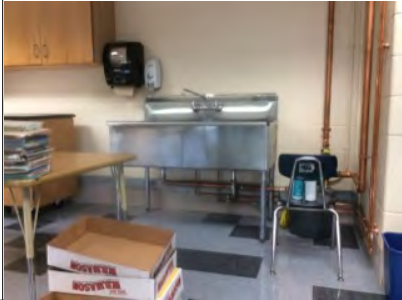
Toe and knee clearances not provided Exposed plumbing underneath sink Dispenser not within reach range	- - 48"	Ensure there is a 27" knee clearance positioned for a forward approach. Insulate or otherwise configure pipes at sink. Relocate paper towel dispenser 44" max. above the finished floor or ground.	1	2034	\$2034
Sinks for Children's Use												
121	OT/PT	1		Sinks for Children's Use	Other

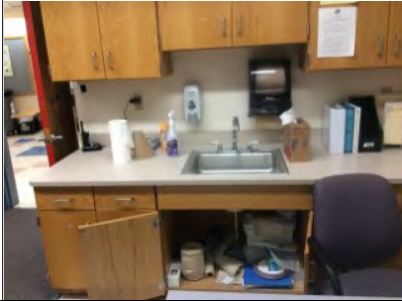
Exposed plumbing underneath Knee or toe clearance not provided	- 25.75"	Insulate or otherwise configure pipes to prevent contact at sink. Provide at least one sink with 24" high knee and toe clearance positioned for a forward approach.	1	1778	\$1778

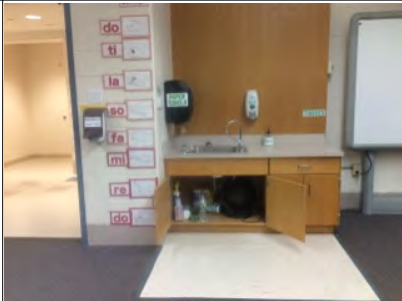
122	Music Room	1	1	Sinks for Children's Use	Classroom

Exposed plumbing underneath Knee or toe clearance not provided	- 22.5"	Insulate or otherwise configure pipes to prevent contact at sink. Provide at least one sink with 24" high knee and toe clearance positioned for a forward approach.	1	1778	\$1778
123	Grade 4	1	13	Sinks for Children's Use	Classroom

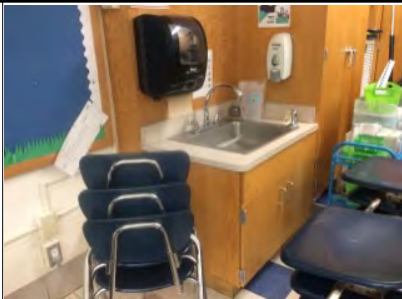
Exposed plumbing underneath Knee or toe clearance not provided	- 22"	Insulate or otherwise configure pipes to prevent contact at sink. Provide at least one sink with 24" high knee and toe clearance positioned for a forward approach.	1	1778	\$1778

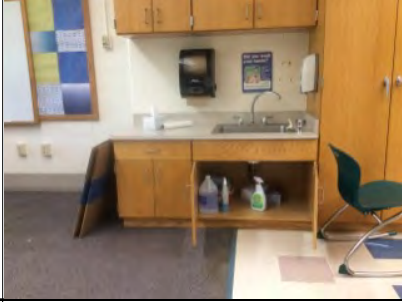
ID	Location	Floor	Room	Element	Type	Photo	Issues	Current Measure	Recommendations	Quantity	Price	Cost Estimation
124	Learning Center for Grades 4-5	1	15	Sinks for Children's Use	Classroom

Exposed plumbing underneath Knee or toe clearance not provided	- 22.5"	Insulate or otherwise configure pipes to prevent contact at sink. Provide at least one sink with 24" high knee and toe clearance positioned for a forward approach.	1	1778	\$1778
125	Grade 5	1	16	Sinks for Children's Use	Classroom

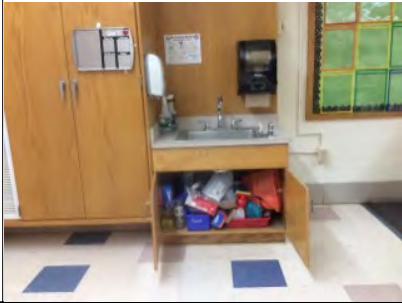
Exposed plumbing underneath Knee or toe clearance not provided	- 22"	Insulate or otherwise configure pipes to prevent contact at sink. Provide at least one sink with 24" high knee and toe clearance positioned for a forward approach.	1	1778	\$1778
126	Grade 2	1	19	Sinks for Children's Use	Classroom

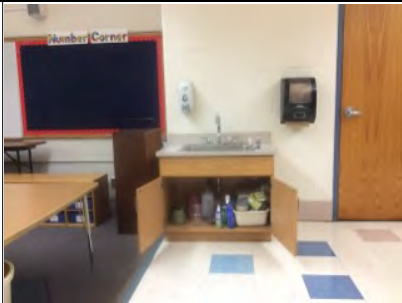
Exposed plumbing underneath Knee or toe clearance not provided	- 22"	Insulate or otherwise configure pipes to prevent contact at sink. Provide at least one sink with 24" high knee and toe clearance positioned for a forward approach.	1	1778	\$1778

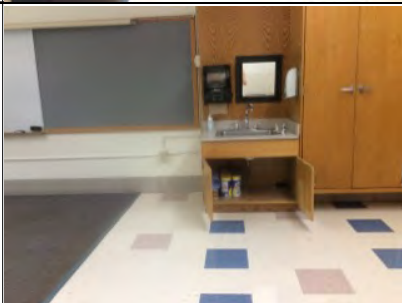
127	Grade 3	1	2	Sinks for Children's Use	Classroom

Exposed plumbing underneath Knee or toe clearance not provided	- 22"	Insulate or otherwise configure pipes to prevent contact at sink. Provide at least one sink with 24" high knee and toe clearance positioned for a forward approach.	1	1778	\$1778
128	Grade 1	1	21	Sinks for Children's Use	Classroom

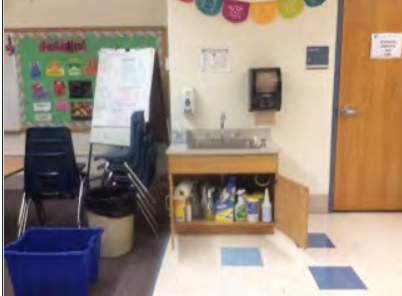
ID	Location	Floor	Room	Element	Type	Photo	Issues	Current Measure	Recommendations	Quantity	Price	Cost Estimation
129	Spanish	1	23	Sinks for Children's Use	N/A

Exposed plumbing underneath Knee or toe clearance not provided	- 22"	Insulate or otherwise configure pipes to prevent contact at sink. Provide at least one sink with 24" high knee and toe clearance positioned for a forward approach.	1	1778	\$1778
130	Steps Room	1	25	Sinks for Children's Use	Classroom

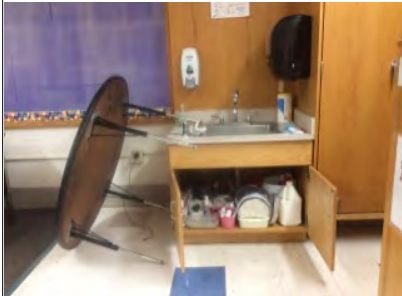
Exposed plumbing underneath Knee or toe clearance not provided	- 22"	Insulate or otherwise configure pipes to prevent contact at sink. Provide at least one sink with 24" high knee and toe clearance positioned for a forward approach.	1	1778	\$1778
131	Learning Center for K-3	1	27	Sinks for Children's Use	Classroom

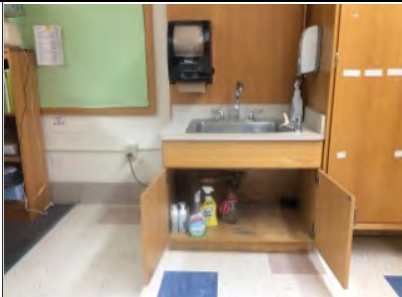
Exposed plumbing underneath Knee or toe clearance not provided	- 22"	Insulate or otherwise configure pipes to prevent contact at sink. Provide at least one sink with 24" high knee and toe clearance positioned for a forward approach.	1	1778	\$1778

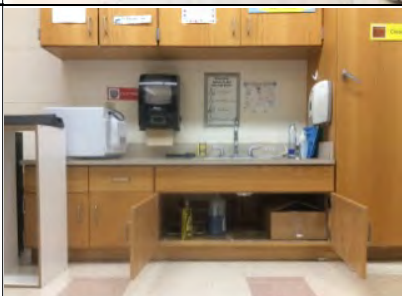
Exposed plumbing underneath Knee or toe clearance not provided	- -	Insulate or otherwise configure pipes to prevent contact at sink. Provide at least one sink with 24" high knee and toe clearance positioned for a forward approach.	1	1778	\$1778

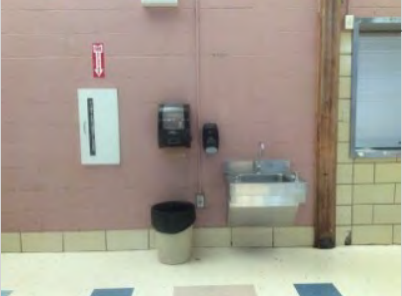
ID	Location	Floor	Room	Element	Type	Photo	Issues	Current Measure	Recommendations	Quantity	Price	Cost Estimation
134	Auditorium/ Cafeteria	1		Sinks for Children's Use	Other

Knee or toe clearance not provided	23"	Provide at least one sink with 24" high knee and toe clearance positioned for a forward approach.	1	1686	\$1686
135	Art Classroom	1	11	Sinks for Children's Use	Classroom

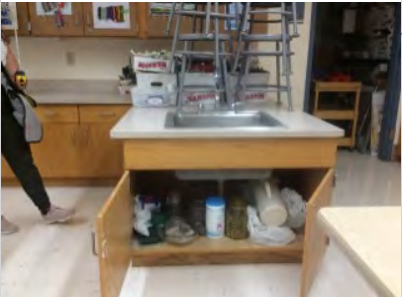
Knee or toe clearance not provided	18.5"	Provide at least one sink with 24" high knee and toe clearance positioned for a forward approach.	1	1686	\$1686
136	Kindergarten	1	6	Sinks for Children's Use	Classroom

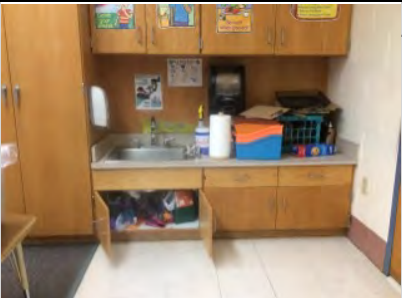
Knee or toe clearance not provided	16.75"	Provide at least one sink with 24" high knee and toe clearance positioned for a forward approach.	1	1686	\$1686
Play and Sport Areas												
Play Areas												
137	Swing Sets North of the Basketball Court and North Side of Central Poured-in- Place Rubber Playground	Ext.		Play Areas	N/A

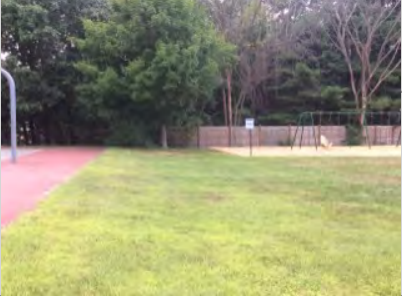
Accessible route not provided to playground Accessible route not provided around playground Accessible route not provided to play components	- - -	Install an accessible route to and around the swing set playground. (Cost estimate for 430' long, 4' wide asphalt route.) Provide an impact-attenuating surface to and around the play components by the swing set. (Cost estimate for 1,380 sq. ft. of poured in place rubber surface.) Install an accessible route on the north side of the central play area. (Cost for 240' long 4' wide asphalt path.)	1	46120	\$46120

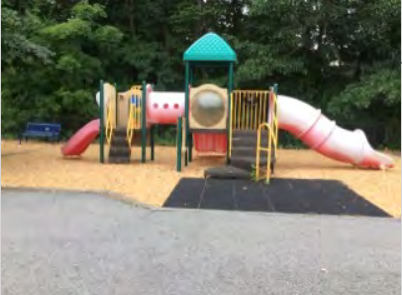
138	Southwest Playground	Ext.		Play Areas	N/A

Accessible route not provided around playground Accessible route not provided to play components	- -	Provide an accessible route around the play area. (Cost estimate for 144' long 4' wide asphalt route, including a route to the bench.) Provide a compliant impact-attenuating surface to and around the play components. (Cost estimate for 1,344 sq. ft. of poured in place rubber surface.)	1	24576	\$24576

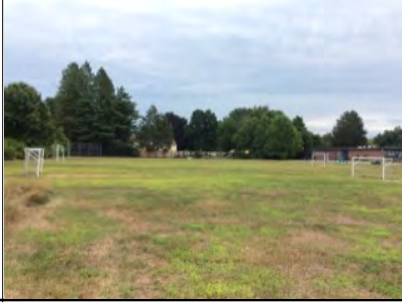
ID	Location	Floor	Room	Element	Type	Photo	Issues	Current Measure	Recommendations	Quantity	Price	Cost Estimation
Field												
139	Soccer Field	Ext.		Field	Soccer

Field not connected to an accessible route	-	Provide an accessible route to each soccer field. (Cost estimate for 80' long by 4' wide stone dust route.)	1	2560	\$2560
140	Baseball Field	Ext.		Field	Baseball

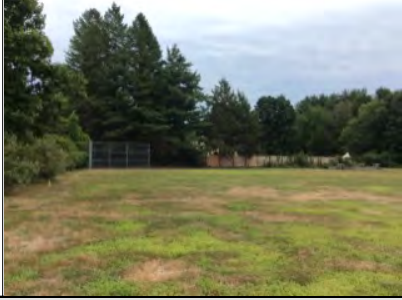
Field not connected to an accessible route	-	Provide an accessible route to the field. (Cost estimate for 60' long, 4' wide asphalt route.)	1	2400	\$2400
Overall Review												
141	Accessible Shower Across From Health Office	1	14

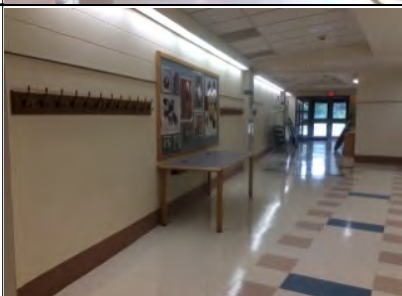
Recommend locating some hooks in the main corridor within recommended children's reach ranges between 40" and 44" high for students in the kindergarten through the fifth grade.	1	-	\$0

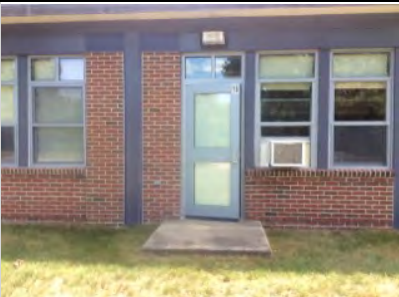
Recommend providing an accessible walkway from each ground level classroom exit door.	1	-	\$0
151	Southwest Playground Gate	Ext.

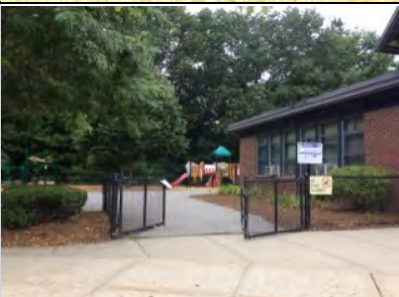
Recommend providing a 10" high solid surface kickplate on the push side of the gate to the southwest playground.	1	-	\$0
152	Swing Sets North of the Basketball Court	Ext.

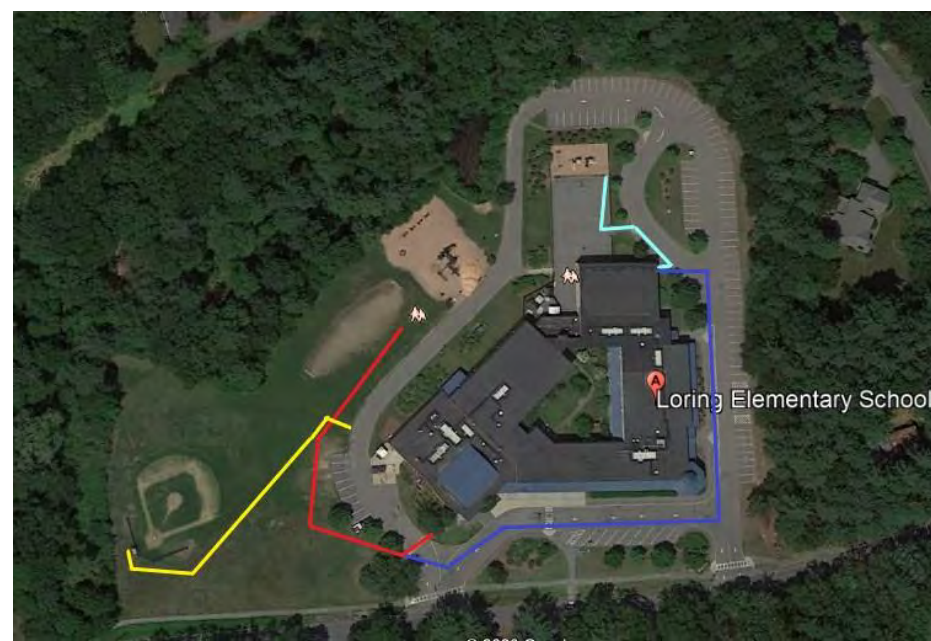
Figure 1: In the following image, the aqua line indicates the approximate route to the upper basketball court and playground. The blue line indicates the approximate route from the upper to

the lower amenities area. The yellow line indicates the approximate location of a new route to the edge of sport activity and team seating at the baseball field. The red line indicates the approximate location of a new route from a cafeteria exit to the future location of the new basketball hoops and the redesigned and rebuilt accessible lower playground. IHCD is including approximate costs to correct issues along the aqua route and for the inclusion of the new yellow route. Sudbury has budgeted for the new red route, the installation of the new basketball hoops, and for the new lower playground. Sudbury also has existing plans to address any excessive slope or other accessibility issues with the blue route and general circulation path between the upper and lower amenities areas.

Accessible route not provided to playground	-	Note: An accessible route is not provided from the school basketball court and upper playground to the lower playground area. See Figure 1 in the report narrative for details regarding the provision of an accessible route between outdoor amenities.	1	-	\$0

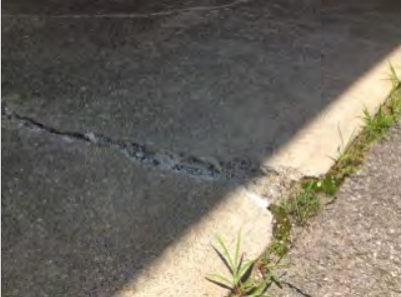
ID	Location	Floor	Room	Element	Type	Photo	Issues	Current Measure	Recommendations	Quantity	Price	Cost Estimation
Approach and Entrance												
Exterior Access Route												
1	Near Gymnasium	Ext.		Exterior Access Route	Exterior

Surface openings > 1/2"	6"	Repair opening. (Cost based on a 4'x4' concrete patch.)	1	256	\$256
2	Courtyard	Ext.		Exterior Access Route	Walkway

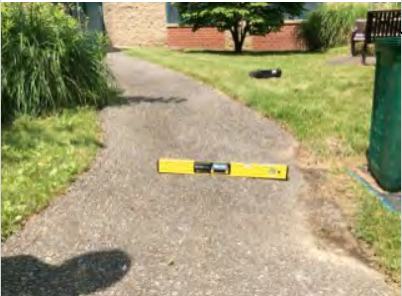
Cross slope > 1:50 (2.00%)	4.5%	Reduce cross slope to be no steeper than 1:50 (2.00%). (Cost base on 15' of asphalt to correct slope.)	1	600	\$600
3	From Main Entrance Towards Exit 11	Ext.		Exterior Access Route	Walkway

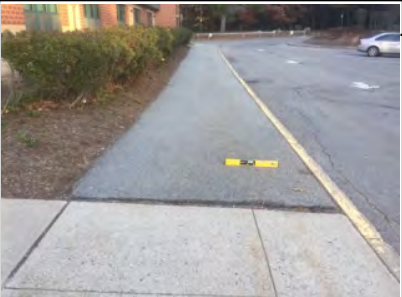
Cross slope > 1:50 (2.00%)	4.7%	Reduce cross slope to be no steeper than 1:50 (2.00%). (Cost for 4'x15' of asphalt to correct slope.)	1	600	\$600
4	From Main Entrance Towards Exit 11	Ext.		Exterior Access Route	Walkway

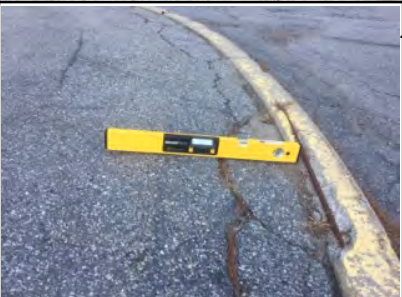
Cross slope > 1:50 (2.00%)	13.6%	Reduce cross slope to be no steeper than 1:50 (2.00%). (Cost for 4'x6' of asphalt to correct slope.)	1	240	\$240

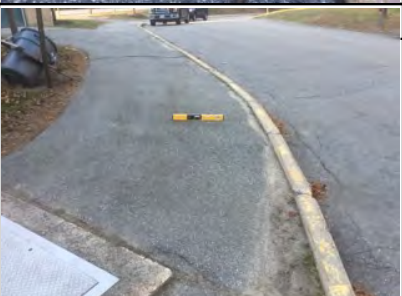
5	From Exit 10 To Exit 8	Ext.		Exterior Access Route	Walkway

Cross slope > 1:50 (2.00%)	8.7%	Reduce cross slope to be no steeper than 1:50 (2.00%). (Cost based on 4'x6' of asphalt to correct slope.)	1	240	\$240

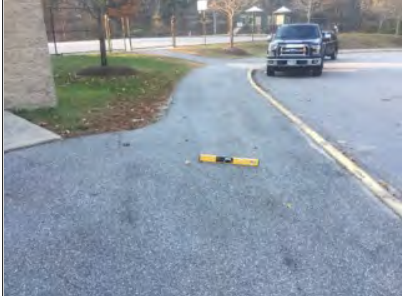
ID	Location	Floor	Room	Element	Type	Photo	Issues	Current Measure	Recommendations	Quantity	Price	Cost Estimation
6	From Exit 8 Towards Basketball Court	Ext.		Exterior Access Route	Walkway

Cross slope > 1:50 (2.00%)	10.3%	Reduce cross slope to be no steeper than 1:50 (2.00%). (Cost based on 4'x6' of asphalt to correct slope.)	1	240	\$240
7	Walkway	Ext.		Exterior Access Route	Walkway

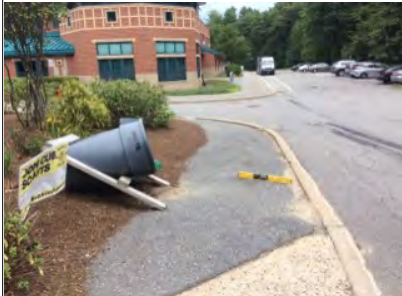
Cross slope > 1:50 (2.00%)	12.8%	Reduce cross slope to be no steeper than 1:50 (2.00%).	1	240	\$240
8	Walkway	Ext.		Exterior Access Route	Walkway

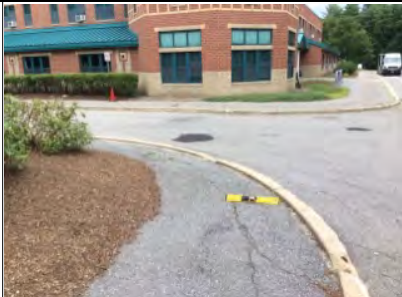
Cross slope > 1:50 (2.00%)	15.8%	Reduce cross slope to be no steeper than 1:50 (2.00%).	1	240	\$240
9	Walkway	Ext.		Exterior Access Route	Walkway

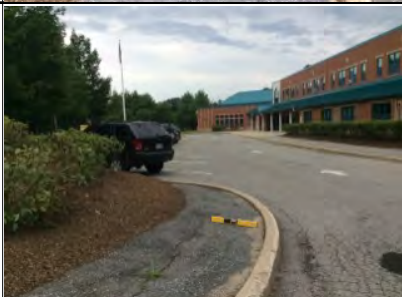
Cross slope > 1:50 (2.00%)	10.9%	Reduce cross slope to be no steeper than 1:50 (2.00%).	1	240	\$240
10	Walkway	Ext.		Exterior Access Route	Walkway

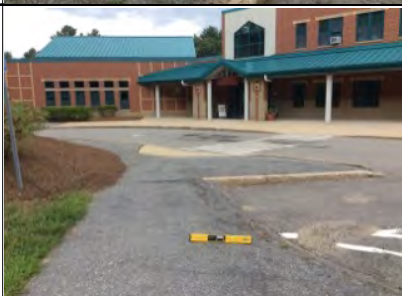
Cross slope > 1:50 (2.00%)	9.7%	Reduce cross slope to be no steeper than 1:50 (2.00%).	1	240	\$240

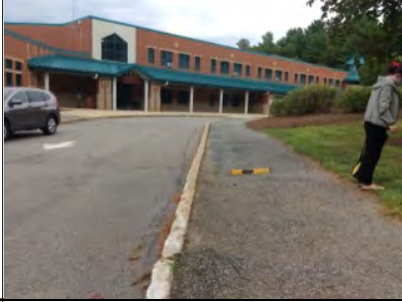
Cross slope > 1:50 (2.00%)	8.3%	Reduce cross slope to be no steeper than 1:50 (2.00%).	1	240	\$240
12	Path to Basketball Court/Upper Playground	Ext.		Exterior Access Route	Walkway

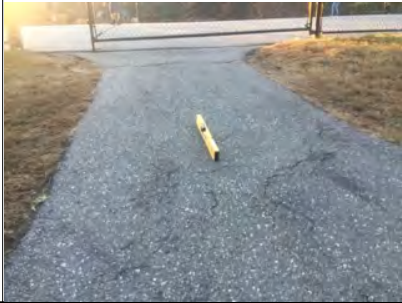
Cross slope > 1:50 (2.00%) Running slope > 1:20 (5%)	4.4% 9.7%	Reduce cross slope to be no steeper than 1:50 (2.00%). Reduce running slope to be no steeper than 1:20 (5%). (Cost based on 4'x6' of asphalt to correct slope.)	1	240	\$240
13	From Exit 11 Towards Exit 10	Ext.		Exterior Access Route	Walkway

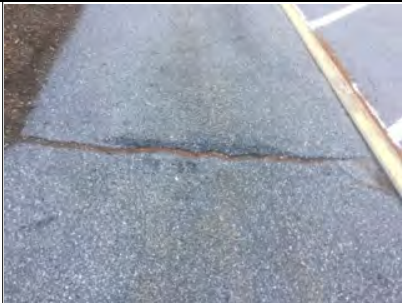
Cross slope > 1:50 (2.00%) Route not maintained in operable working condition	3.8% -	Reduce cross slope to be no steeper than 1:50 (2.00%). Ensure the accessible route is maintained in operable working condition. (Cost for 4'x6' of asphalt to correct slope and repair surface opening.)	1	240	\$240

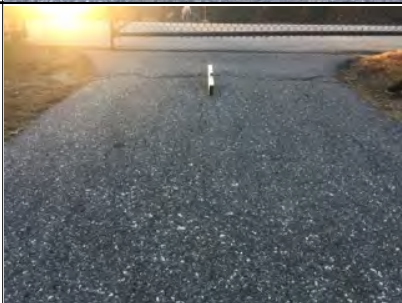
Running slope > 1:20 (5%)	7%	Reduce running slope to be no steeper than 1:20 (5%). (Cost based on 4'x6' of asphalt to correct slope.)	1	240	\$240
15	Courtyard to Lobby Entrance	Ext.		Exterior Access Route	Walkway

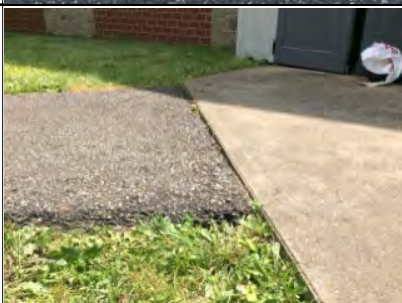
Level changes > 1/4"	-	Alter change in level to be 1/4" high max. (Cost based on a 4'x4' asphalt patch.)	1	160	\$160

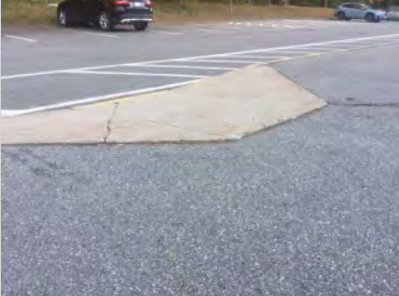
ID	Location	Floor	Room	Element	Type	Photo	Issues	Current Measure	Recommendations	Quantity	Price	Cost Estimation
16	Curb Ramp Opposite Exit 10	Ext.		Exterior Access Route	Exterior

Level changes > 1/4"	.75"	Alter change in level to be 1/4" high max. (Cost based on a concrete patch.)	1	256	\$256
17	From Exit 10 To Exit 8	Ext.		Exterior Access Route	Walkway

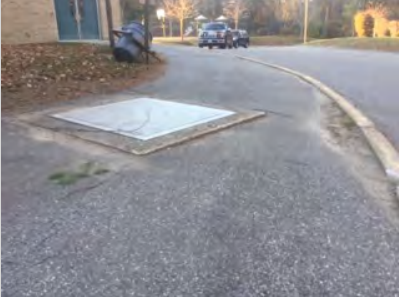
Level changes > 1/4"	1"	Alter change in level to be 1/4" high max. (Cost based on 2'x10' of beveled asphalt to reduce change in level.)	1	200	\$200
18	Exit 8	Ext.		Exterior Access Route	Walkway
