Curtis Middle School

Town of Sudbury ADA Transition Plan

January 2021

Institute for Human Centered Design

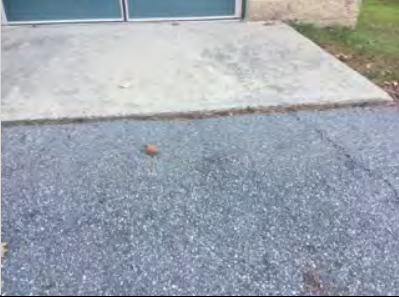
Level changes > 1/4"	1	Alter change in level to be 1/4" high max. (Cost based on an asphalt patch.)	1	160	\$160
19	Curb Ramp at Basketball Court	Ext.		Exterior Access Route	Exterior

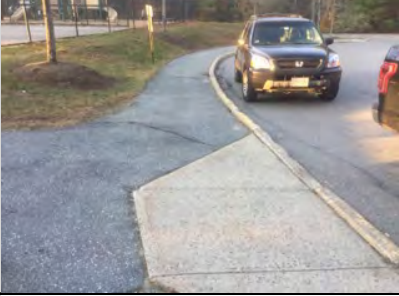
Level changes > 1/4"	2"	Alter change in level to be 1/4" high max. (Cost based on asphalt patch to correct change in level.) (Cost included in ID #37 - Cost for a new compliant curb ramp.)	1	-	\$0

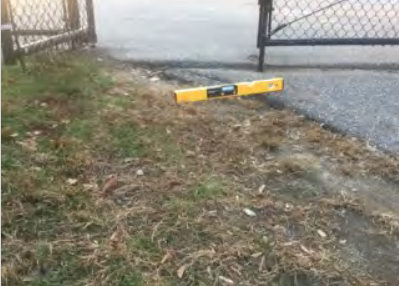
20	Small Gate Entry to Basketball Court/Upper Playground	Ext.		Exterior Access Route	Exterior

Level changes > 1/4"	2"	Alter change in level to be 1/4" high max. (Cost for an asphalt patch.)	1	160	\$160

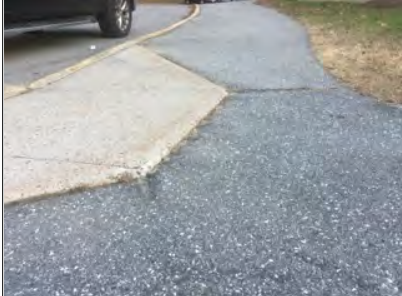
Level changes > 1/4"	1"	Alter change in level to be 1/4" high max. (Cost based on asphalt patch to correct change in level.) (Cost included in ID #37 - Cost for a new compliant curb ramp.)	1	-	\$0
22	Door 9	Ext.		Exterior Access Route	Exterior

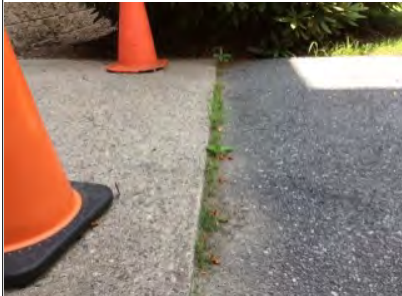
Level changes > 1/4" Accessible route not provided	.75"	Alter change in level to be 1/4" high max. Ensure an accessible route is provided. (Cost based on an asphalt patch.)	1	160	\$160
23	Door 8	Ext.		Exterior Access Route	Exterior

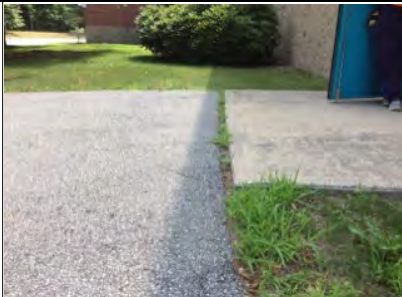
Route not maintained in operable working condition	2"	Ensure the accessible route is maintained in operable working condition. Repair 2" gap with asphalt patch.	1	160	\$160
24	From Main Entrance Towards Exit 11	Ext.		Exterior Access Route	Walkway

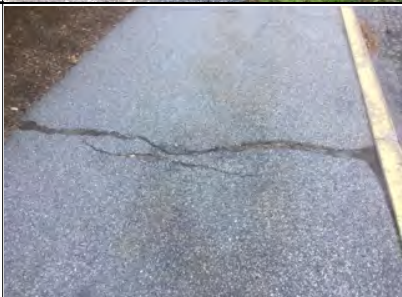
Route not maintained in operable working condition	-	Ensure the accessible route is maintained in operable working condition. Repair deteriorated asphalt.	1	160	\$160

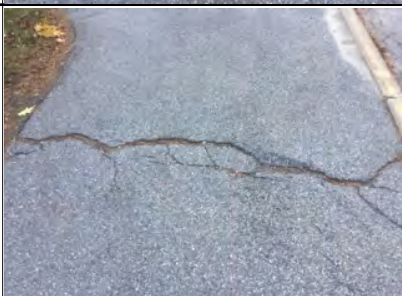
25	From Exit 10 To Exit 8	Ext.		Exterior Access Route	Walkway

Route not maintained in operable working condition	-	Ensure the accessible route is maintained in operable working condition. Repair deteriorated asphalt. (Cost based on an asphalt patch.)	1	160	\$160

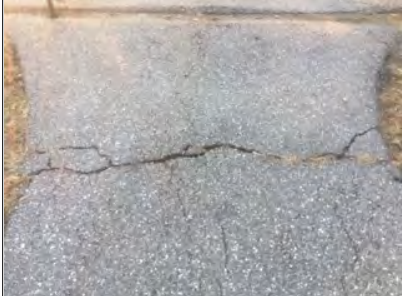
ID	Location	Floor	Room	Element	Type	Photo	Issues	Current Measure	Recommendations	Quantity	Price	Cost Estimation
26	Path to Basketball Court/Upper Playground	Ext.		Exterior Access Route	Walkway

Route not maintained in operable working condition	-	Ensure the accessible route is maintained in operable working condition. (Cost based on 4'x4' of asphalt to repair surface.)	1	160	\$160
27	Entry to Basketball Court/Upper Playground	Ext.		Exterior Access Route	Exterior

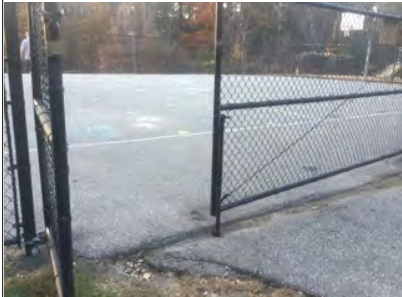
Route not maintained in operable working condition	-	Ensure the accessible route is maintained in operable working condition. Repair surface at gate to basketball court. (Cost based on an asphalt patch.)	1	160	\$160
28	Garden Box	Ext.		Exterior Access Route	Exterior

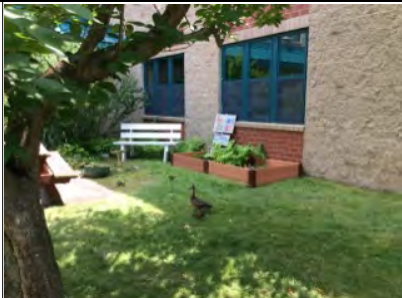
Accessible route not provided	-	Ensure an accessible route is provided to the garden box. (Cost based on a 4' wide min. x 6' long stone dust path from existing walkway to garden box.)	1	192	\$192

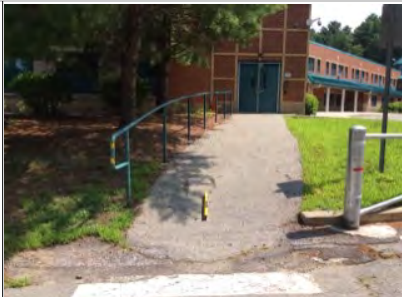
Curb Ramp												
29	Exit From Cafeteria	Ext.		Curb Ramp	N/A

Curb ramp not provided Running slope > 1:12 (8.33%) Handrails not provided at both sides if rise is > 6"	- 25%	Provide a curb ramp at intersection. Provide a handrail on both sides. (Cost estimate for a new concrete curb ramp and 30' of metal handrail.)	1	5020	\$5020
30	Crosswalk Near Woodside Road	Ext.		Curb Ramp	N/A

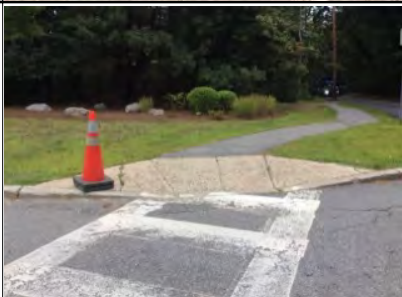
Running slope > 1:12 (8.33%)	10.7%	Reduce running slope to be no steeper than 1:12 (8.33%). (Cost estimate for a new concrete curb ramp.)	1	2800	\$2800

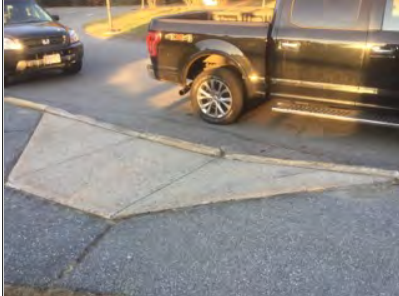
ID	Location	Floor	Room	Element	Type	Photo	Issues	Current Measure	Recommendations	Quantity	Price	Cost Estimation
31	Curb Ramp 2 Near Basketball Court	Ext.		Curb Ramp	N/A

Running slope > 1:12 (8.33%) Transition from curb ramp to street not flush Curb ramp flares > 1:10 (10%)	13.4% - 18.1%	Reduce running slope to be no steeper than 1:12 (8.33%). Ensure transition from curb ramp to street is flush or free of changes in level. Reduce slope at curb ramp flares to be no steeper than 1:10 (10%). (Cost estimate for a new concrete curb ramp.)	1	2800	\$2800
32	Crosswalk Near Woodside Road	Ext.		Curb Ramp	N/A

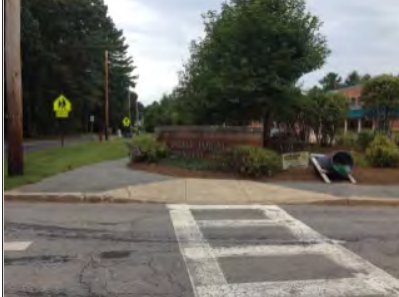
Running slope > 1:12 (8.33%) Landing not provided at top of curb ramp	10.7% -	Reduce running slope to be no steeper than 1:12 (8.33%). Provide landing at top of curb ramp or reconfigure ramp. (Cost estimate for a new concrete curb ramp.)	1	2800	\$2800
33	Curb Ramp at Basketball Court	Ext.		Curb Ramp	N/A

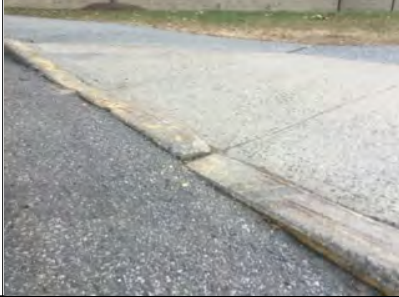
Transition from curb ramp to street not flush	2"	Ensure transition from curb ramp to street is flush or free of changes in level. (Cost included in ID #37 - Cost for a new compliant curb ramp.)	1	-	\$0

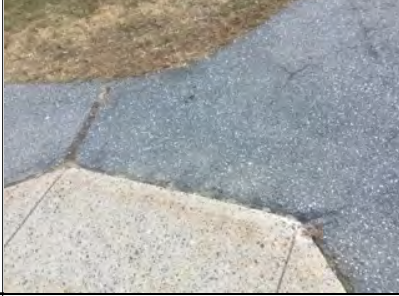
34	Curb Ramp at Basketball Court	Ext.		Curb Ramp	N/A

Transition from curb ramp to street not flush	-	Ensure transition from curb ramp to street is flush or free of changes in level. (Cost included in ID #37 - Cost for a new compliant curb ramp.)	1	-	\$0
35	Curb Ramp at Basketball Court	Ext.		Curb Ramp	N/A

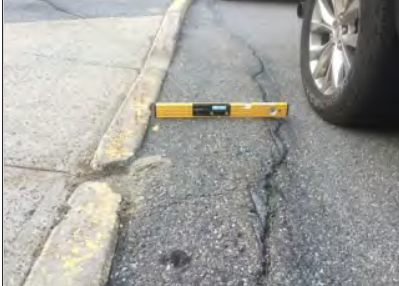
Transition from curb ramp to street not flush	-	Ensure transition from curb ramp to street is flush or free of changes in level. (Cost included in ID #37 - Cost for a new compliant curb ramp.)	1	-	\$0

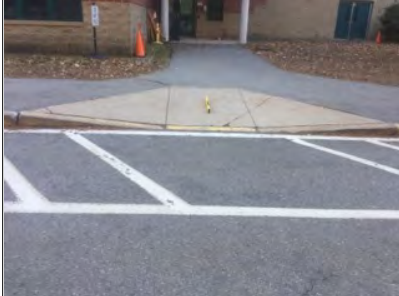
ID	Location	Floor	Room	Element	Type	Photo	Issues	Current Measure	Recommendations	Quantity	Price	Cost Estimation
36	Curb Ramp Opposite Exit 10	Ext.		Curb Ramp	N/A

Curb ramp flares > 1:10 (10%)	14%	Reduce slope at up hill curb ramp flare to be no steeper than 1:10 (10%). (Cost estimate for concrete to reduce slope.)	1	256	\$256
37	Curb Ramp at Basketball Court	Ext.		Curb Ramp	N/A

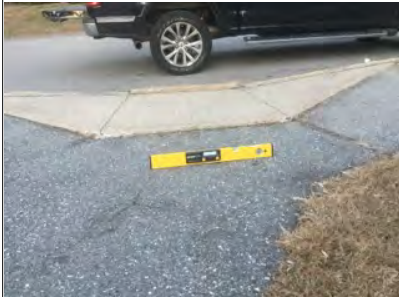
Landing not provided at top of curb ramp Cross slope > 1:50 (2%) (MAAB)	- 3.3%	Provide a 5'x5' landing at top of curb ramp. Reduce cross slope at curb ramp to be no steeper than 1:50 (2%). (Cost for a new compliant concrete curb ramp addressing all shown curb ramp issues.)	1	2800	\$2800
Off-Street Parking Lot or Garage												
38	By Baseball Field	Ext.		Off-Street Parking Lot or Garage	N/A

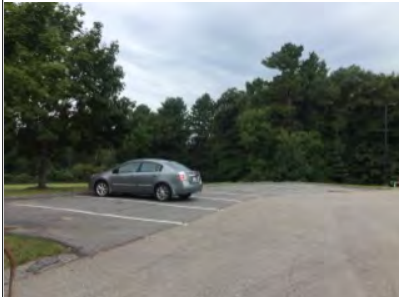
Total # of parking Total # of designated accessible parking spaces Total # of designated van accessible spaces Sign not provided Sign does not have the designation "Van Accessible"	9 - - - -	Provide one compliant van accessible parking space and access aisle each 8' wide min. (re-stripe). Provide a sign with the International Symbol of Accessibility with the bottom of the sign 60" min. above the ground and the top 96" max. above the ground. Add the designation "Van Accessible" to the sign located at the van accessible space.	1	800	\$800

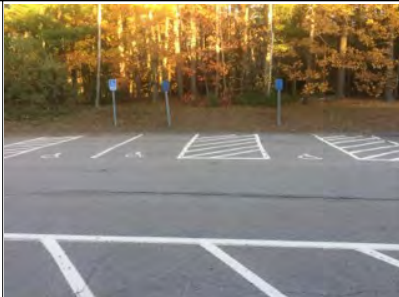
39	Accessible Parking Opposite Exit 11 and 10	Ext.		Off-Street Parking Lot or Garage	N/A

Total # of designated accessible parking spaces Total # of designated van accessible spaces Sign does not have the designation "Van Accessible"	2 1 -	Add the designation "Van Accessible" to the sign located at the van accessible space (the space furthest to the right in this photograph). Ensure there is at least 60" clear height measured to the bottom of the sign.	1	500	\$500
Exterior Stair												
40	Staircase Lower Level	Ext.		Exterior Stair	N/A

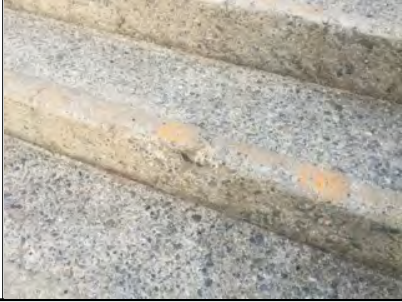
Not maintained in operable working condition	-	Ensure stairs are maintained in operable working condition. The third step from the top, the third step from the middle landing and the last step at the bottom show some chipping and deterioration. Repair surface.	1	Labor	\$0
Access to Goods and Services												
Means of Egress												
42	Egress Door 9	1	154	Means of Egress	N/A

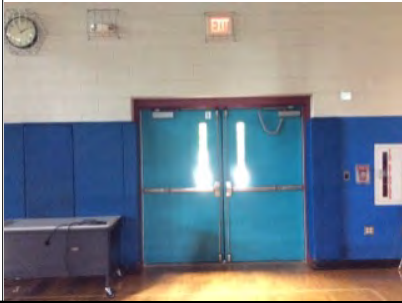
Tactile exit sign not provided	-	Ensure tactile exit signs with raised characters and braille are provided at exit doors. Mount signs between 48"- 60" above the finished floor located on the latch side of the door.	1	232	\$232
43	Egress Door 10	1		Means of Egress	N/A

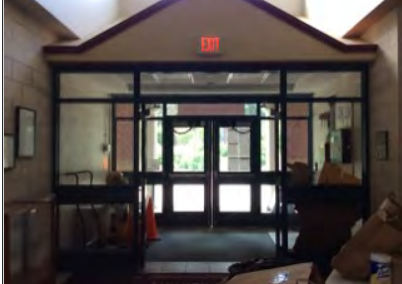
Tactile exit sign not provided Illuminated ISA symbol not provided (MAAB)	- -	Ensure tactile exit signs with raised characters and braille are provided at exit doors. Mount signs between 48"- 60" above the finished floor located on the latch side of the door. Provide an illuminated sign with the International Symbol of Accessibility.	1	432	\$432

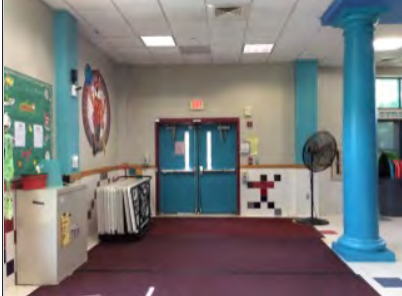
ID	Location	Floor	Room	Element	Type	Photo	Issues	Current Measure	Recommendations	Quantity	Price	Cost Estimation
46	Cafetorium Egress	1		Means of Egress	N/A

Tactile exit sign not provided Illuminated ISA symbol not provided (MAAB)	- -	Ensure tactile exit signs with raised characters and braille are provided at exit doors. Mount signs between 48" - 60" above the finished floor located on the latch side of the door. Provide an illuminated sign with the International Symbol of Accessibility.	1	432	\$432
47	Door 6 at Gymnasium	1		Means of Egress	N/A

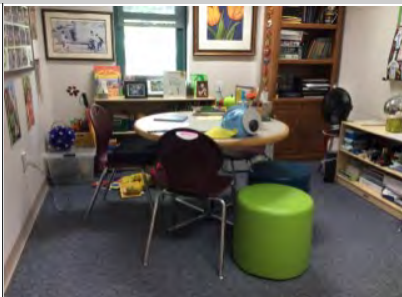
Route < 36" wide	-	Ensure that a clear width of 36" min. is maintained at the accessible route.	1	Labor	\$0

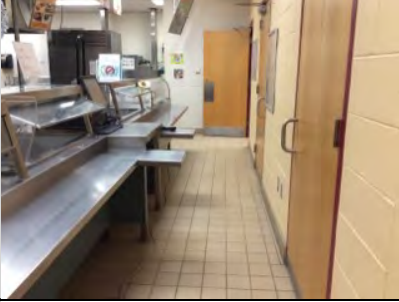
ID	Location	Floor	Room	Element	Type	Photo	Issues	Current Measure	Recommendations	Quantity	Price	Cost Estimation
51	Cafetorium	1		Interior Access Route	N/A

Route < 36" wide	29"	Ensure that a clear width of 36" min. is maintained at the accessible route. (Width decreases at extended counter. If students walk past that counter, maintain 36" min. clear width.)	1	Labor	\$0
52	Music Practice	1	164	Interior Access Route	N/A

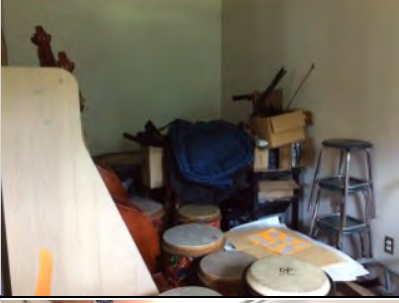
Route < 36" wide	-	Ensure that a clear width of 36" min. is maintained at the accessible route.	1	Labor	\$0
53	Work Room	1		Interior Access Route	N/A

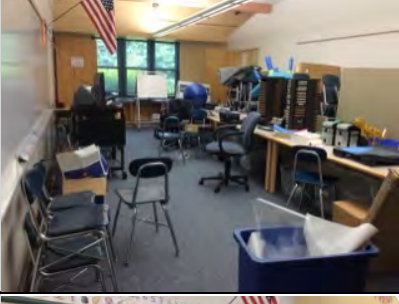
Route < 36" wide	-	Ensure that a clear width of 36" min. is maintained at the accessible route.	1	Labor	\$0
54	Special Education	1	159	Interior Access Route	N/A

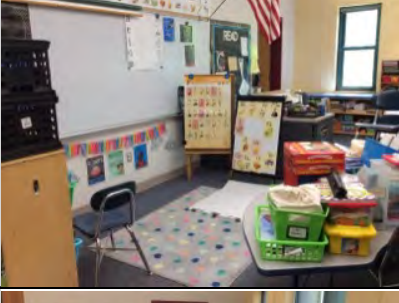
Route < 36" wide	-	Ensure that a clear width of 36" min. is maintained at the accessible route.	1	Labor	\$0
55	Classroom 235	2	235	Interior Access Route	N/A

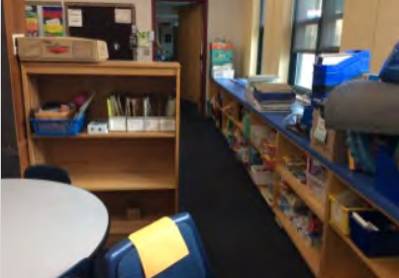
Route < 36" wide	29"	Ensure that a clear width of 36" min. is maintained at the accessible route.	1	Labor	\$0

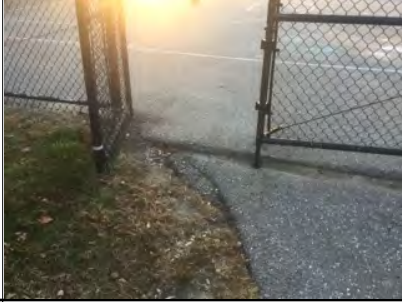
Clear width at door < 32"	24"	Widen the gate so that there is 32" min. clear width.	1	Labor	\$0
57	Room 107	1	107	Doors, Doorways, & Gates	Office

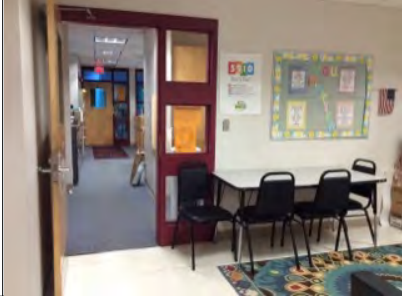
Maneuvering clearance(s) not provided	-	Remove chair to provide 18" min. pull-side maneuvering clearance at door.	1	Labor	\$0
58	Room 110	1	110	Doors, Doorways, & Gates	Office

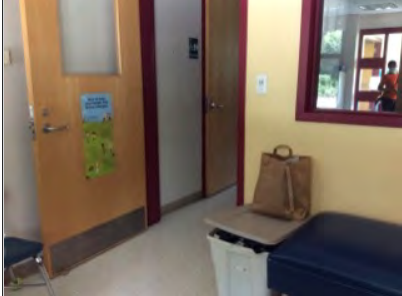
Maneuvering clearance(s) not provided	-	Remove stored items to provide 18" min. pull-side maneuvering clearance at door.	1	Labor	\$0
59	Boys' Toilet Room	1	167	Doors, Doorways, & Gates	Toilet Room

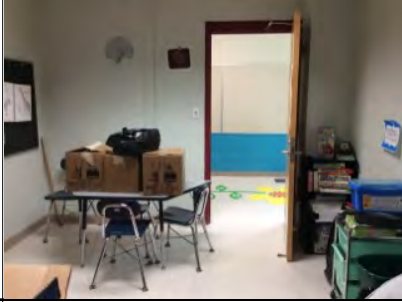
ID	Location	Floor	Room	Element	Type	Photo	Issues	Current Measure	Recommendations	Quantity	Price	Cost Estimation
61	Psychologist's Office	1		Doors, Doorways, & Gates	Office

Maneuvering clearance(s) not provided	-	Remove stored objects to provide 18" min. pull-side maneuvering clearance at door.	1	Labor	\$0
62	Kindergarten	1	135	Doors, Doorways, & Gates	Classroom

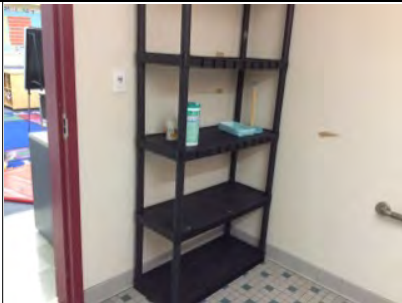
Maneuvering clearance(s) not provided	14"	Remove shelving to provide 18" min. pull-side maneuvering clearance at door.	1	Labor	\$0
64	Men's Toilet Room	1	127	Doors, Doorways, & Gates	Toilet Room

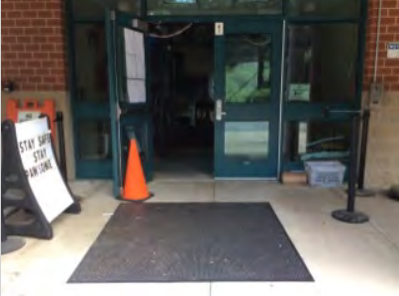
ID	Location	Floor	Room	Element	Type	Photo	Issues	Current Measure	Recommendations	Quantity	Price	Cost Estimation
71	Main Entrance Door 1	Ext.		Doors, Doorways, & Gates	Emergency Egress

Mat not securely attached	-	Secure the mat.	1	Labor	\$0
72	Administrative Office	1		Doors, Doorways, & Gates	Office

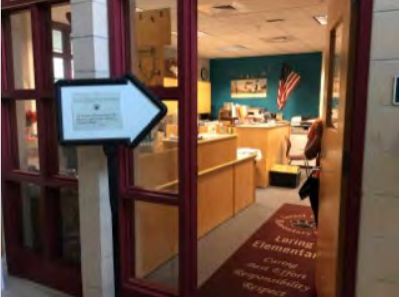
Mat not securely attached	-	Secure the mat.	1	Labor	\$0
73	Cafetorium	1	185	Doors, Doorways, & Gates	Circulation

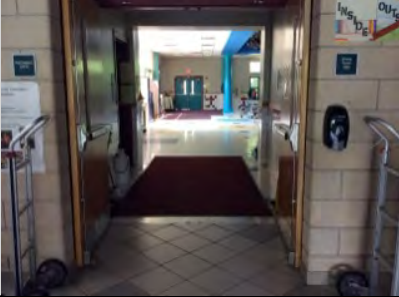
Mat not securely attached	-	Secure the mat.	1	Labor	\$0
74	Hallway	1		Doors, Doorways, & Gates	Circulation

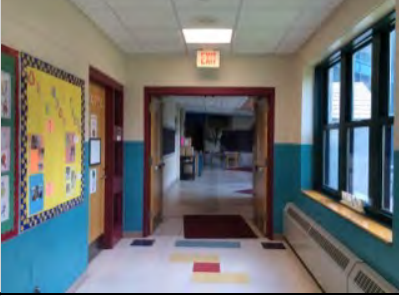
Mat not securely attached	-	Secure the mat.	1	Labor	\$0
75	Cafetorium Egress	1		Doors, Doorways, & Gates	Emergency Egress

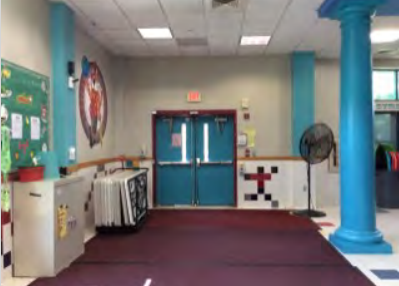
Mat not securely attached	- -	Secure the mat.	1	Labor	\$0

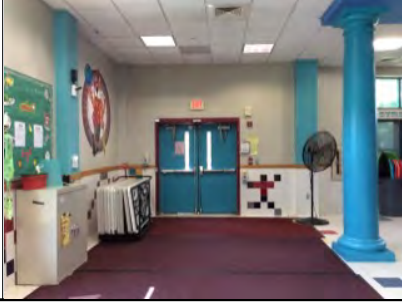
Mat not securely attached	- -	Secure the mat.	1	Labor	\$0
Ramps												
77	Ramp to Stage	1	189	Ramps	Interior

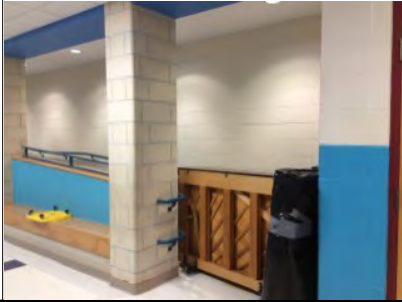
Not maintained in operable working condition	-	Remove stored items from ramp.		Labor	\$0
Stairways												
78	Stairs to Stage	1	188	Stairways	Other

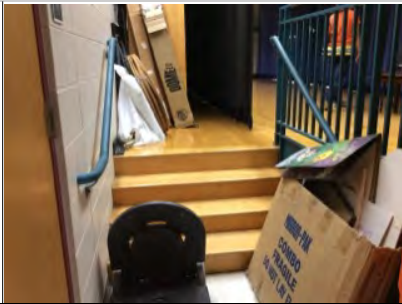
Not maintained in operable working condition	-	Remove stored items blocking stair landing.	1	Labor	\$0
79	Cafetorium Stage	1		Stairways	Other

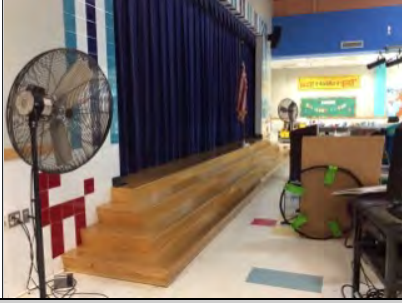
Handrails not provided	-	Provide handrails on at least one side of the stage. (Cost based on 6' of wood railing.)	1	352	\$352
Operable Parts												
80	Main Entrance Door 1	Ext.		Operable Parts	Other

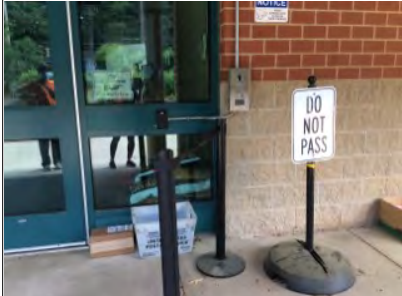
Clear floor space is not provided	-	Keep stored items away from intercom.	1	Labor	\$0

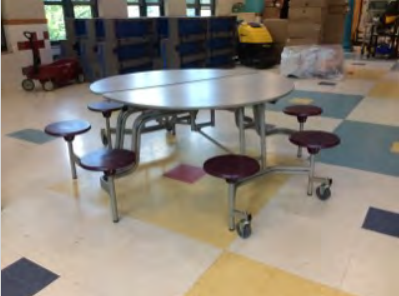
ID	Location	Floor	Room	Element	Type	Photo	Issues	Current Measure	Recommendations	Quantity	Price	Cost Estimation
Dining or Work Surfaces												
81	Cafetorium	1		Dining or Work Surfaces	Dining Surface

Knee or toe clearance not provided	-	Provide at least 1 dining surface with 24" min. knee and toe clearance.	1	1100	\$1100
82	PT/OT	1		Dining or Work Surfaces	Work Surface

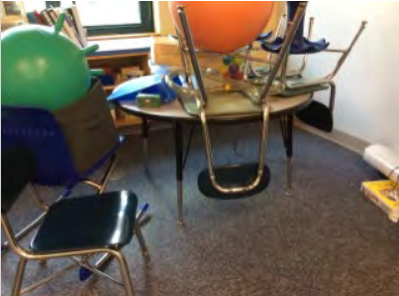
Knee or toe clearance not provided	22"	Provide at least 1 work surface with 24" min. knee and toe clearance.	1	700	\$700
Assembly Area												
83	Cafetorium Stage	1		Assembly Area	N/A

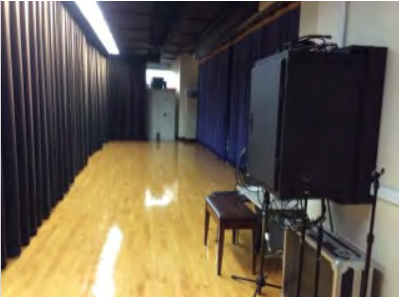
Assistive listening devices not provided	-	If audible communication is integral to the use of the space, provide an assistive listening system.	1	1214	\$1214
Picnic Tables												
84	Lower Playground	Ext.		Picnic Tables	N/A

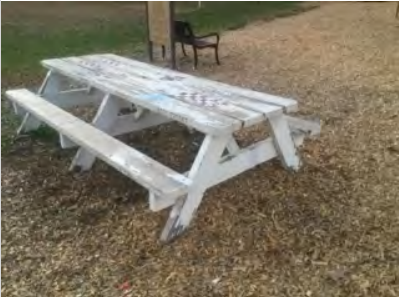
At least 5% accessible spaces not provided	-	Ensure that at least 5% (minimum one) of the picnic tables in this area are accessible. (Cost based on a new accessible picnic table.)	1	1400	\$1400

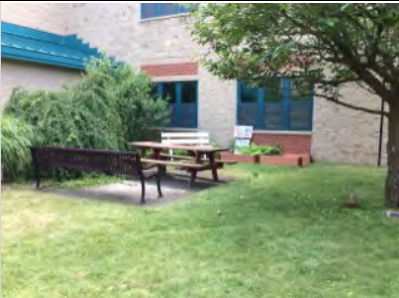
85	Courtyard	Ext.		Picnic Tables	N/A

Toe or knee clearance at tables not provided Picnic table not on an accessible route	- -	Provide at least 1 picnic table in this area with toe and knee clearance. Ensure that the dining surface is connected to an accessible route. (Cost based on an accessible picnic table.)	1	1400	\$1400

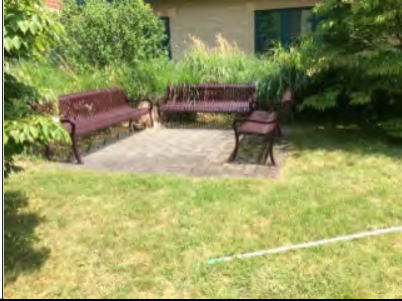
No accessible route to one bench in area	-	Provide an accessible route to 20% of benches in this area. (Cost based on a 48" wide min. x 12' long stone dust path with a max. cross slope of 1:50 (2.00%) and a max. running slope of 1:20 (5.00%).	1	384	\$384
Toilet & Bathing Rooms												
Lavatory												
87	Women's Toilet Room	1		Lavatory	N/A

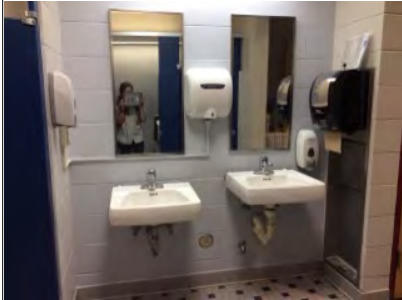
Clear floor space not provided at lavatory	-	Provide at least one lavatory with a 30" min. by 48" min. clear floor space positioned for a forward approach. (Relocate paper towel dispenser out of clear floor space at lavatory.)	1	353	\$353
Toilet Compartment												
88	Men's Toilet Room	1	127	Toilet Compartment	Accessible Compartment

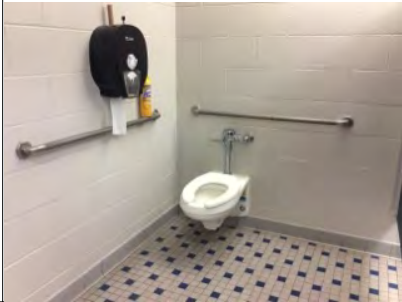
Flush control not on open side Non-compliant toilet paper dispenser	- -	Provide the flush control on the open side of the toilet (transfer side). Relocate toilet paper so that it is 24" min. high, located under the grab bar, and between 7" and 9" from the front of the toilet. Replace dispenser as it does not allow continuous paper flow.	1	727	\$727

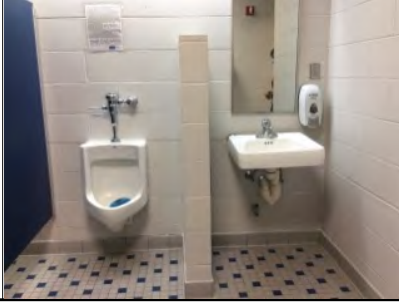
Rim > 17" high	18.5"	Provide at least one urinal with the rim no higher than 17" above the finished floor.	1	3248	\$3248
Dispensers												
91	Boys' Toilet Room	1	167	Dispensers	Paper Towel Dispenser

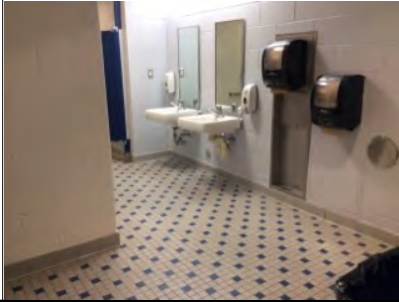
Dispenser acts as a protruding object	-	Relocate dispenser out of the circulation path or place a cane-detectable barrier under the dispenser.	1	306	\$306
92	Women's Toilet Room	1		Dispensers	Paper Towel Dispenser

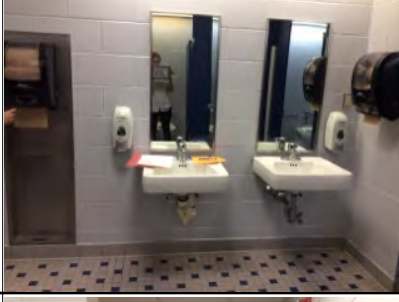
Dispenser acts as a protruding object	-	Relocate dispenser out of the circulation path or place a cane-detectable barrier under the dispenser.	1	306	\$306

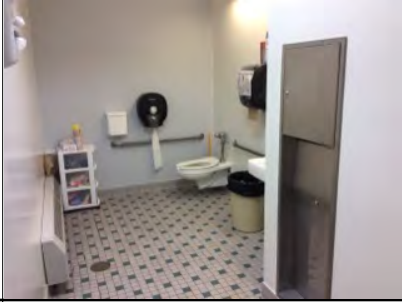
Clearance at toilet < 60" clear wide	34"	Remove storage cabinet to provide a clear floor space that is 60" wide min.	1	Labor	\$0
96	Spanish Classroom Single-User Toilet Room	1	133	Single-User Toilet (Children)	N/A

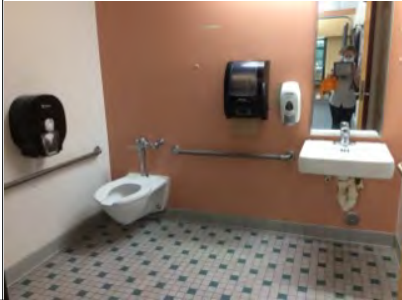
Flush control not on open side Non-compliant toilet paper dispenser	- -	Move the flush control to the open side. Mount flush control between 20" - 30" above the floor. Relocate toilet paper dispenser so that it is between 14"- 19" above the floor and between 7"- 9" in front of the toilet. Ensure dispensers and other devices are not mounted above grab bars. Also relocate the paper towel and soap dispensers from above the grab bar.	1	1433	\$1433
97	Kindergarten Single-User Toilet Room	1	135	Single-User Toilet (Children)	N/A

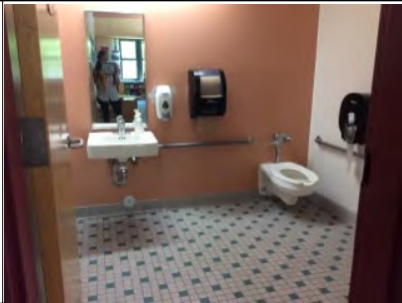
Non-compliant toilet paper dispenser	- -	Relocate toilet paper dispenser so that it is between 14"- 19" above the floor and between 7"- 9" in front of the toilet. Ensure dispensers and other devices are not mounted above grab bars./Replace dispenser as it does not allow continuous paper flow. Also relocate the paper towel and soap dispensers from above the grab bar.	1	1058	\$1058

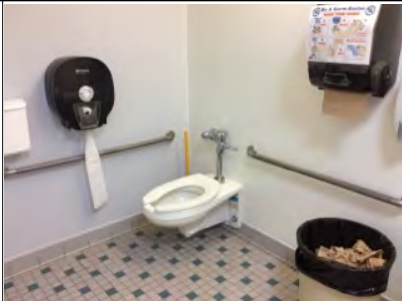
98	Single-User Toilet Room	1	109	Single-User Toilet (Children)	N/A

Non-compliant toilet paper dispenser Paper towel dispenser and tampon dispenser above grab bar.	-	Relocate toilet paper dispenser so that it is between 14"- 19" above the floor and between 7"- 9" in front of the toilet. Ensure dispensers and other devices are not mounted above grab bars./Replace dispenser as it does not allow continuous paper flow. Relocate all dispensers so they are not located above the grab bars. (MAAB)	3	300	\$900
Toilet Compartment (Children)												
99	Girls' Toilet Room	2		Toilet Compartment (Children)	Accessible Compartment

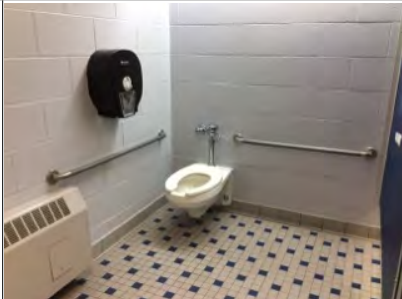
Side or rear grab bar < 25" or > 27" high (Ages 9 - 12) Non-compliant toilet paper dispenser	43" -	Relocate side grab bar to 25"- 27" above the floor. Relocate toilet paper dispenser so that it is between 14"- 19" above the floor and between 7"- 9" in front of the toilet. Ensure dispensers and other devices are not mounted above grab bars./Replace dispenser as it does not allow continuous paper flow.	1	609	\$609

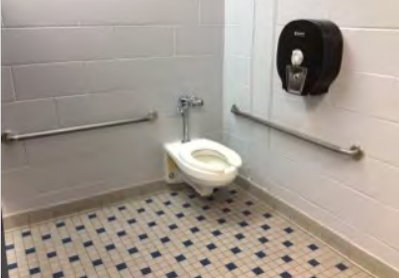
Non-compliant toilet paper dispenser	-	Relocate toilet paper dispenser so that it is between 14"- 19" above the floor and between 7"- 9" in front of the toilet. Ensure dispensers and other devices are not mounted above grab bars./Replace dispenser as it does not allow continuous paper flow.	1	353	\$353

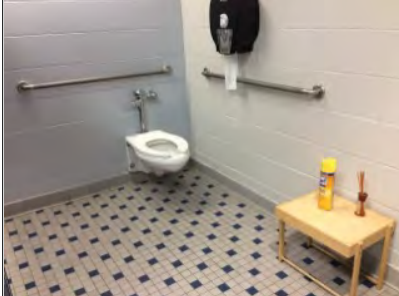
Non-compliant toilet paper dispenser	-	Relocate toilet paper dispenser so that it is between 14"- 19" above the floor and between 7"- 9" in front of the toilet. Ensure dispensers and other devices are not mounted above grab bars. Replace dispenser as it does not allow continuous paper flow.	1	353	\$353
106	Boys' Toilet Room	2	241	Toilet Compartment (Children)	Accessible Compartment

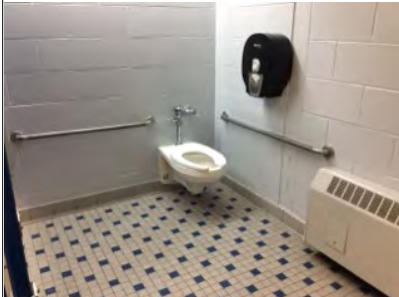
Non-compliant toilet paper dispenser	-	Relocate toilet paper dispenser so that it is between 14"- 19" above the floor and between 7"- 9" in front of the toilet. Ensure dispensers and other devices are not mounted above grab bars./Replace dispenser as it does not allow continuous paper flow.	1	353	\$353
107	Girls' Toilet Room	2	226	Toilet Compartment (Children)	Accessible Compartment

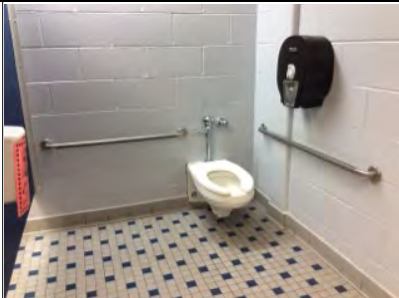
Non-compliant toilet paper dispenser	-	Relocate toilet paper dispenser so that it is between 14"- 19" above the floor and between 7"- 9" in front of the toilet. Ensure dispensers and other devices are not mounted above grab bars./Replace dispenser as it does not allow continuous paper flow.	1	353	\$353

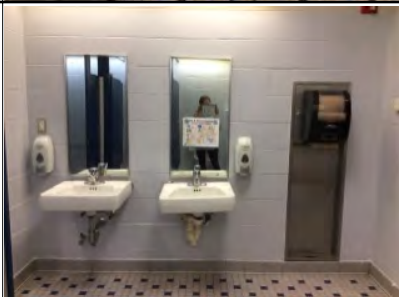
Toe or knee clearances not provided	23"	Provide at least one lavatory with 25" min. knee clearance positioned for a forward approach. Ensure toe clearance is also provided.	1	1686	\$1686

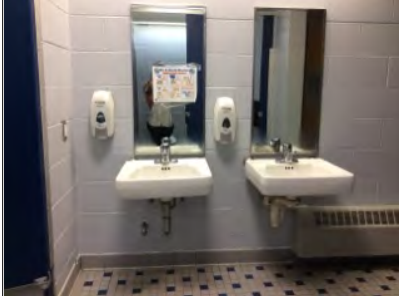
Toe or knee clearances not provided	23"	Provide at least one lavatory with 25" min. knee clearance positioned for a forward approach. Ensure toe clearance is also provided.	1	1686	\$1686
111	Girl's Room	1		Lavatory (Children)	N/A

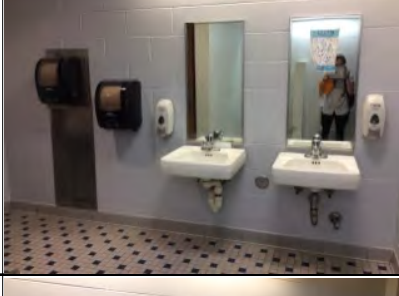
Toe or knee clearances not provided	23.25"	Provide at least one lavatory with 25" min. knee clearance positioned for a forward approach. Ensure toe clearance is also provided.	1	1686	\$1686
113	Girls Toilet Room	1	146	Lavatory (Children)	N/A

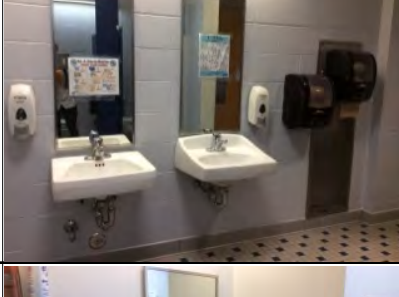
Toe or knee clearances not provided	23.25"	Provide at least one lavatory with 25" min. knee clearance positioned for a forward approach. Ensure toe clearance is also provided.	1	1686	\$1686

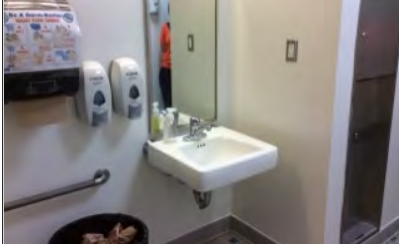
114		1	109	Lavatory (Children)	N/A

Toe or knee clearances not provided Exposed plumbing underneath	22" -	Provide at least one lavatory with 25" min. knee clearance positioned for a forward approach. Ensure toe clearance is also provided. Insulate or otherwise configure pipes to prevent contact, for at least one lavatory.	1	1778	\$1778

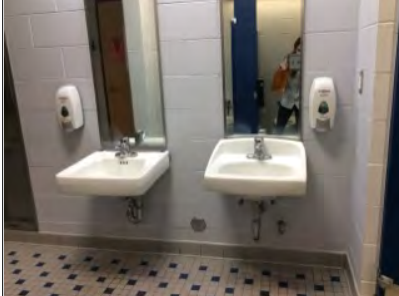
Toe or knee clearances not provided Exposed plumbing underneath	22.5" -	Provide at least one lavatory with 25" min. knee clearance positioned for a forward approach. Ensure toe clearance is also provided. Insulate or otherwise configure pipes to prevent contact, for at least one lavatory.	1	1778	\$1778
116	Kindergarten Single-User Toilet Room	1	135	Lavatory (Children)	N/A

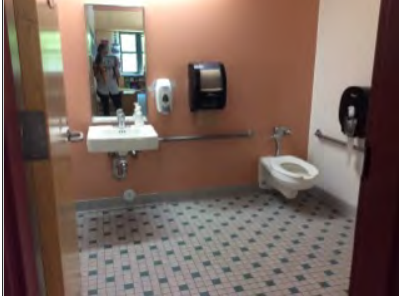
Toe or knee clearances not provided Exposed plumbing underneath	23.5" -	Provide at least one lavatory with 25" min. knee clearance positioned for a forward approach. Ensure toe clearance is also provided. Insulate or otherwise configure pipes to prevent contact, for at least one lavatory.	1	1778	\$1778
117	Girls Toilet Room	1	146	Lavatory (Children)	N/A

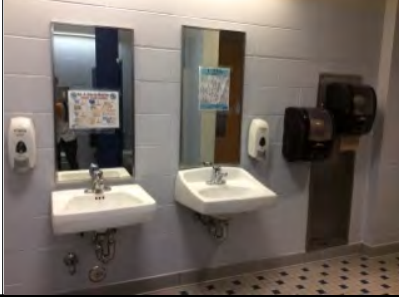
Exposed plumbing underneath	-	Insulate or otherwise configure pipes to prevent contact, for at least one lavatory.	1	92	\$92

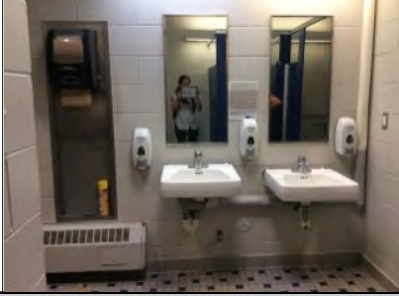
118	Men's Room	1	127	Lavatory (Children)	N/A

Exposed plumbing underneath	-	Insulate or otherwise configure pipes to prevent contact, for at least one lavatory.	1	92	\$92
Dispensers (Children)												
119	Girls Toilet Room	1	168	Dispensers (Children)	Paper Towel Dispenser

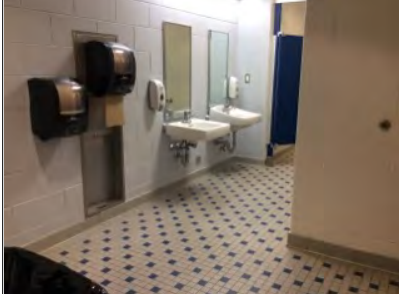
Dispenser is a protruding object	-	Relocate dispenser out of the circulation path or place a cane-detectable barrier under the dispenser.	1	306	\$306

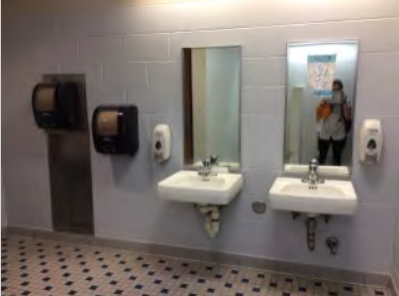
Dispenser is a protruding object	-	Relocate paper towel dispenser out of the circulation path or place a cane-detectable barrier under the dispenser.	1	306	\$306
121	Girls Toilet Room	1	146	Dispensers (Children)	Paper Towel Dispenser

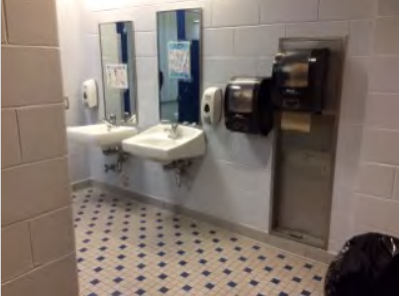
Dispenser is a protruding object	-	Relocate dispenser out of the circulation path or place a cane-detectable barrier under the dispenser.	1	306	\$306
Urinal (Children)												
122	Boys' Toilet Room	2	241	Urinal (Children)

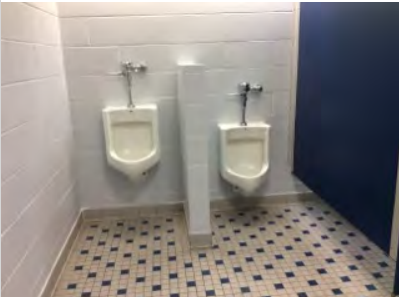
Rim > 15" high (MAAB)	16.5"	Provide at least one urinal with the rim no higher than 15" above the finished floor.	1	3248	\$3248
Additional Access												
Drinking Fountains												
123	Drinking Fountain	1		Drinking Fountains	Low

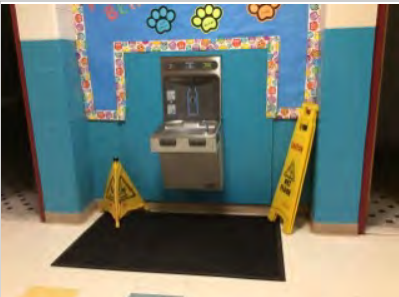
No drinking fountain provided for standing users	-	Provide an additional drinking fountain for standing users or install a Hi-Lo drinking fountain.	1	4028	\$4028

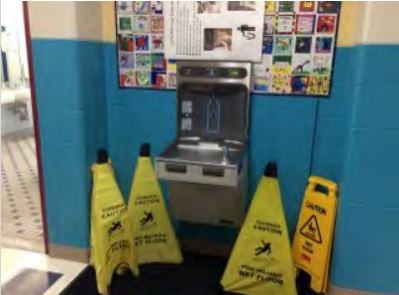
124	Hallway	1	147	Drinking Fountains	Low

No drinking fountain provided for standing users	-	Provide an additional drinking fountain for standing users or install a Hi-Lo drinking fountain.	1	4028	\$4028

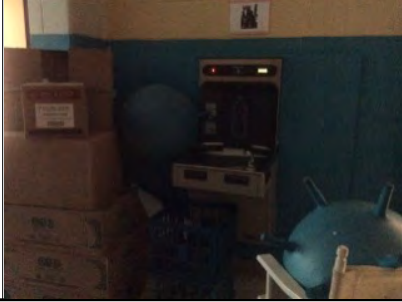
No drinking fountain provided for standing users	-	Provide an additional drinking fountain for standing users or install a Hi-Lo drinking fountain.	1	4028	\$4028
Sink												
126	Health Exam Room	1	108	Sink	Other

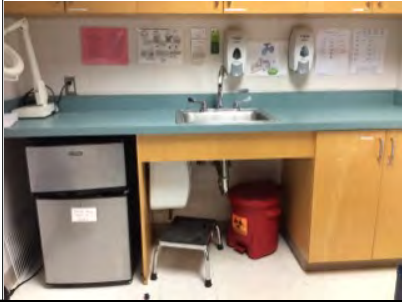
Clear floor space not provided at sink Exposed plumbing underneath sink	- -	Provide a 30" by 48" clear floor space positioned for a forward approach (relocate stored objects). Insulate or otherwise configure pipes at sink.	1	92	\$92
127	Learning Center	1	115	Sink	Other

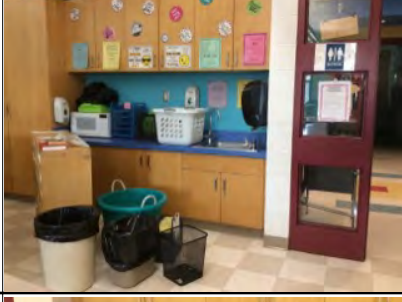
Toe and knee clearances not provided	20.75"	Ensure there is a 27" knee clearance positioned for a forward approach.	1	1686	\$1686
128	Grade 4 Classroom	2	216	Sink	Classroom

Toe and knee clearances not provided	-	Ensure there is a 25" knee clearance positioned for a forward approach.	1	1686	\$1686

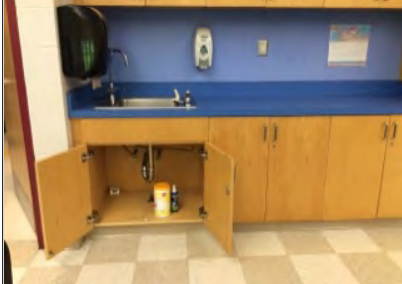
129	Music Room	1	164	Sink	Other

Toe and knee clearances not provided Exposed plumbing underneath sink	- -	Ensure there is a 27" knee clearance positioned for a forward approach. Insulate or otherwise configure pipes at sink.	1	1778	\$1778

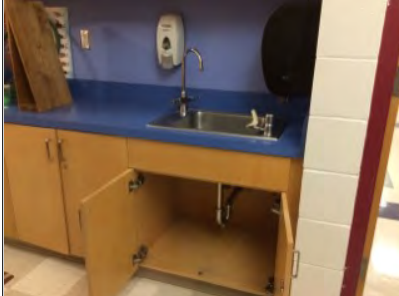
ID	Location	Floor	Room	Element	Type	Photo	Issues	Current Measure	Recommendations	Quantity	Price	Cost Estimation
130	Work Room	1		Sink	Other

Toe and knee clearances not provided Exposed plumbing underneath sink	- -	Ensure there is a 27" knee clearance positioned for a forward approach. Insulate or otherwise configure pipes at sink.	1	1778	\$1778
131	Grade 3 Classroom	2	236	Sink	Classroom

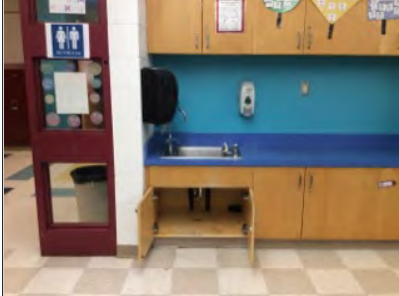
Toe and knee clearances not provided Exposed plumbing underneath sink	21" -	Ensure there is a 27" knee clearance positioned for a forward approach. Insulate or otherwise configure pipes at sink.	1	1778	\$1778
132	Grade 2 Classroom	2	233	Sink	Classroom

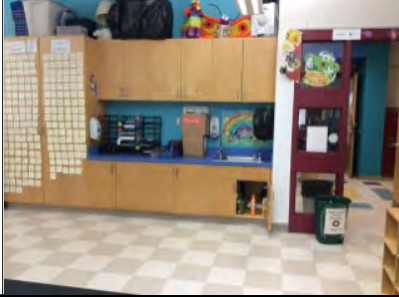
Toe and knee clearances not provided Exposed plumbing underneath sink	- -	Ensure there is a 27" knee clearance positioned for a forward approach. Insulate or otherwise configure pipes at sink.	1	1778	\$1778
133	Cafetorium	1		Sink	Other

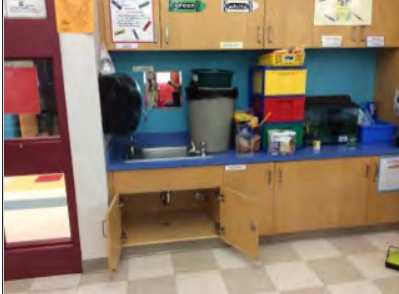
Sinks for Children's Use												
134	Grade 1 Classroom	1	162	Sinks for Children's Use	Classroom

Exposed plumbing underneath Knee or toe clearance not provided	- 20"	Insulate or otherwise configure pipes to prevent contact, for at least one sink. Provide at least one sink with 25" high knee and toe clearance positioned for a forward approach.	1	1778	\$1778

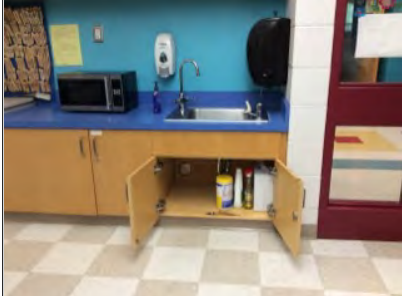
ID	Location	Floor	Room	Element	Type	Photo	Issues	Current Measure	Recommendations	Quantity	Price	Cost Estimation
135	Literacy	1	161	Sinks for Children's Use	Other

Exposed plumbing underneath Knee or toe clearance not provided	- -	Insulate or otherwise configure pipes to prevent contact, for at least one sink. Provide at least one sink with 25" high knee and toe clearance positioned for a forward approach.	1	1778	\$1778
136	Special Education	1	159	Sinks for Children's Use	Classroom

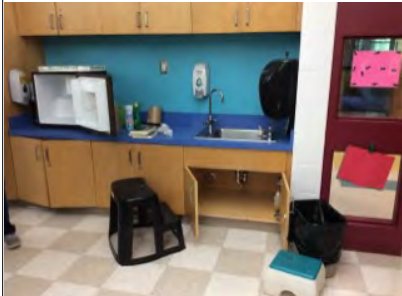
Exposed plumbing underneath Knee or toe clearance not provided	- -	Insulate or otherwise configure pipes to prevent contact, for at least one sink. Provide at least one sink with 25" high knee and toe clearance positioned for a forward approach.	1	1778	\$1778
137	Kindergarten	1	135	Sinks for Children's Use	Classroom

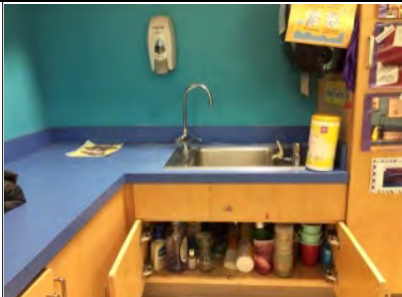
Exposed plumbing underneath Knee or toe clearance not provided	- -	Insulate or otherwise configure pipes to prevent contact, for at least one sink. Provide at least one sink with 25" high knee and toe clearance positioned for a forward approach.	1	1778	\$1778

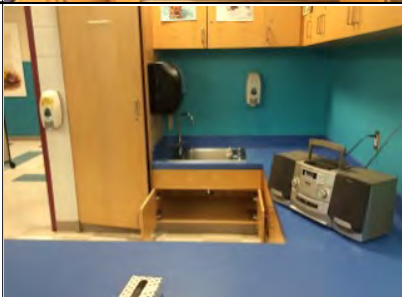
138	Spanish	1	133	Sinks for Children's Use	Classroom

Exposed plumbing underneath Knee or toe clearance not provided	- -	Insulate or otherwise configure pipes to prevent contact, for at least one sink. Provide at least one sink with 25" high knee and toe clearance positioned for a forward approach.	1	1778	\$1778
139	Grade 5 Classroom	2	220	Sinks for Children's Use	Classroom

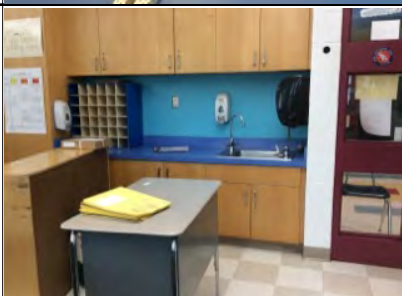
Knee or toe clearance not provided	-	Provide at least one sink with 25" high knee and toe clearance positioned for a forward approach.	1	1686	\$1686

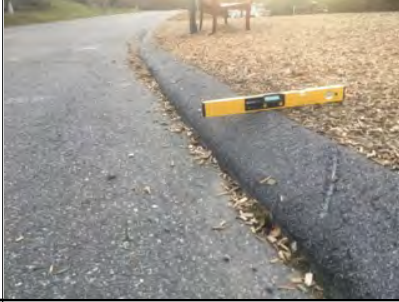
ID	Location	Floor	Room	Element	Type	Photo	Issues	Current Measure	Recommendations	Quantity	Price	Cost Estimation
Play Areas												
140	Entry - Lower Playground Border at Street	Ext.		Play Areas	N/A

Accessible route not provided to playground	-	Install an accessible route to the playground. Reduce change in level at the playground border to 1/2" max. beveled for a width of 4' wide min. Note: Costs are not included in this catalog because IHCD has been told that Sudbury has budgeted for a new compliant lower playground.	1	-	\$0
141	Route Between Upper and Lower Outdoor Amenities	Ext.		Play Areas	N/A

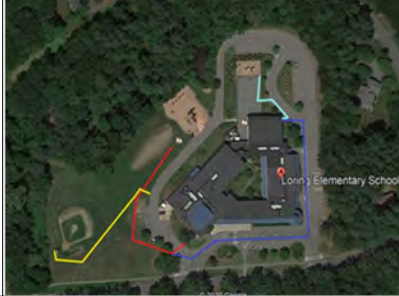
Accessible route not provided to playground	-	Note: An accessible route is not provided from the school basketball court and upper playground to the lower playground area. See Figure 1 in the report narrative for details regarding the provision of an accessible route between outdoor amenities.	1	-	\$0

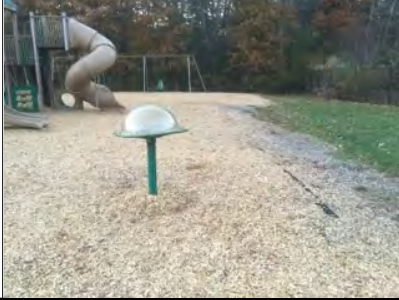
142	Lower Playground	Ext.		Play Areas	N/A

Accessible route not provided around playground	-	Provide an accessible route around the play area. Note: Costs are not included in this catalog for an accessible route around the lower playground because IHCD has been told that Sudbury has budgeted for a new compliant lower playground.	1	-	\$0
143	Upper Playground	Ext.		Play Areas	N/A

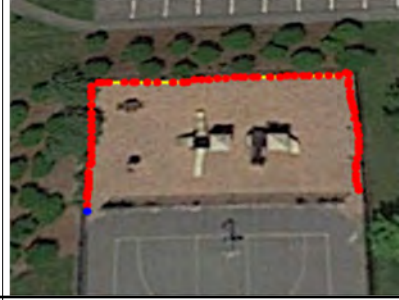
Accessible route not provided around playground	-	Provide an accessible route around the play area. (Cost estimate for a 4' wide min. by 150' stone dust path around the perimeter sides of the playground not bordered by the fence.)	1	4800	\$4800
144	Upper Playground	Ext.		Play Areas	N/A

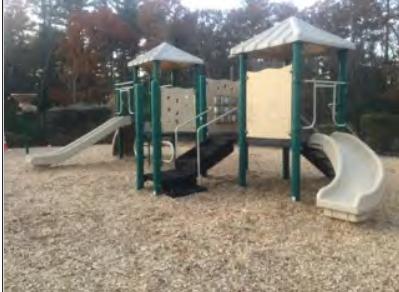
Accessible route not provided to play components	-	Provide a compliant impact-attenuating surface to and around the play components. (Cost estimate for 1,200 sq. ft. of poured-in-place rubber surface.)	1	16800	\$16800

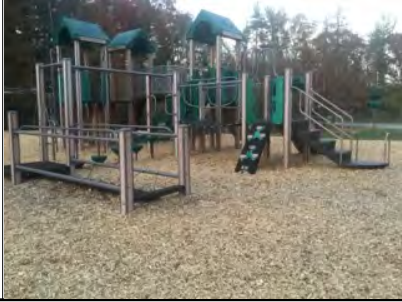
ID	Location	Floor	Room	Element	Type	Photo	Issues	Current Measure	Recommendations	Quantity	Price	Cost Estimation
145	Lower Playground	Ext.		Play Areas	N/A

Accessible route not provided to play components	-	Provide a compliant impact-attenuating surface to and around the play components. (Cost estimate for 1500 sq. ft. of poured-in-place rubber surface.) Note: Costs for this remedy are not included in this catalog because IHCD has been told that Sudbury has budgeted for a new compliant lower playground.	1	-	\$0
Field												
146	Baseball Field	Ext.		Field	Baseball

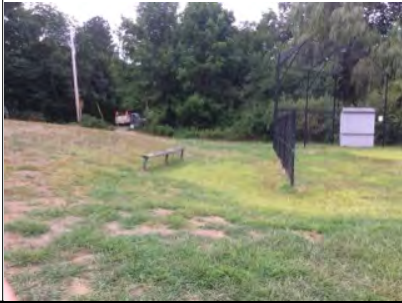
Accessible spaces not provided at team seating Field not connected to an accessible route	- -	Provide a 36" x 48" clear floor space at team seating. Provide an accessible route to the field. (Cost estimate for a 4' wide min. x 240' long stone dust path providing an accessible route to the boundary of sport activity at the baseball field and connecting to the team seating.)	1	7680	\$7680

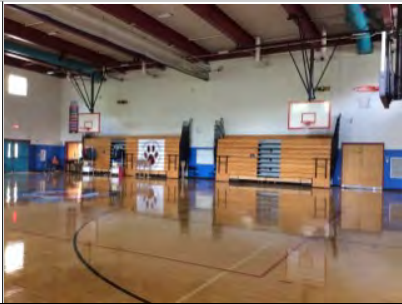
Court												
147	Gymnasium	1	154	Court	Basketball

Accessible spaces are not provided at sidelines seating	-	Provide a 36" x 48" clear floor space at sidelines seating. Number of accessible seats required is based on the total number of bleacher seats. See the 2010 ADA Standards for Accessible Design Table 221.2.1.	1	-	\$0
Best Practice												
Bench												
148	Courtyard	Ext.		Bench	N/A

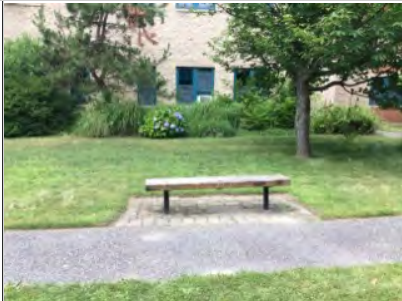
Recommend providing a 36"x48" stable, firm and slip resistant surface at the end of at least one bench in this area so someone using a wheeled mobility device can sit at the end of the bench with shoulder alignment with someone seated on the bench. Suggest asphalt or stone dust as the surface.	1	-	\$0

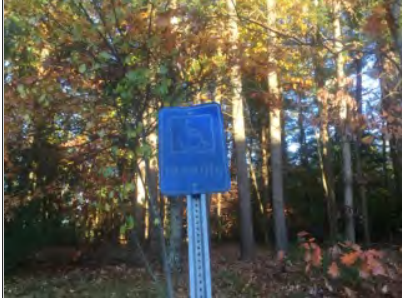
ID	Location	Floor	Room	Element	Type	Photo	Issues	Current Measure	Recommendations	Quantity	Price	Cost Estimation
Sign with International Symbol of Accessibility (ISA)												
149	Accessible Parking Opposite Exit 11 and 10	Ext.		Sign with International Symbol of Accessibility (ISA)	N/A

Recommend replacing or repainting the signs with the International Symbol of Accessibility to increase contrast between text and symbols and background and improve legibility of accessible parking signs.	2	-	\$0

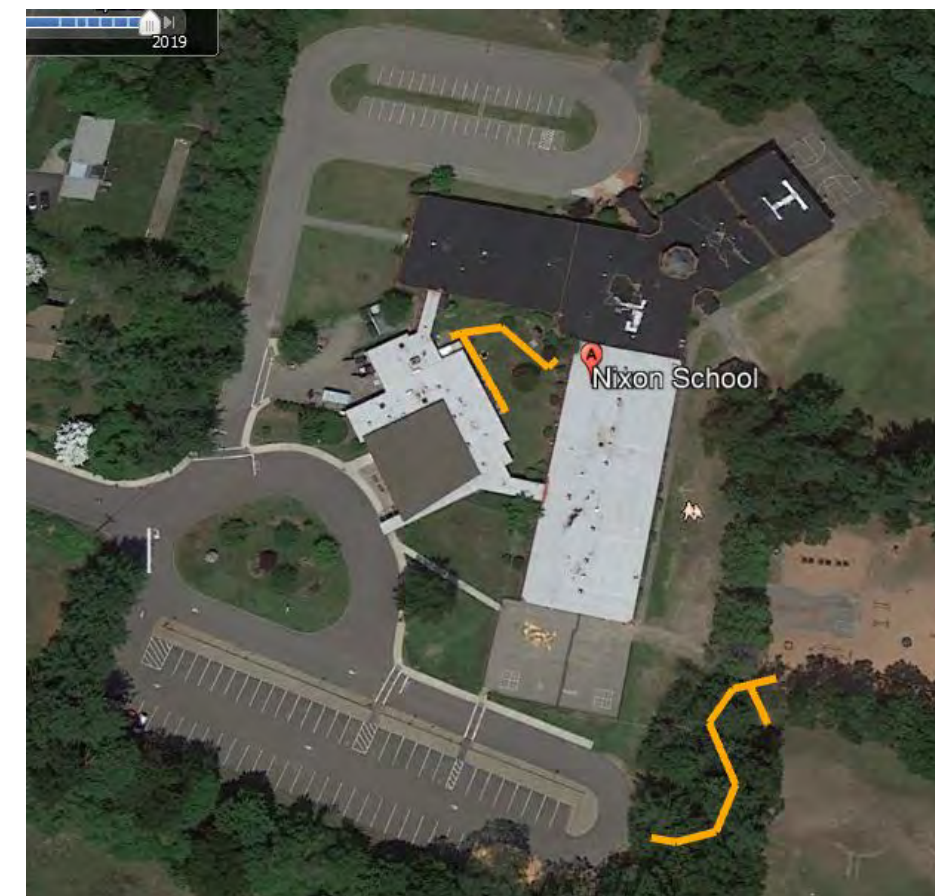
Figure 1: In the following image, orange lines show recommended stone dust routes in the courtyard, to the soccer field and between the playground and front parking lot:

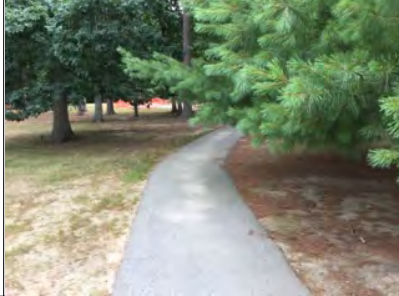
ID	Location	Floor	Room	Element	Type	Photo	Issues	Current Measure	Recommendations	Quantity	Price	Cost Estimation
Approach and Entrance												
Exterior Access Route												
1	Path to Basketball Court From Back Entrance	Ext.		Exterior Access Route	Walkway

Obstructed by protruding objects	-	Trim low hanging branches in trees.	1	200	\$200
2	Back Road From Playground to Front Parking	Ext.		Exterior Access Route	Walkway

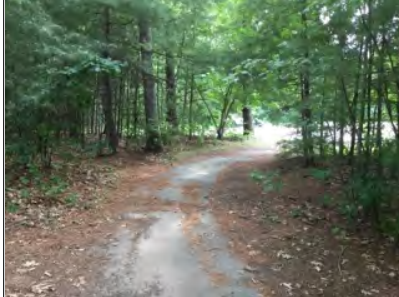
Surface openings > 1/2" Level changes > 1/4" Surface is not stable, firm, and slip-resistant	1" -	Alter change in level to be 1/4" high max. Repair surface. (Cost estimate for a 188' long, 4' wide stone dust route.)	1	6016	\$6016
3	Path to Basketball Court From Back Entrance	Ext.		Exterior Access Route	Exterior

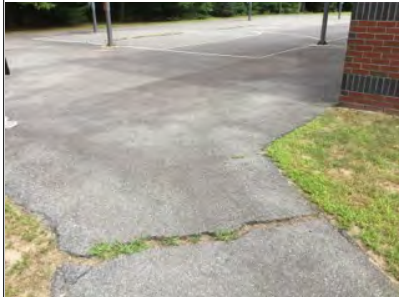
Surface openings > 1/2" Route not maintained in operable working condition	2"	Repair asphalt so that openings are 1/2" max. Ensure the accessible route is maintained in operable working condition. (Cost estimate for 6' long by 4' wide area of asphalt.)	1	240	\$240
